# Supporting Report Appendix G Preliminary Design of Structural Measures for Flood Mitigation

#### PREPARATORY SURVEY FOR FLOOD RISK MANAGEMENT PROJECT FOR CAGAYAN DE ORO RIVER (FRIMP-CDOR) IN THE REPUBLIC OF THE PHILIPPINES

# FINAL REPORT

# Appendix G PRELIMINARY DESIGN OF STRUCTURAL MEASURES FOR FLOOD MITIGATION

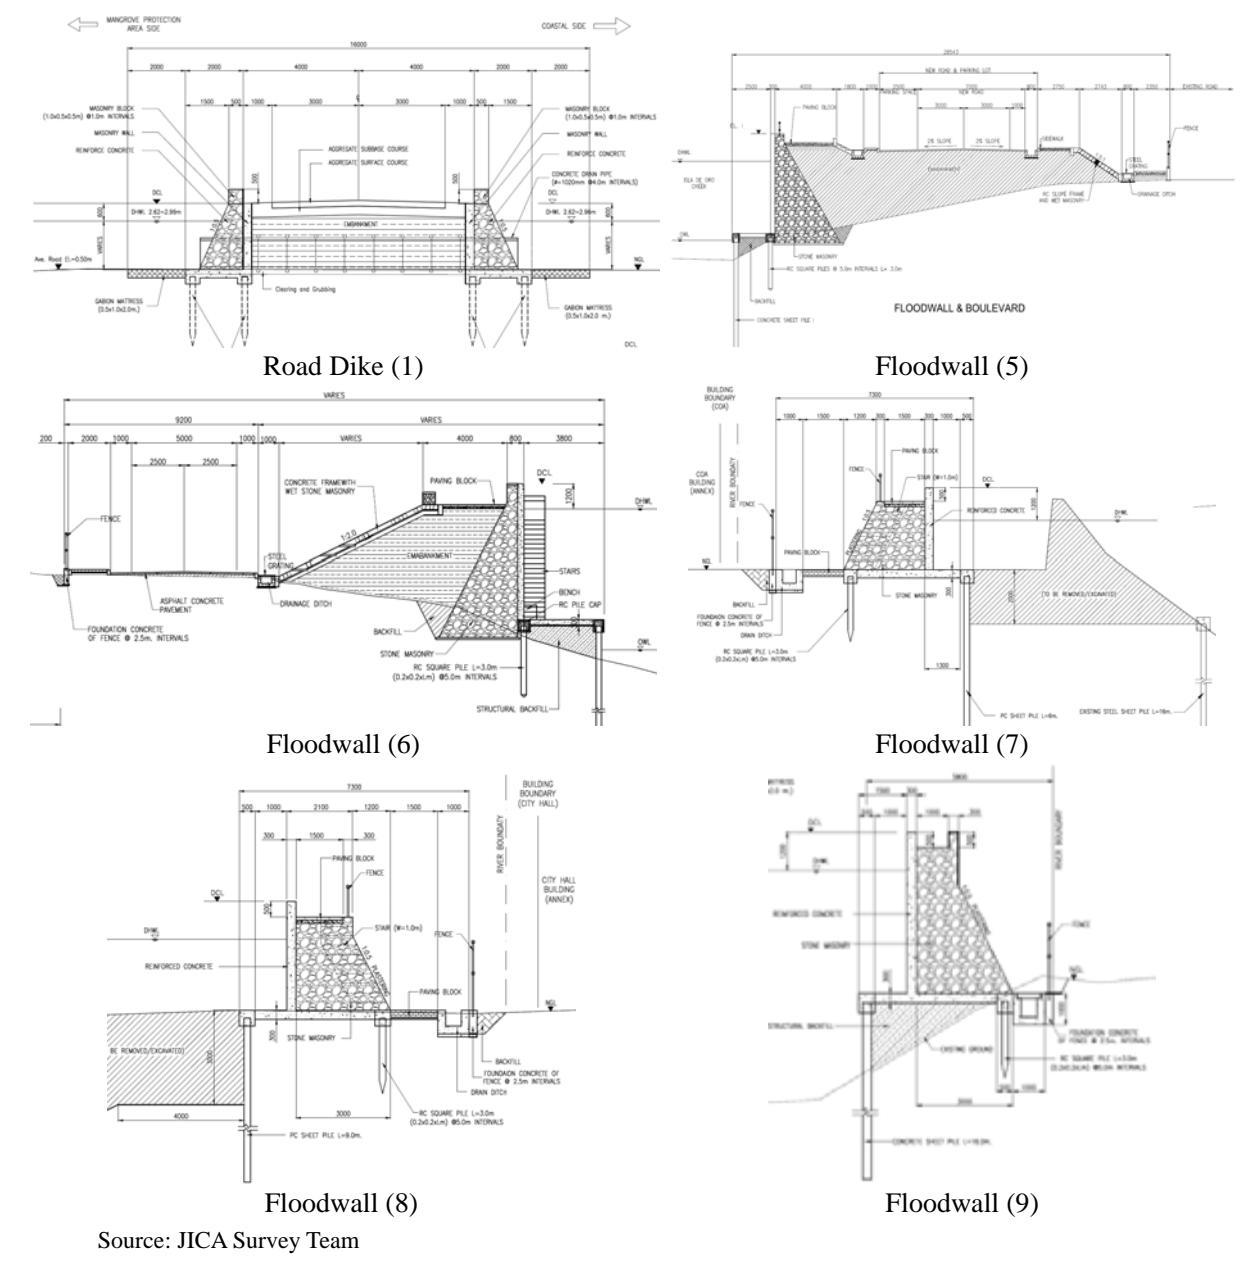
Figure 1.1.3 Designs of Concrete Floodwall

Basic designs of the Concrete Floodwall are prepared as shown below

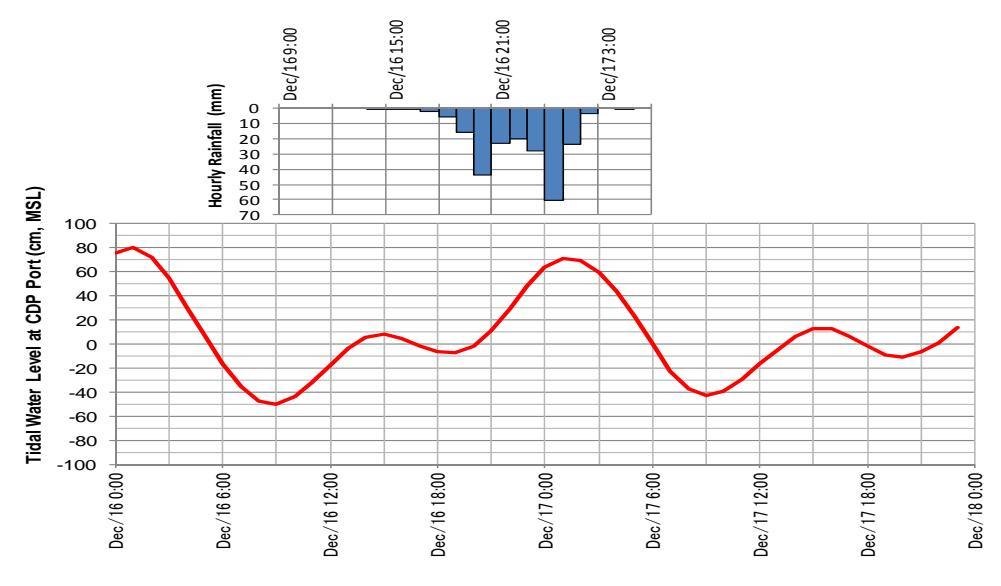
#### Figure 1.6.5 Observed Tide Level in Macajalar Bay during Sendong

The observed tide level at Macajaral Bay during Sendong taken by NAMRIA together with the hourly rainfall record at Talakag is presented in figure below. At the time of peak rainfall on Dec.17 1:00 a.m, the tide level was at daily peak of 0.71 m above MSL. No tidal surge was observed at this station.

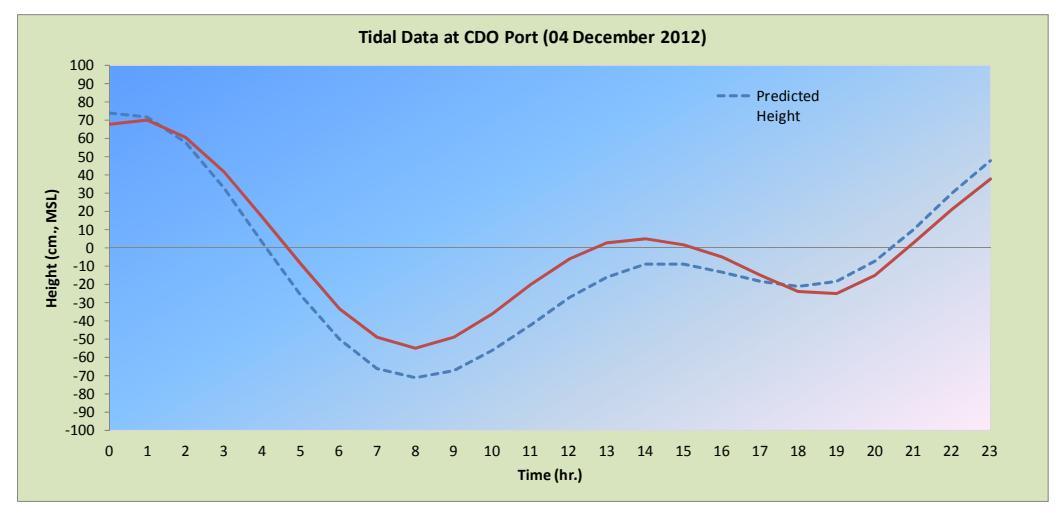
Observed tide level and the astronomical tide data during TY Pablo in December 4, 2012 is presented figure below. From 1:00 to 17:00, the observed tide level is higher than the astronomical one. The maximum variance of +22 cm was recorded on 10:00. Comparing with the discharge hydrograph at Cabla Bridge, the peak flood was recorded on 15:00, but no tidal surge was observed in this period.

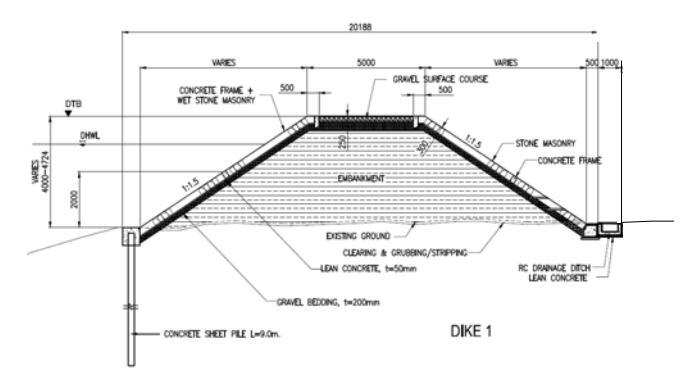
Earth Dike-1: Designed slope of 1:1.5 covered with concrete slope protection and sheet pile foundation for the areas with limited land. Required length of sheet pile is applied to avoid seepage failure and lateral slide of soil.

Earth Dike-1 (Case of Flood Plain Area Width: less than 10m) Source: JICA Survey Team

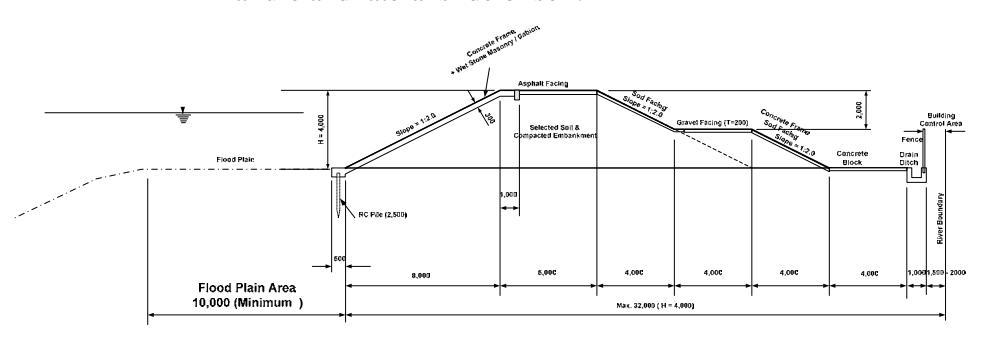
Earth Dike-2: Designed slope of 1:2.0 without sheet pile foundation for the areas with sufficient land space. Sufficient seepage length (width of dike) and sufficient width of flood plain are designed to avoid seepage failure and lateral slide of soil.

Earth Dike-2 (Case of Flood Plain Area Width: more than 10m)

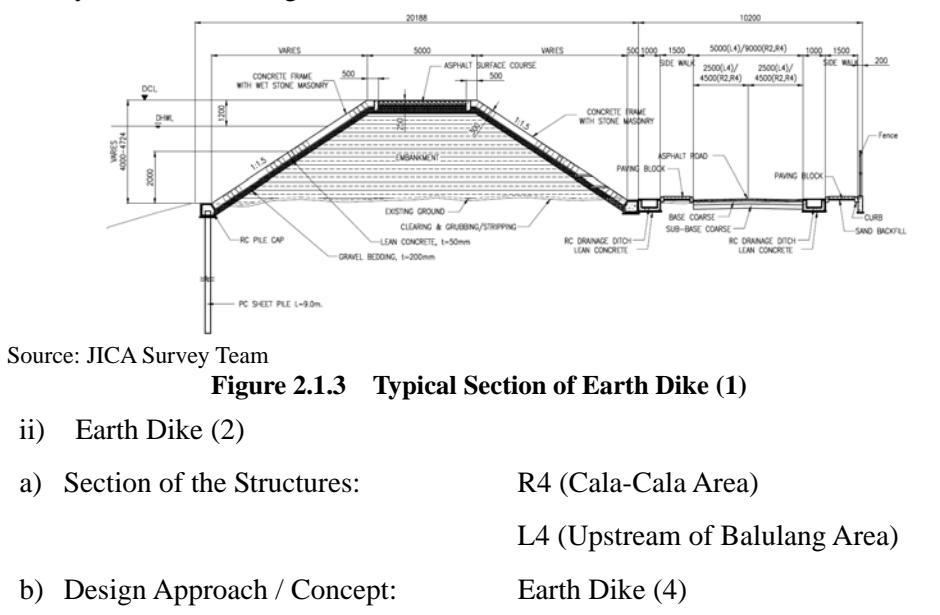
Earth Dike (1) is designed as shown below Figure 2.1.3, in which asphalt road (width=5 to 9 m) will be provided for operation and maintenance on the earth dike, public traffic uses at normal time and evacuation during natural disaster such as heavy rain and flooding.

Slope of the Earth Dike at river side shall be provided with concrete frame wet stone masonry, and sod facing or riprap shall be provided on the land side slopes. The following designs are made against slope failure and erosion / scouring the earth dike and structural foundation.

- Each slope of the dike face shall be 1:2.0,
- Reinforced Concrete Square Pile (depth L= 3.0m) should be installed at foundation of concrete of the concrete fame on the slope in the river side,
- Concrete cutoff wall (depth more than L= 1.0m) or sheet pile should be provided to prevent sliding on the dike slope or foundation, and
- Foundation of dike or low water channel should be protected with gabion matters and revetment / footing against erosion/scouring.

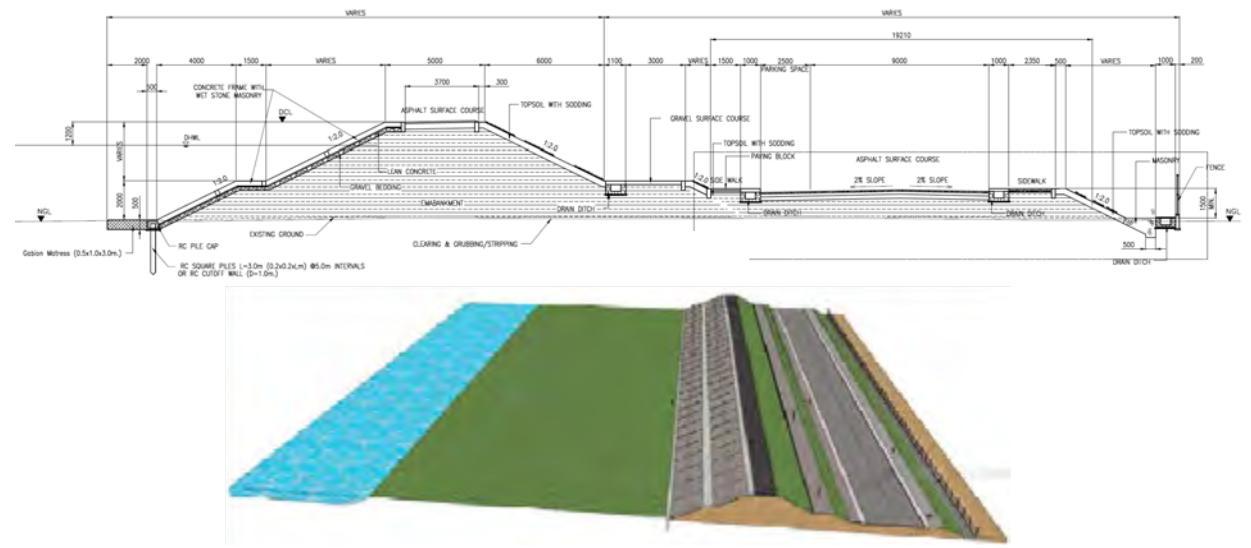
Suitable width of road and side drain ditch will be provided at toe of the dike slope on the land side for the operation and maintenance of the dike. In addition, Boulevard road (2-lane highway road: width = 10.5m) is designed at toe of the dike for not only operation & maintenance on the dike but also public traffic use at all the time of normal and disaster conditions as shown in the following, Figure 2.1.4 including 3-D image.

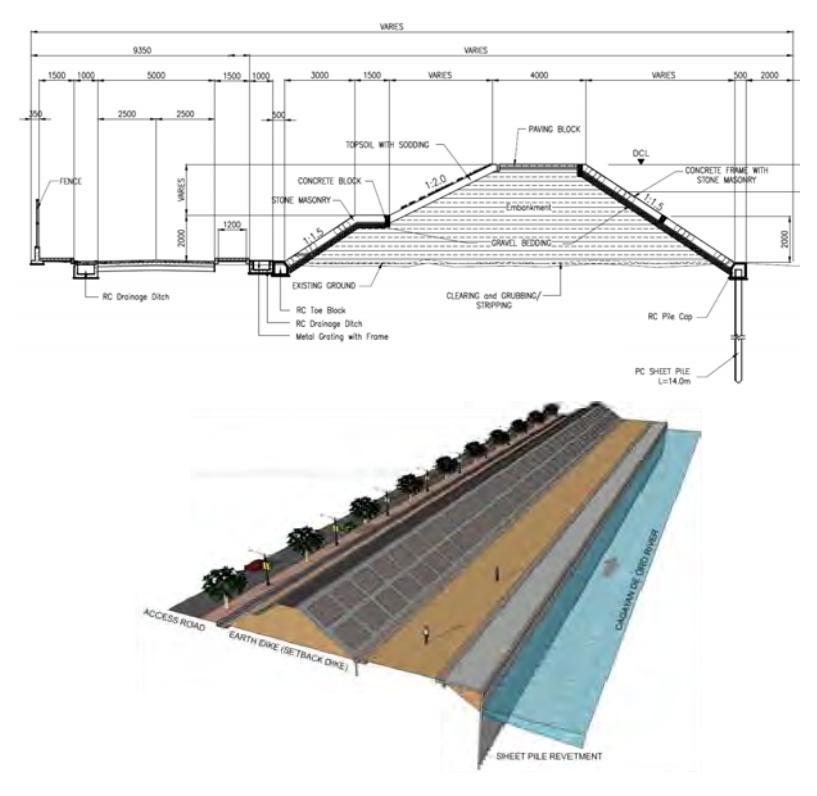
Typical section of the Earth Dike (3) constructed at  $2^{nd}$  stage construction work is designed as shown in below, Figure 2.1.6. Sheet pile (depth L= 14.0m) should be designed at toe of the dike in the river side against dike and foundation sliding based geological condition of the site.

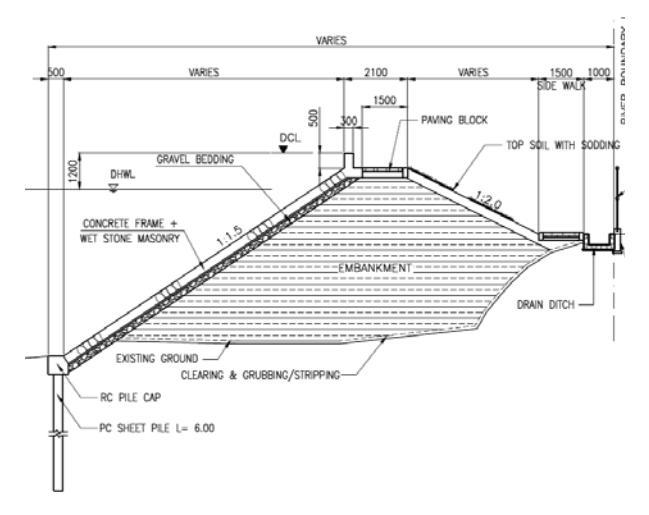
Earth Dike (4) is provided along the river bank immediate upstream of the St. Augustine Cathedral following the river boundary. Concrete frame with stone masonry slope protection (slope= 1:1.5) and sheet pile foundation (depth L=6.0m) is required in the river side for stability of the earth embankment. Typical section of the Earth Dike (4) is shown in Figure 2.1.7 as below.

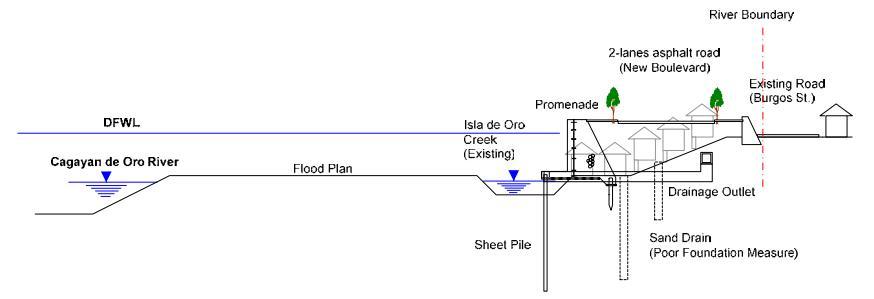
Design of Alternative-2 (Floodwall) has been selected as structural measures in this section in a hydraulic view point, which are designed subject to provision of Boulevard (2-lanes asphalt road) as shown in Figure 2.1.11.

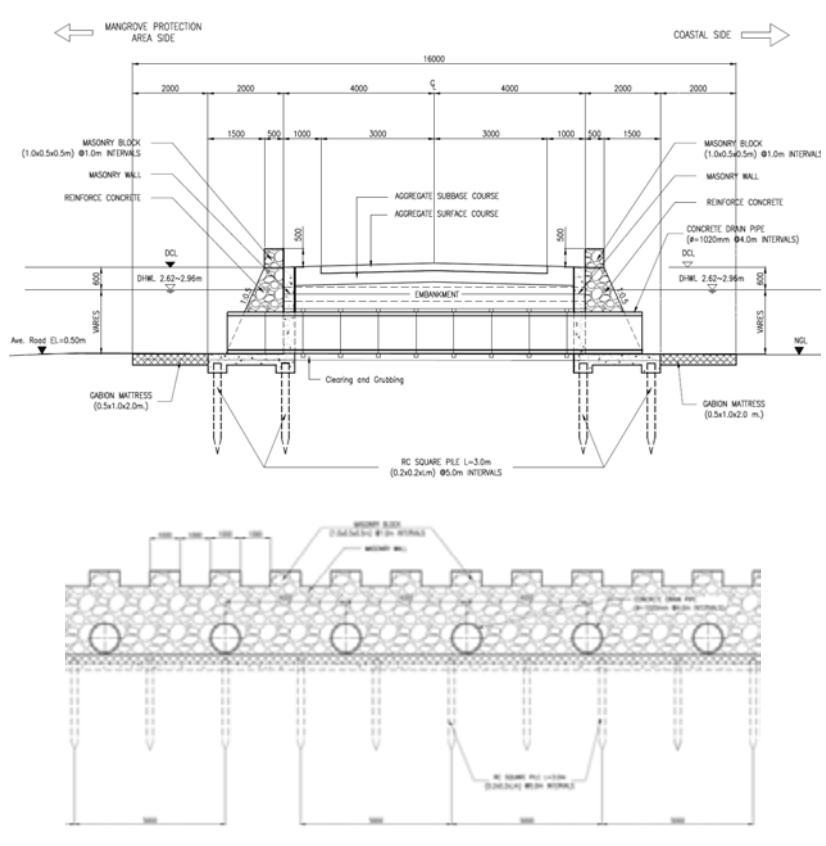
Road Dike (1) is designed as shown in Figures 2.2.2, in which concrete floodwall will be provided at both sides of embankment of road dike with installation of concrete square pile into foundation and cross drainage pipe (dia.=1.0m) to flow flood or tidal water.

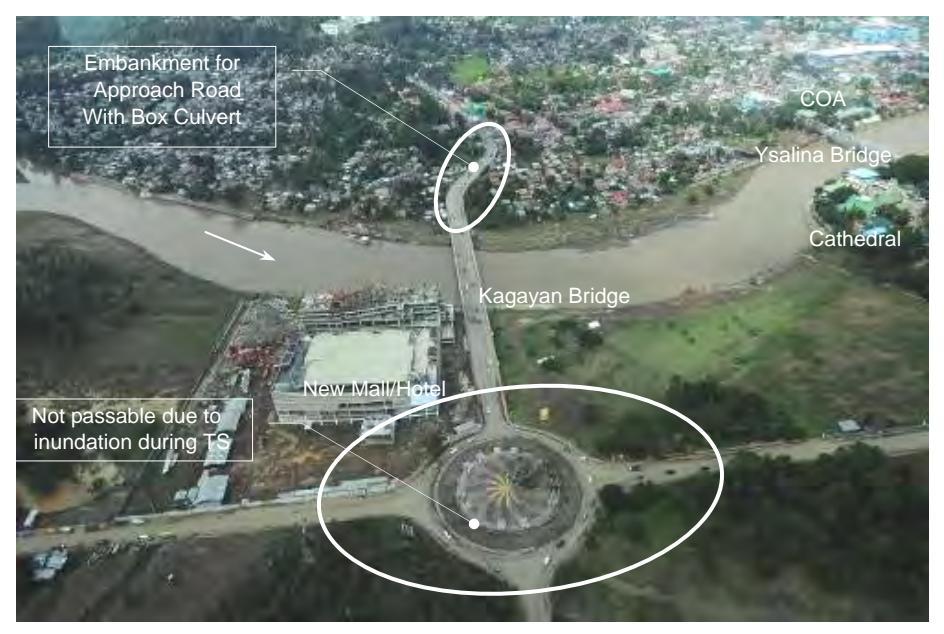
The photograph in Figure 2.3.1 shows the situation of flood damage in the downstream of the box culvert under the left approach road after TS Sendong. At that time of TS Sendon, flood water had passed through the culvert, and the houses/buildings in the downstream of the culvert were seriously damaged due to flood flow with high velocity.

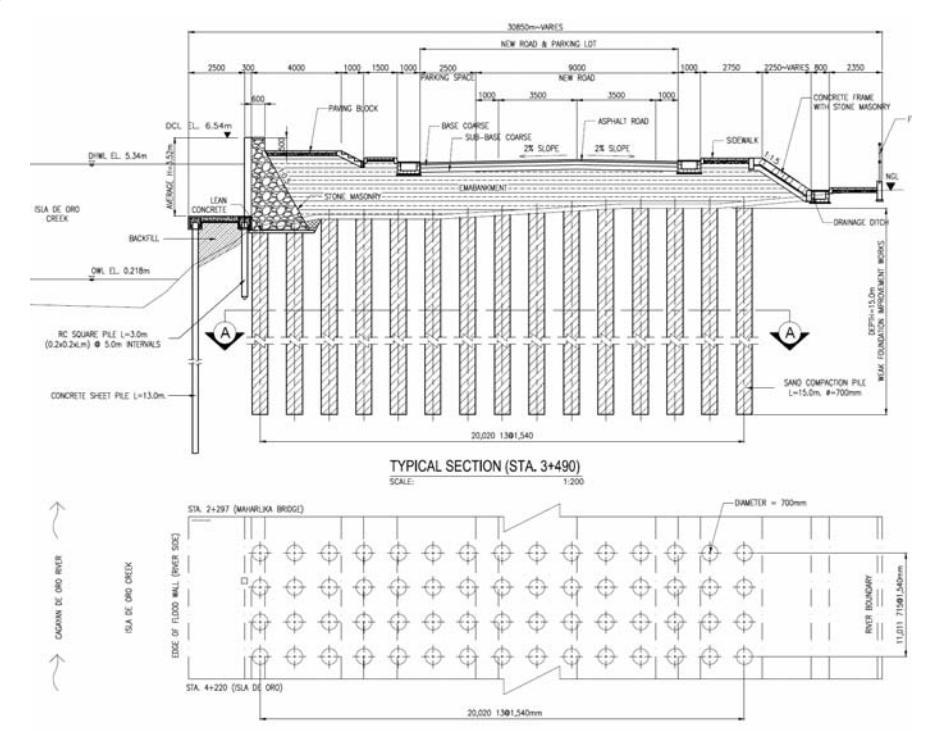
Mixing (CDM) Method. Design of structural measures of Alternative -2 and Weak foundation improvement works for loose sand / sandy soil foundation at this section is designed as shown in below.

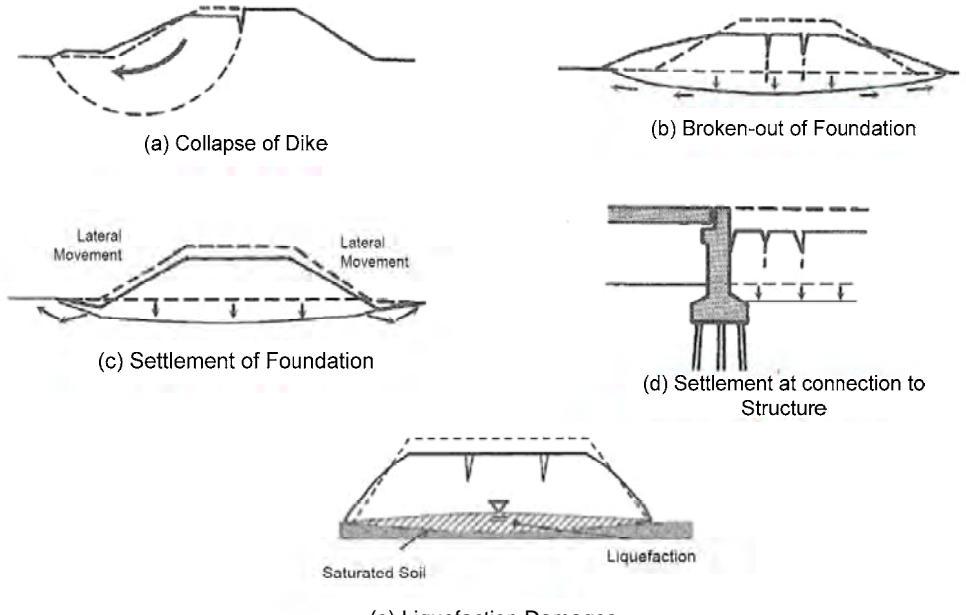
- (a) Collapse of Dike
- (b) Broken-out of foundation
- (c) Settlement of foundation
- (d) Settlement at connection to structure (Bridge abutment)
- (e) Liquefaction damages

(e) Liquefaction Damages

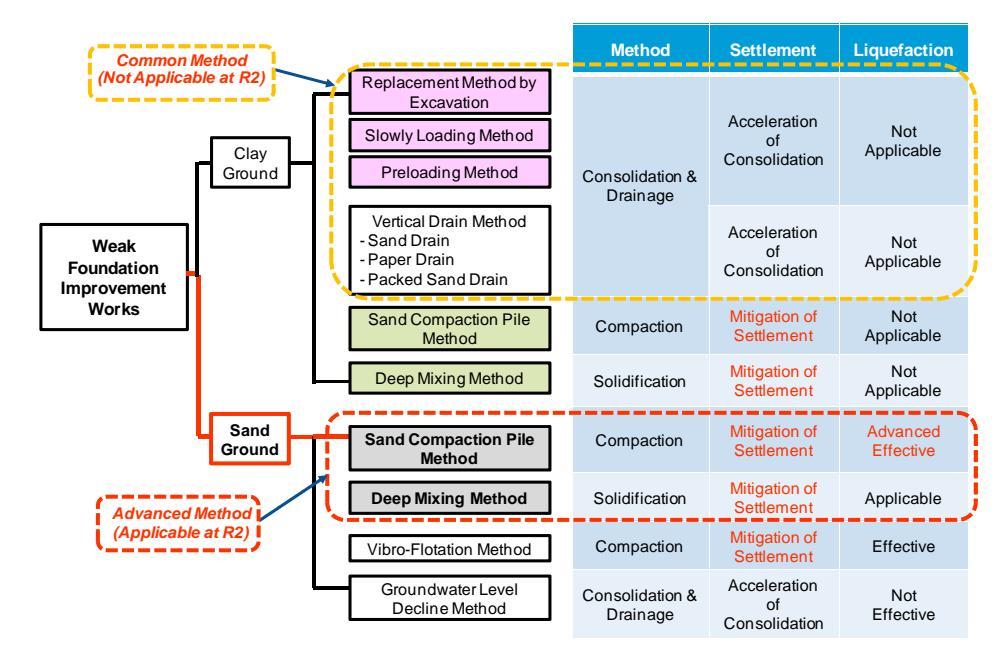
Based on geological condition dominated by sand and sandy silt, Sand Compaction Piling Work (SCP) and Cement Deep mixing Work (CDM) are selected as applicable weak foundation improvement works for R2 site in technical view point as shown in Figure 3.1.2. Common foundation improvement works such as Pre-loading and Vertical drainage methods are not suitable against settlement and liquefaction damages in this section.

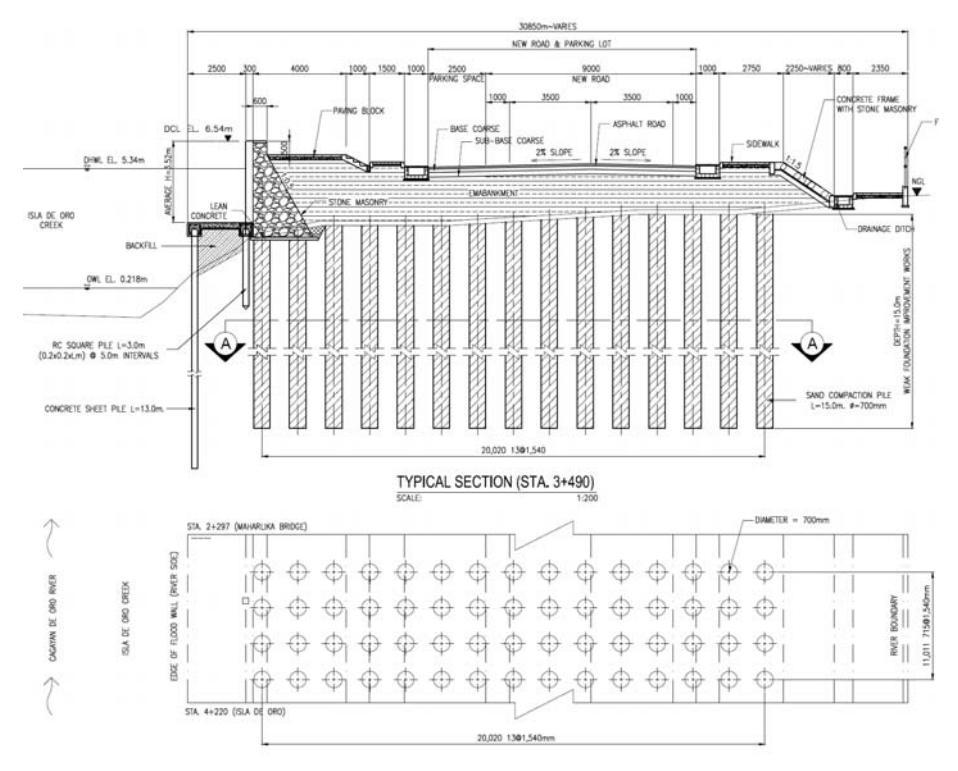
## Figure 3.2.2 Typical Design of Floodwall with Boulevard and Sand Compaction Pile (SCP) in R2 section

Typical section and plan of structural measure (Floodwall and Embanked Road) and weak foundation improvement works at Sta. 2+980 - 4+220 is shown in below, Figure 3.2.2.

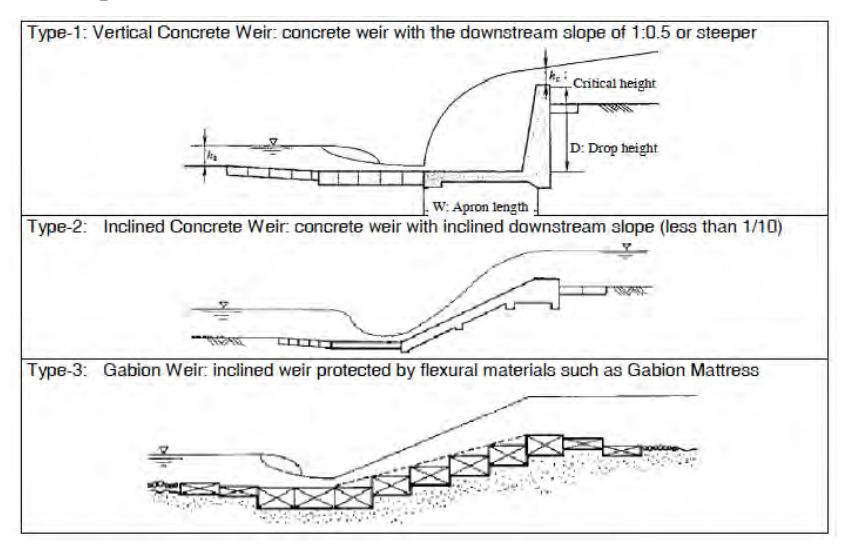
Figure 3.2.3 Type of Spillway of Retarding Basin

Type of the spillway is selected to be Type-1 shown in Figurer 3.2.3 in technical and economical view points.

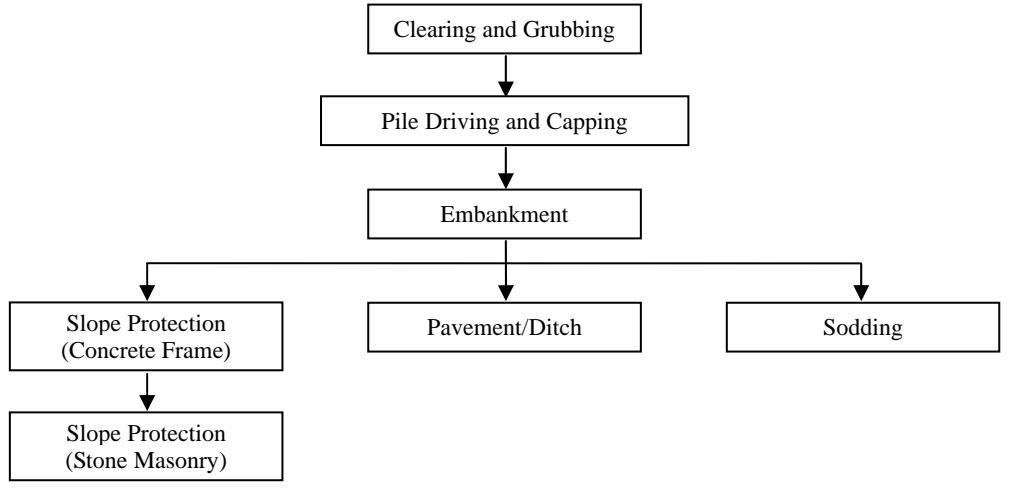
Flow of construction of the dike is shown in Figure 1.4.2.

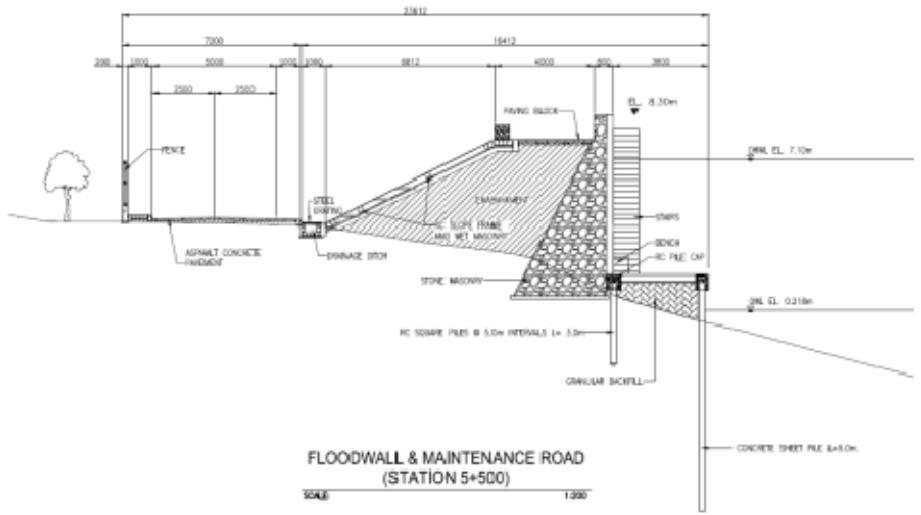
Flood wall consists of pile foundation, concrete retaining wall, stone masonry, embankment, road pavement, sodding and pedestrian. Standard cross section of the flood wall is presented in Figure 1.4.3.

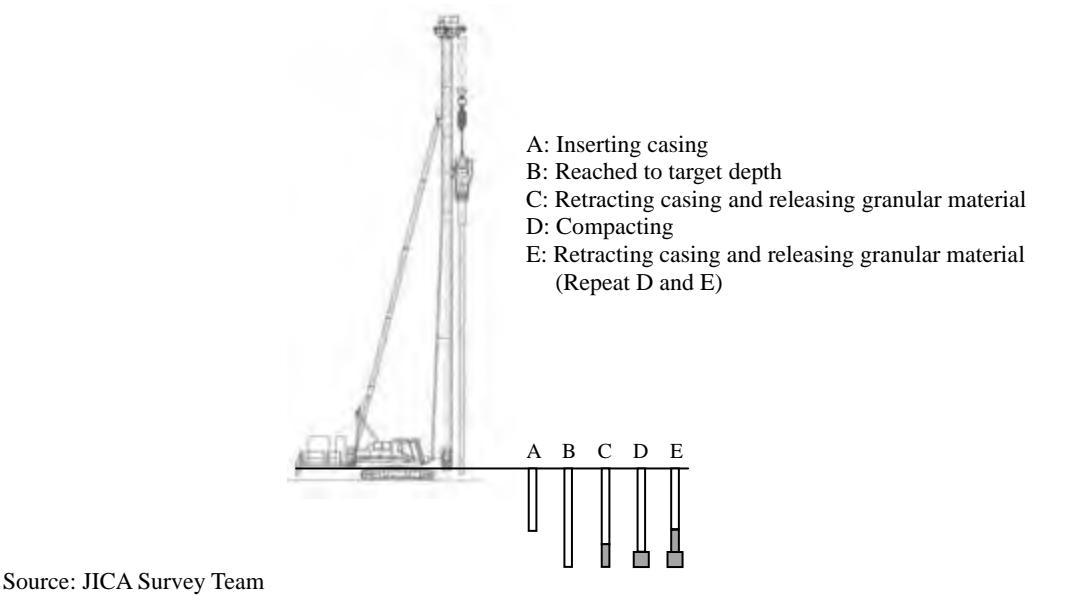
Figure 1.4.7 Procedure of Sand Compaction Pile Method

Weak foundation area spreads and was found at R2 section, Isla de Oro and Isla Delta areas. Considering the technical, environment and economic view points, the sand compaction pile method is proposed for the weak foundation improvement measures. Initially, casing pipe is installed into the ground with vibrohammer, charging the casing and hopper filled with specified sand materials. Secondary, after being lowered to the desired depth, the casing is retracted in a designed distance such as fifty centimeters (50cm) as the sand materials are released from the tip of casing. Then it was compacted to the desired strength filling sand materials into the pile. The second procedure is repeated until the optimal densification is achieved for the target layer of the foundation.
