Preparatory Survey  
for Ganga Rejuvenation Project  
(Varanasi)

Water Quality Examination

March 2017

**Sai International Sansthan**

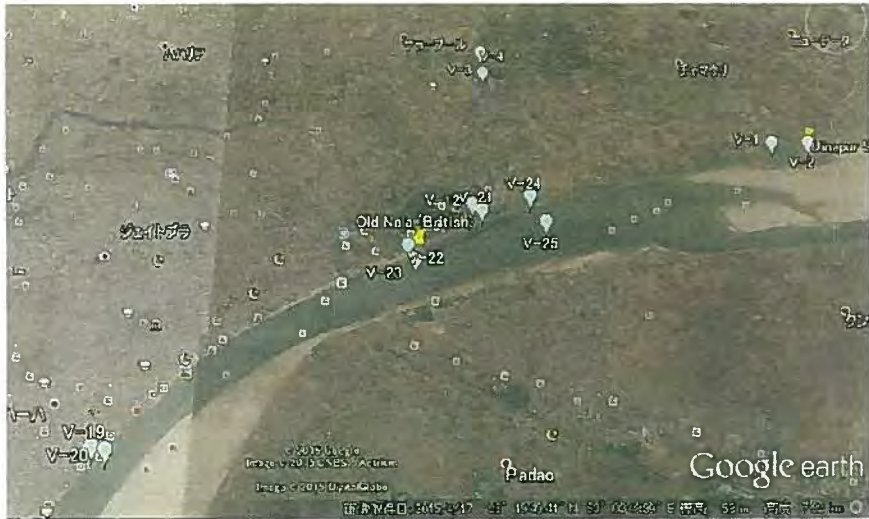
Photo 1.1 Dashashwamegh Ghat, Varuna River Mouth and Dinapur STP & Outfall

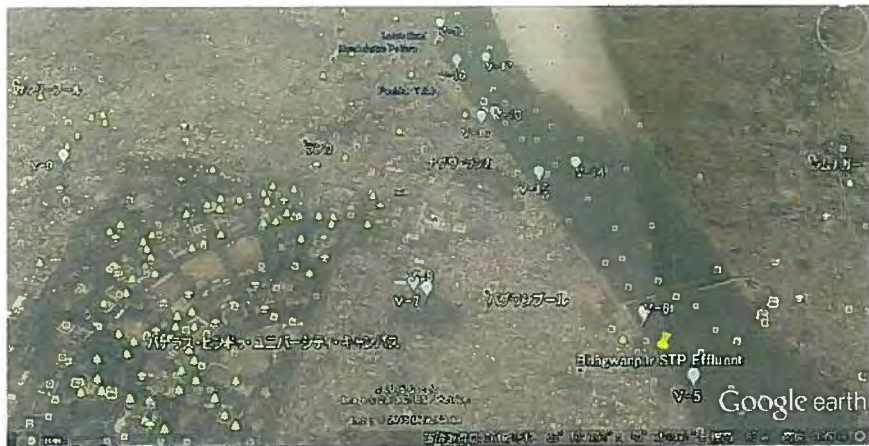
Photo 1.2 Bhagwanpur STP & Outfall, Assi Nara U/S & Mouth and Intake Tower

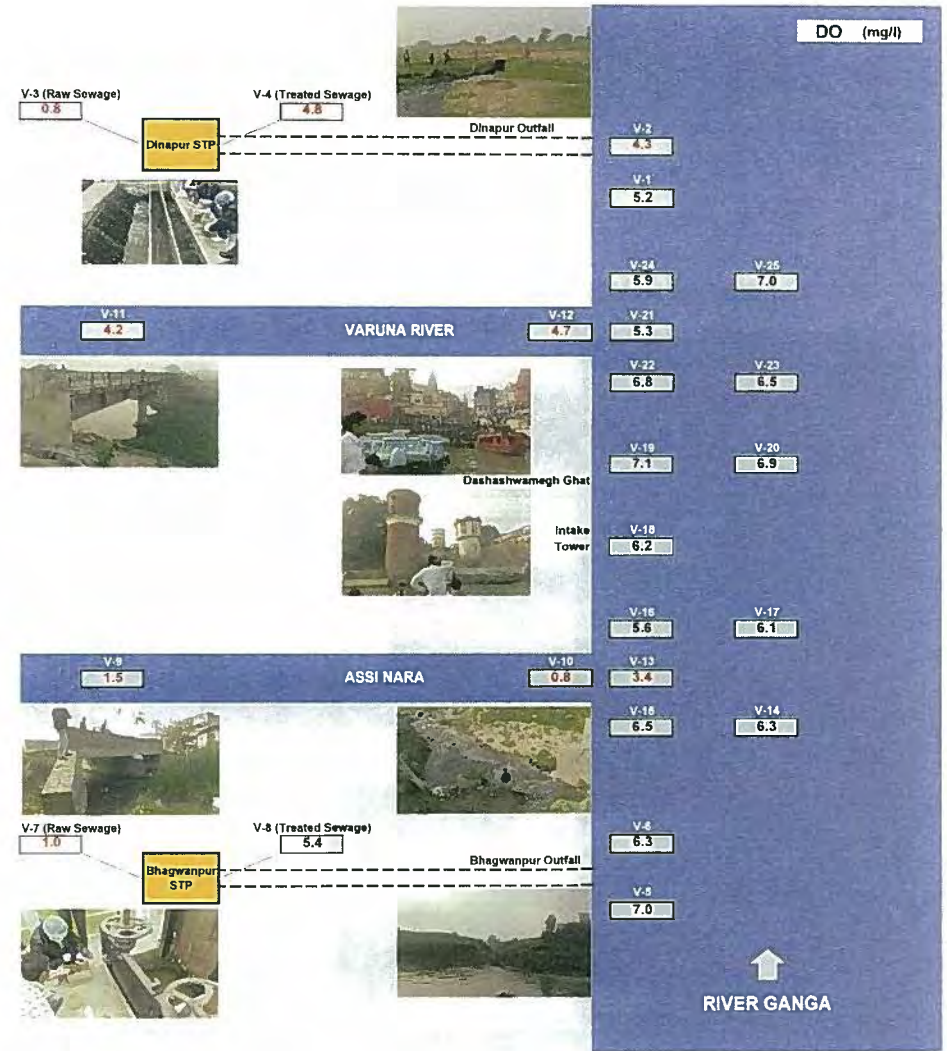
Figure 3.1 Results of First Water Quality Examination (DO) (Sampled on December 8-9, 2015)

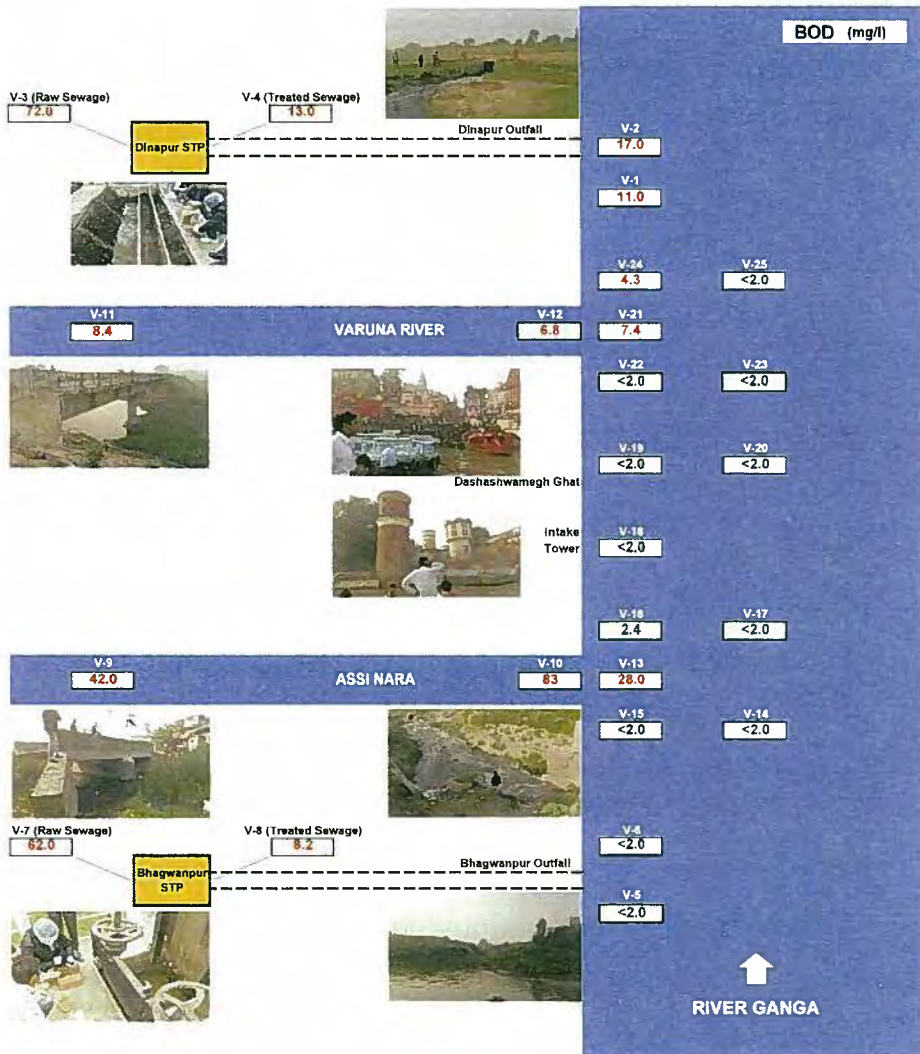
Figure 3.2 Results of First Water Quality Examination (BOD) (Sampled on December 8-9, 2015)

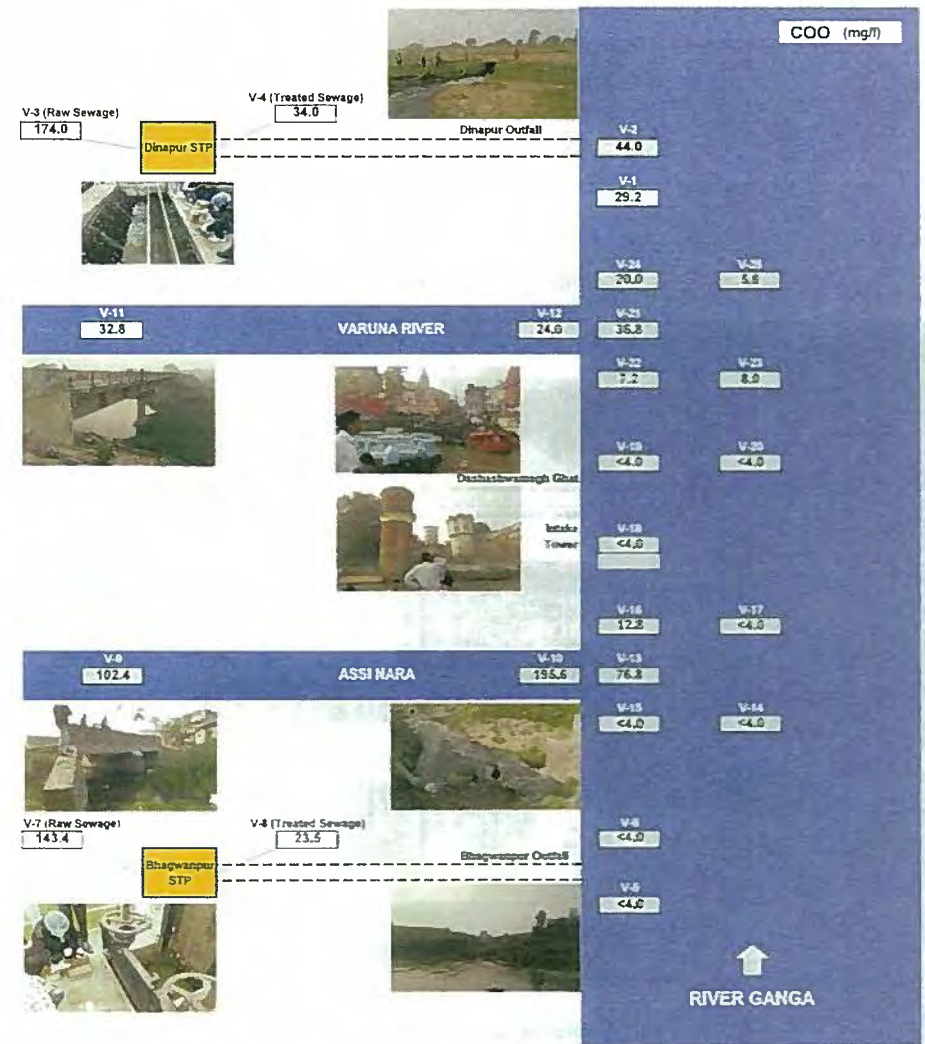
Figure 3.3 Results of First Water Quality Examination (COD) (Sampled on December 8-9, 2015)

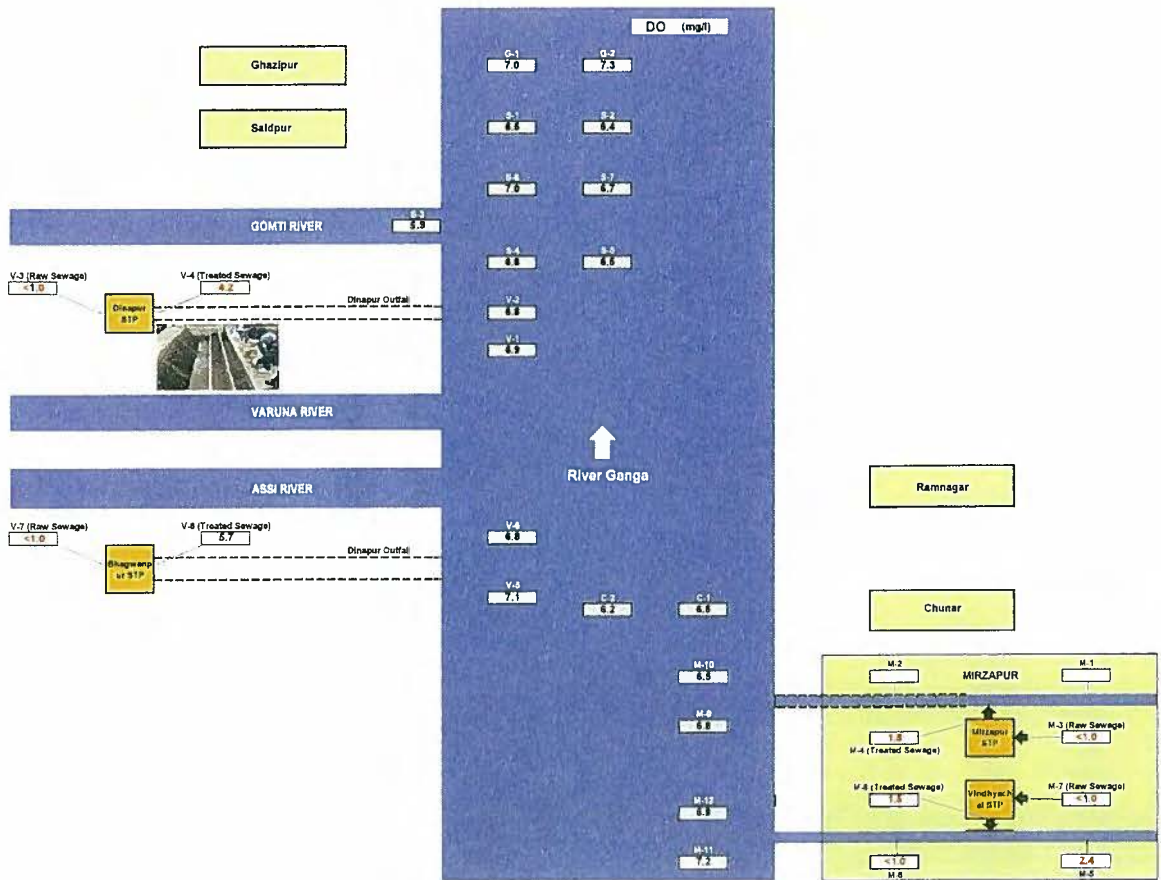
Figure 4.1 Results of Second Water Quality Examination (DO) (Sampled on March 26-28, 2016)

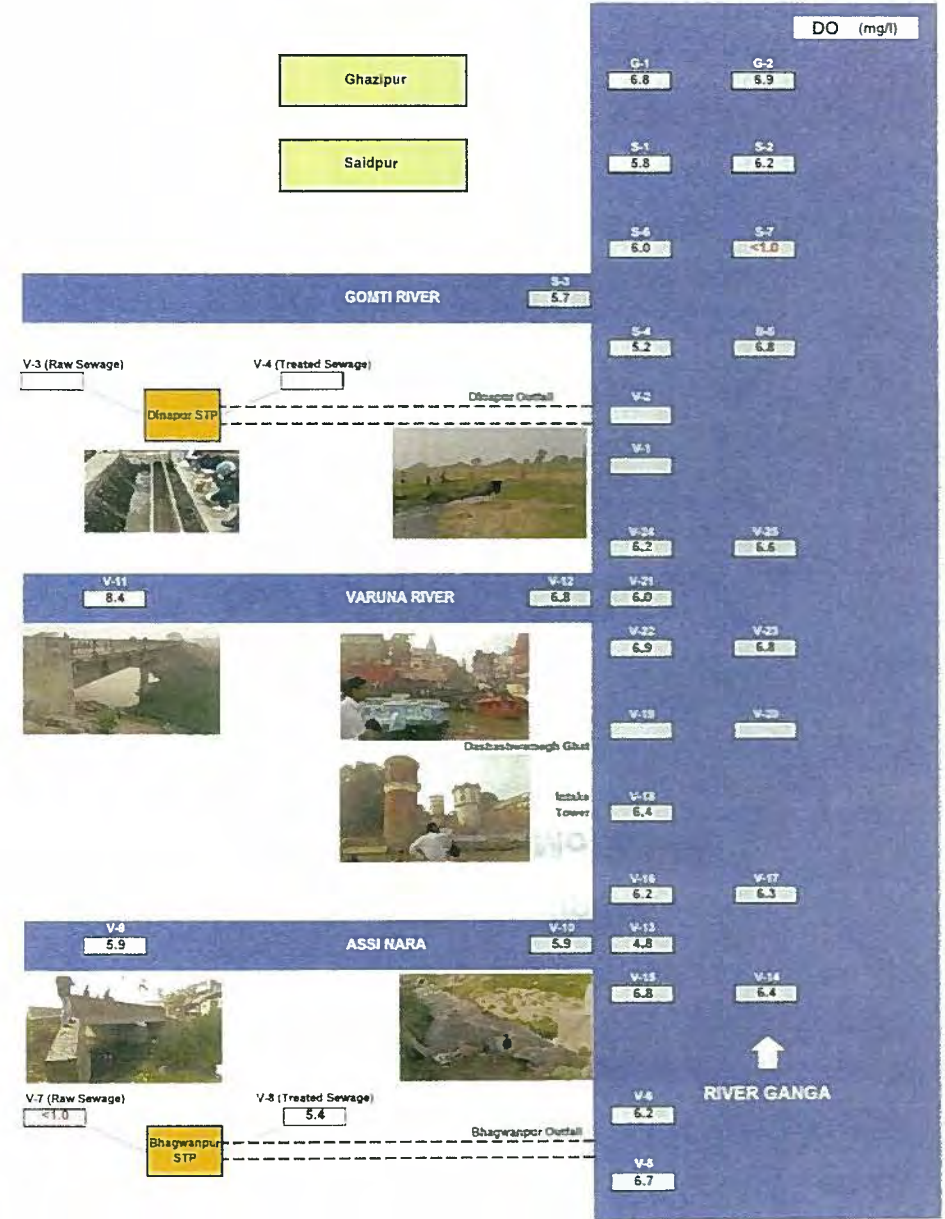
Figure 5.1 Results of Third Water Quality Examination (DO) (Sampled on July 18-20, 2016)

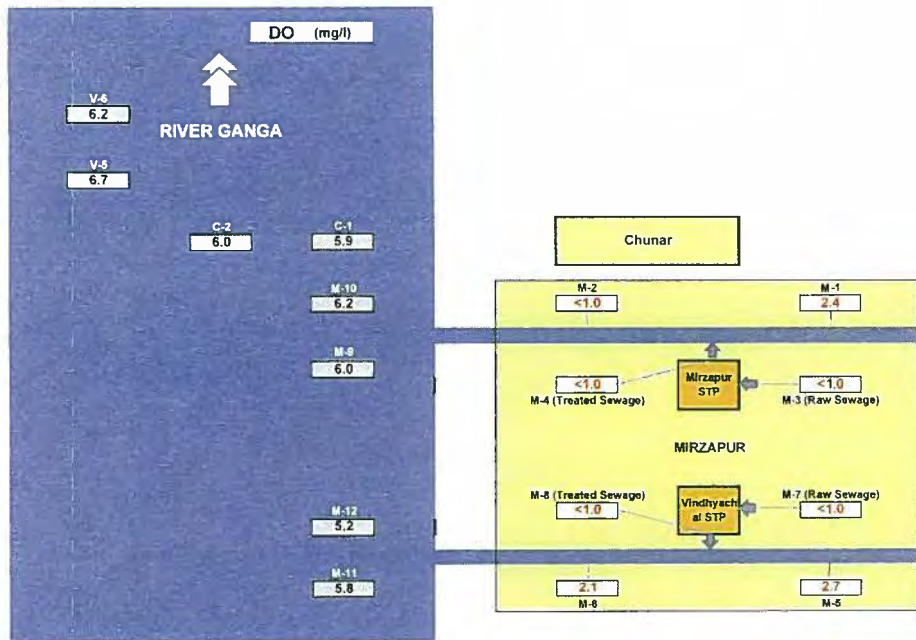
Figure 5.2 Results of Third Water Quality Examination (DO) (Sampled on July 18-20, 2016)

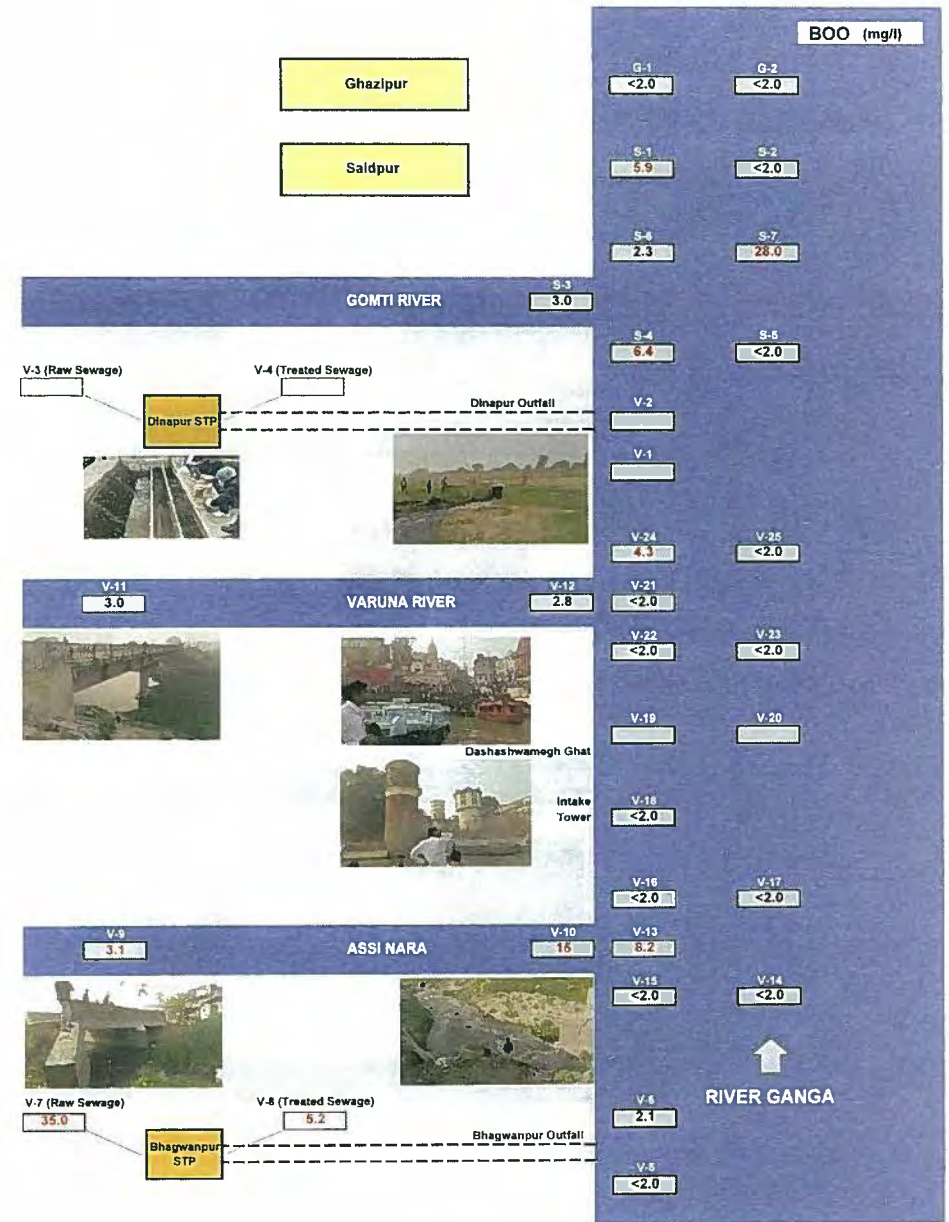
Figure 5.3 Results of Third Water Quality Examination (BOD) (Sampled on July 18-20, 2016)

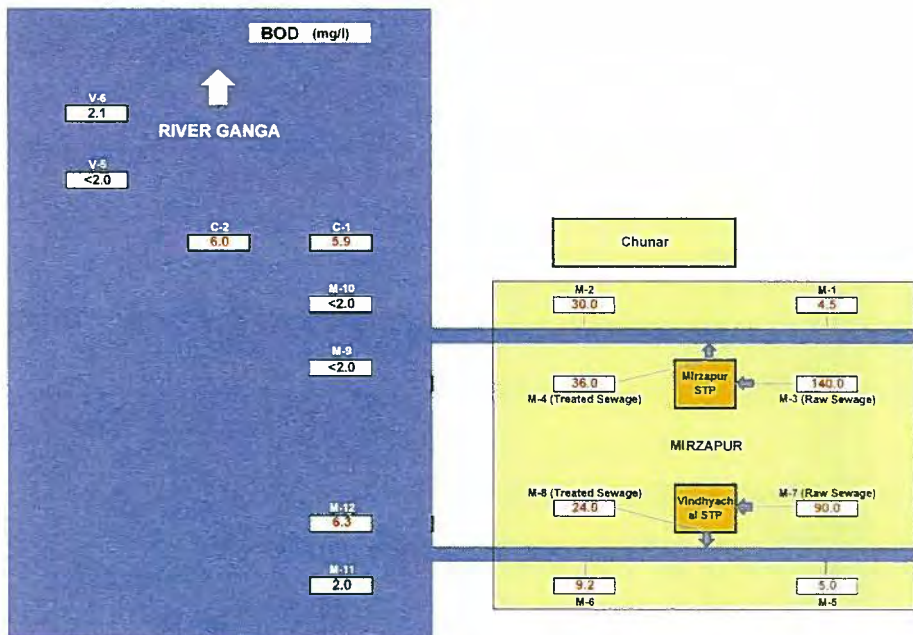
Figure 5.4 Results of Third Water Quality Examination (BOD) (Sampled on July 18-20, 2016)

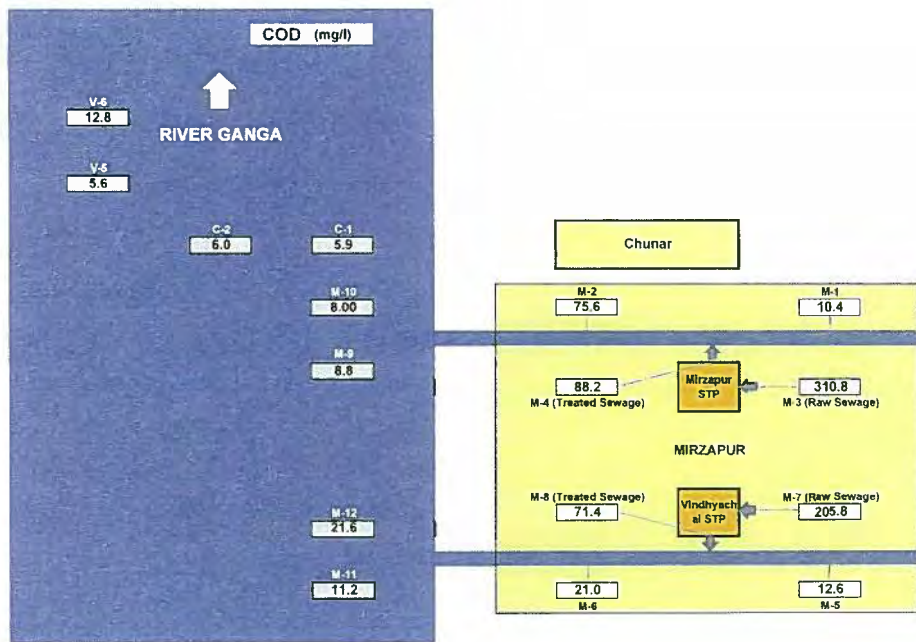
Figure 5.6 Results of Third Water Quality Examination (COD) (Sampled on July 18-20, 2016)
