**REPORT
ON

GEOLOGICAL SURVEY
FOR

THE PROJECT FOR THE ESTABLISHMENT OF JAPAN-MYANMAR
VOCATIONAL TRAINING INSTITUTE (AUNG SAN)
LOWER MINGALARDON ROAD, SINGUU WARD, AUNG SAN, INSEIN
TOWNSHIP, YANGON REGION**

**Ø6" TUBE WELL DRILLING WORK,
AQUIFER AND WELL TEST REPORT
GTHS COMPOUND, AUNG SAN,
INSEIN TOWNSHIP**

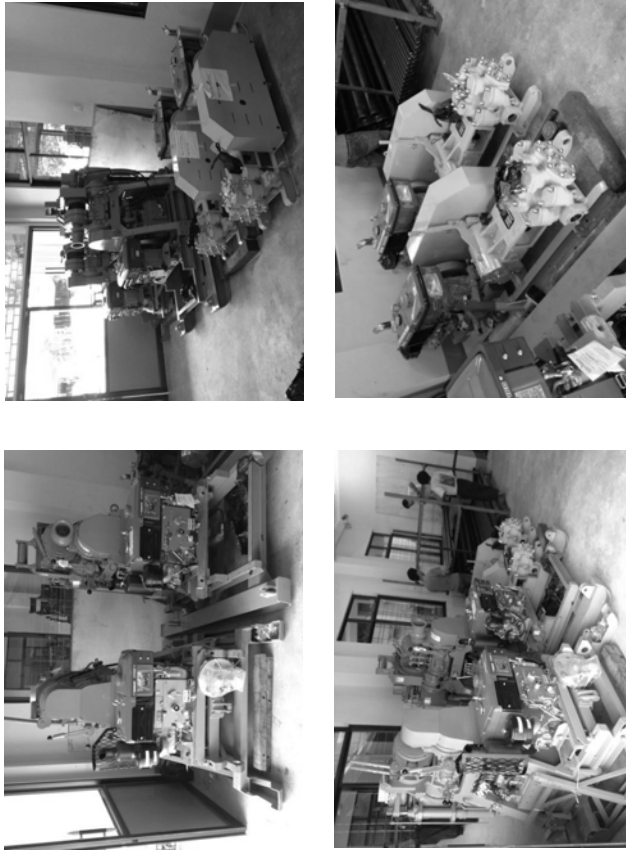
Photo - 1.2 : Boring Equipments

One number of boring equipment of TOHO D2K-92 and one number of YWE were applied in field investigation works to study general condition of soil layers under planned area for future construction. The photos of boring equipment were presented in following photo – 1.2.

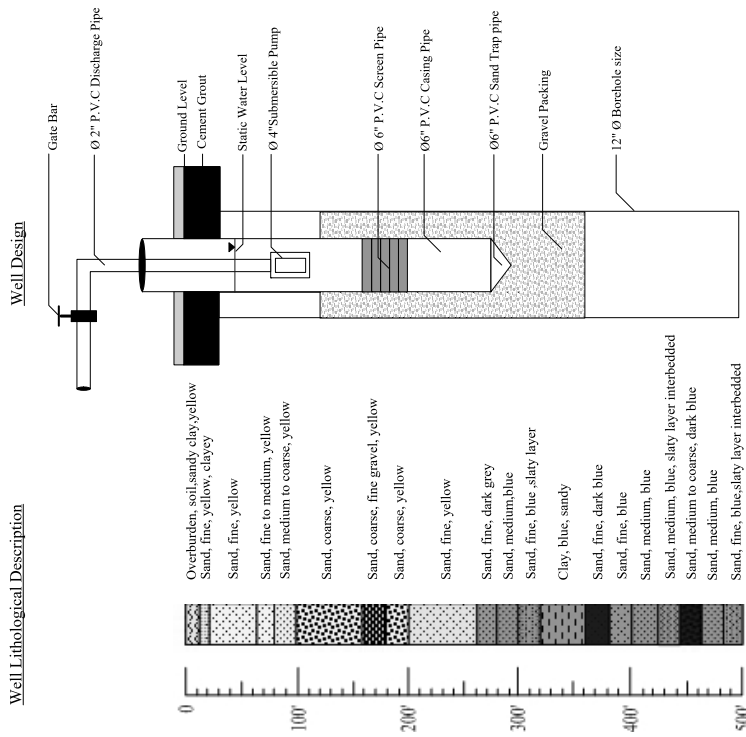
Figure (6.1) Well Log and Well Design of Investigation Site

The well log and well design of investigation well is shown in figure (6.1). Testing well is accommodated 6"Ø PVC casing pipe, 2"Ø PVC raiser pipe and submersible pump.

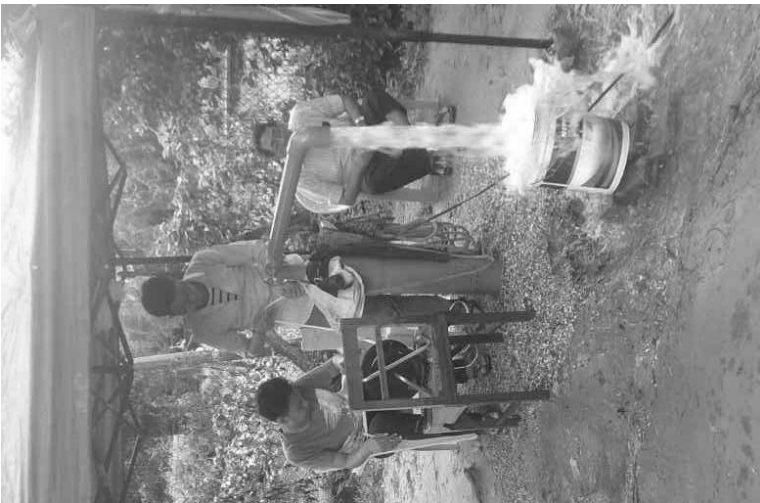
Figure (7.9) Measurement step-drawdown Test at Investigation Site

The drawdown in a pumped well consisting of two components, the aquifer loss and well loss. A step drawdown test is conducted to determine these losses. Excessive losses are caused by damaging of the aquifer during drilling and completion of the well. This test also shows the information regarding the relation between discharge and drawdown of the well, which is useful for selecting of optimum pump and depth of pumping. During pumping the water level measured by electric water level indicator. Figure (7.9)
