Project GWADAR MINI PORT Sample No. B-6 S6-1  
 Location of project GWADAR, PAKISTAN Condition of drainage U-U

TRIAXIAL COMPRESSION TEST (Mohr's circle)

# CONSOLIDATION TEST ( $\bar{p} - c_v, m_v, K$ curves)

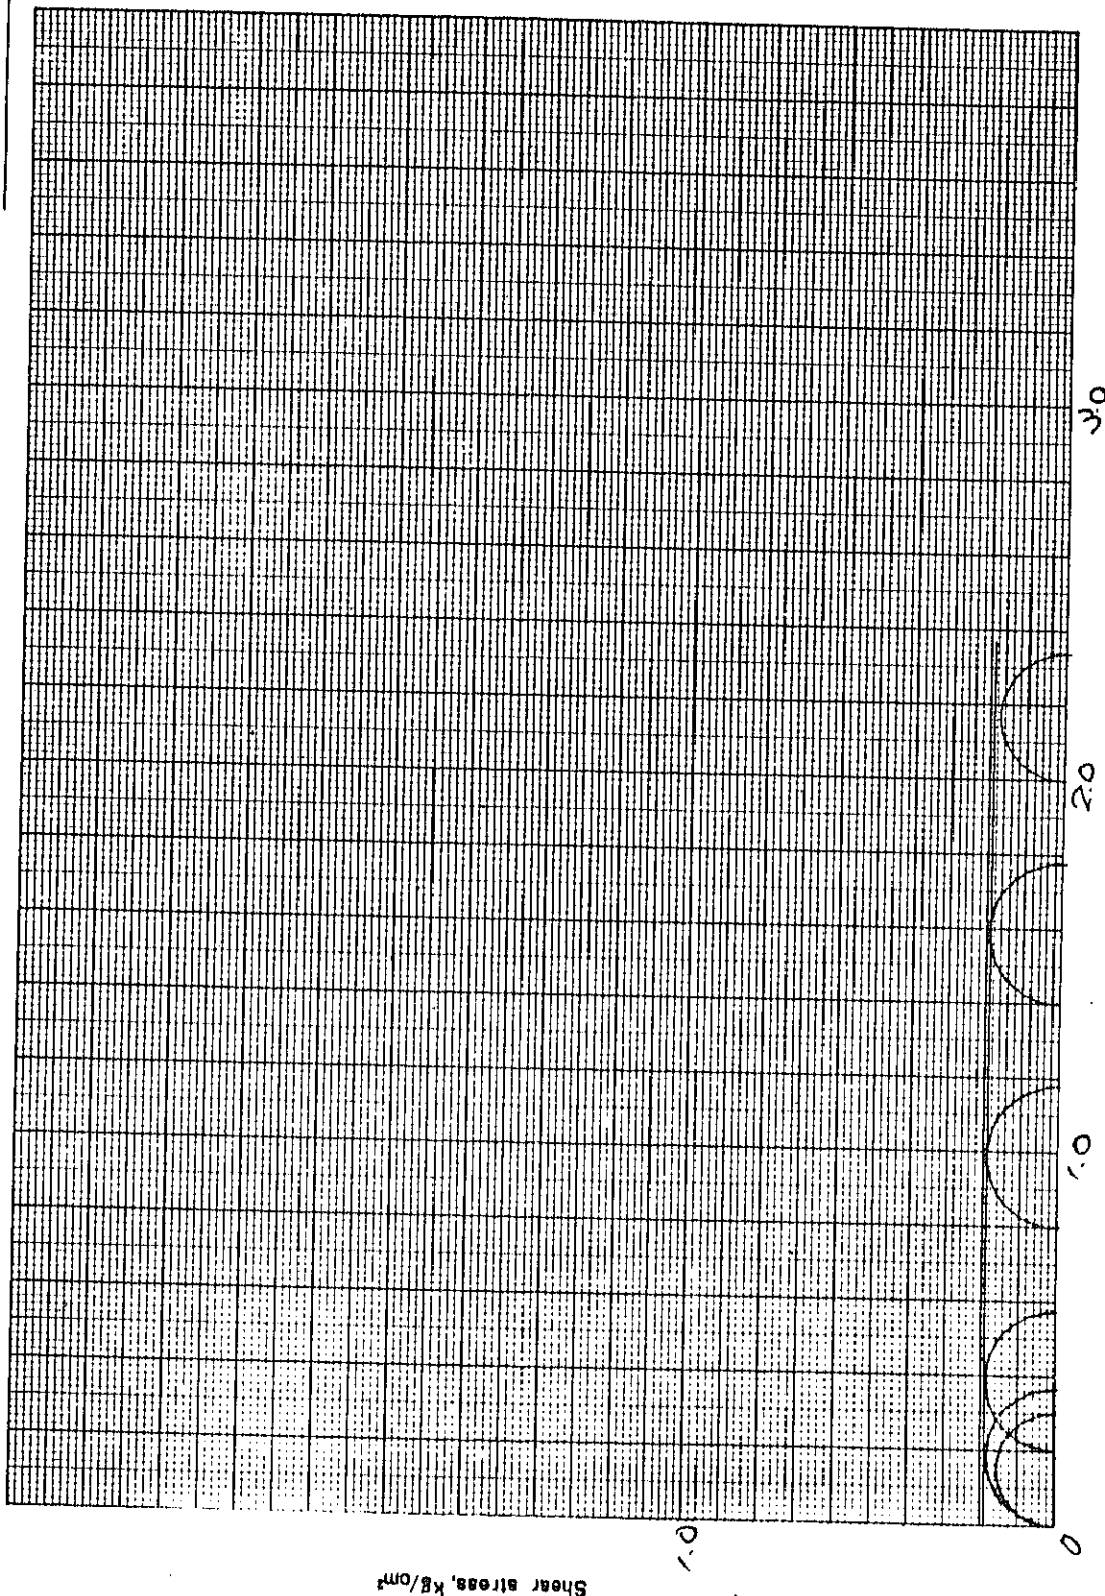
Depth of Sample 2.00 - 2.87 m  
 Angle of internal friction 0°  
 Cohesion 0.19 kg/cm<sup>2</sup>

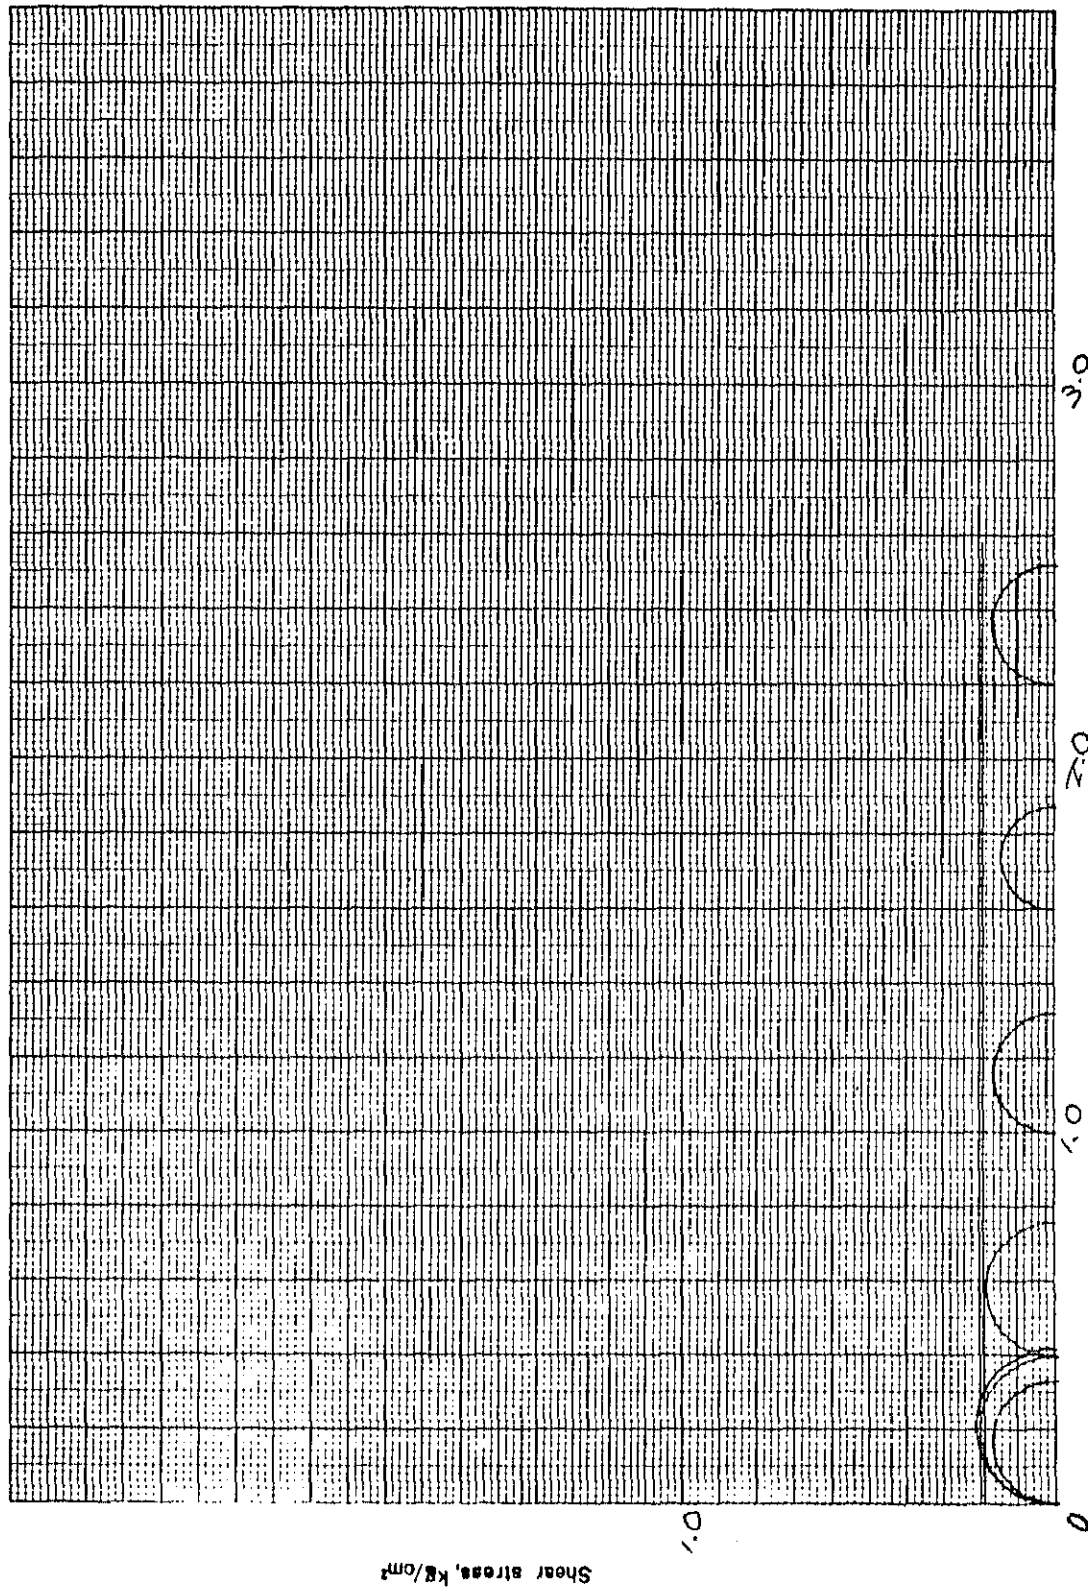
Project GWADAR MINI PORT Sample No. B-6 S6-2 Depth of Sample 4.00 - 4.78 m  
 Location of project GWADAR, PAKISTAN Condition of drainage U-U Angle of internal friction 0°  
 Cohesion 0.19 kg/cm<sup>2</sup>

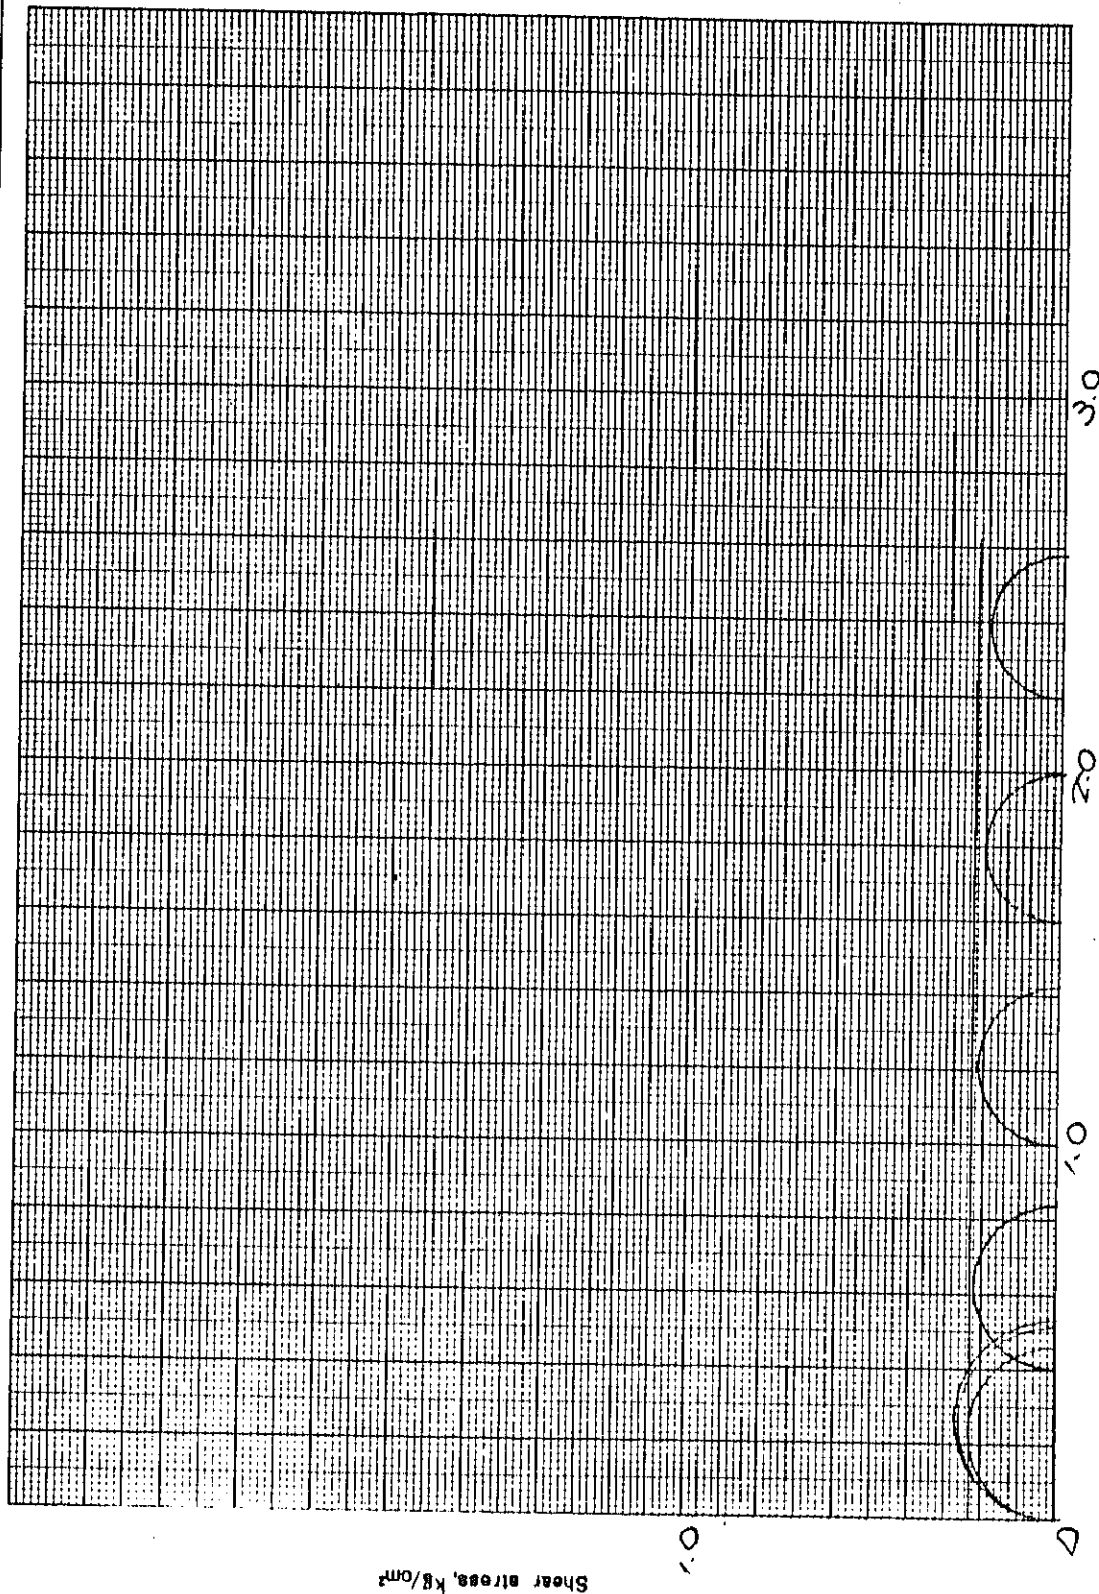
Sample No. B-6 S6-3

Depth of Sample 6.00 - 6.86 m

Angle of internal friction 0°

Cohesion 0.23 kg/cm<sup>2</sup>

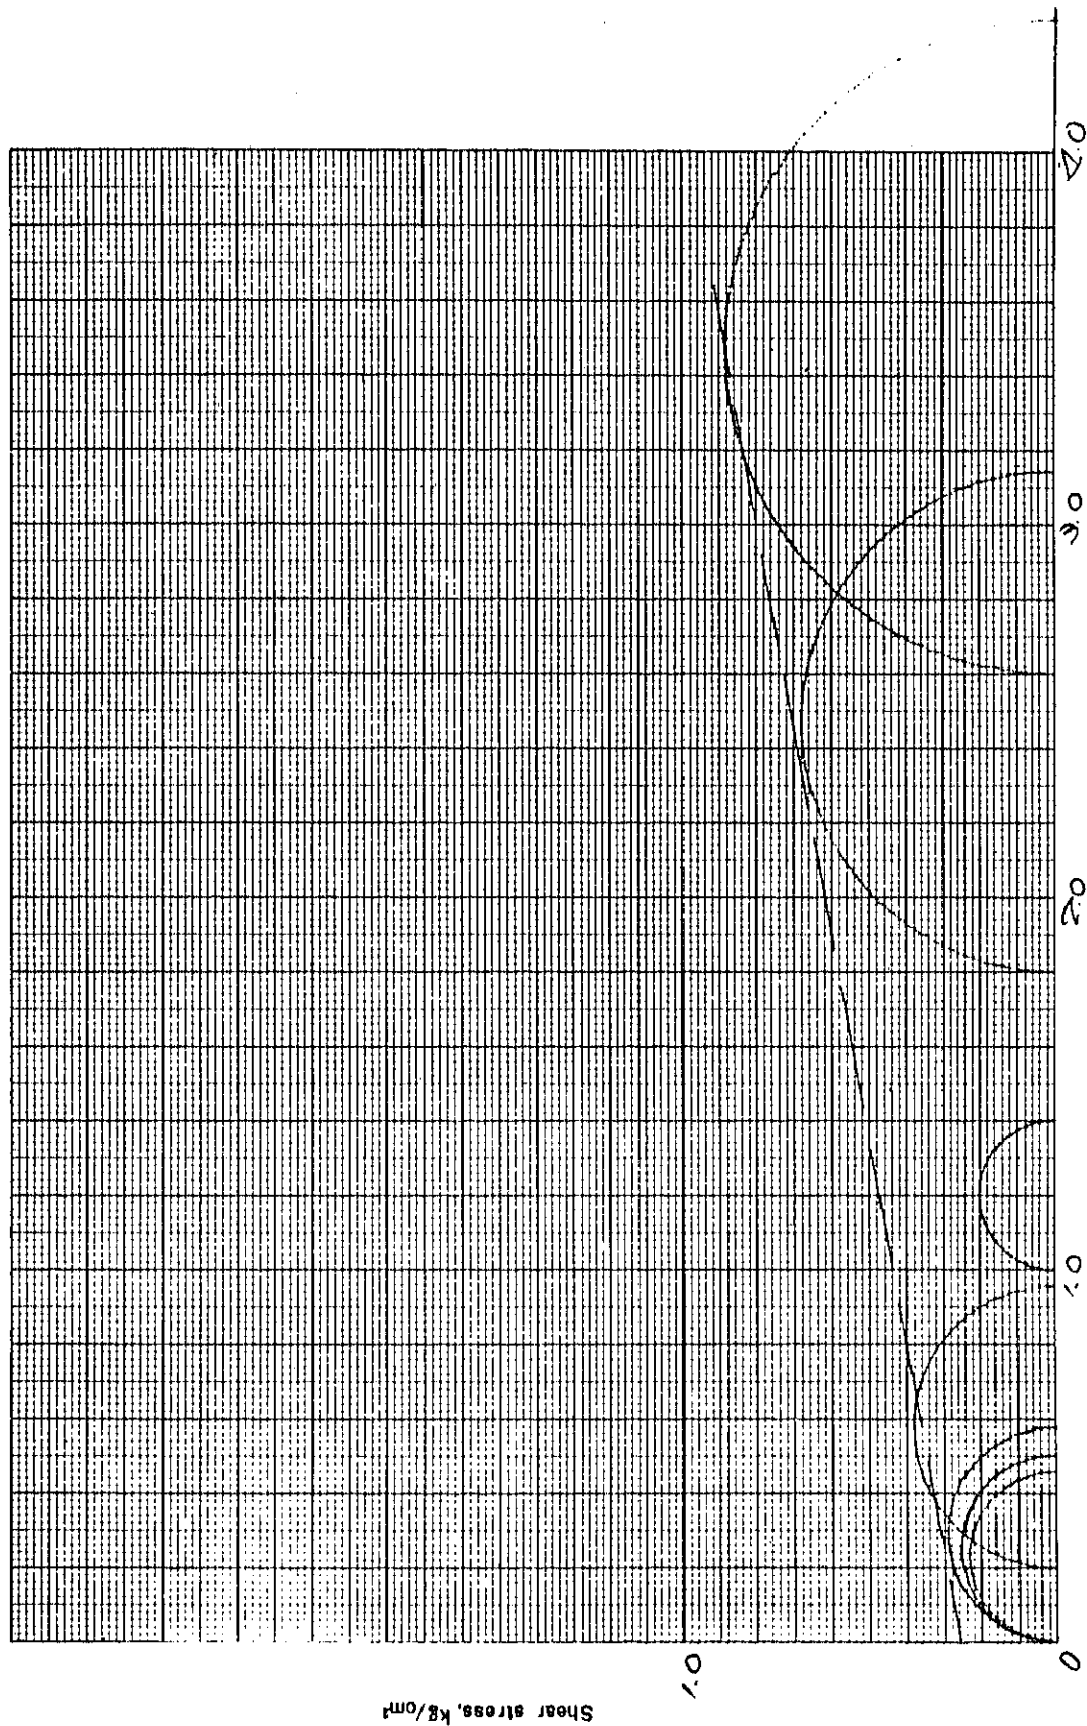
TRIAxIAL COMPRESSION TEST (Mohr's circle)

S6-4

Depth of Sample 9.00 - 9.87 m

Angle of internal friction (10°)

Cohesion (0.26) kg/cm<sup>2</sup>

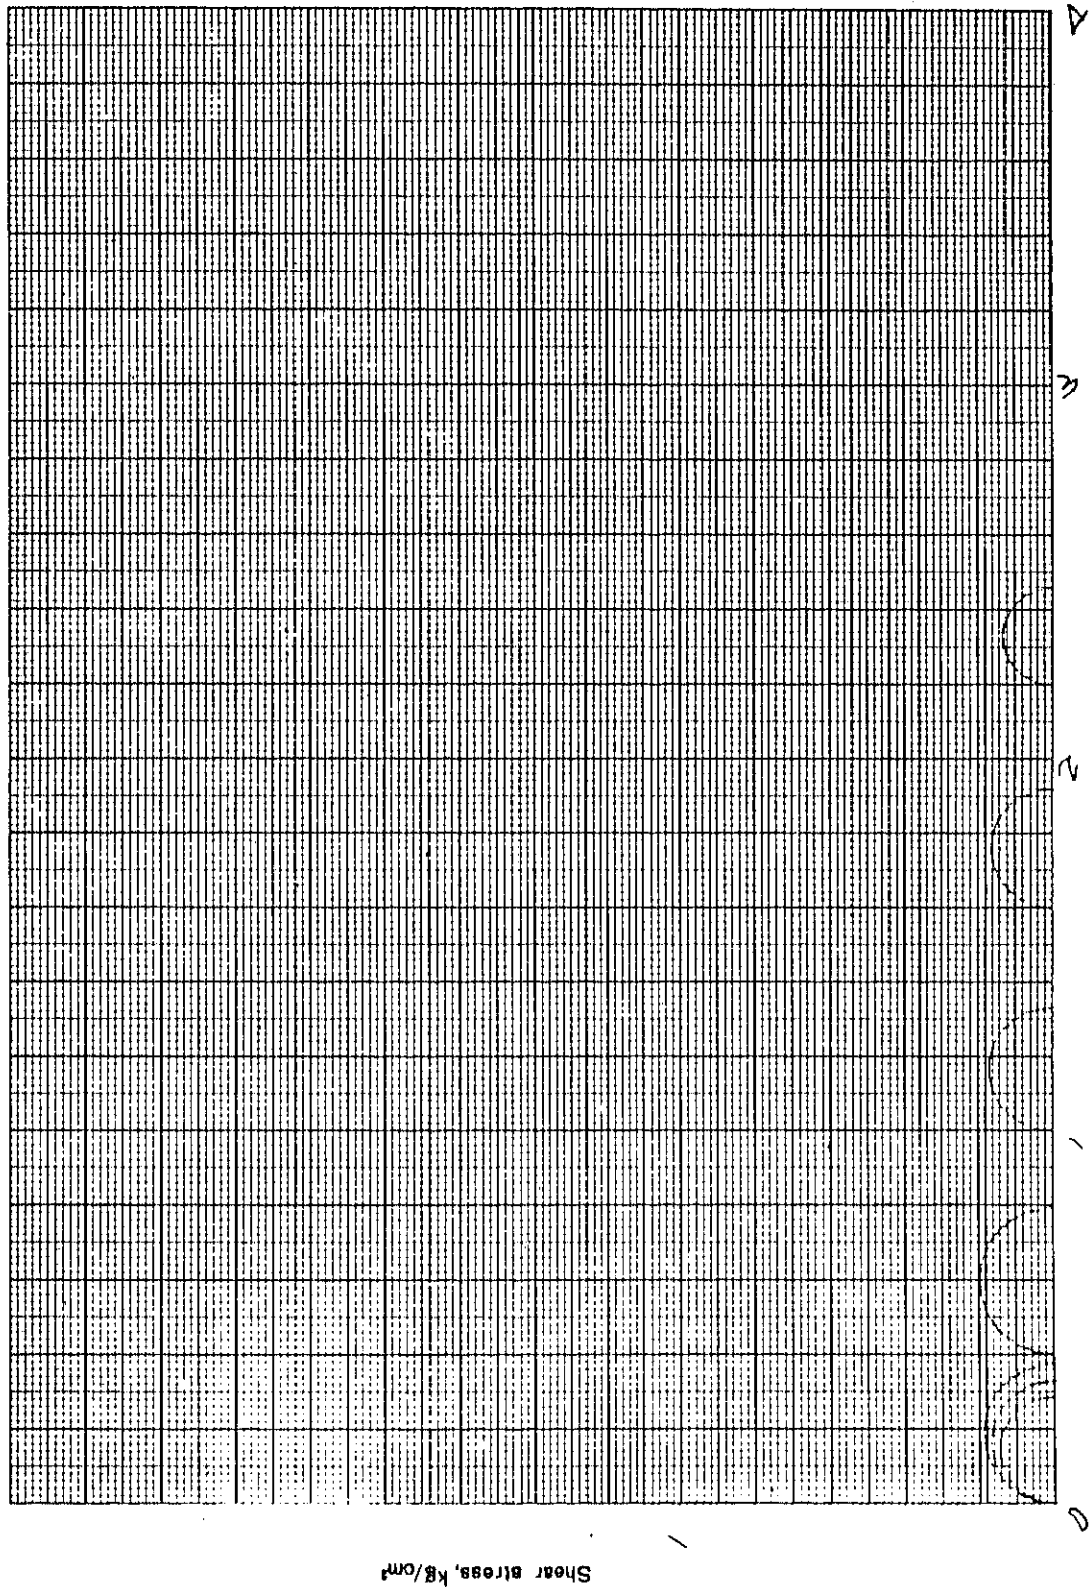
TRIAXIAL COMPRESSION TEST (Mohr's circle)

Project GWADAR MINI PORT Sample No. B-7 S7-1 Depth of Sample 3.00 - 3.78 m  
 Location of project GWADAR, PAKISTAN Condition of drainage U-U Angle of internal friction 0°  
 Cohesion 0.18 kg/cm<sup>2</sup>

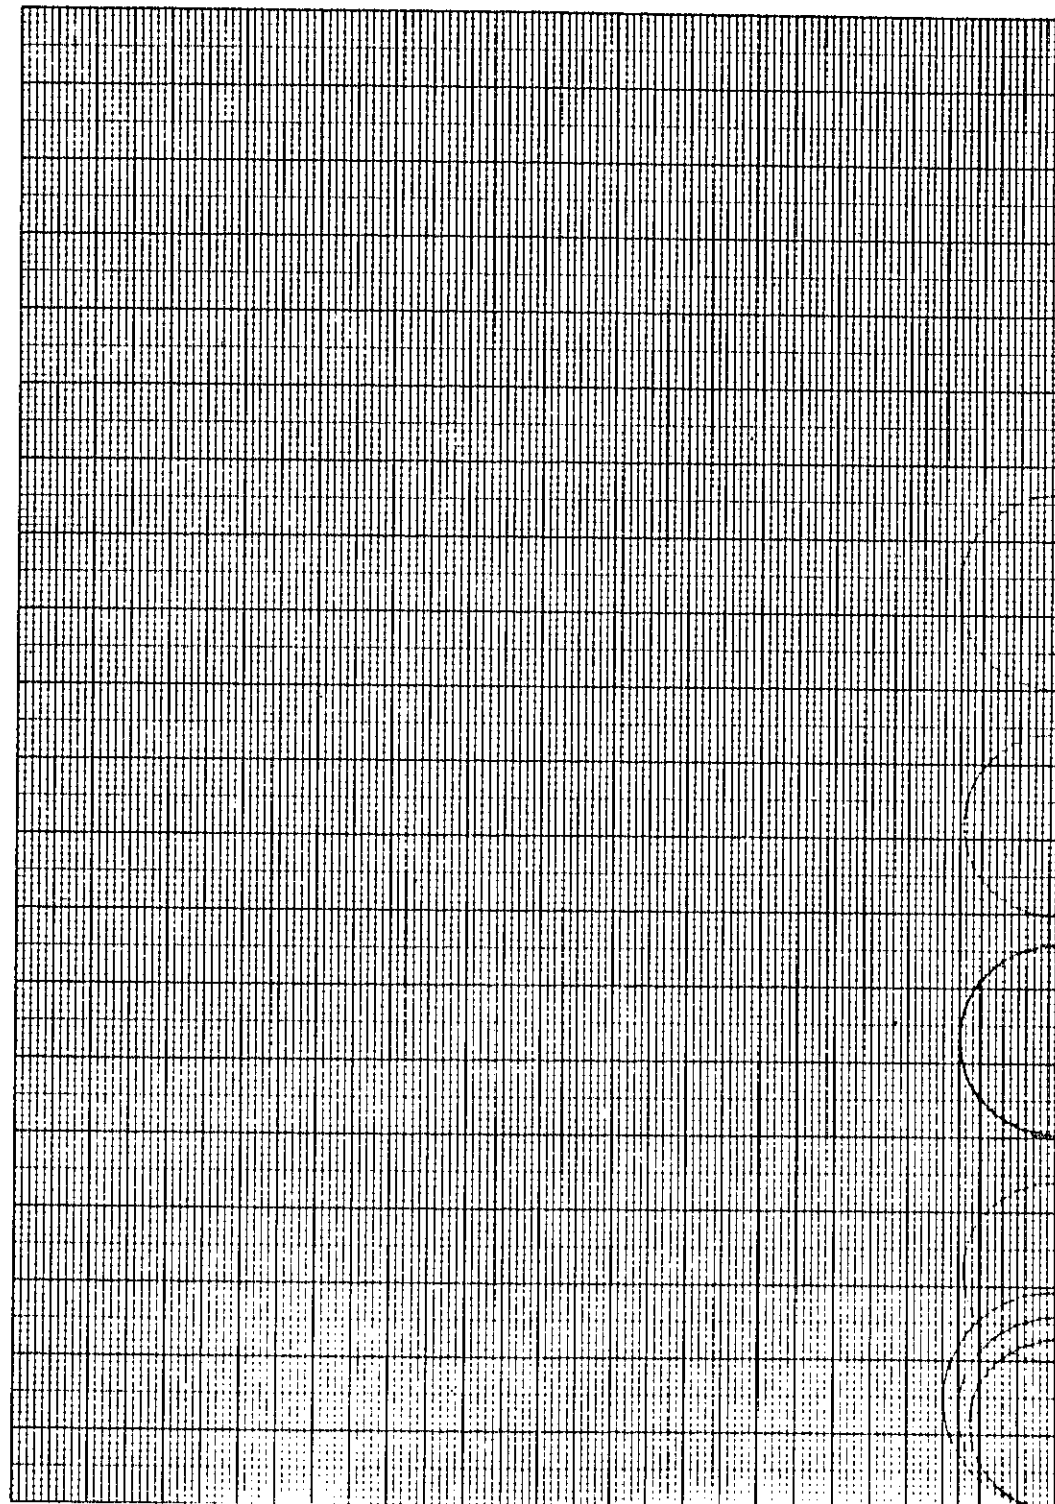
TRIAXIAL COMPRESSION TEST (Mohr's circle)

S7-3

Depth of Sample 7.00 - 7.82 m

Angle of internal friction 0°

Cohesion 0.26 kg/cm<sup>2</sup>

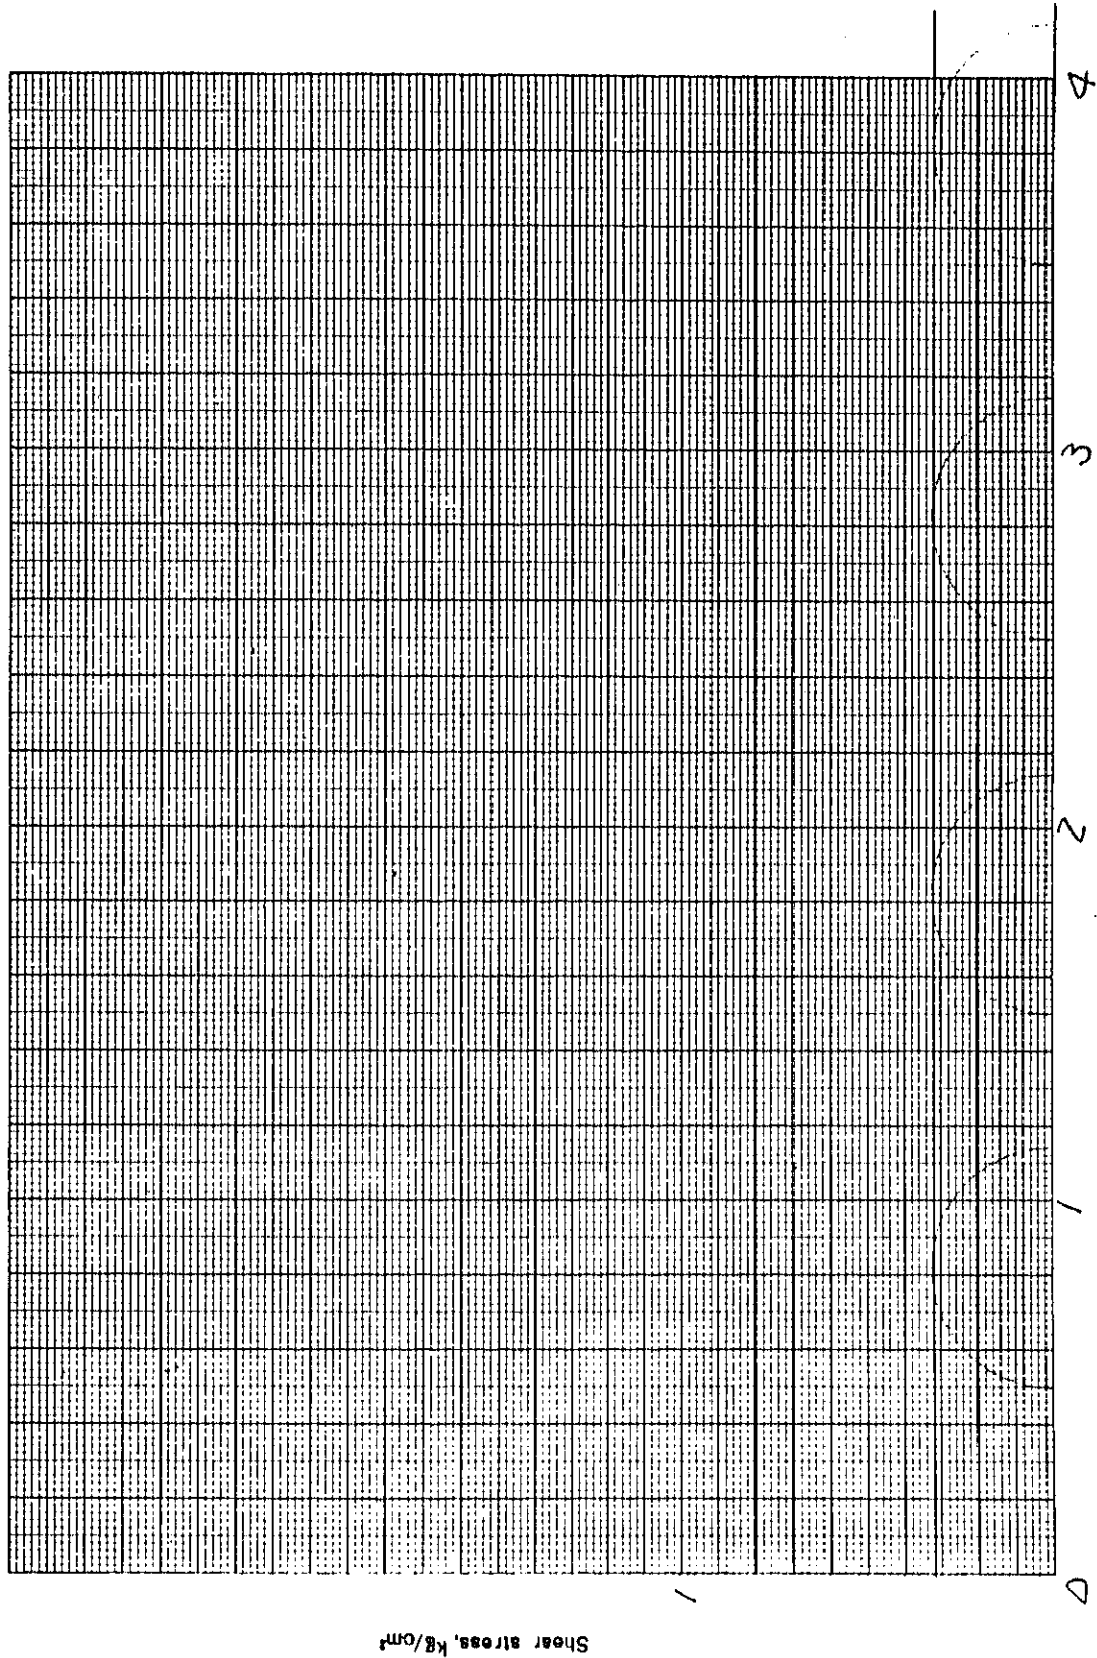
TRIAXIAL COMPRESSION TEST (Mohr's circle)

S7-5

Depth of Sample 15.00 - 15.72 m

Angle of internal friction 0°

Cohesion 0.32 kg/cm<sup>2</sup>

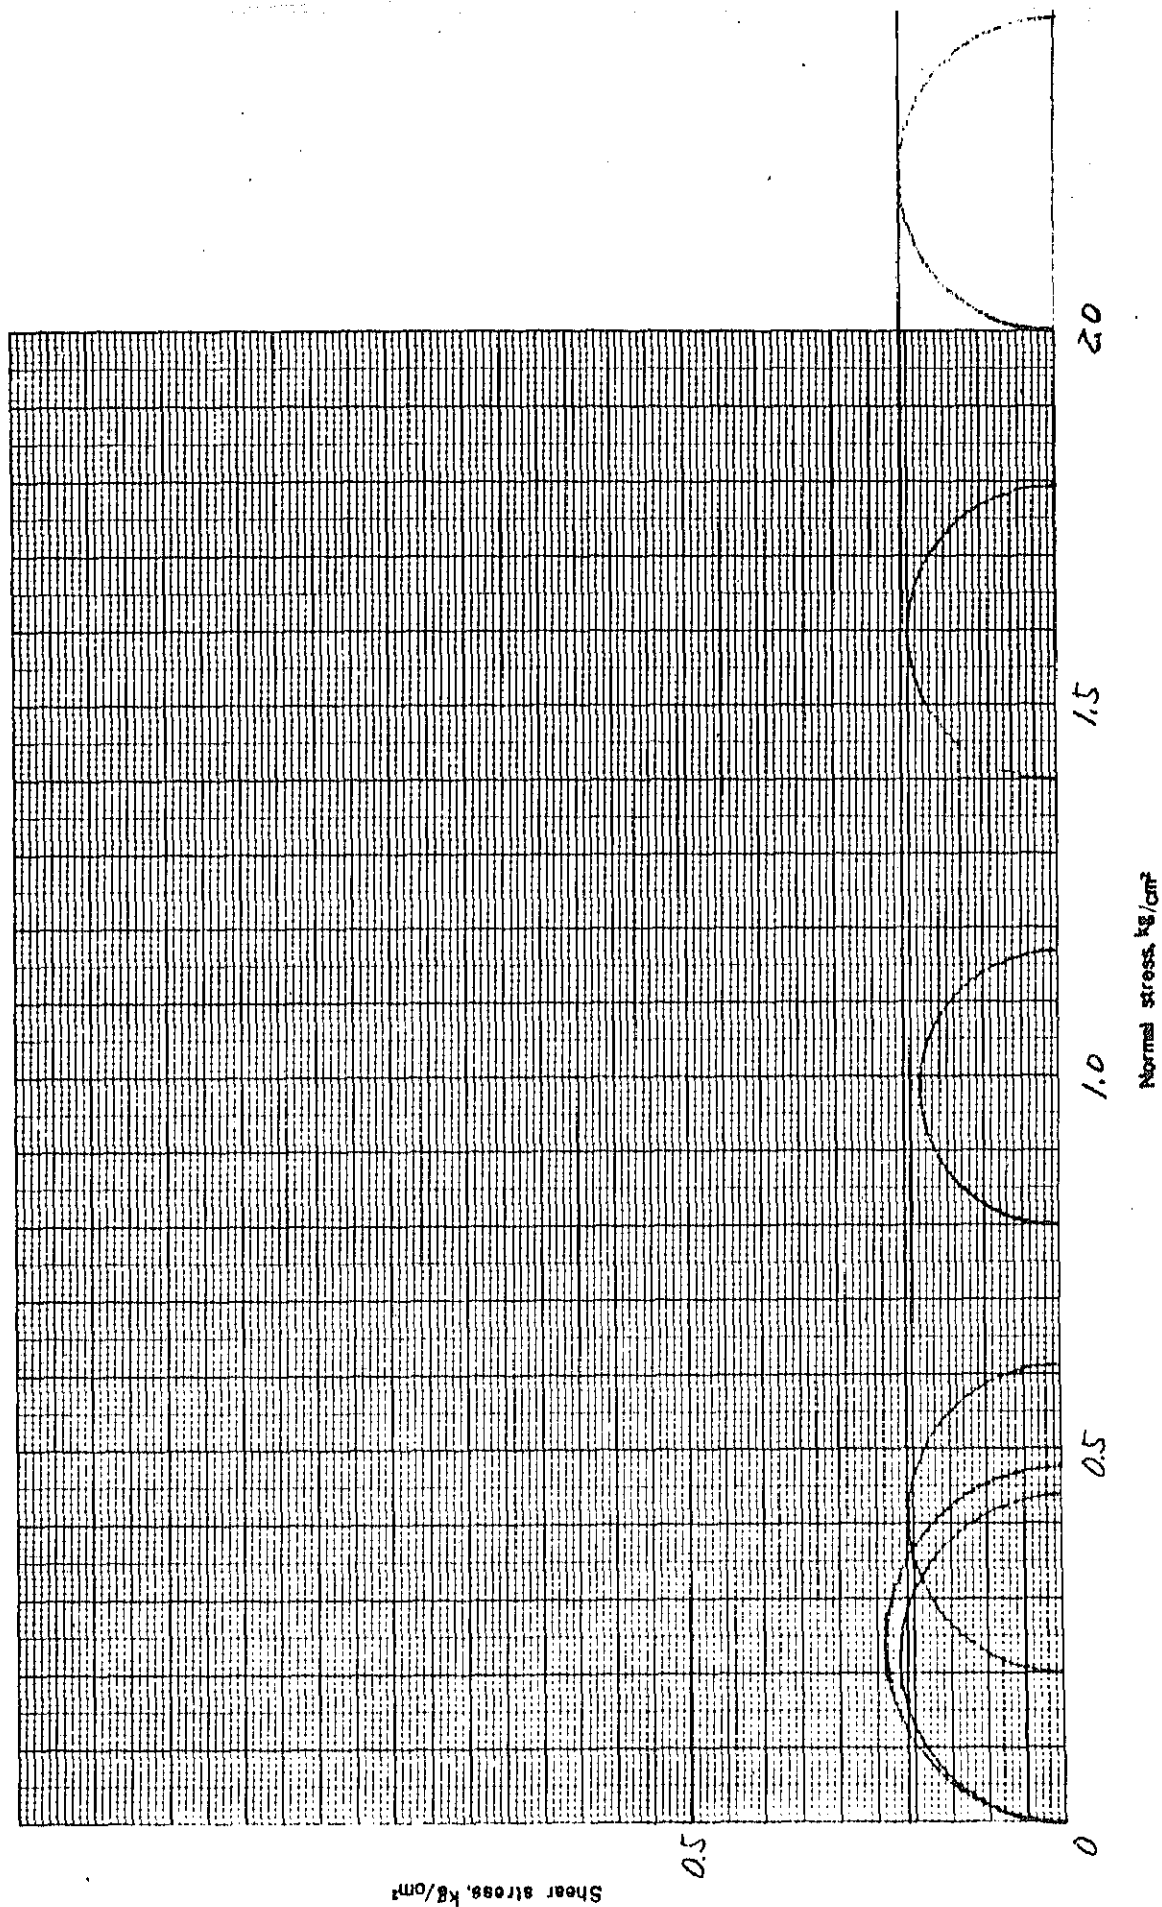
TRIAXIAL COMPRESSION TEST (Mohr's circle)

S8-2

Depth of Sample 3.00 - 3.74 m

Angle of internal friction 0°

Cohesion 0.21 kg/cm<sup>2</sup>

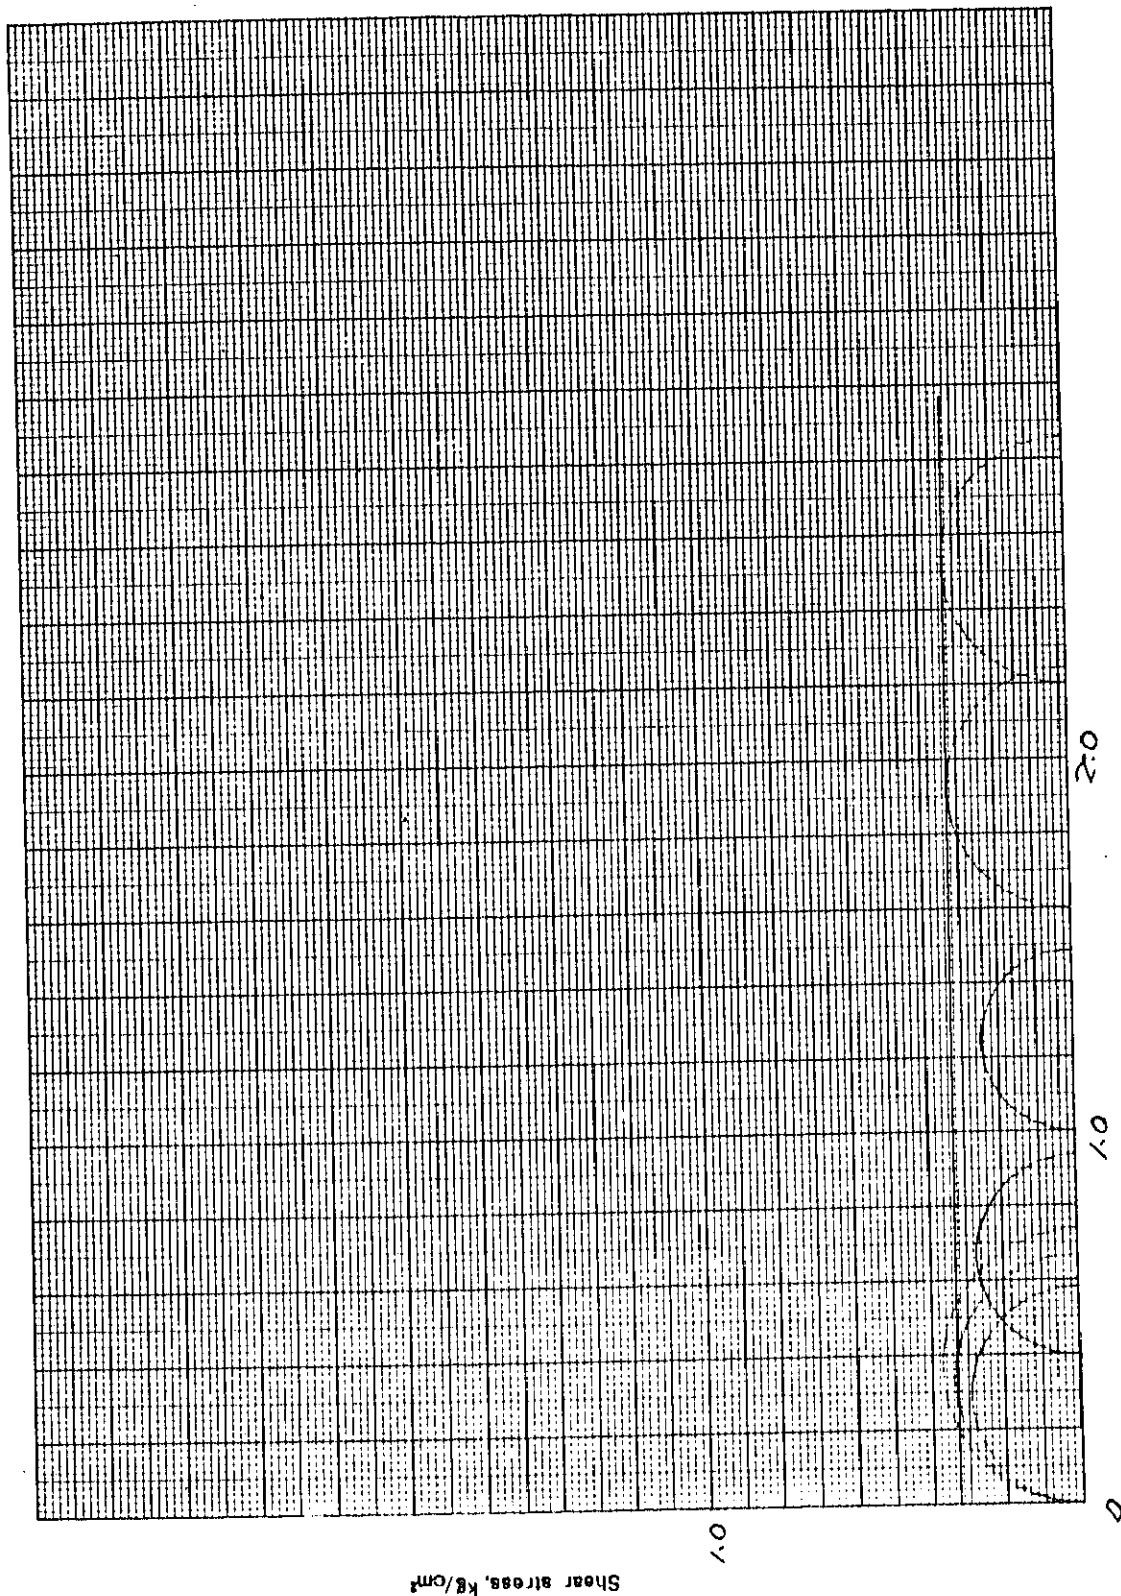
TRIAXIAL COMPRESSION TEST (Mohr's circle)

Project GWADAR MINI PORT Sample No. B-8 SB-4D  
 Location of project GWADAR, PAKISTAN Condition of drainage U-U  
 Depth of Sample 7.00 - 7.65 m  
 Angle of internal friction 0°  
 Cohesion 0.33 kg/cm<sup>2</sup>

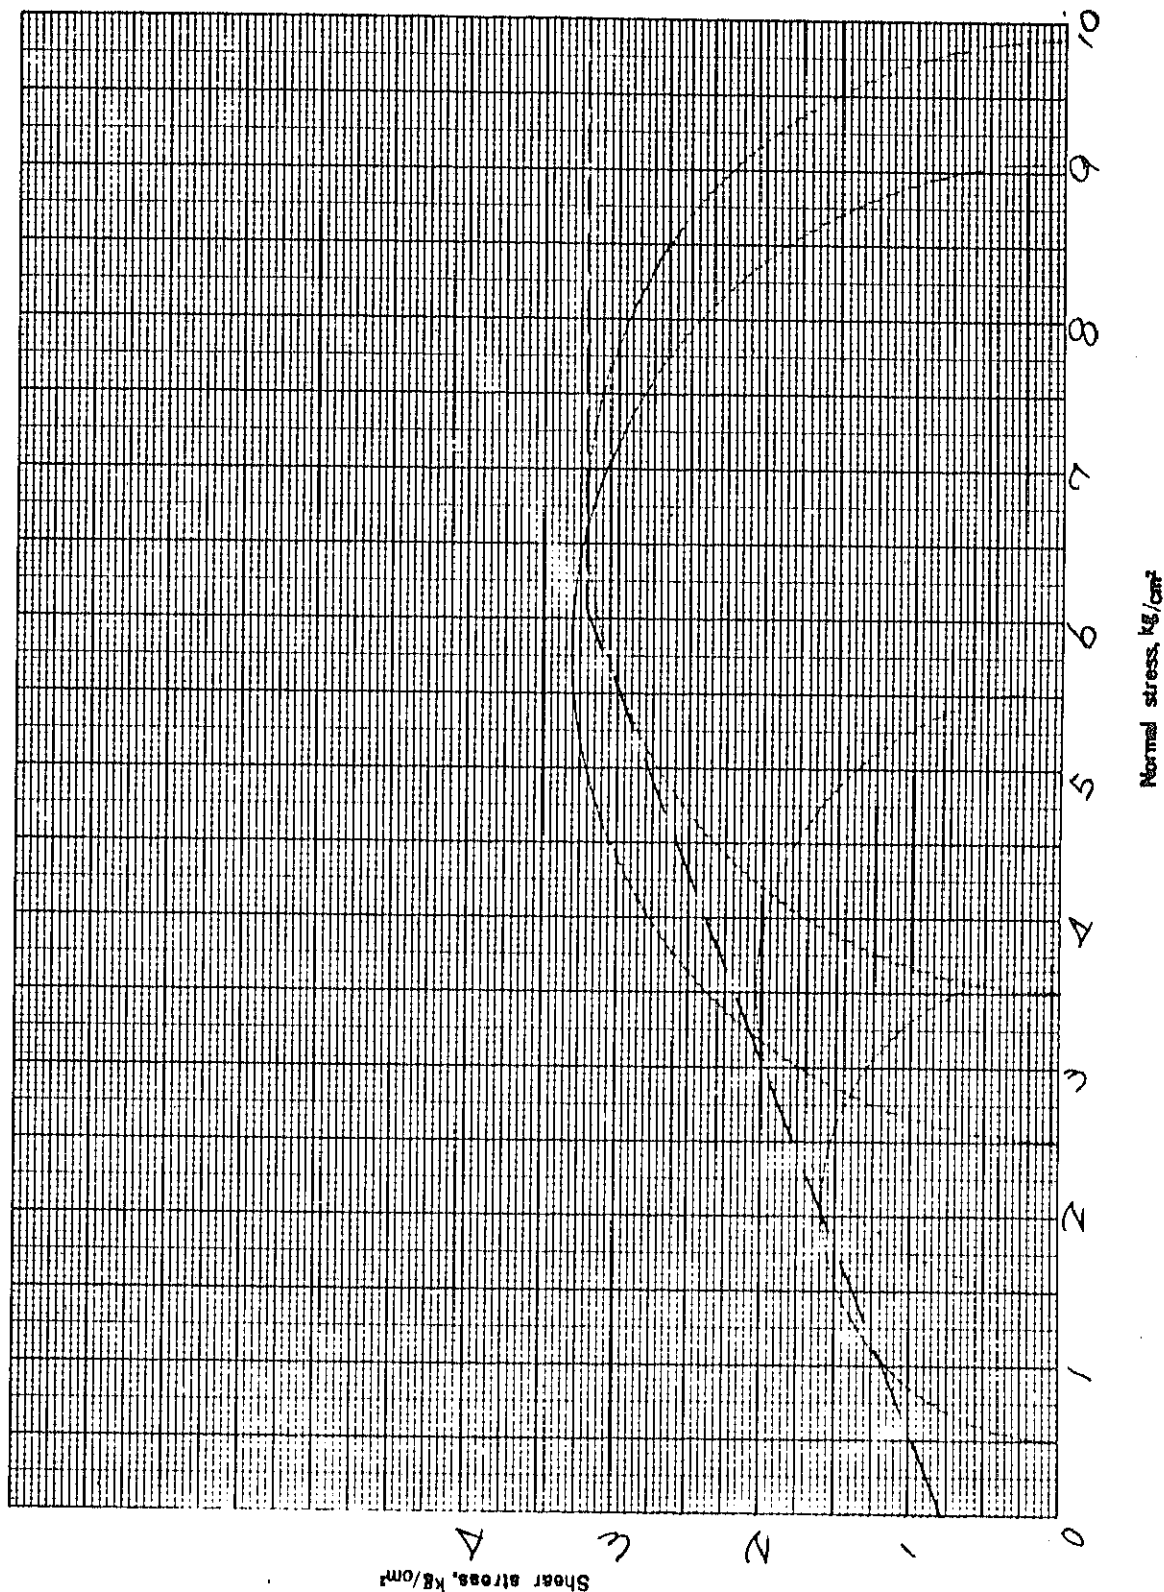
TRIAXIAL COMPRESSION TEST (MOHR'S CIRCLES)

Project GWADAR MINI PORT Sample No. B-8 S8-7D  
 Location of project GWADAR, PAKISTAN Condition of drainage U-U  
 Depth of Sample 15.00 - 15.60 m  
 Angle of internal friction 22° (0°)  
 Cohesion 0.78 (3.2) kg/cm<sup>2</sup>

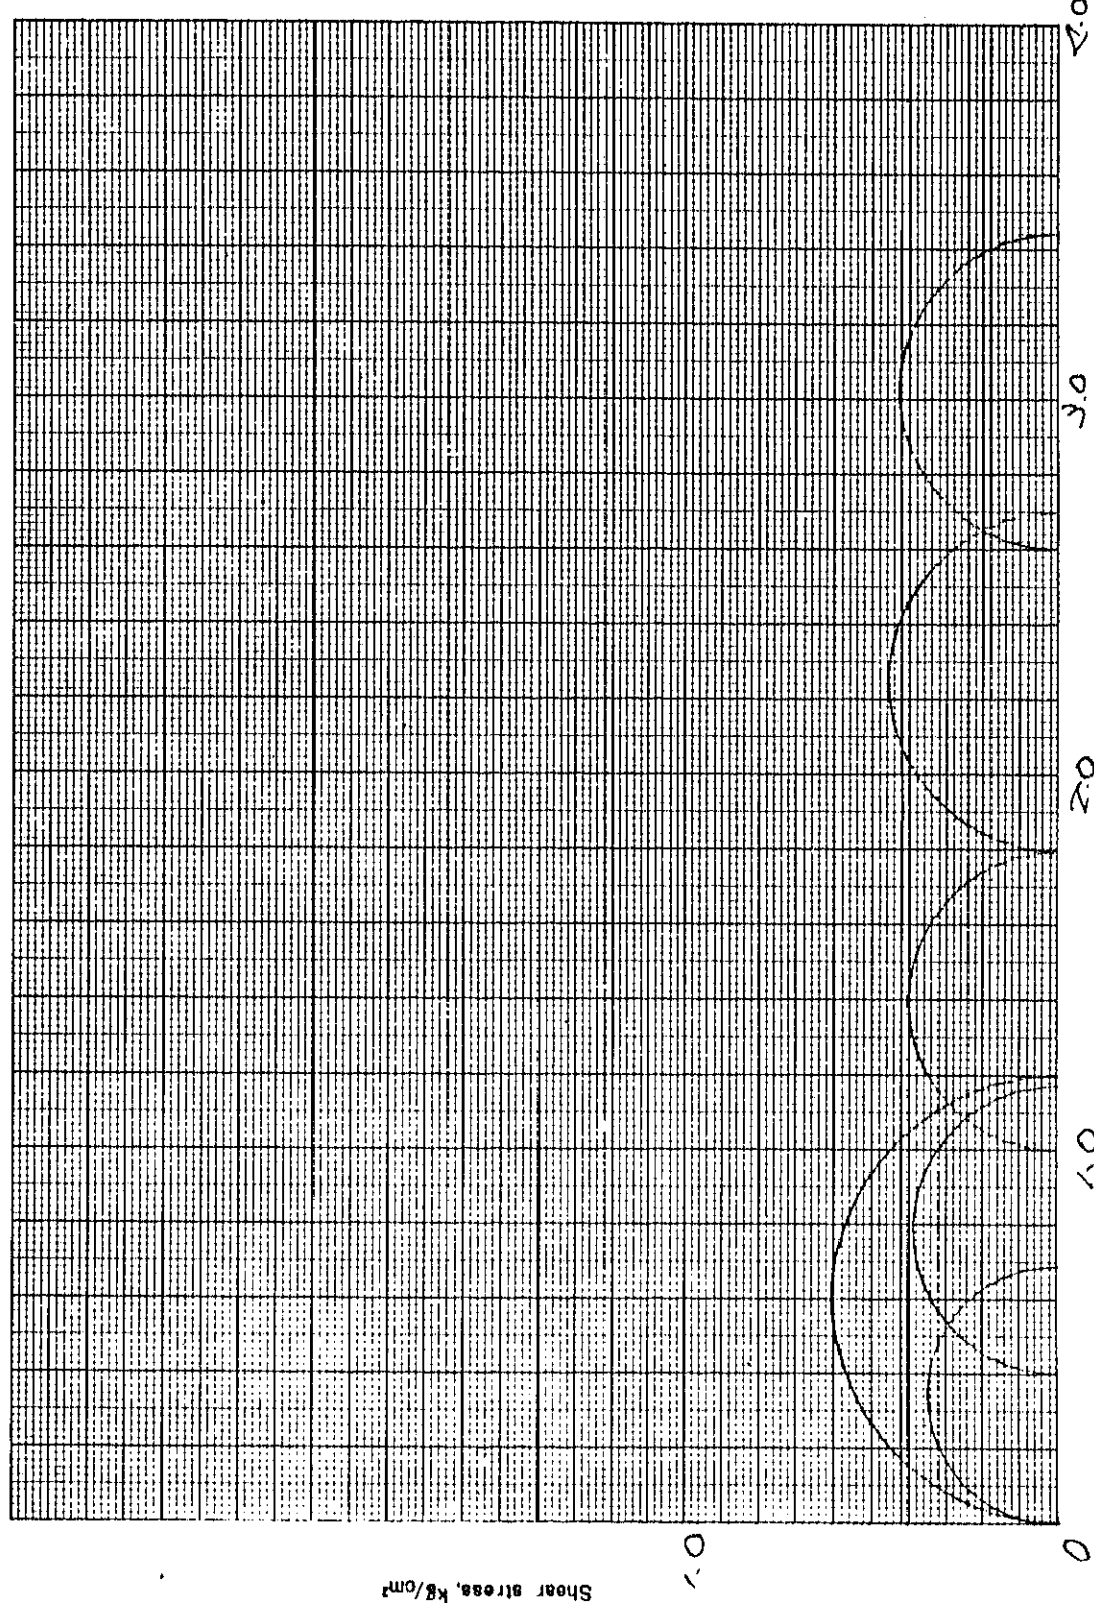
TRIAXIAL COMPRESSION TEST (Mohr's circle)

Sample No. B-9 S9-3

Depth of Sample 7.00 - 7.80 m

Angle of internal friction 0°

Cohesion 0.42 kg/cm<sup>2</sup>

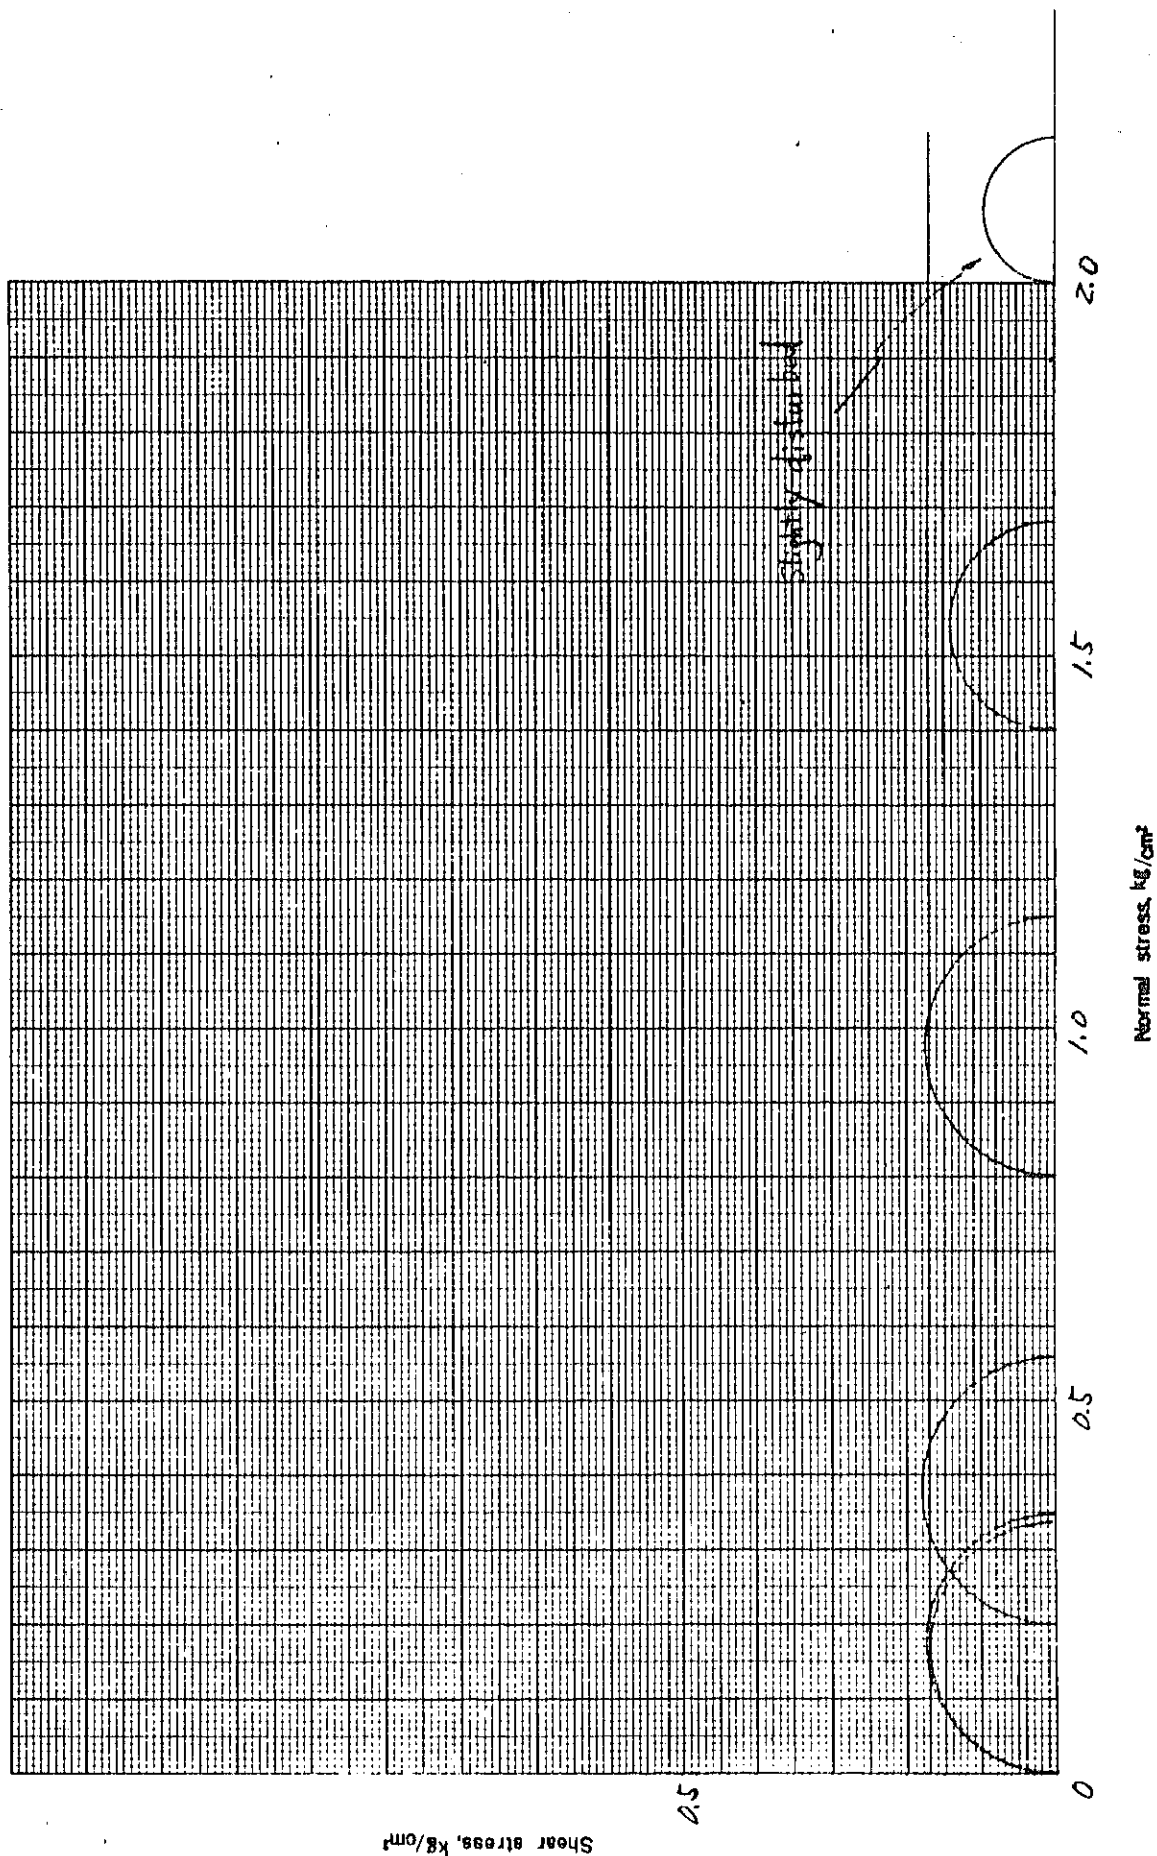
TRIAXIAL COMPRESSION TEST (Mohr's circles)

Project GWADAR MINI PORT Sample No. B-10 SLO-2 Depth of Sample 2.50 - 3.31 m  
 Location of project GWADAR, PAKISTAN Condition of drainage U-U Angle of internal friction 0°  
 Cohesion 0.17 kg/cm<sup>2</sup>
