Project GWADAR MINI PORT Sample No. B-6 S6-1  
 Location of project GWADAR, PAKISTAN Condition of drainage U-U

TRIAXIAL COMPRESSION TEST (Mohr's circle)

# CONSOLIDATION TEST ( $\bar{p} - c_v, m_v, K$ curves)

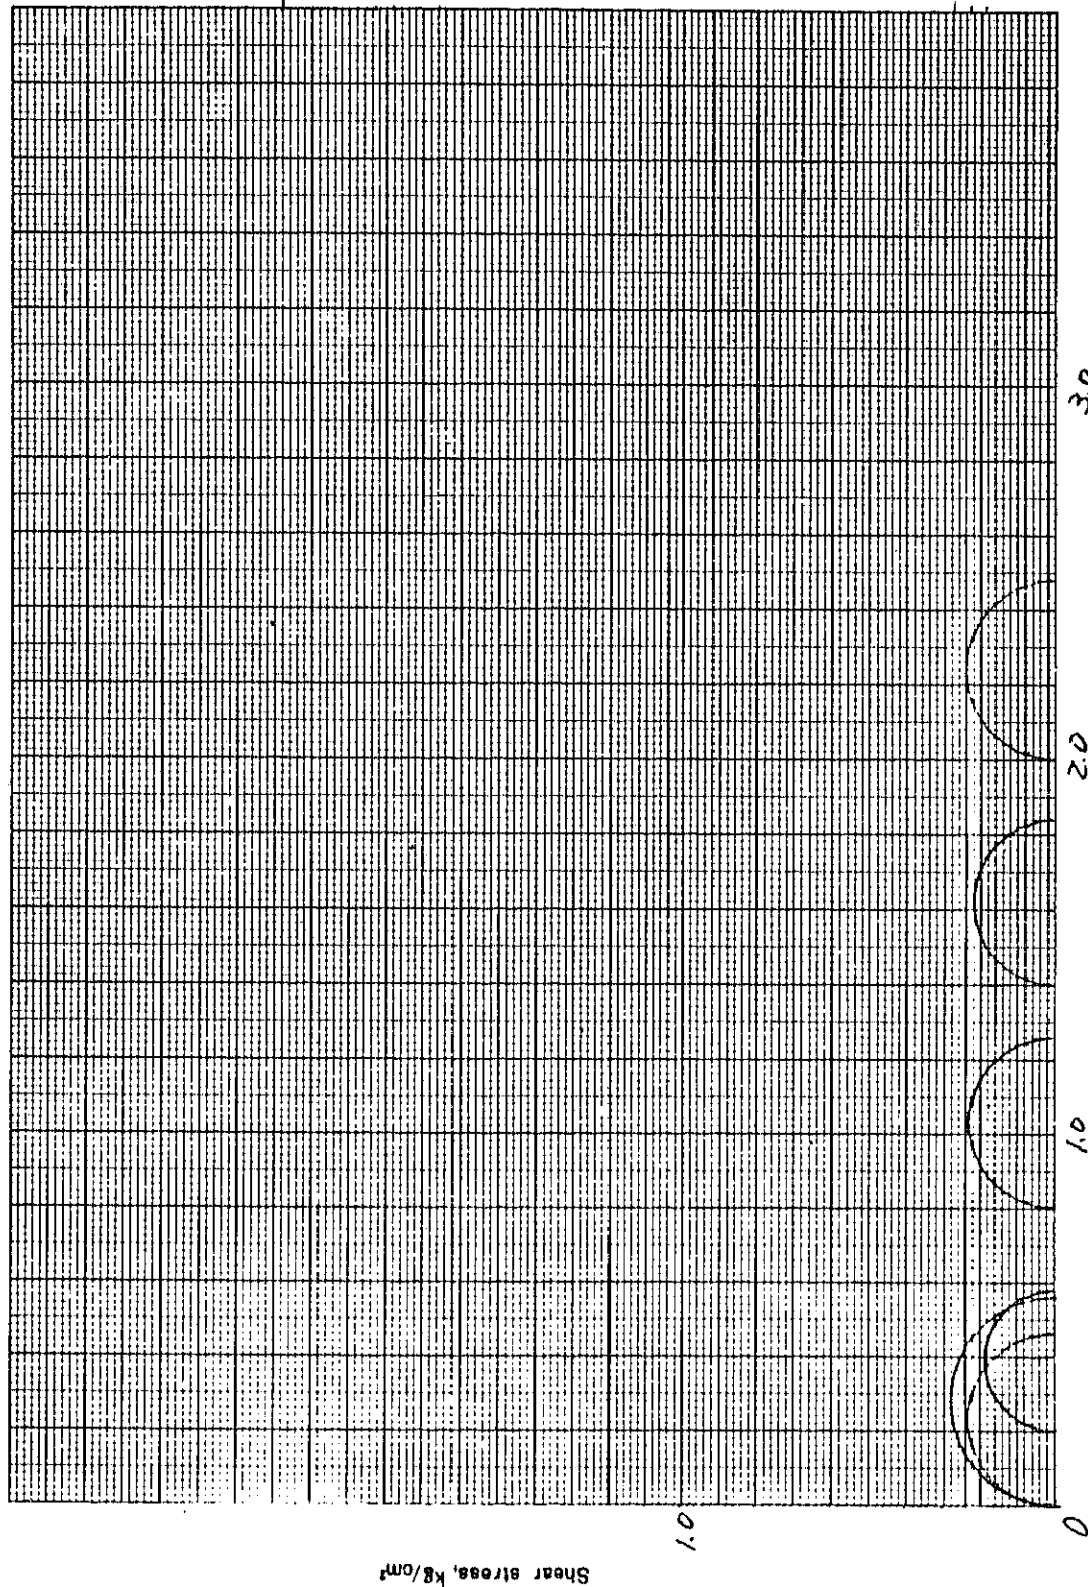
TRIAXIAL COMPRESSION TEST (Mohr's circle)

Project GWADAR MINI PORT Sample No. B-10 SLO-4 Depth of Sample 4.80 - 5.61 m  
 Location of project GWADAR, PAKISTAN Condition of drainage U-U Angle of internal friction 0°  
 Cohesion 0.24 kg/cm<sup>2</sup>

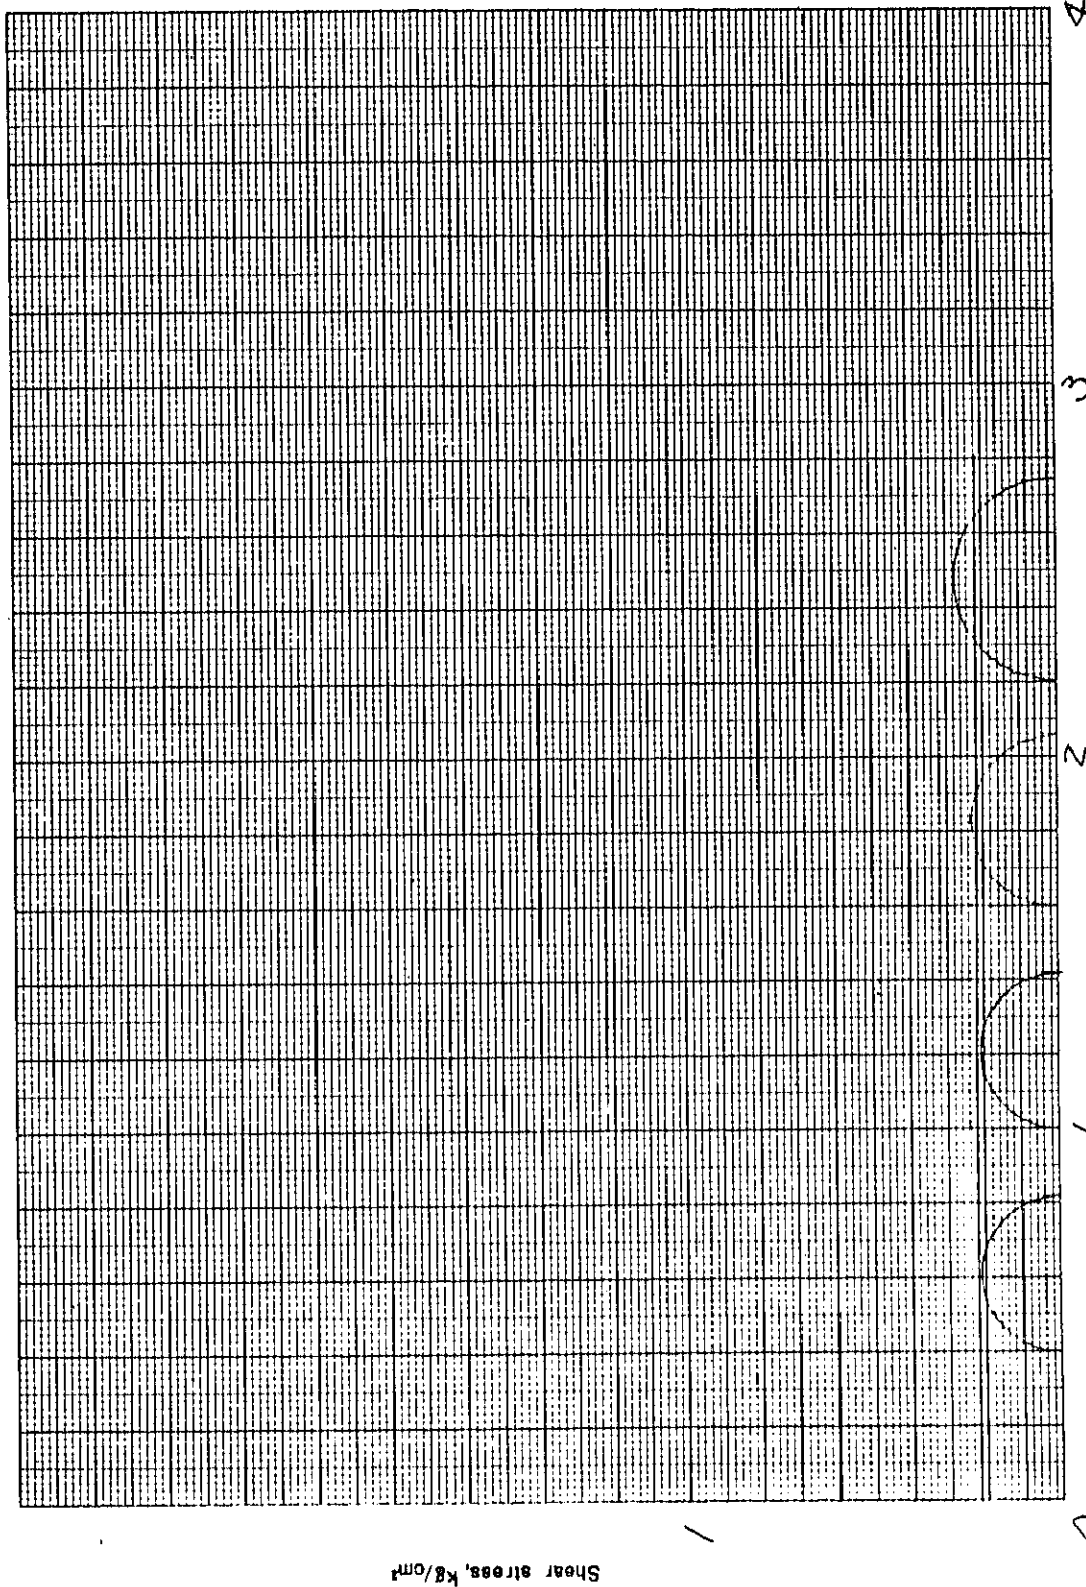
TRIAXIAL COMPRESSION TEST (Mohr's circles)

S10-6

Depth of Sample 6.30 - 6.80 m

Angle of internal friction 0°

Cohesion 0.22 kg/cm<sup>2</sup>

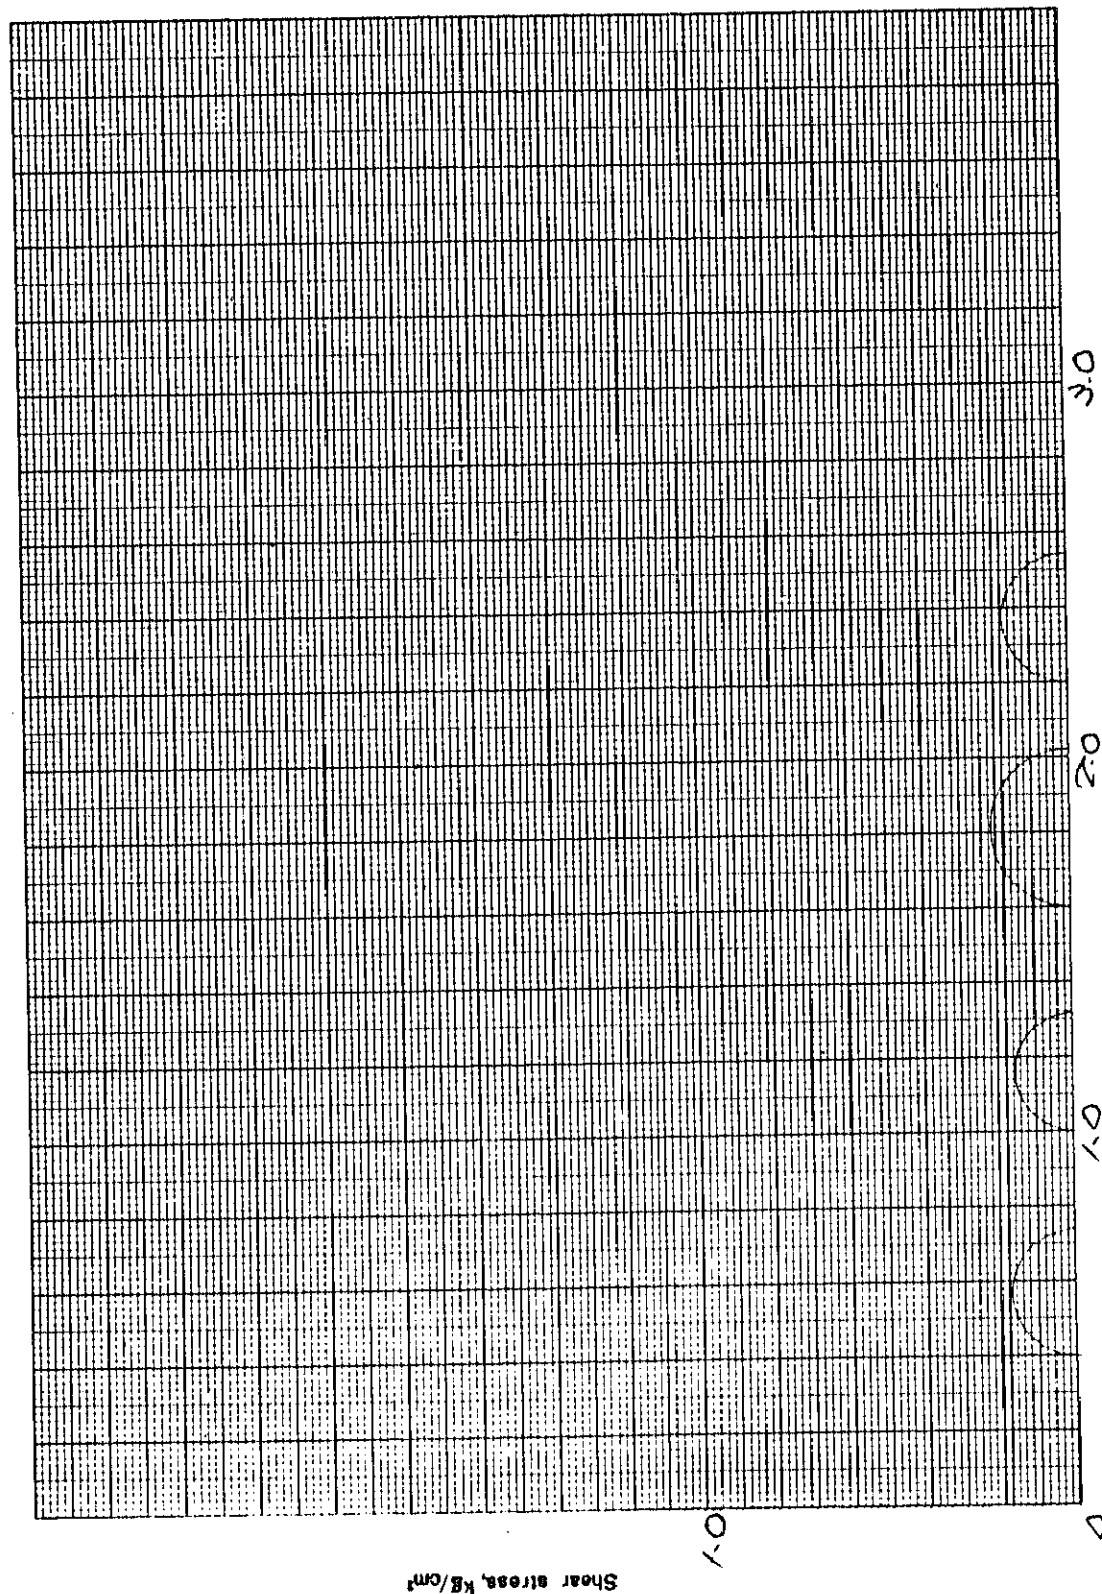
TRIAXIAL COMPRESSION TEST (Mohr's circle)

Project GWADAR MINI PORT Sample No. B-10 S10-7D Top  
 Location of project GWADAR, PAKISTAN Condition of drainage U-U  
 Depth of Sample 8.00 - 8.25 m  
 Angle of internal friction 0°  
 Cohesion 0.18 kg/cm<sup>2</sup>

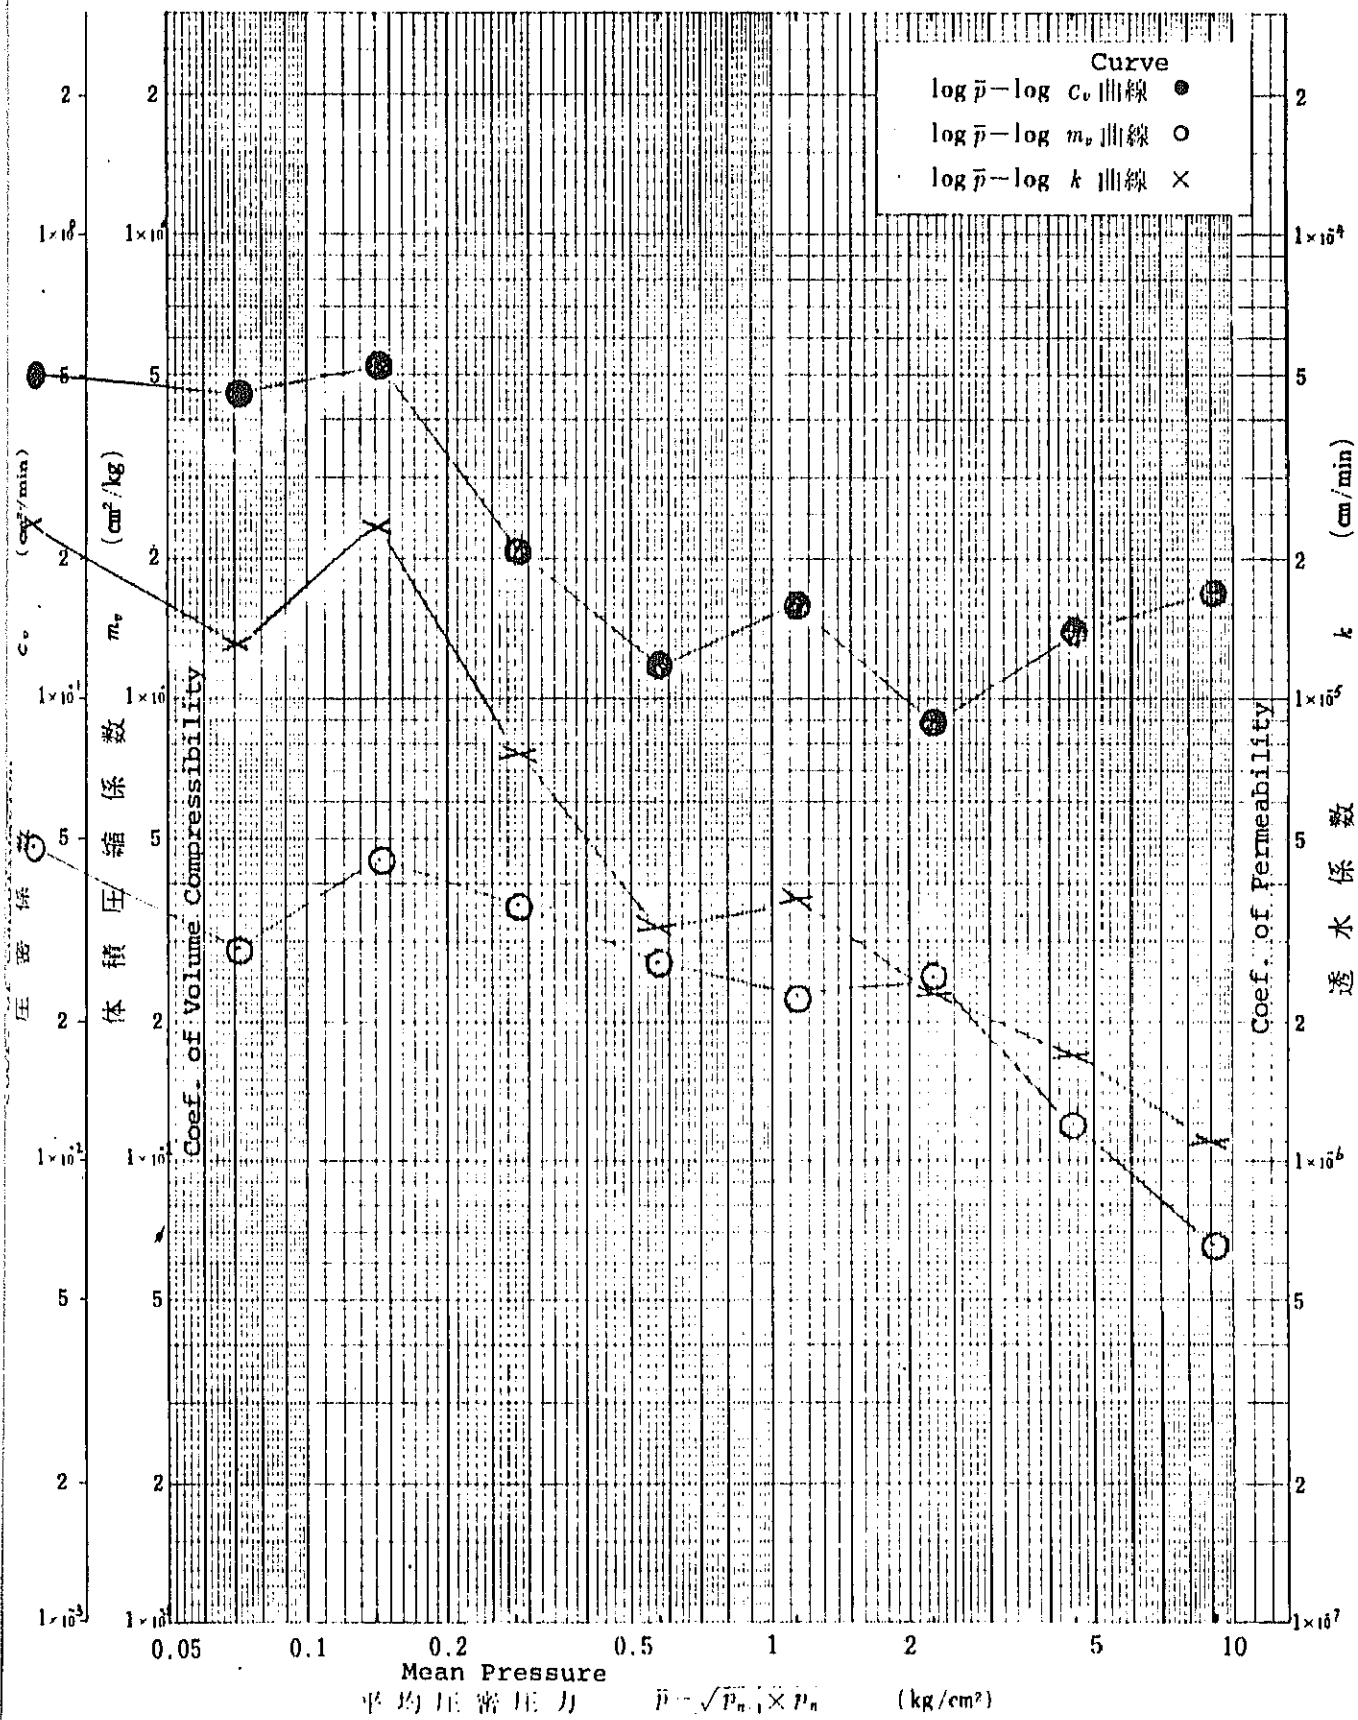
Sample No., Depth: B-1 S1-2 (4.00m-4.83m)

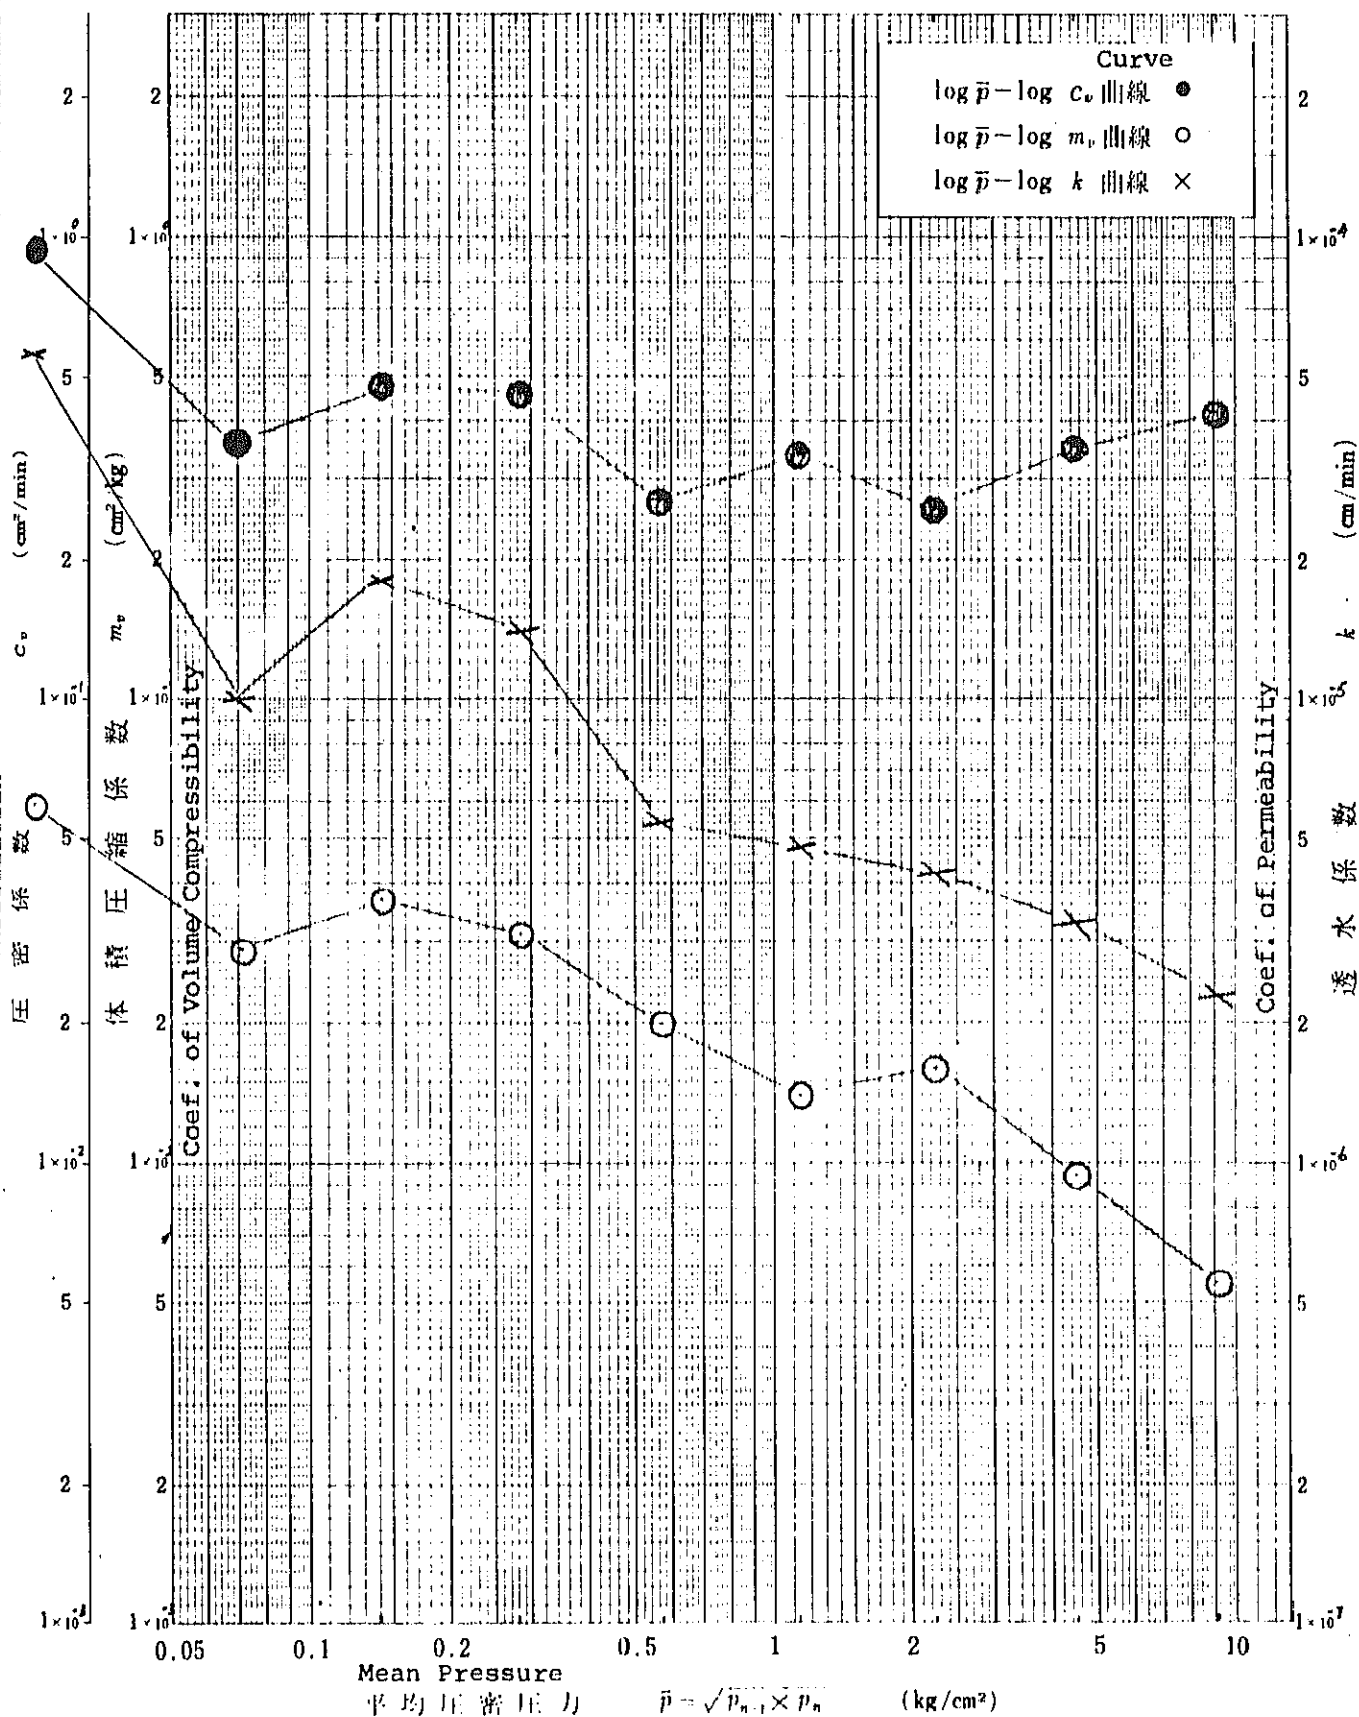
# CONSOLIDATION TEST ( $\bar{p} - c_v, m_v, K$ curves)

Sample No., Depth: B-1 S1-3 (6.00m-6.79m)

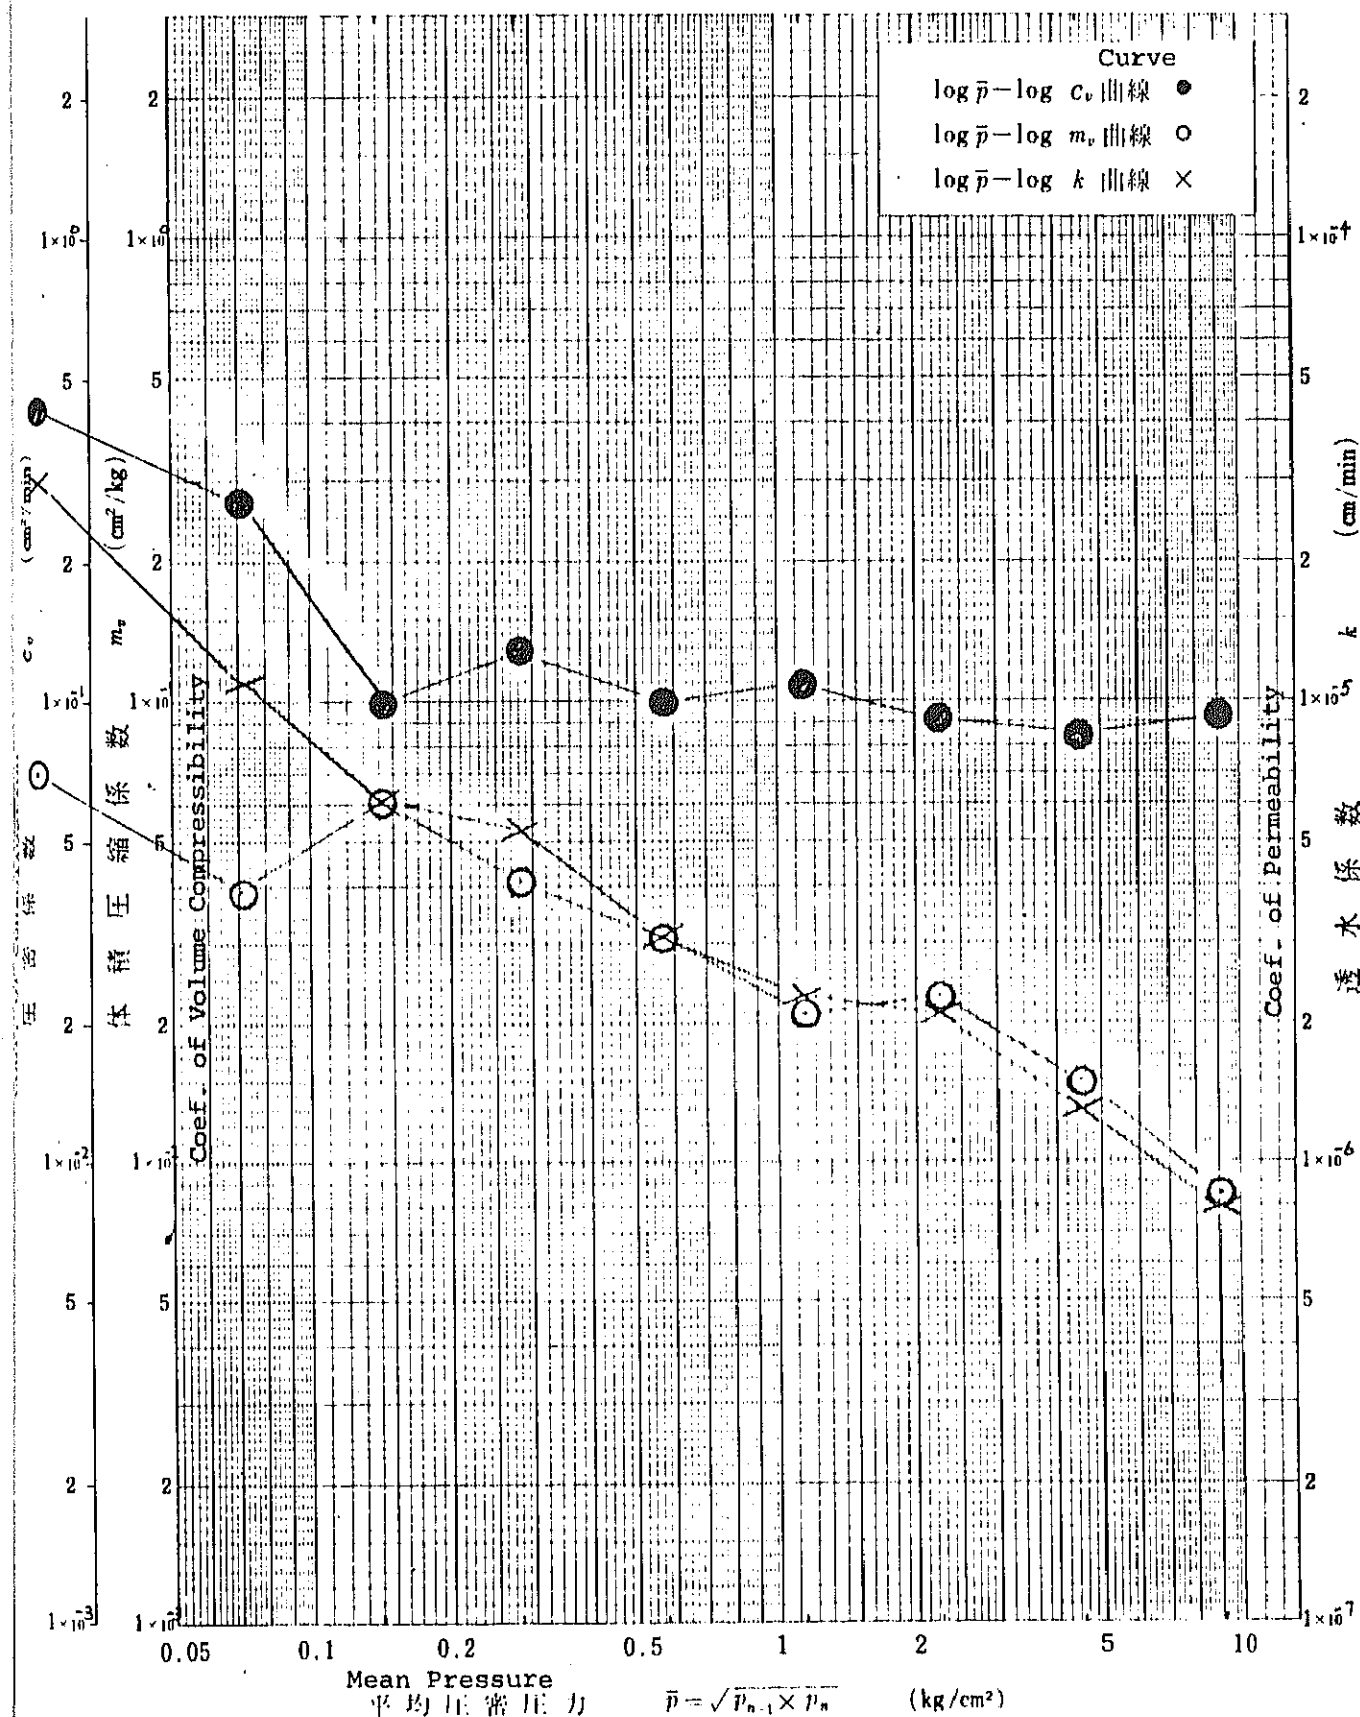
# CONSOLIDATION TEST ( $\bar{p}$ - $c_v$ , $m_v$ , $k$ curves)

Project & Location: GWADAR MINI PORT, PAKISTAN Date of Testing: Dec. 6, 1979  
 Sample No., Depth: B-1 S1-4 ( 9.00m-9.84m) Tested by: T. SAGAE

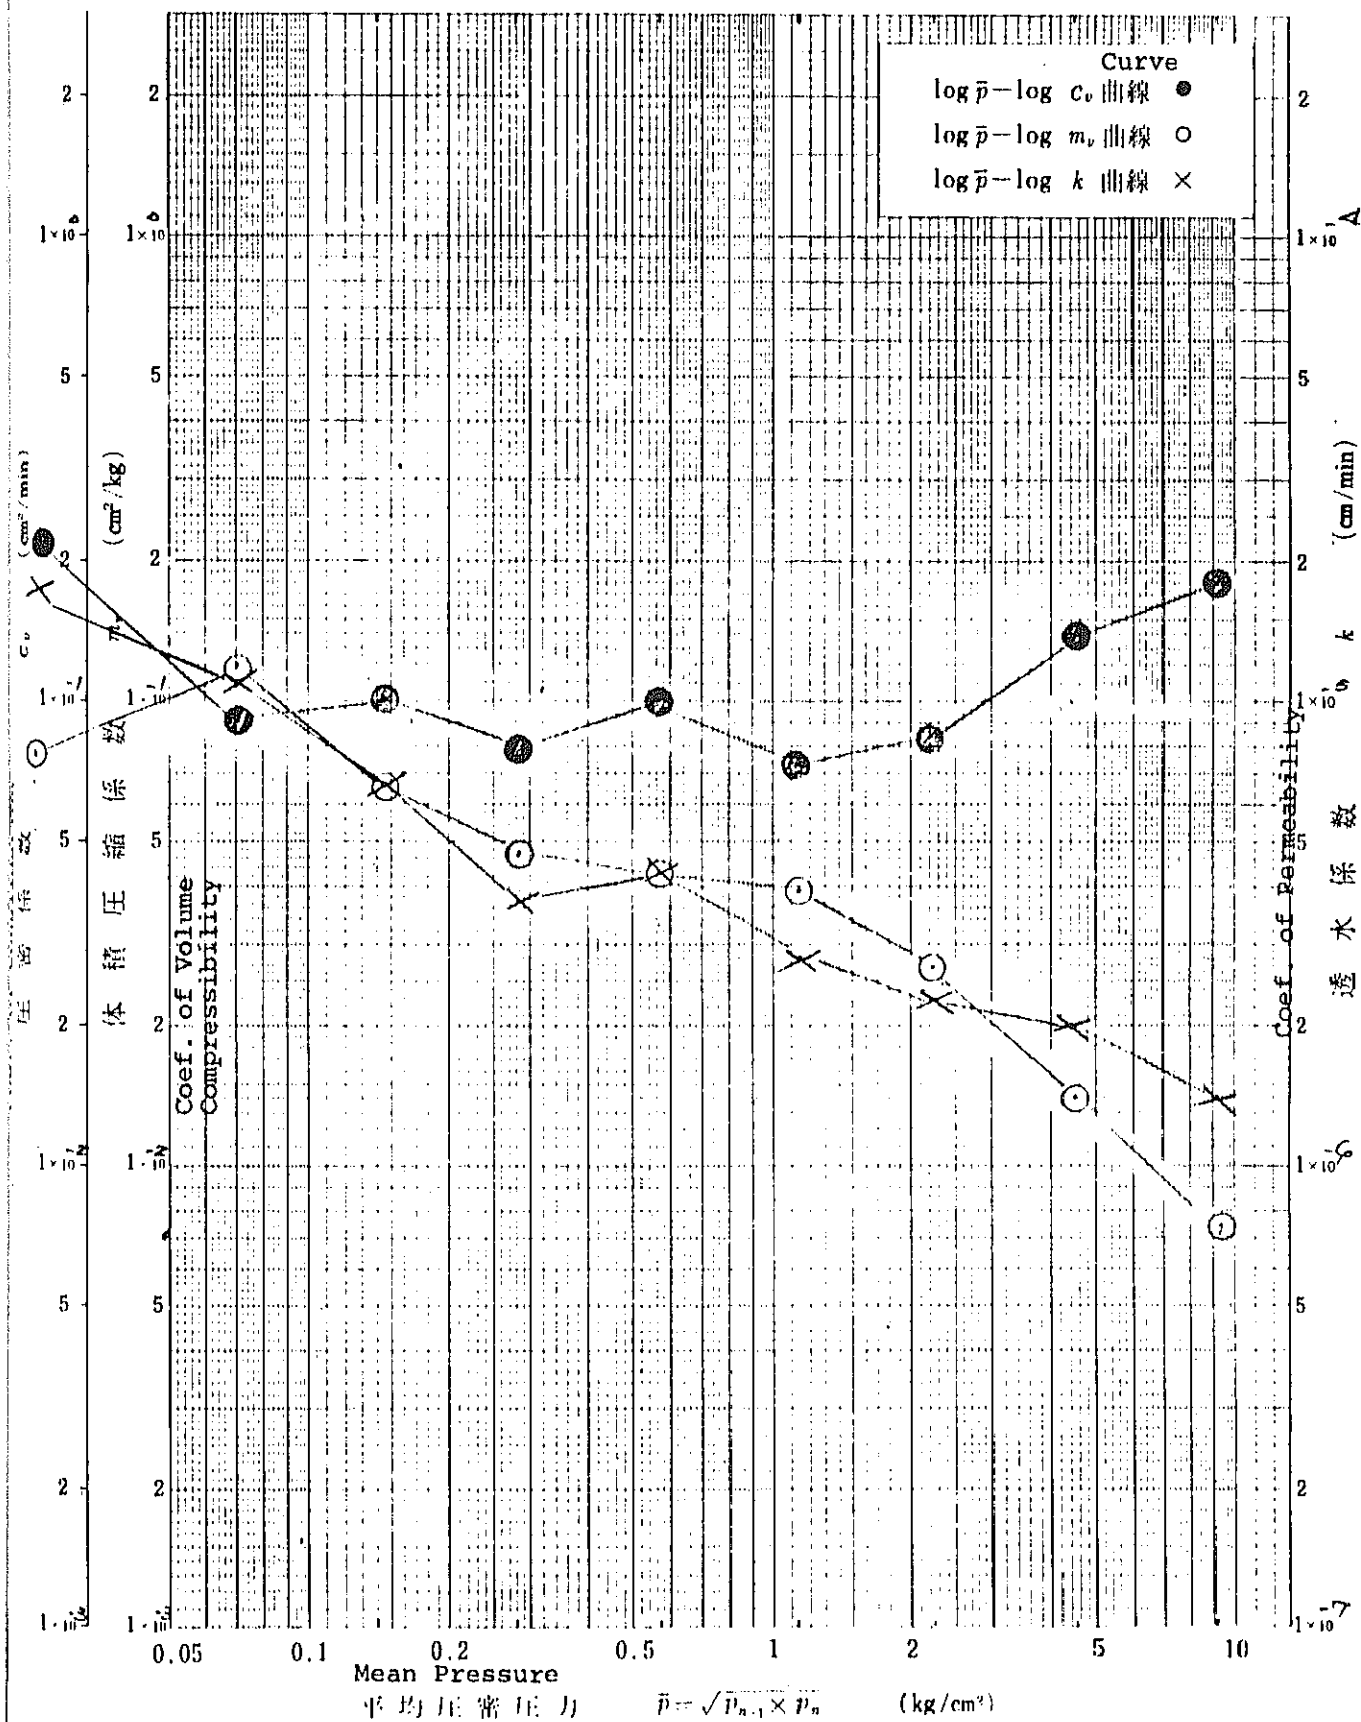
# CONSOLIDATION TEST ( $\bar{p}$ - $c_v$ , $m_v$ , $k$ curves)

Sample No., Depth: B-2 S2 - 1 ( 2.50m - 3.20m)

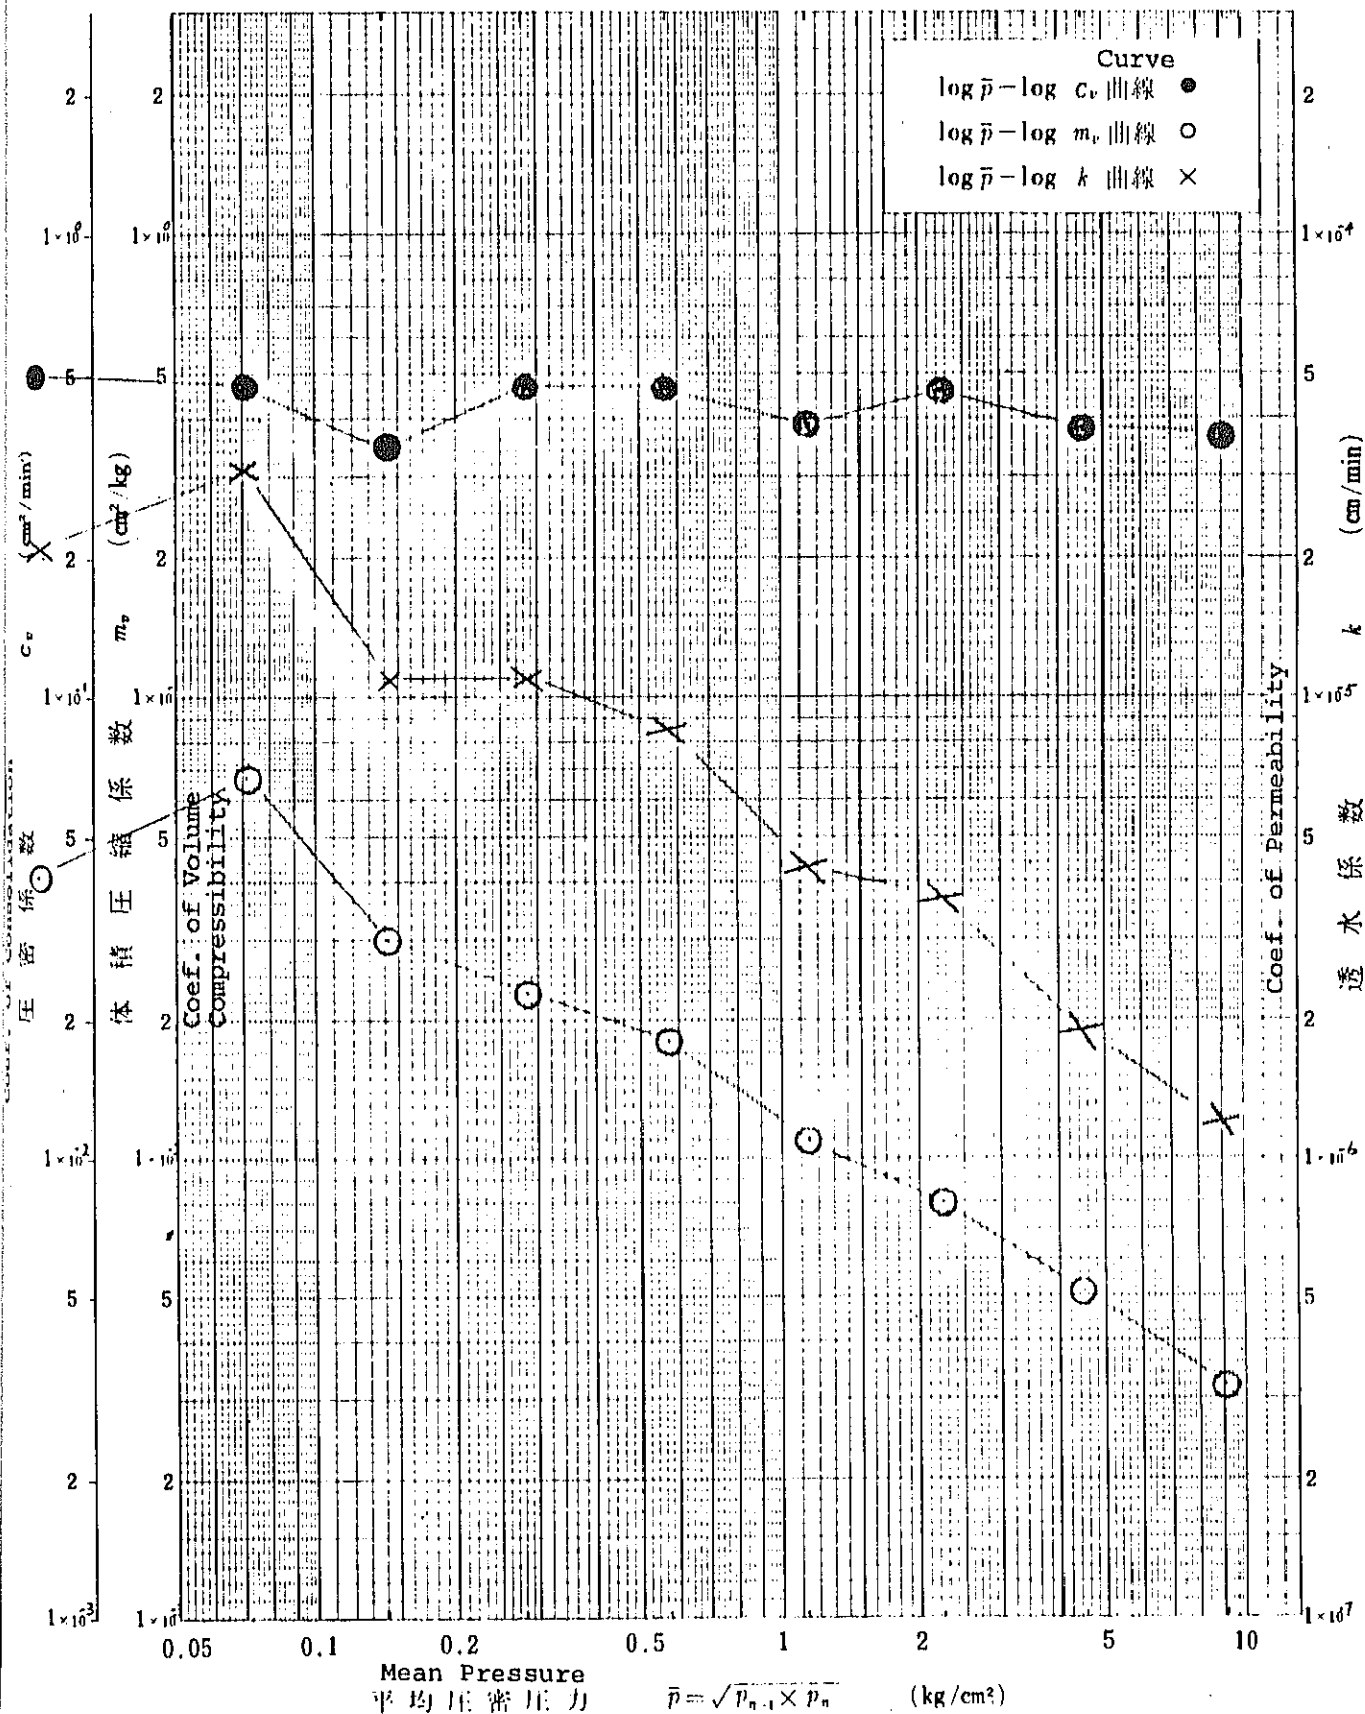
# CONSOLIDATION TEST ( $\bar{p} - c_v, m_v, k$ curves)

Project & Location: GWADAR MINI PORT, PAKISTAN Date of Testing: Oct. 31, 1979  
 Sample No., Depth: B-2 S2 - 2 (4.00 m - 4.70m) Tested by: T. SAGAE

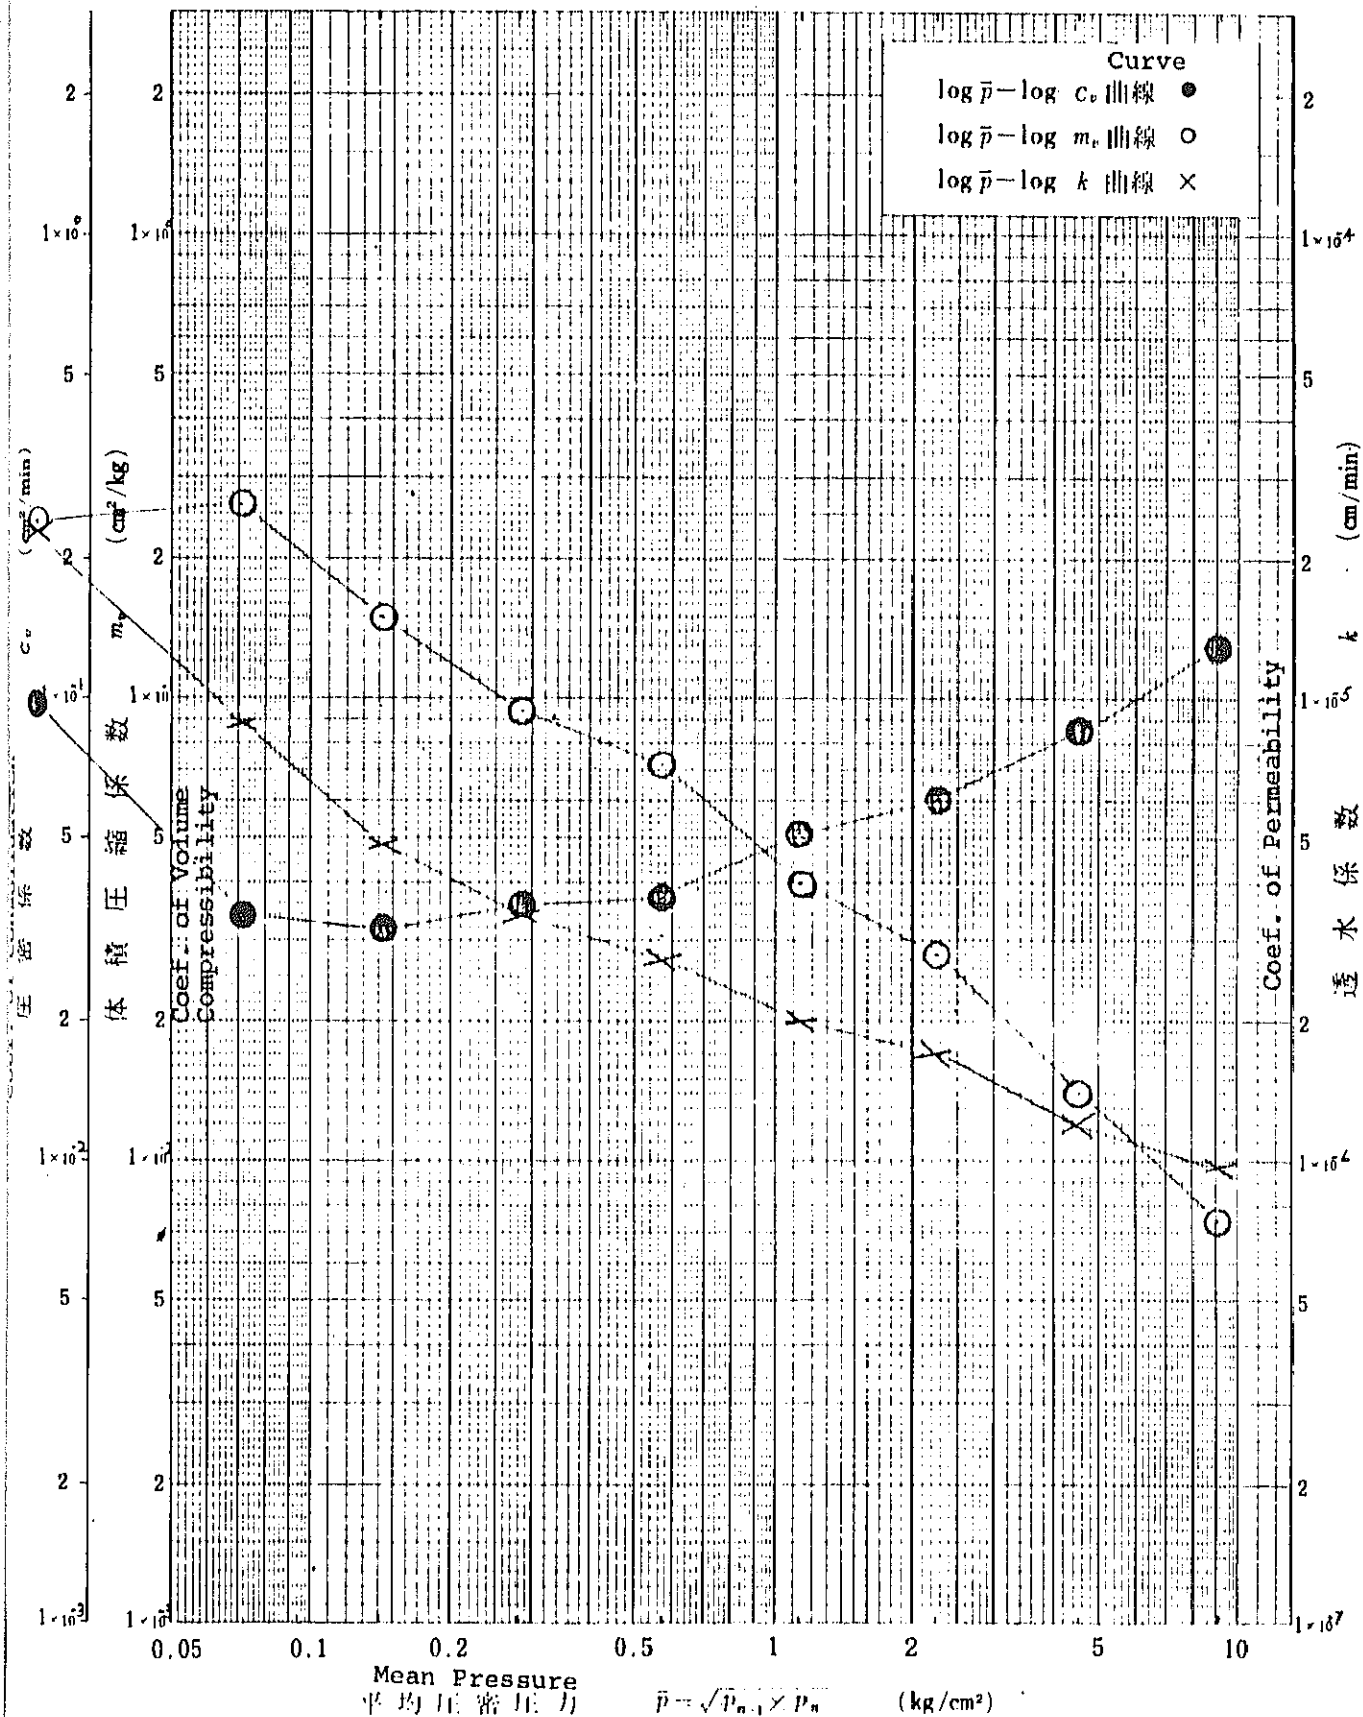
# CONSOLIDATION TEST ( $\bar{p} - c_v, m_v, K$ curves)

Sample No., Depth: B-3 S3 -2 (3.00 m - 3.80m) Tested by: T. SAGAE

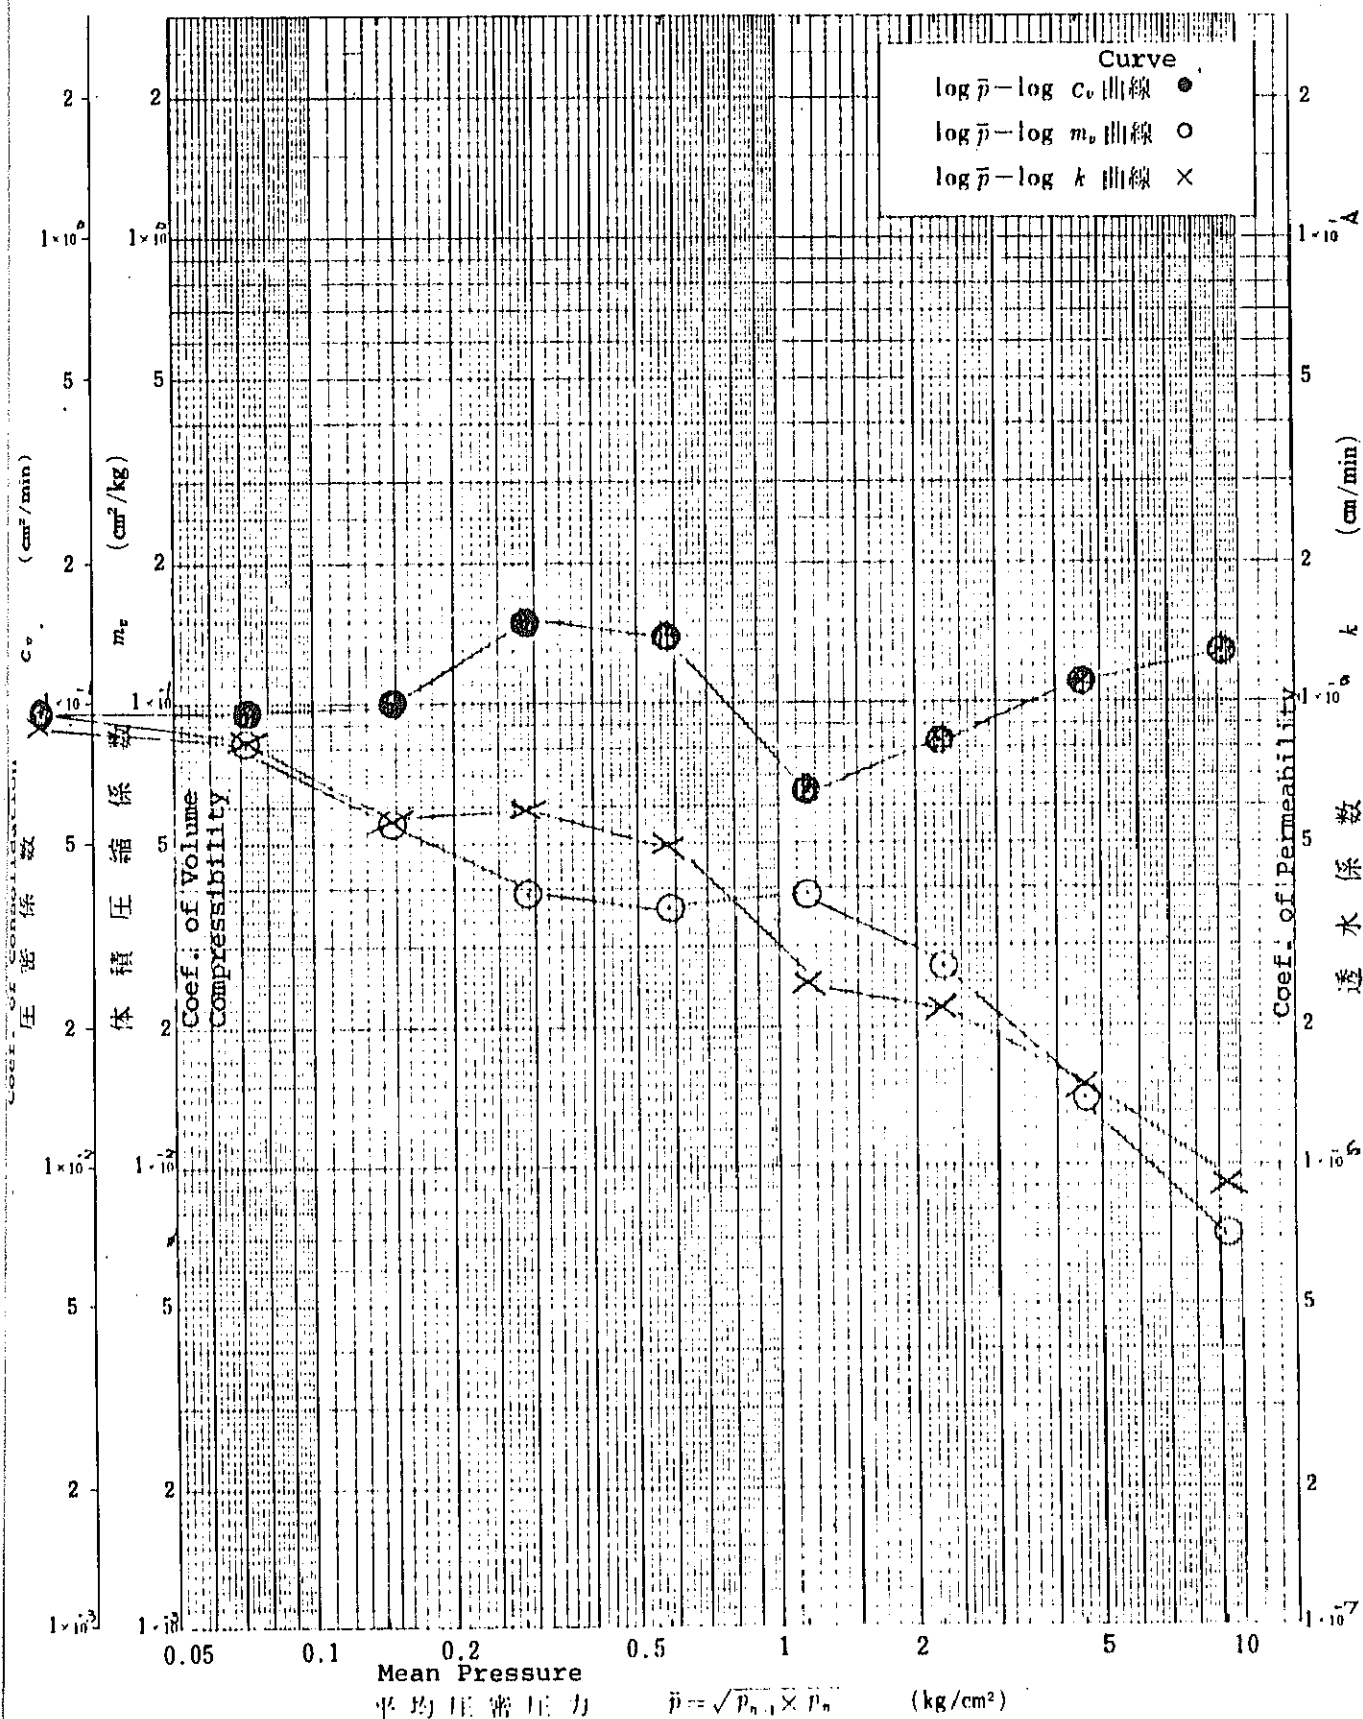
# CONSOLIDATION TEST ( $\bar{p} - c_v, m_v, k$ curves)

Project & Location: GWADAR MINI PORT, PAKISTAN Date of Testing: Oct. 31, 1979  
 Sample No., Depth: B-3 S3 - 3 ( 5.00m - 5.82m) Tested by: T. SAGAE
