Project GWADAR MINI PORT Sample No. B-6 S6-1  
 Location of project GWADAR, PAKISTAN Condition of drainage U-U

TRIAXIAL COMPRESSION TEST (Mohr's circle)

# CONSOLIDATION TEST ( $\bar{p} - c_v, m_v, K$ curves)

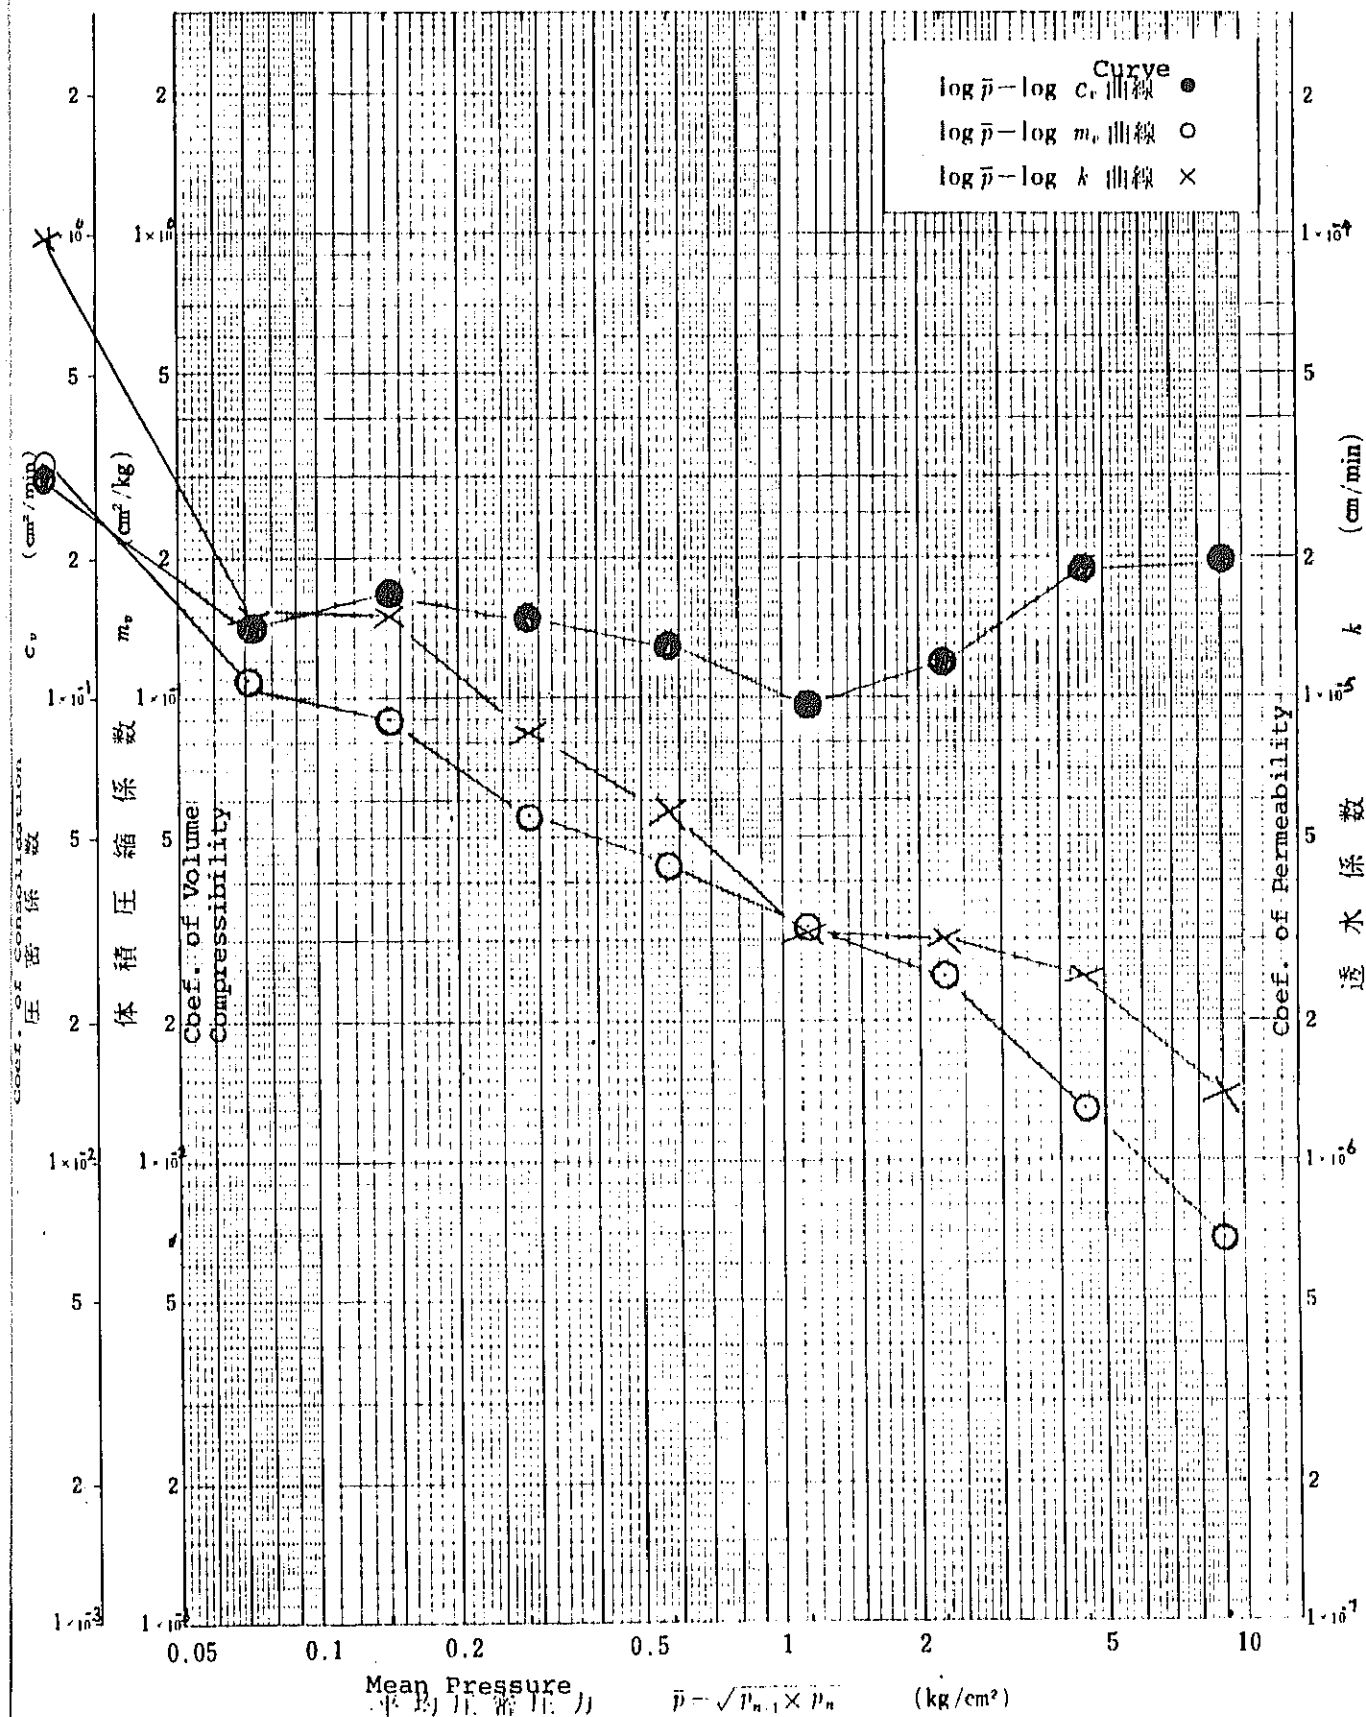
# CONSOLIDATION TEST ( $\bar{p} - c_v, m_v, k$ curves)

Sample No., Depth: B-3! S3'-2 (3.00 m - 3.84m) Tested by: T. SAGAE

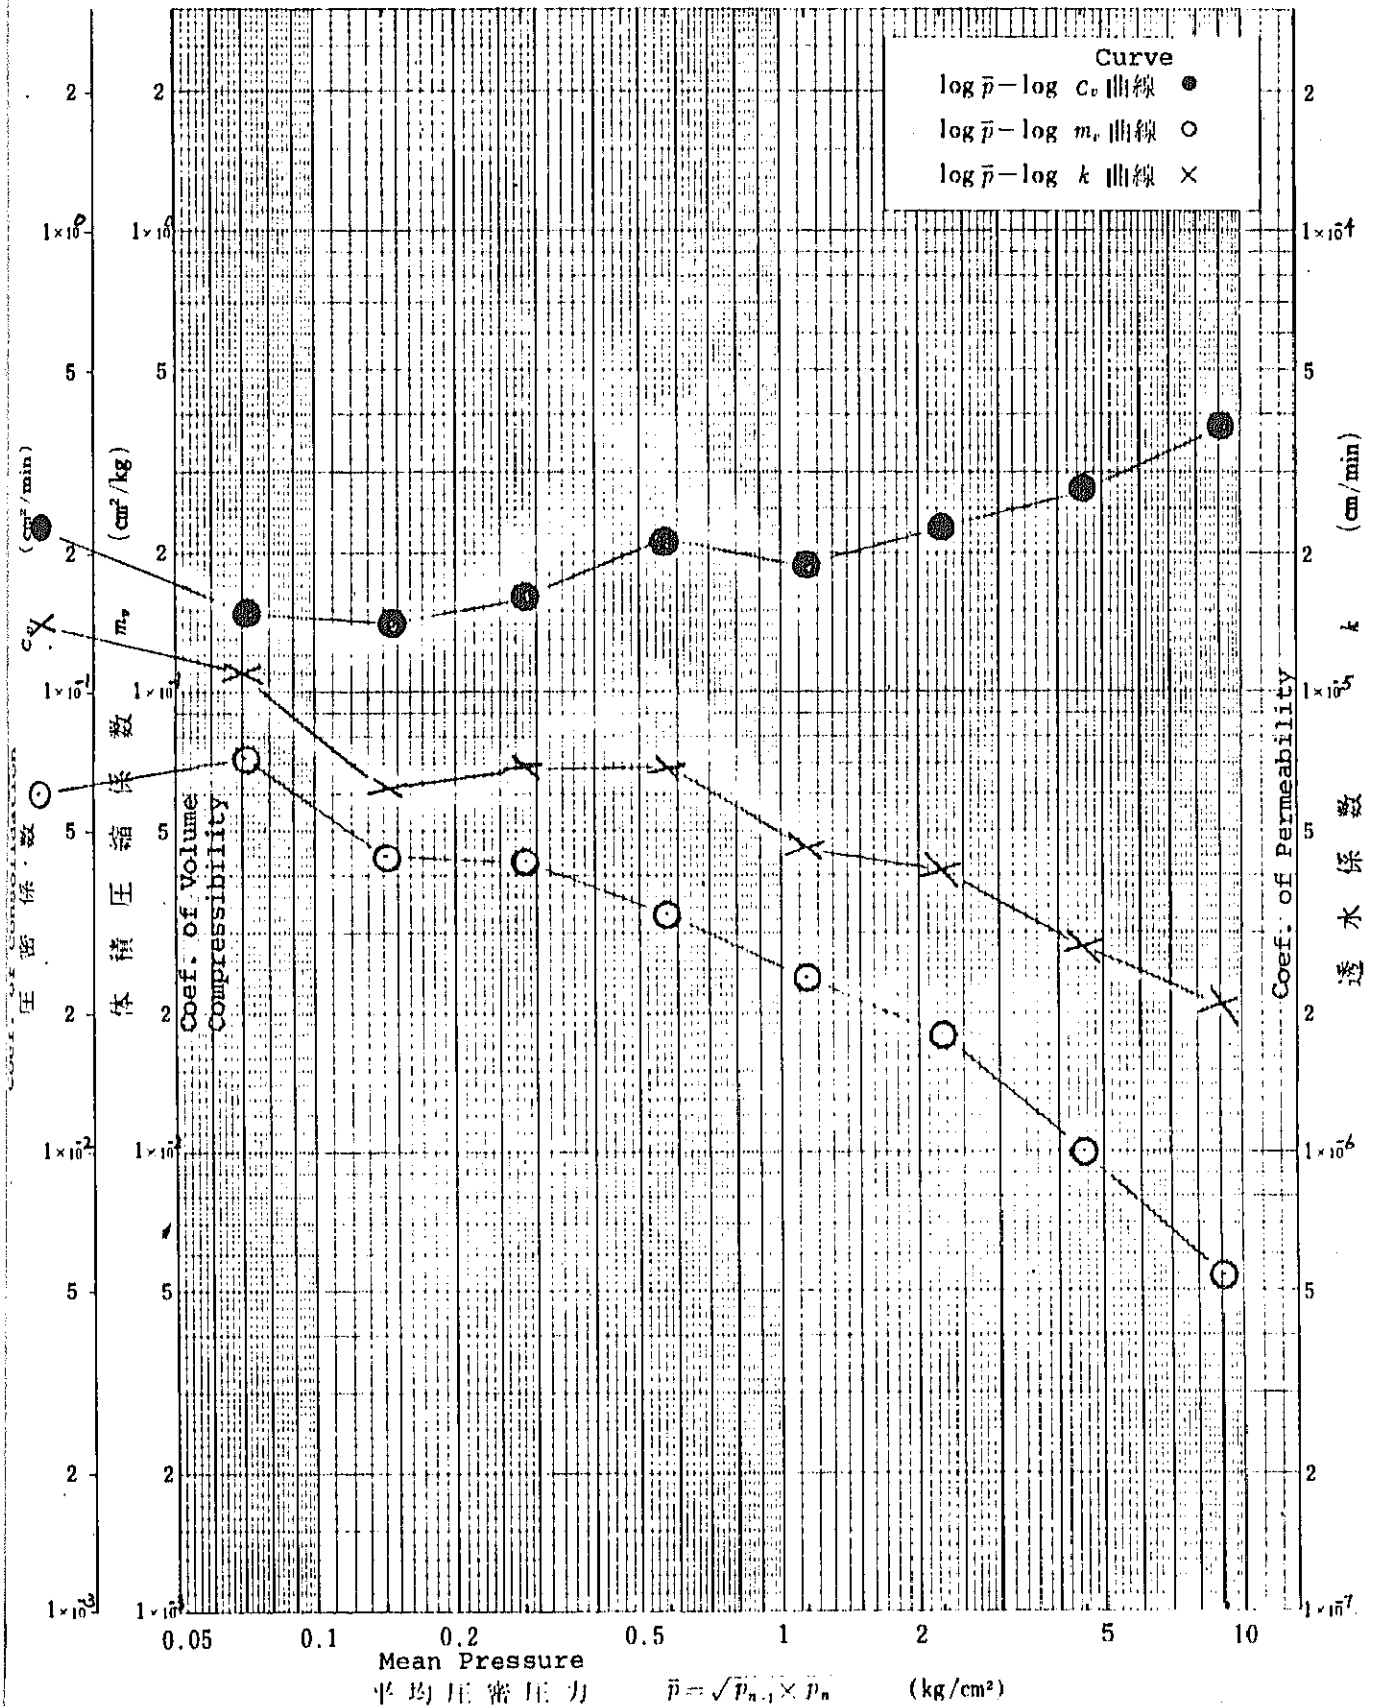
# CONSOLIDATION TEST ( $\bar{p} - c_v, m_v, K$ curves)

Project & Location: GWADAR MINI PORT, PAKISTAN Date of Testing: Dec. 6, 1979  
 Sample No., Depth: B-3' S3'- 4 (5.00 m - 5.85m) Tested by: T. SAGAE

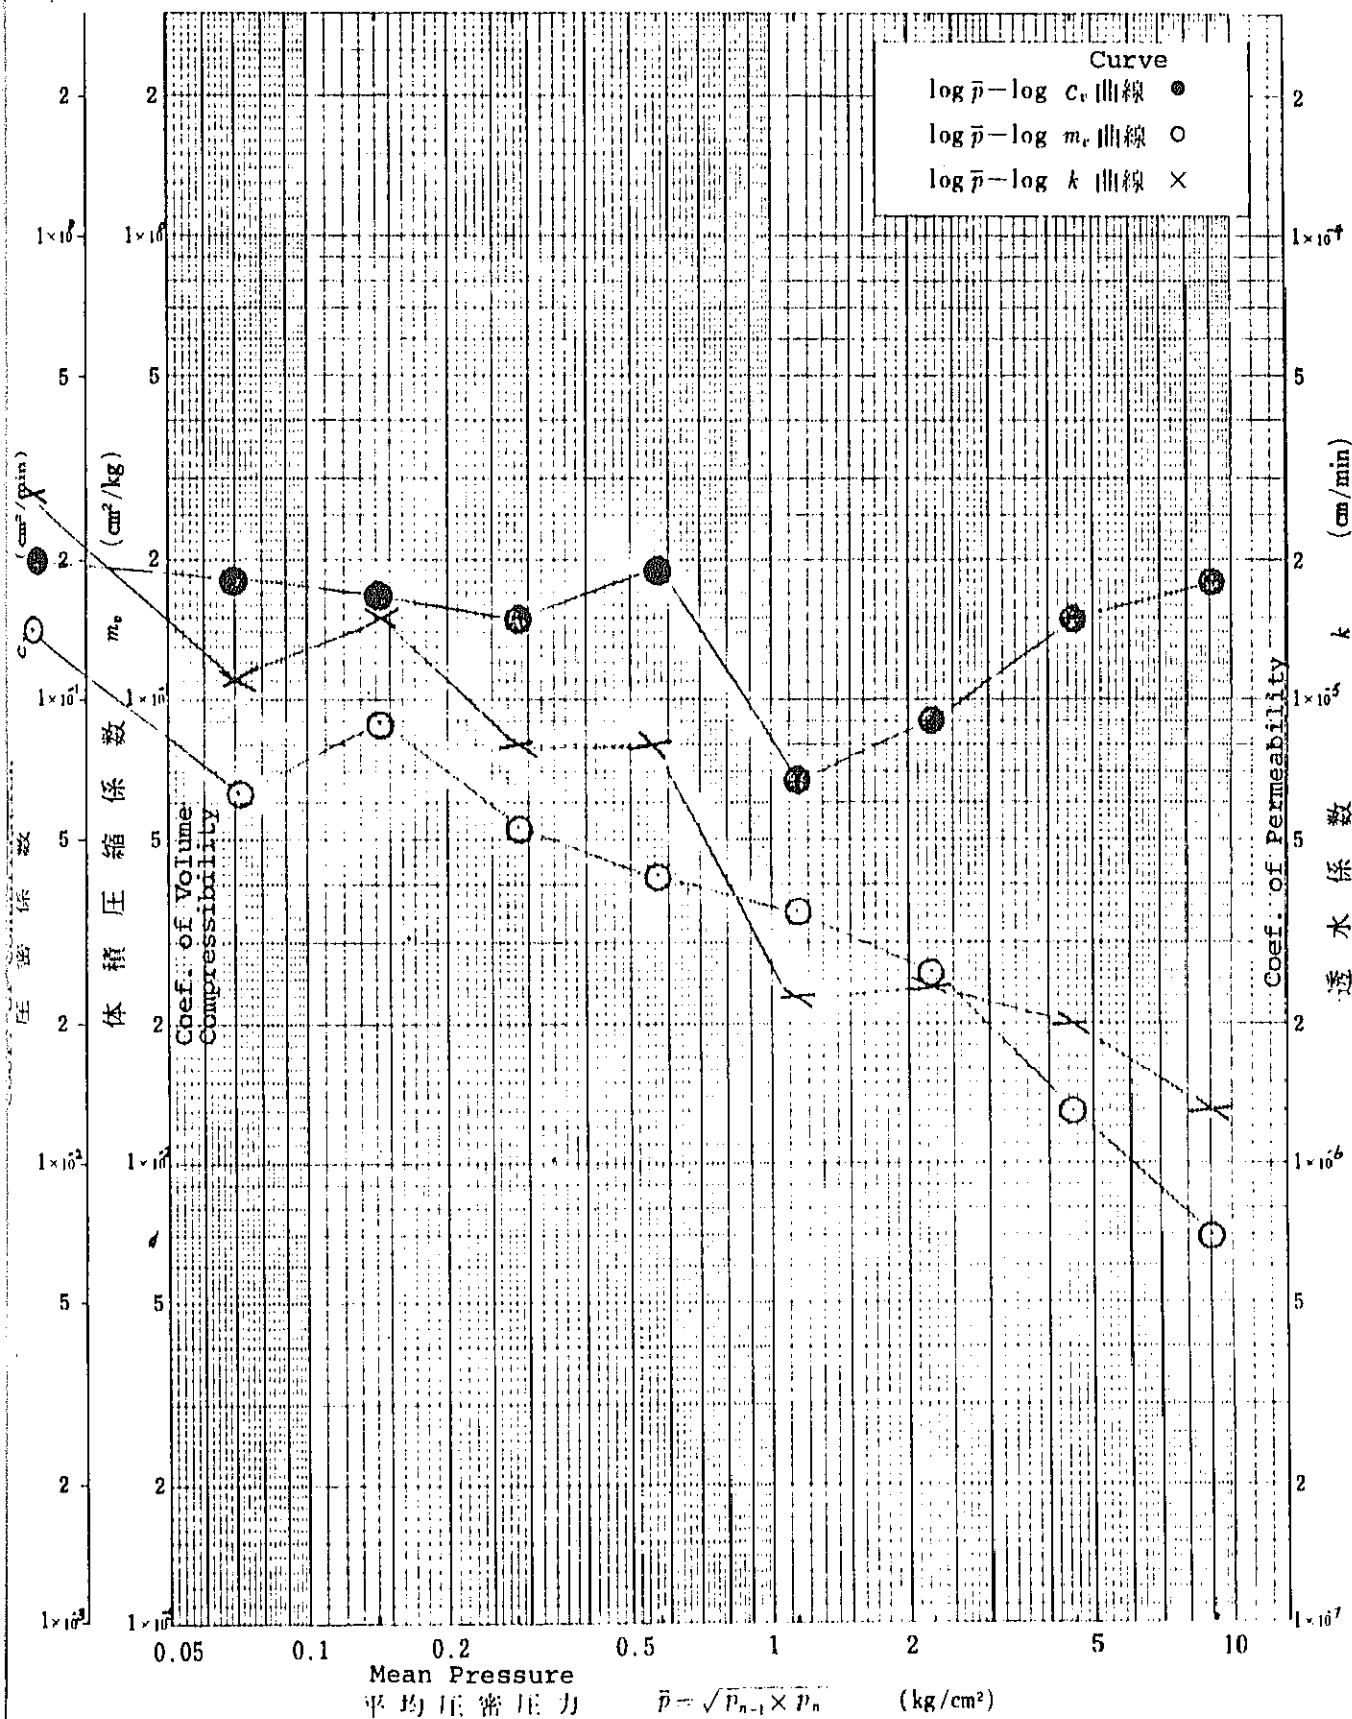
# CONSOLIDATION TEST ( $\bar{p} - c_v, m_v, K$ curves)

Sample No., Depth: B-4 S4-3 (4.00m-4.85m) Tested by: T. SAGAE

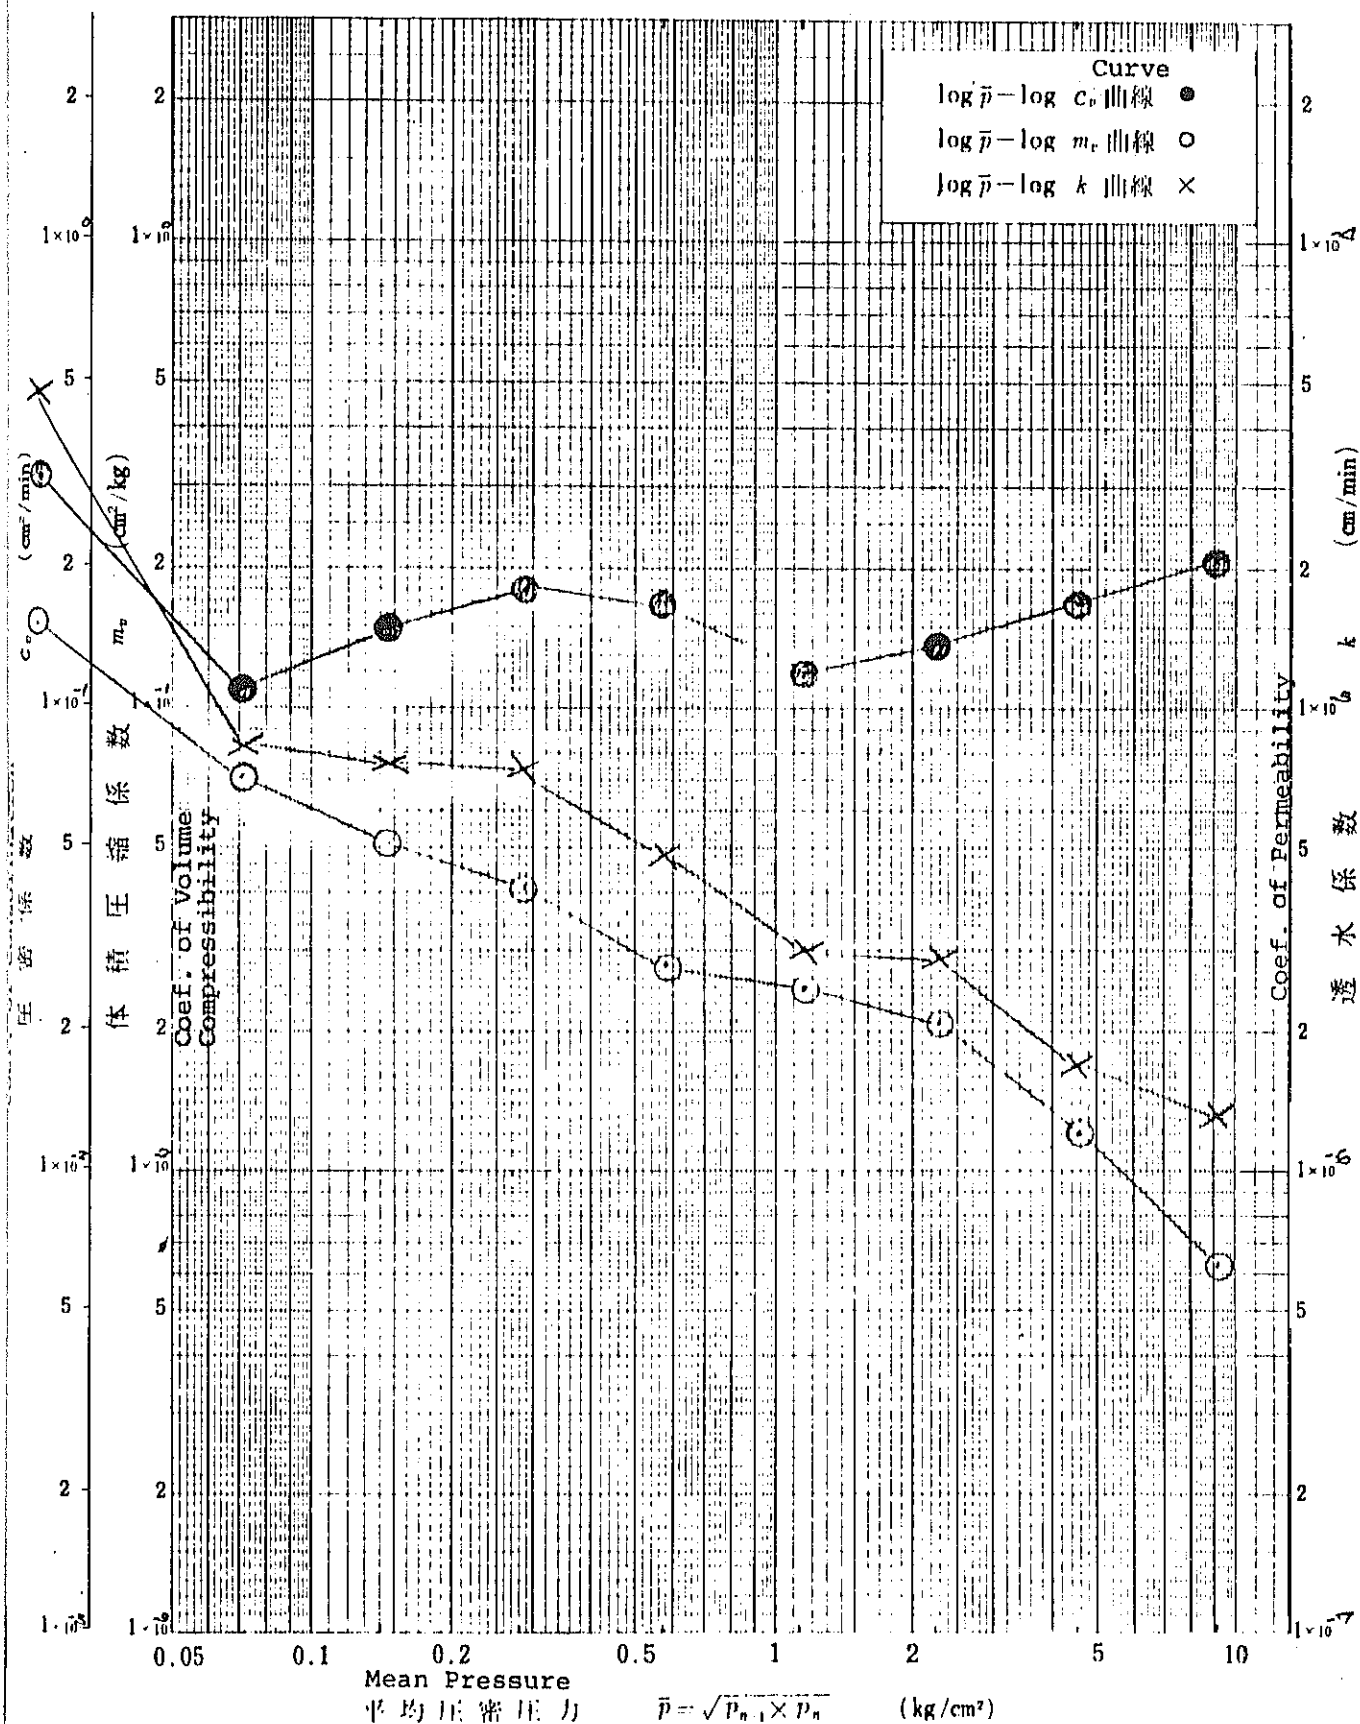
# CONSOLIDATION TEST ( $\bar{p} - c_v, m_v, K$ curves)

Sample No., Depth: B-4 S4 - 4 ( 5.00m - 5.50m) Tested by: T. SAGAE  
 .....Top.....

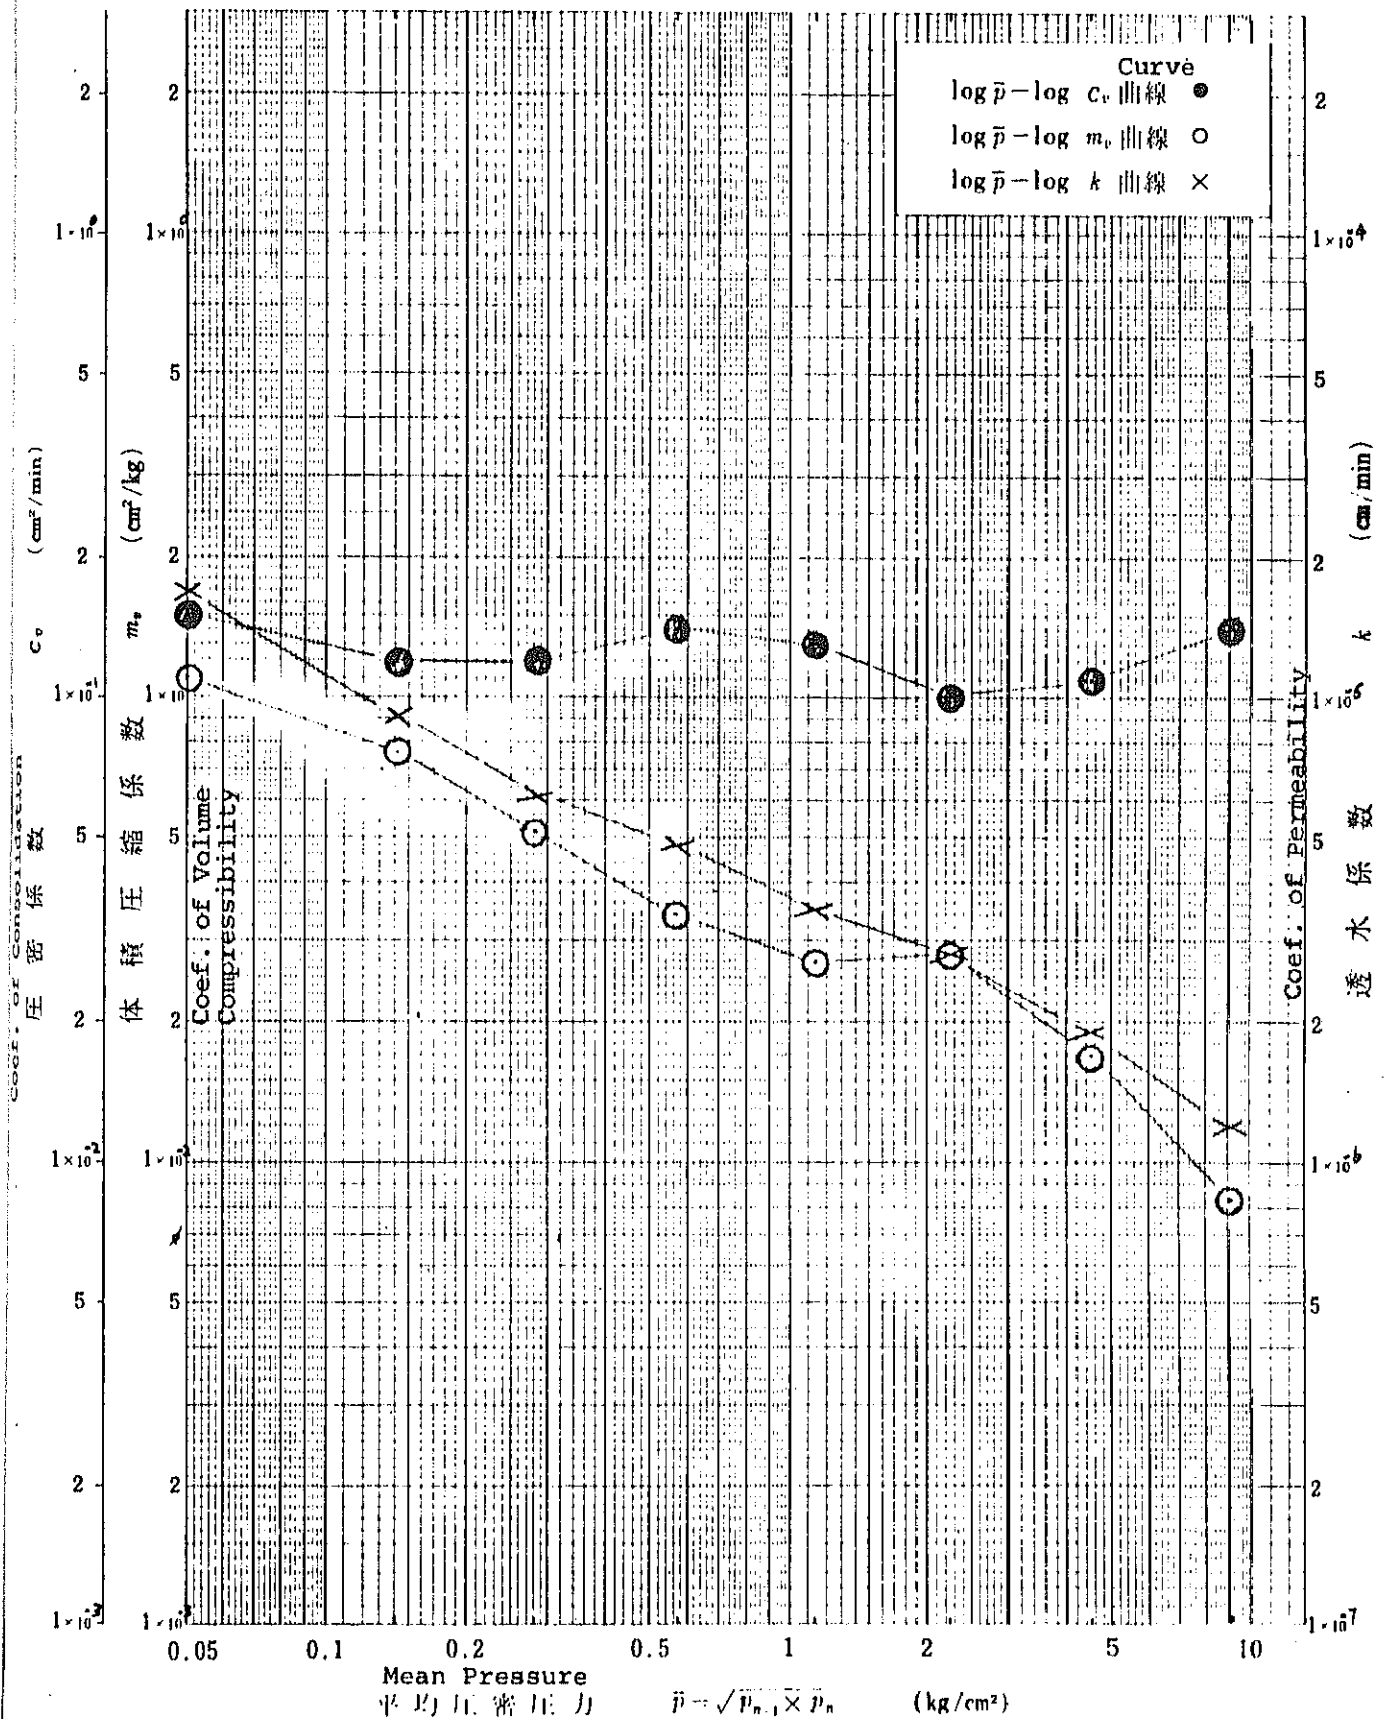
# CONSOLIDATION TEST ( $\bar{p} - c_v, m_v, K$ curves)

Sample No., Depth: B-4 S 4-6D (11.00m-11.67m)

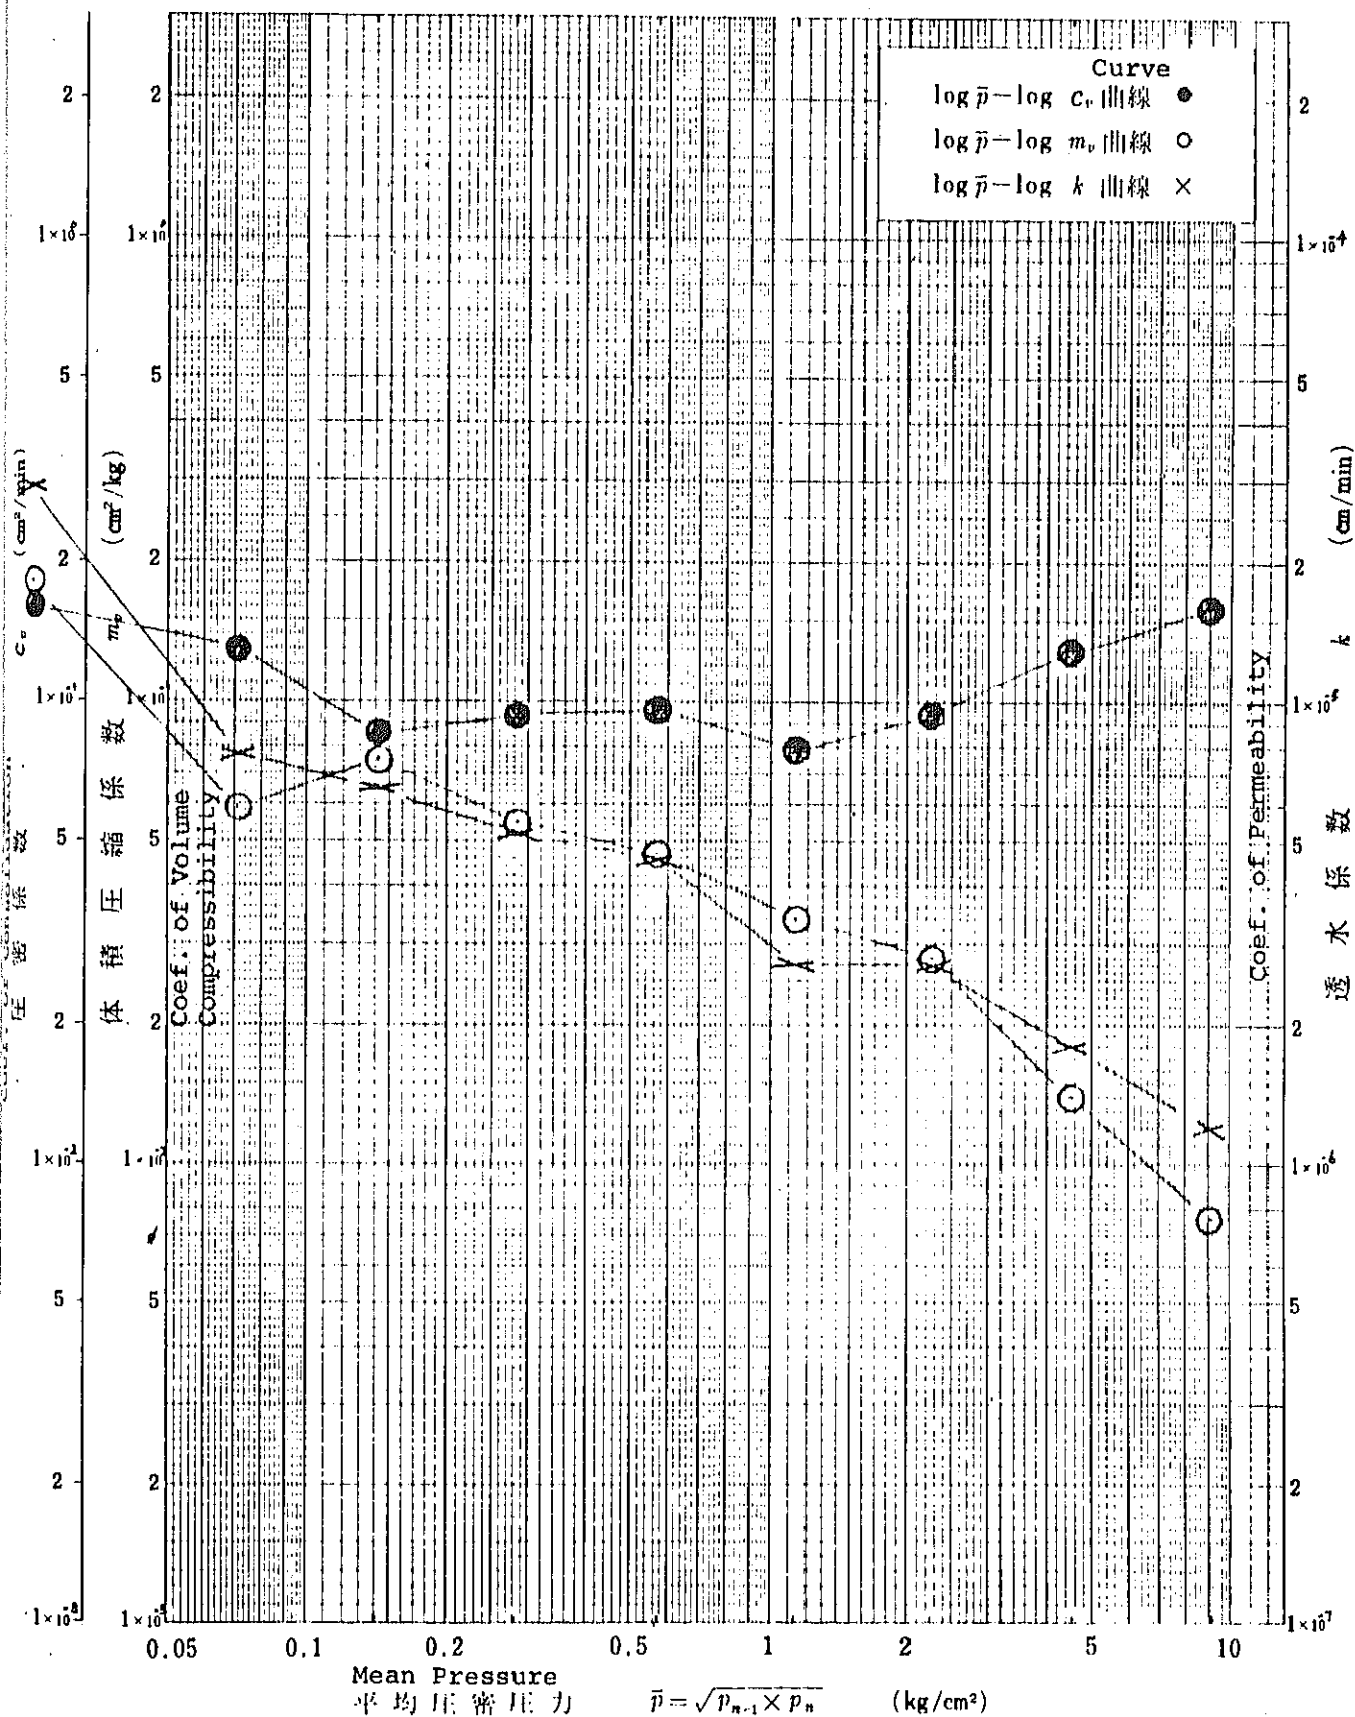
# CONSOLIDATION TEST ( $\bar{p} - c_v, m_v, K$ curves)

Sample No., Depth: B-5 S5 - 1 (3.00m-3.74m)

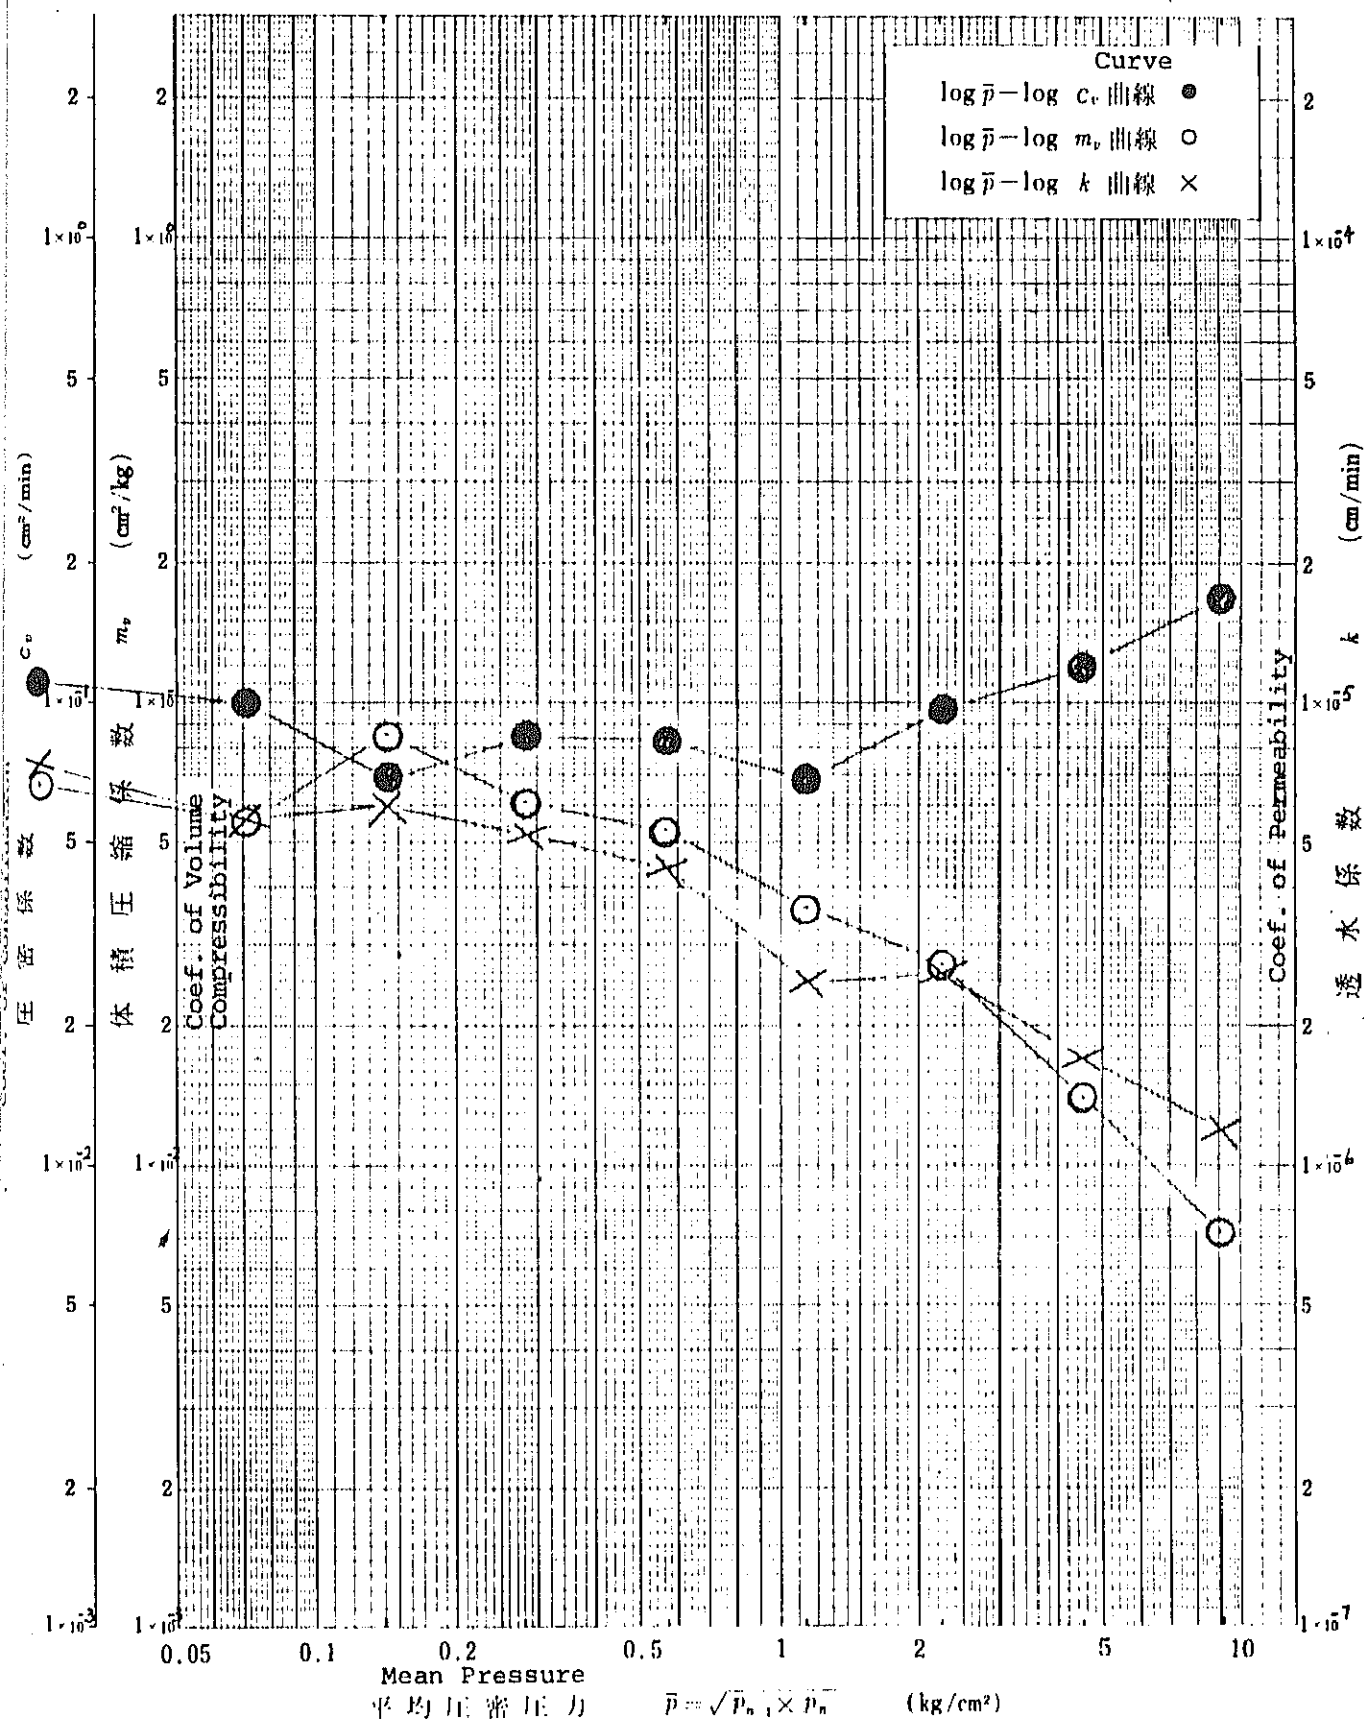
# CONSOLIDATION TEST ( $\bar{p} - c_v, m_v, k$ curves)

Sample No., Depth: B-6 S6 - 1 (2.00m - 2.87m)

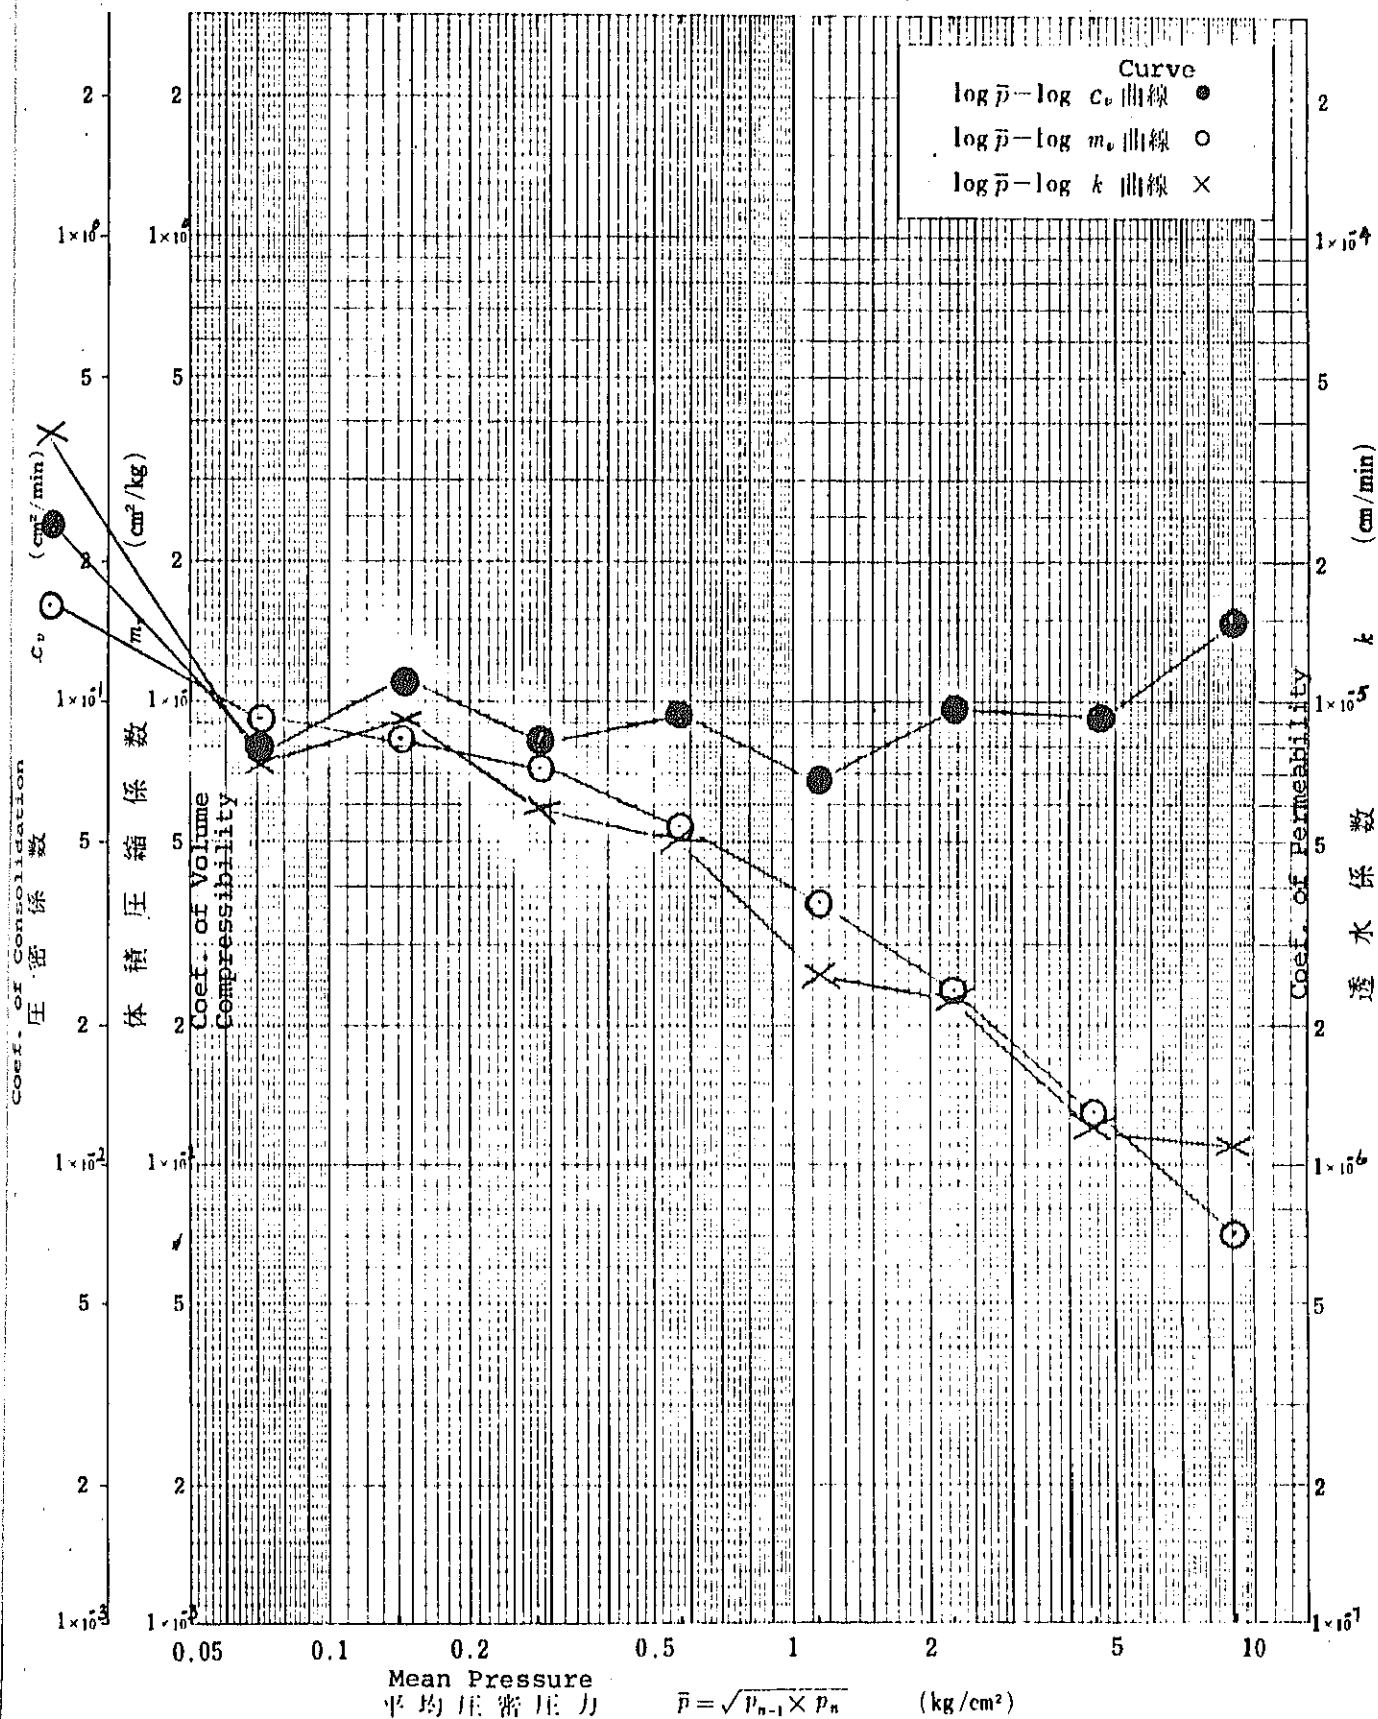
# CONSOLIDATION TEST ( $\bar{p} - c_v, m_v, K$ curves)

Sample No., Depth: B-6 S6-3 (6.00 m - 6.86m)

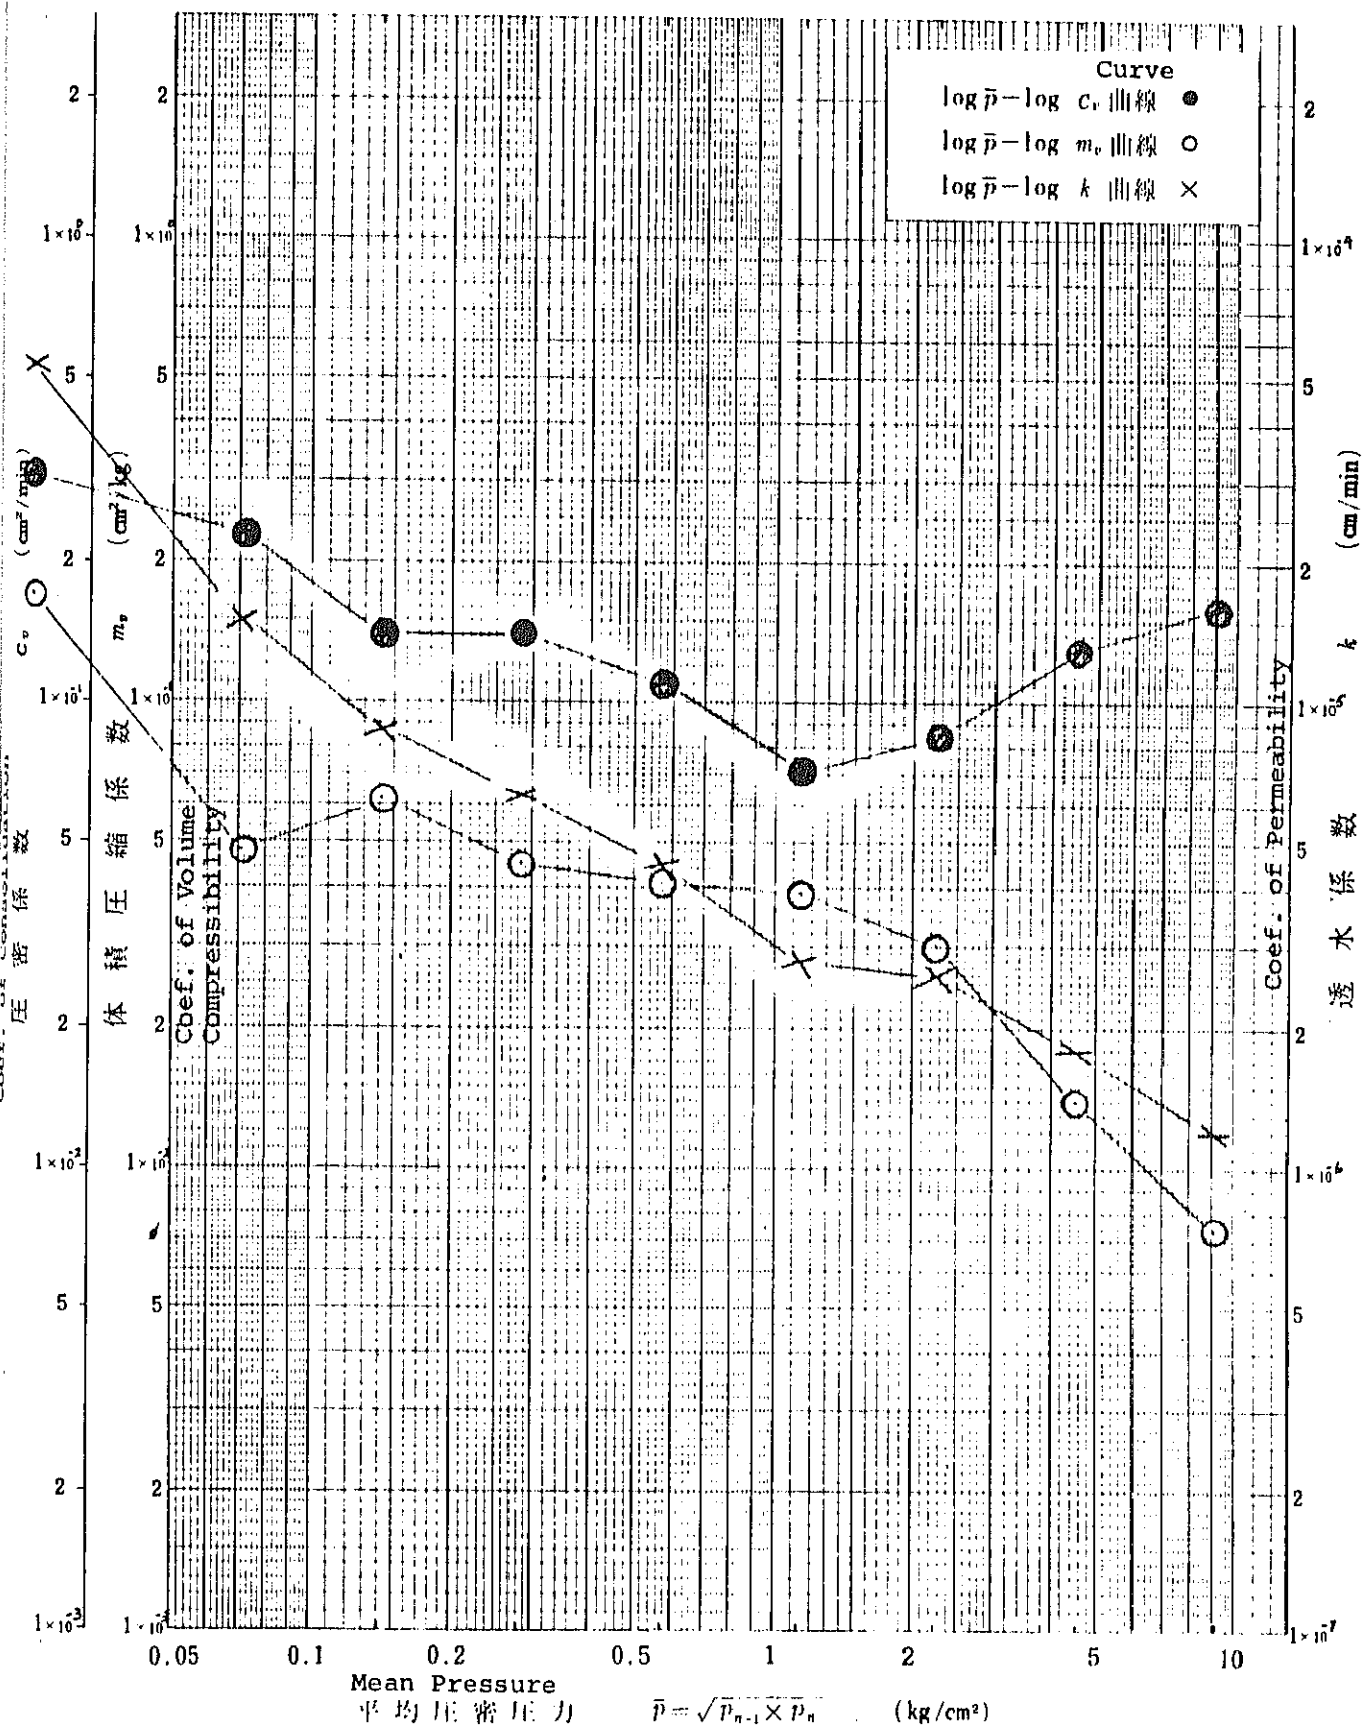
# CONSOLIDATION TEST ( $\bar{p} - c_v, m_v, K$ curves)

Sample No., Depth: B-7 S7-1 (3.00 m - 3.78m)
