THE REPUBLIC OF VENEZUELA
COMPREHENSIVE IMPROVEMENT
OF THE APURE RIVER BASIN
JAPAN INTERNATIONAL COOPERATION AGENCY

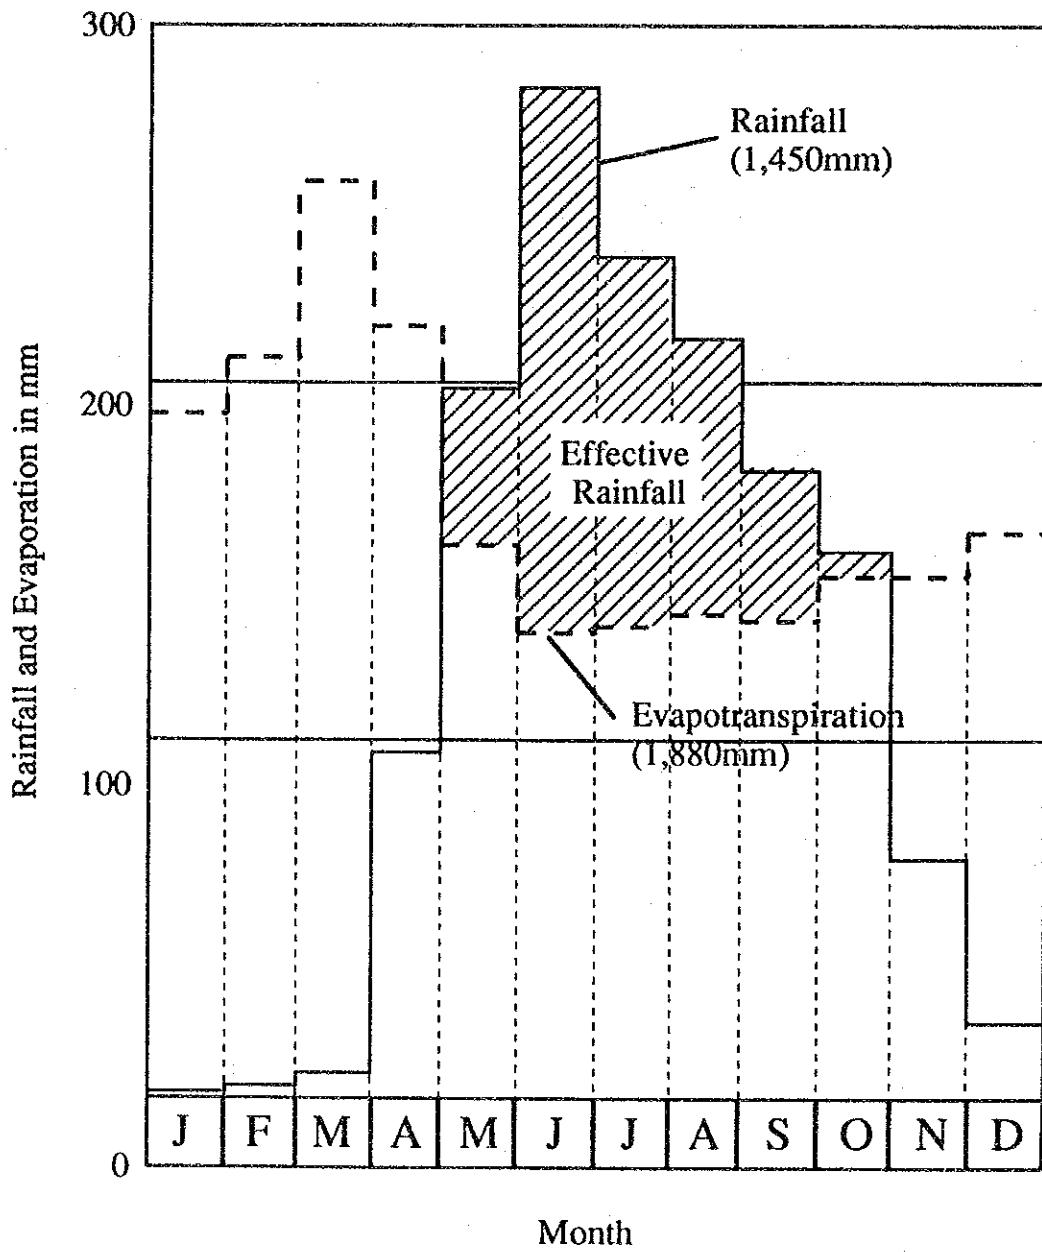
Fig. 6.4.8 Water Balance in Module

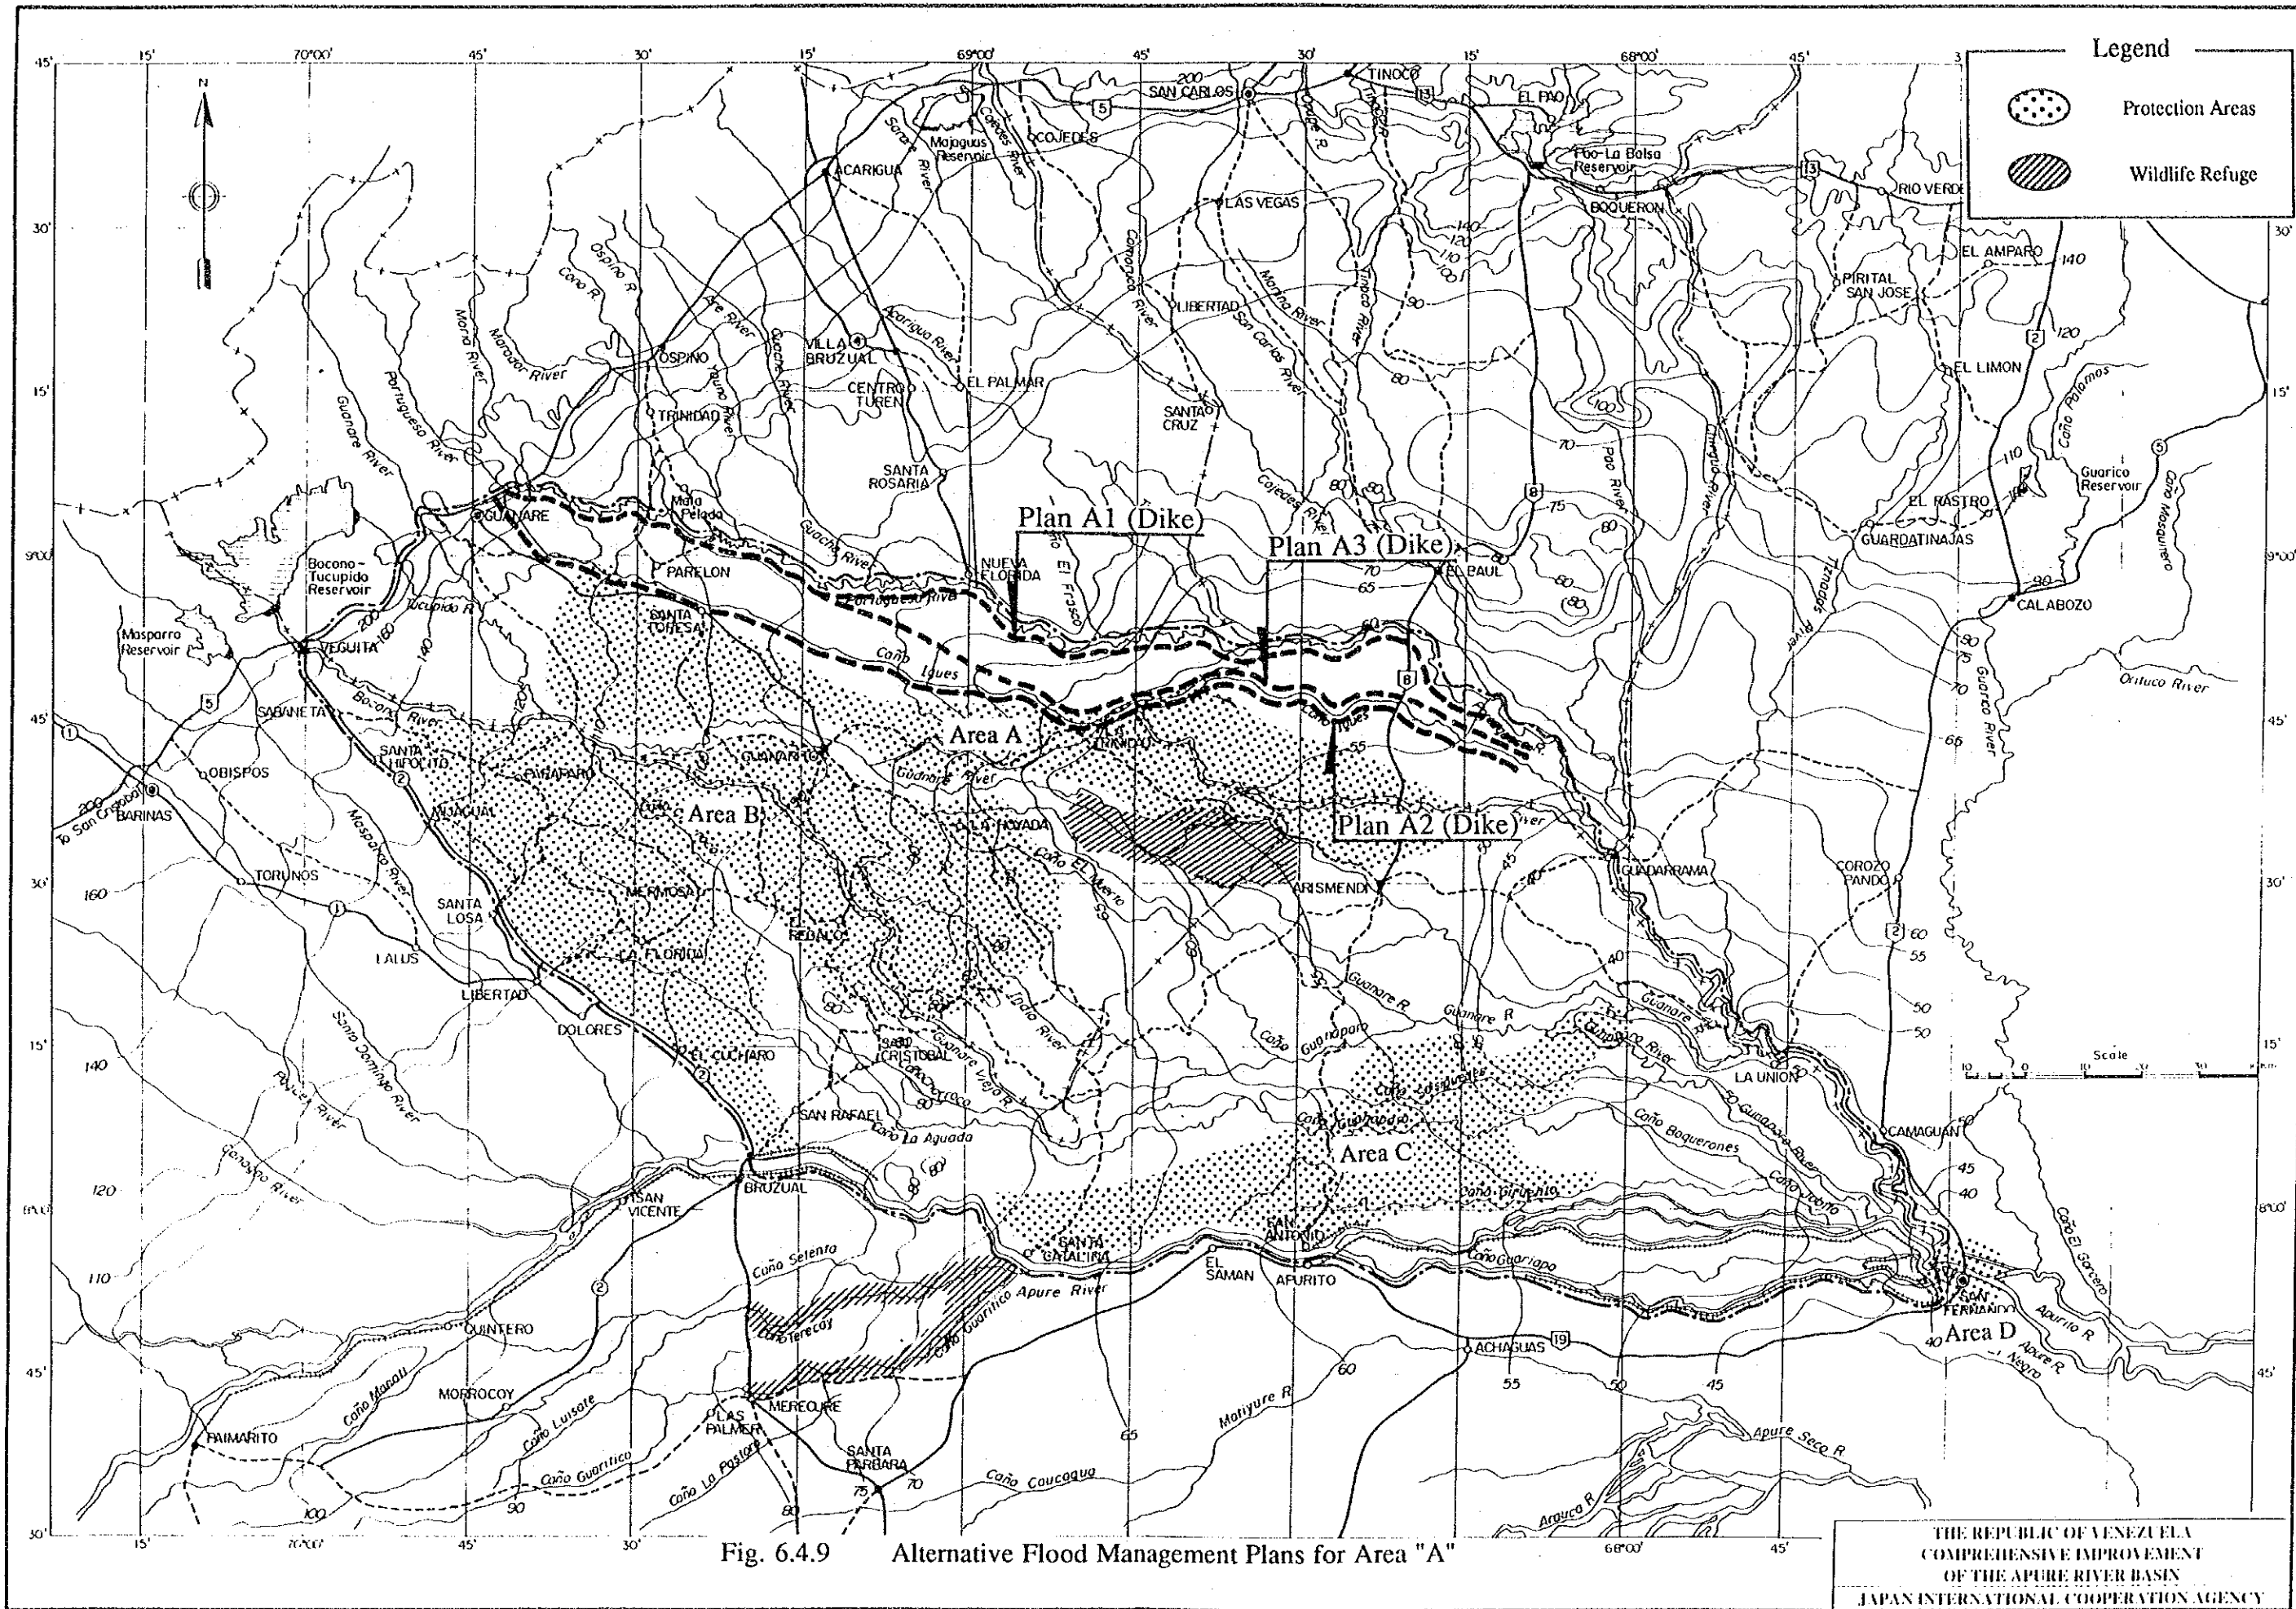
Fig. 6.4.9 Alternative Flood Management Plans for Area "A"

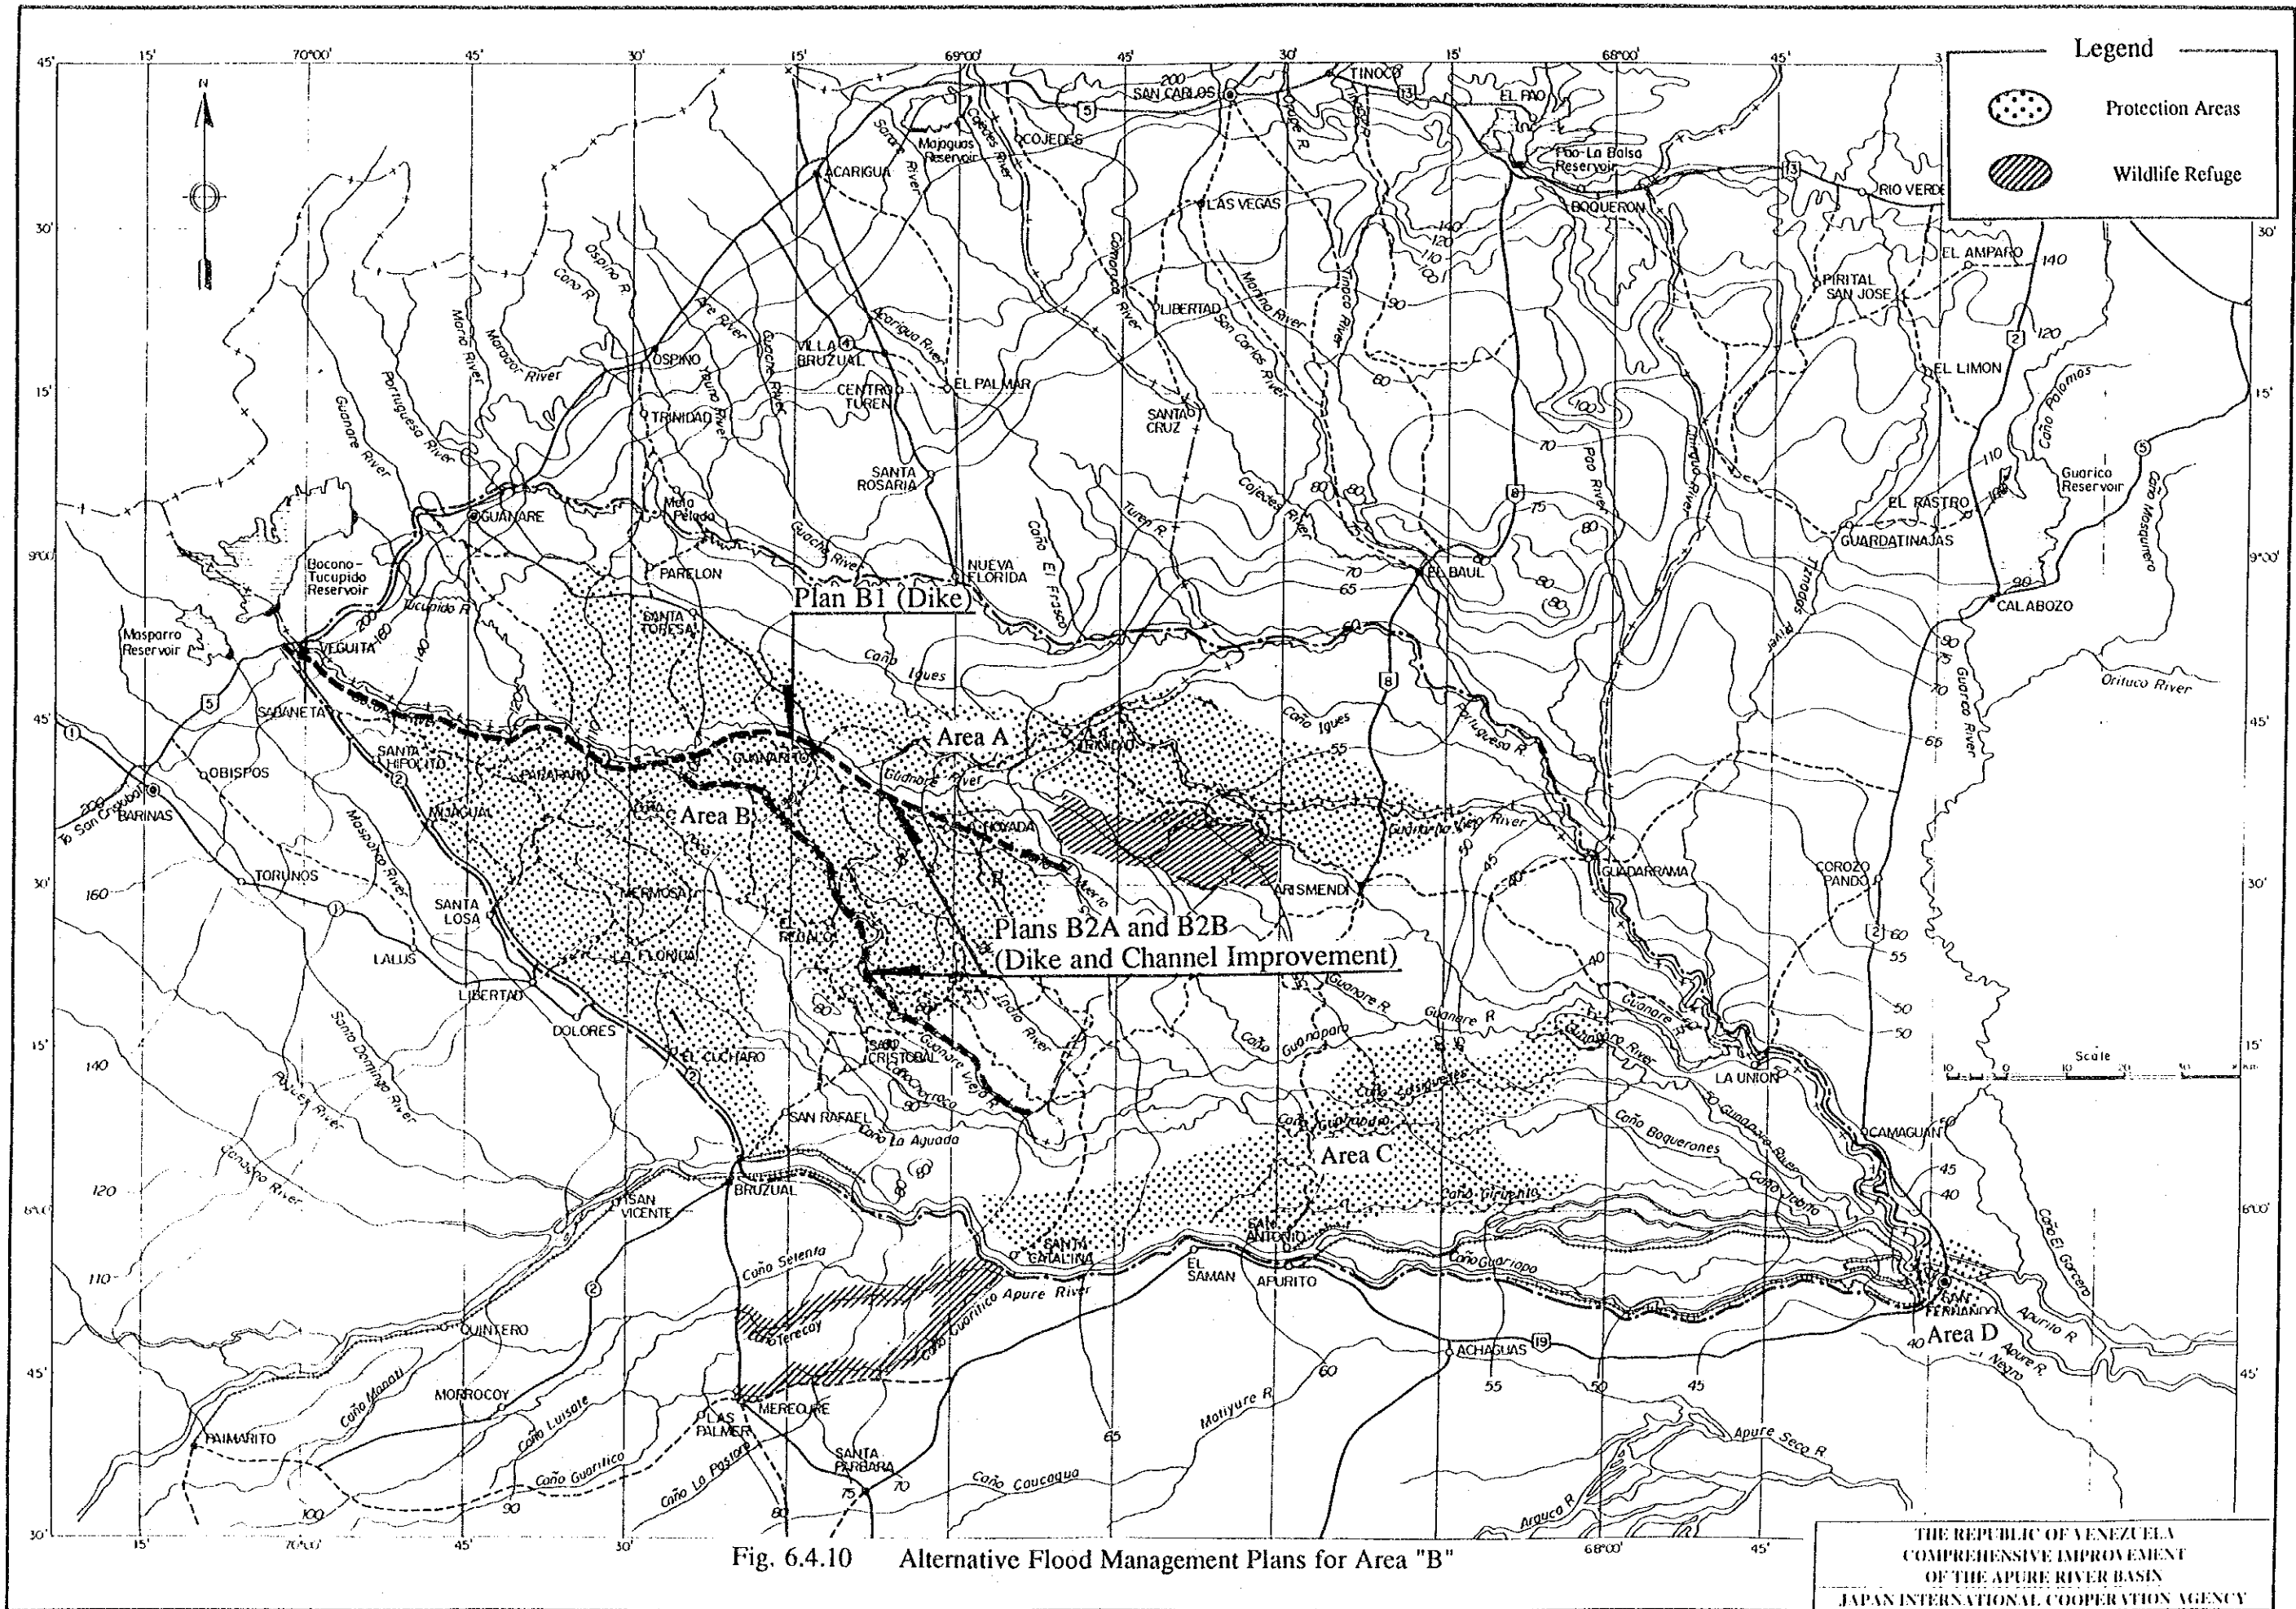
Fig. 6.4.10 Alternative Flood Management Plans for Area "B"

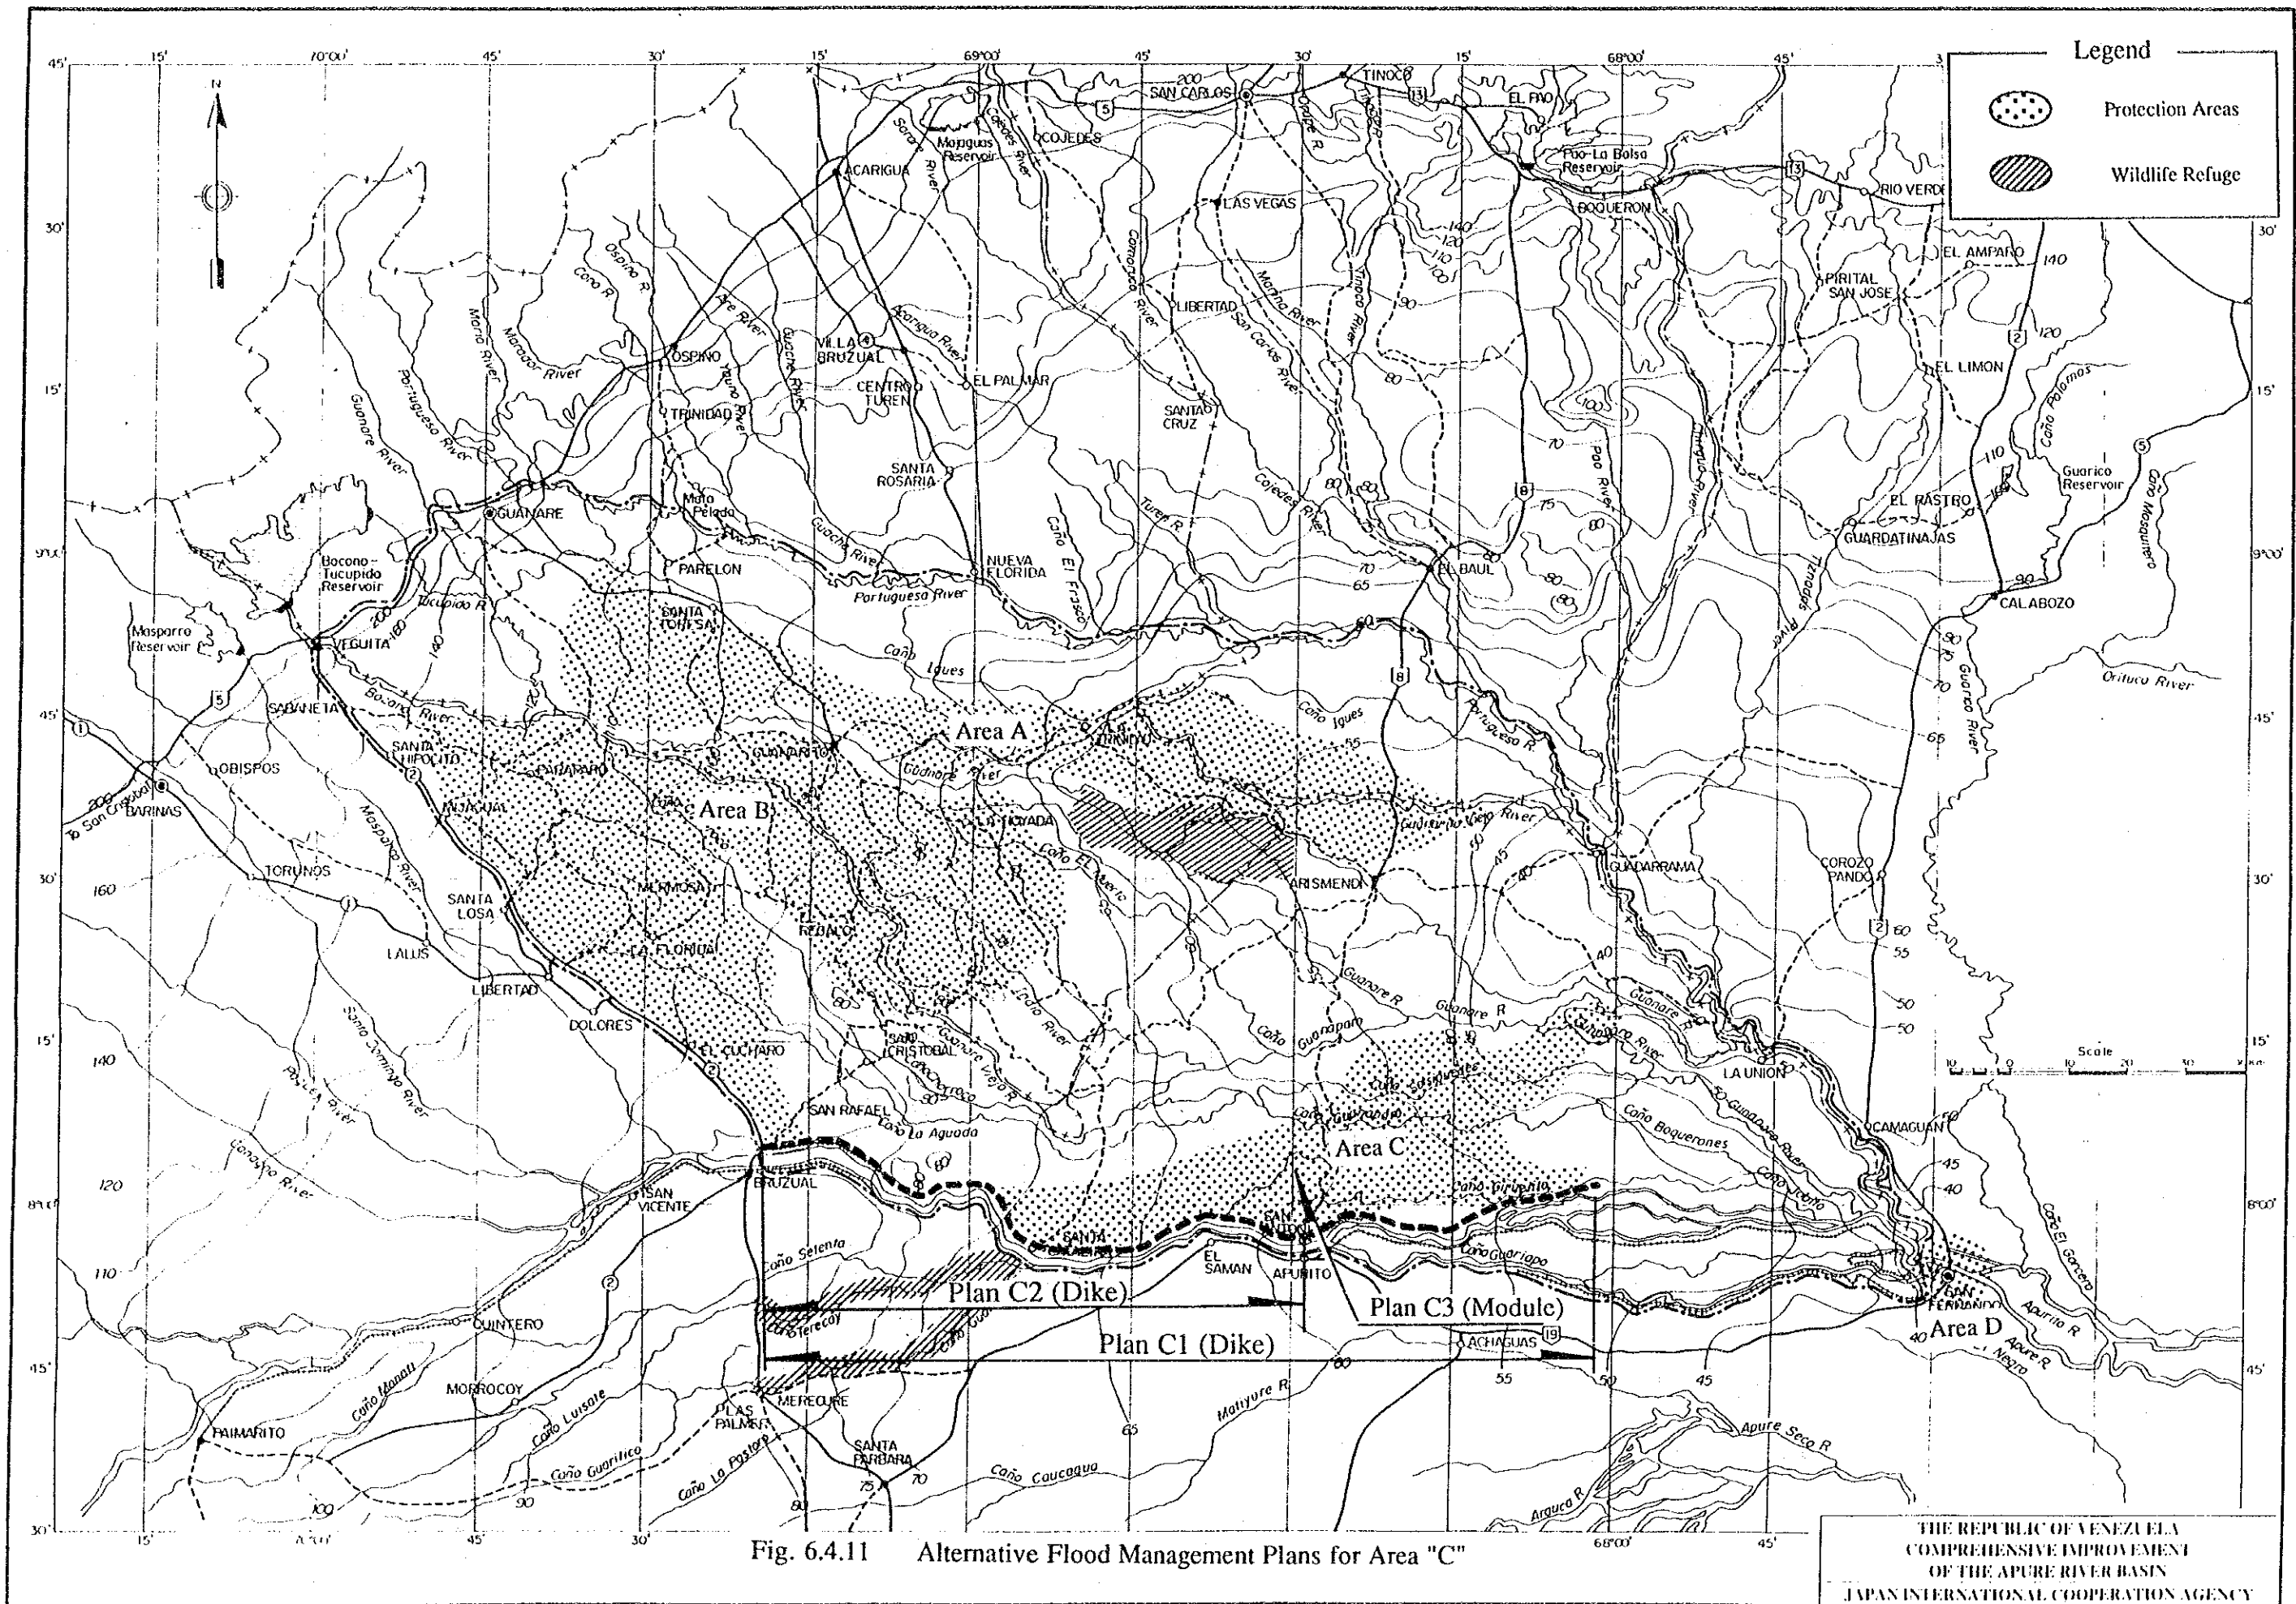
Fig. 6.4.11 Alternative Flood Management Plans for Area "C"

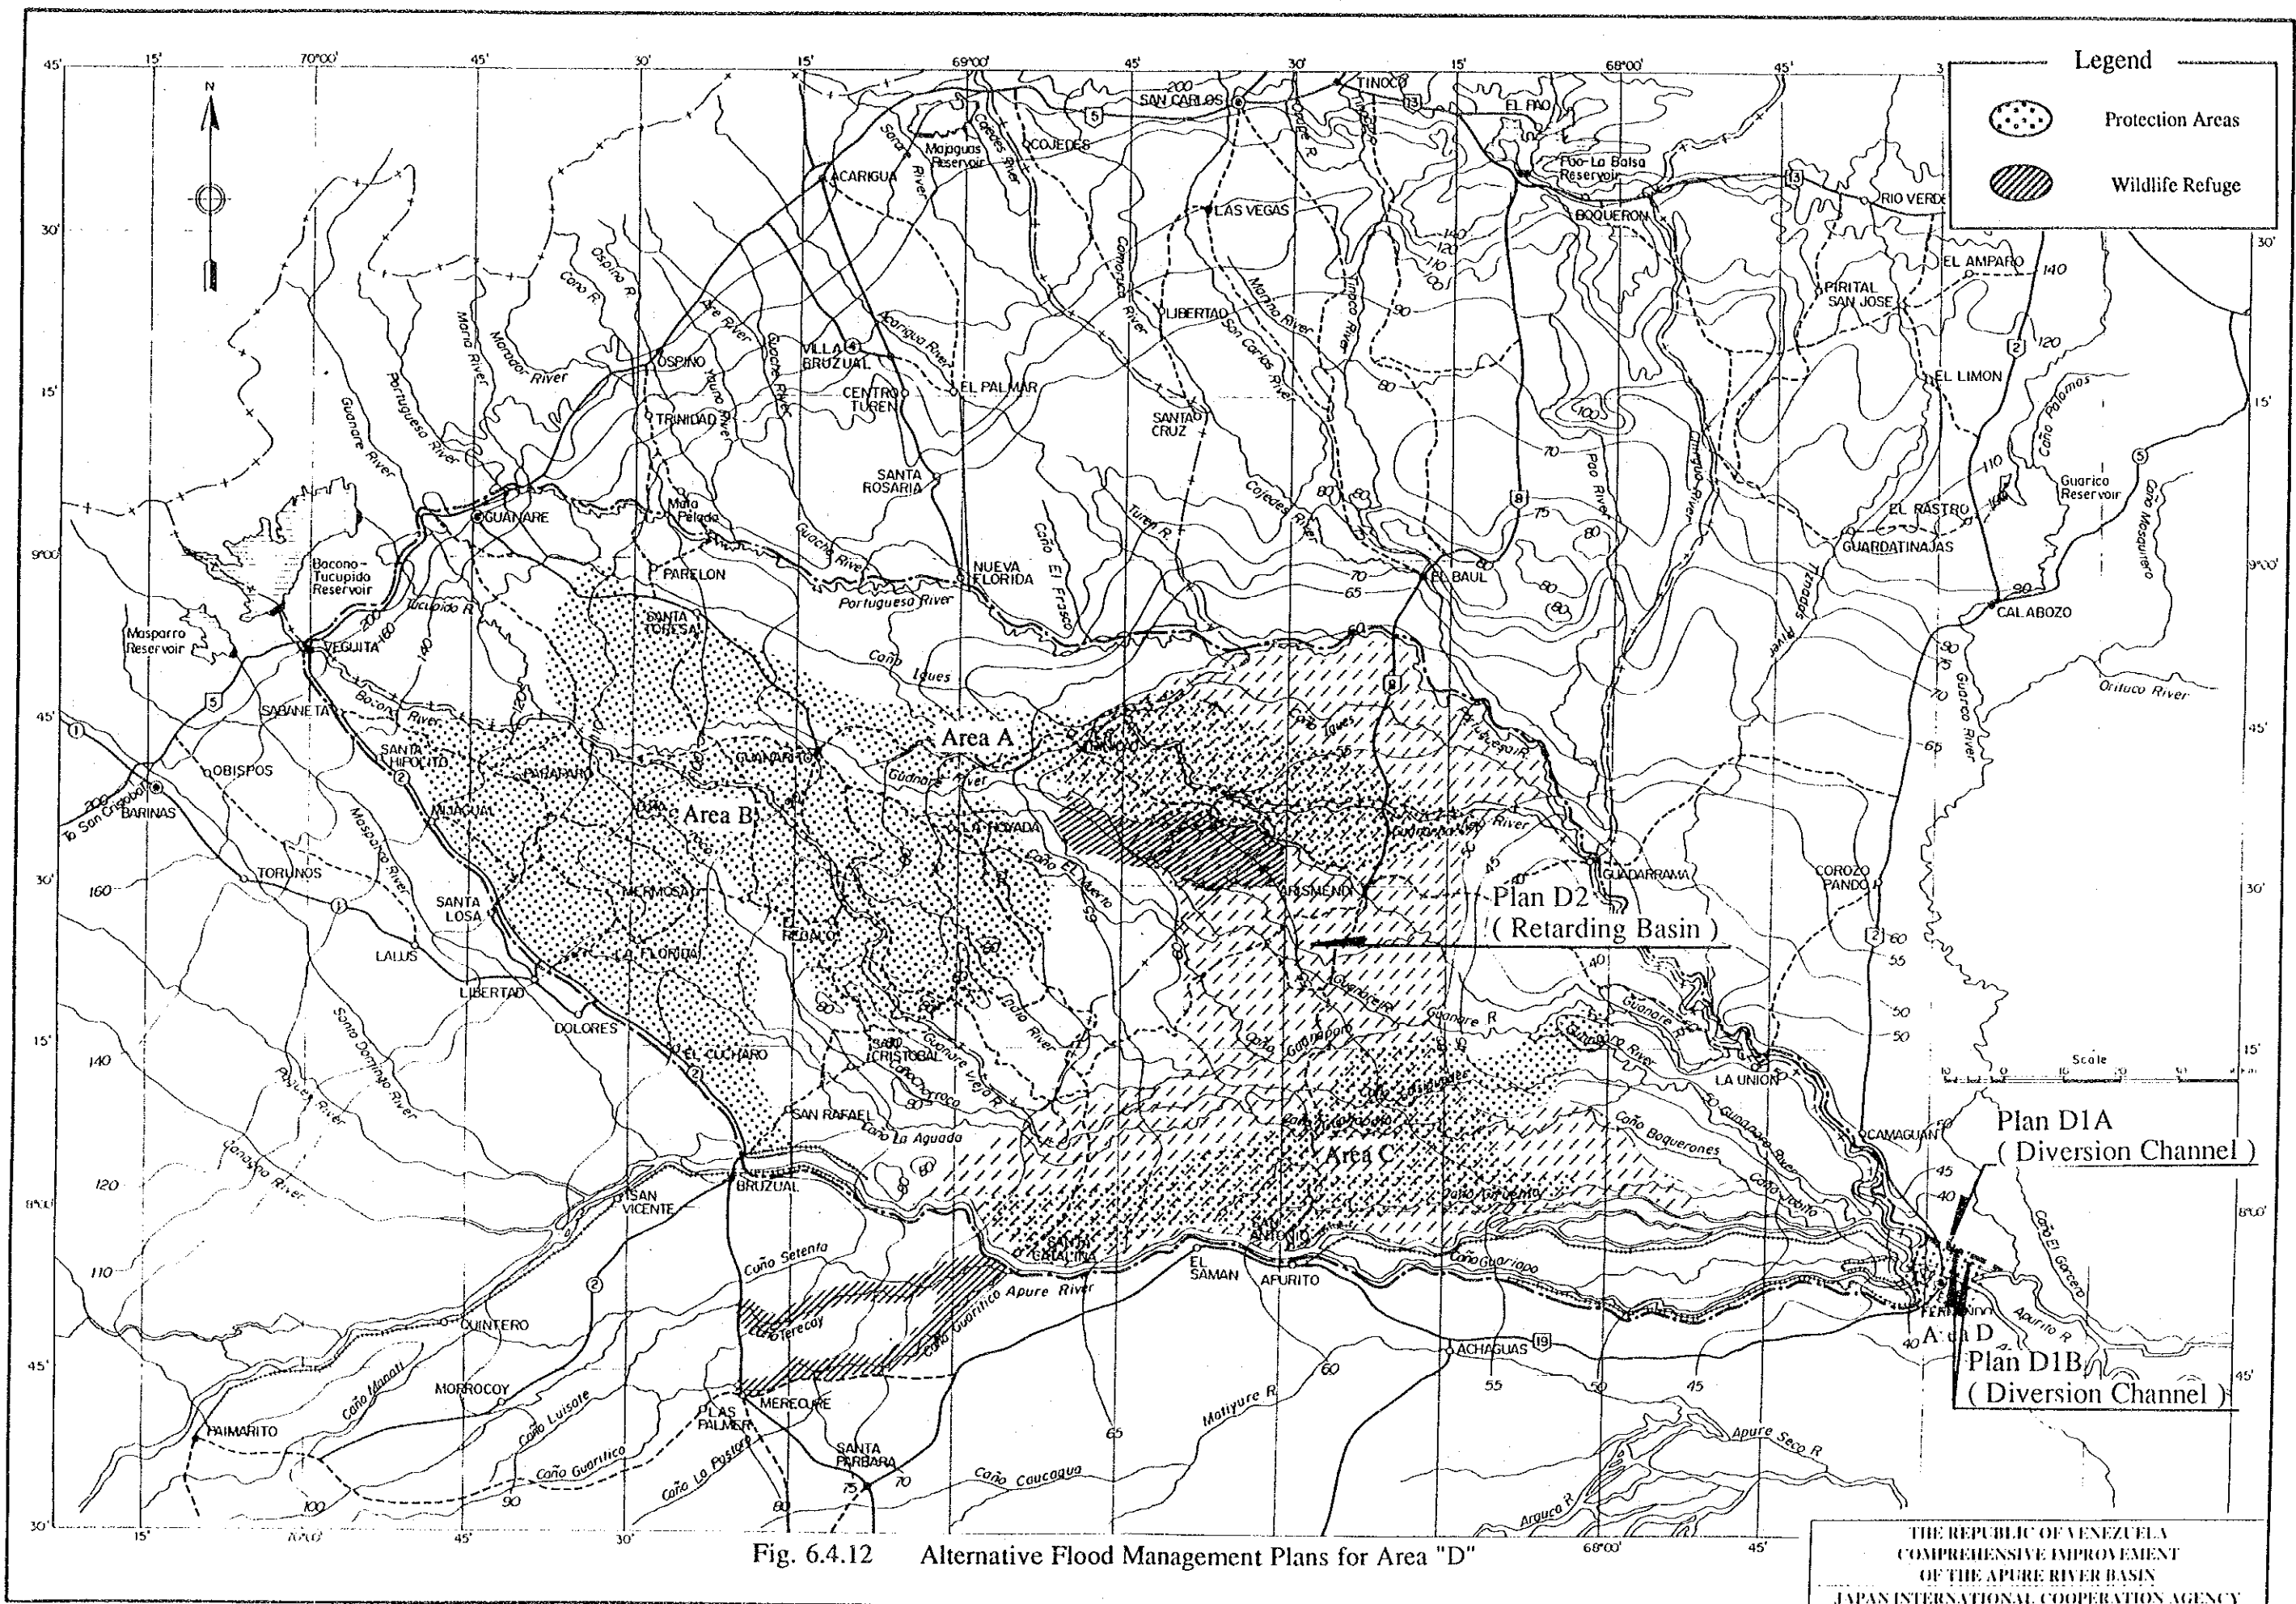
Fig. 6.4.12 Alternative Flood Management Plans for Area "D"

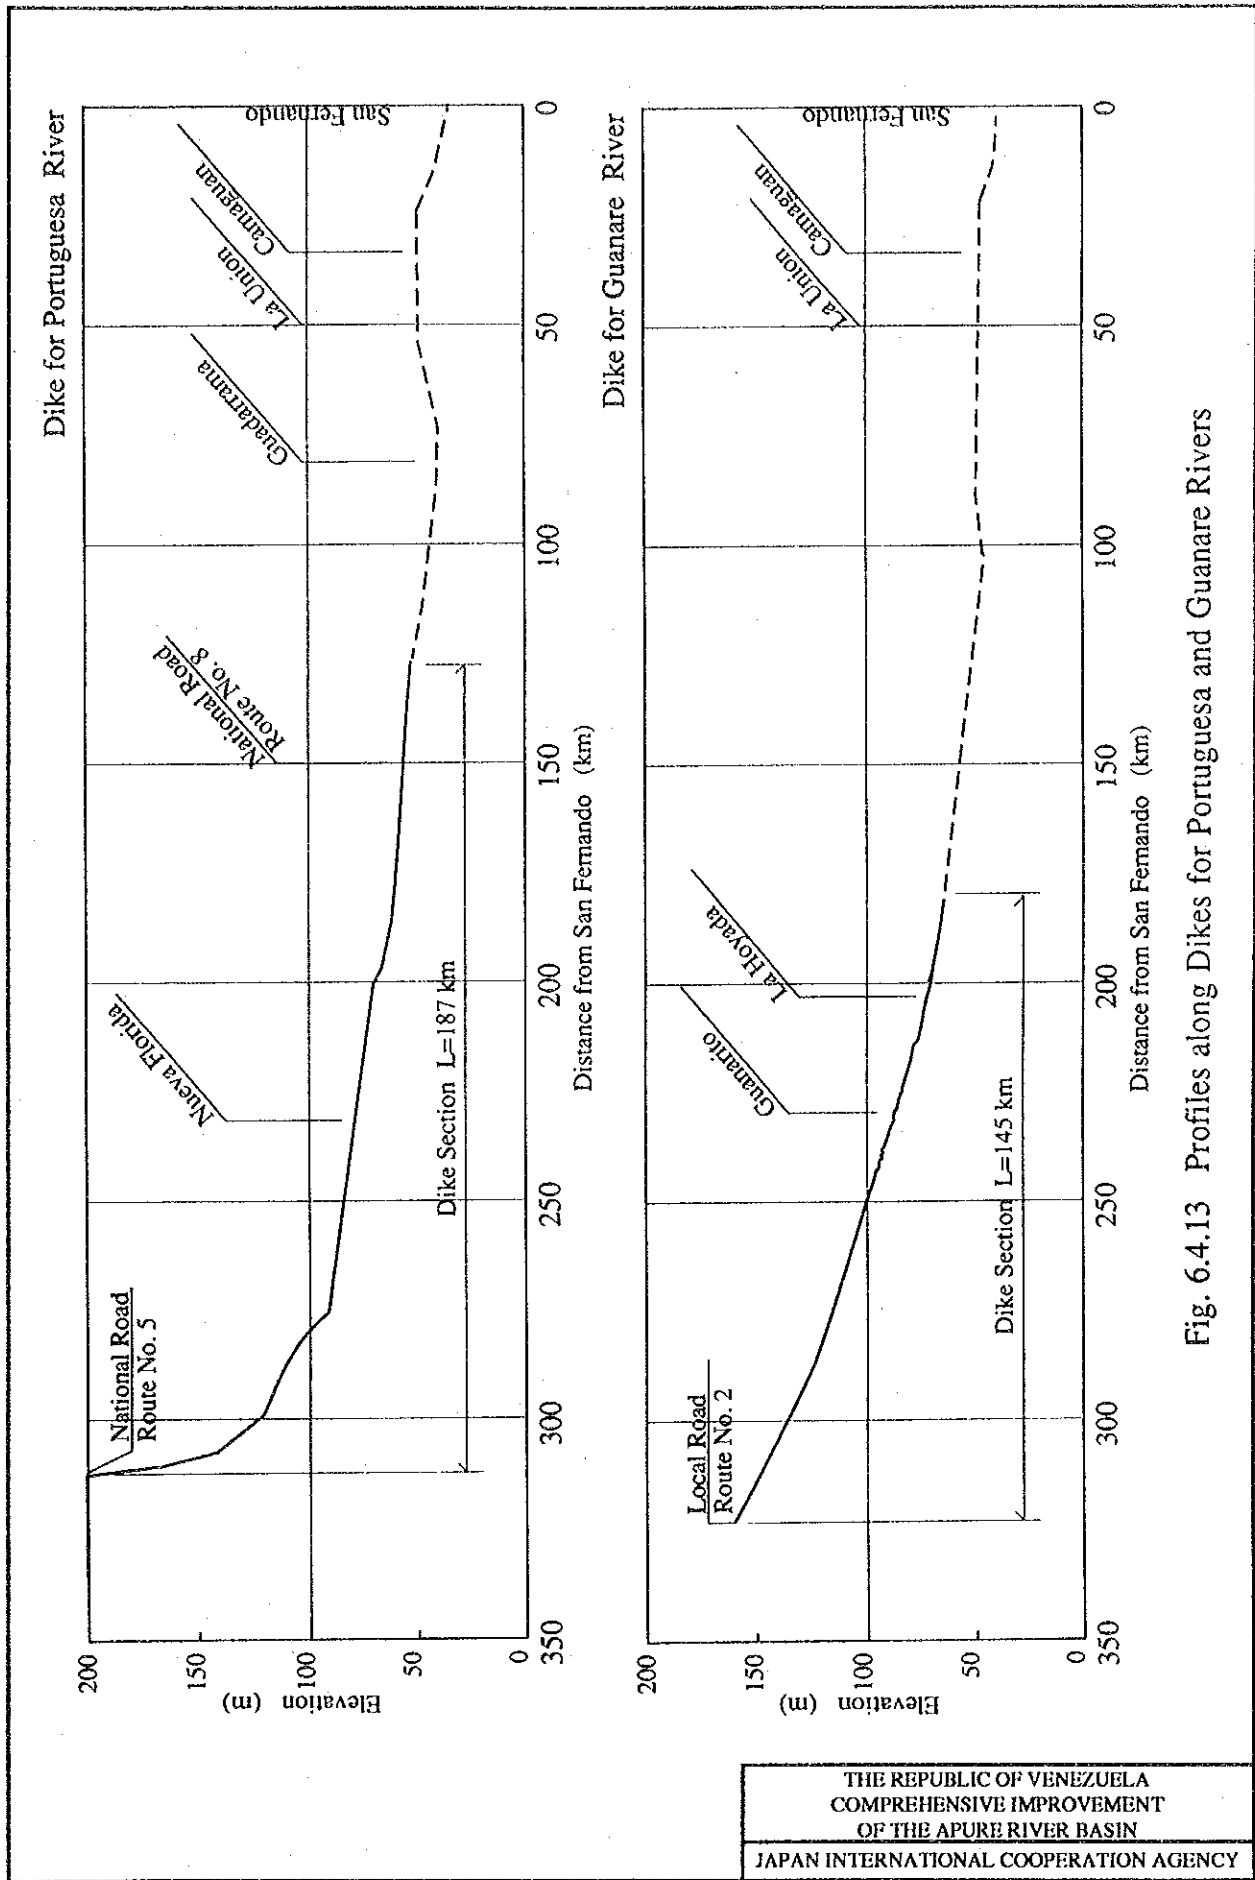
Fig. 6.4.13 Profiles along Dikes for Portuguesa and Guanare Rivers

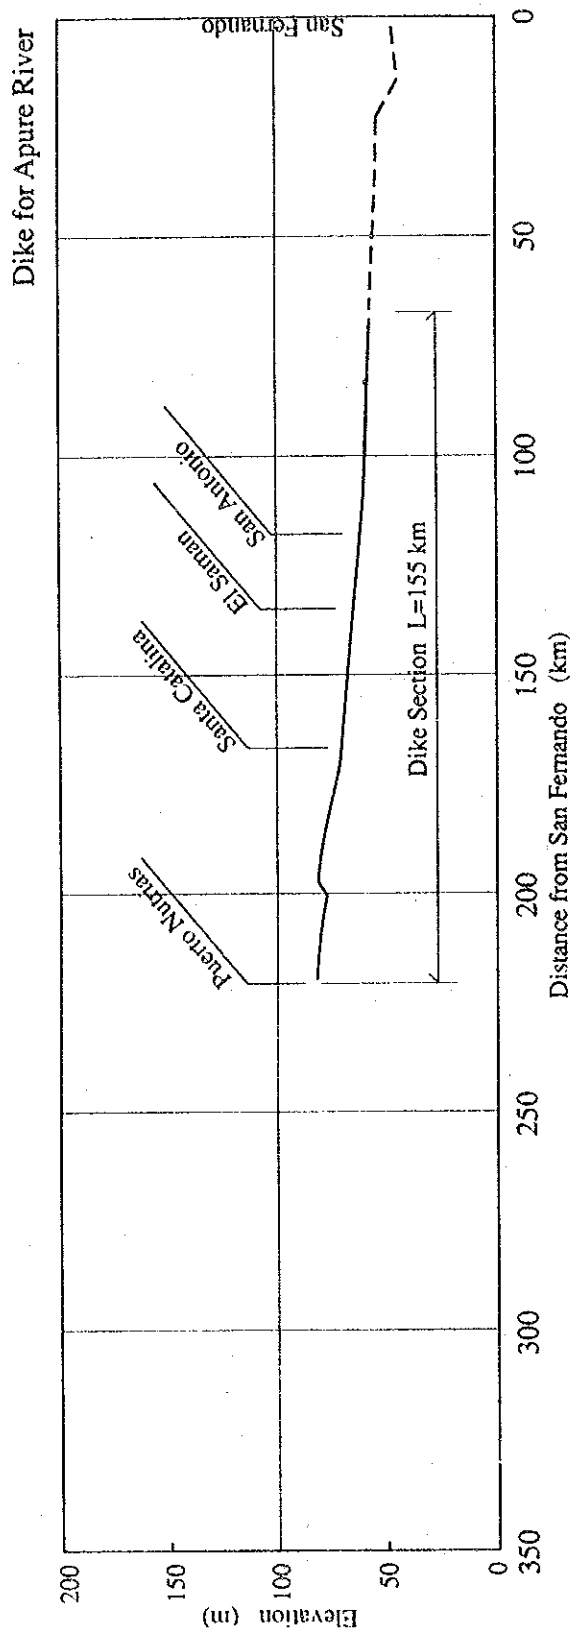
Fig. 6.4.14 Profiles along Dikes for Apure River

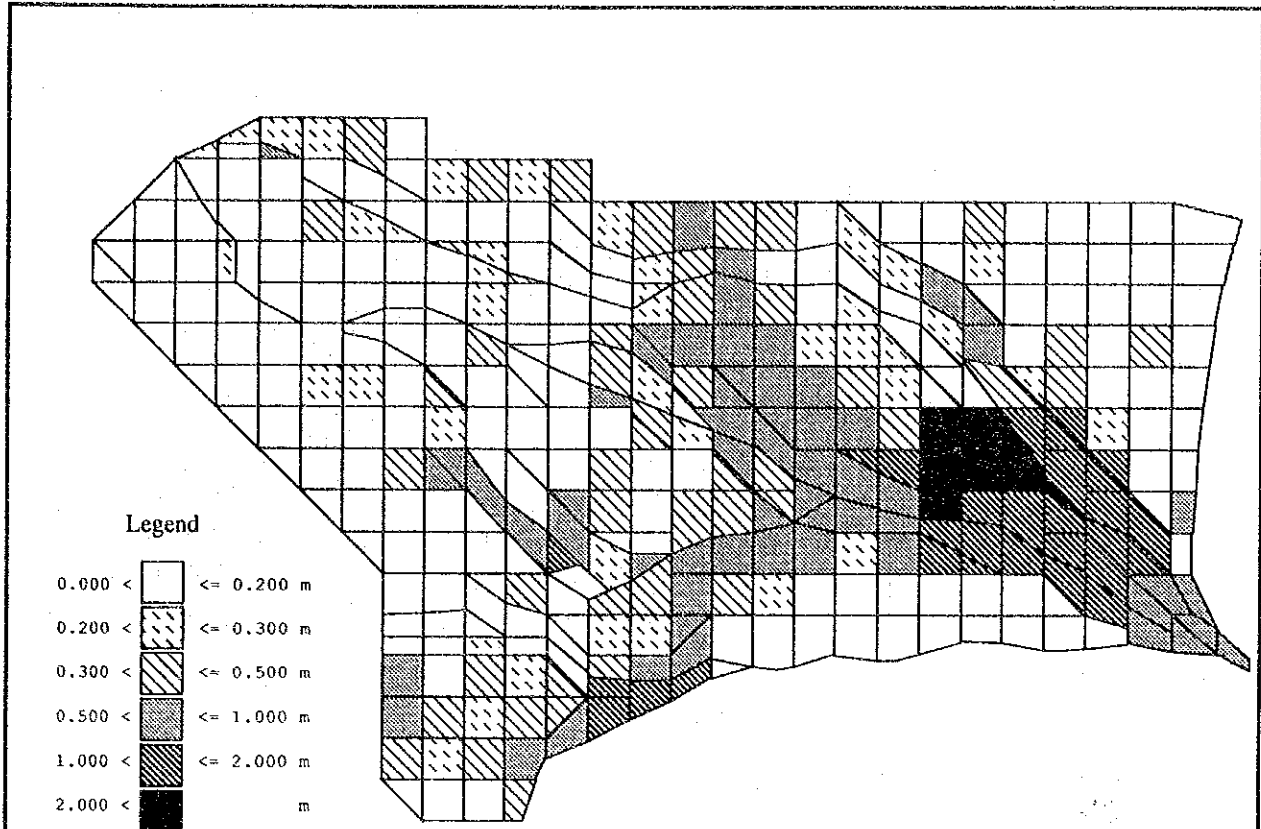
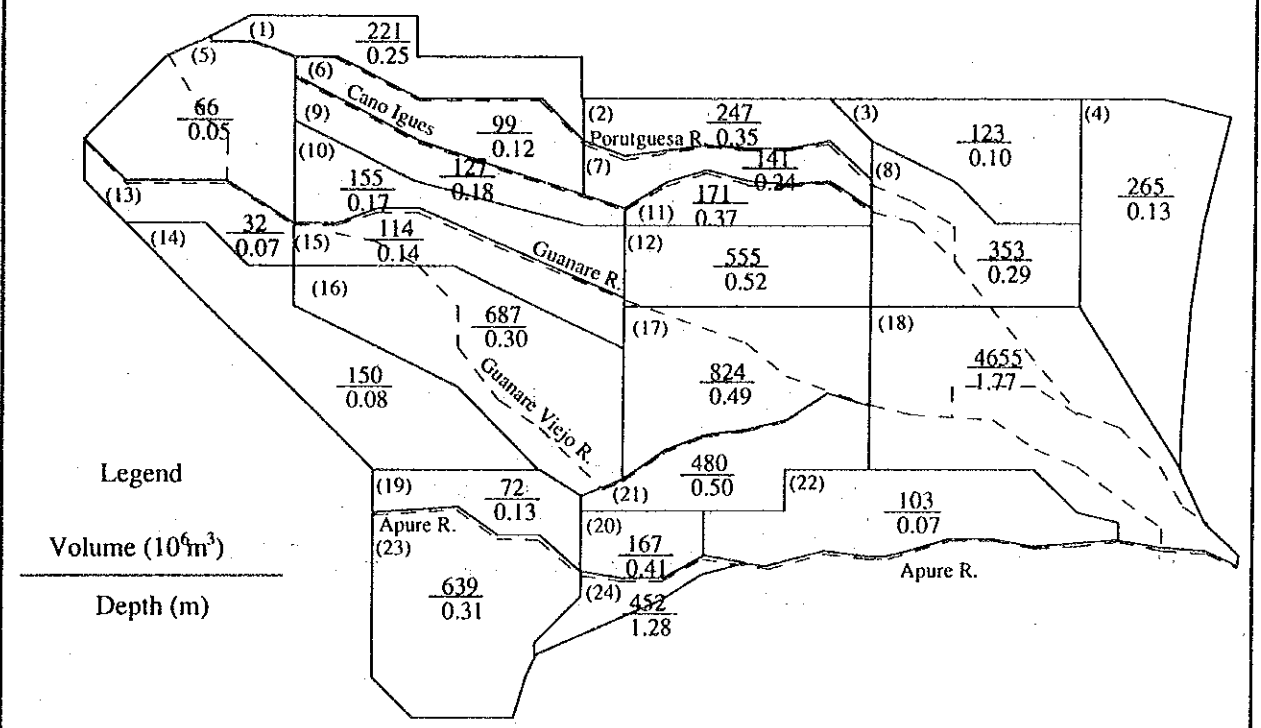
Fig. 6.4.15 Maximum Inundation (Present condition -10-yr Return Period)
