THE REPUBLIC OF VENEZUELA
COMPREHENSIVE IMPROVEMENT
OF THE APURE RIVER BASIN
JAPAN INTERNATIONAL COOPERATION AGENCY

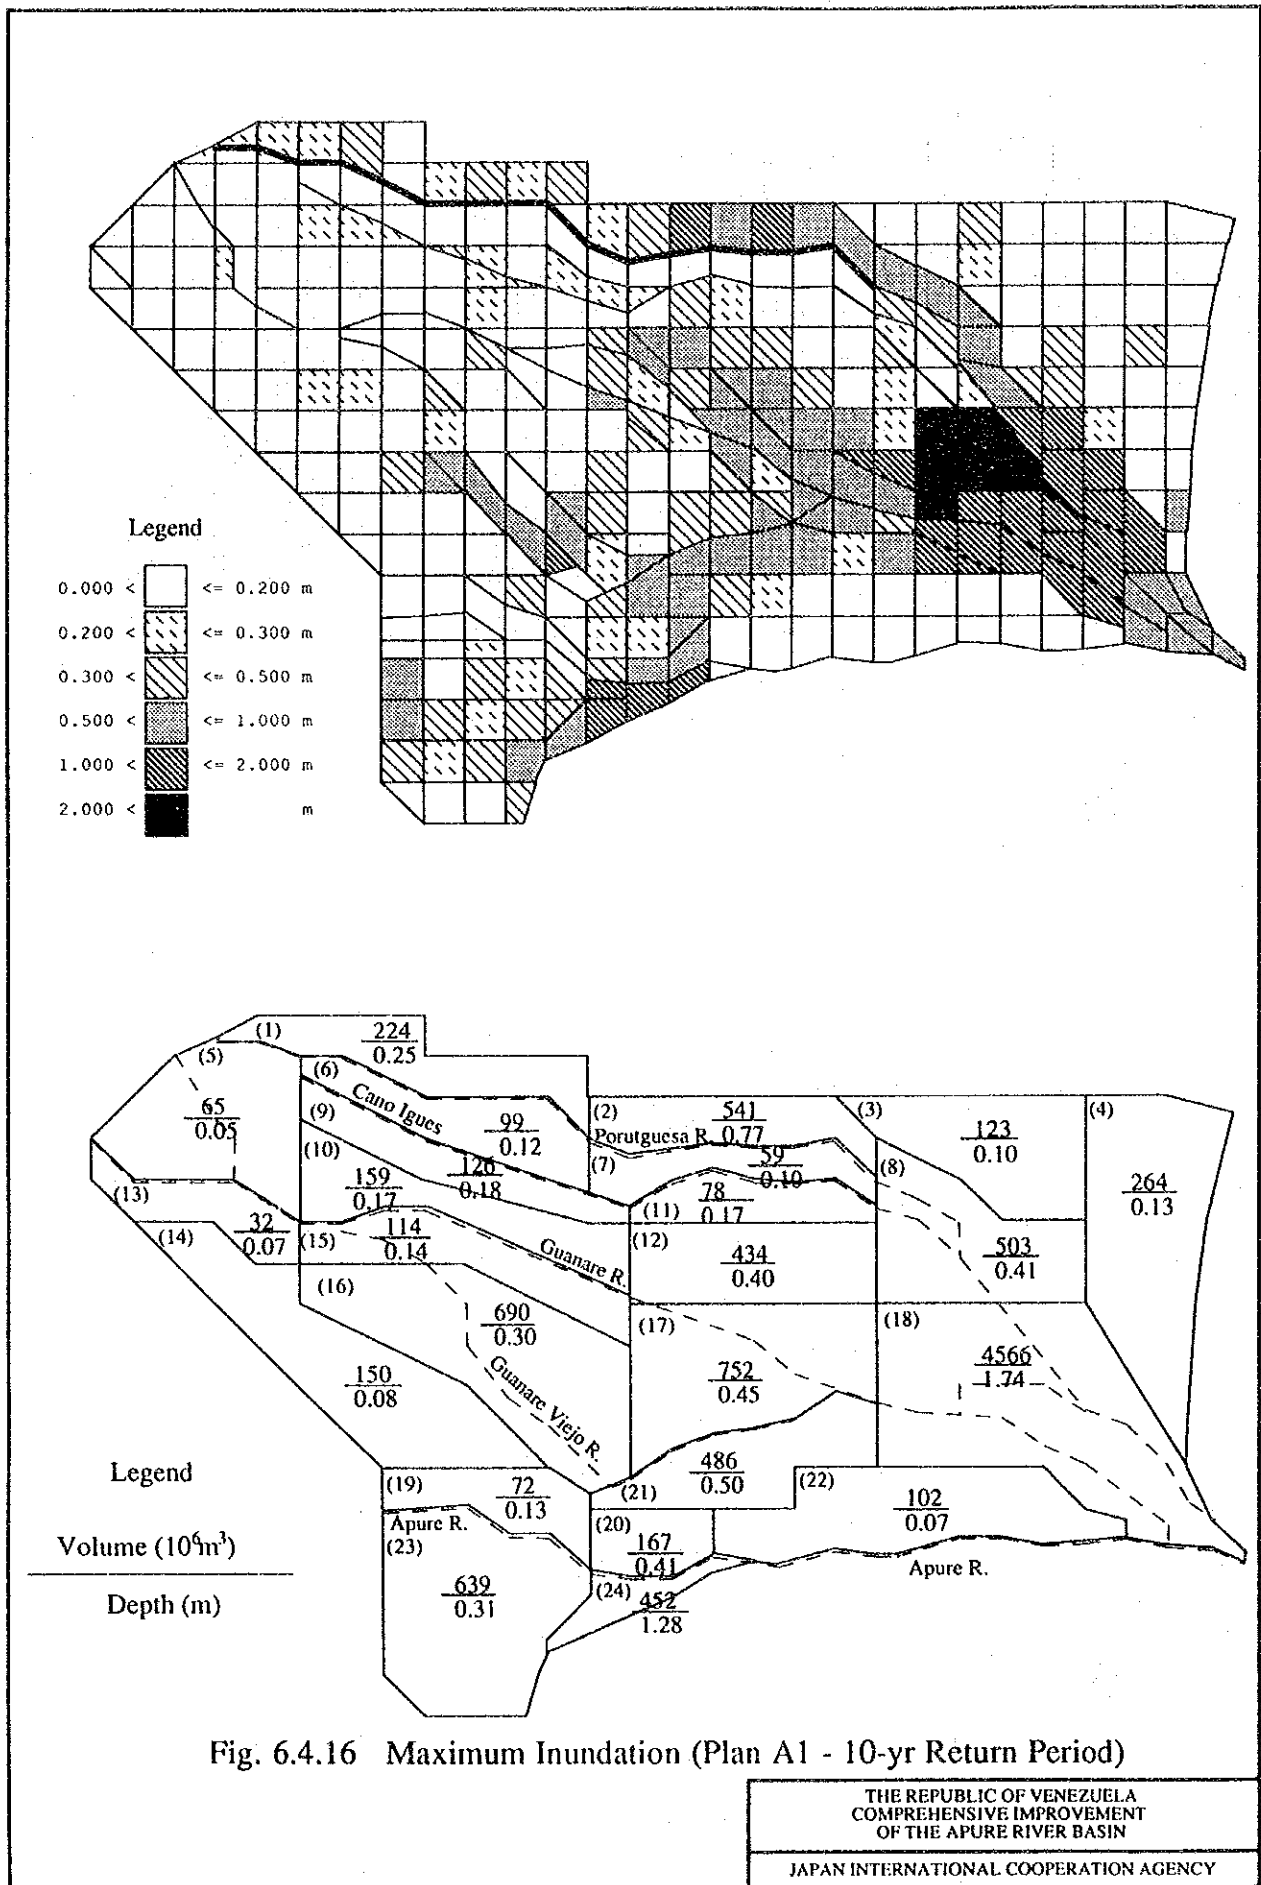
Fig. 6.4.16 Maximum Inundation (Plan A1 - 10-yr Return Period)

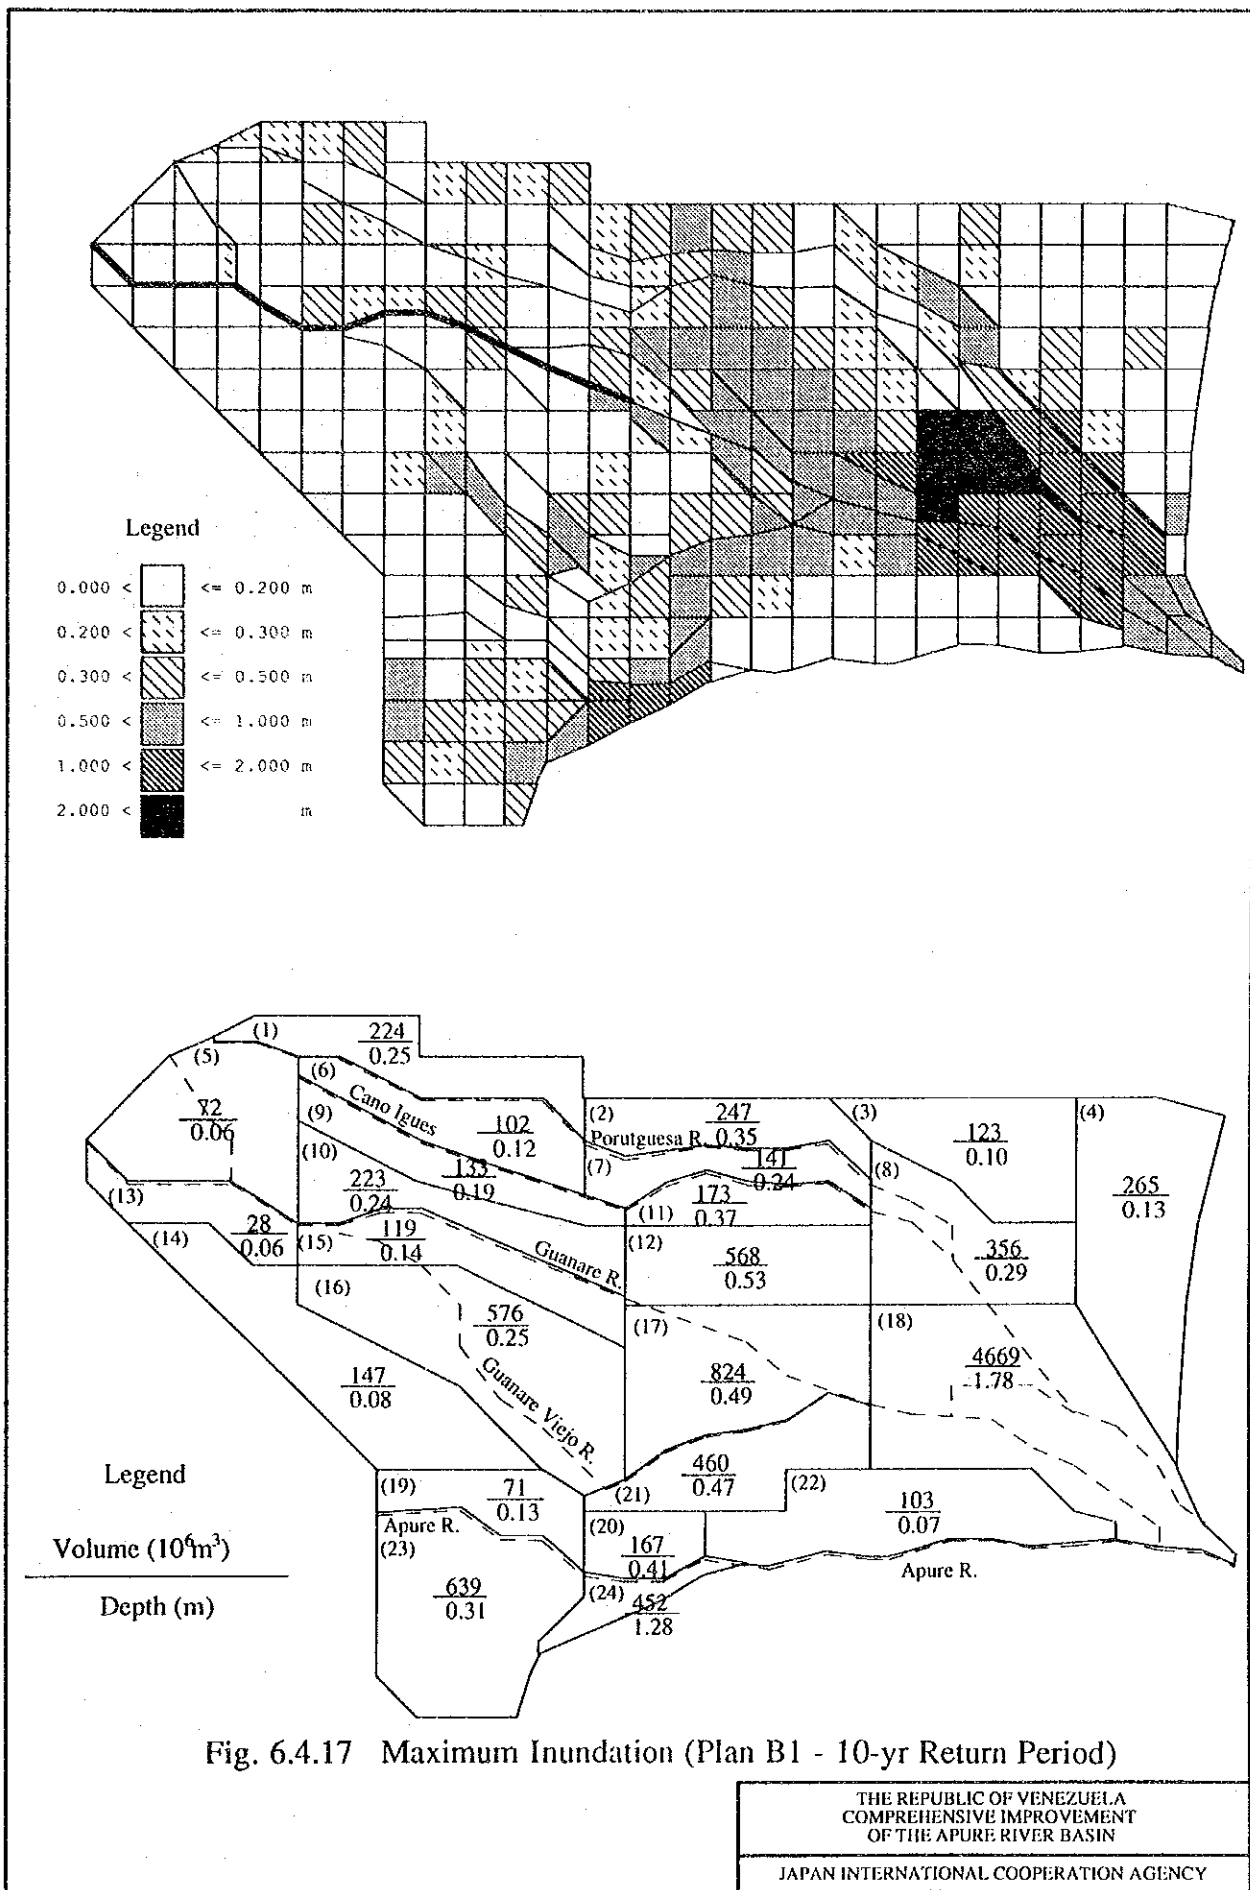
Fig. 6.4.17 Maximum Inundation (Plan B1 - 10-yr Return Period)

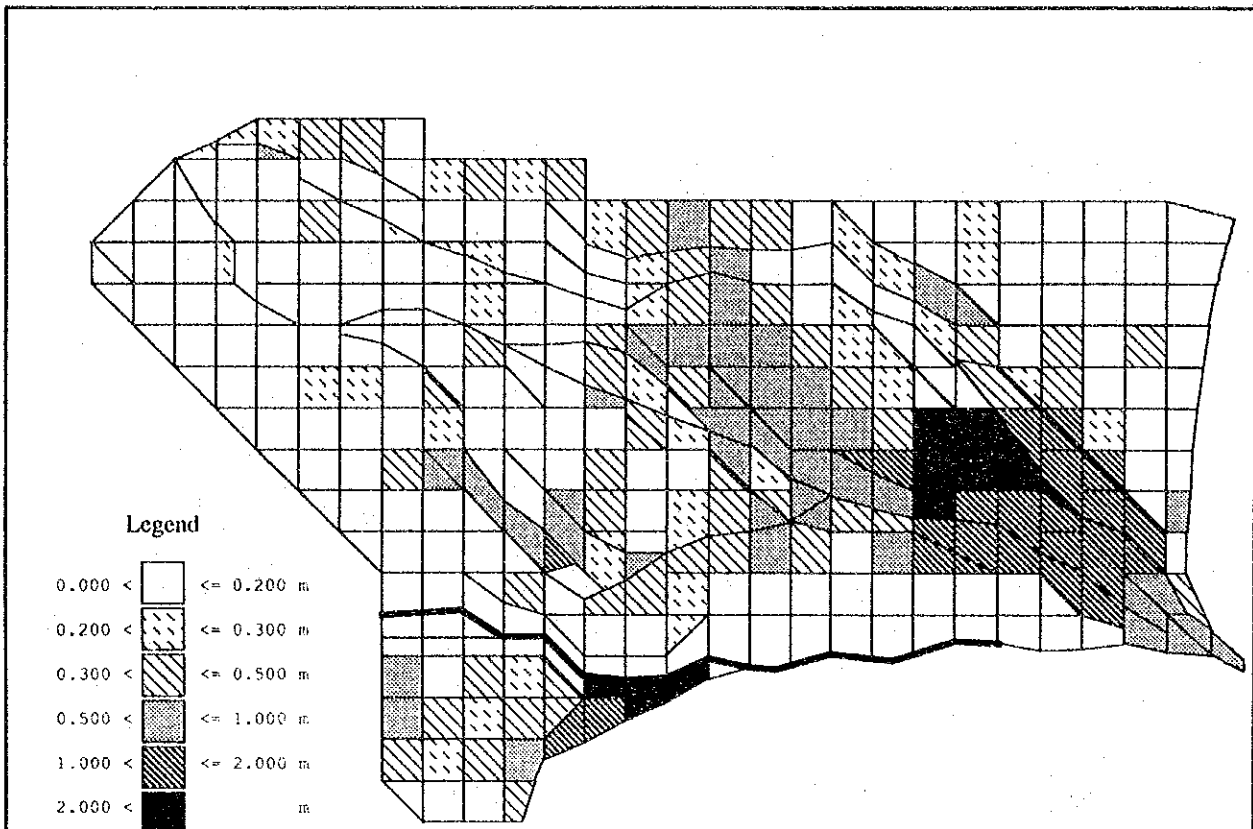
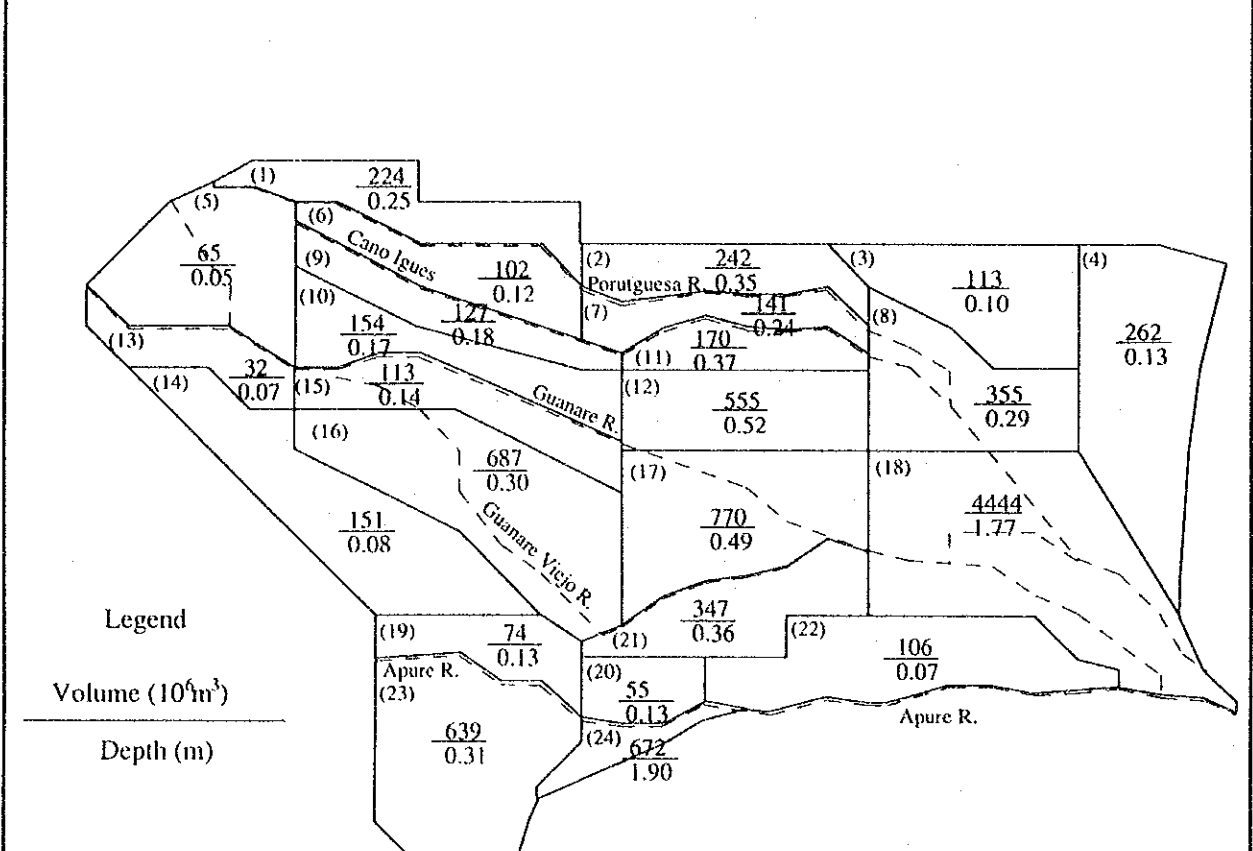
Fig. 6.4.18 Maximum Inundation (Plan C1 - 10-yr Return Period)

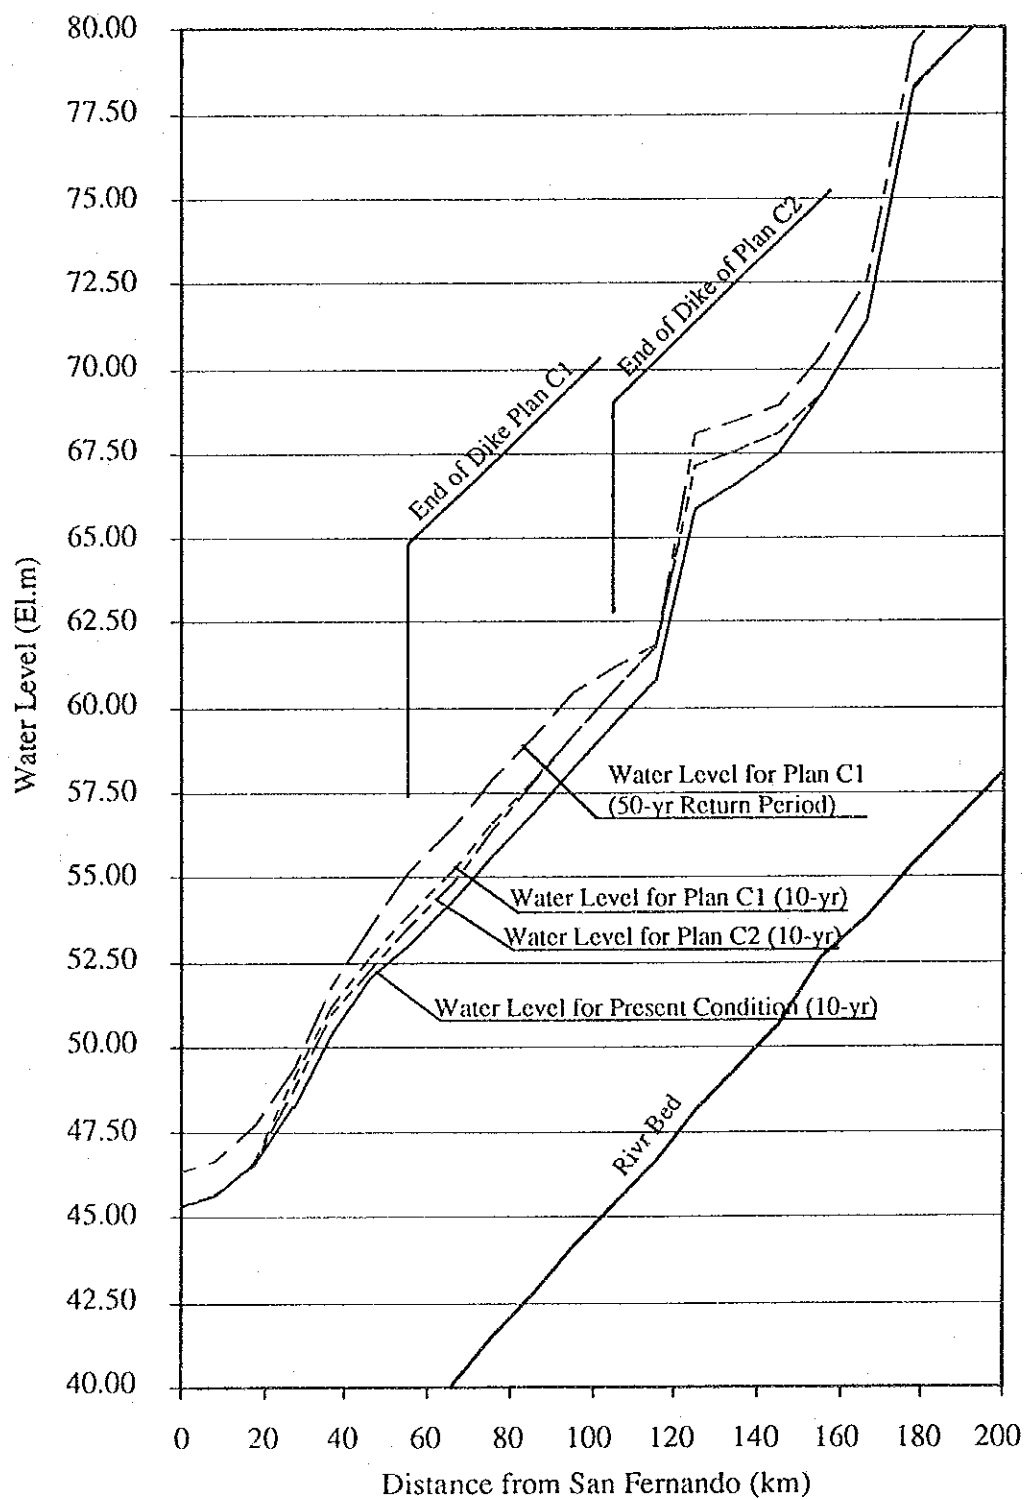
Fig. 6.4.19 Profile of Water Level of Apure River for Plans C1 and C2 (10- year Return Period)

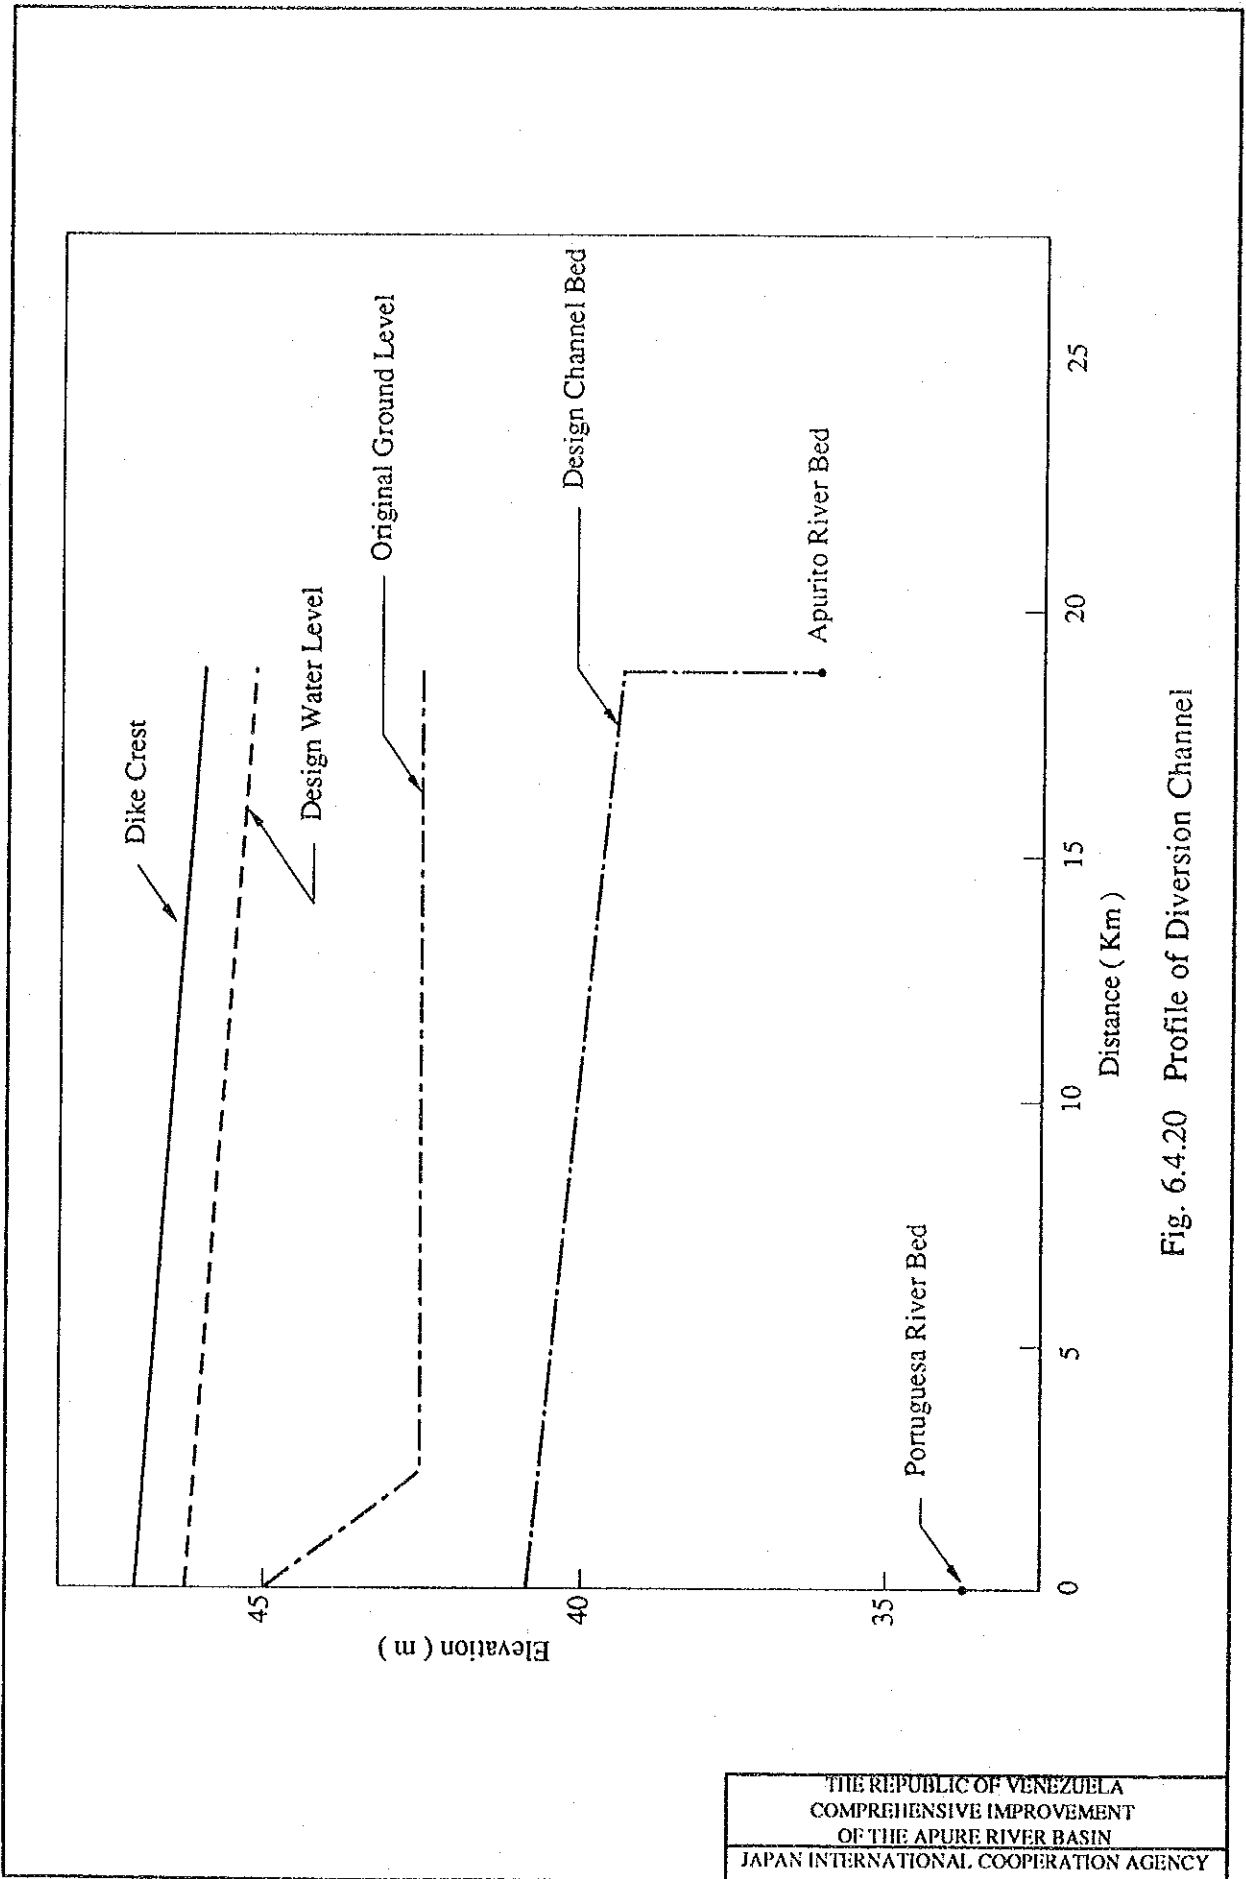
Fig. 6.4.20 Profile of Diversion Channel

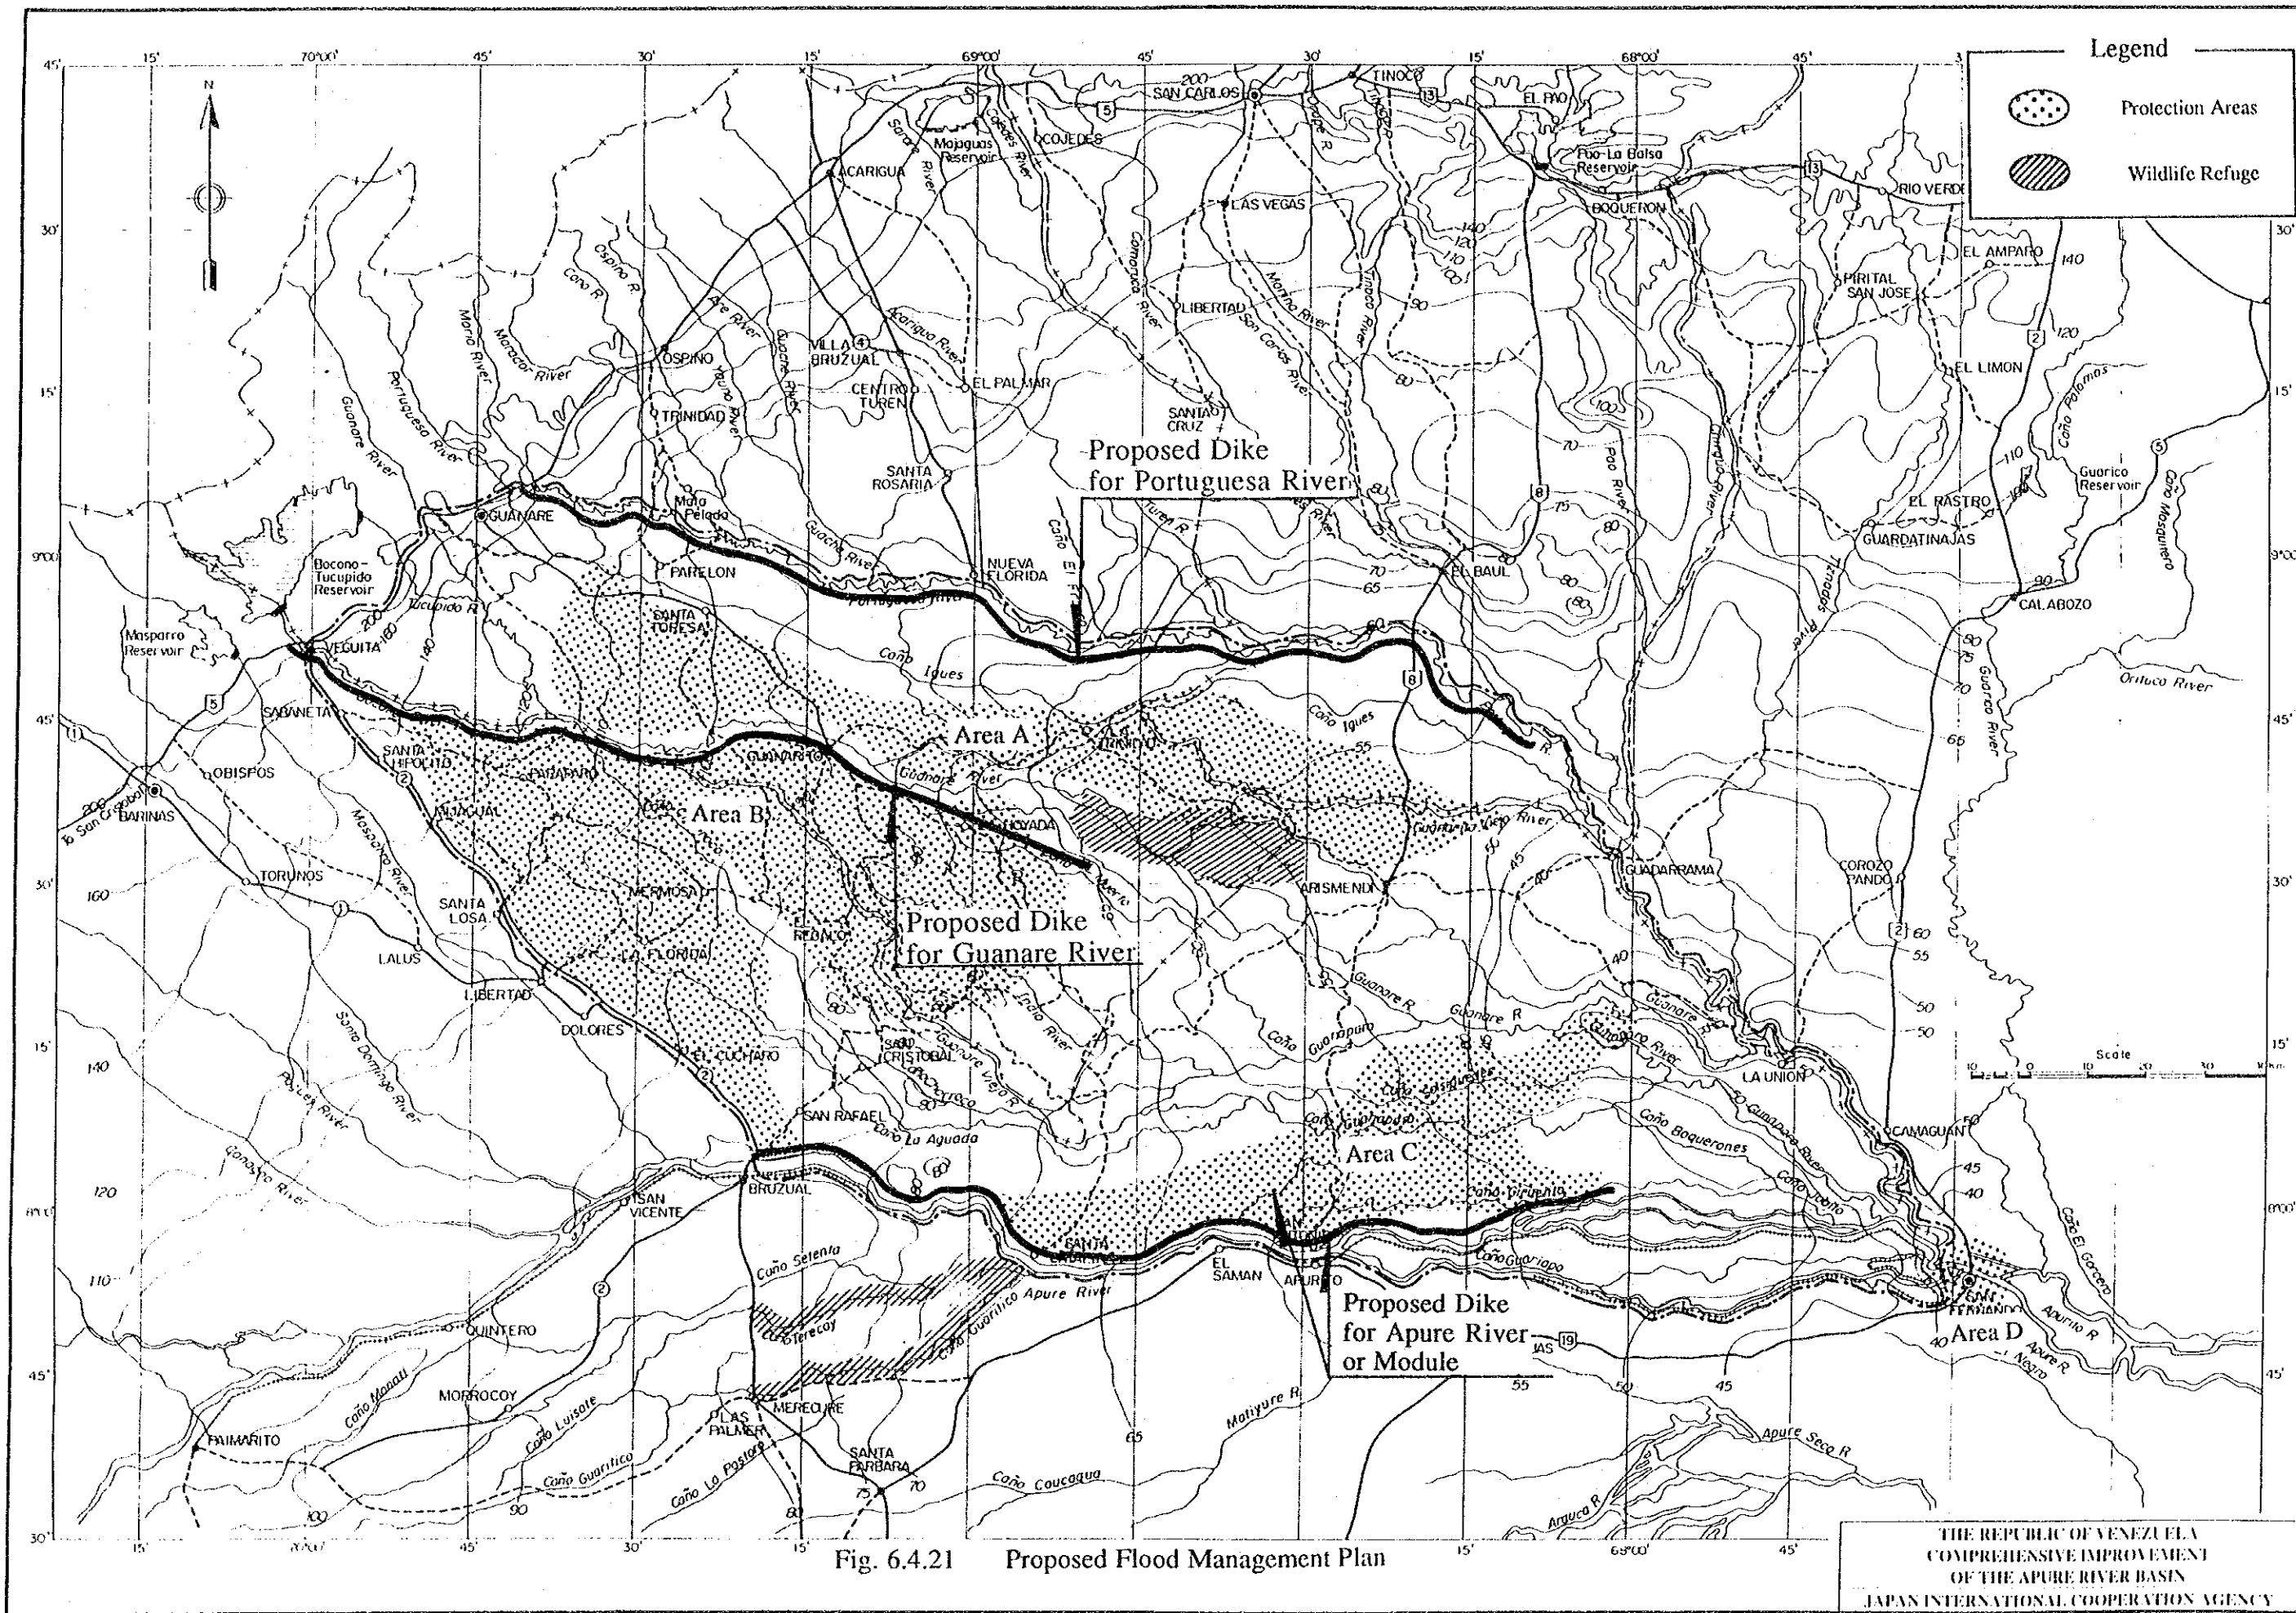
Fig. 6.4.21 Proposed Flood Management Plan

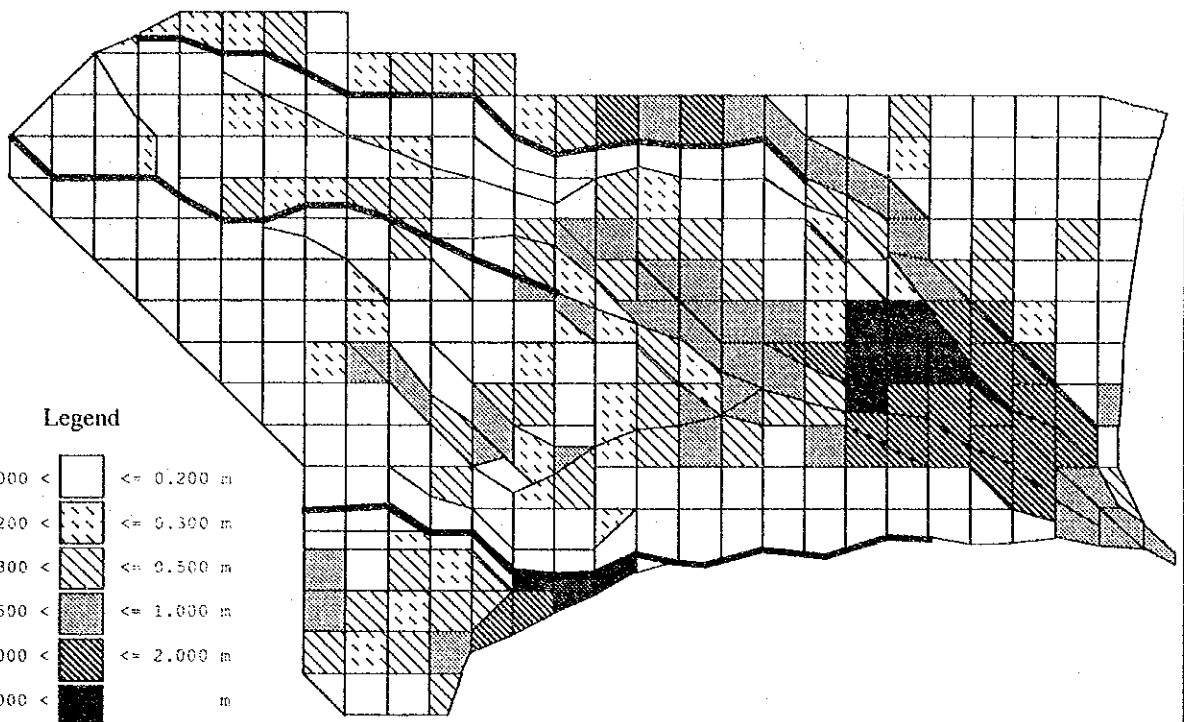
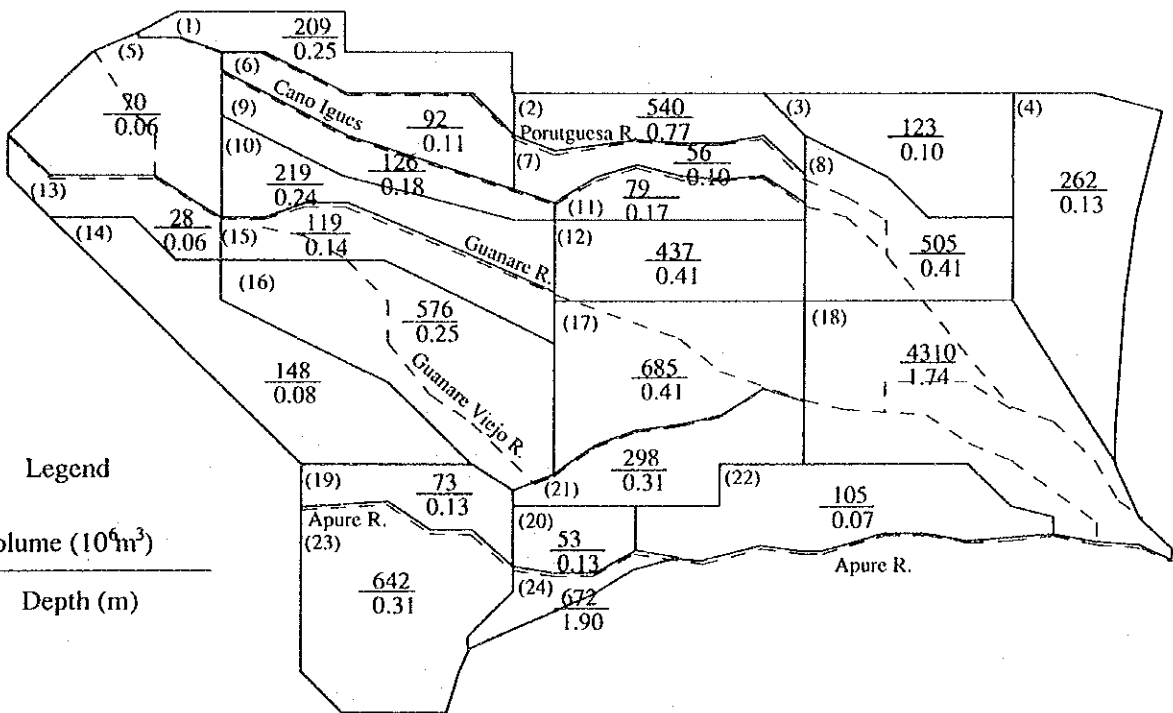
Fig. 6.4.22 Maximum Inundation for Proposed Management Plan (10-yr Return Period)

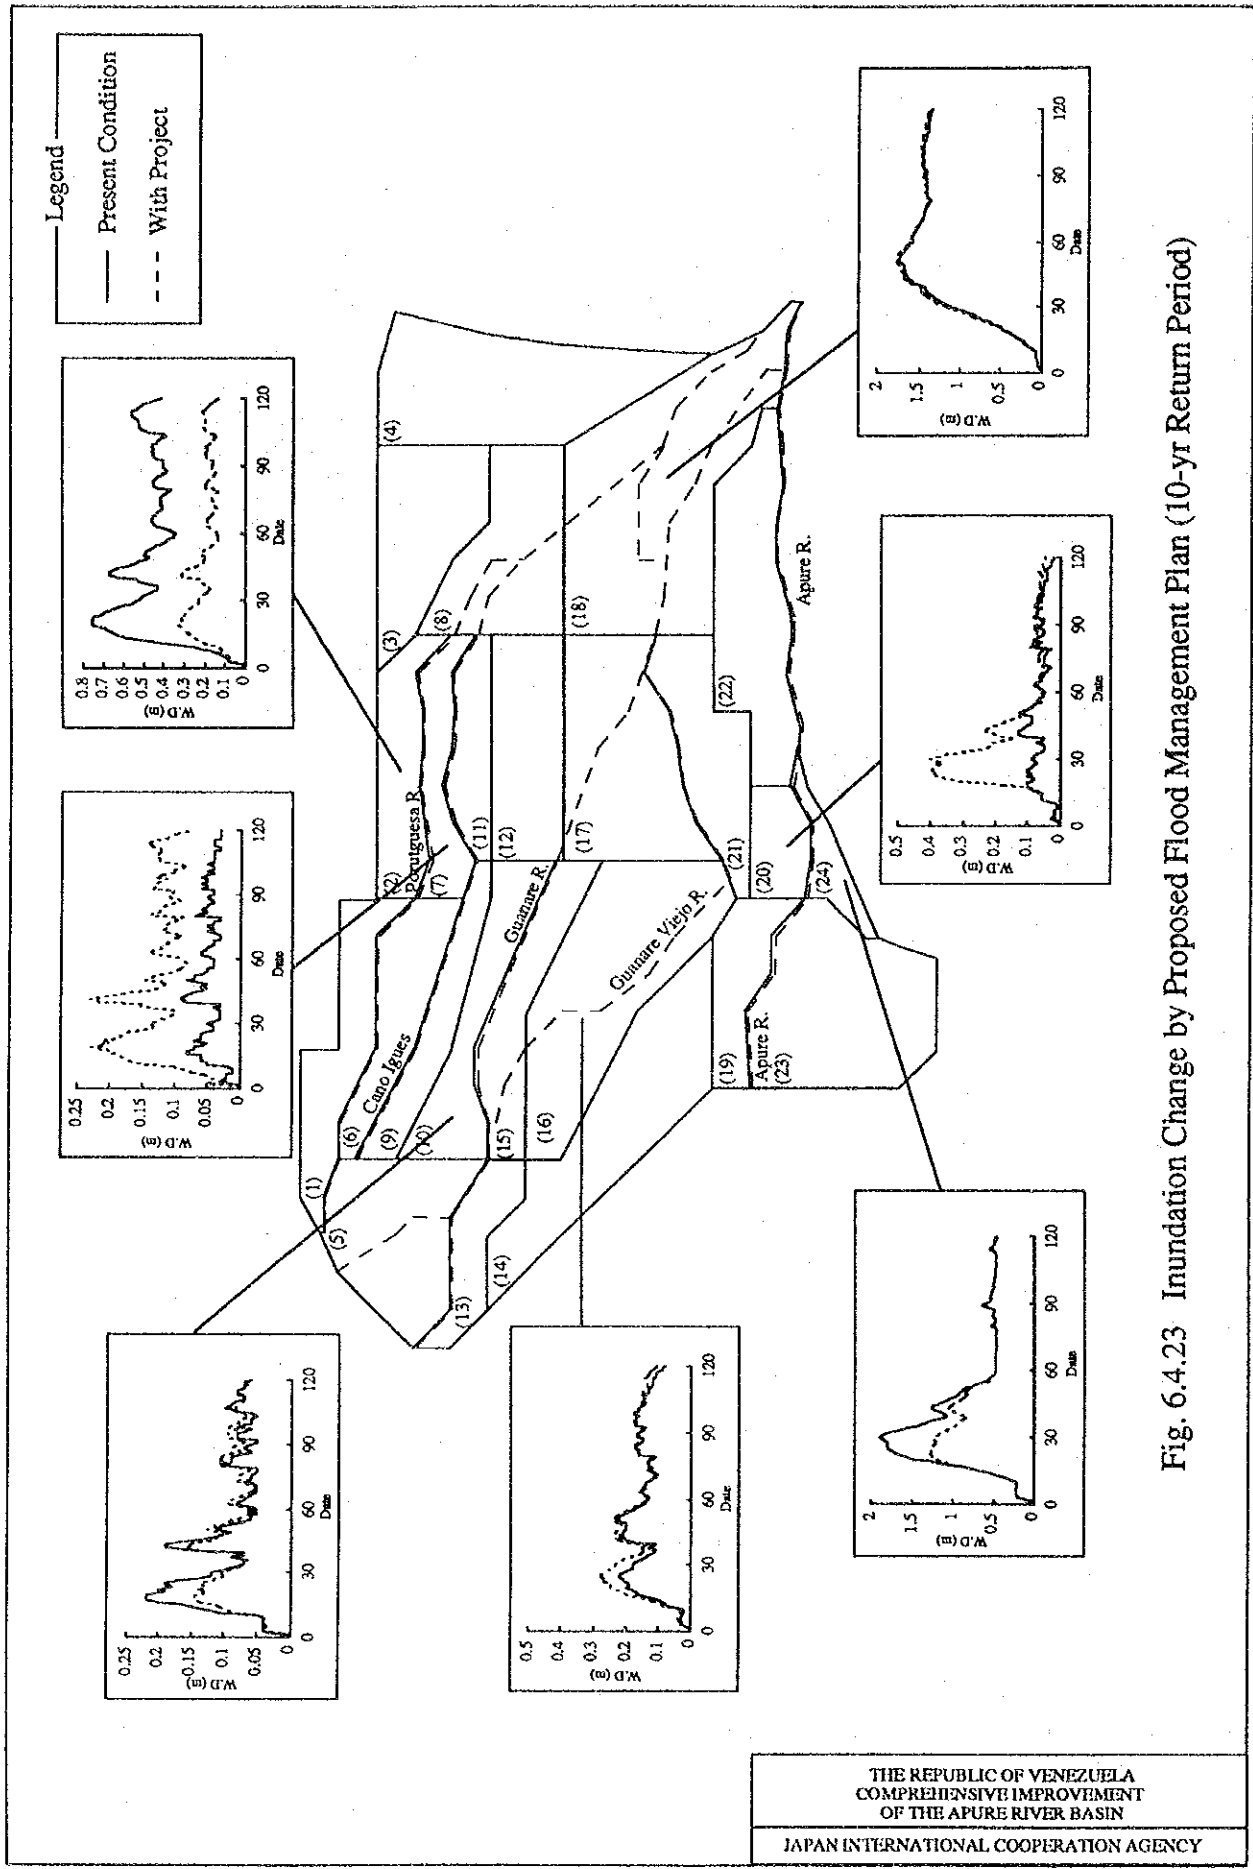
Fig. 6.4.23 Inundation Change by Proposed Flood Management Plan (10-yr Return Period)

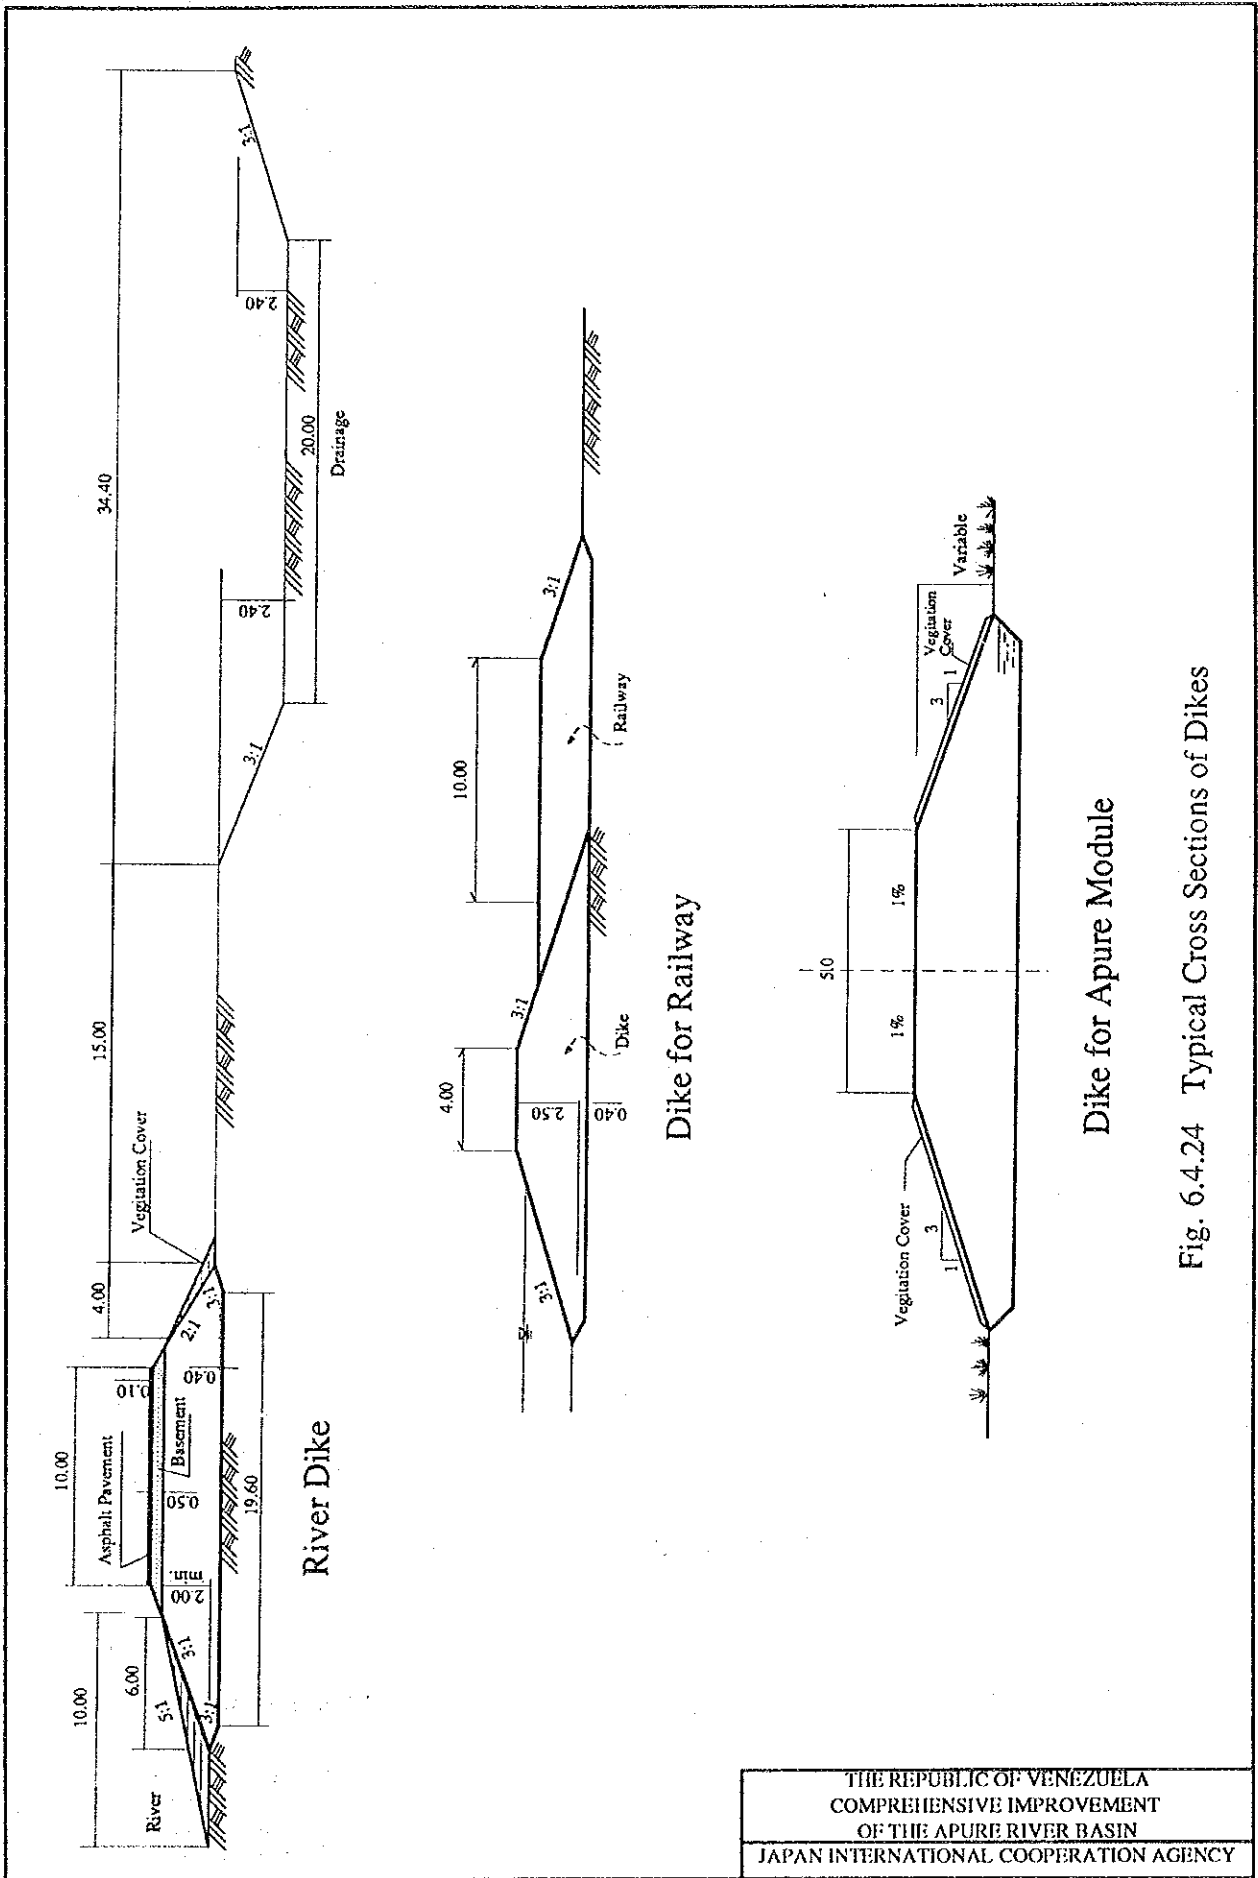
Dike for Apure Module

Fig. 6.4.24 Typical Cross Sections of Dikes

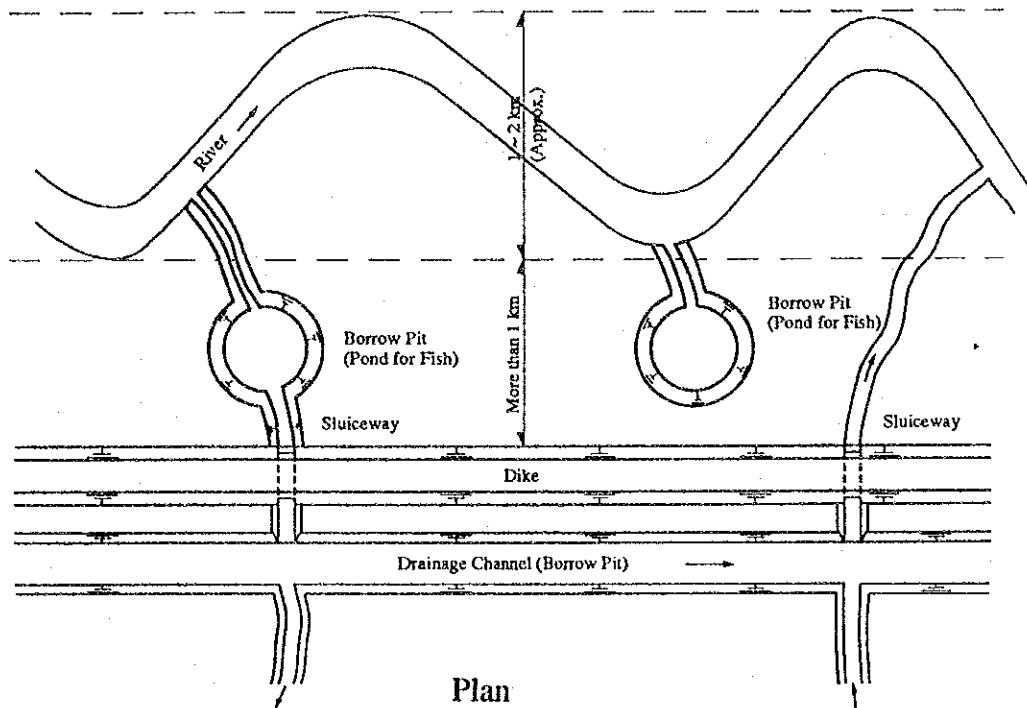
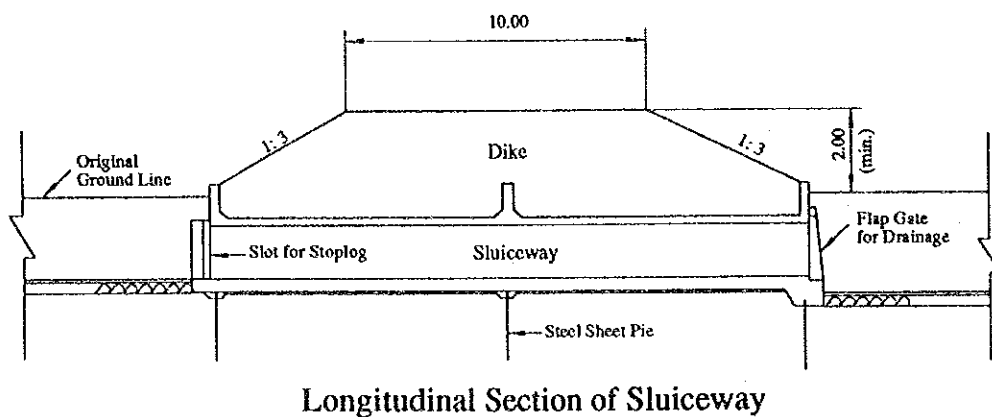
Fig. 6.4.25 Typical Arrangement of Dike, Borrow Pit and Sluiceway
