# **ATTACHMENT-1**

## **WATER QUALITY RESULTS**

**The Study on Water Supply System  
for Siem Reap Region in Cambodia**

**Japan International Cooperation Agency**

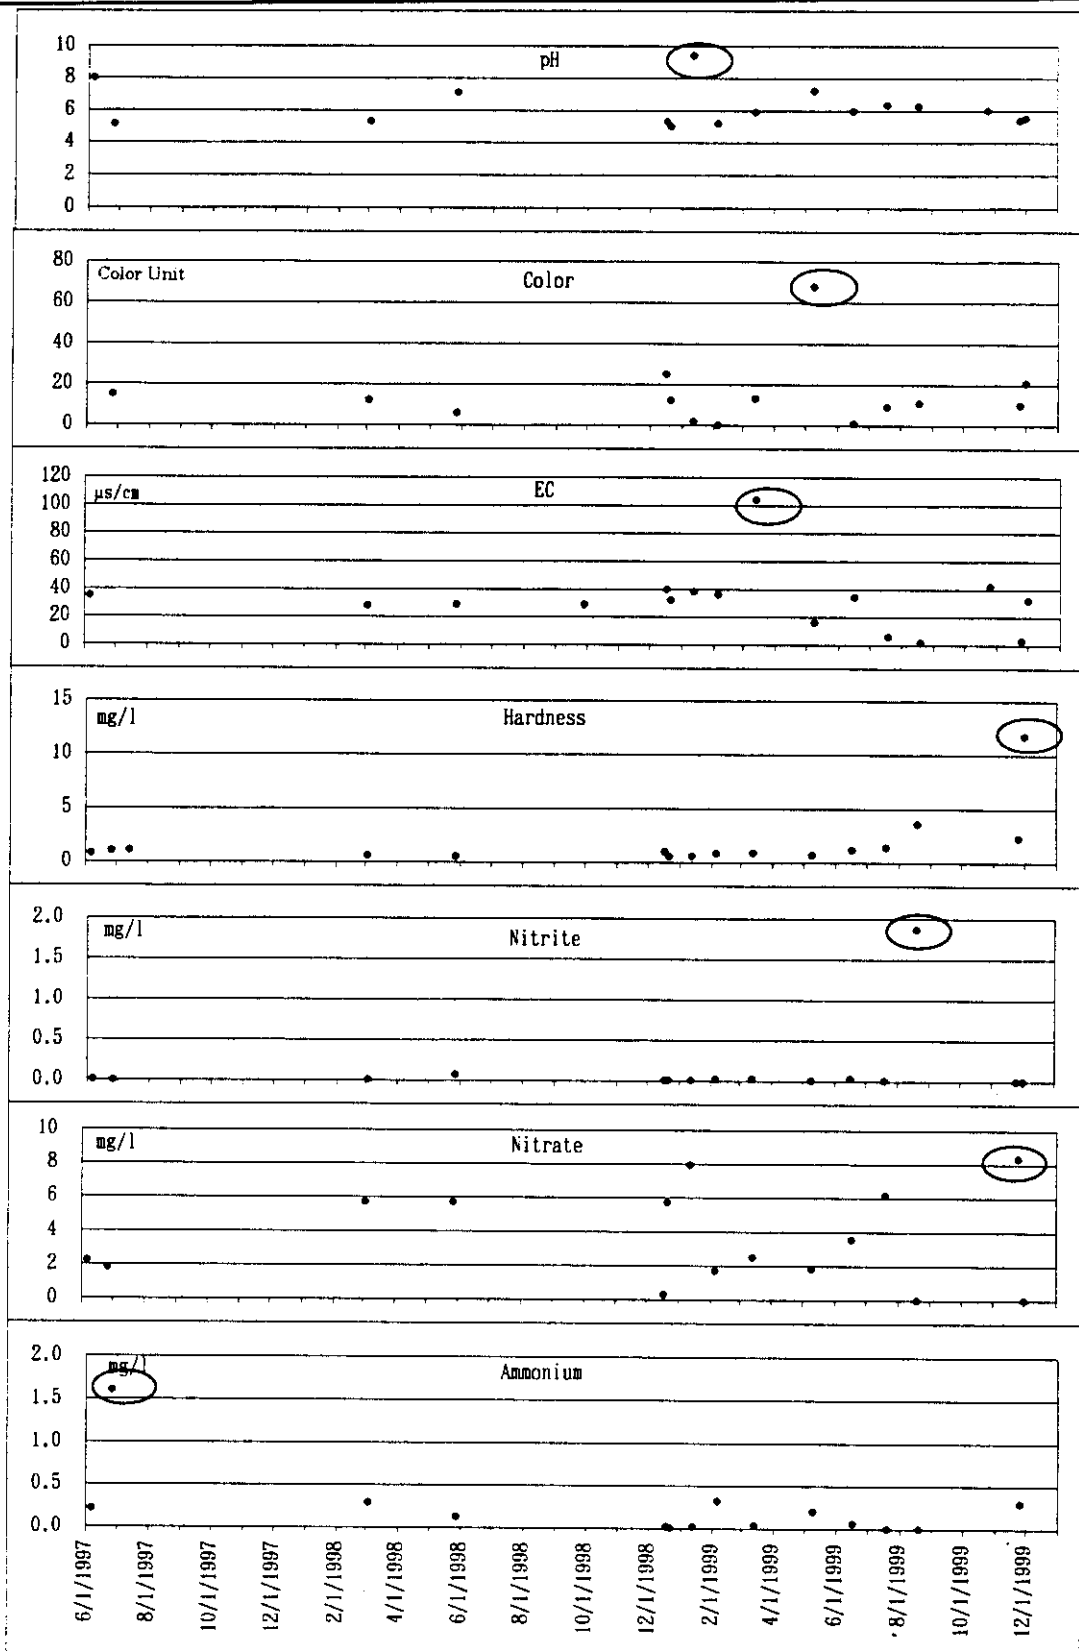
○ Data out of Statistical Significance

**Figure 1.1**  
**Water Quality Results of Groundwater  
from the Well No. WT4 (1/3)**

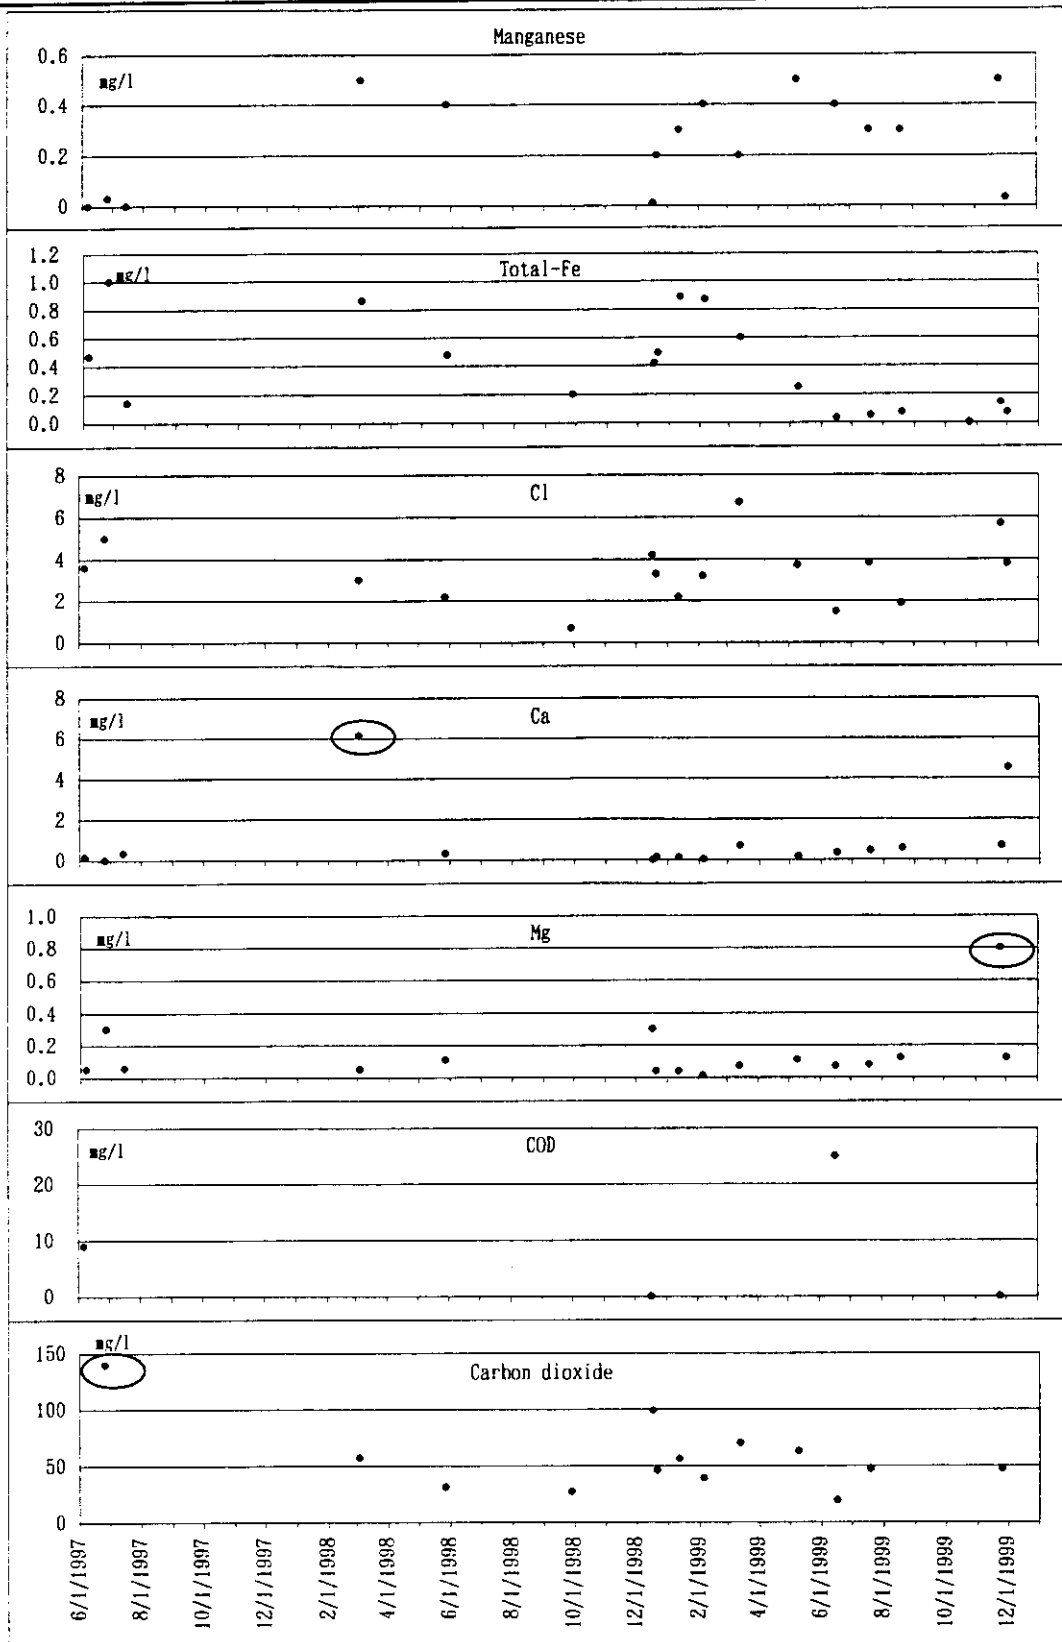
○ Data out of Statistical Significance

**Figure 1.1**  
Water Quality Results of Groundwater  
from the Well No. WT4 (2/3)

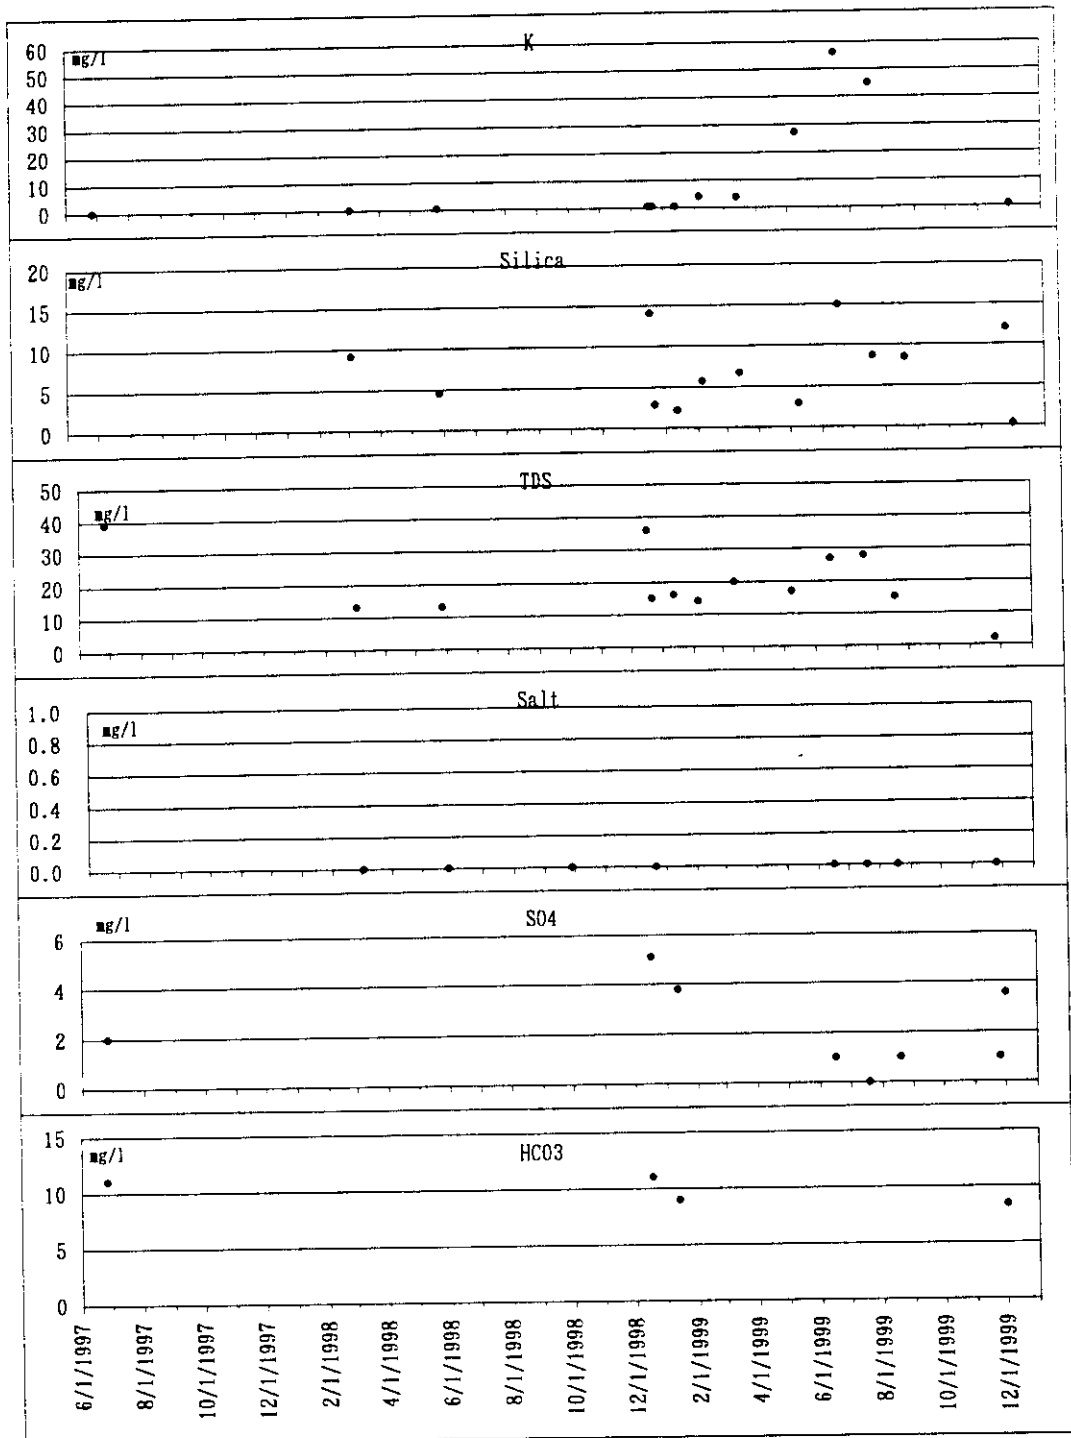
○ Data out of Statistical Significance

Figure 1.1  
Water Quality Results of Groundwater  
from the Well No. WT4 (3/3)

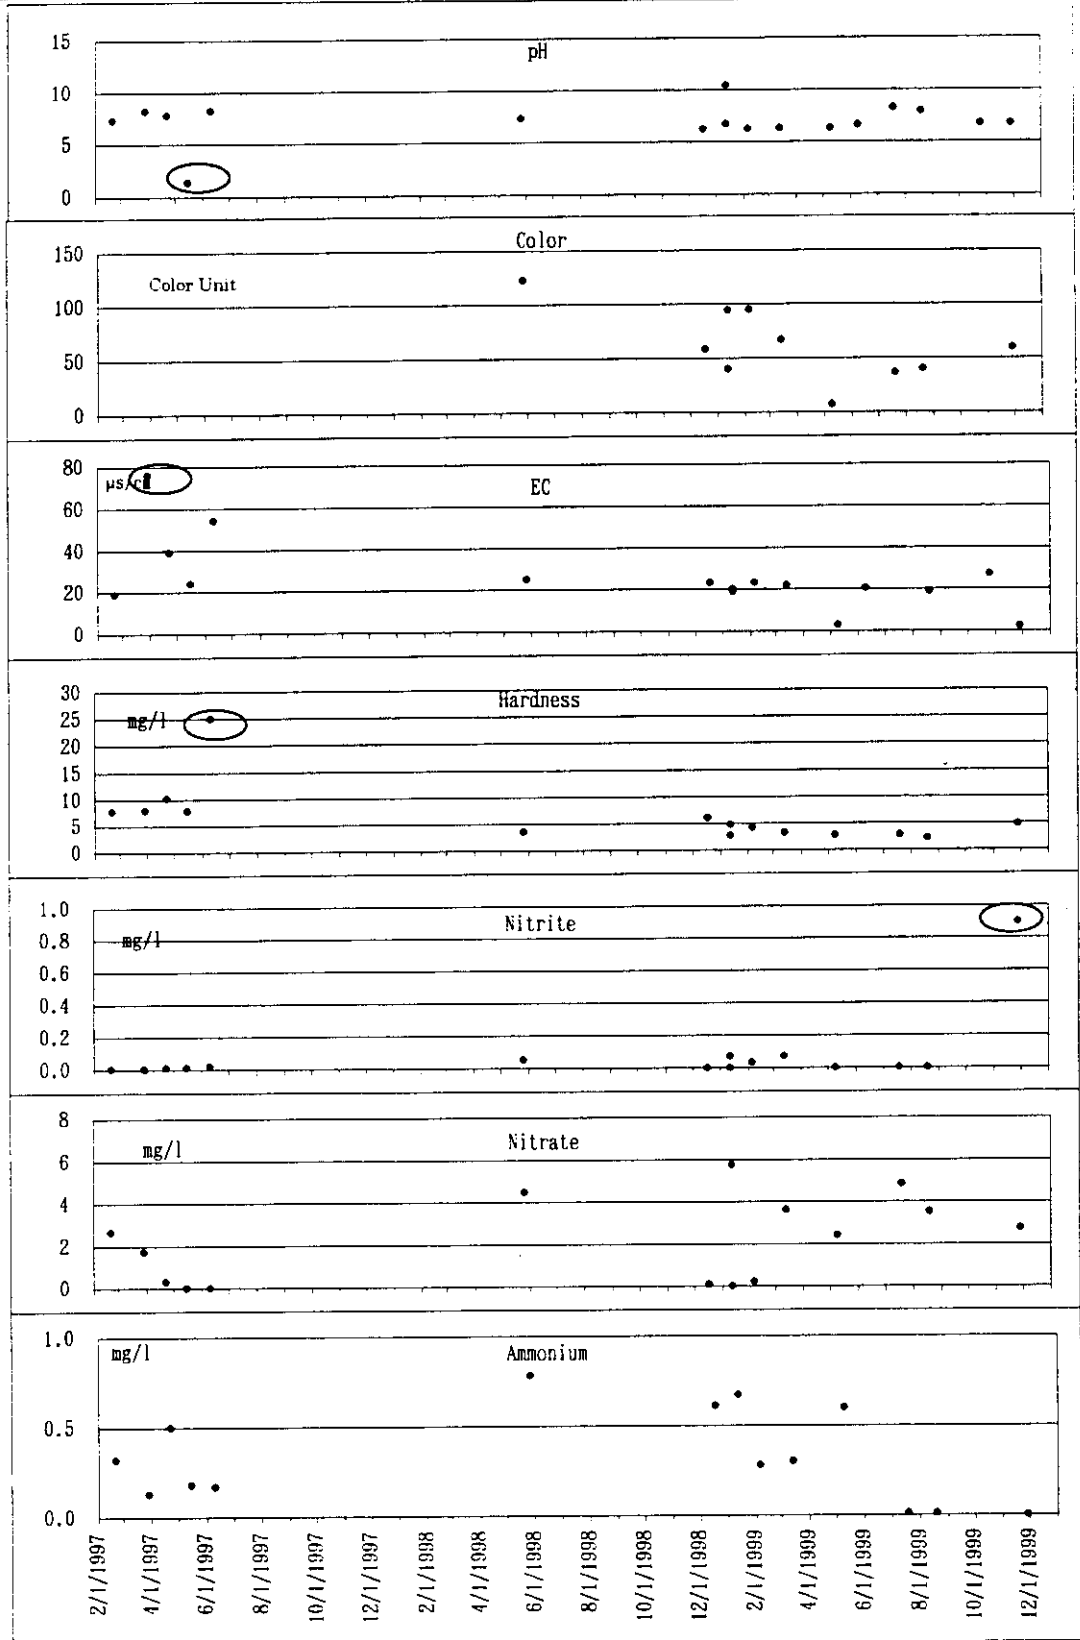
○ Data out of Statistical Significance

Figure 1.2 Water Quality Results of West Baray Reservoir (1/3)

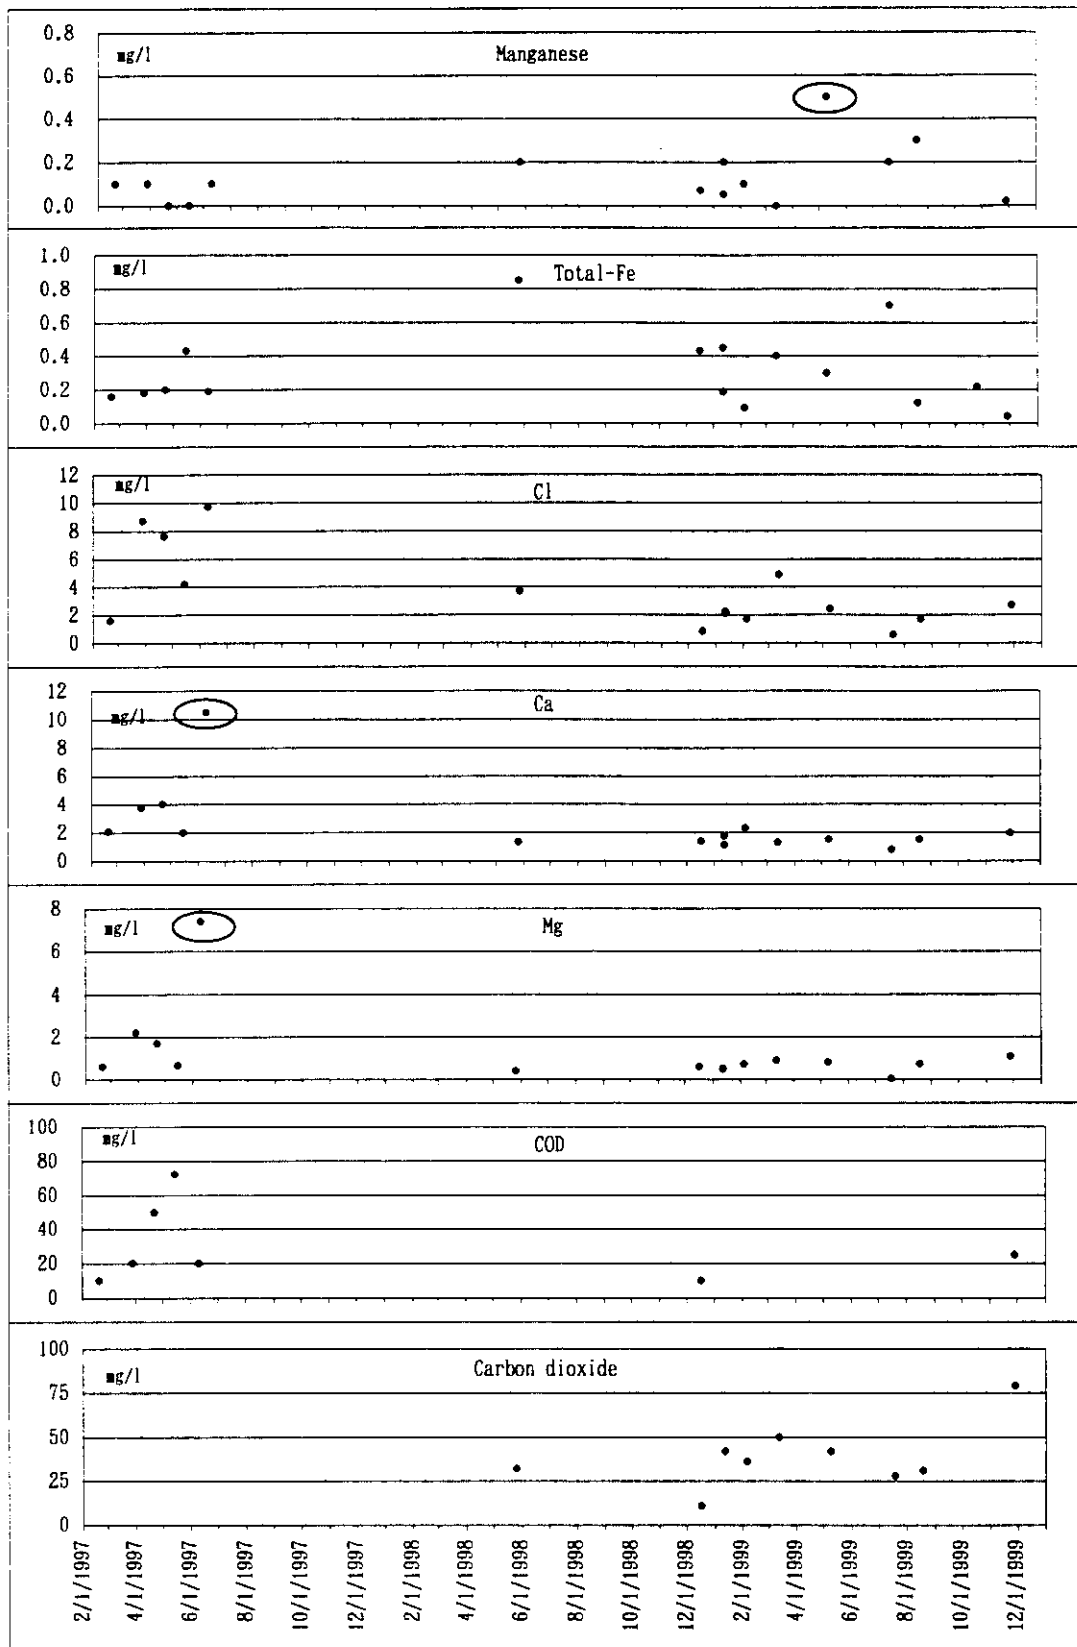
○ Data out of Statistical Significance

Figure 1.2  
Water Quality Results of West Baray  
Reservoir (2/3)

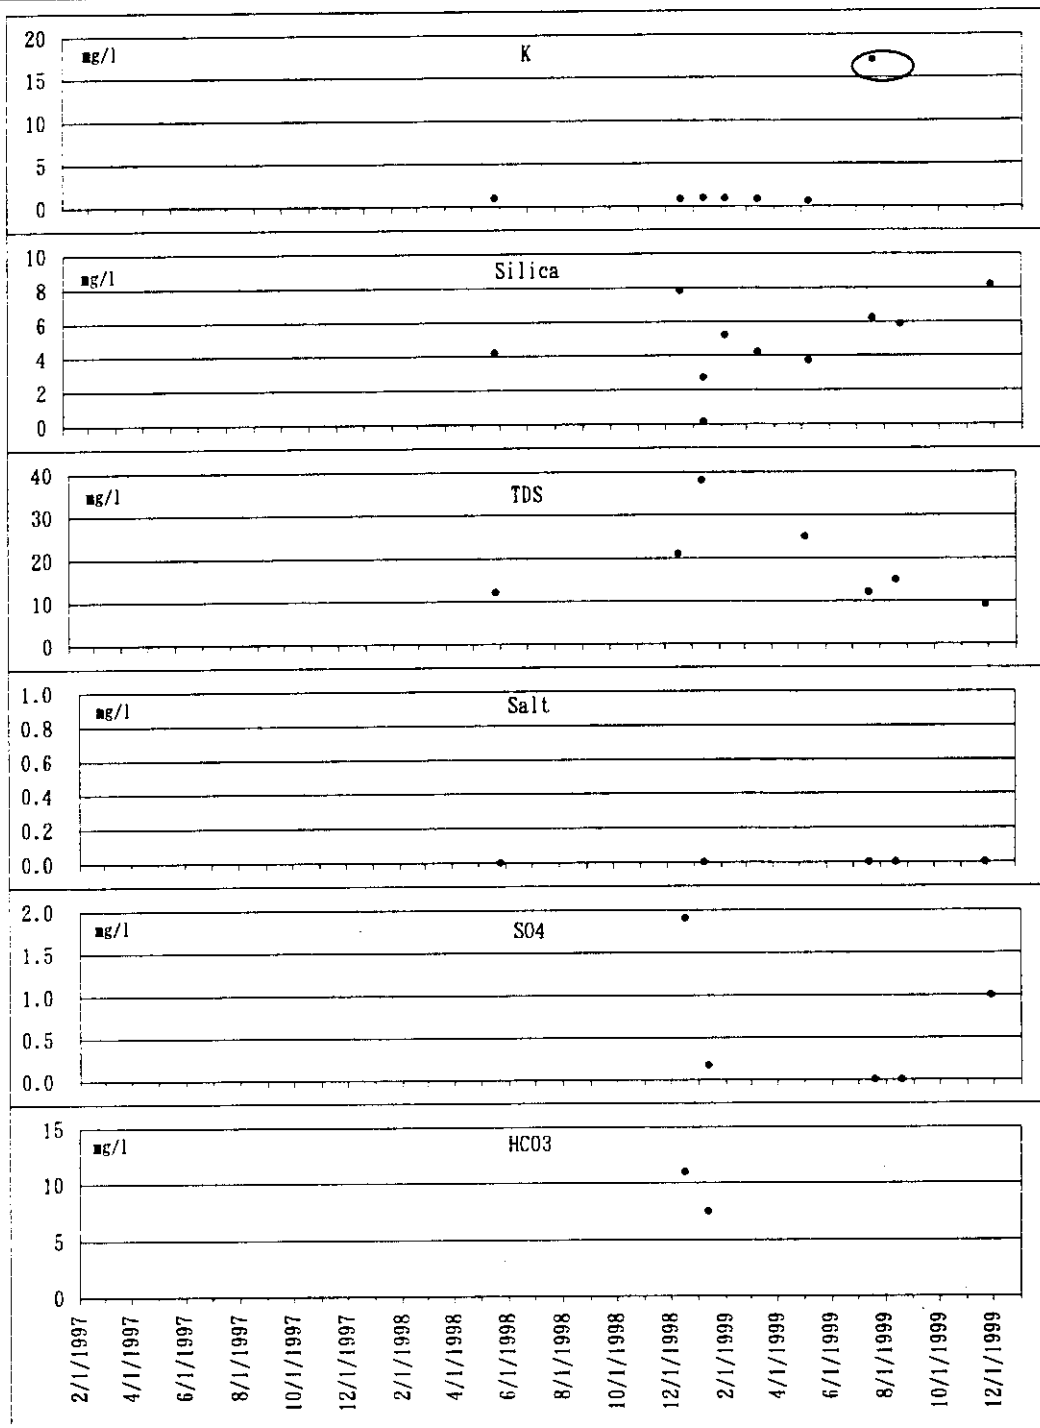
○ Data out of Statistical Significance

Figure 1.2  
Water Quality Results of West Baray  
Reservoir (3/3)

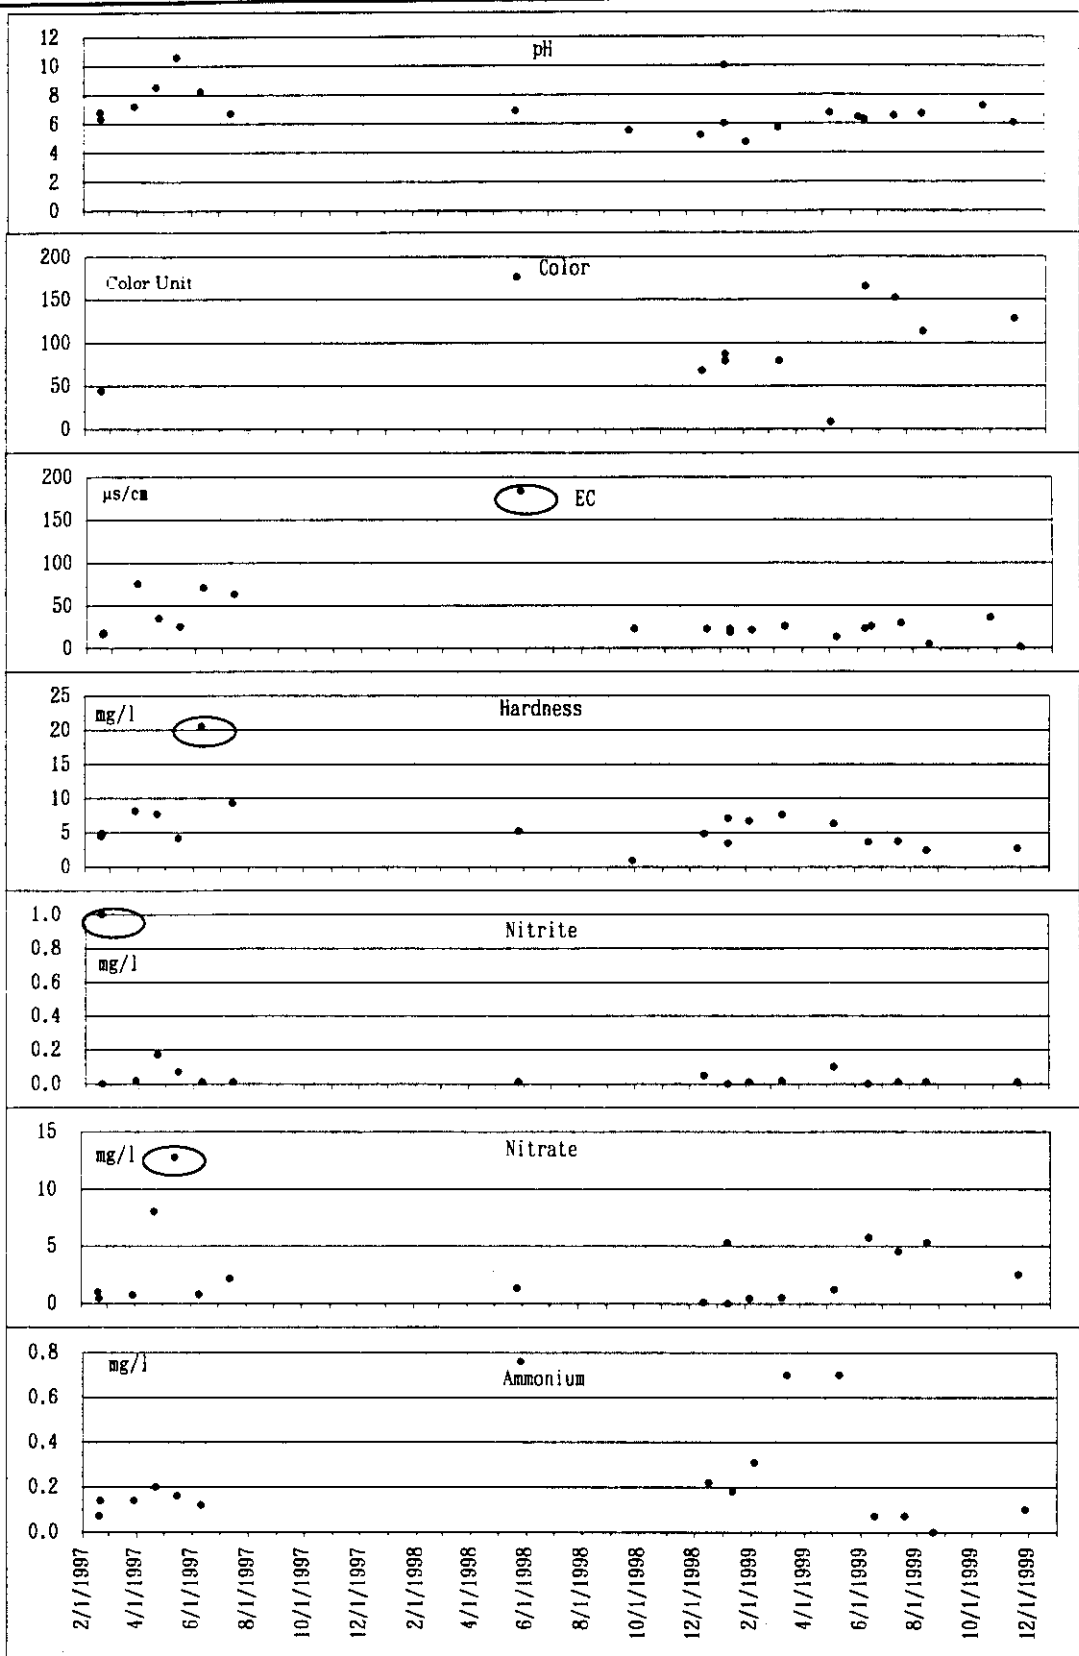
○ Data out of Statistical Significance

**Figure 1.3**  
**Water Quality Results of Siem Reap River  
Water at Angkor Bridge (1/3)**

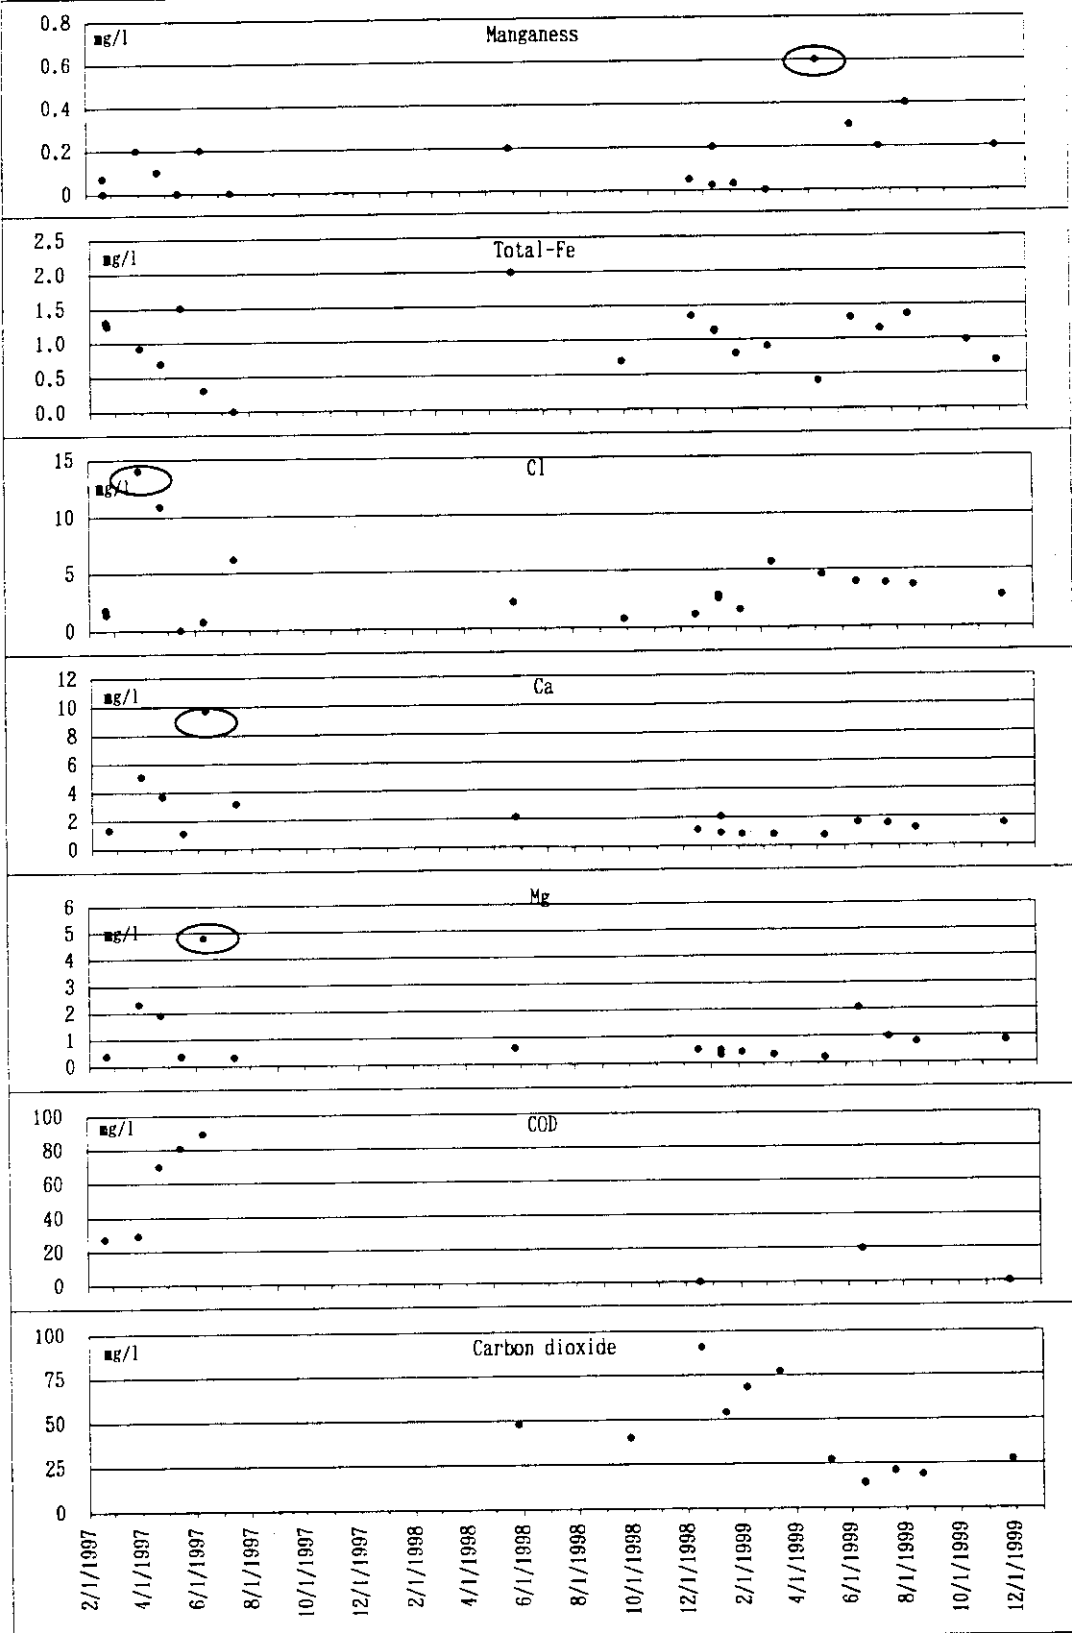
○ Data out of Statistical Significance

**Figure 1.3**  
Water Quality Results of Siem Reap River  
Water at Angkor Bridge (2/3)

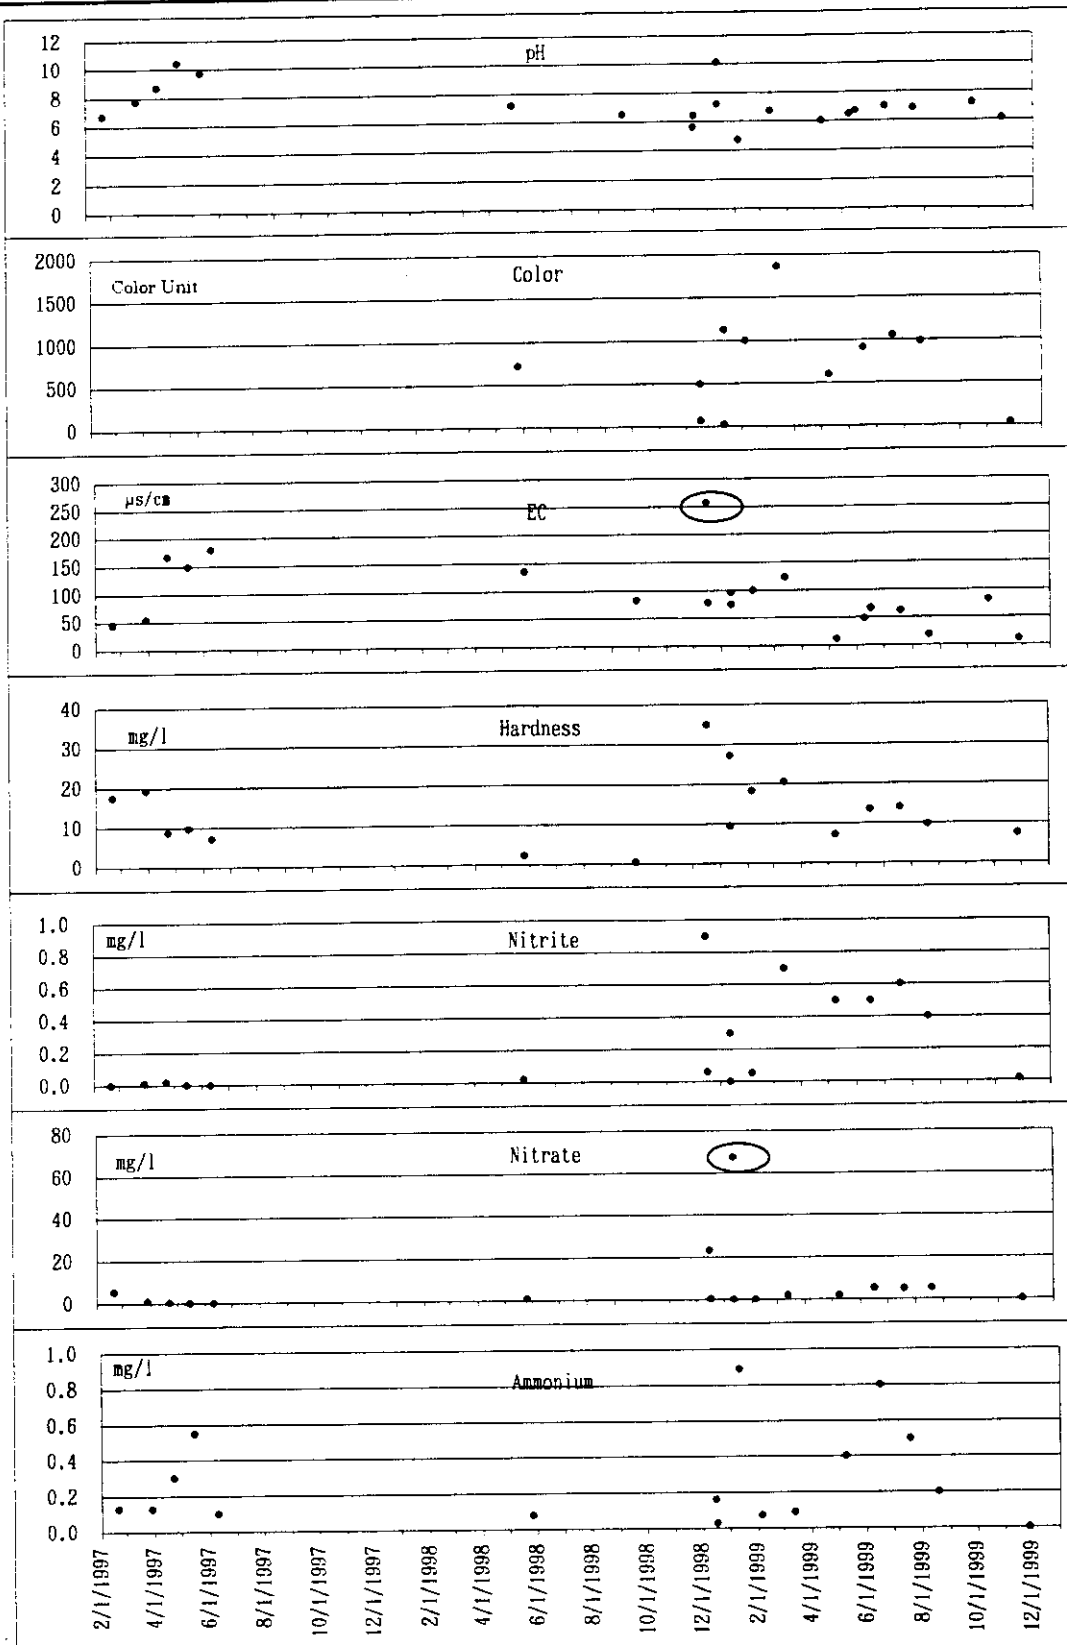
○ Data out of Statistical Significance

Figure 1.4  
Water Quality Results of Lake Tonle Sap  
(1/3)

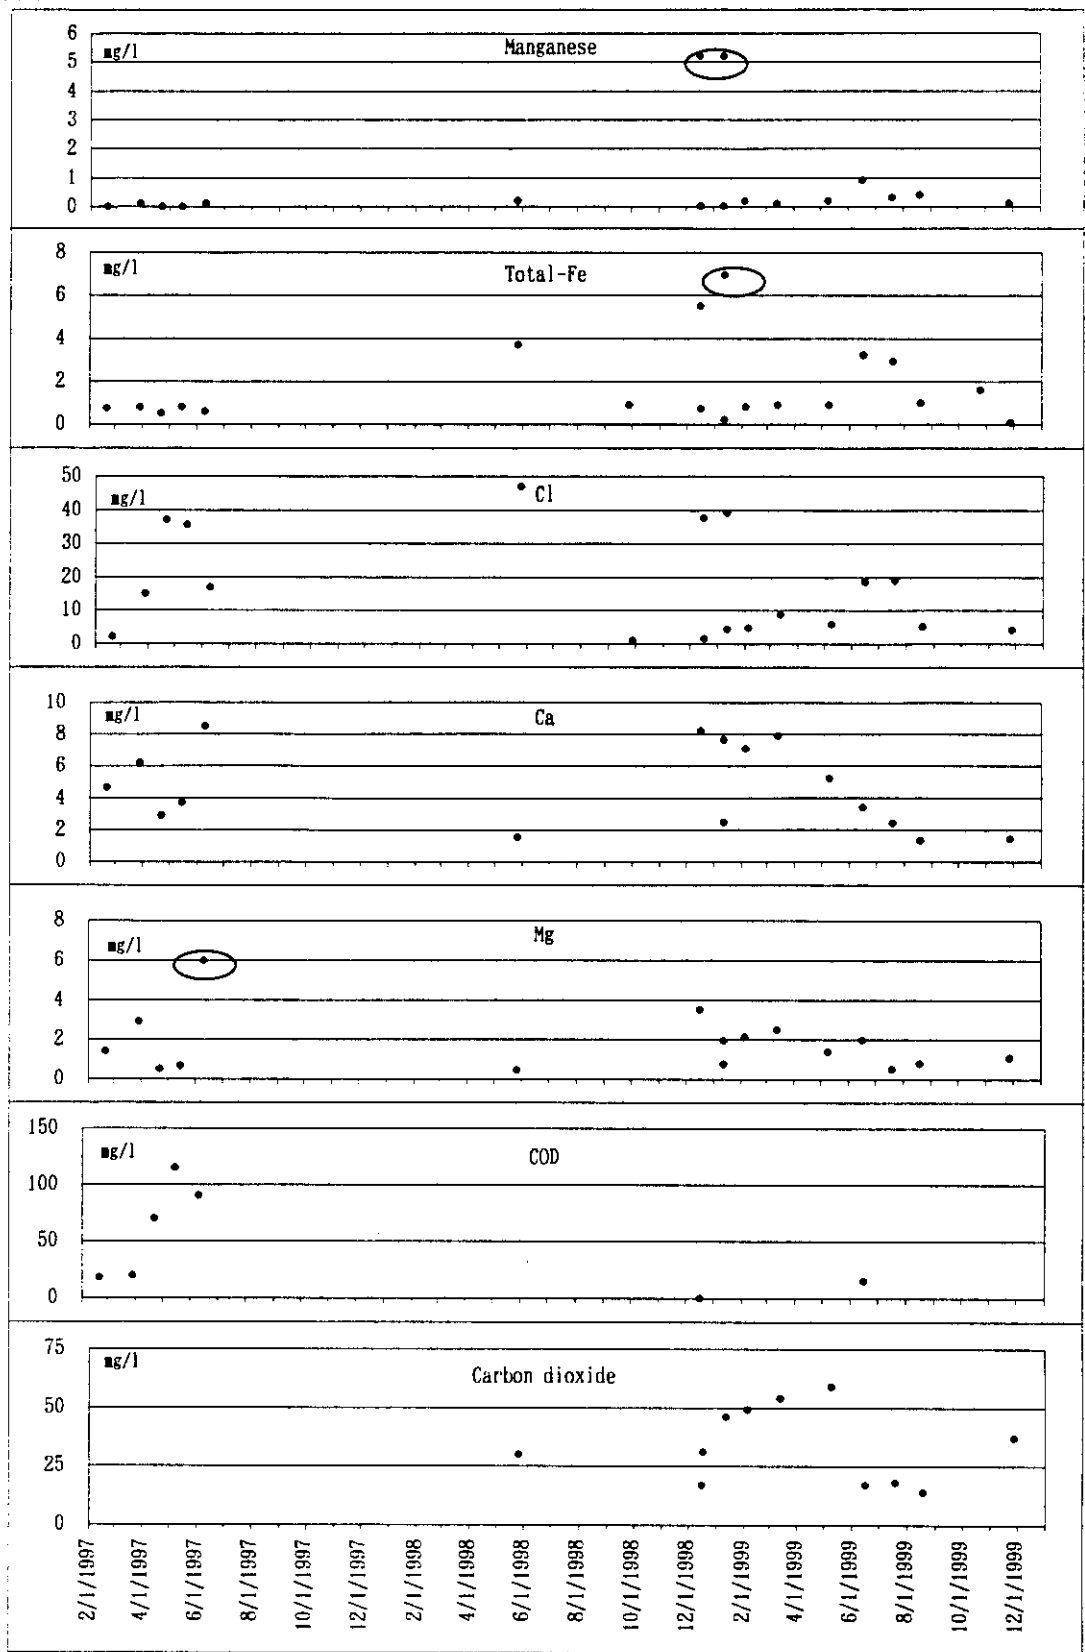
○ Data out of Statistical Significance

Figure 1.4  
Water Quality Results of Lake Tonle Sap  
(2/3)

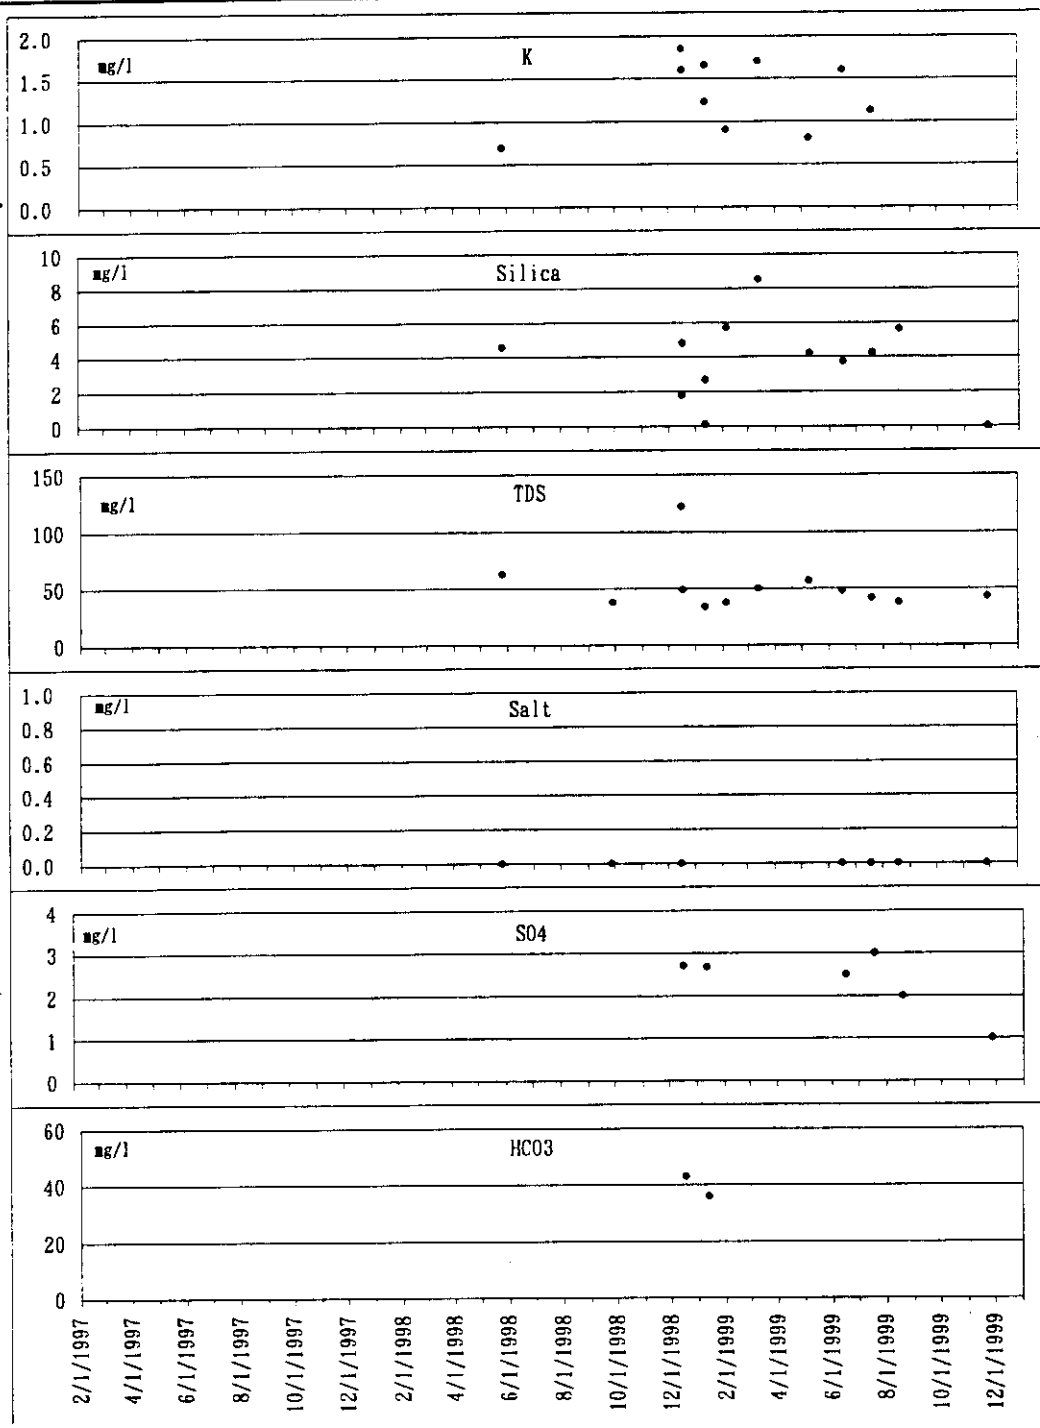
○ Data out of Statistical Significance

Figure 1.4 Water Quality Results of Lake Tonle Sap (3/3)

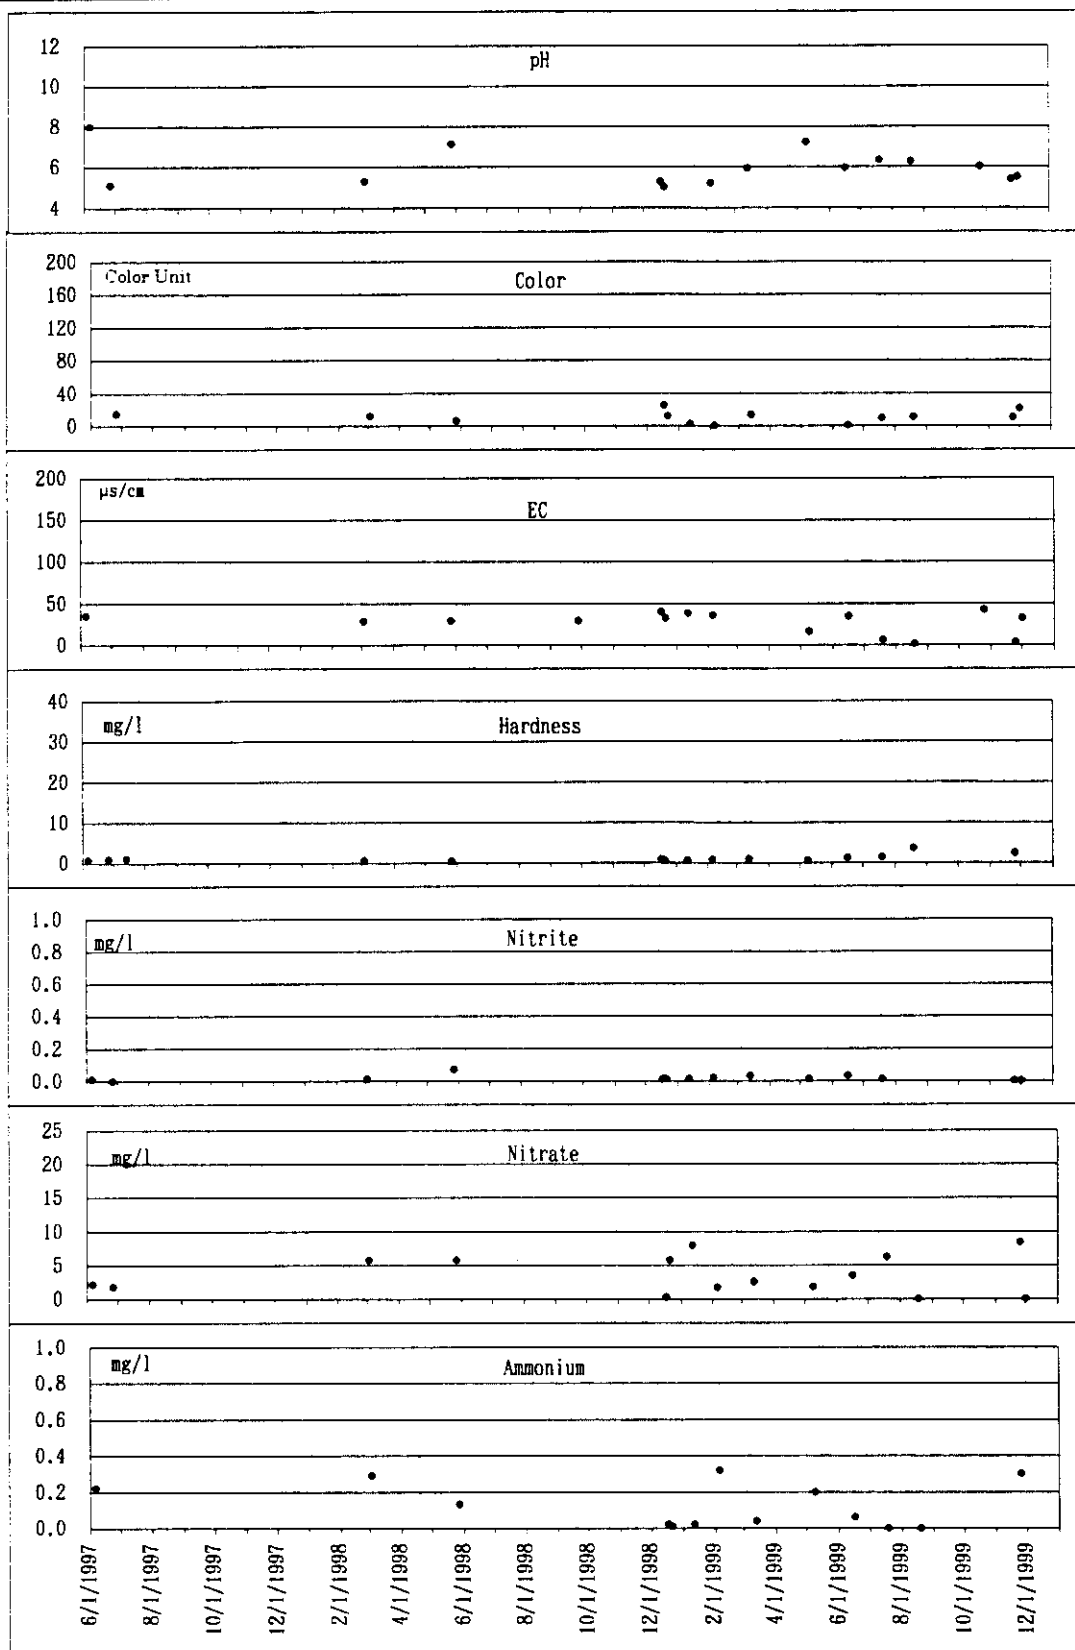
**Figure 2.1**  
Results After Data Screening  
(Groundwater from the Well No. WT4)  
(1/3)

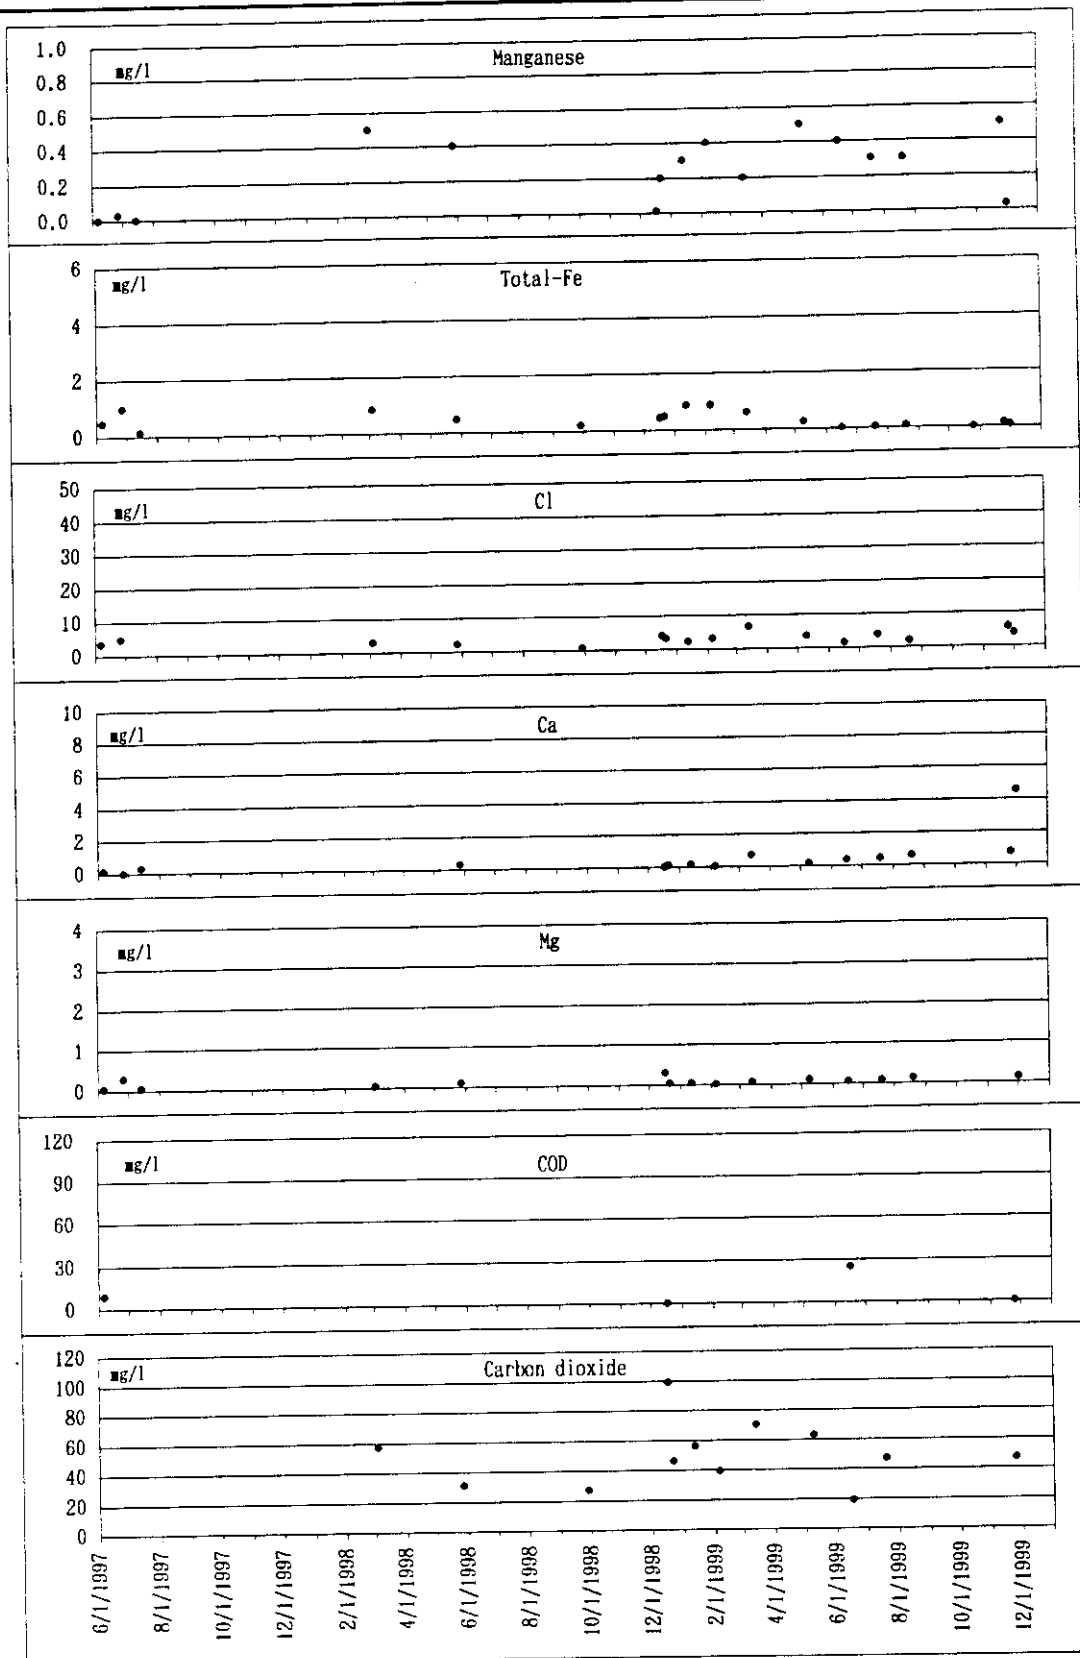
**Figure 2.1**  
Results After Data Screening  
(Groundwater from the Well No. WT4)  
(2/3)
