# **ATTACHMENT-1**

## **WATER QUALITY RESULTS**

**The Study on Water Supply System  
for Siem Reap Region in Cambodia**

**Japan International Cooperation Agency**

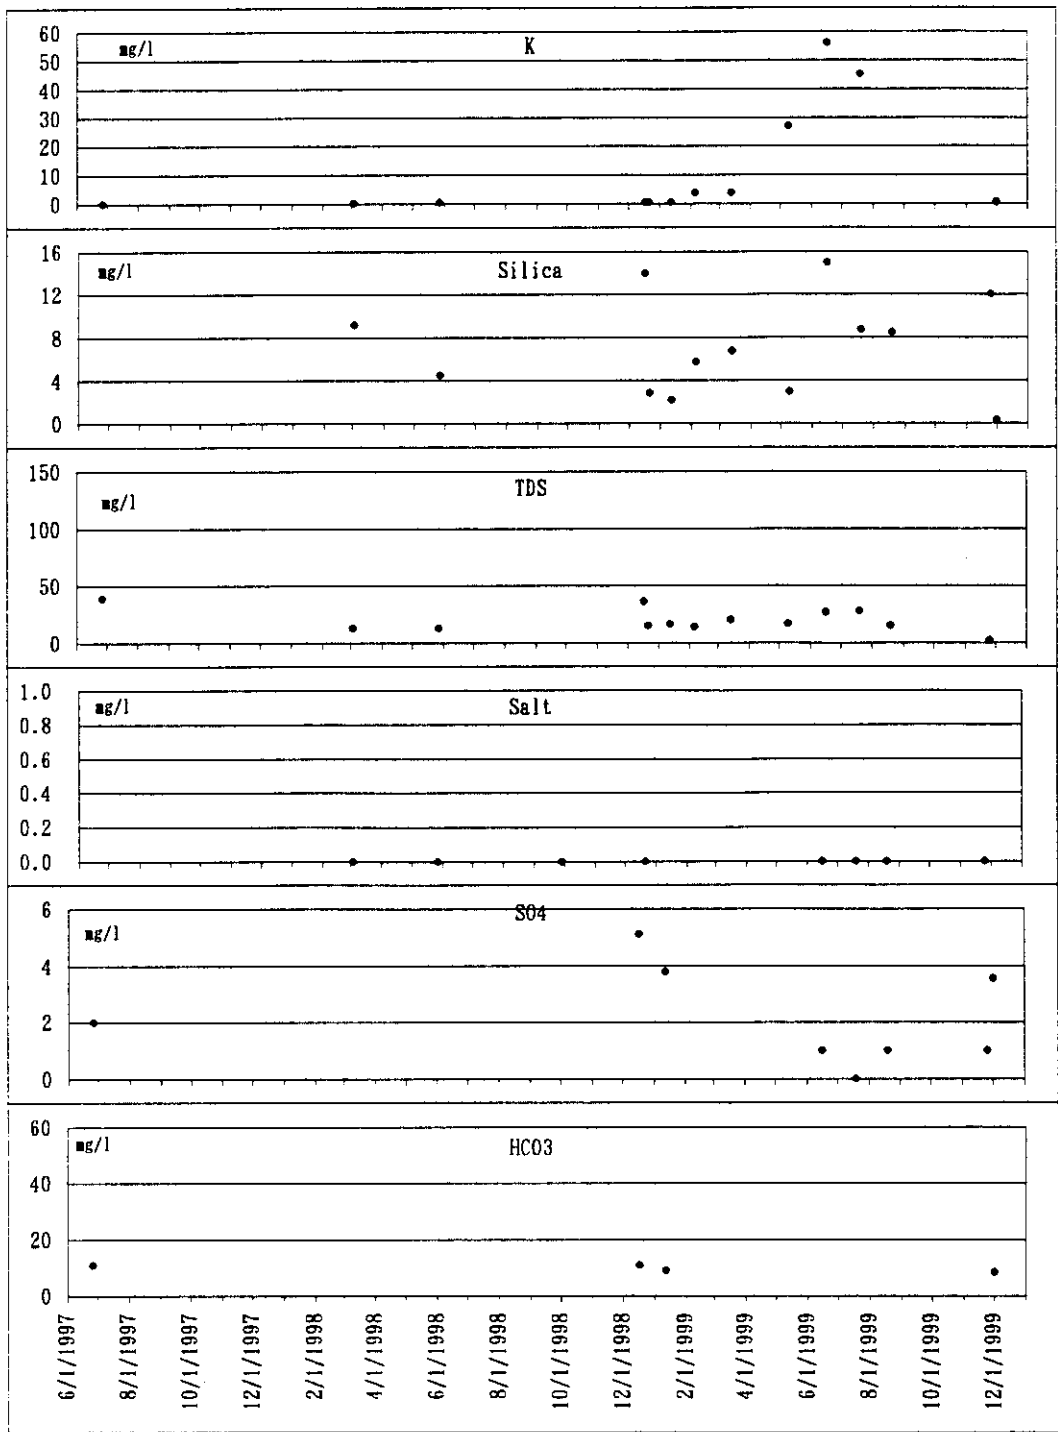
Figure 2.1

Results After Data Screening

(Groundwater from the Well No. WT4)  
(3/3)

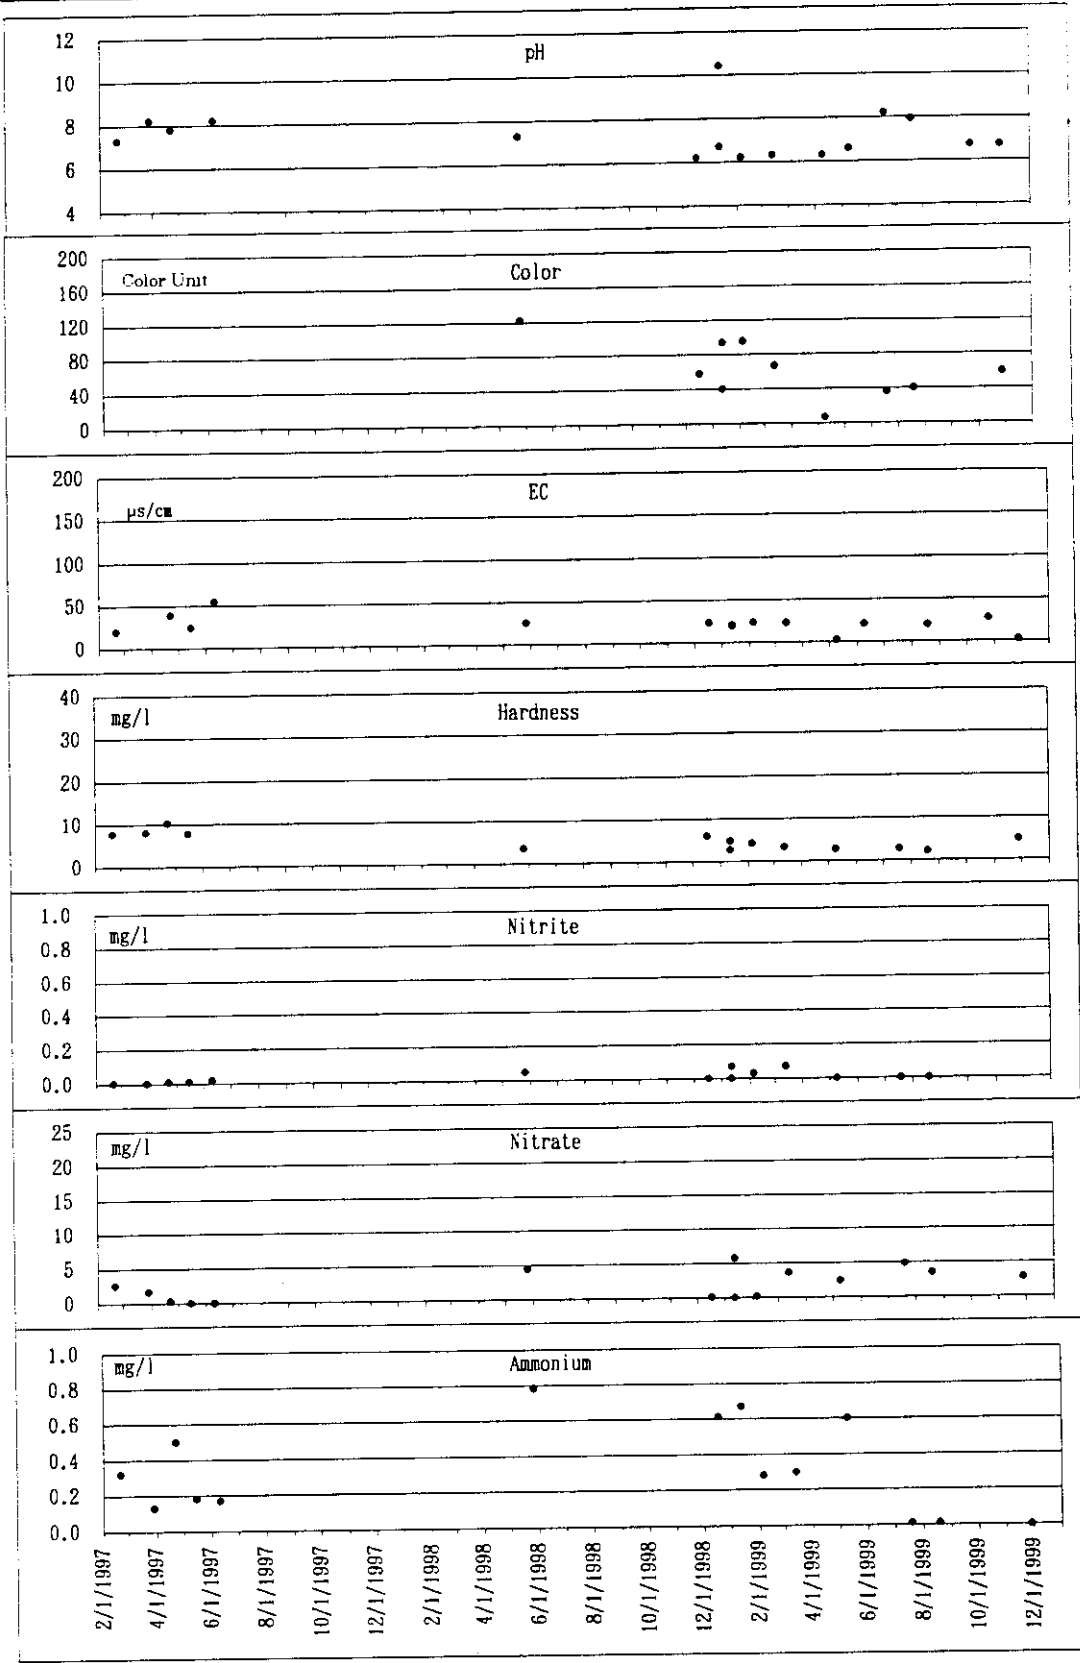
**Figure 2.2**  
Results After Data Screening  
(West Baray Reservoir) (1/3)

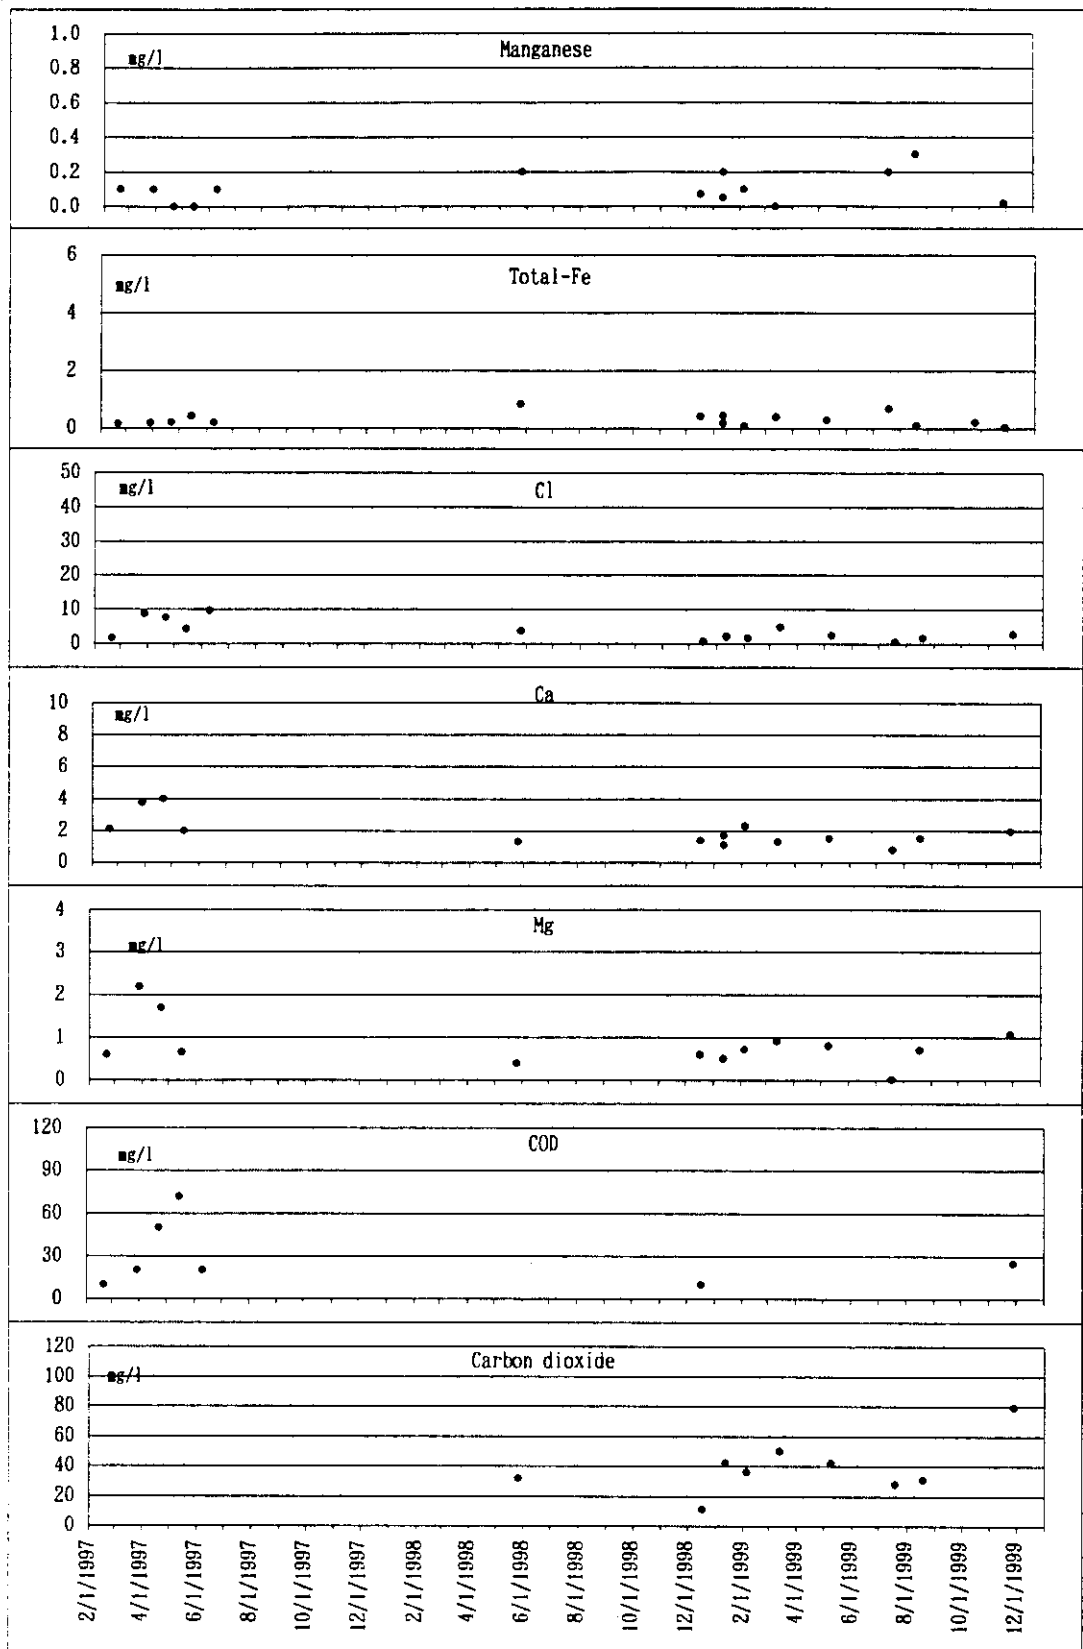
**Figure 2.2**  
Results After Data Screening  
(West Baray Reservoir) (2/3)

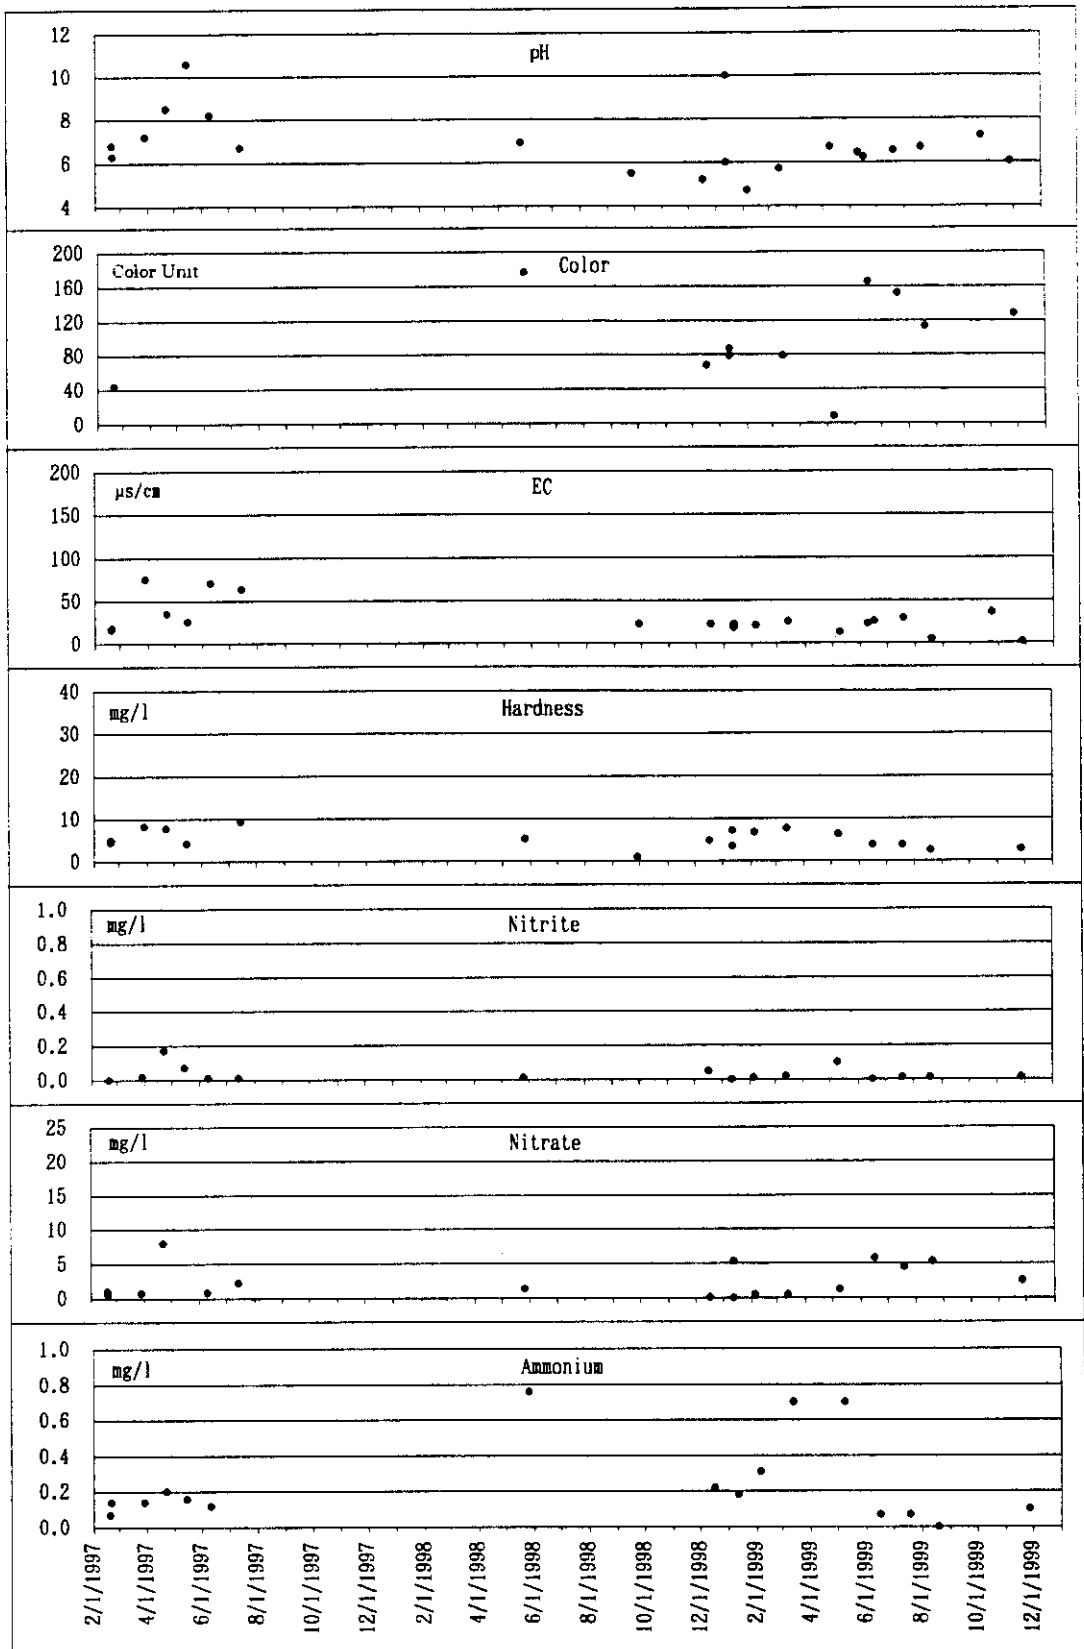
**Figure 3.3**  
Results After Data Screening  
(Siem Reap River Water  
at Angkor Bridge) (1/3)

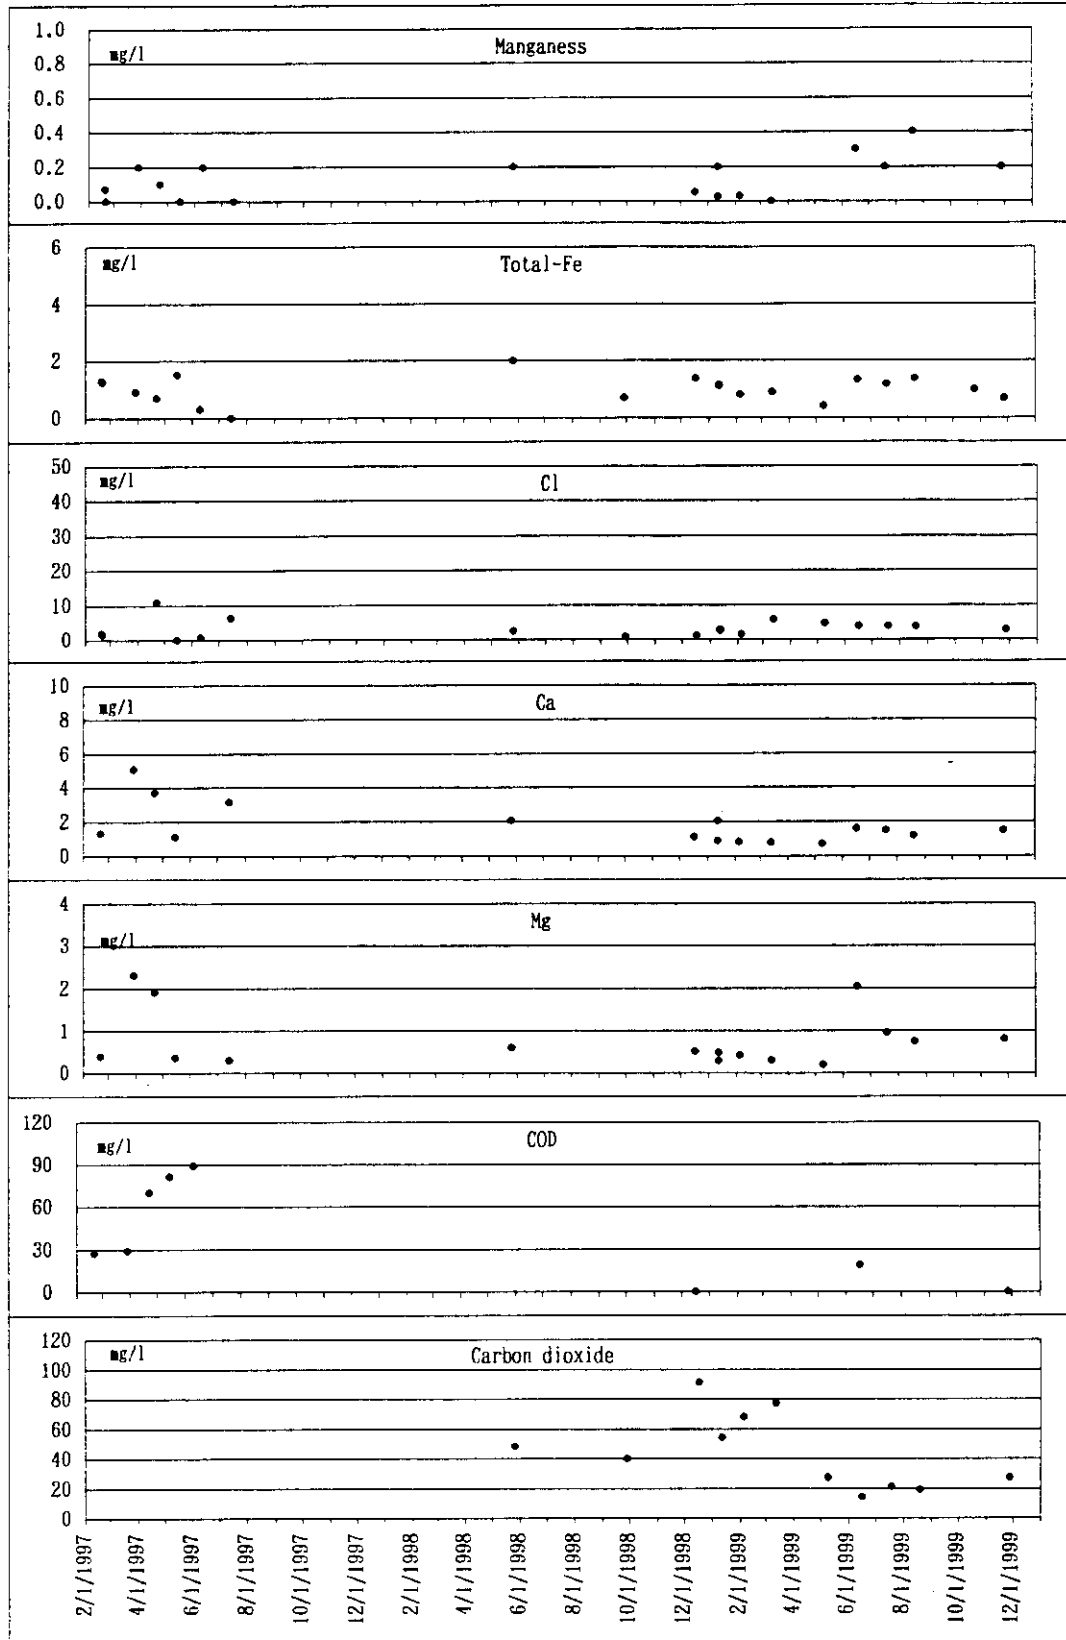
**Figure 3.3**  
Results After Data Screening  
(Siem Reap River Water  
at Angkor Bridge) (2/3)

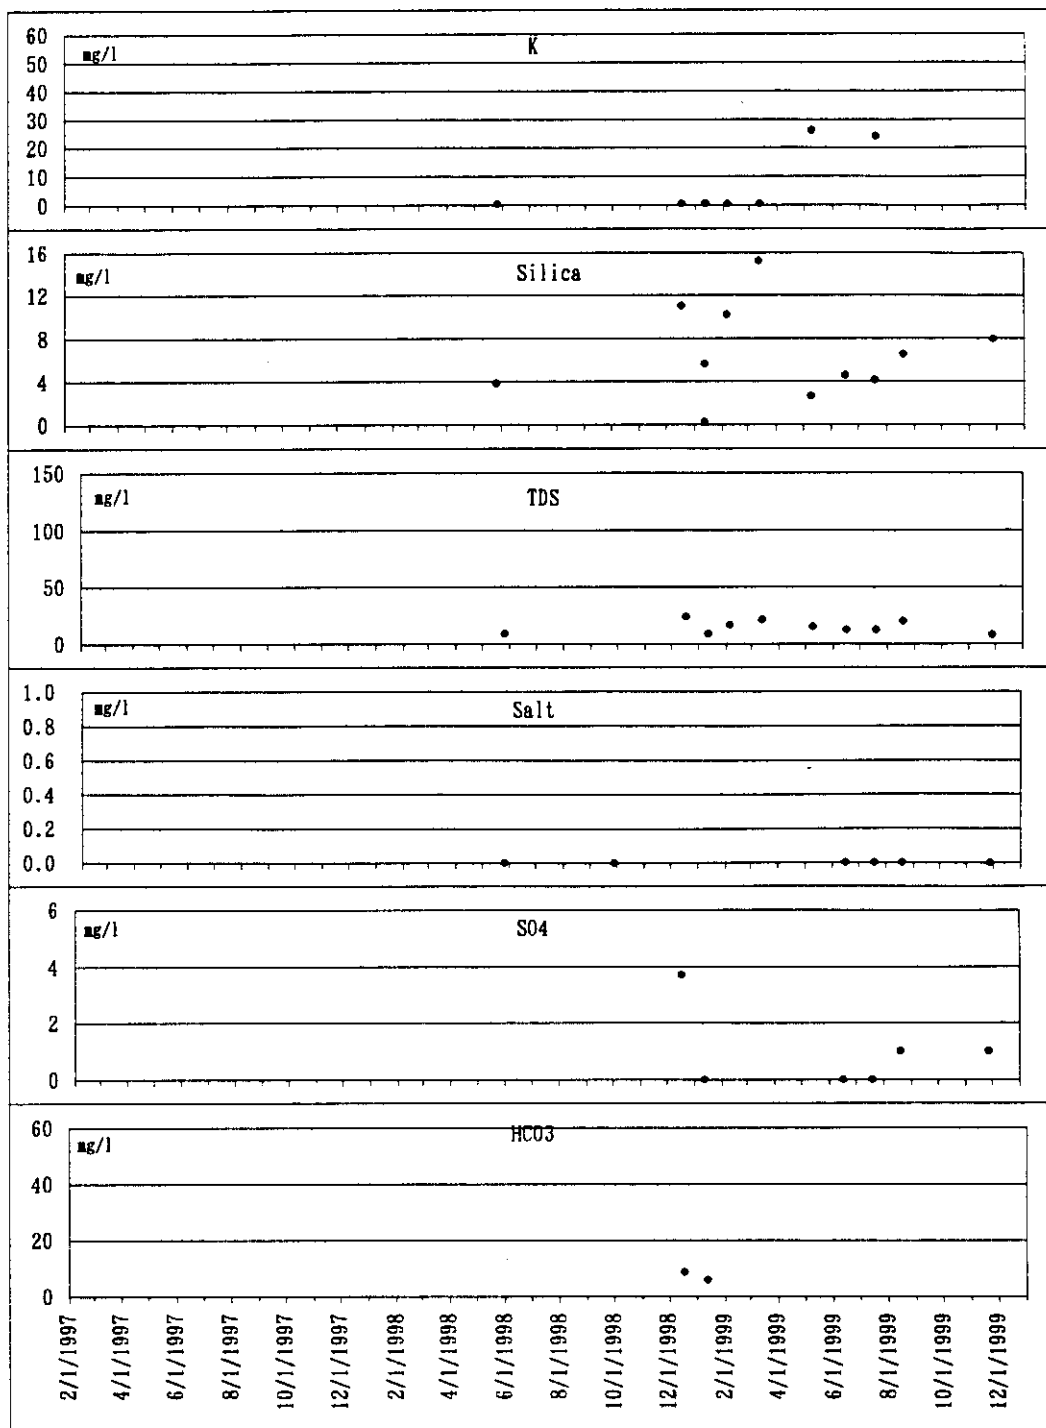
**Figure 3.3**  
Results After Data Screening  
(Siem Reap River Water  
at Angkor Bridge) (3/3)

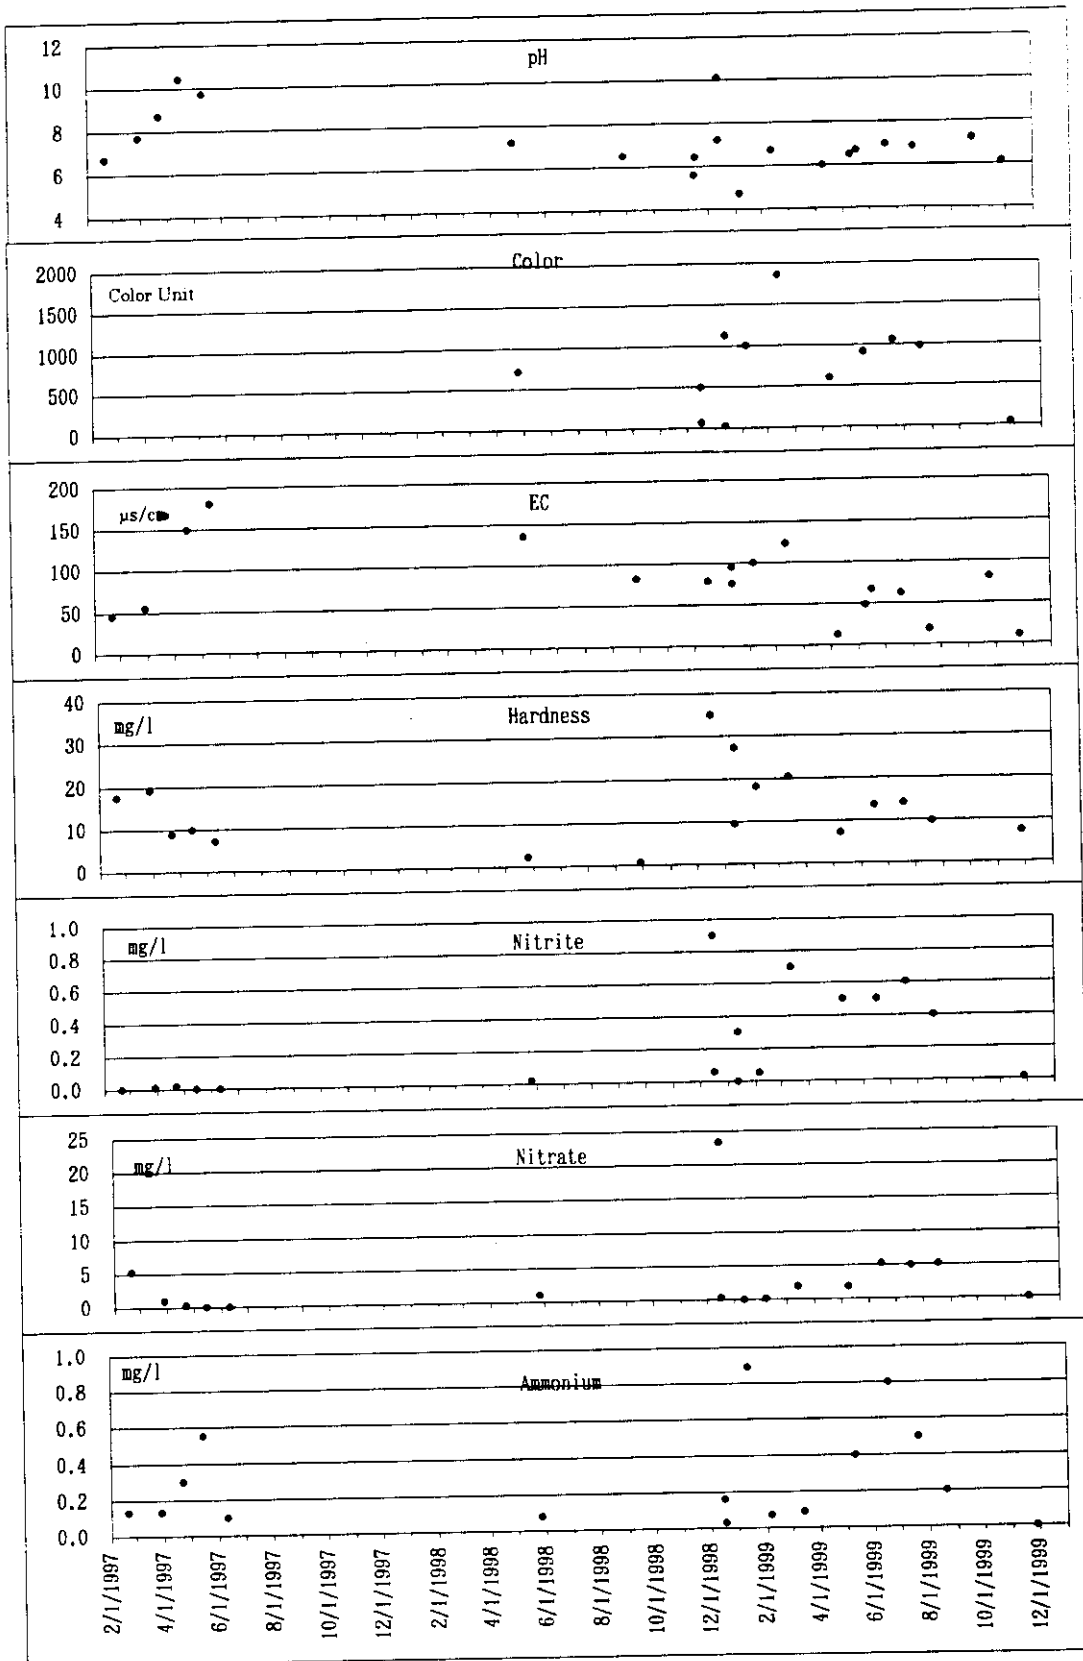
Figure 4.4  
Results After Data Screening  
(Lake Tonle Sap) (1/3)

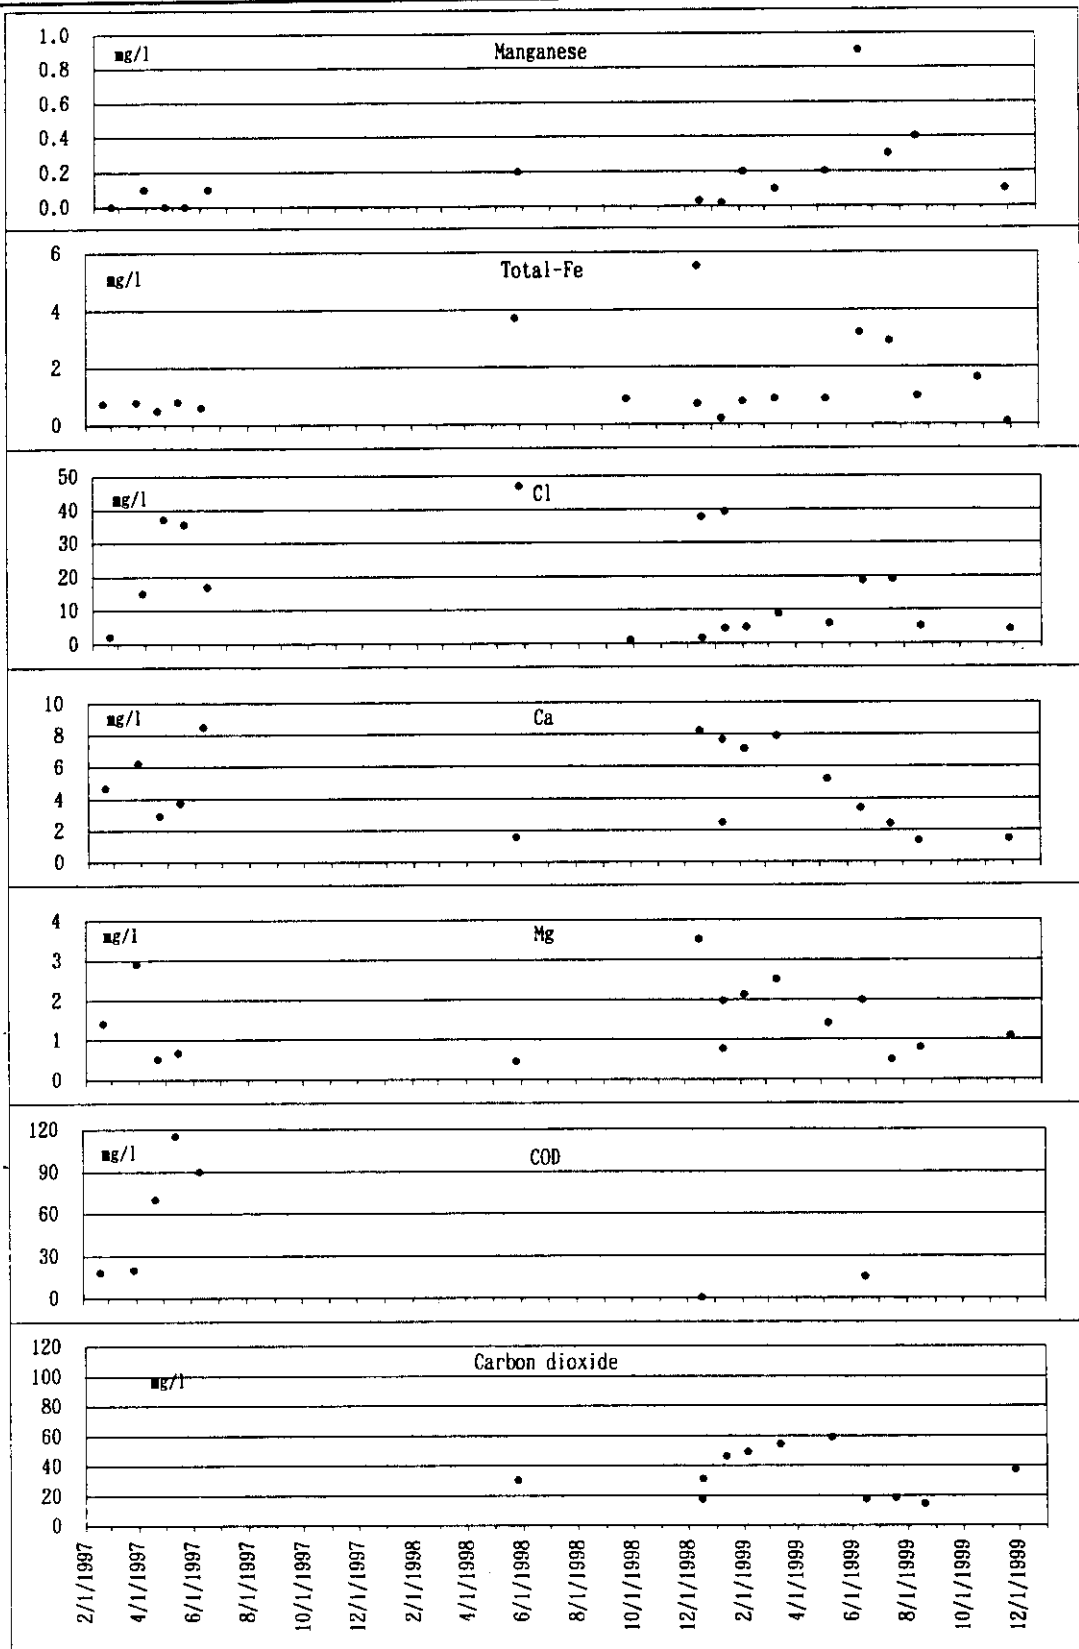
Figure 4.4  
Results After Data Screening  
(Lake Tonle Sap) (2/3)

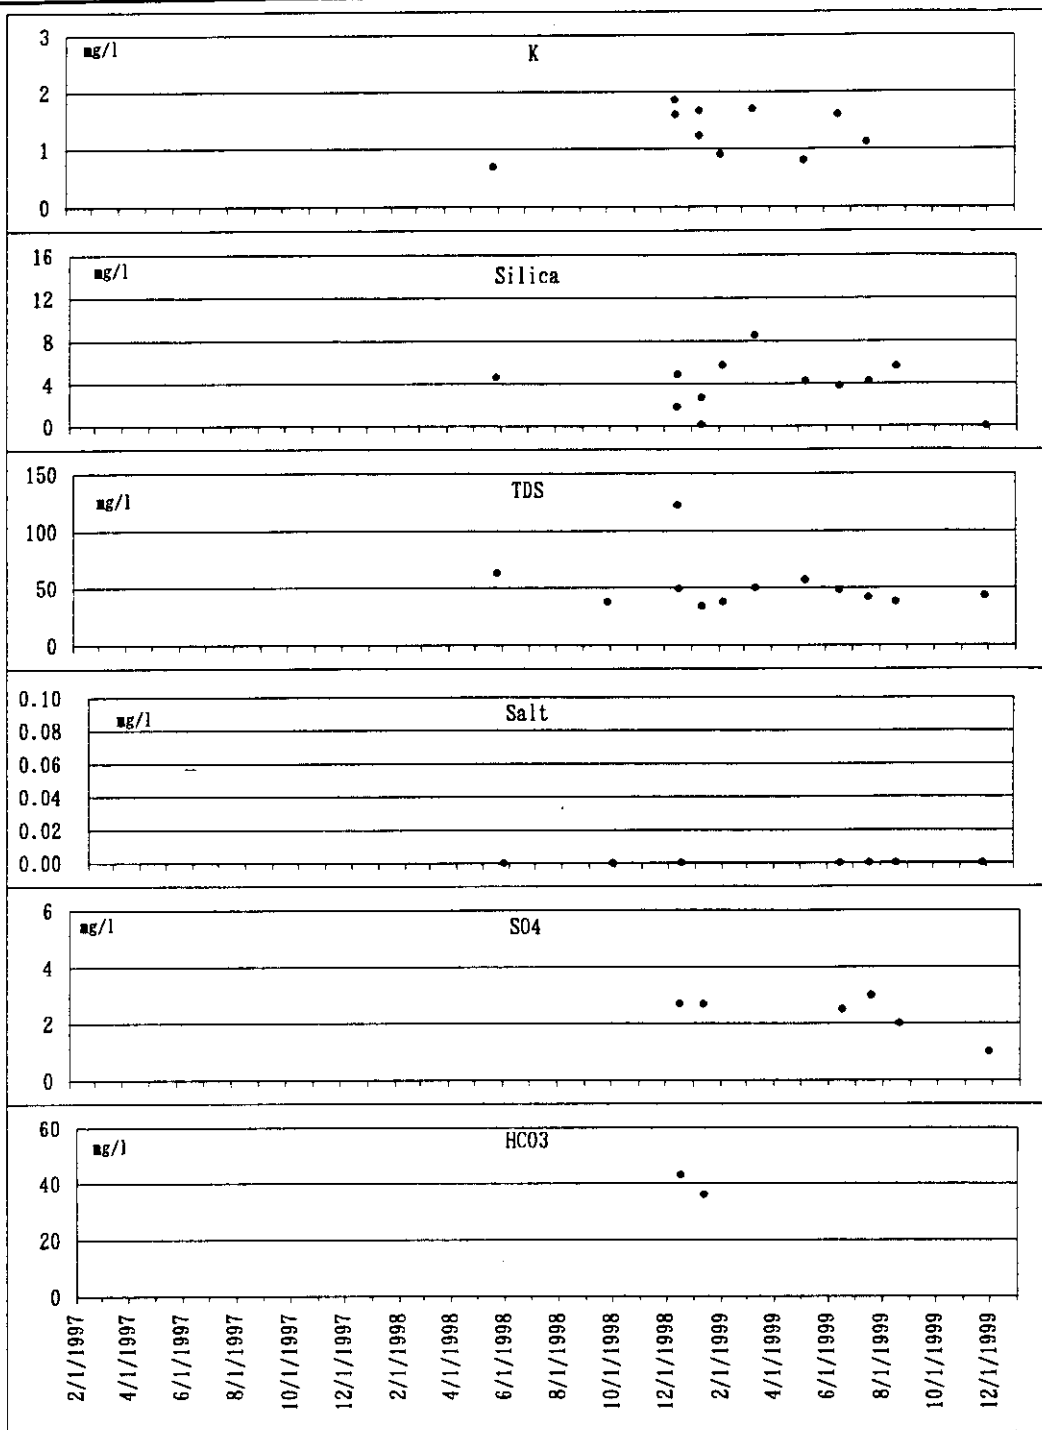
Figure 4.4  
Results After Data Screening  
(Lake Tonle Sap) (3/3)
