THE STUDY ON
 INTEGRATED URBAN DRAINAGE IMPROVEMENT
 FOR MELAKA AND SUNGAI PETANI IN MALAYSIA
 JAPAN INTERNATIONAL COOPERATION AGENCY

Fig. VI-1
 Outline of Storm Outfall Structure

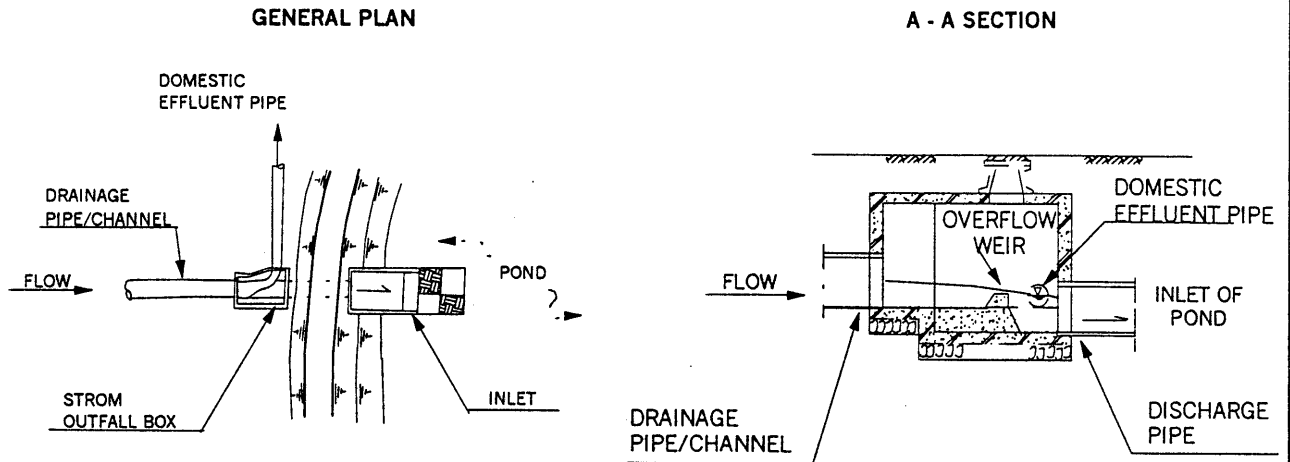
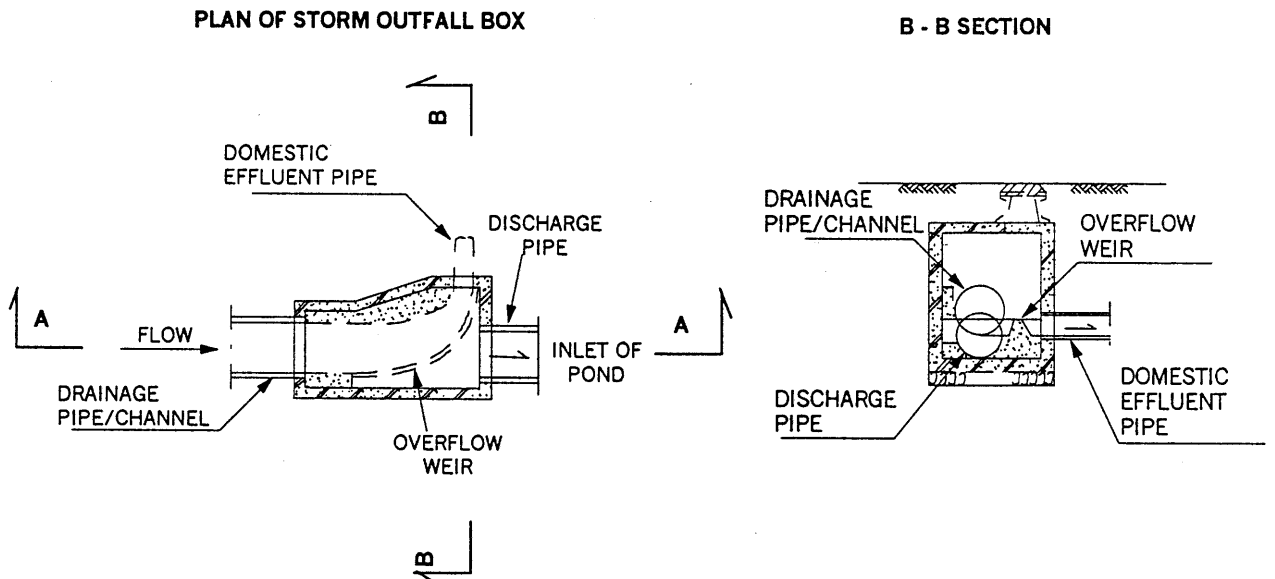
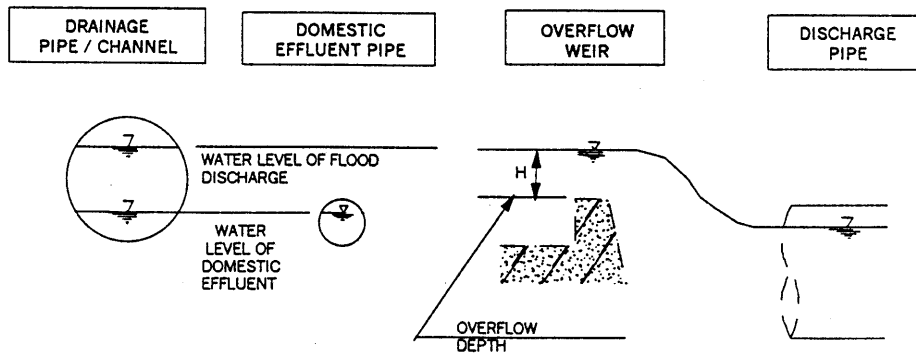
STORM OUTFALL BOX

STRUCTURAL CONDITION OF STORM OUTFALL

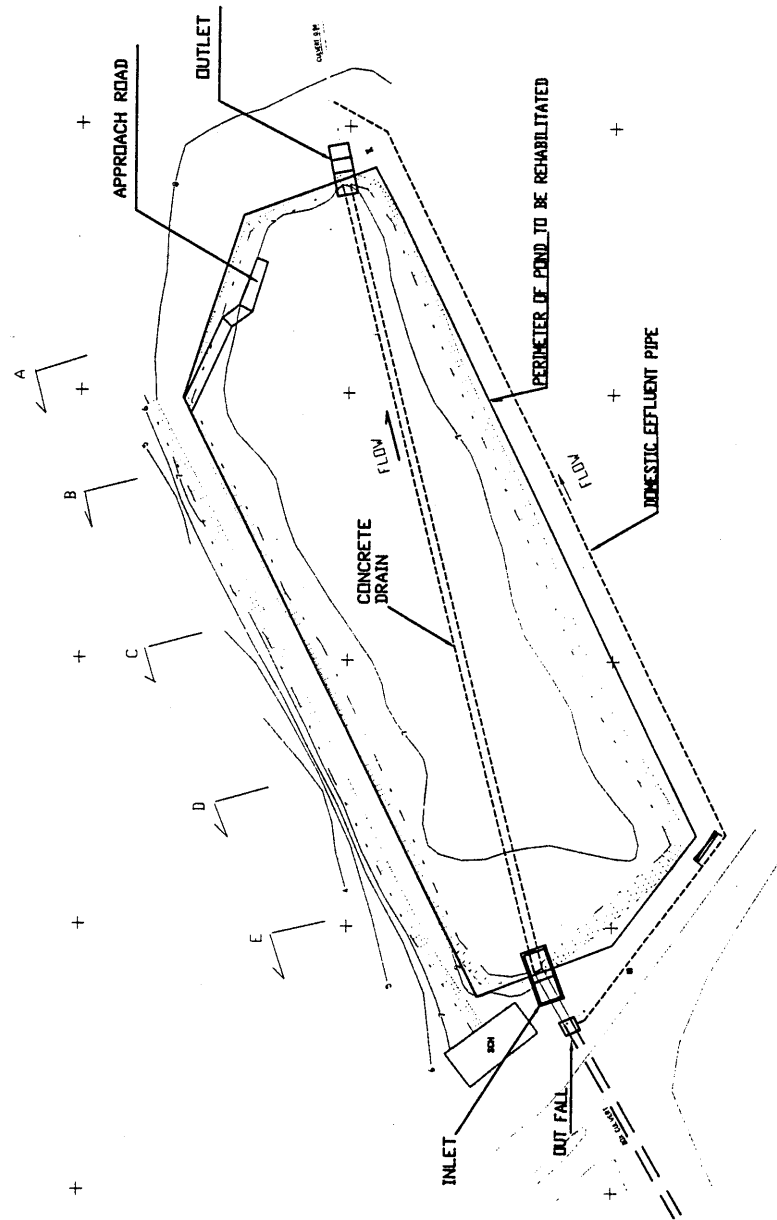
Fig. VI-2
 Rehabilitation of Existing Detention Pond
 at Taman Sri Wang (Sg. Petani)

CROSS - SECTIONS

PLAN OF POND (TAMAN SRI WANG, SUNGAI PETANI)

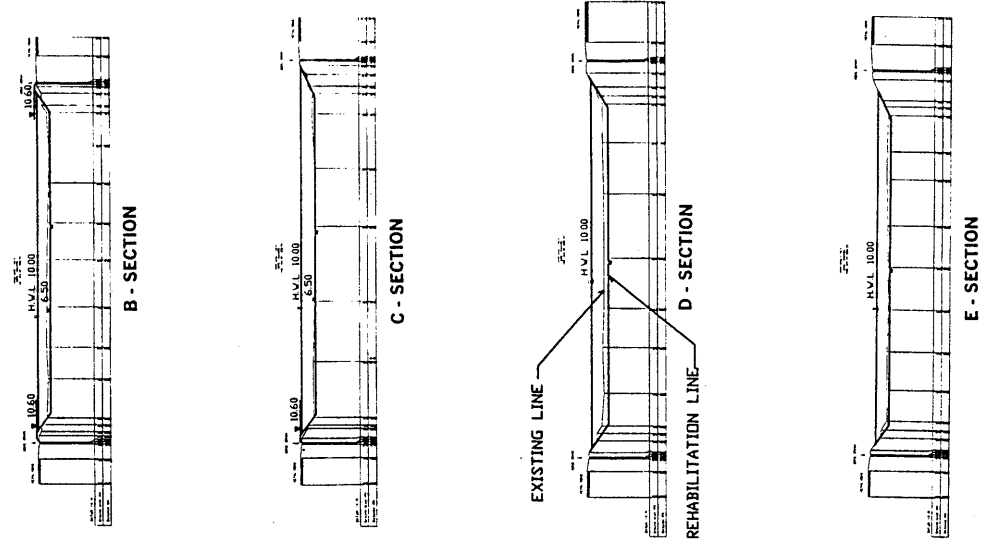
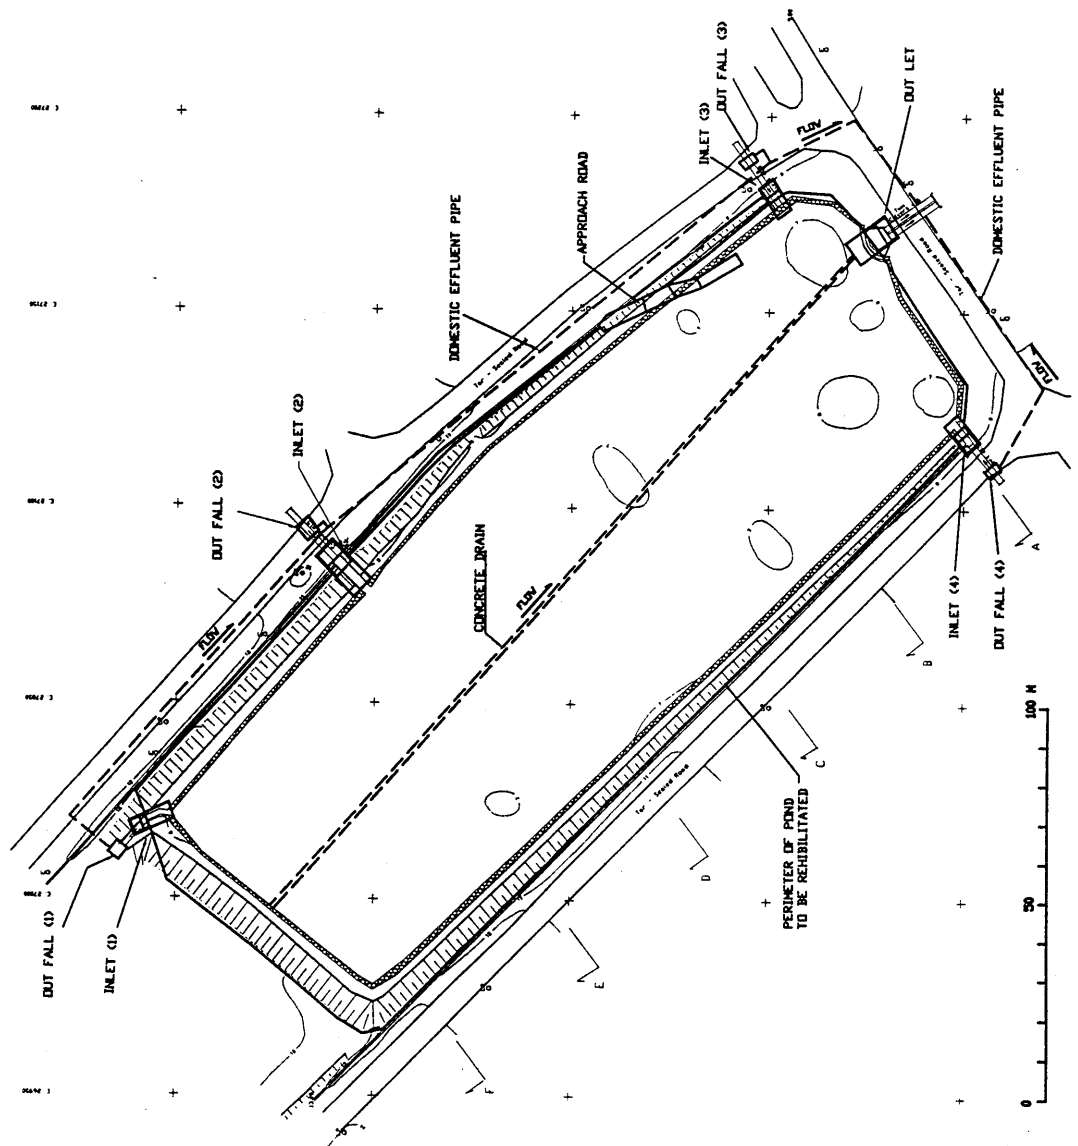
Fig. VI-4
 Rehabilitation of Existing Detention Pond
 at Kawasan Industri Bukit Rambai
 (Melaka)

PLAN OF POND (KAWASAN INDUSTRI BUKIT RAMBAI, MELAKA)

CROSS - SECTIONS

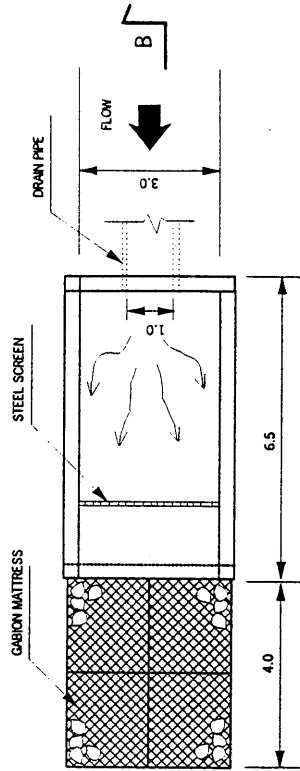
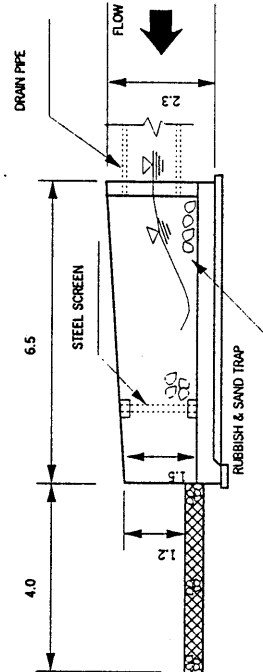
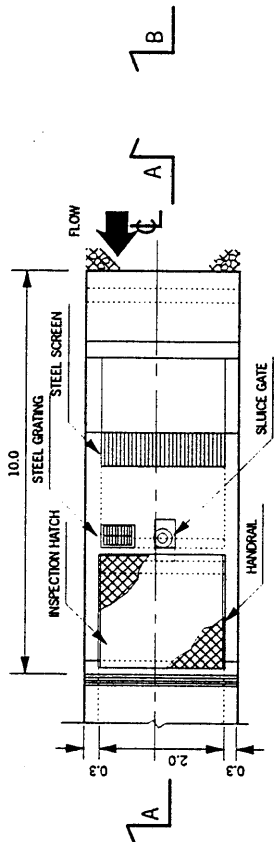
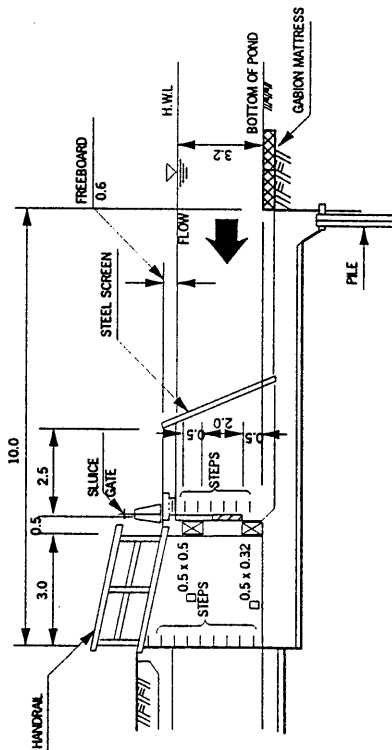
Fig. VI-5
 Typical In/Outlets Structure for Detention
 Pond

PLAN OF INLET STRUCTURE

B - B SECTION

PLAN OF OUTLET STRUCTURE

A - A SECTION

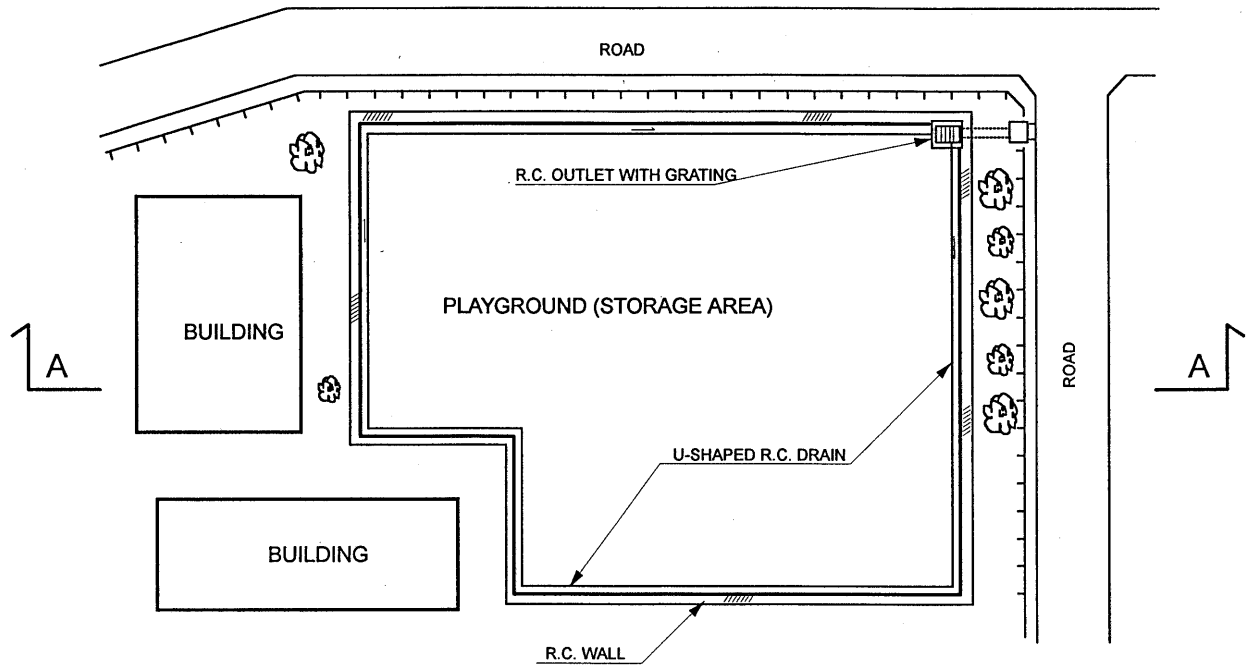
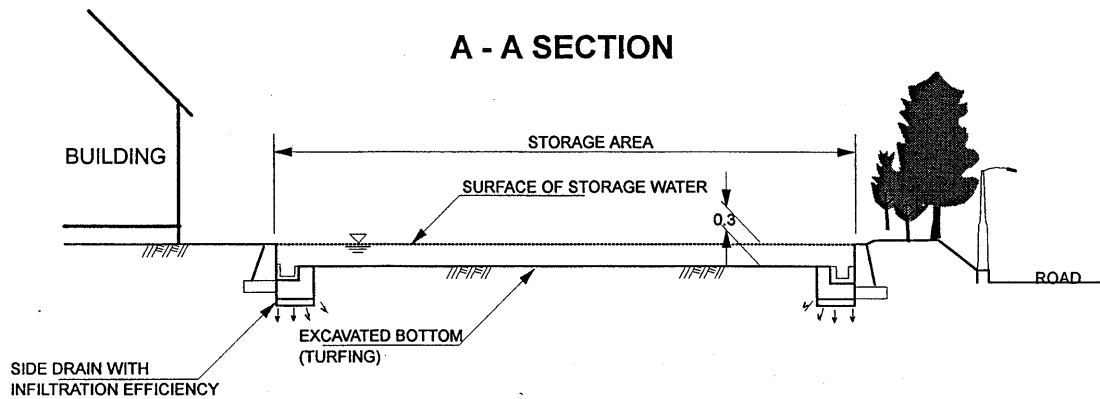
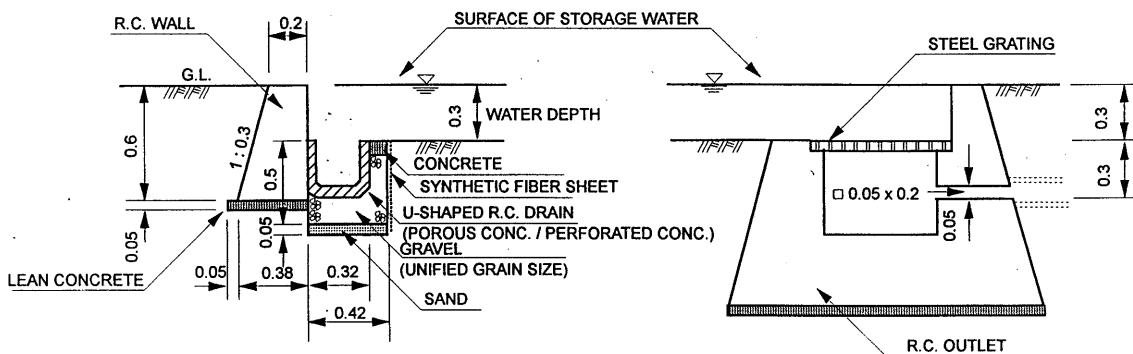
Fig. VI-6
Typical Plan of Storage Facility
in Public Open Space
(On-site Detention Pond)

PLAN OF STORAGE IN PUBLIC SPACE

A - A SECTION

TYPICAL SECTION OF R.C. WALL W / DRAIN AND R.C. OUTLET
