Photos

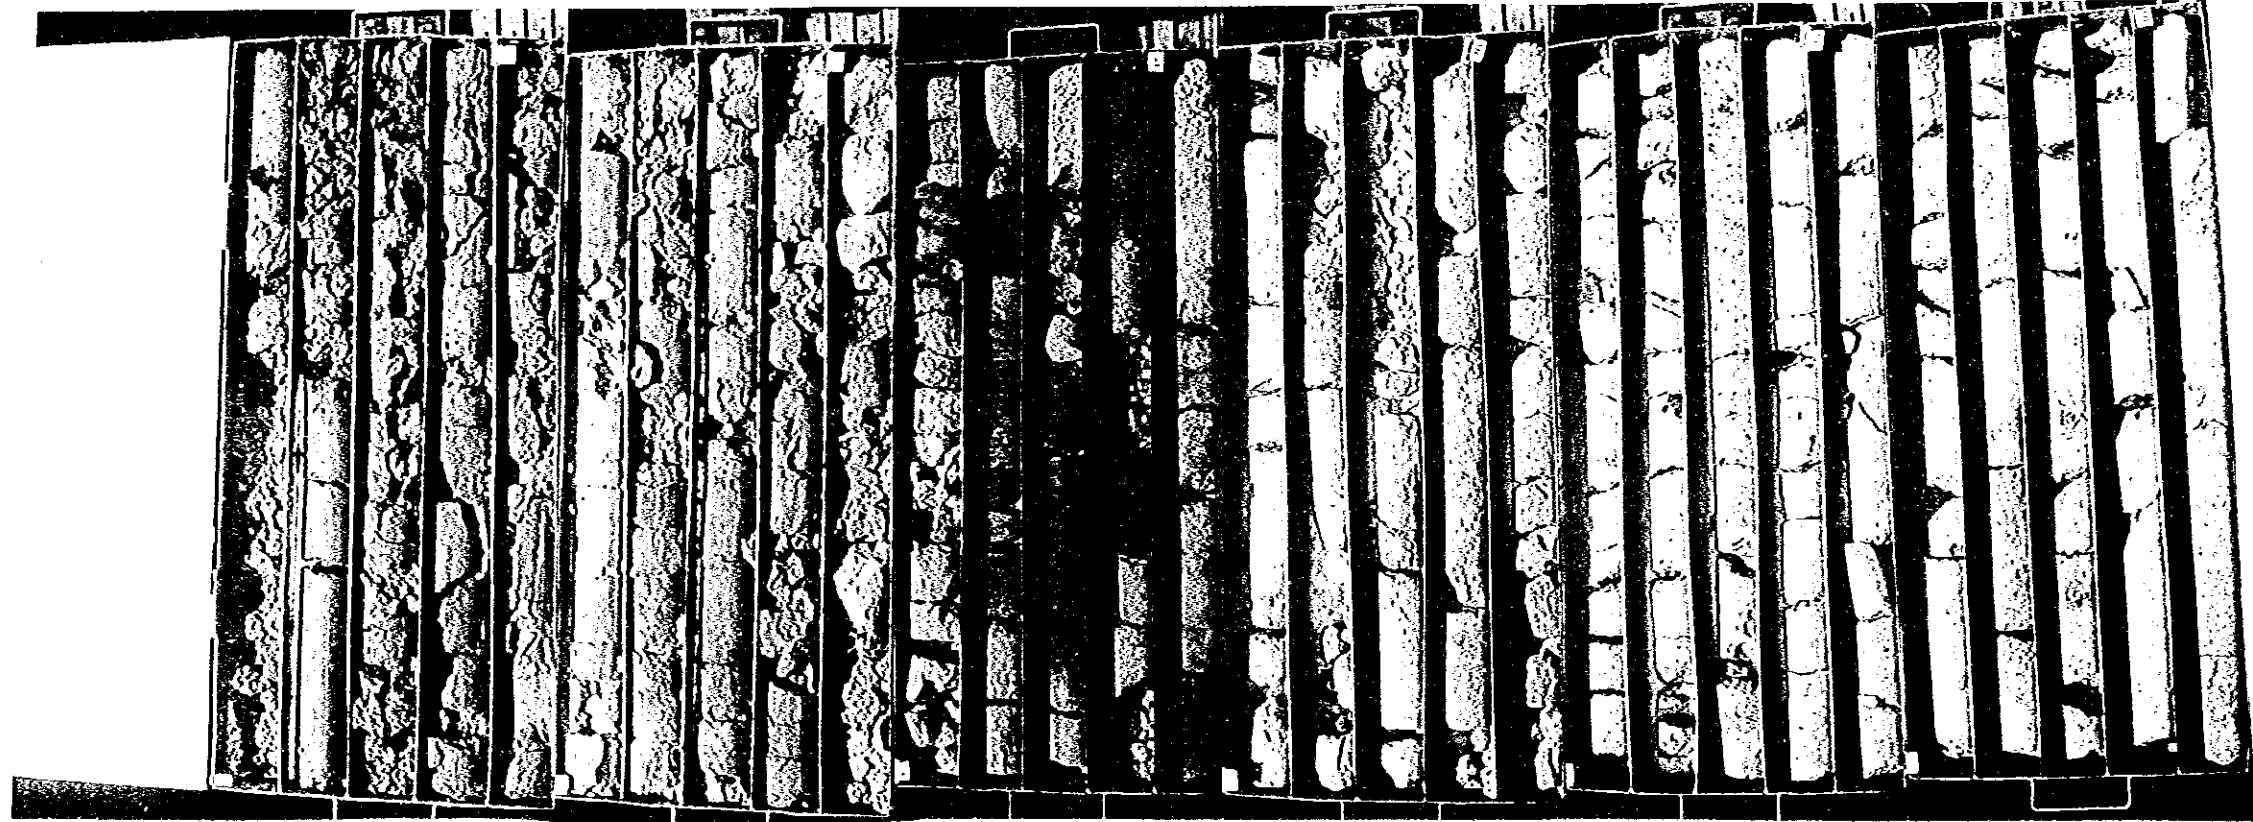
Photo 1.1.1 Drilling Core Photograph of Bore Hole No. B - 4 (1 of 4)

Bore Hole No. : B-4
Location : Damsite
Ground Elevation : EL. 137.77 m
Total Depth : 95 m
Depth : 0 ~ 30 m

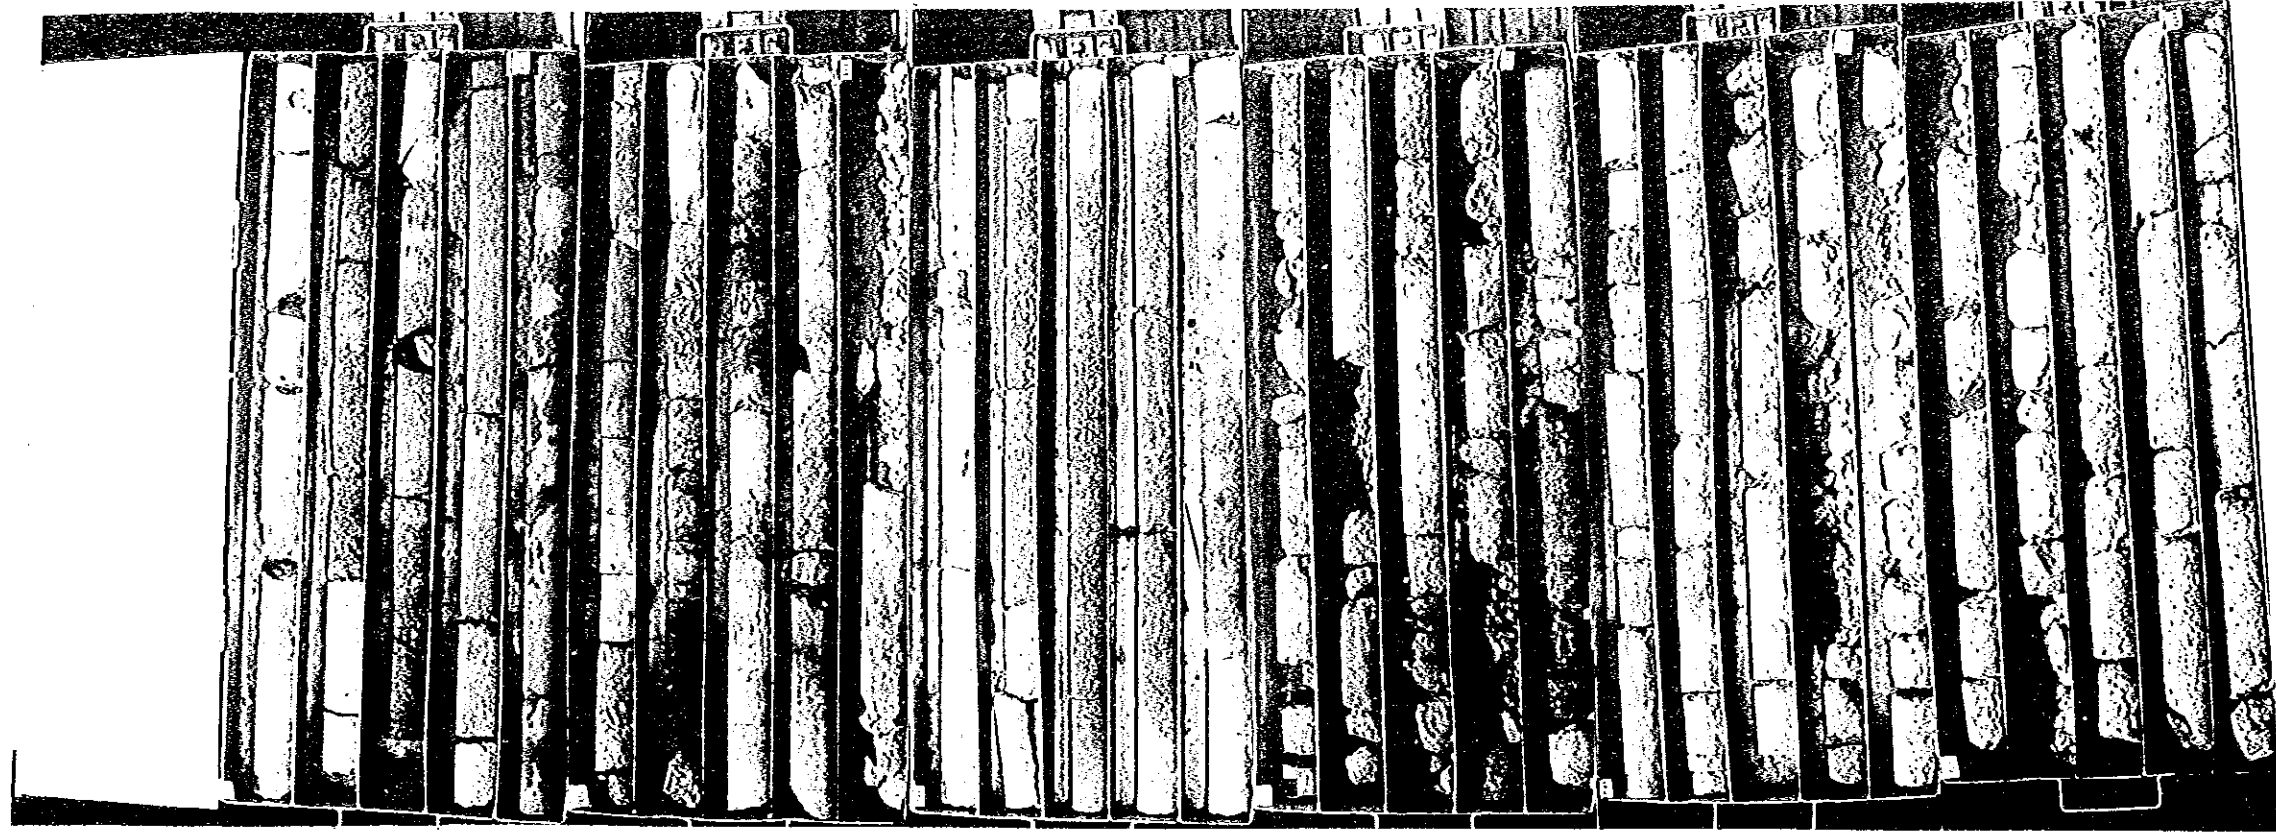
Photo 1.1.1 Drilling Core Photograph of Bore Hole No. B - 4 (2 of 4)

Bore Hole No. : B-4
Location : Damsite
Ground Elevation : EL. 137.77 m
Total Depth : 95 m
Depth : 30 ~ 60 m

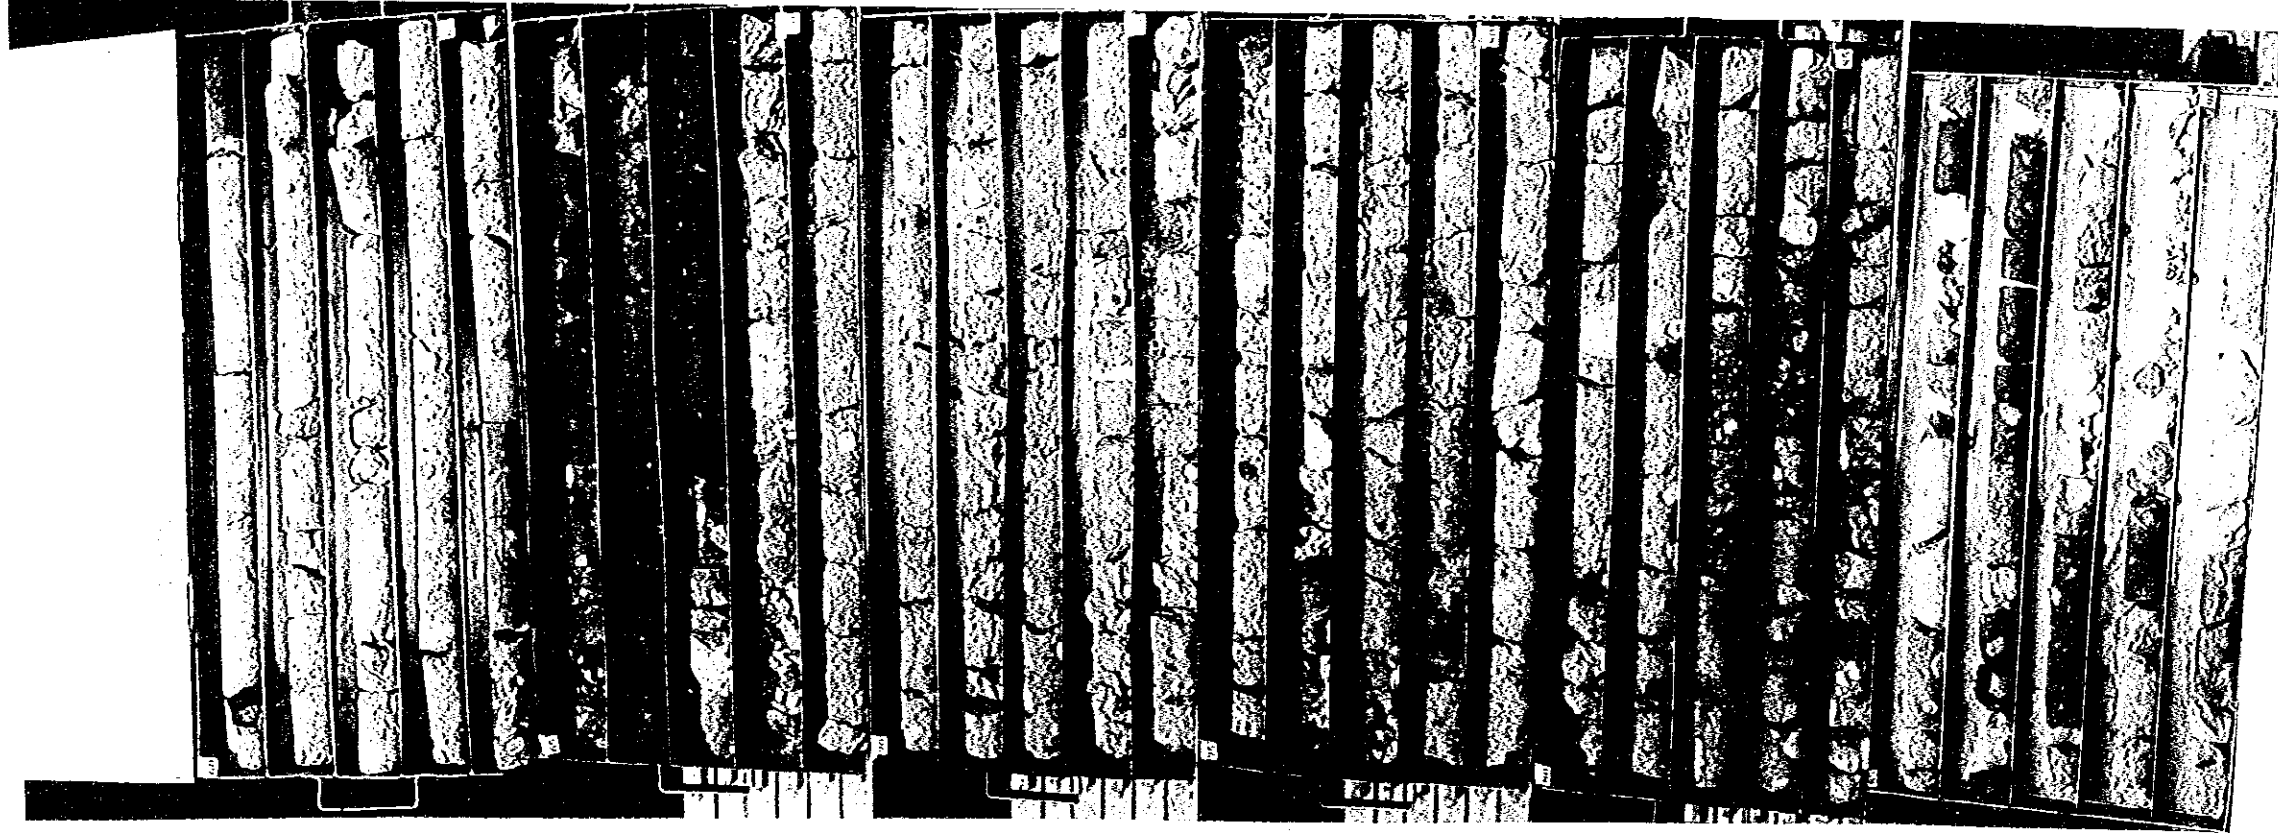
Photo 1.1.1 Drilling Core Photograph of Bore Hole No. B - 4 (3 of 4)

Bore Hole No. : B-4
Location : Damsite
Ground Elevation : EL. 137.77 m
Total Depth : 95 m
Depth : 60 ~ 90 m

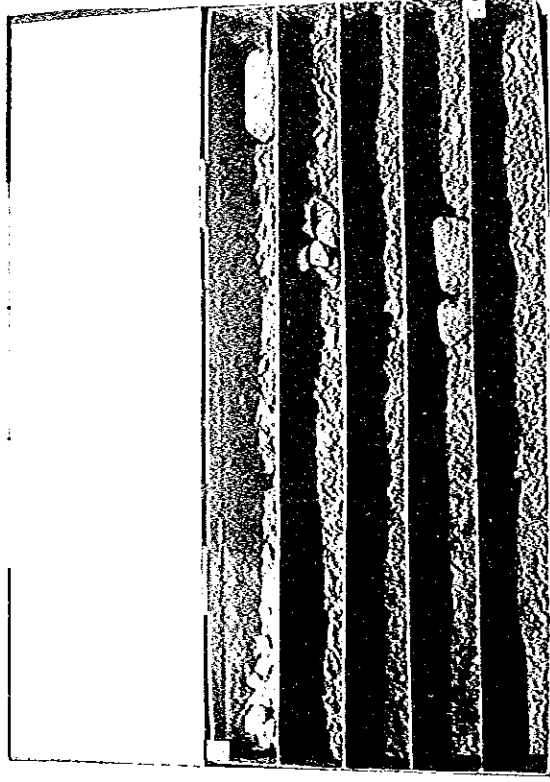
Photo 1.1.1 Drilling Core Photograph of Bore Hole No. B - 4 (4 of 4)

Bore Hole No. : B-4
Location : Damsite
Ground Elevation : EL. 137.77 m
Total Depth : 95 m
Depth : 90 ~ 95 m

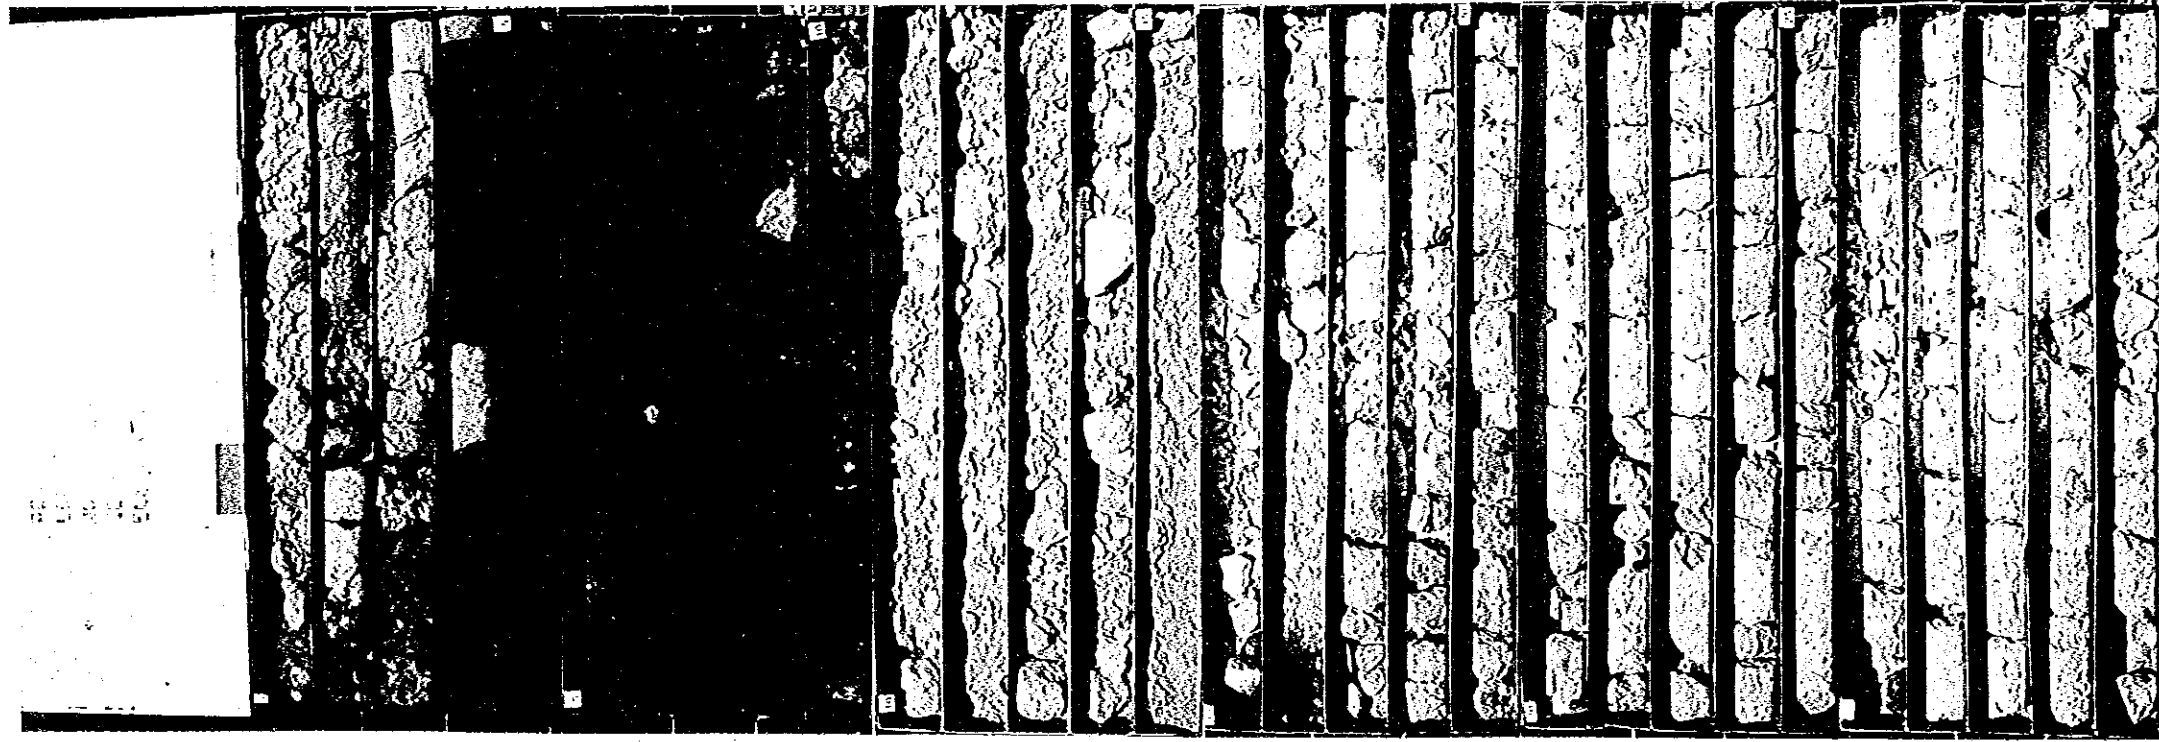
Photo 1.1.2 Drilling Core Photograph of Bore Hole No. B - 5 (1 of 4)

Bore Hole No. : B-5
Location : Damsite
Ground Elevation : EL. 88.57 m
Total Depth : 100 m
Depth : 0 ~ 30 m

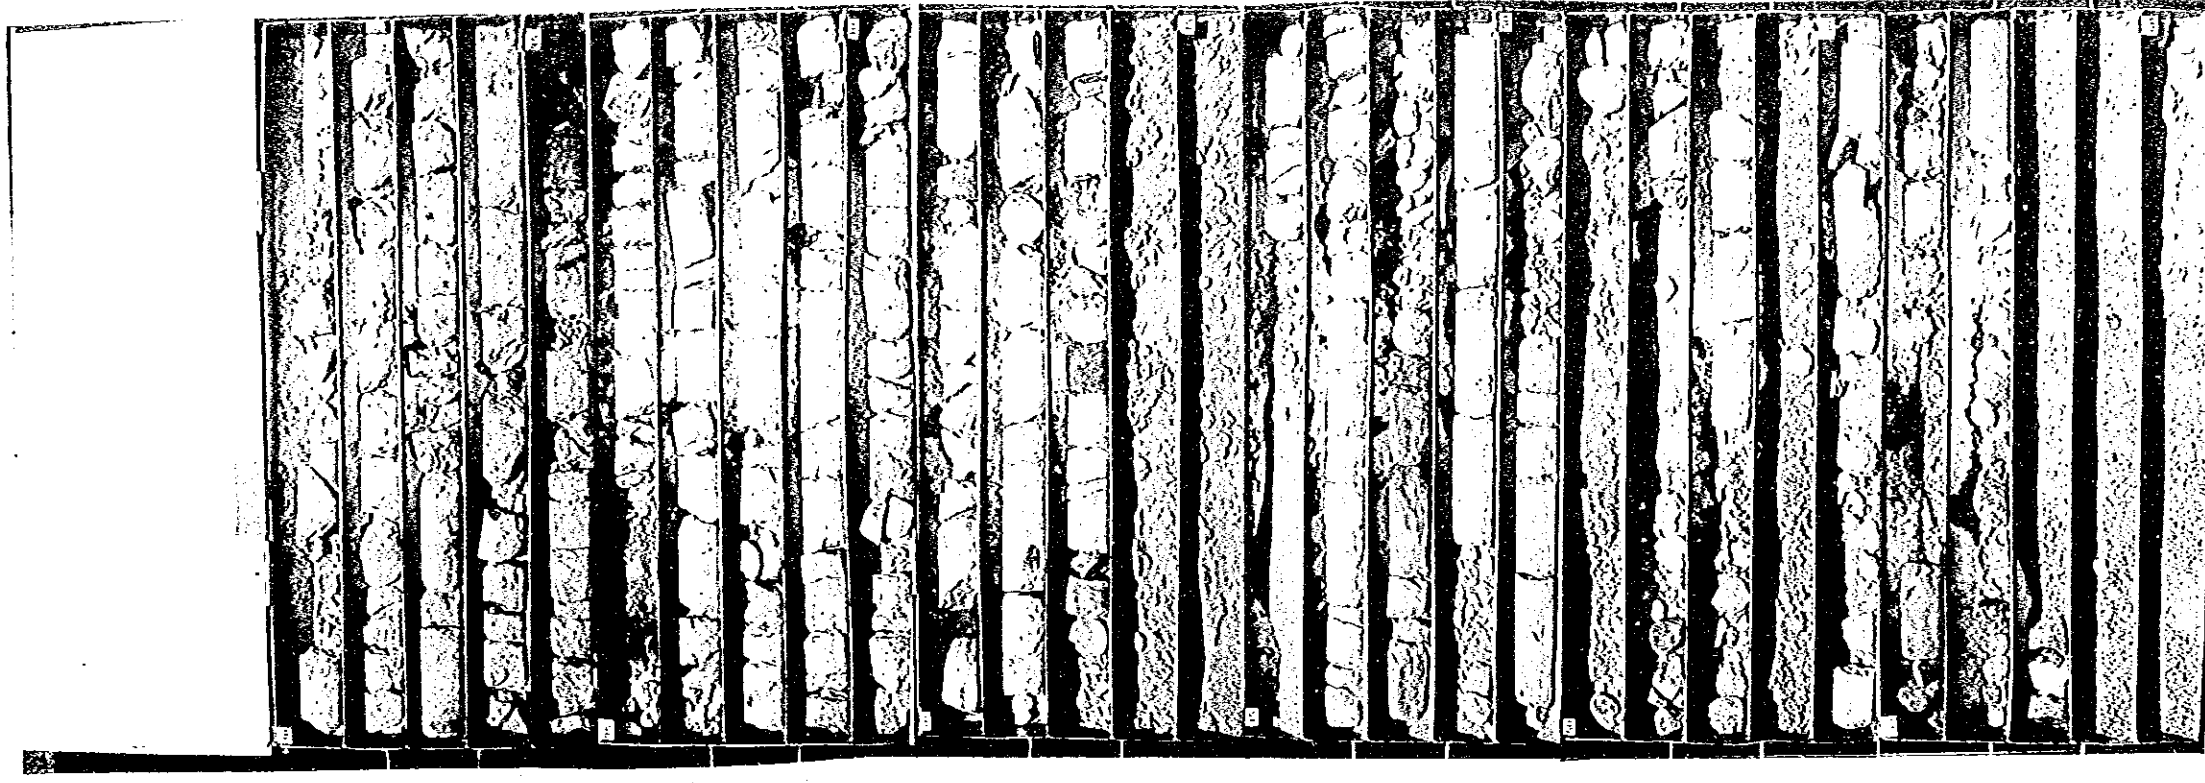
Photo 1.1.2 Drilling Core Photograph of Bore Hole No. B - 5 (2 of 4)

Bore Hole No. : B-5
Location : Damsite
Ground Elevation : EL. 88.57 m
Total Depth : 100 m
Depth : 30 ~ 60 m

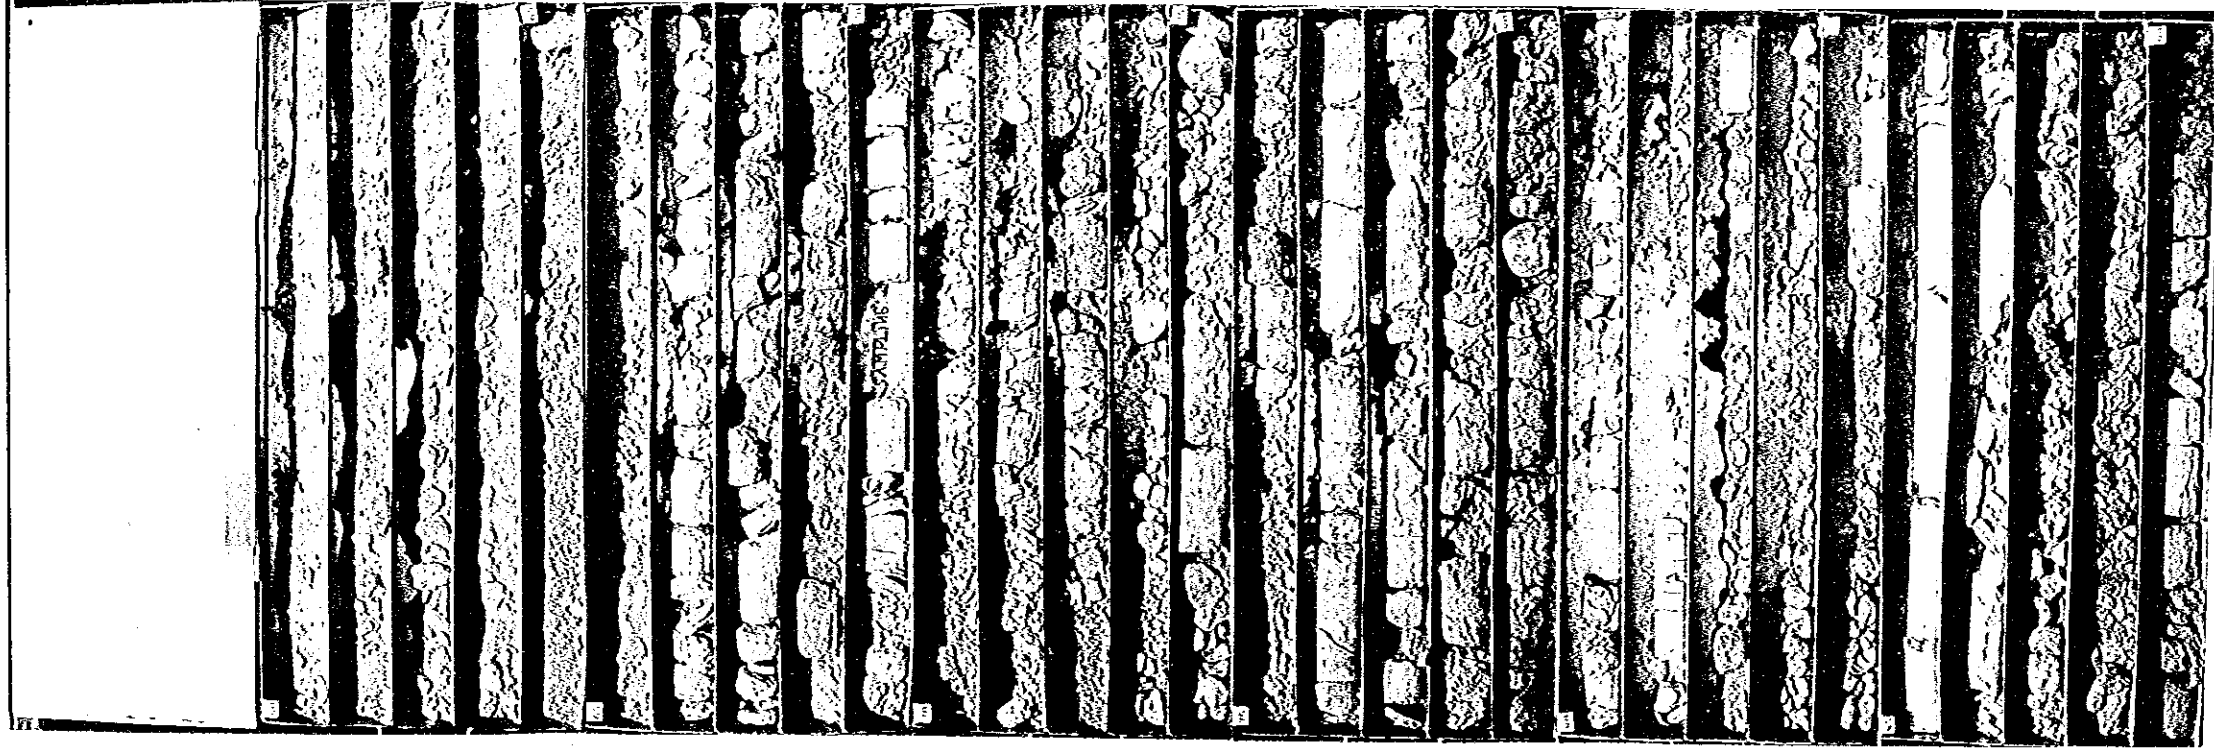
Photo 1.1.2 Drilling Core Photograph of Bore Hole No. B - 5 (3 of 4)

Bore Hole No. : B-5
Location : Damsite
Ground Elevation : EL. 88.57 m
Total Depth : 100 m
Depth : 60 ~ 90 m

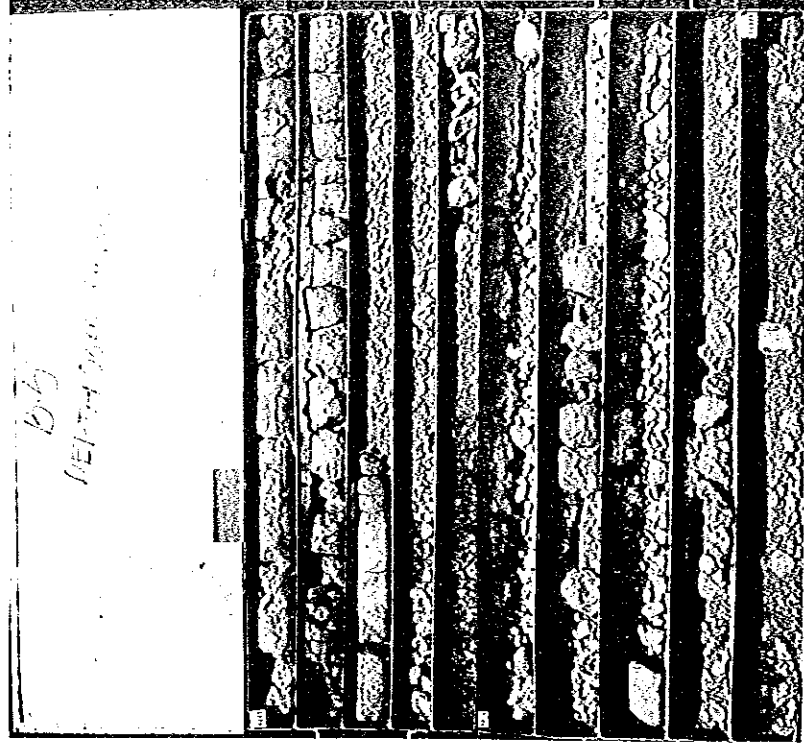
Photo 1.1.2 Drilling Core Photograph of Bore Hole No. B - 5 (4 of 4)

Bore Hole No. : B-5
Location : Damsite
Ground Elevation : EL. 88.57 m
Total Depth : 100 m
Depth : 90 ~ 100 m

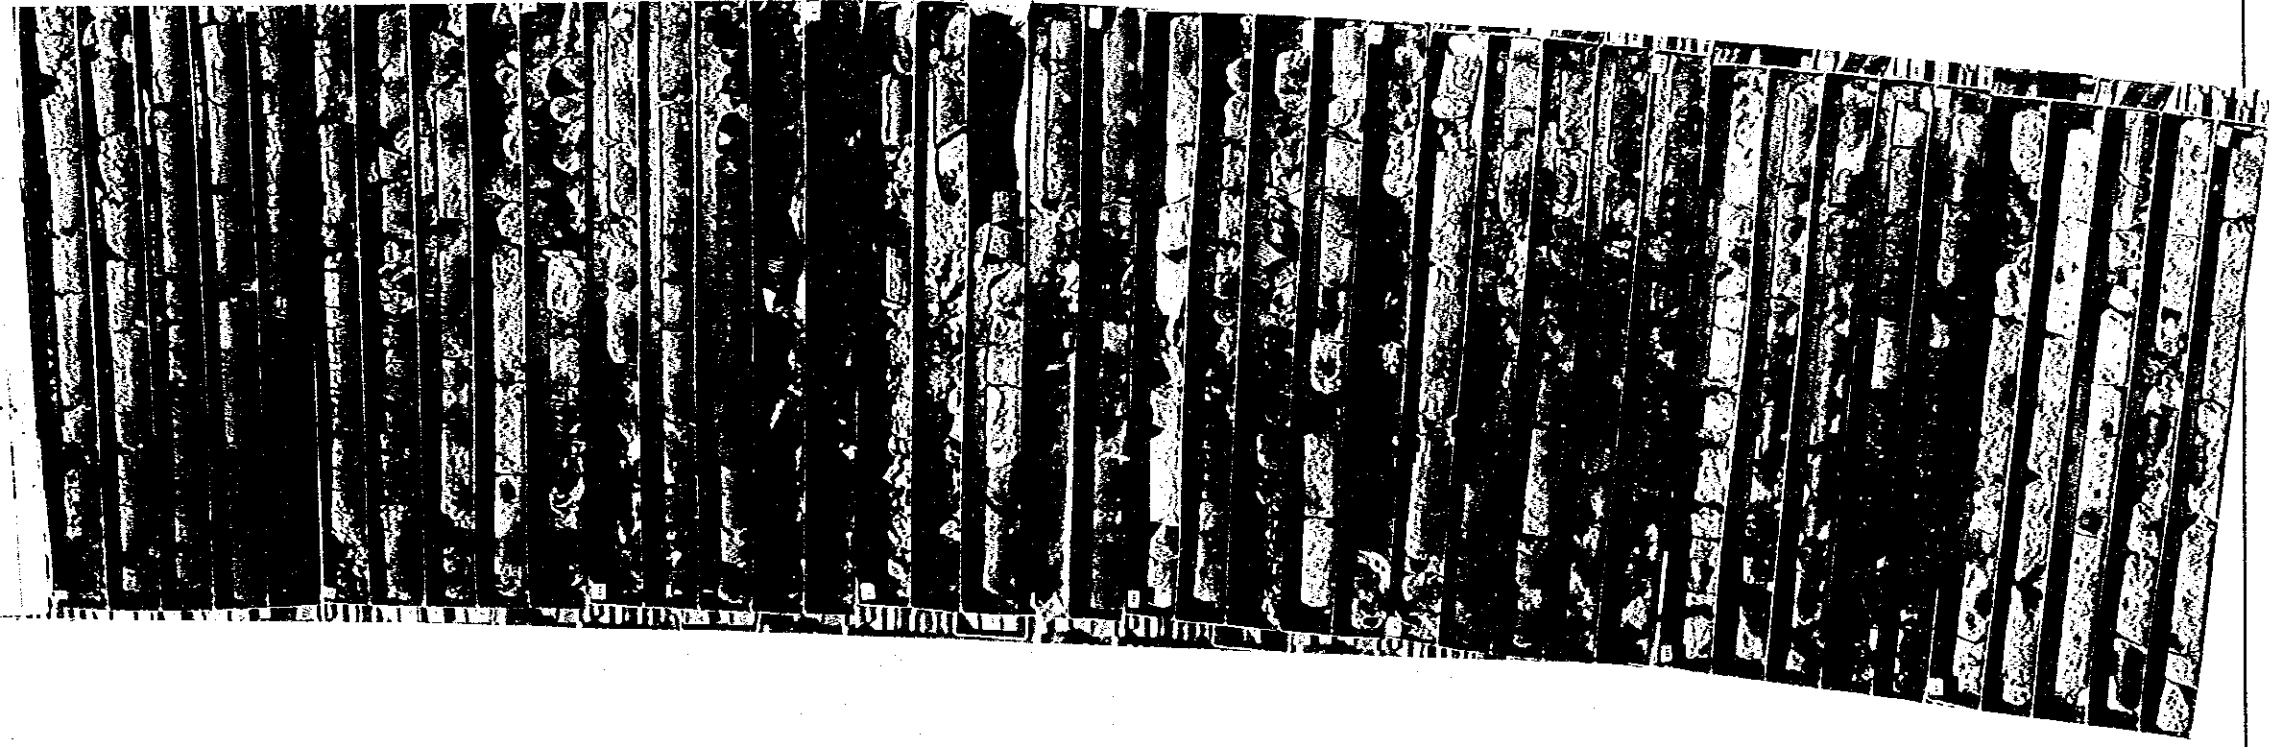
Photo 1.1.3 Drilling Core Photograph of Bore Hole No. B-6 (1 of 4)

Bore Hole No. : B-6
 Location : Damsite
 Ground Elevation : EL. 148.10 m
 Total Depth : 130 m
 Depth : 0 ~ 40 m

PROJECT : G-15 SARANG
 LOCATION : NAM SAN
 HOLE NO. : B-6
 DEPTH : 0
 ELEVATION : 148.10

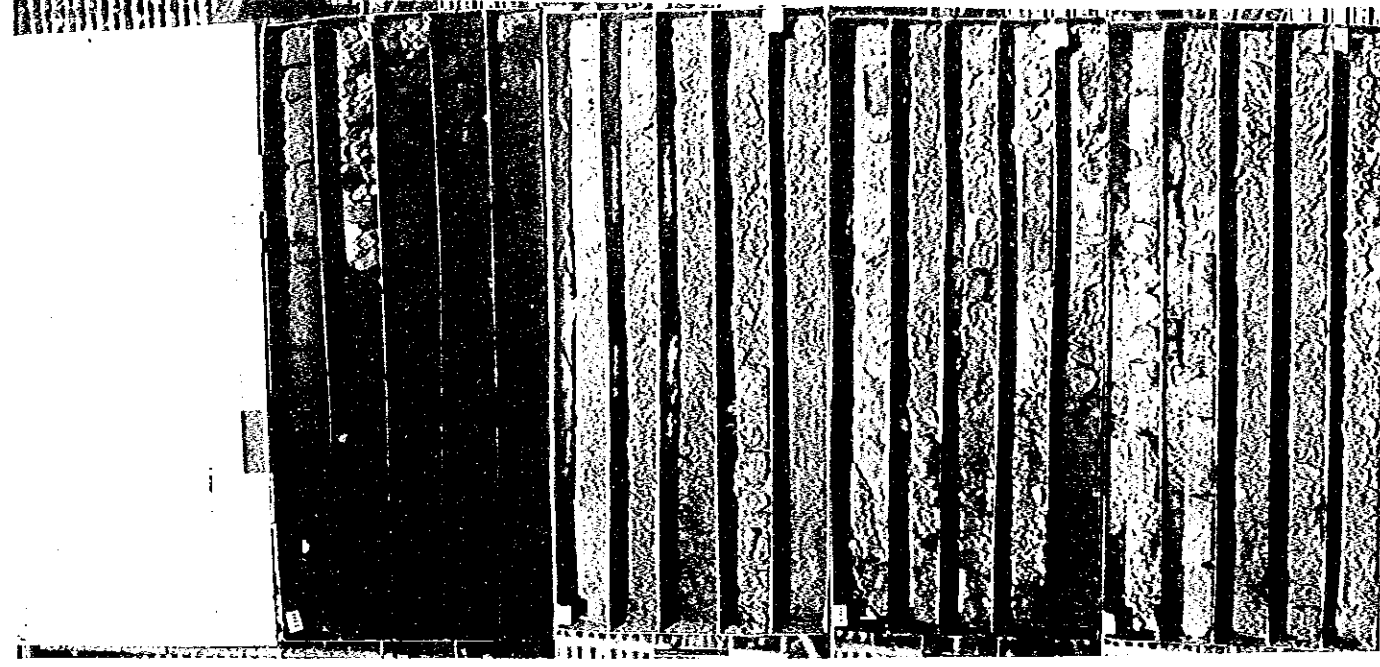
Photo 1.1.3 Drilling Core Photograph of Bore Hole No. B-6 (4 of 4)

Bore Hole No. : B-6
Location : Damsite
Ground Elevation : EL. 148.10 m
Total Depth : 130 m
Depth : 110 ~ 130 m

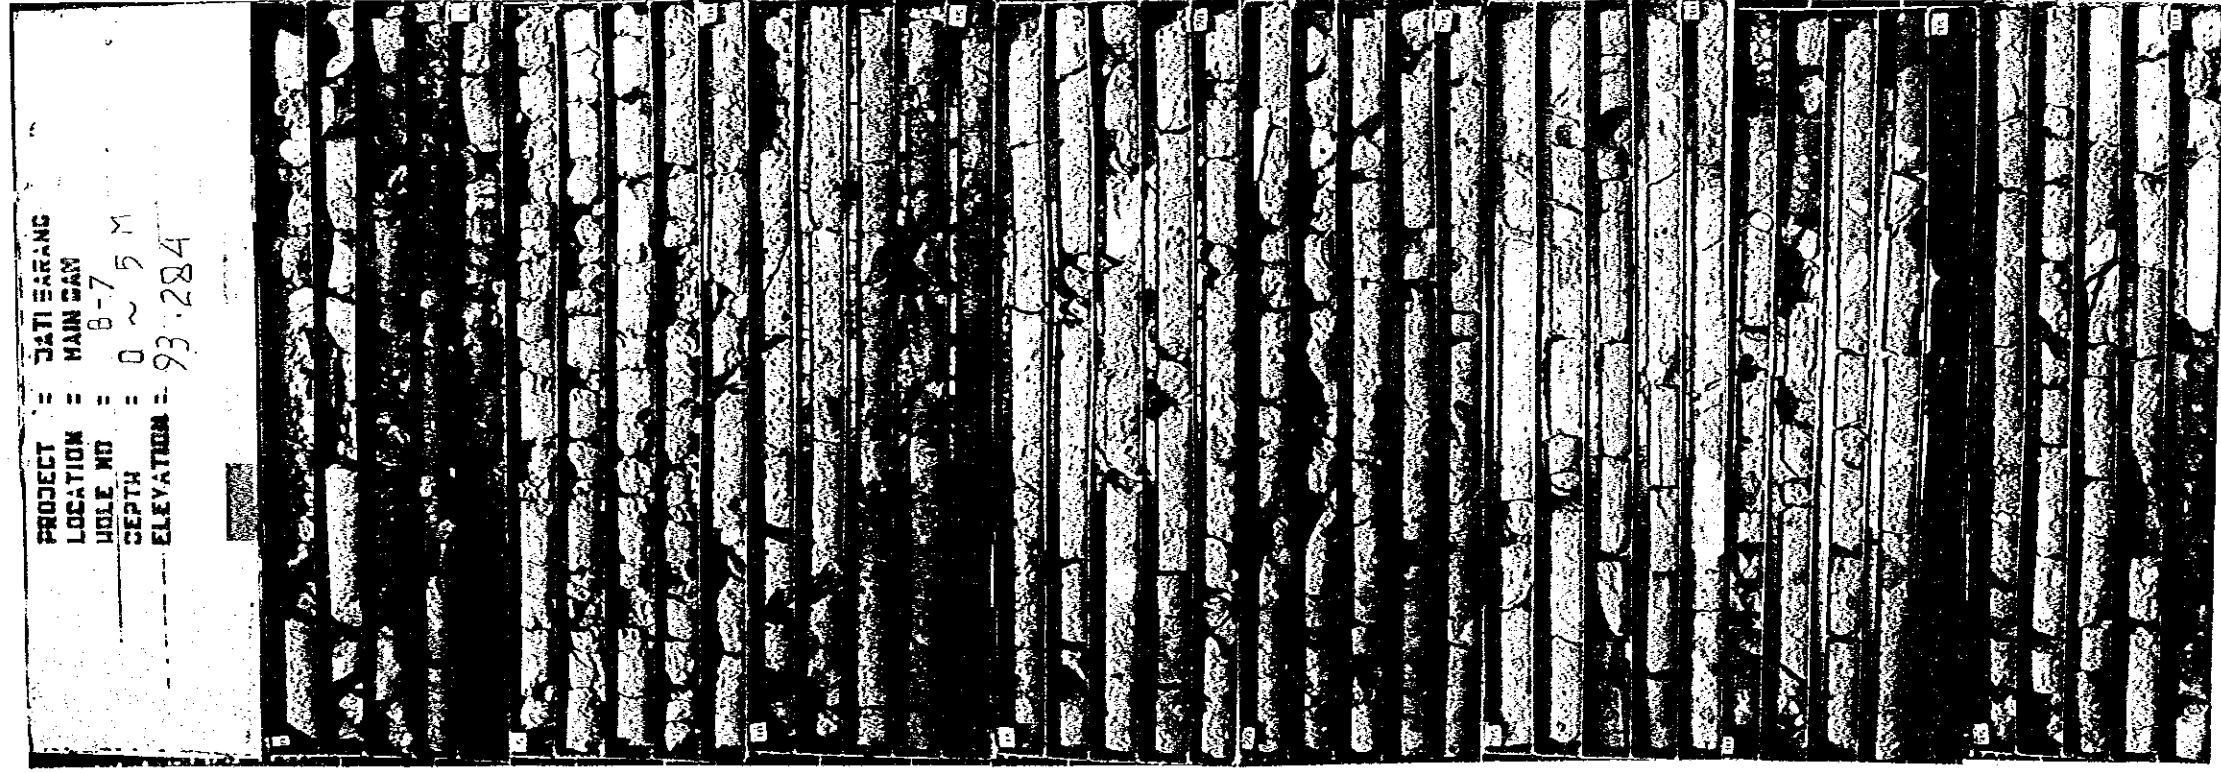
Photo 1.1.4 Drilling Core Photograph of Bore Hole No. B - 7 (1 of 2)

Bore Hole No. : B-7
 Location : Dam site
 Ground Elevation : EL. 90.42 m
 Total Depth : 70 m
 Depth : 0 ~ 40 m

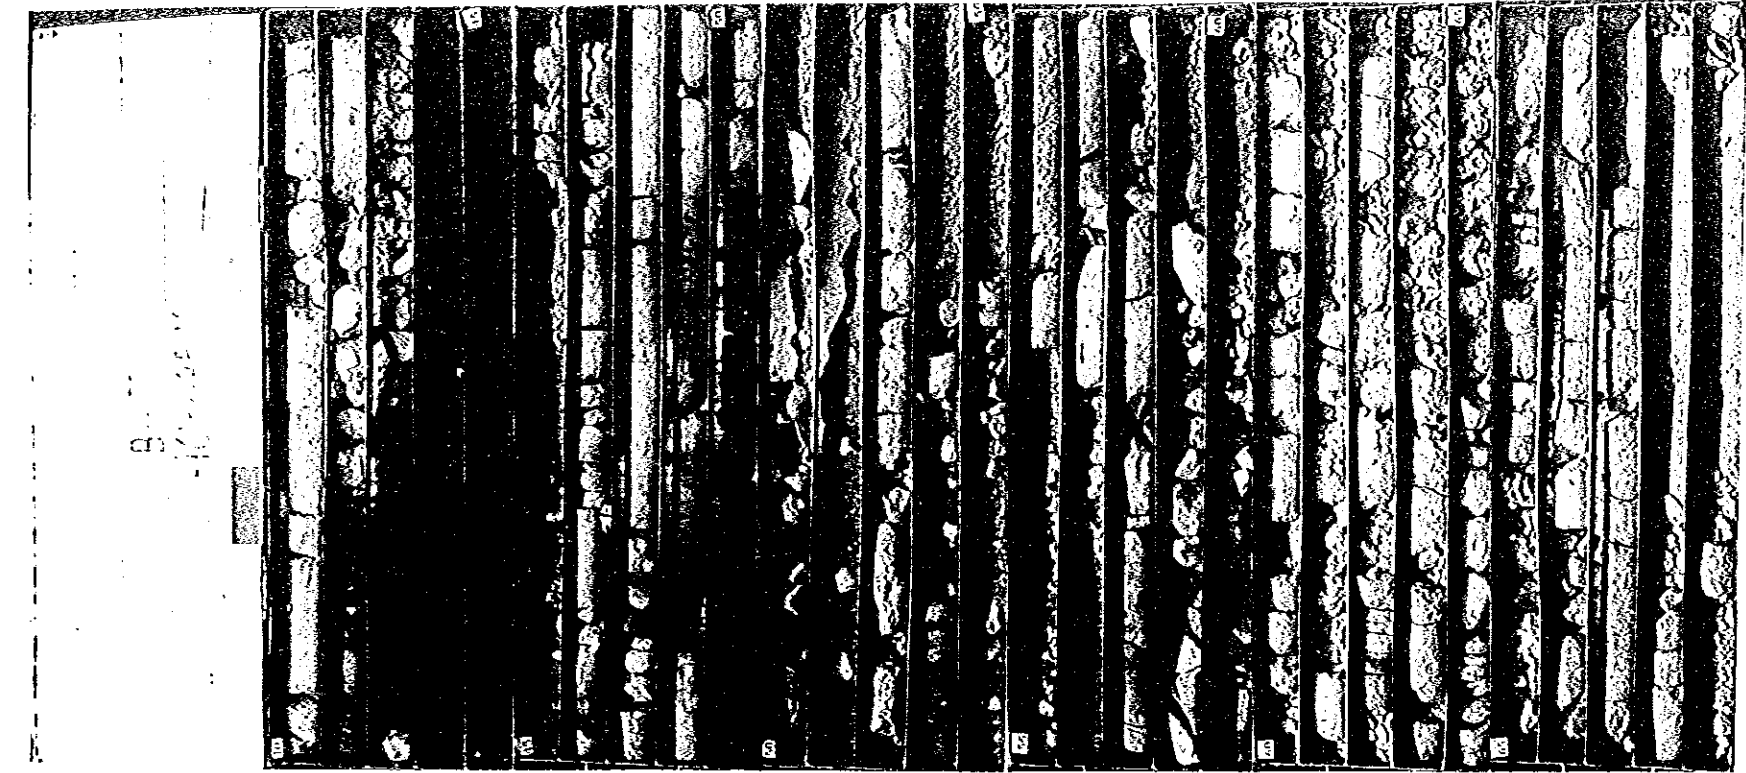
Photo 1.1.4 Drilling Core Photograph of Bore Hole No. B - 7 (2 of 2)

Bore Hole No. : B-7
 Location : Dam site
 Ground Elevation : EL. 90.42 m
 Total Depth : 70 m
 Depth : 40 ~ 70 m

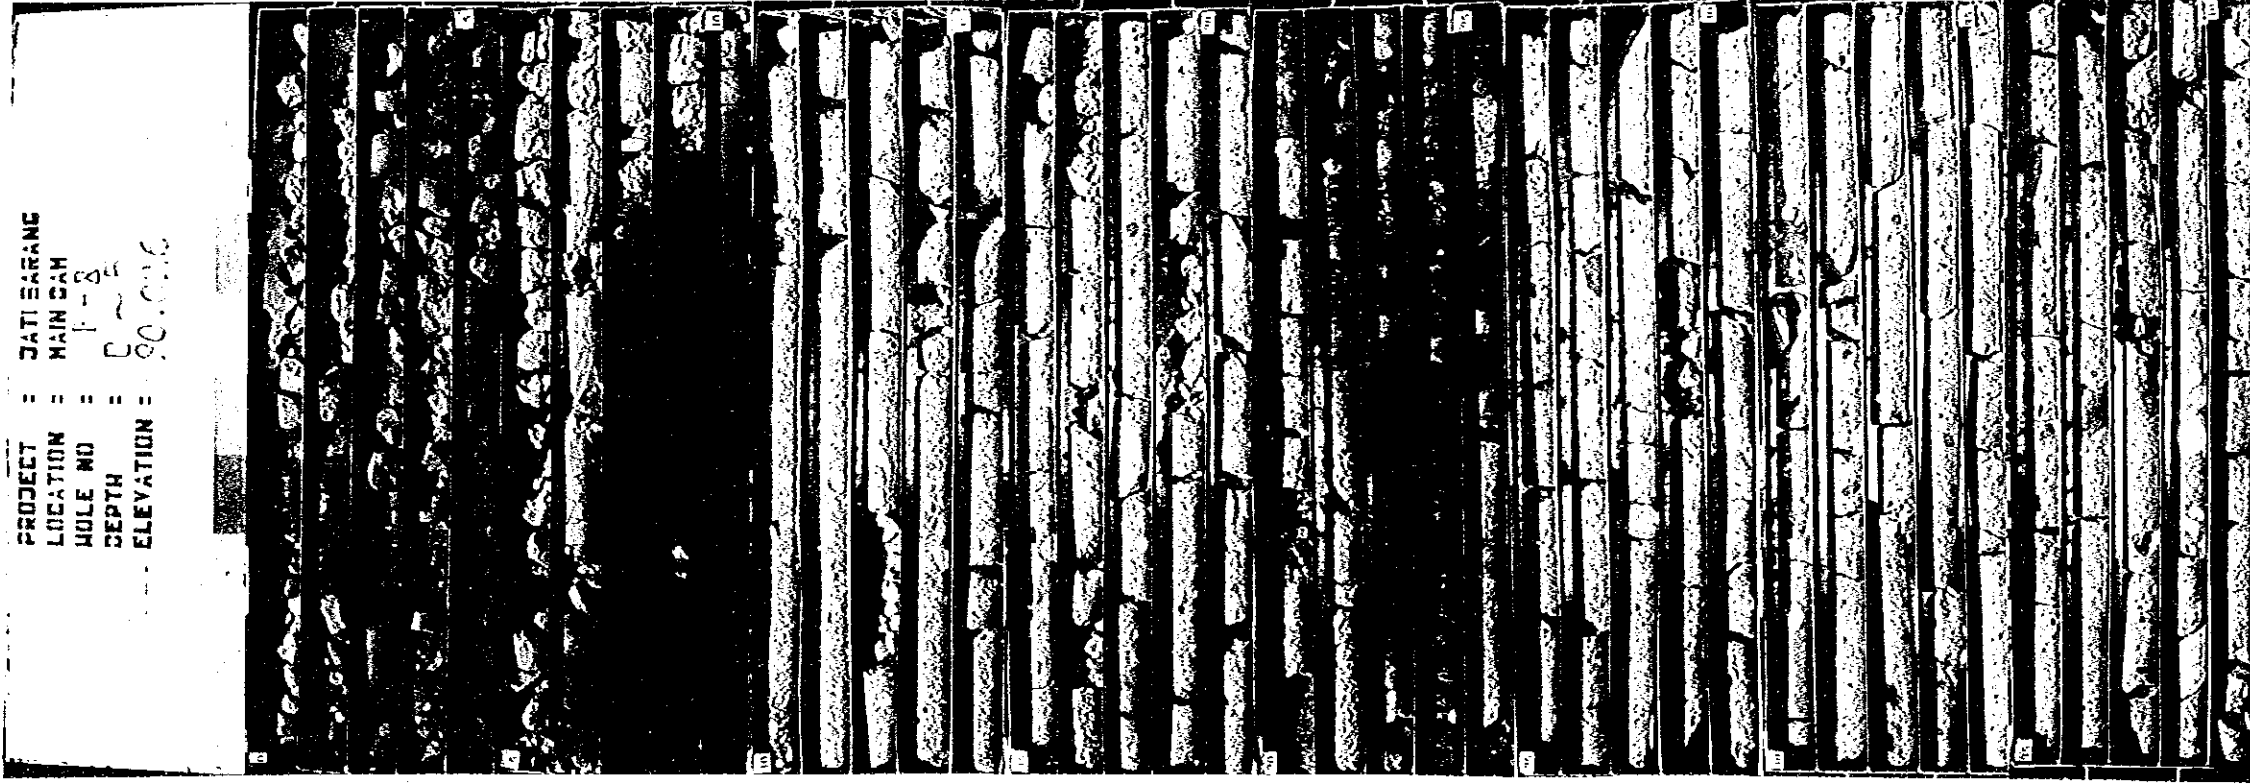
Photo 1.1.5 Drilling Core Photograph of Bore Hole No. B - 8 (1 of 2)

Bore Hole No. : B-8
 Location : Damsite
 Ground Elevation : EL. 87.17 m
 Total Depth : 70 m
 Depth : 0 ~ 40 m

PROJECT = DATI SARANG
 LOCATION = MAIN DAM
 HOLE NO = P-8
 DEPTH = 0 ~ 70
 ELEVATION = 80.000

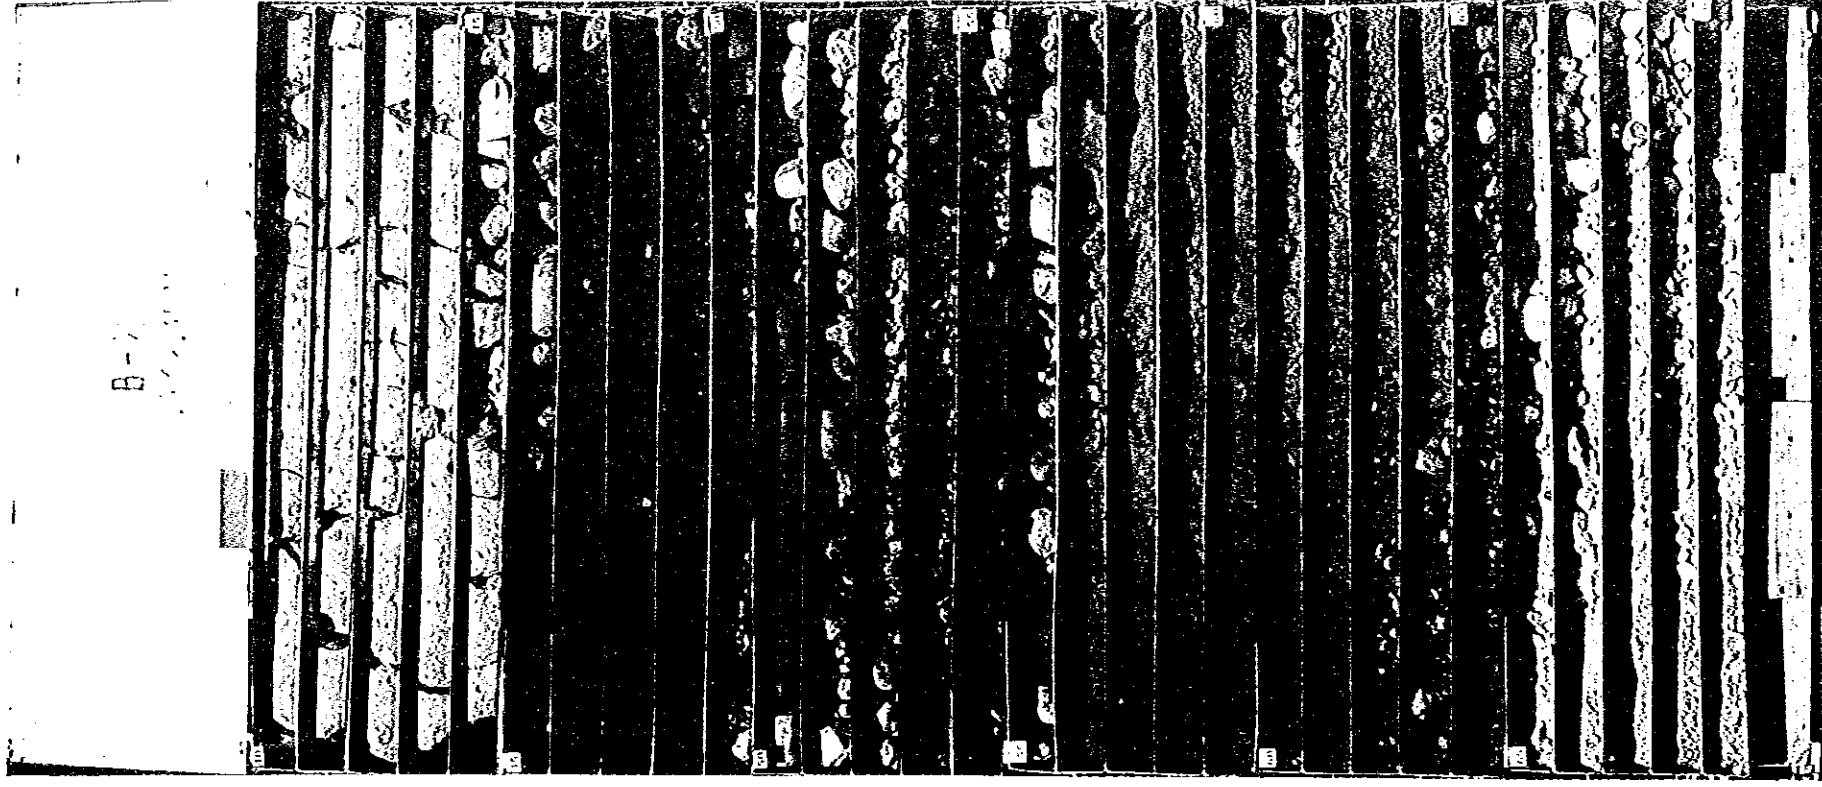
Photo 1.1.5 Drilling Core Photograph of Bore Hole No. B - 8 (2 of 2)

Bore Hole No. : B-8
 Location : Damsite
 Ground Elevation : EL. 87.17m
 Total Depth : 70 m
 Depth : 40 ~ 70 m

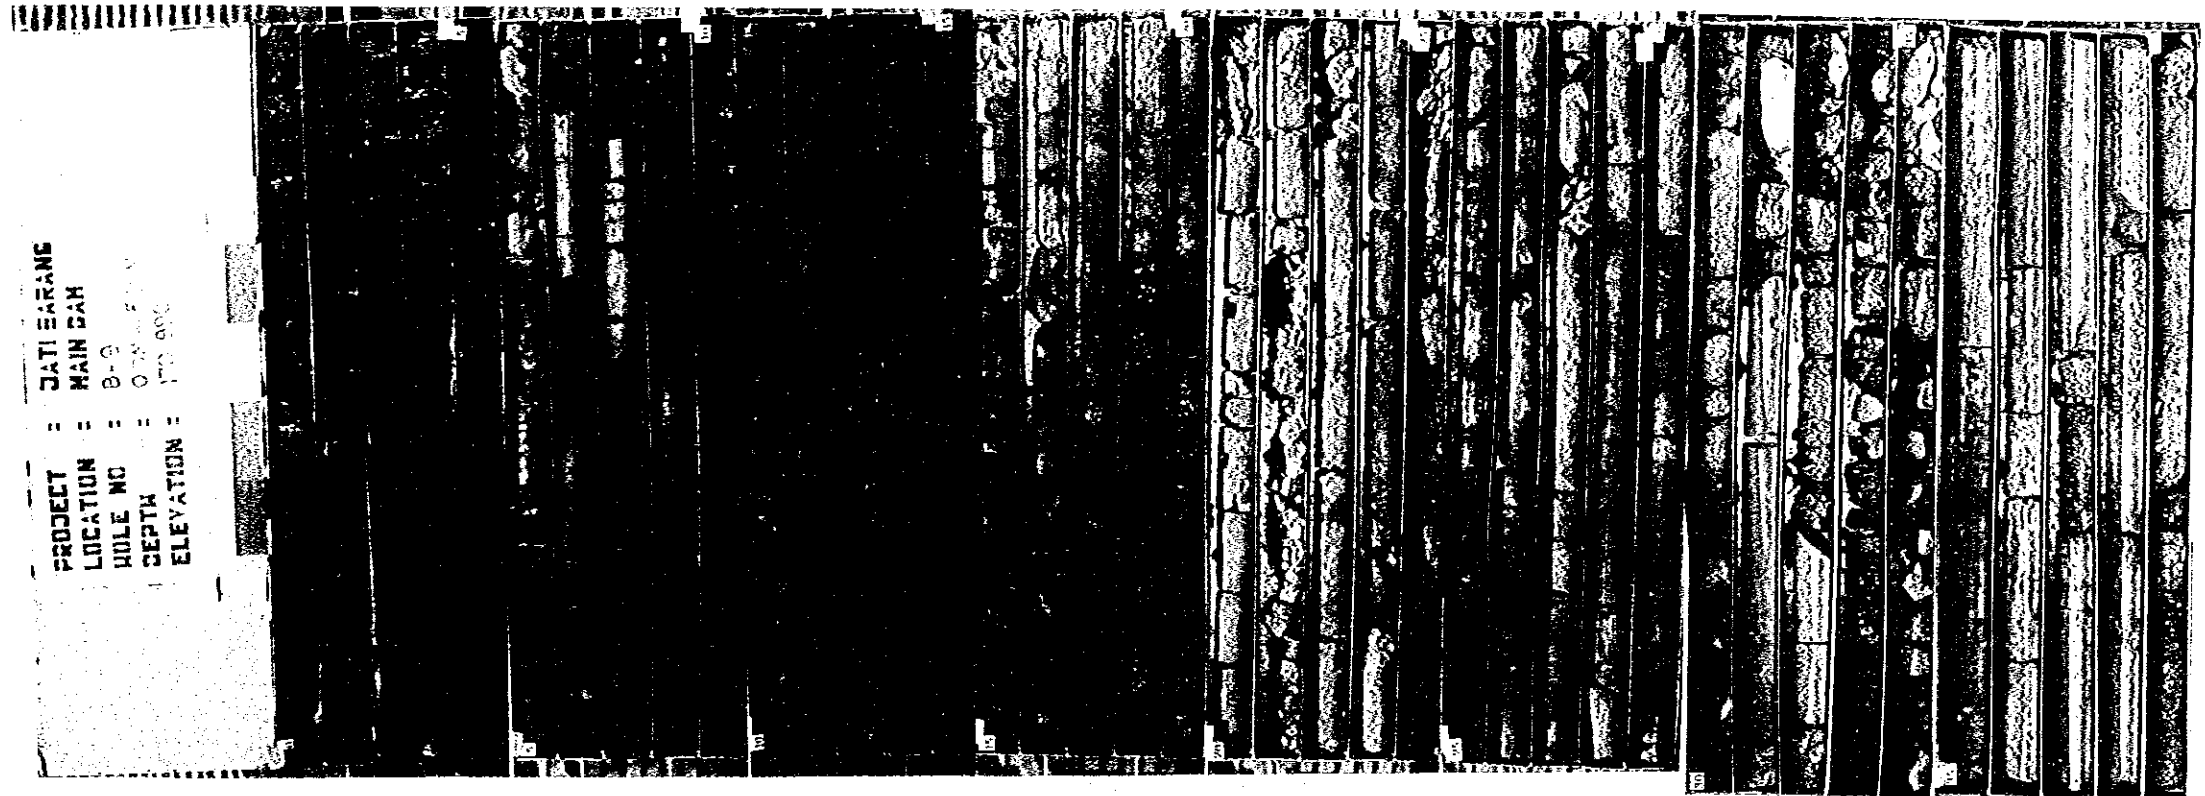
Photo 1.1.6 Drilling Core Photograph of Bore Hole No. B - 9 (1 of 3)

Bore Hole No. : B-9
 Location : Damsite
 Ground Elevation : EL. 170.99 m
 Total Depth : 90 m
 Depth : 0 ~ 40 m
