Photos

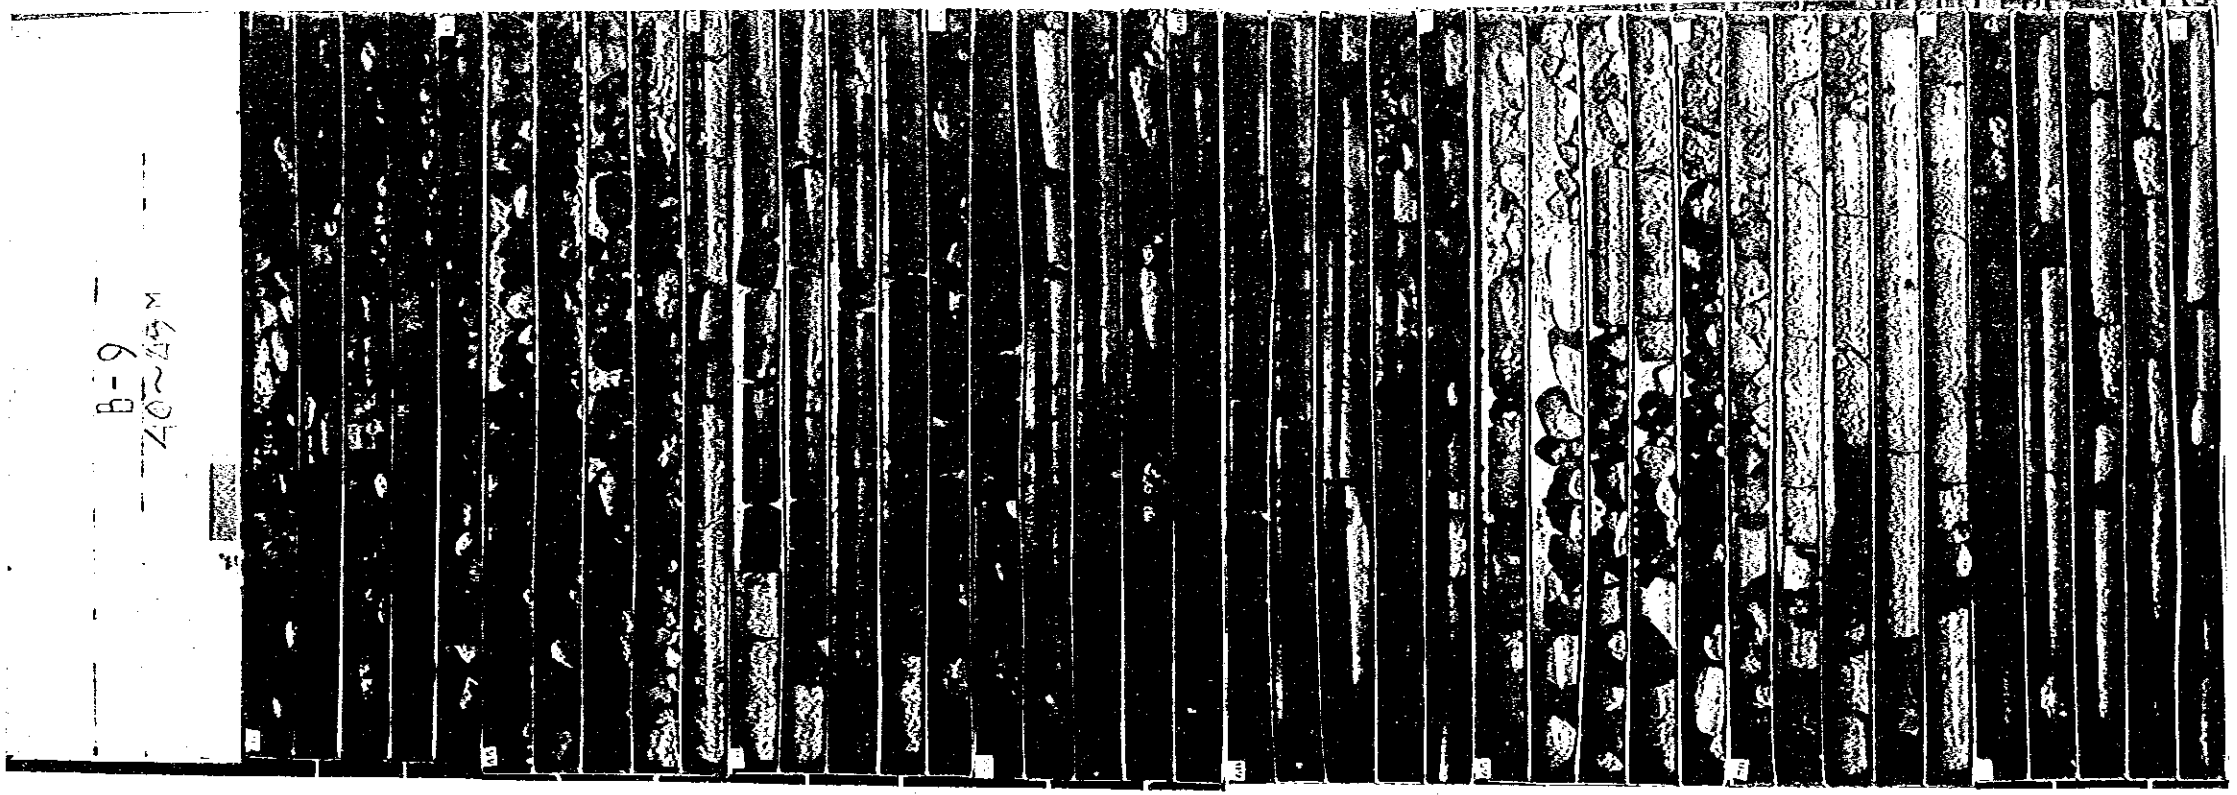
Photo 1.1.6 Drilling Core Photograph of Bore Hole No. B - 9 (2 of 3)

Bore Hole No. : B-9
 Location : Damsite
 Ground Elevation : EL. 170.99 m
 Total Depth : 90 m
 Depth : 40 ~ 80 m

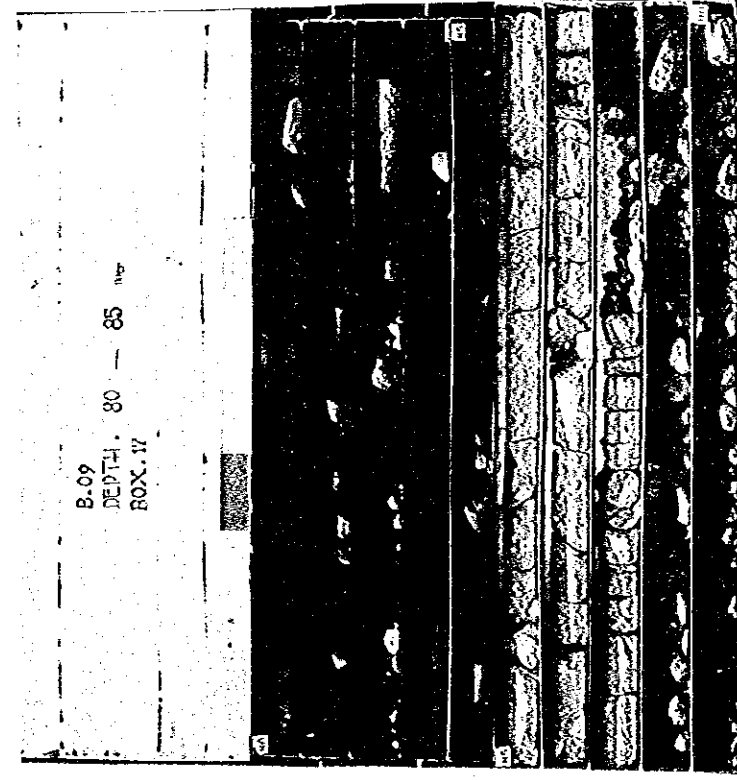
Photo 1.1.6 Drilling Core Photograph of Bore Hole No. B - 9 (3 of 3)

Bore Hole No. : B-9
 Location : Damsite
 Ground Elevation : EL. 170.99 m
 Total Depth : 90 m
 Depth : 80 ~ 90 m

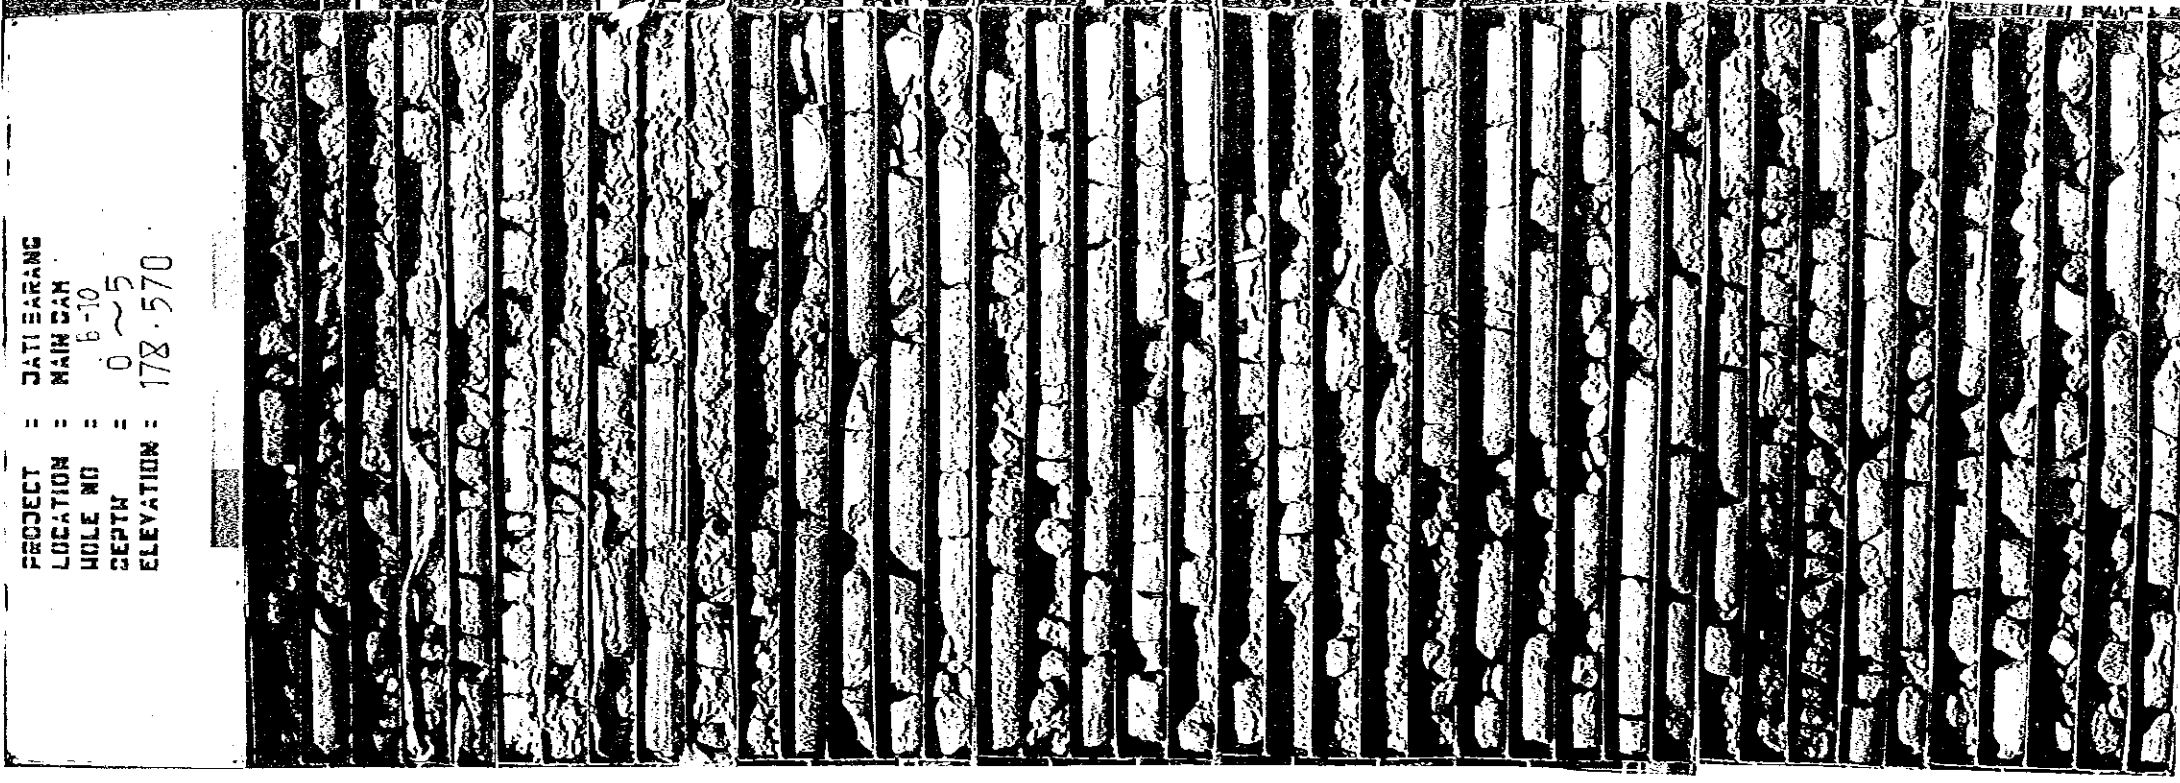
Photo 1.1.7 Drilling Core Photograph of Bore Hole No. B - 10 (1 of 3)

Bore Hole No. : B-10
 Location : Damsite
 Ground Elevation : EL. 178.12 m
 Total Depth : 90 m
 Depth : 0 ~ 40 m

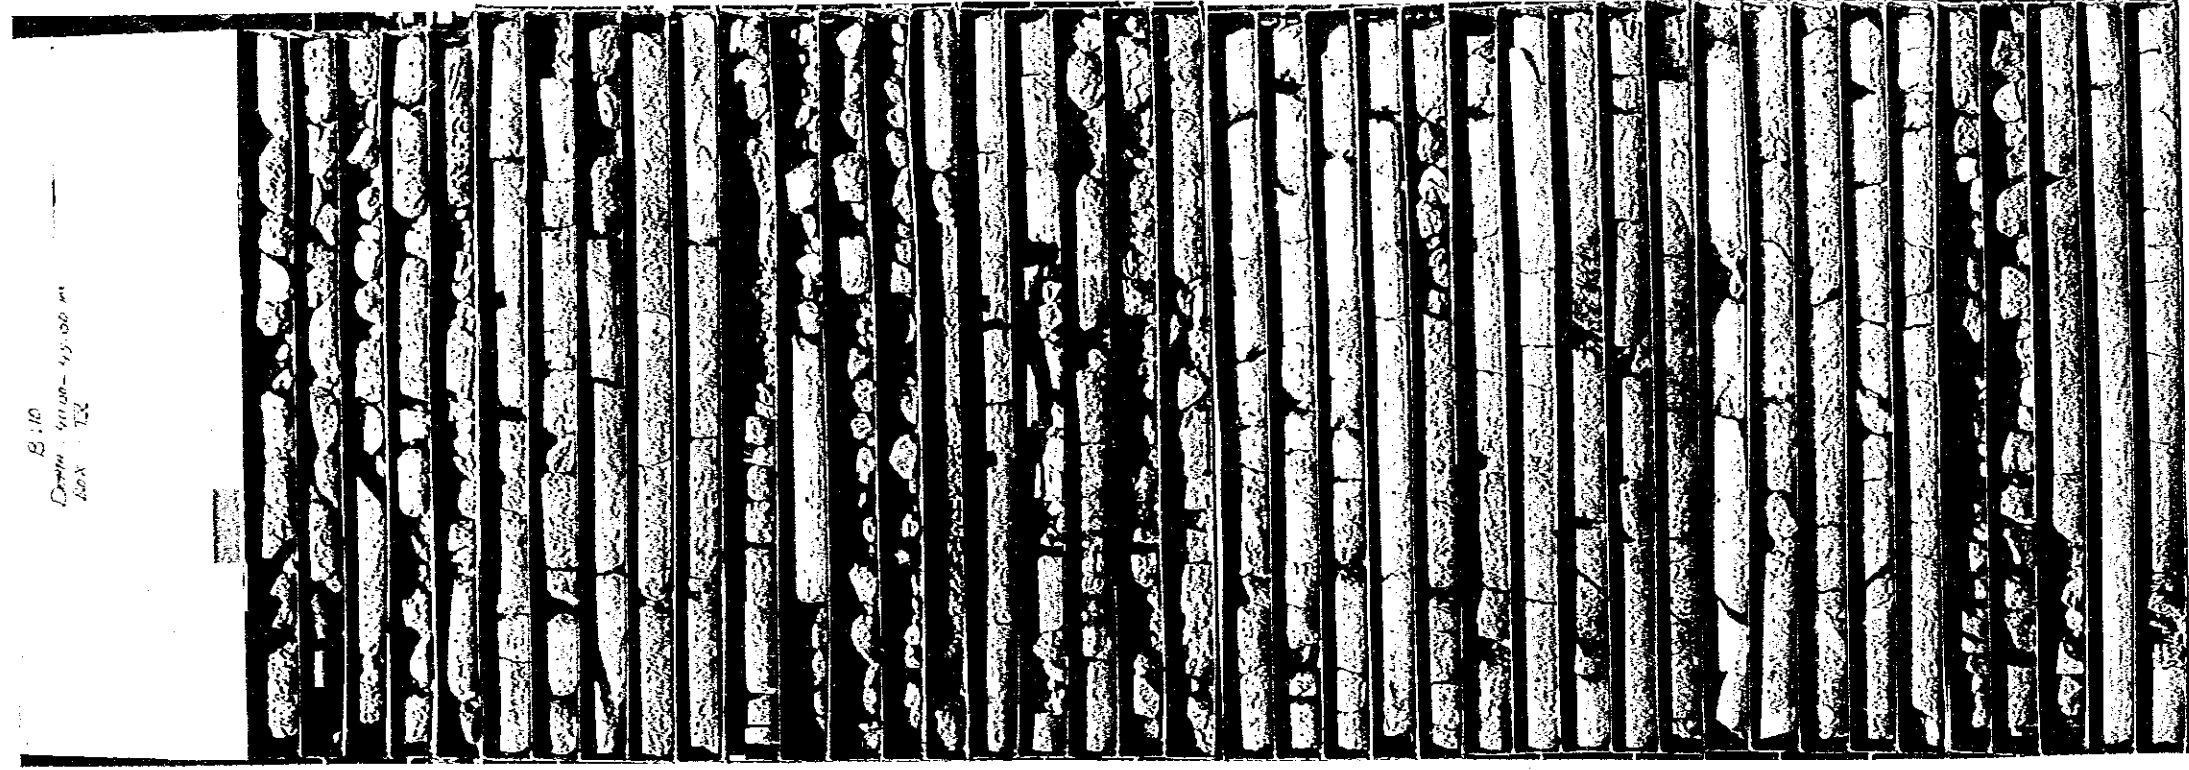
Photo 1.1.7 Drilling Core Photograph of Bore Hole No. B - 10 (2 of 3)

Bore Hole No. : B-10
Location : Damsite
Ground Elevation : EL. 178.12 m
Total Depth : 90 m
Depth : 40 ~ 80 m

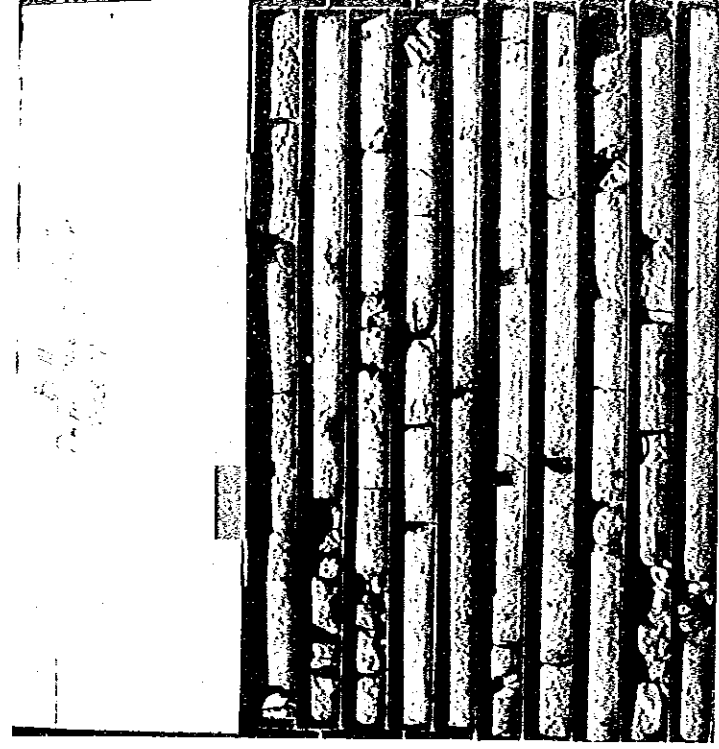
Photo 1.1.7 Drilling Core Photograph of Bore Hole No. B - 10 (3 of 3)

Bore Hole No. : B-10
Location : Damsite
Ground Elevation : EL. 178.12 m
Total Depth : 90 m
Depth : 80 ~ 90 m

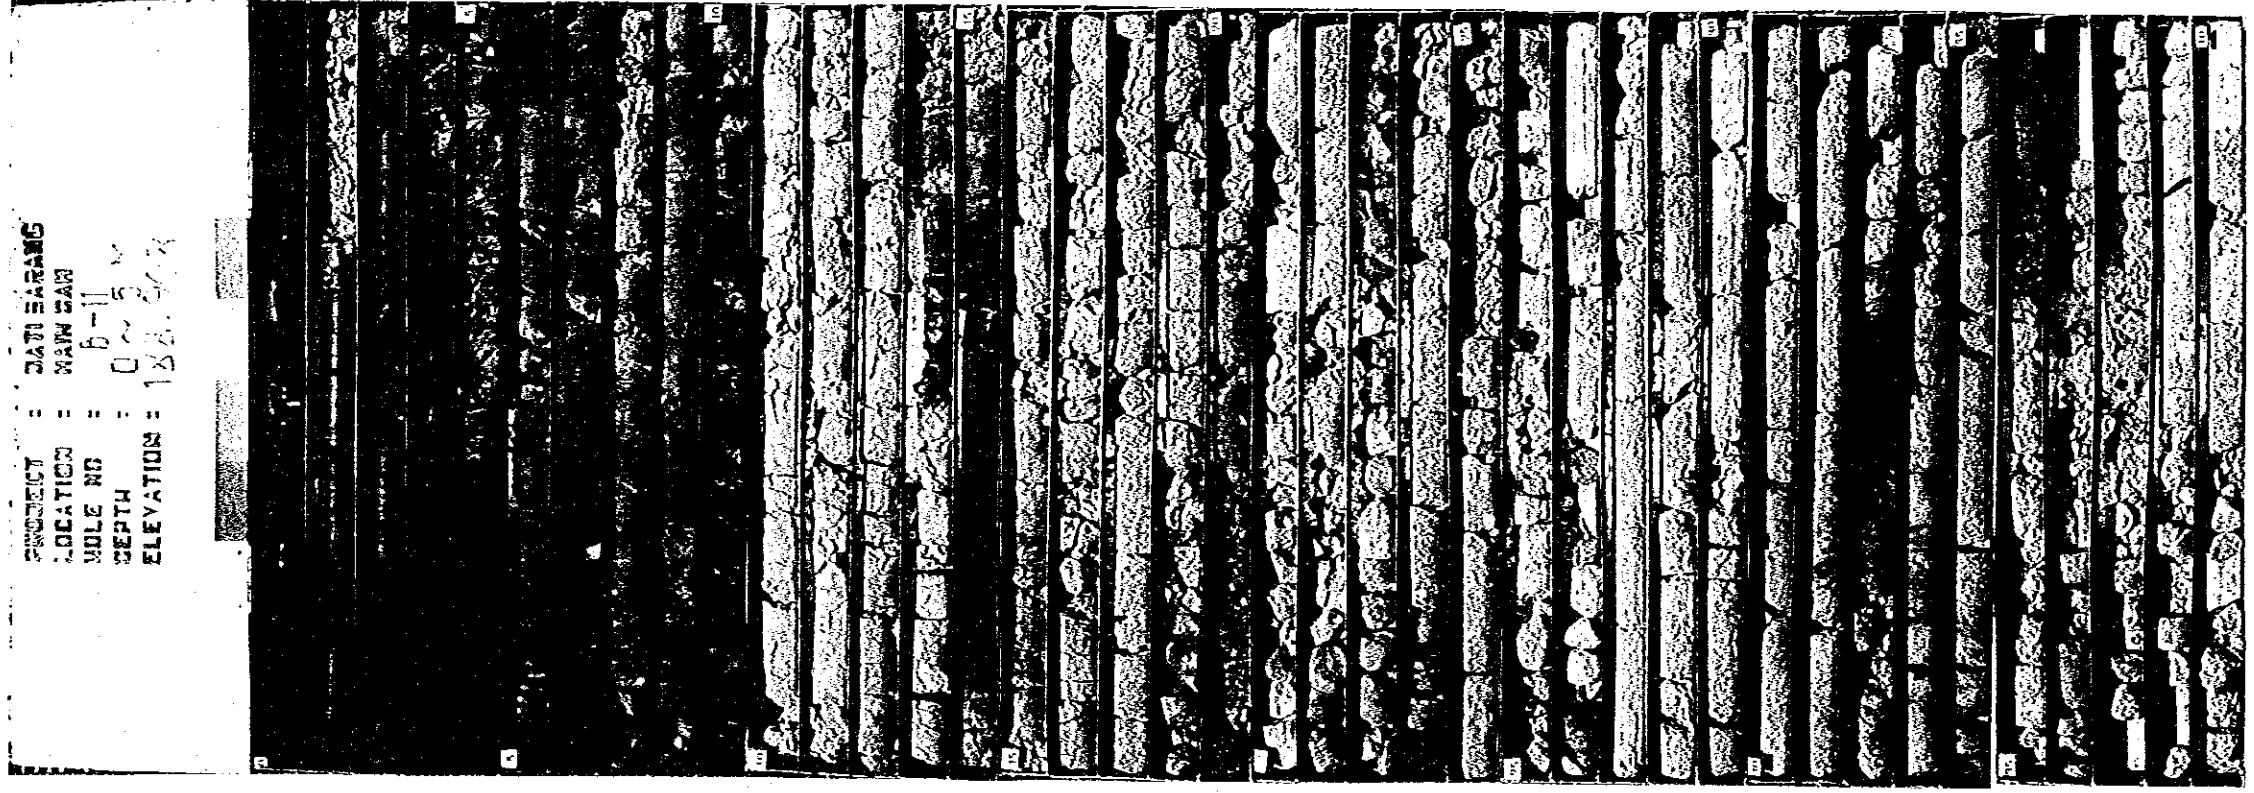
Photo 1.1.8 Drilling Core Photograph of Bore Hole No. B - 11 (1 of 3)

Bore Hole No. : B-11
 Location : Damsite
 Ground Elevation : EL. 188.91 m
 Total Depth : 100 m
 Depth : 0 ~ 40 m

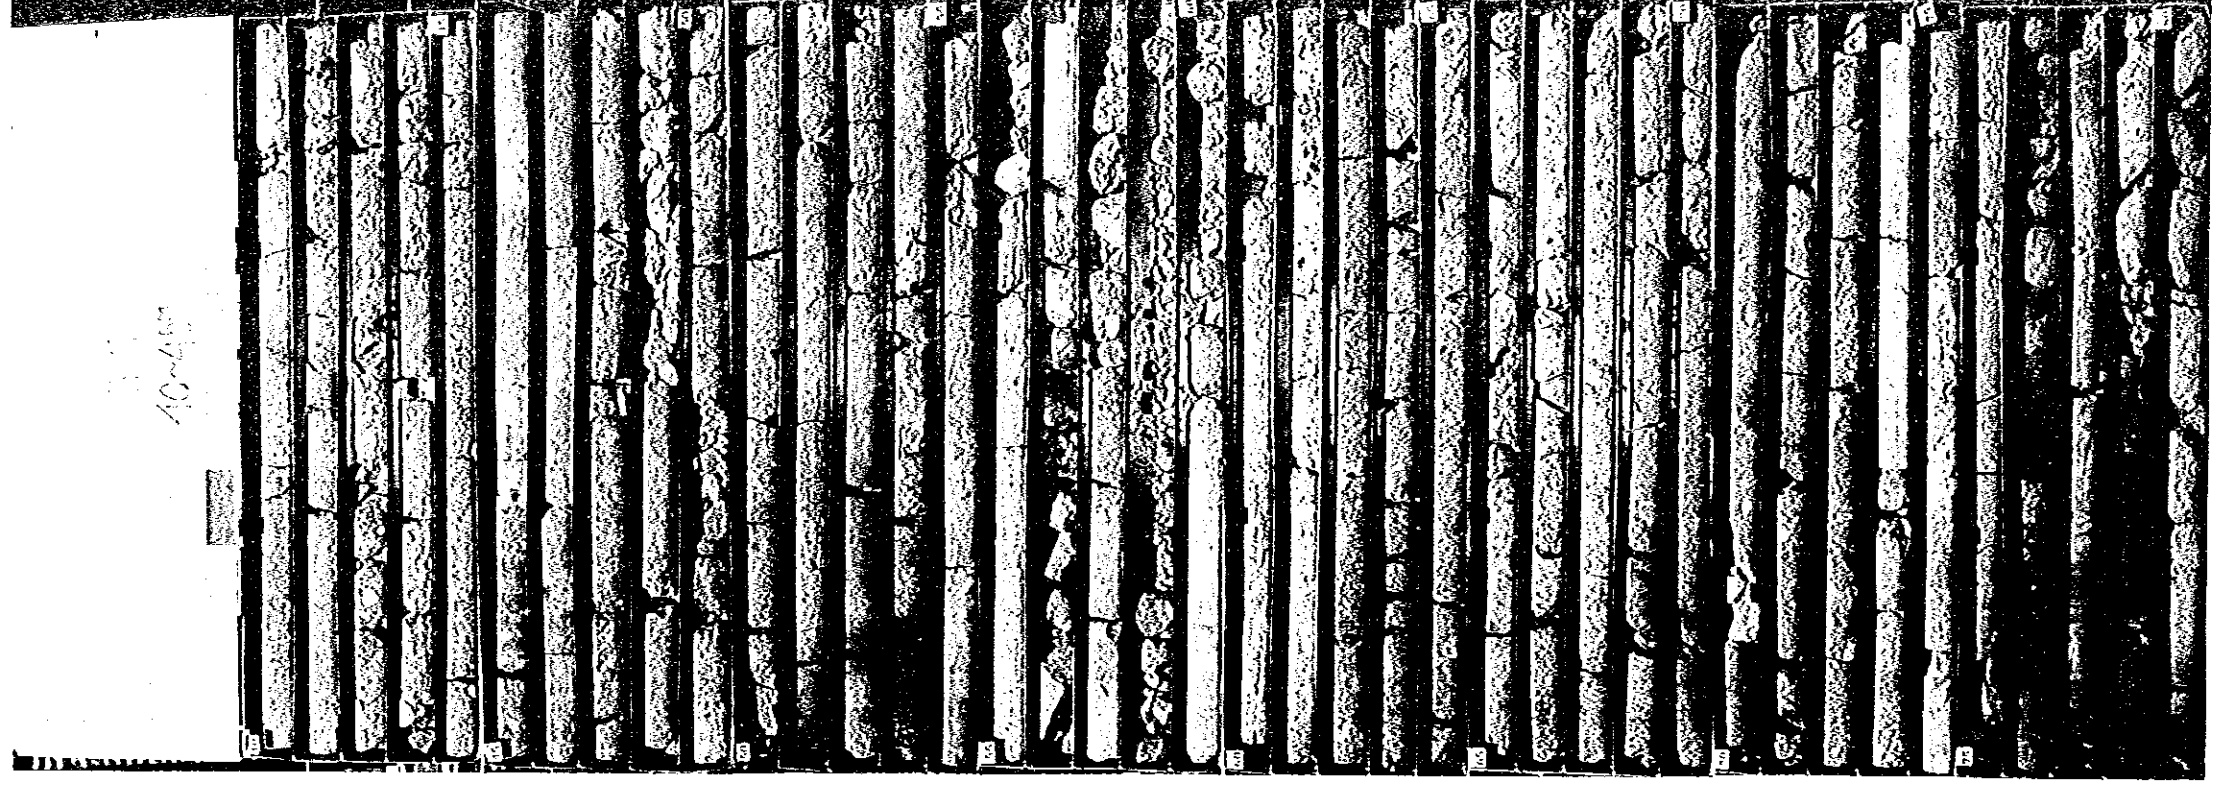
Photo 1.1.8 Drilling Core Photograph of Bore Hole No. B - 11 (2 of 3)

Bore Hole No. : B-11
 Location : Damsite
 Ground Elevation : EL. 188.91 m
 Total Depth : 100 m
 Depth : 40 ~ 80 m

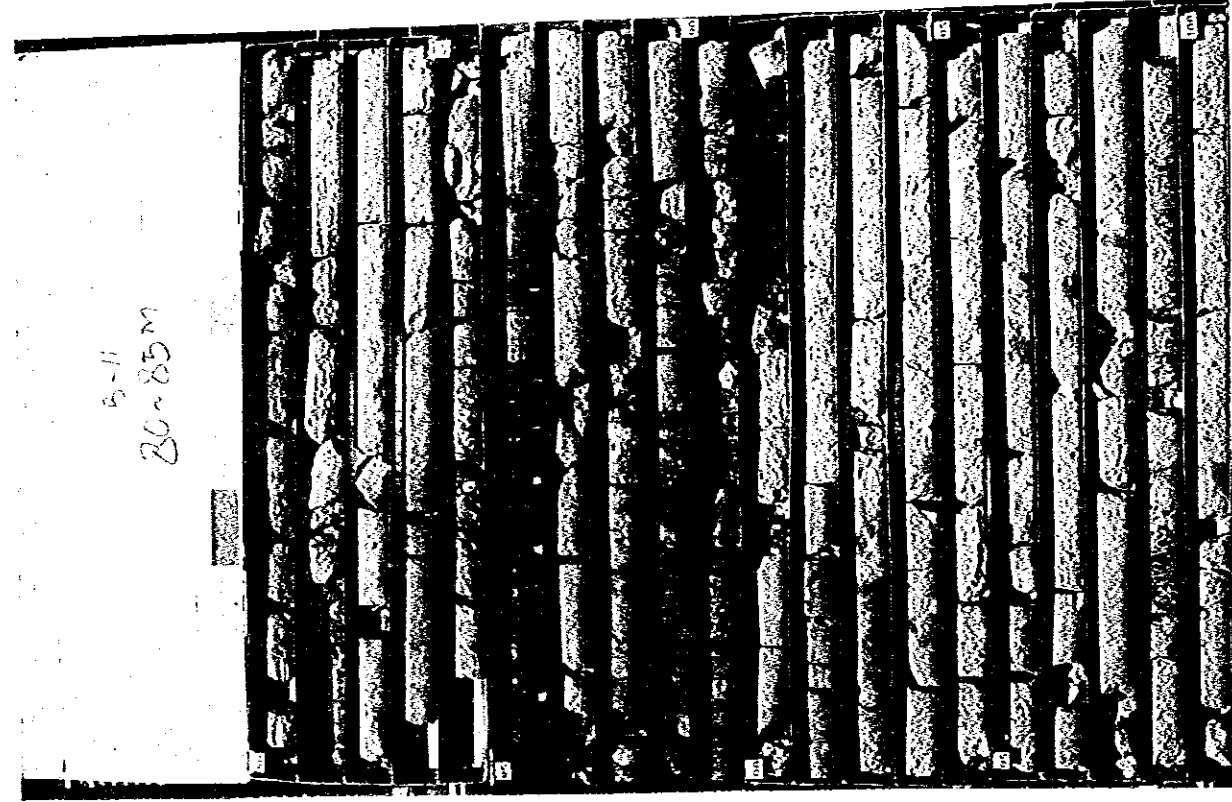
Photo 1.1.8 Drilling Core Photograph of Bore Hole No. B - 11 (3 of 3)

Bore Hole No. : B-11
 Location : Dam site
 Ground Elevation : EL. 188.91 m
 Total Depth : 100 m
 Depth : 80 ~ 100 m

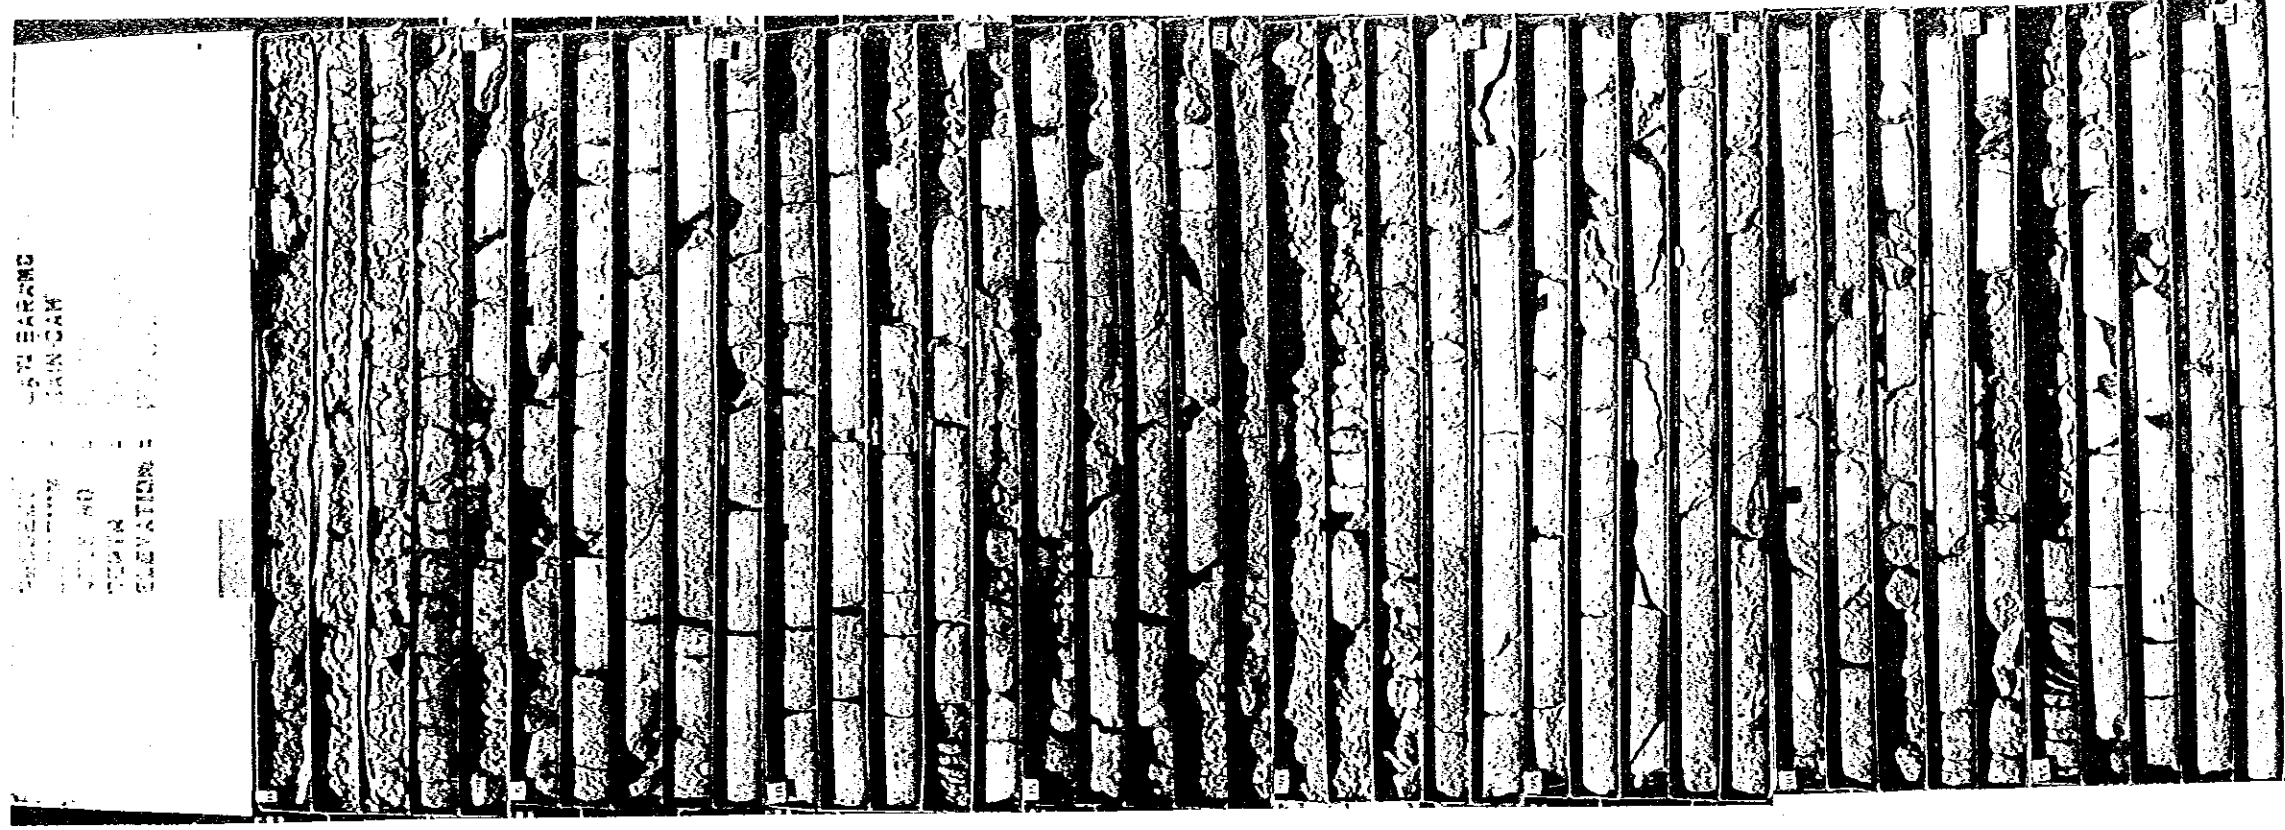
Photo 1.1.9 Drilling Core Photograph of Bore Hole No. B - 12 (1 of 2)

Bore Hole No. : B-12
 Location : Dam site
 Ground Elevation : EL. 137.07 m
 Total Depth : 80 m
 Depth : 0 ~ 40 m
