COMPREHENSIVE DISASTER PREVENTION AROUND MAYON VOLCANO IN
THE REPUBLIC OF THE PHILIPPINES

JAPAN INTERNATIONAL COOPERATION AGENCY

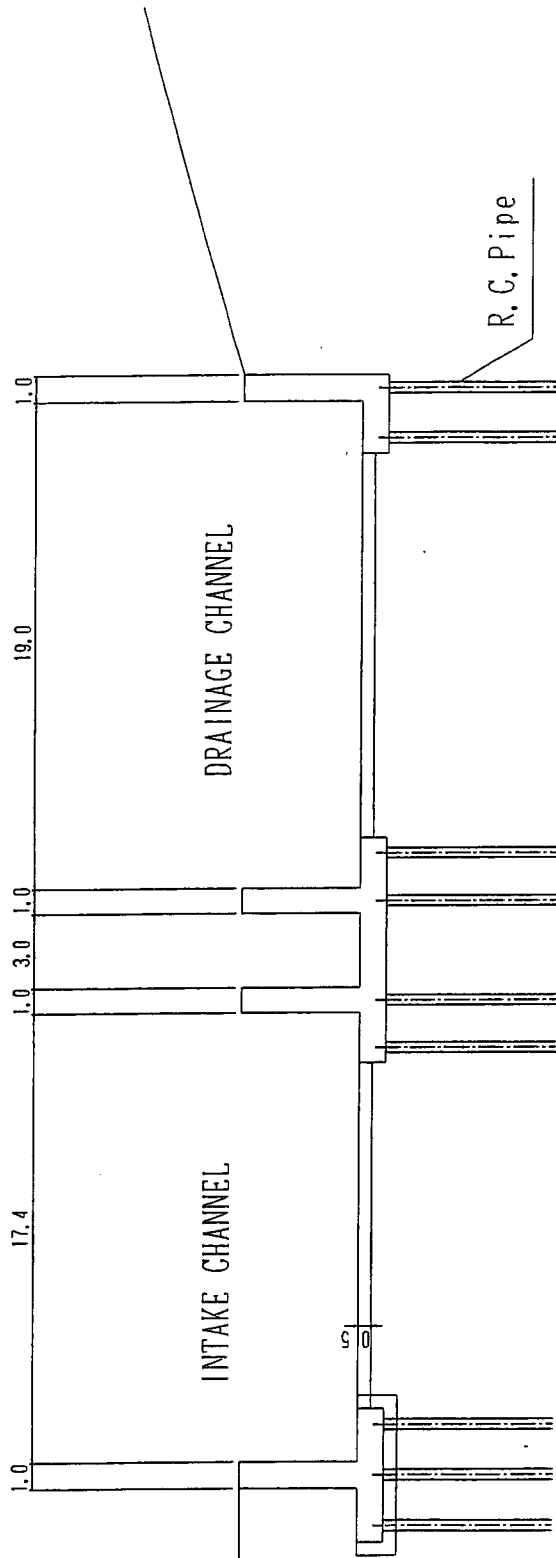
Figure 8.2.12
Profile of Intake Channel and Drainage Channel at Macabalo

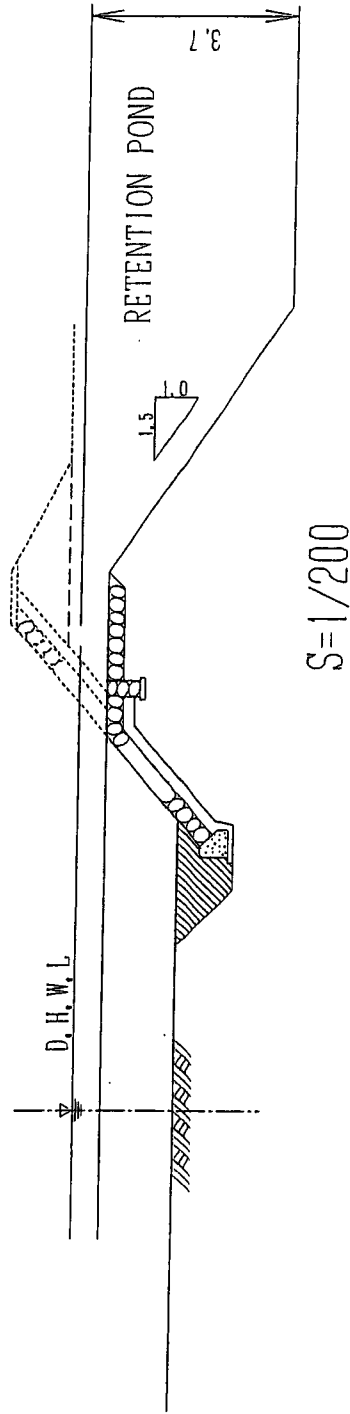
Figure 8.2.13
Profile of Inlet Overflow Section (Section-1)

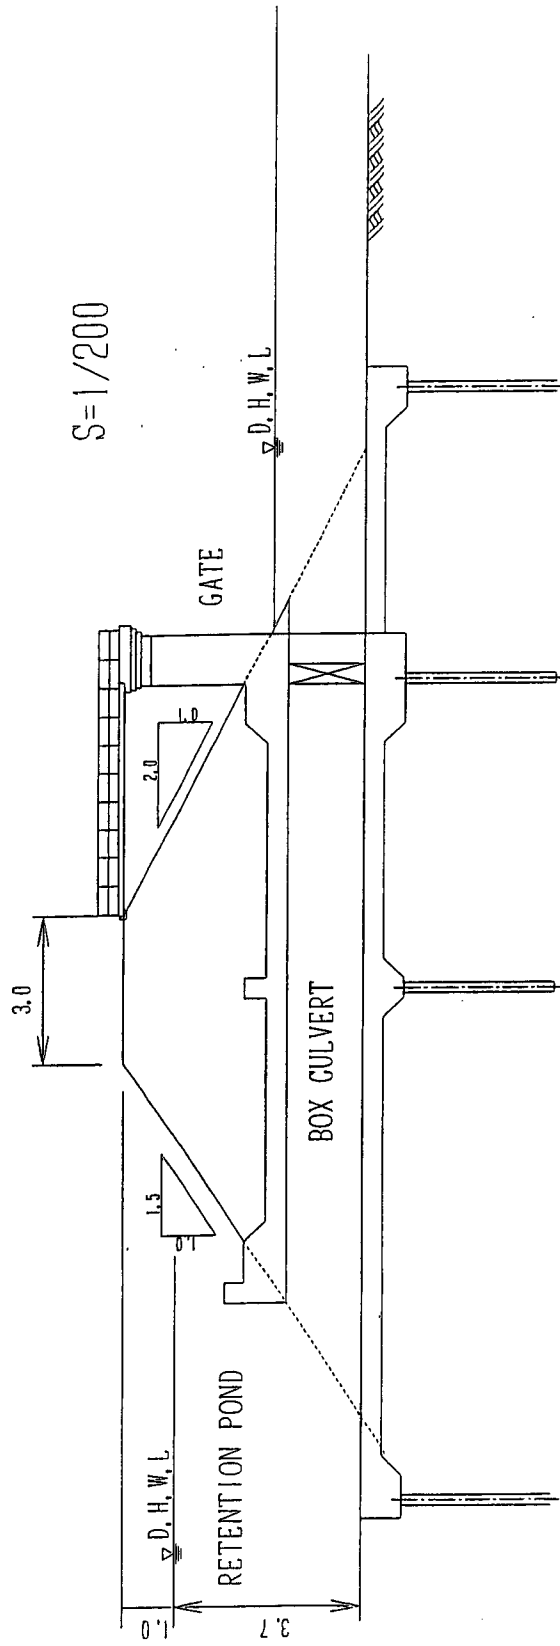
Figure 8.2.14
Profile of Outlet Overflow Section (Section-2)

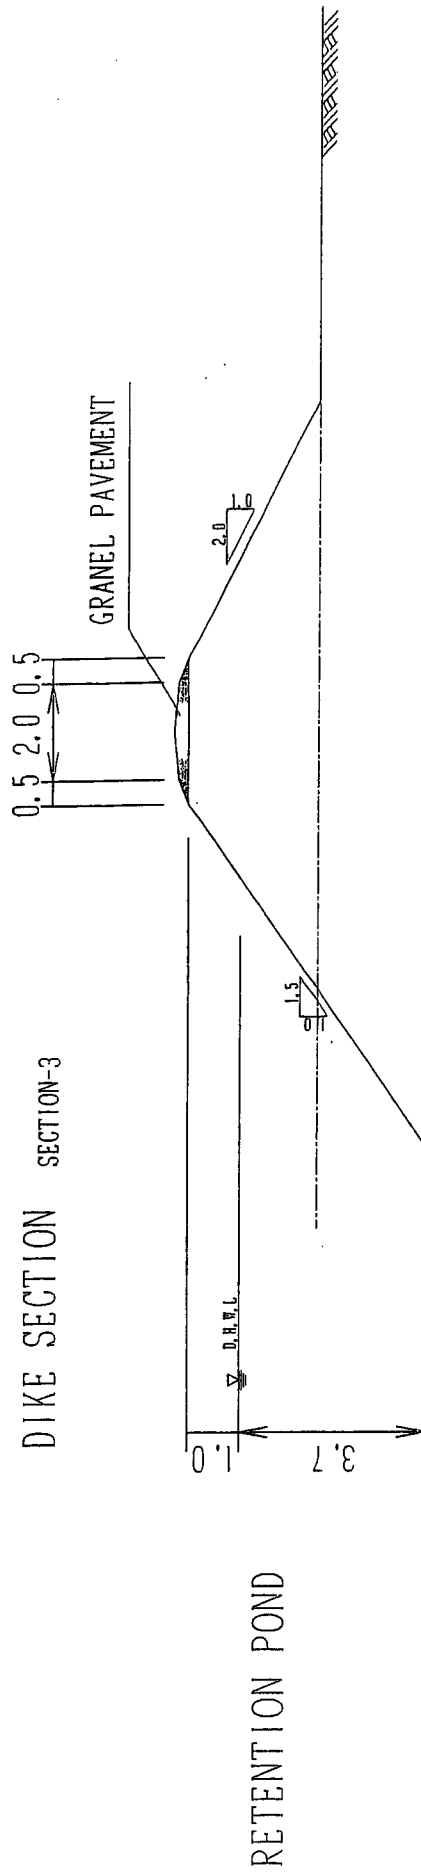
Figure 8.2.15
Profile of Dike Section (Section-3)

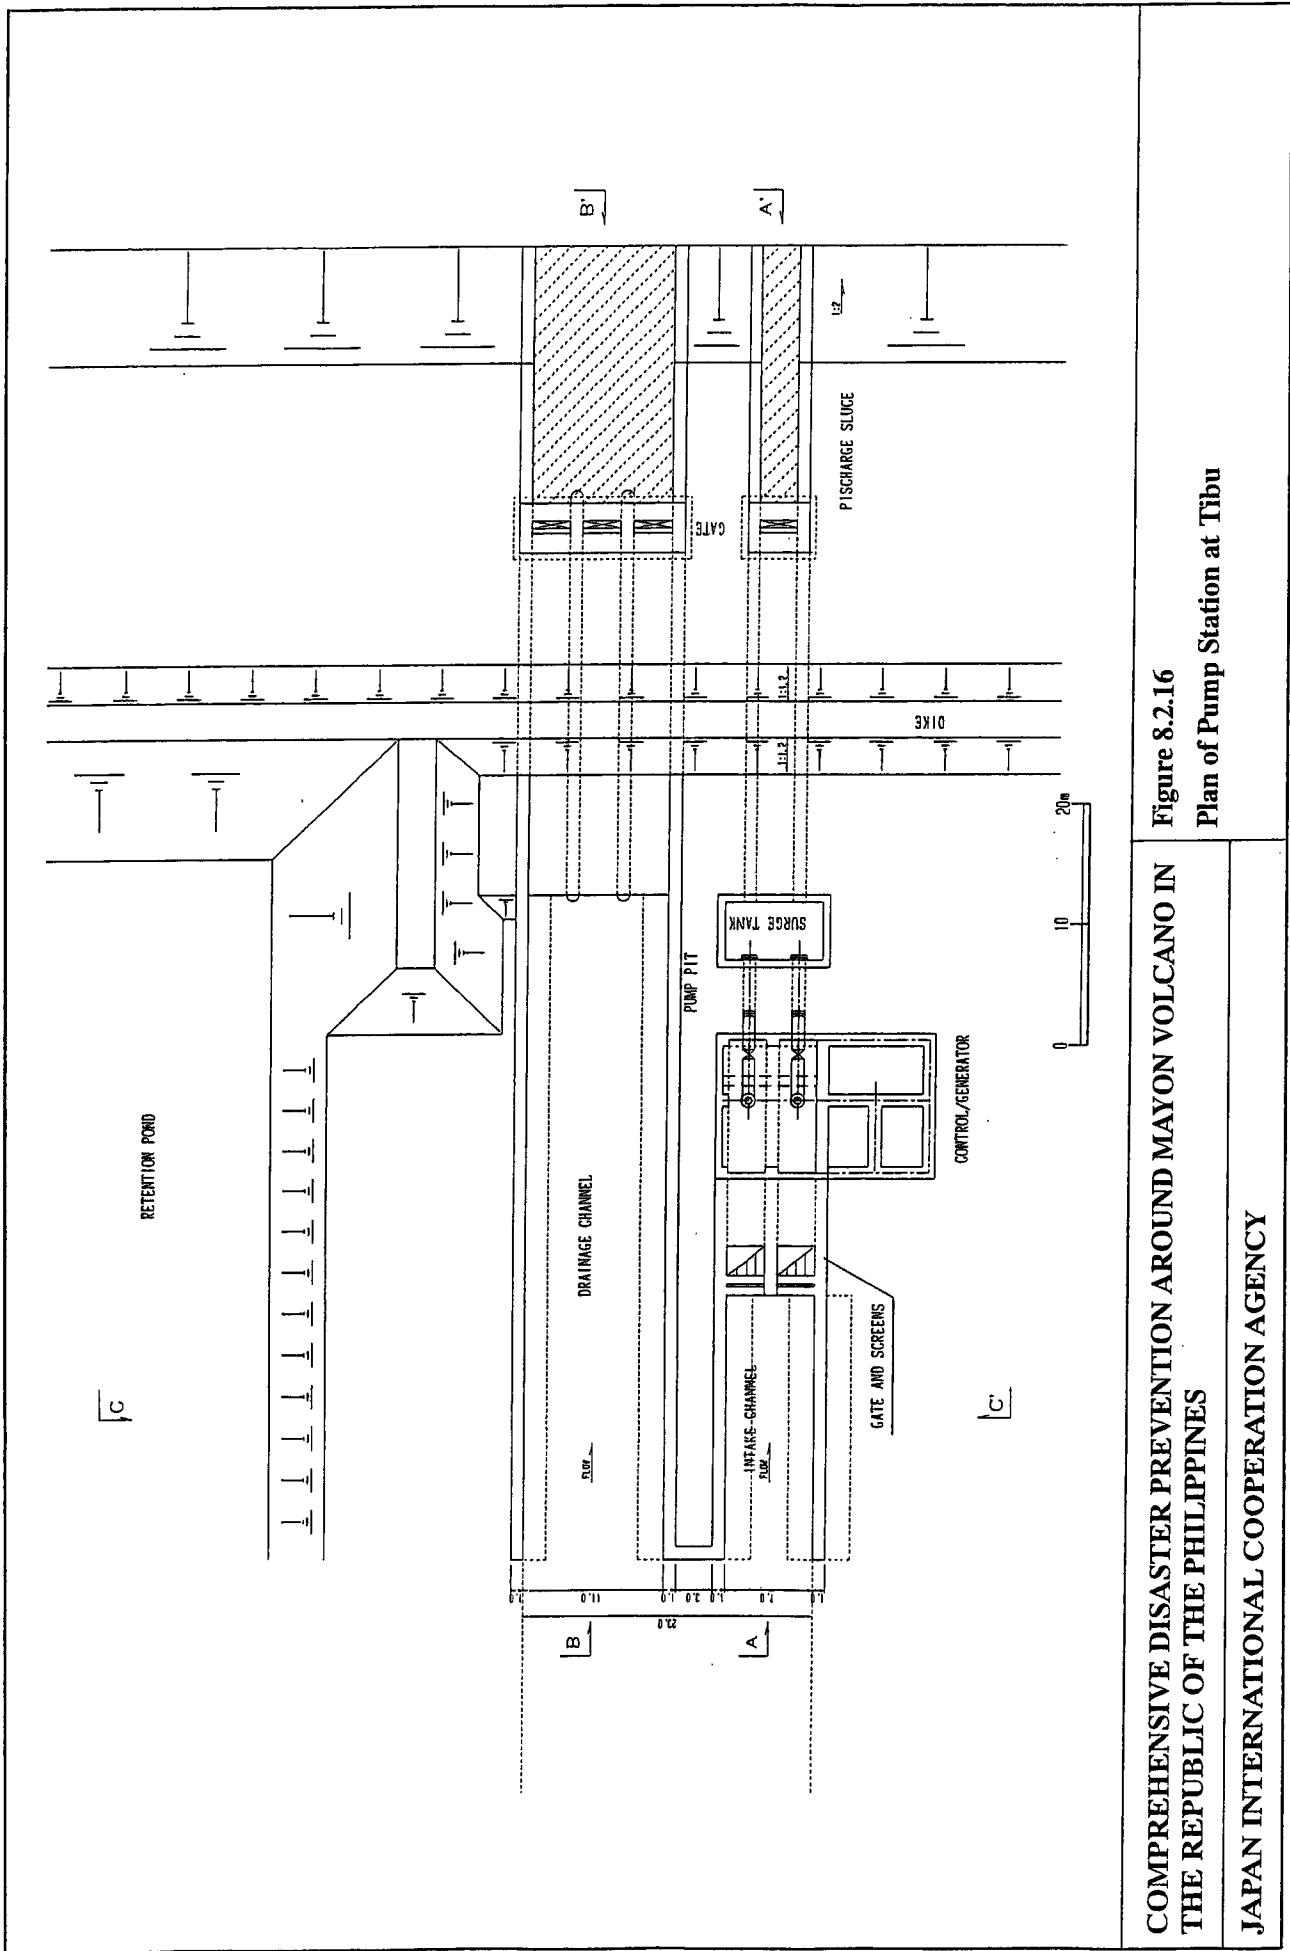
Figure 8.2.16
Plan of Pump Station at Tibu

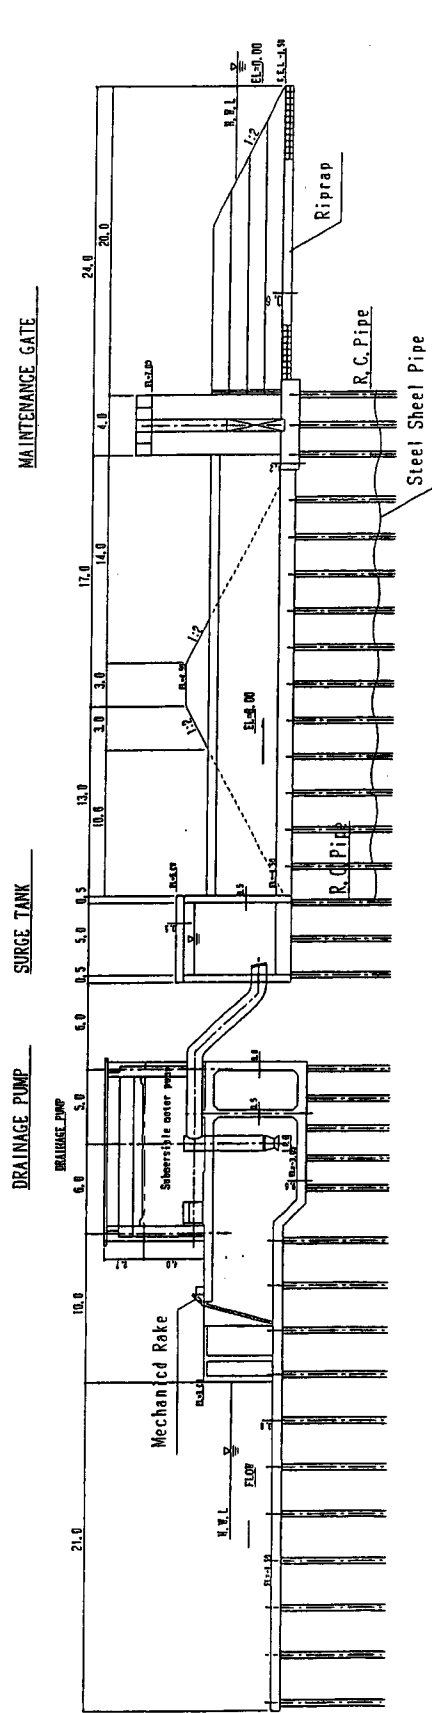
Figure 8.2.17
Profile of Drainage Pump at Tibu

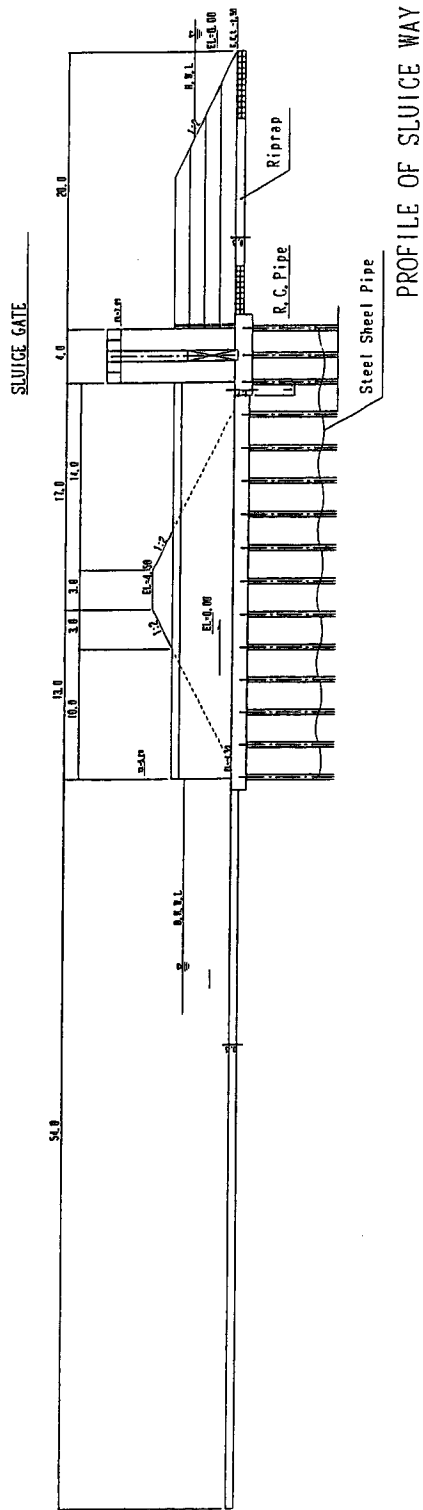
Figure 8.2.18
Profile of Sluice Way at Tibu

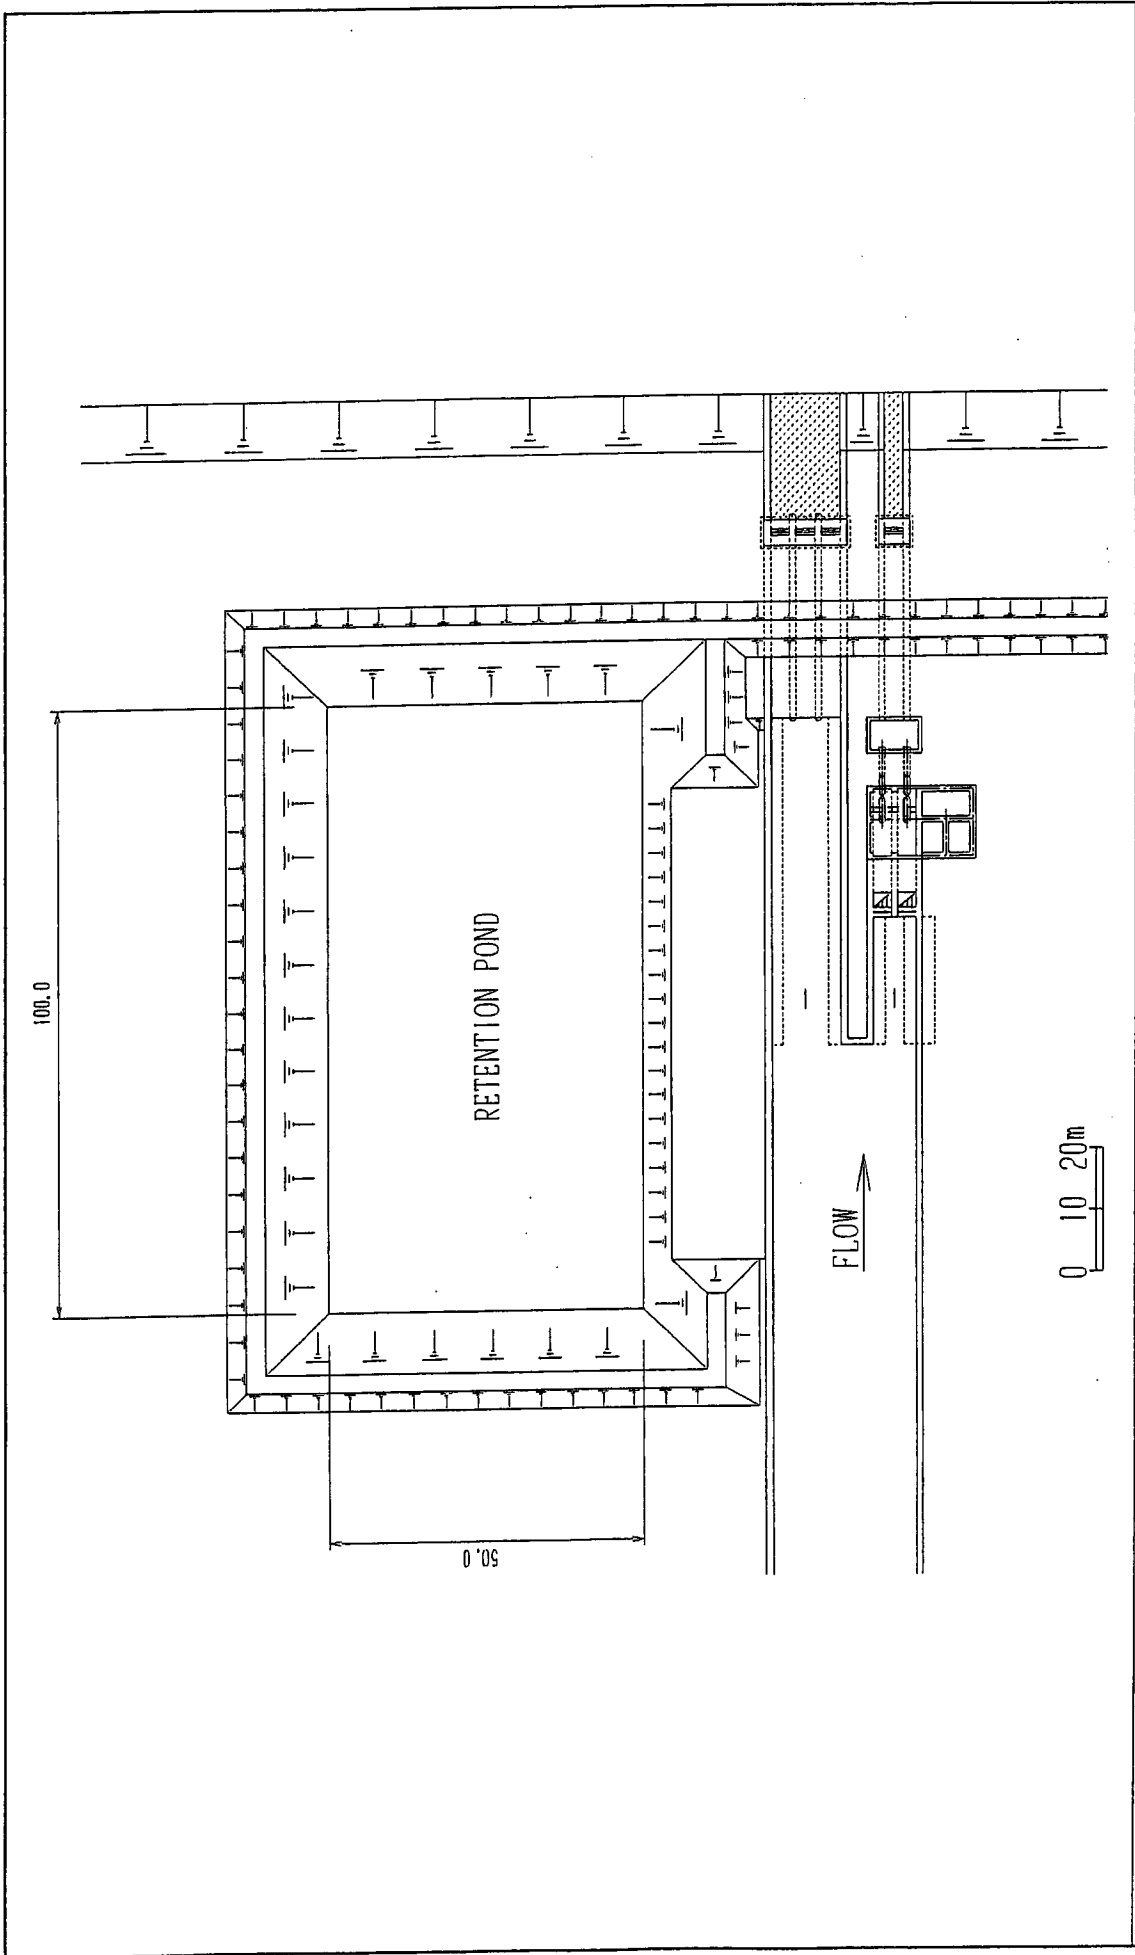
Figure 8.2.19
Plan of Retention Pond at Tibu

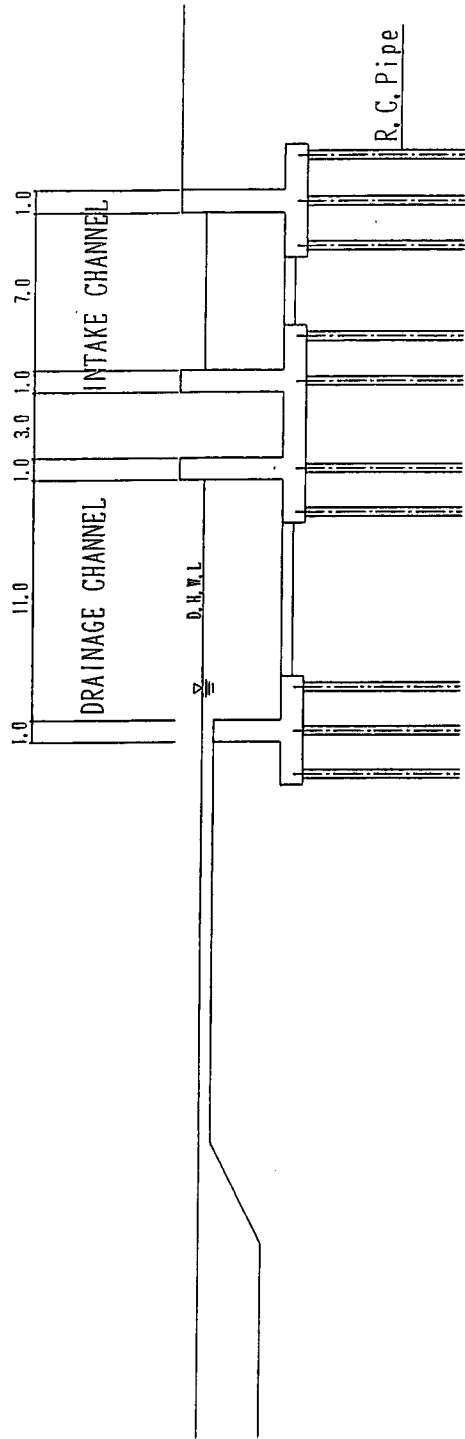
Figure 8.2.20

Profile of Drainage Channel and Intake Channel at Tibu

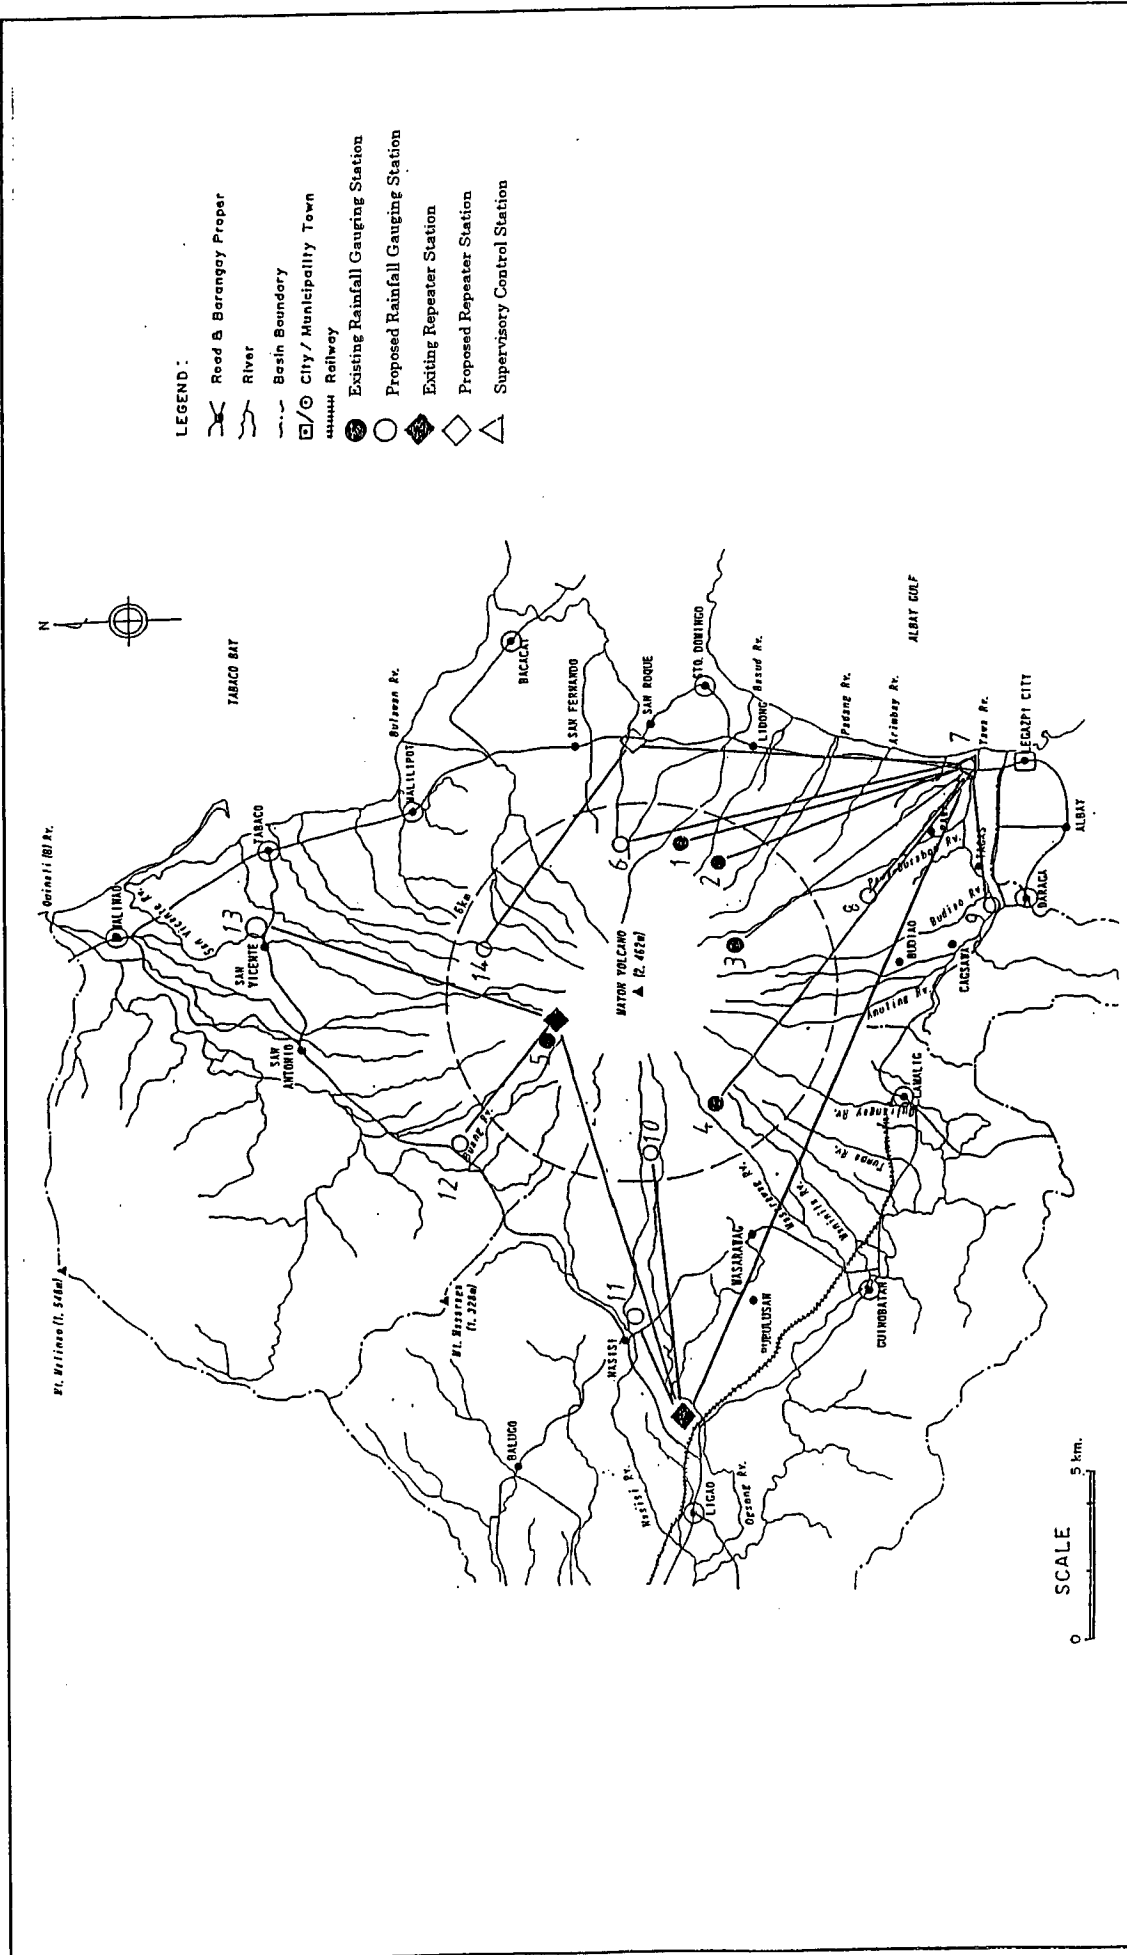
Figure 8.3.2
Radio Circuit Plan for Rainfall Gauging Station

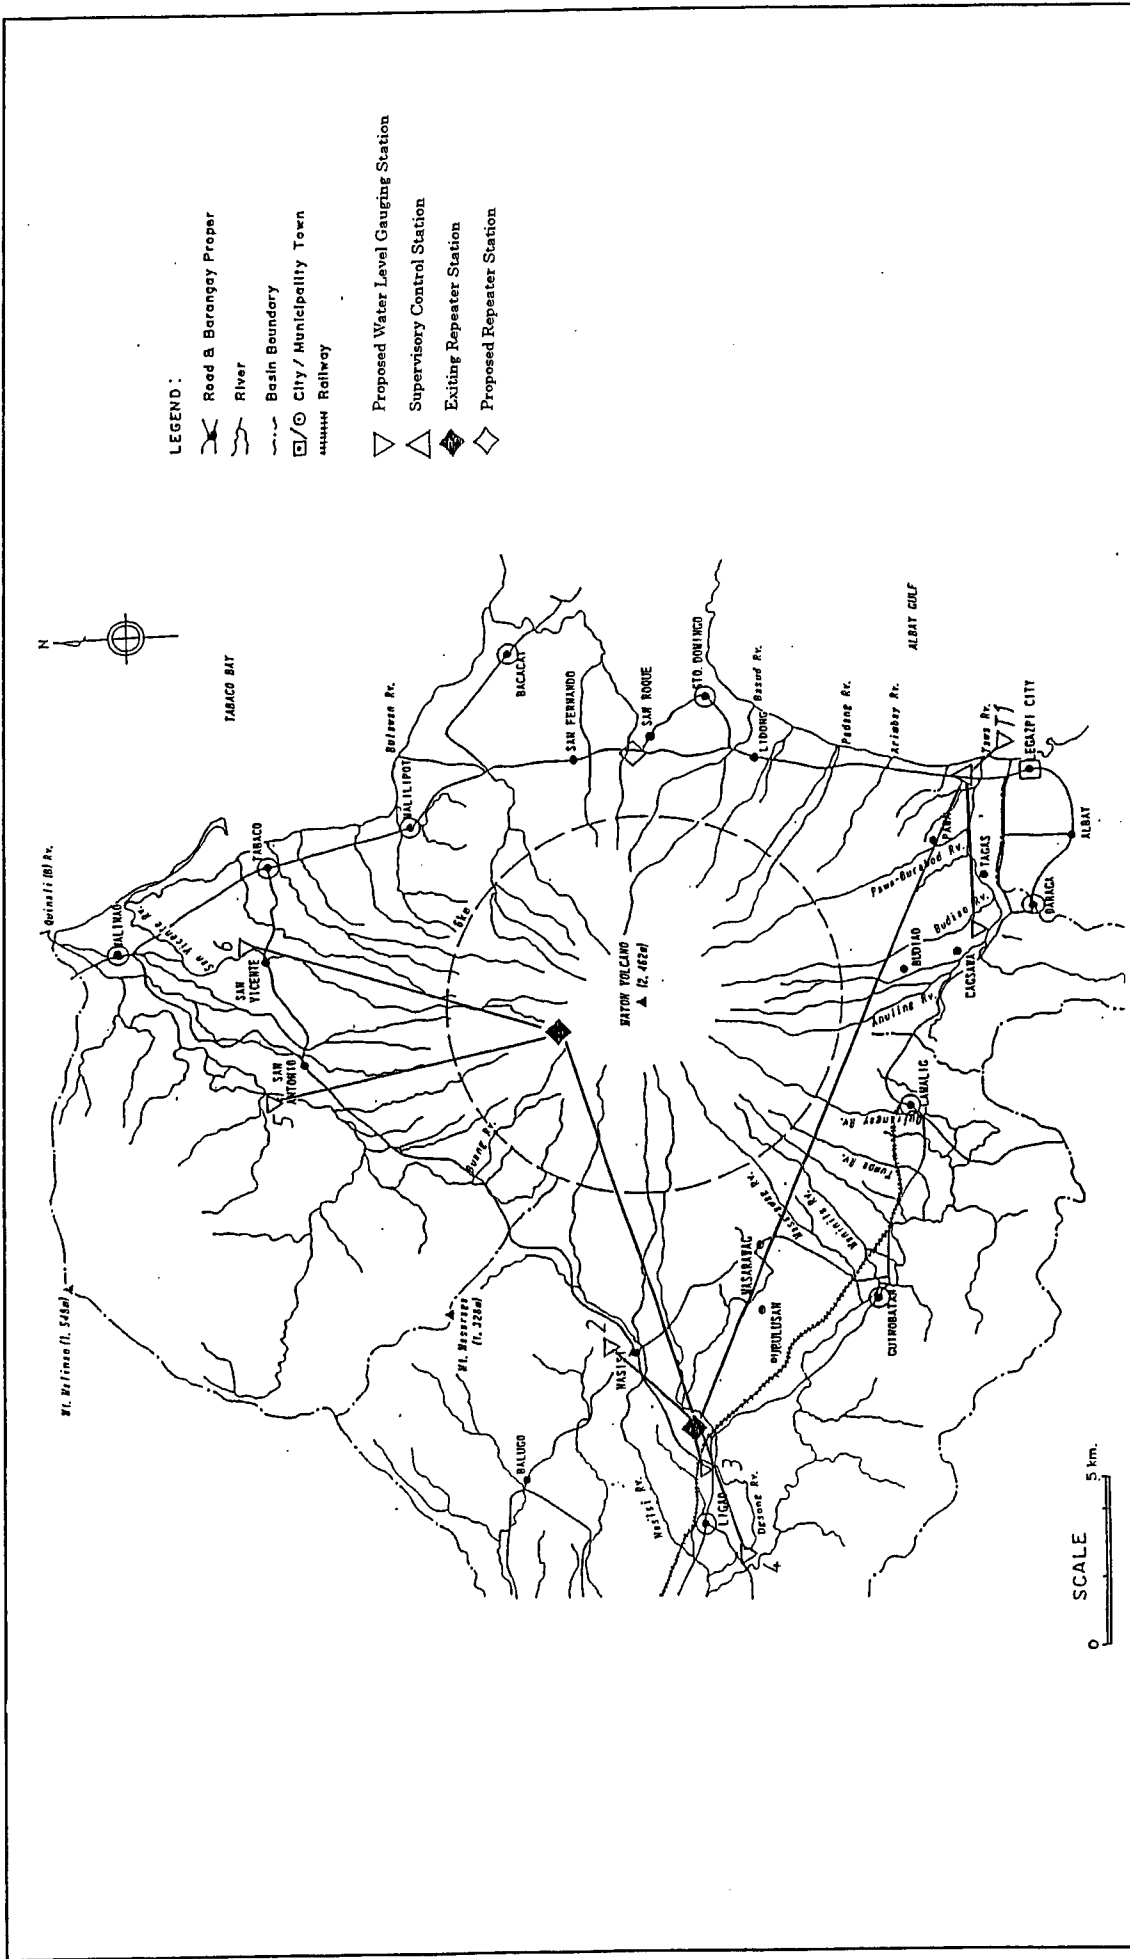
Figure 8.3.3
Radio Circuit Plan for Water Level Gauging Station

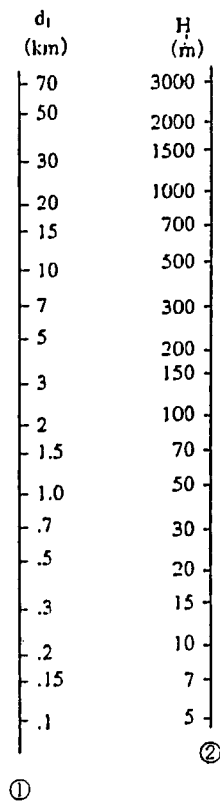
Figure 8.3.4
Chart to Estimate Sharing Loss

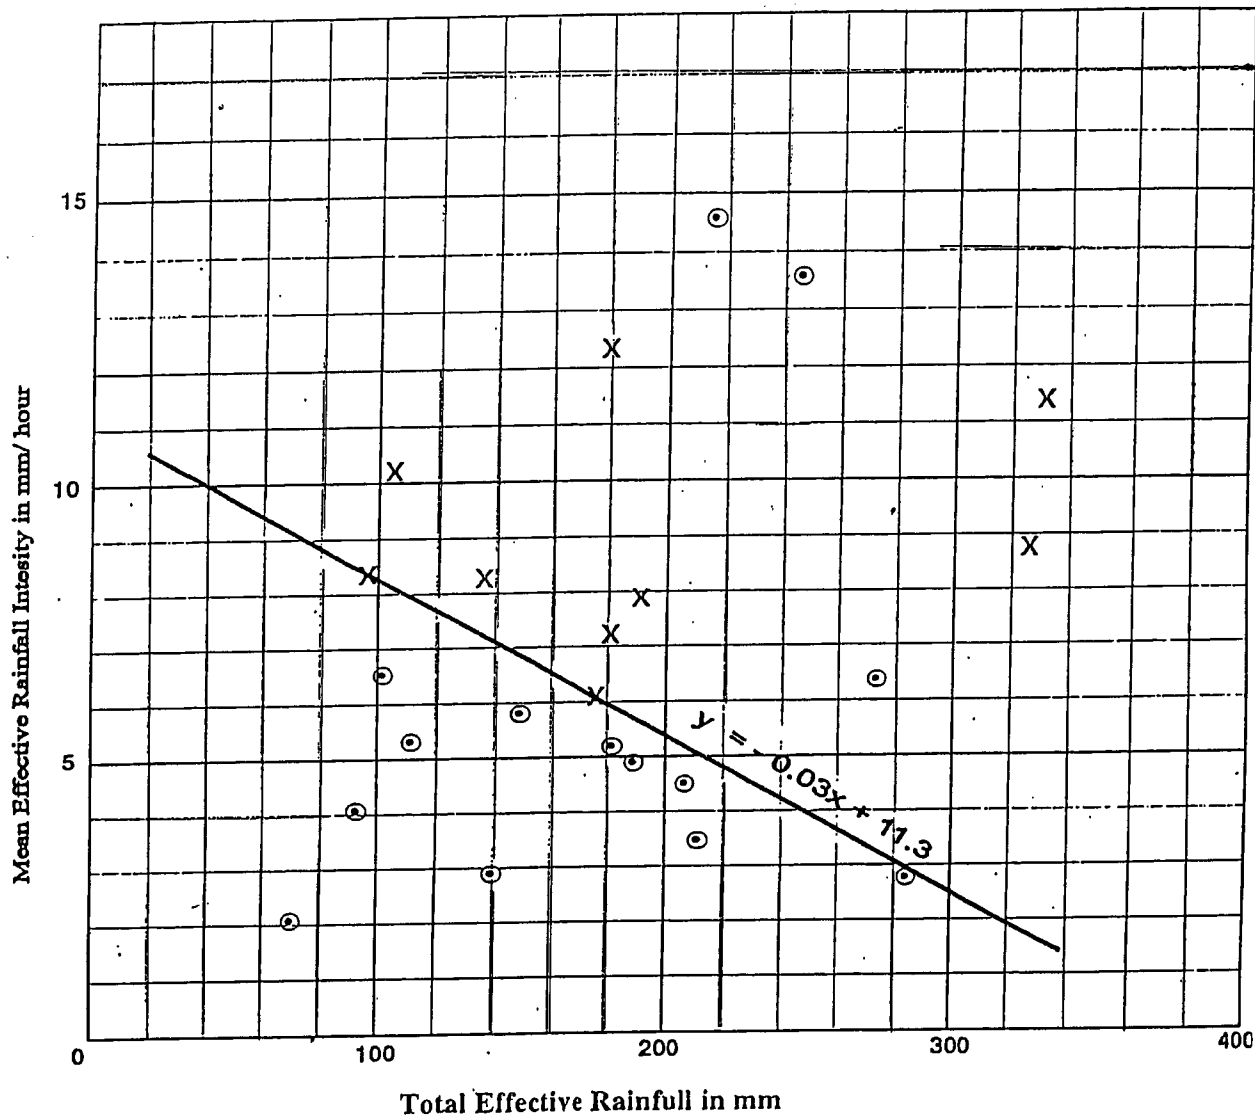
⊙ : Plotting position for a heavy rainfall which did not record the occurrence of mud and debris flow.

X : Plotting position for a rainfall which is supposed to be the trigger of the occurred mud and debris flow

Figure 8.3.5
Critical Line of Mud and Debris Flow

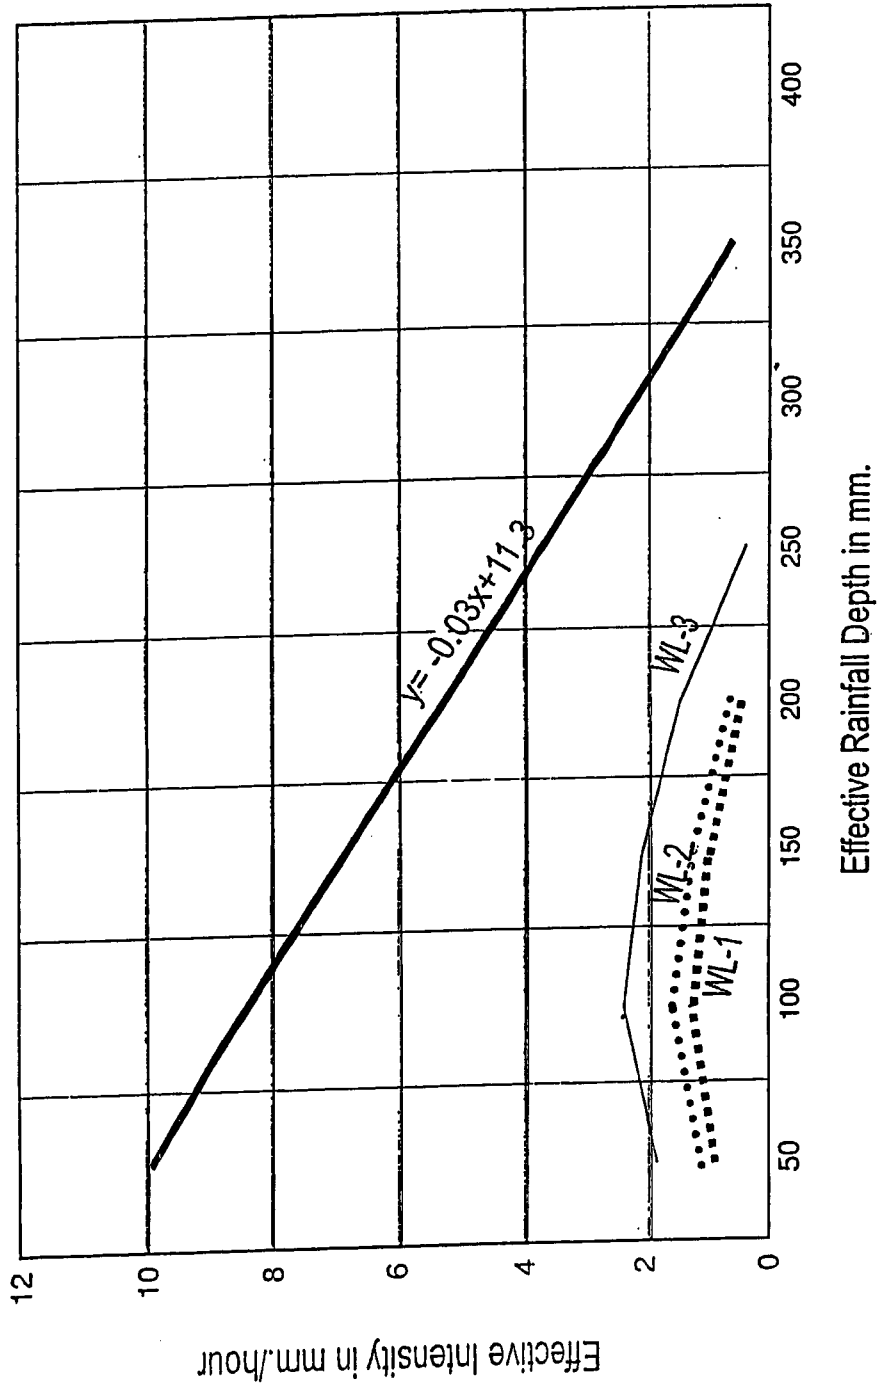
Figure 8.3.6
Critical and Warning Lines

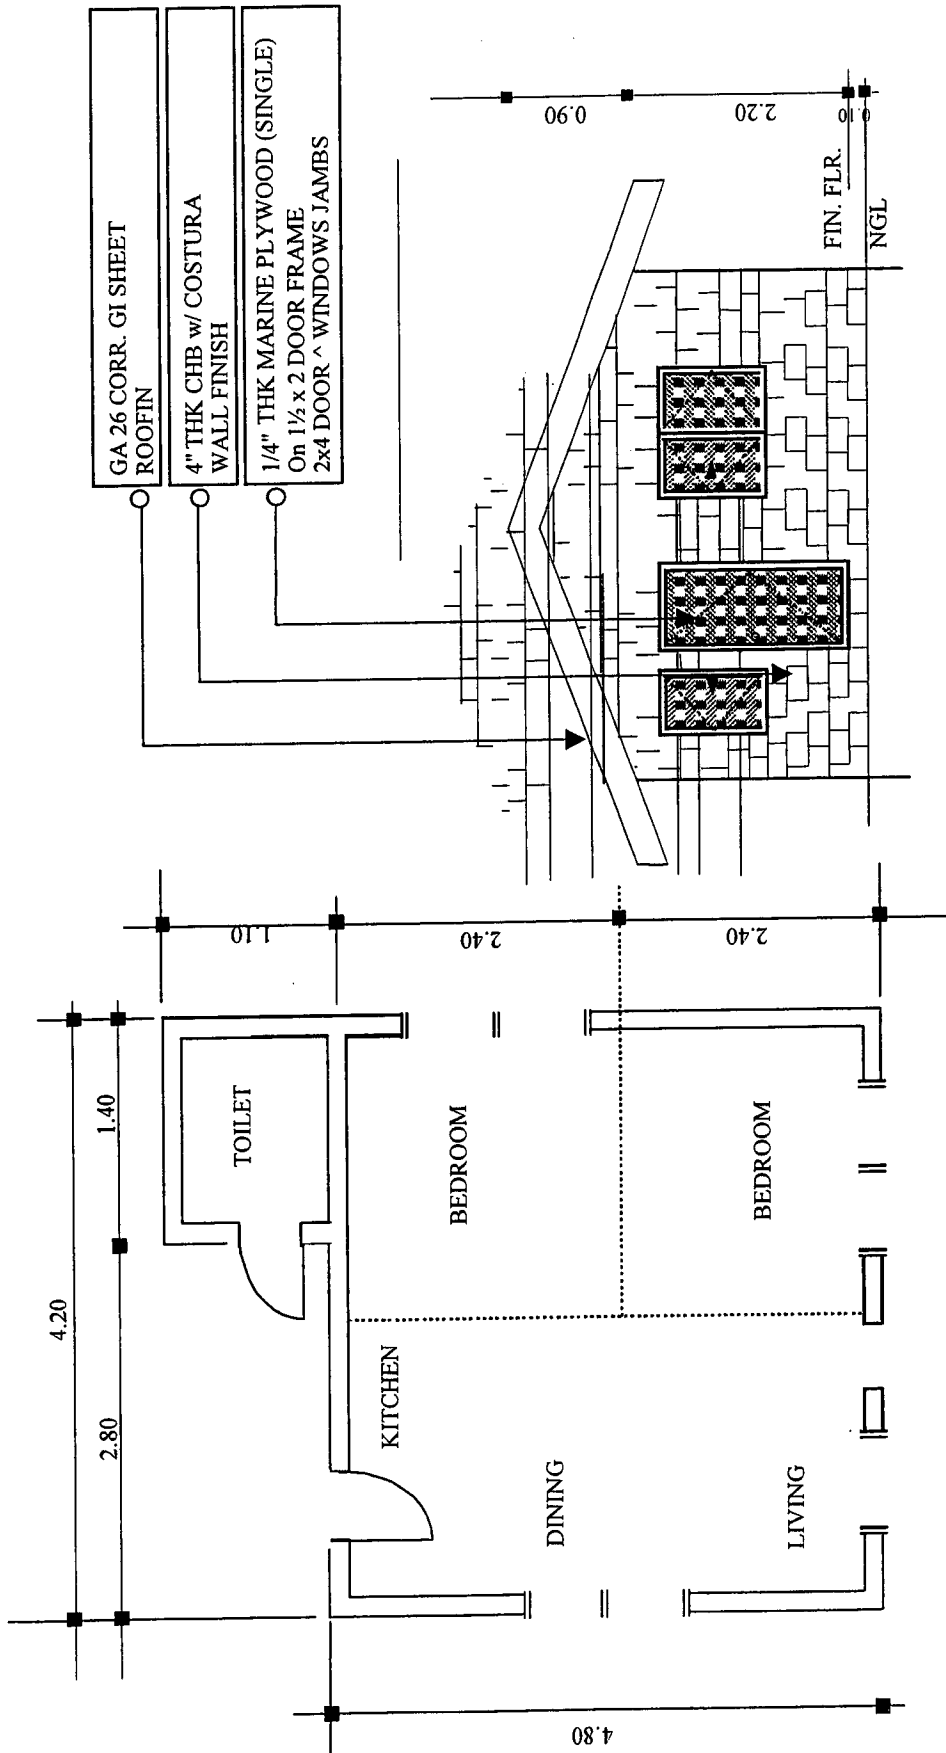
Figure 8.5.3
Standard Housing Layout Plan/Elevation

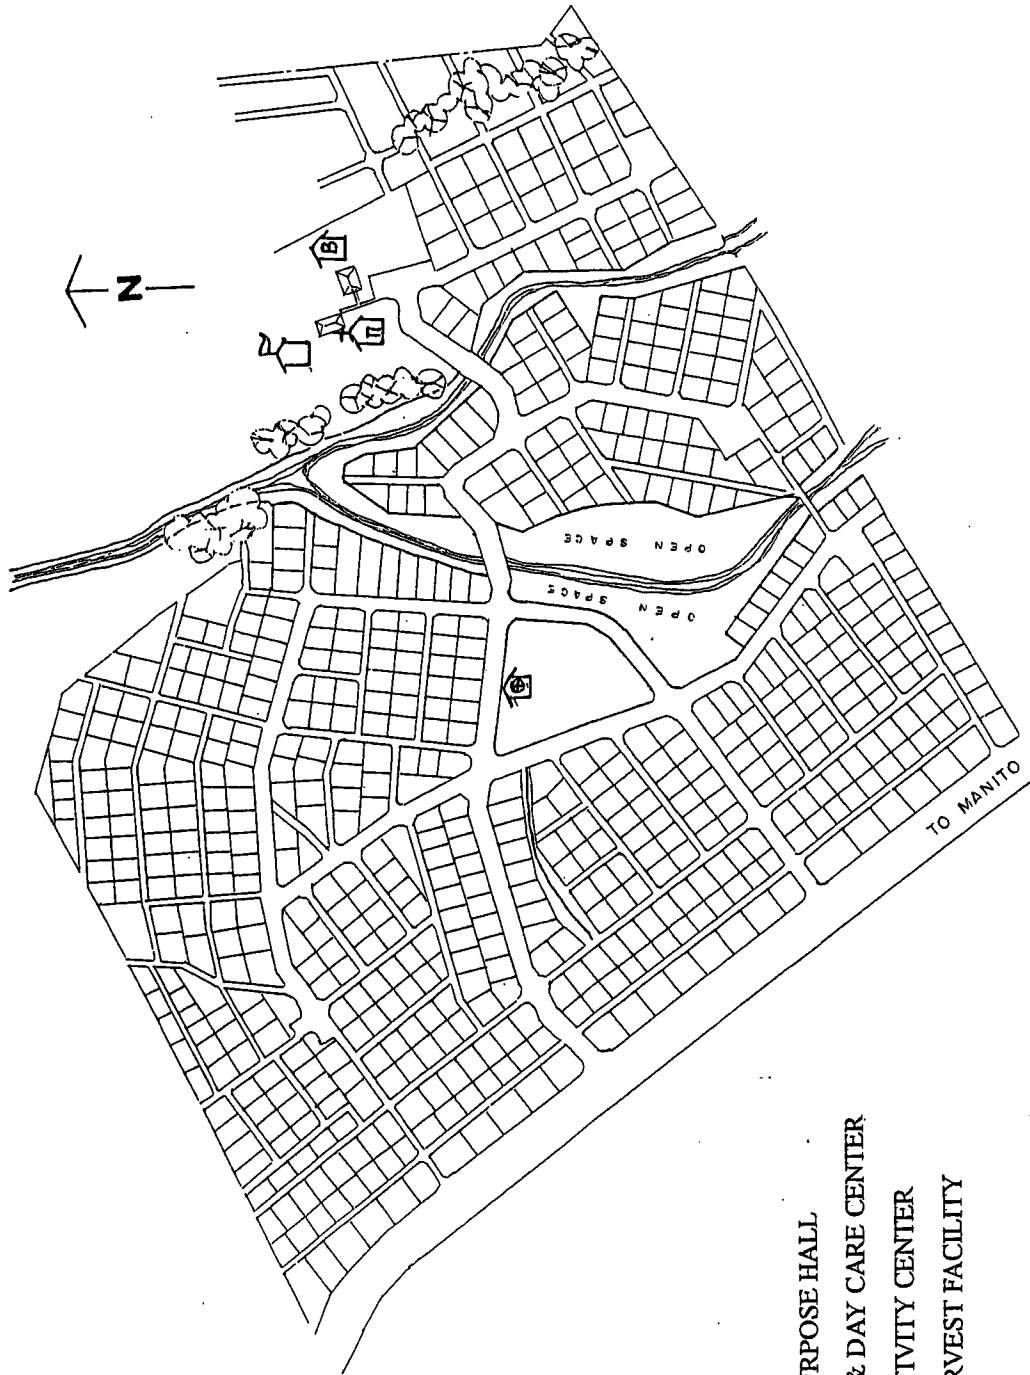
Figure 8.5.5
Community and Livelihood Facilities Layout for Banquerohan
Phase I

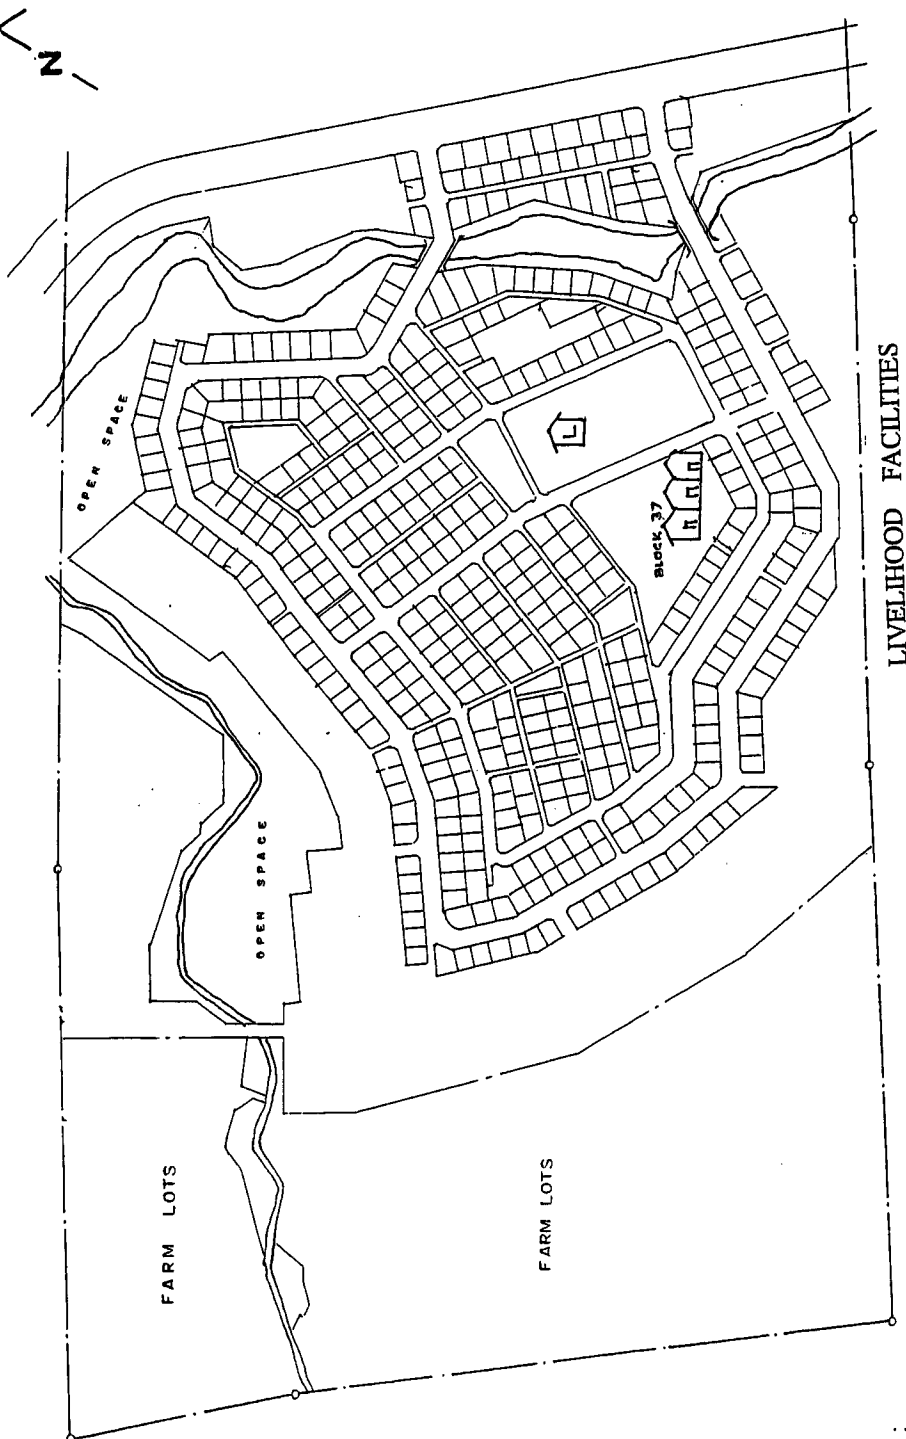
Figure 8.5.6
Community and Livelihood Facilities Layout for Banquerohan
Phase II

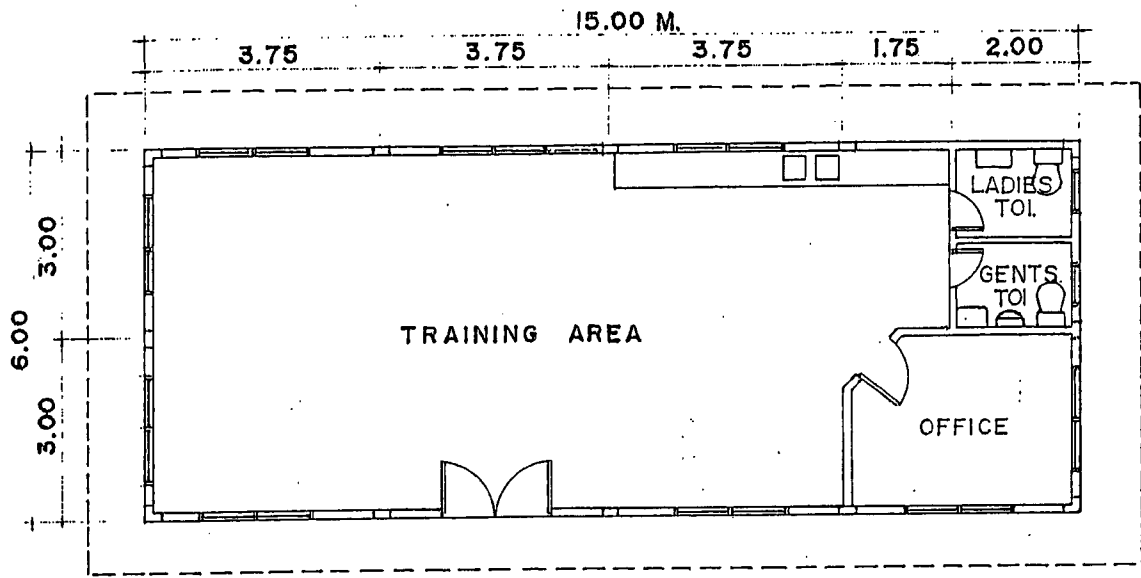
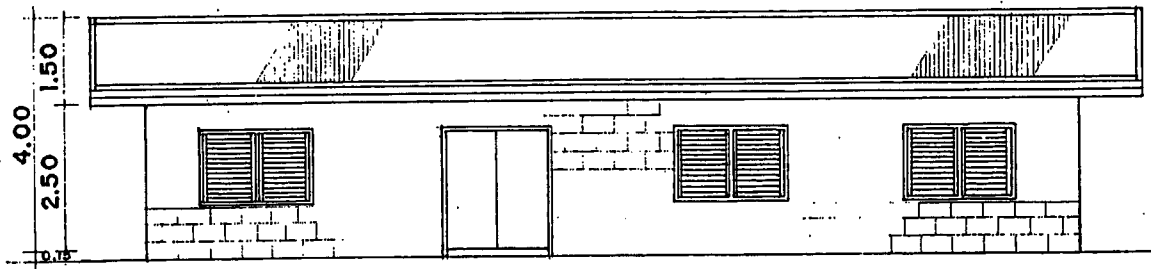
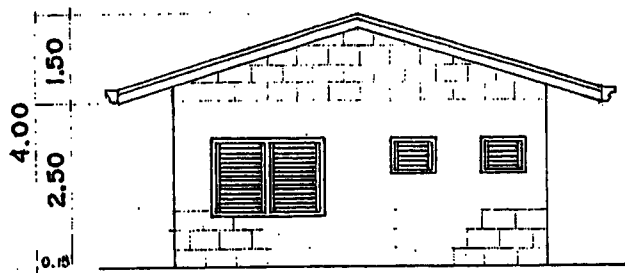
FLOOR PLAN

FRONT ELEVATION

RIGHT SIDE ELEVATION

Figure 8.5.7
Productivity Center Layout Plan
