COMPREHENSIVE DISASTER PREVENTION AROUND MAYON VOLCANO IN THE REPUBLIC OF THE PHILIPPINES
Figure VI 3.9
Hazard Map of Lahar and Debris Flow (2)
 JAPAN INTERNATIONAL COOPERATION AGENCY

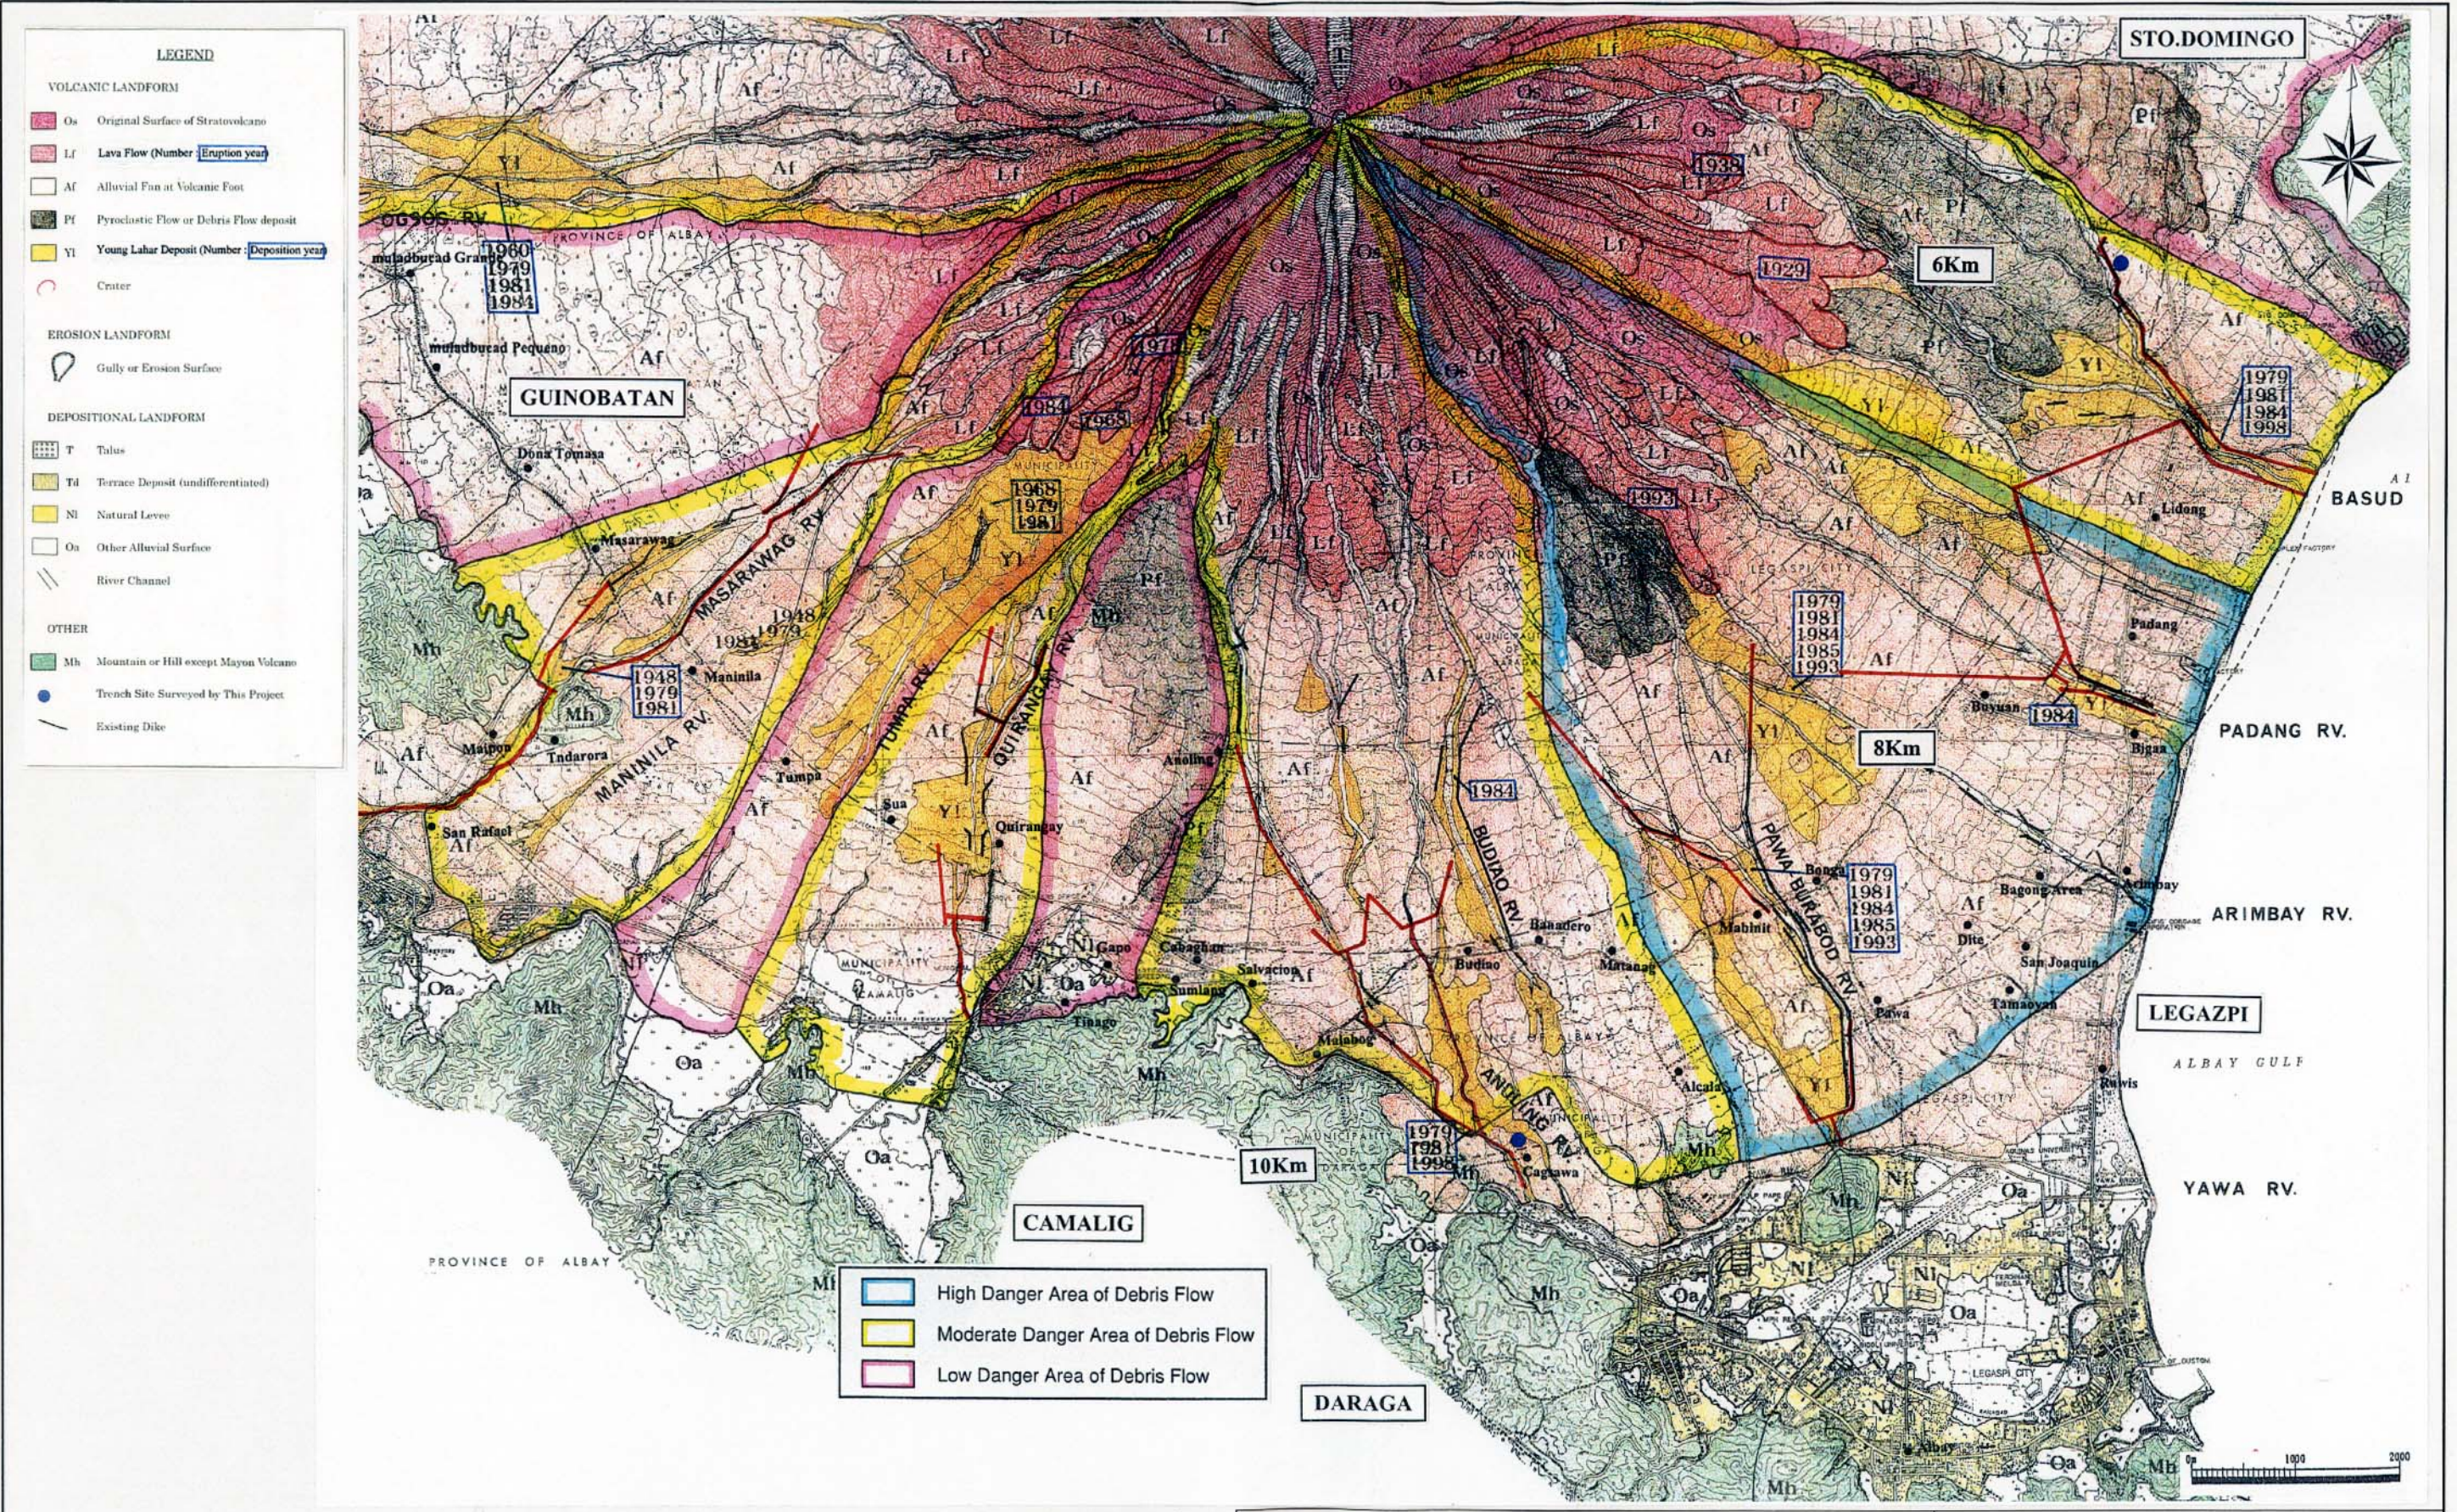
Note 1. The base map is 1/25,000 geomorphological classification map made on July 1999 in this study.
Note 2. Contour lines of the base map are based on 1/25,000 topographic map made in 1980 by JICA.
