**COMPREHENSIVE DISASTER PREVENTION  
AROUND MAYON VOLCANO IN  
THE REPUBLIC OF THE PHILIPPINES**

**JAPAN INTERNATIONAL COOPERATION AGENCY**

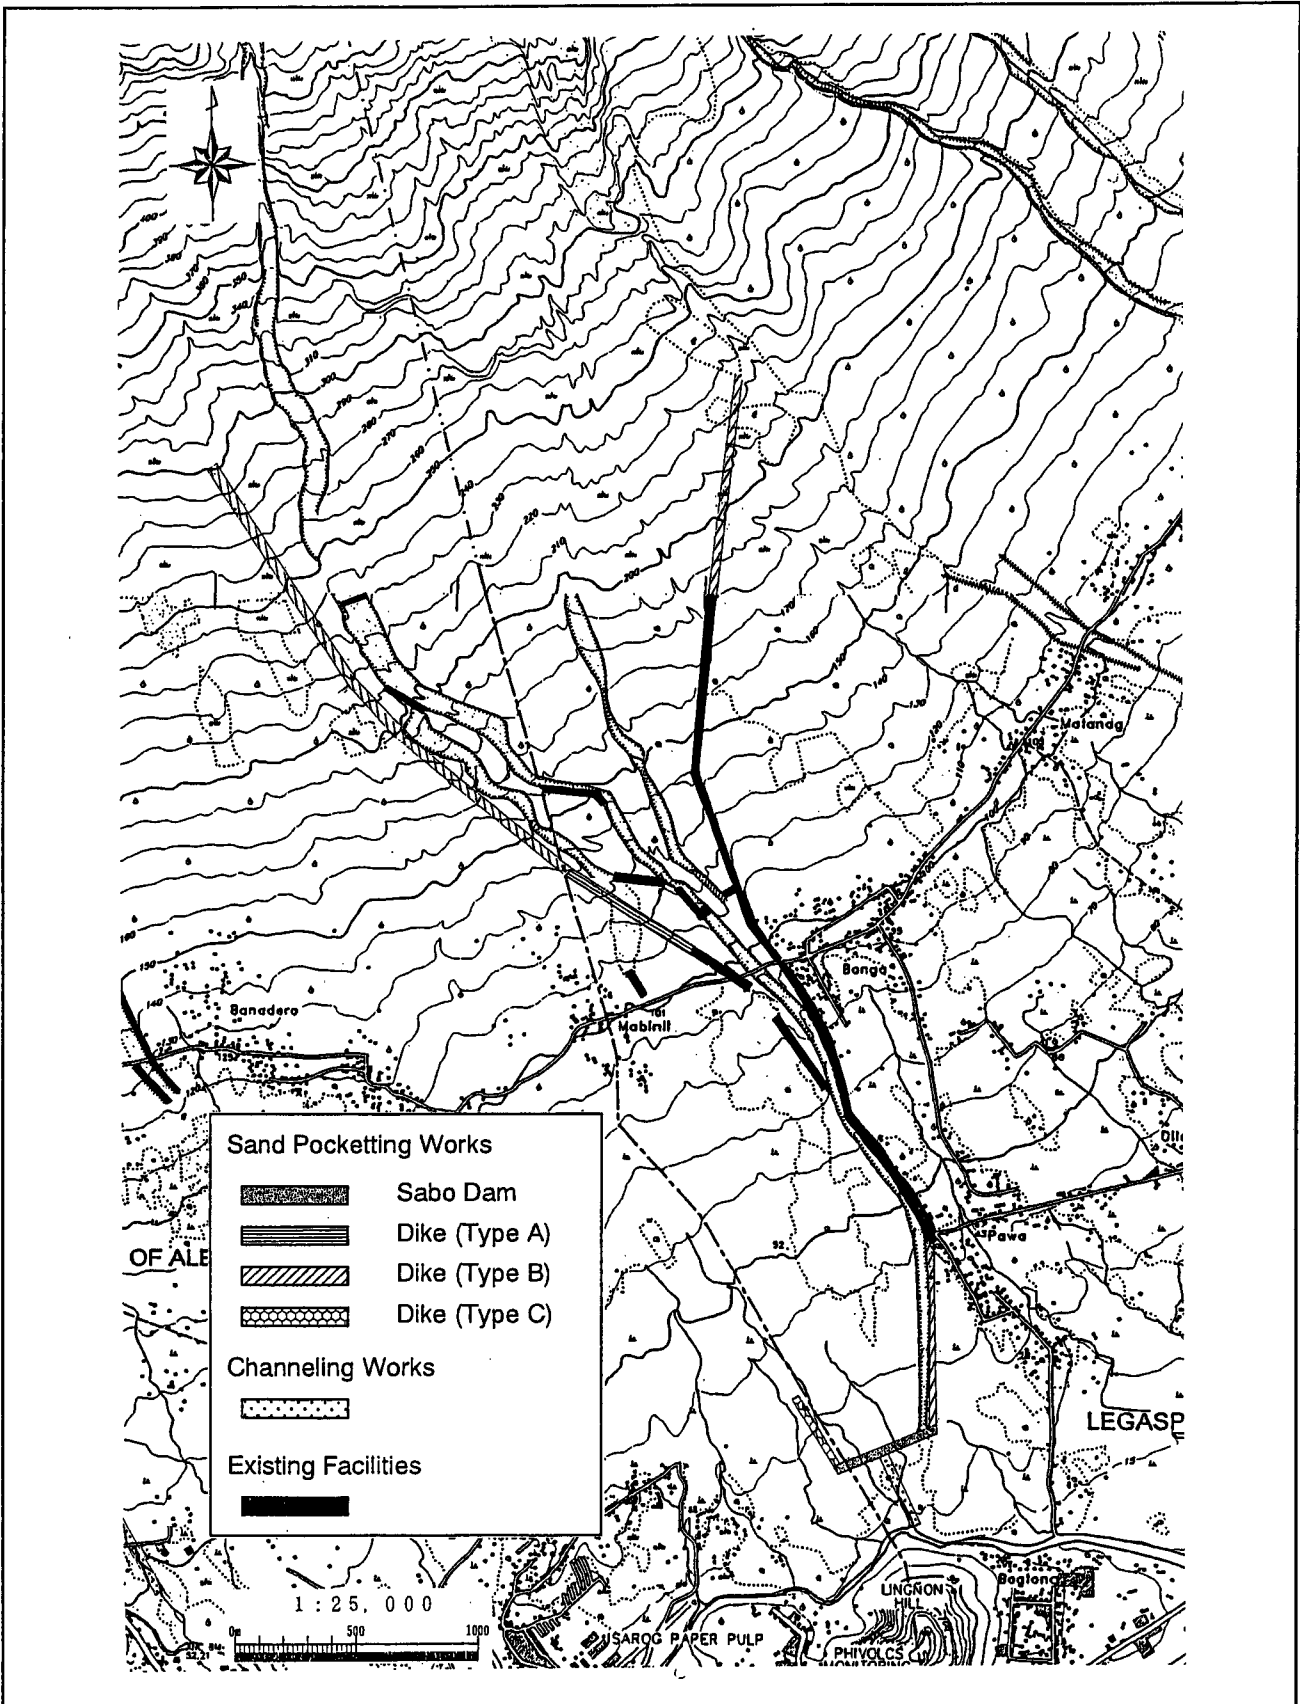
**Figure XV 3.3**

**Layout Plan of Sabo Facilities in the  
Pawa-Burabod River**

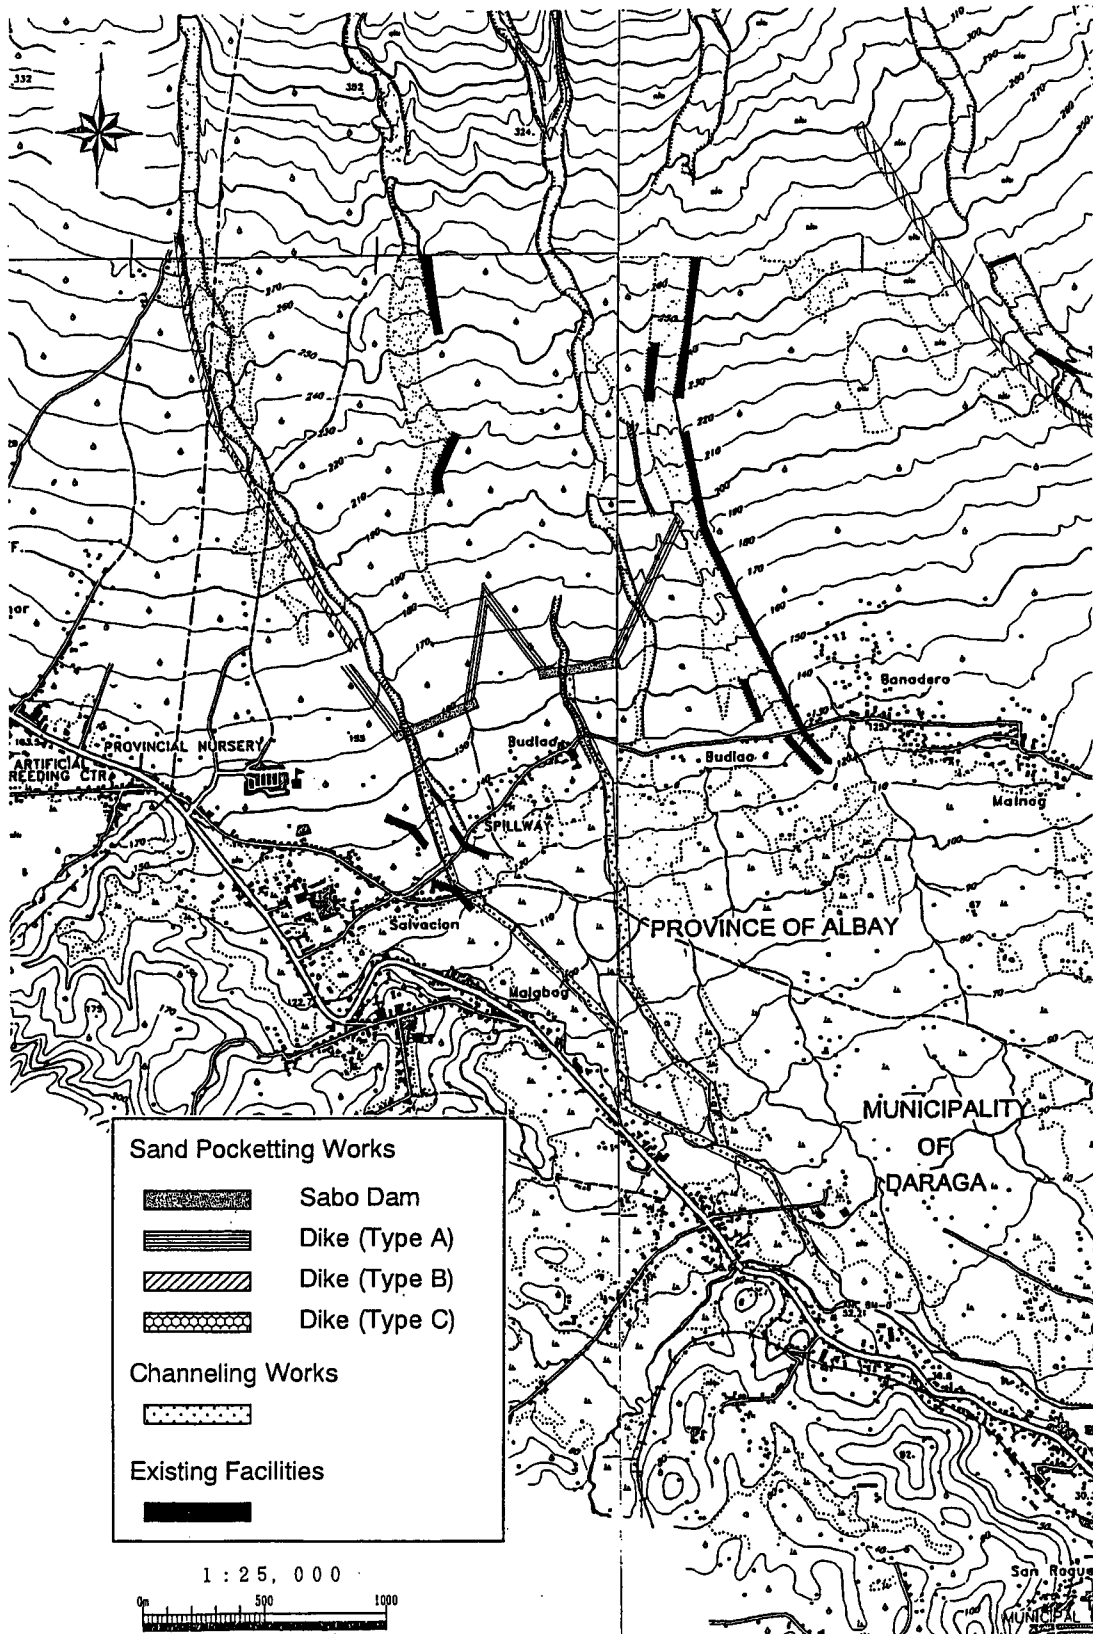
Figure XV 3.4

Layout Plan of Sabo Facilities in the Anoling  
River and the Budiao River

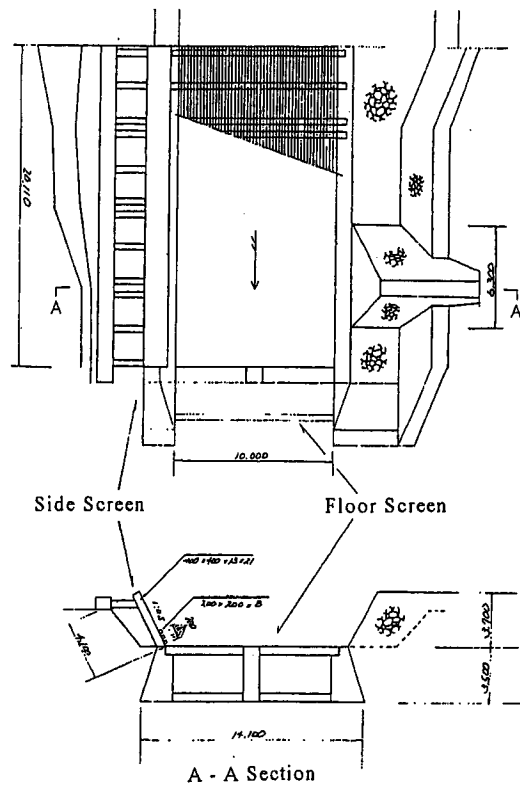
Screen Dam Design

Figure XV 4.1  
Screen Dam Design in Japan

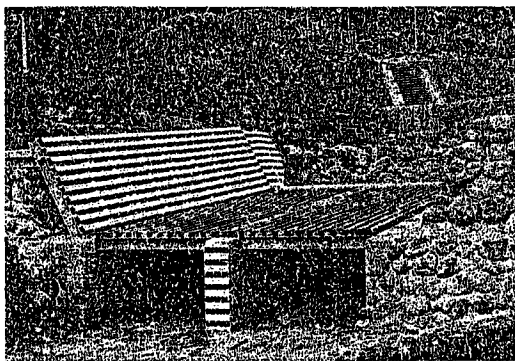
Screen Dam

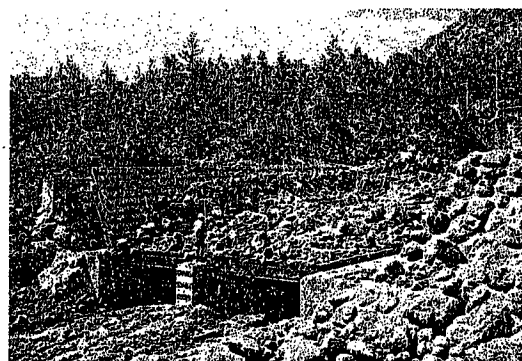
Trapped Debris Materials on Screen
