DRAFT
TENDER DOCUMENTS FOR CONSTRUCTION
OF
HISTORIC OLD SALT DEVELOPMENT SUB-PROJECT
THE TOURISM SECTOR DEVELOPMENT PROJECT

VOLUME IV
DRAWINGS

(2) NEW HISTORIC OLD SALT MUSEUM

Historic House Museum Of
Abu Jaber
Drawing Title:
Existing Condition
Site Plan

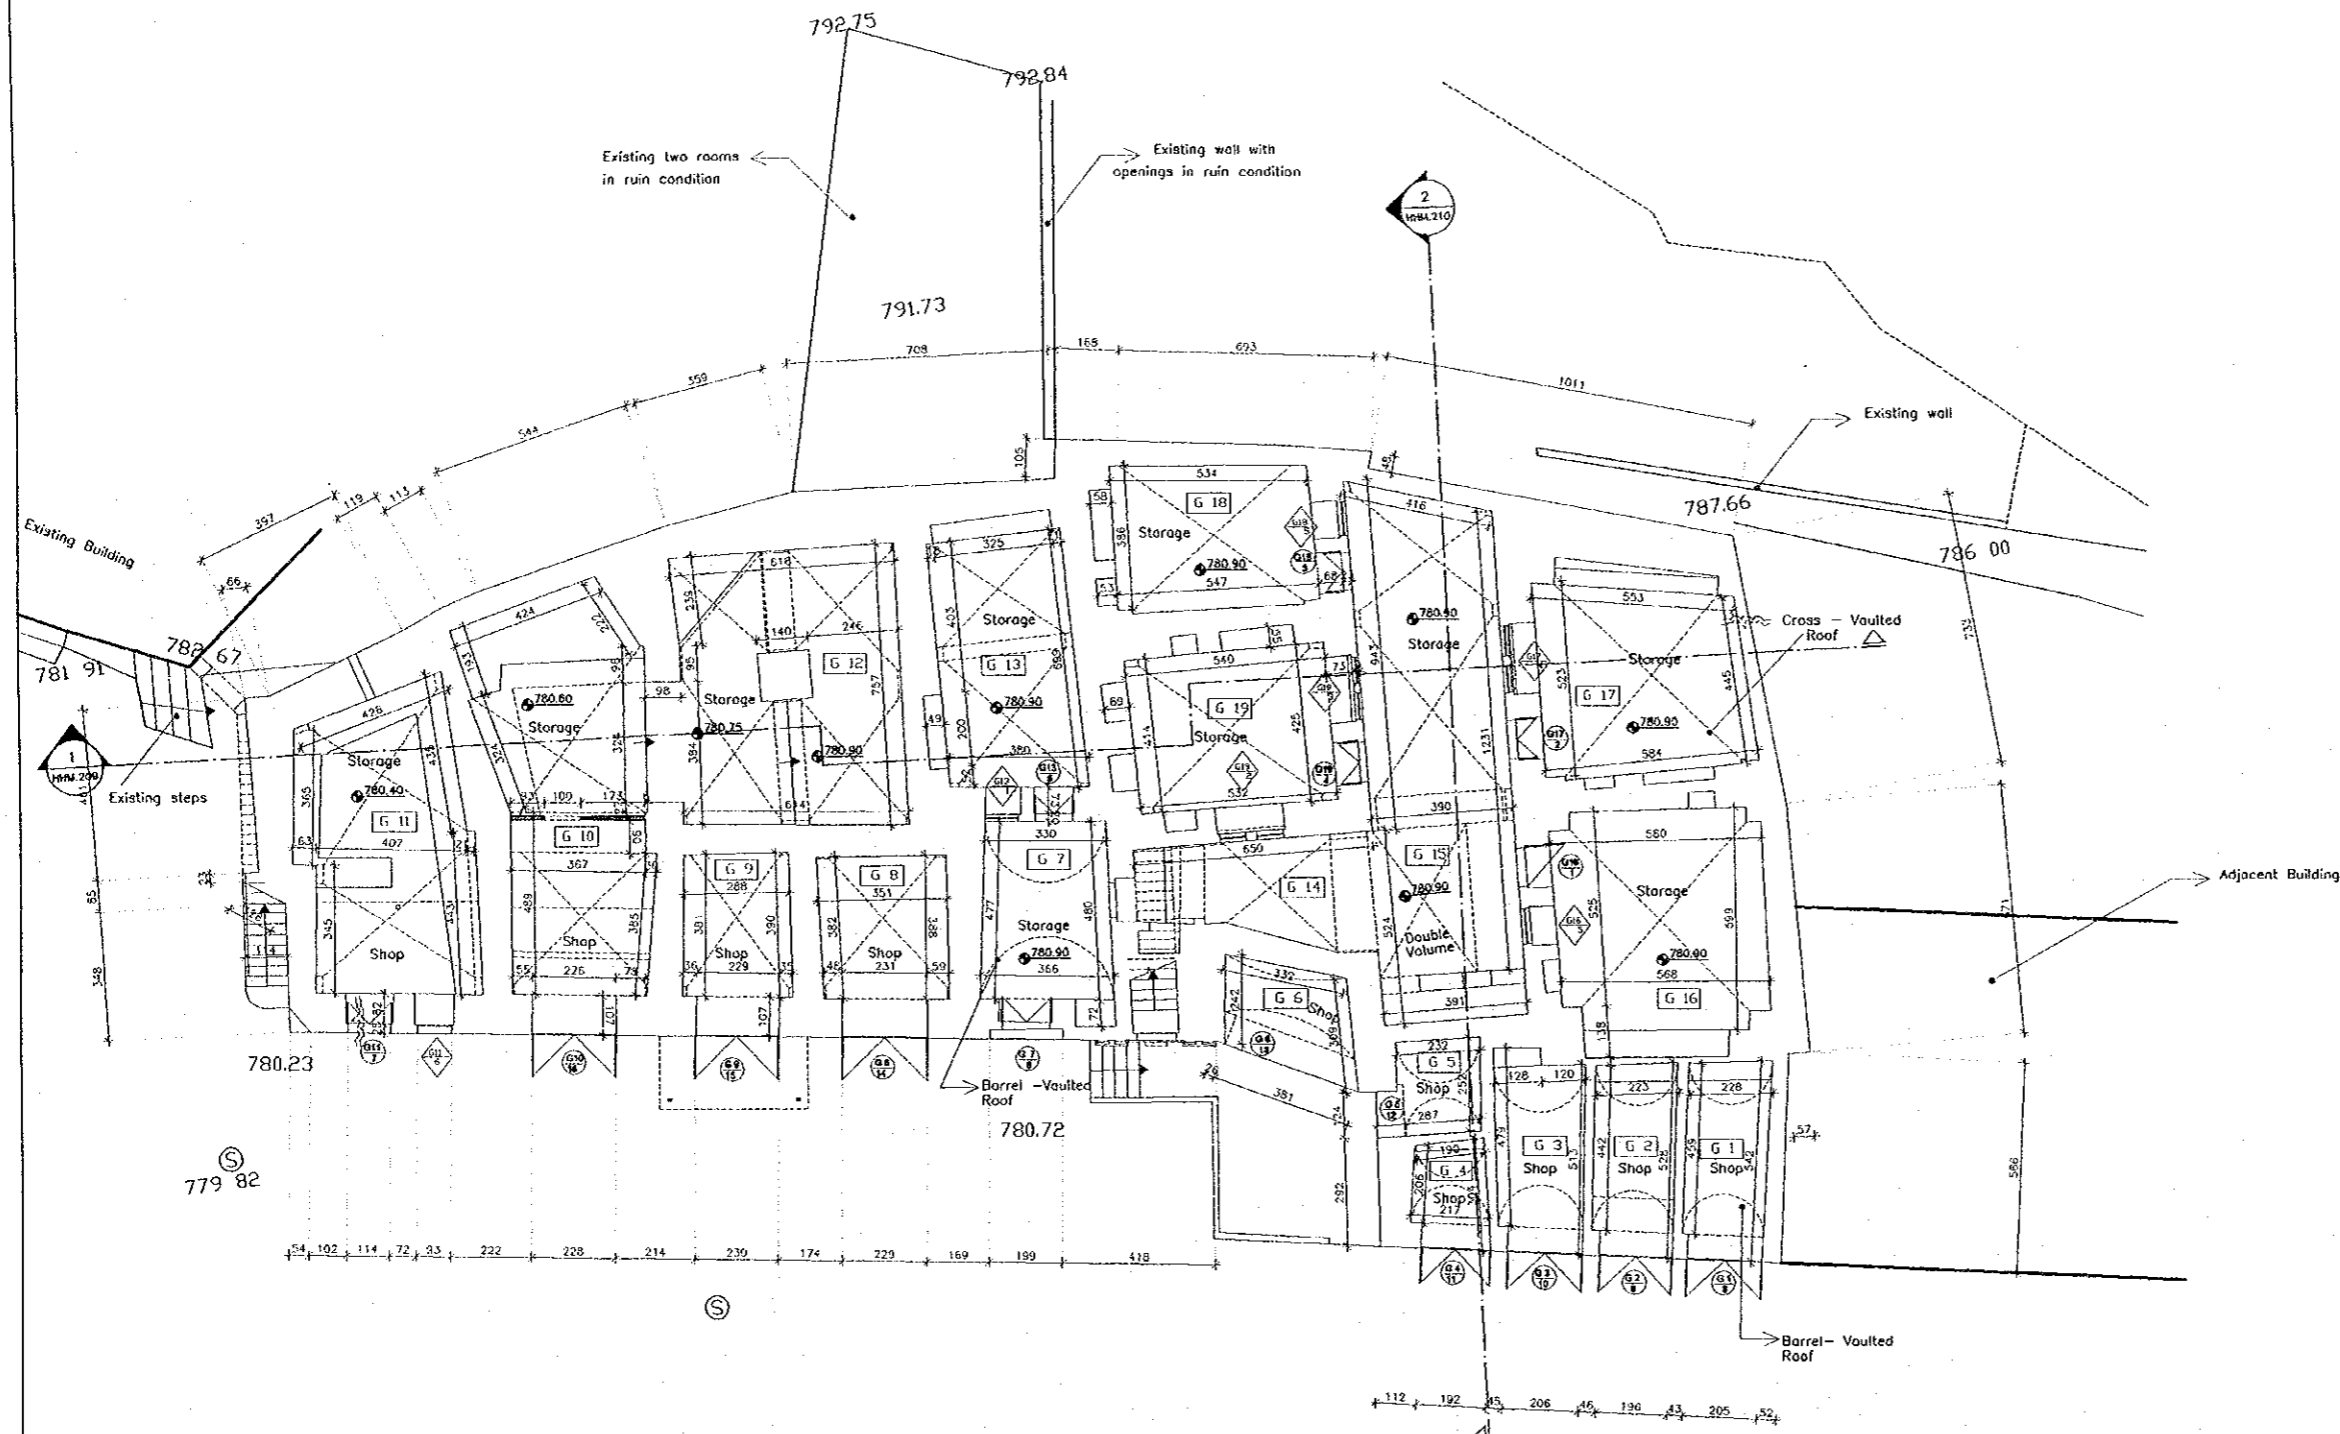
Scale:
1:100
Drawing No.:
HHM.A-102

Drawing Title:
Existing Condition
Ground Floor Plan

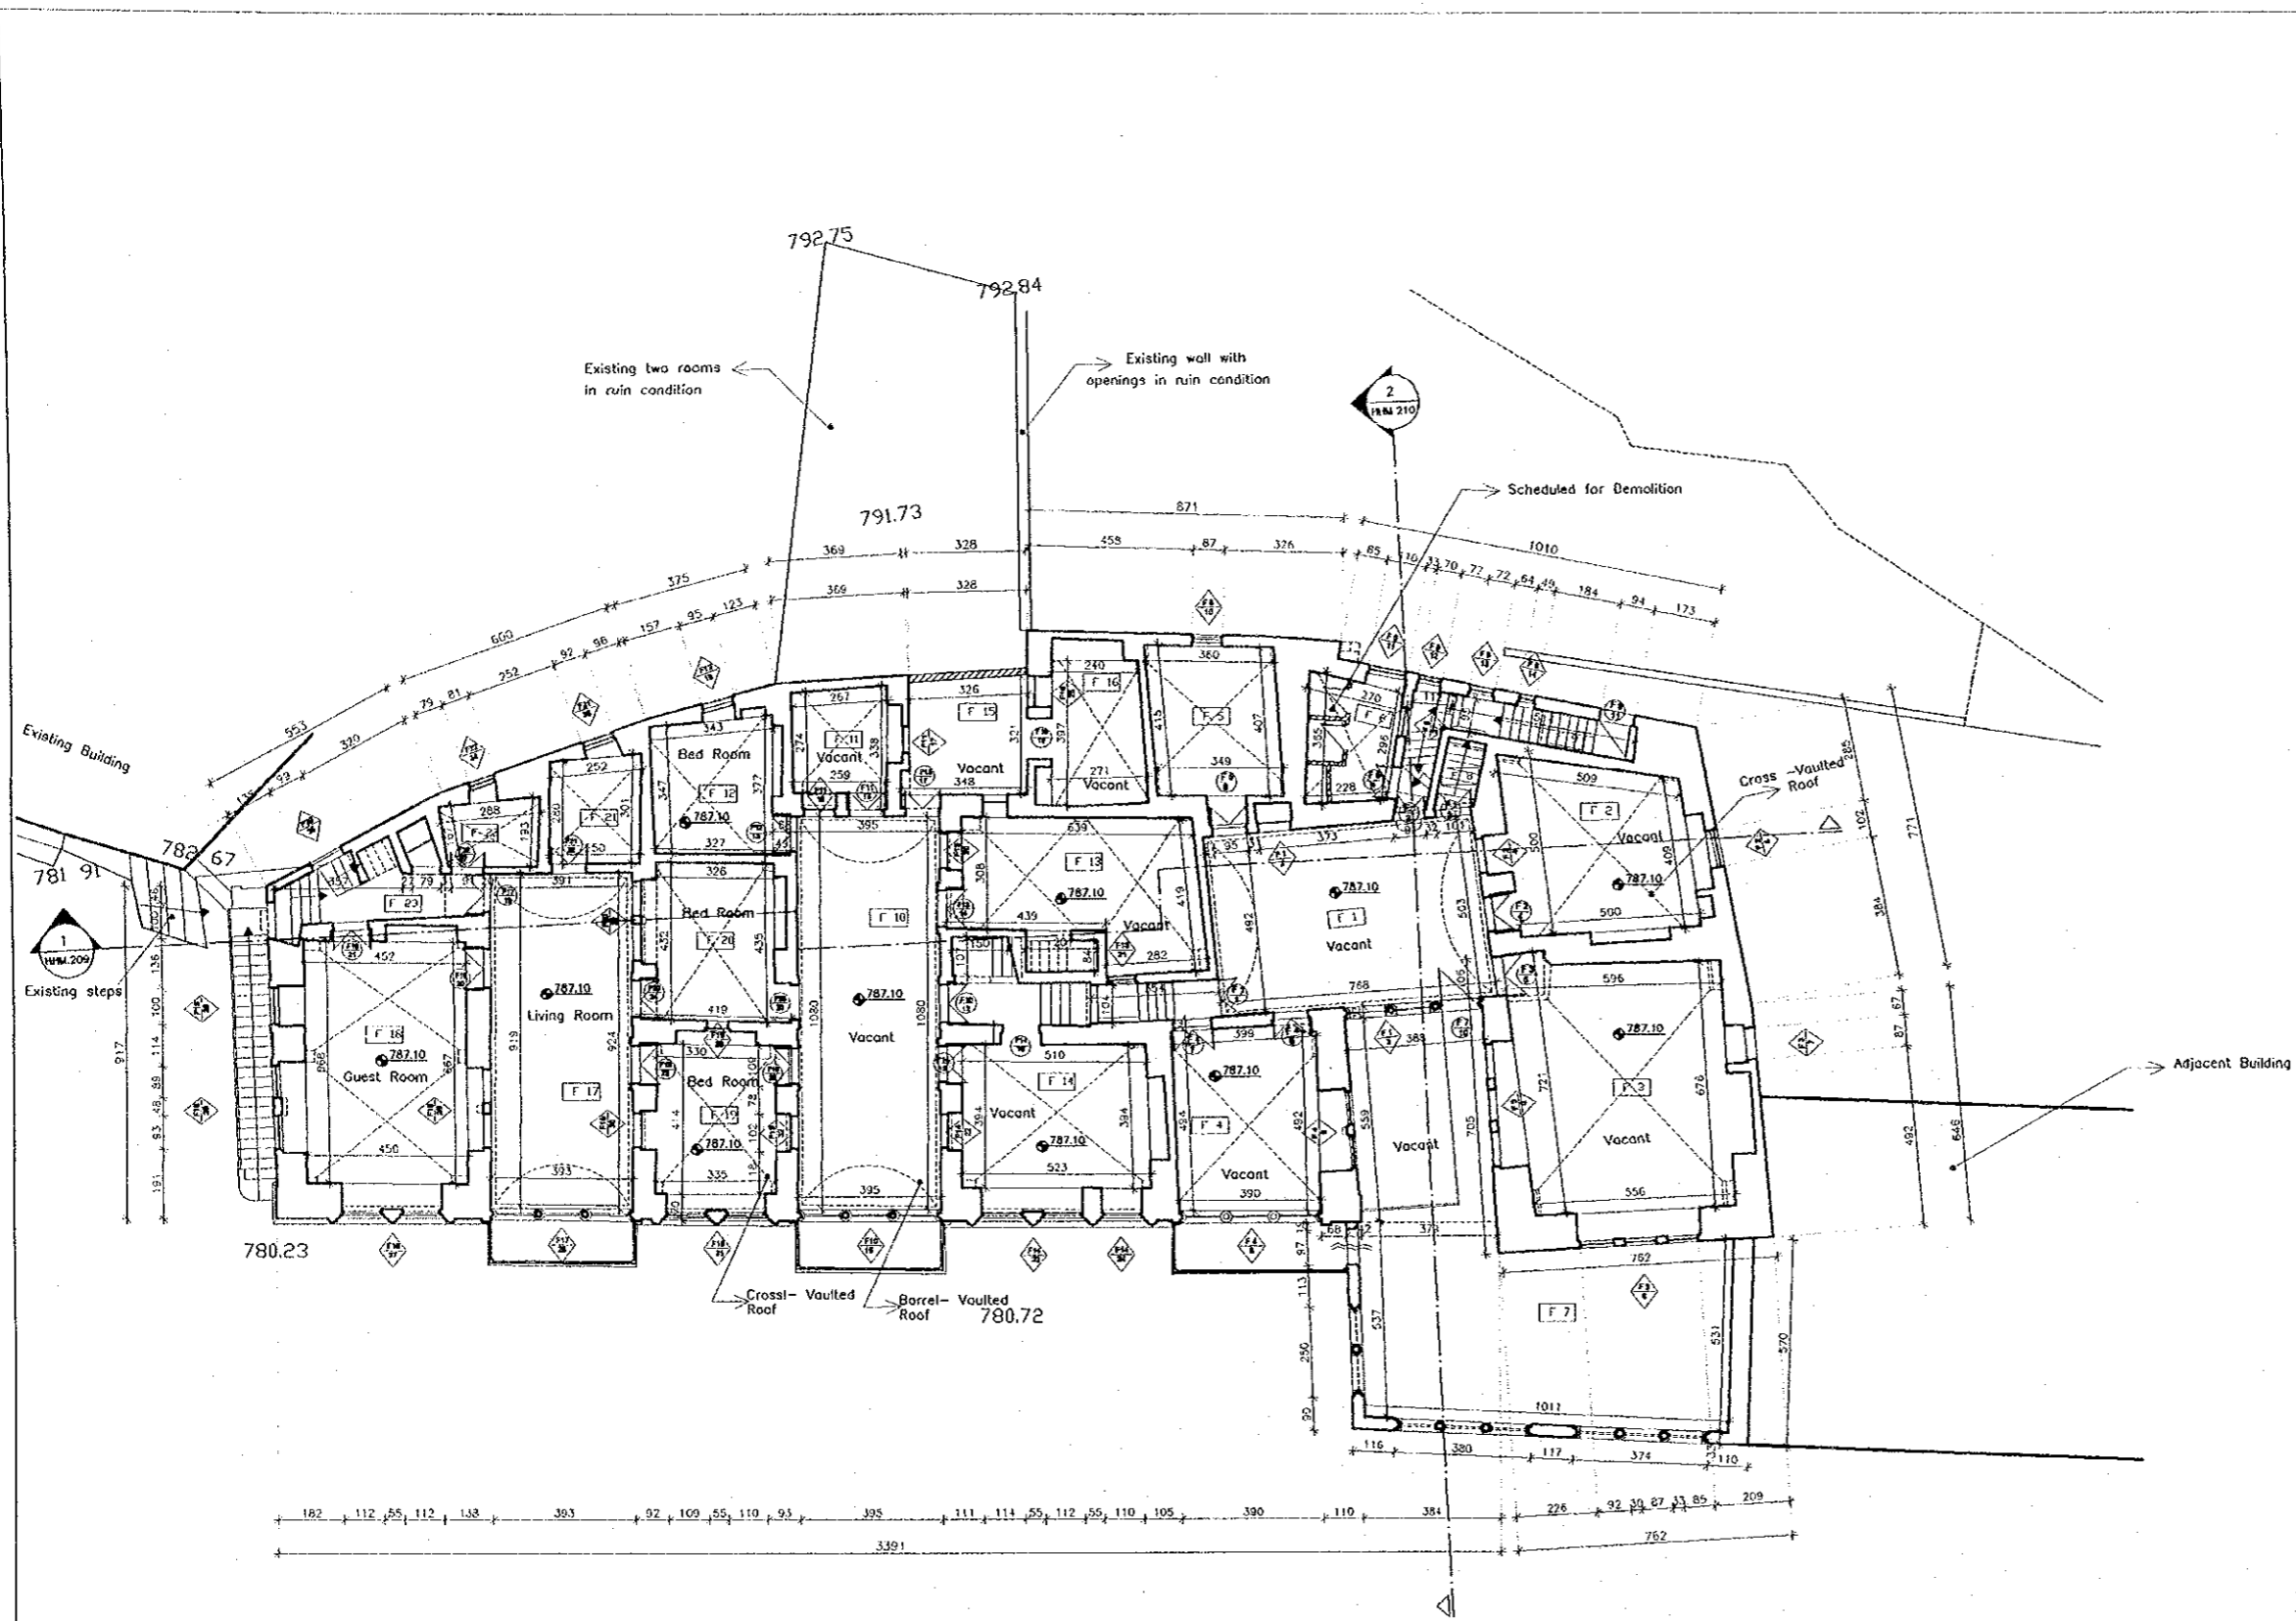
Scale:
1:100
Drawing No.:
HHM.A-103

Historic House Musuem Of
Abu Jaber
Drawing Title:
Existing Condition
First Floor Plan

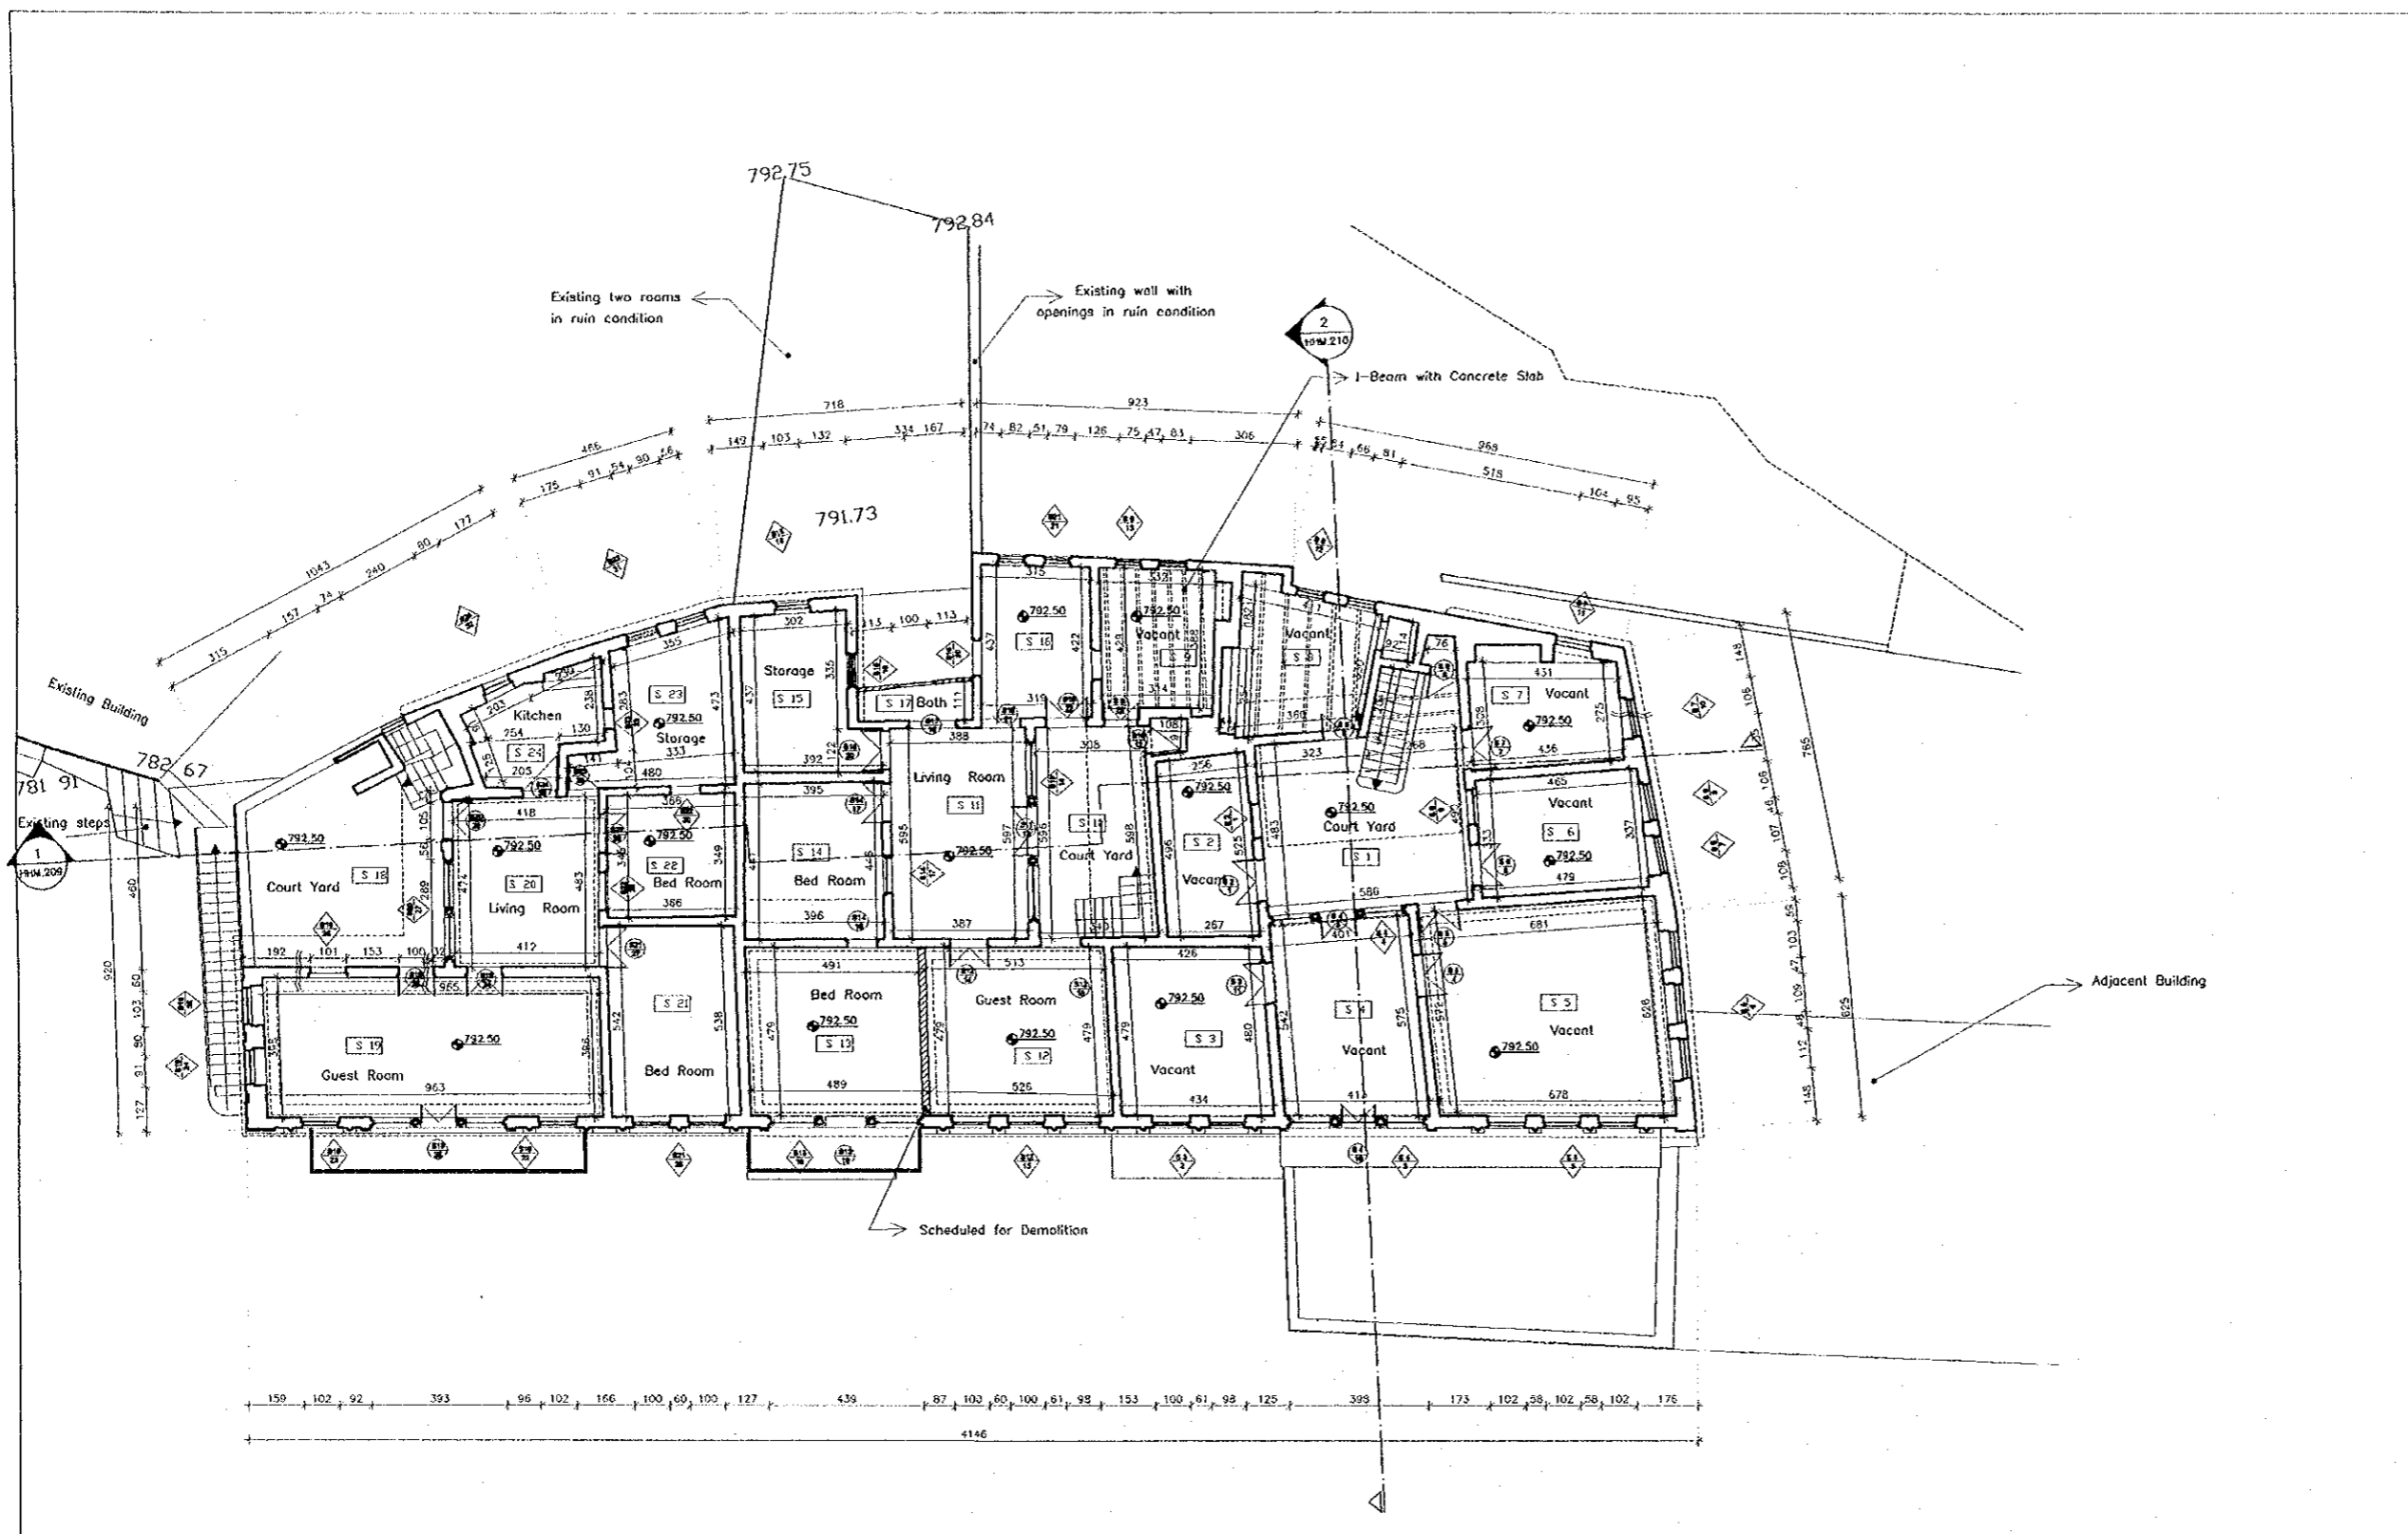
Scale: 1:100
Drawing No.: HHM.A-104

Historic House Museum Of
Abu Jaber
Drawing Title:
Existing Condition
Second Floor Plan

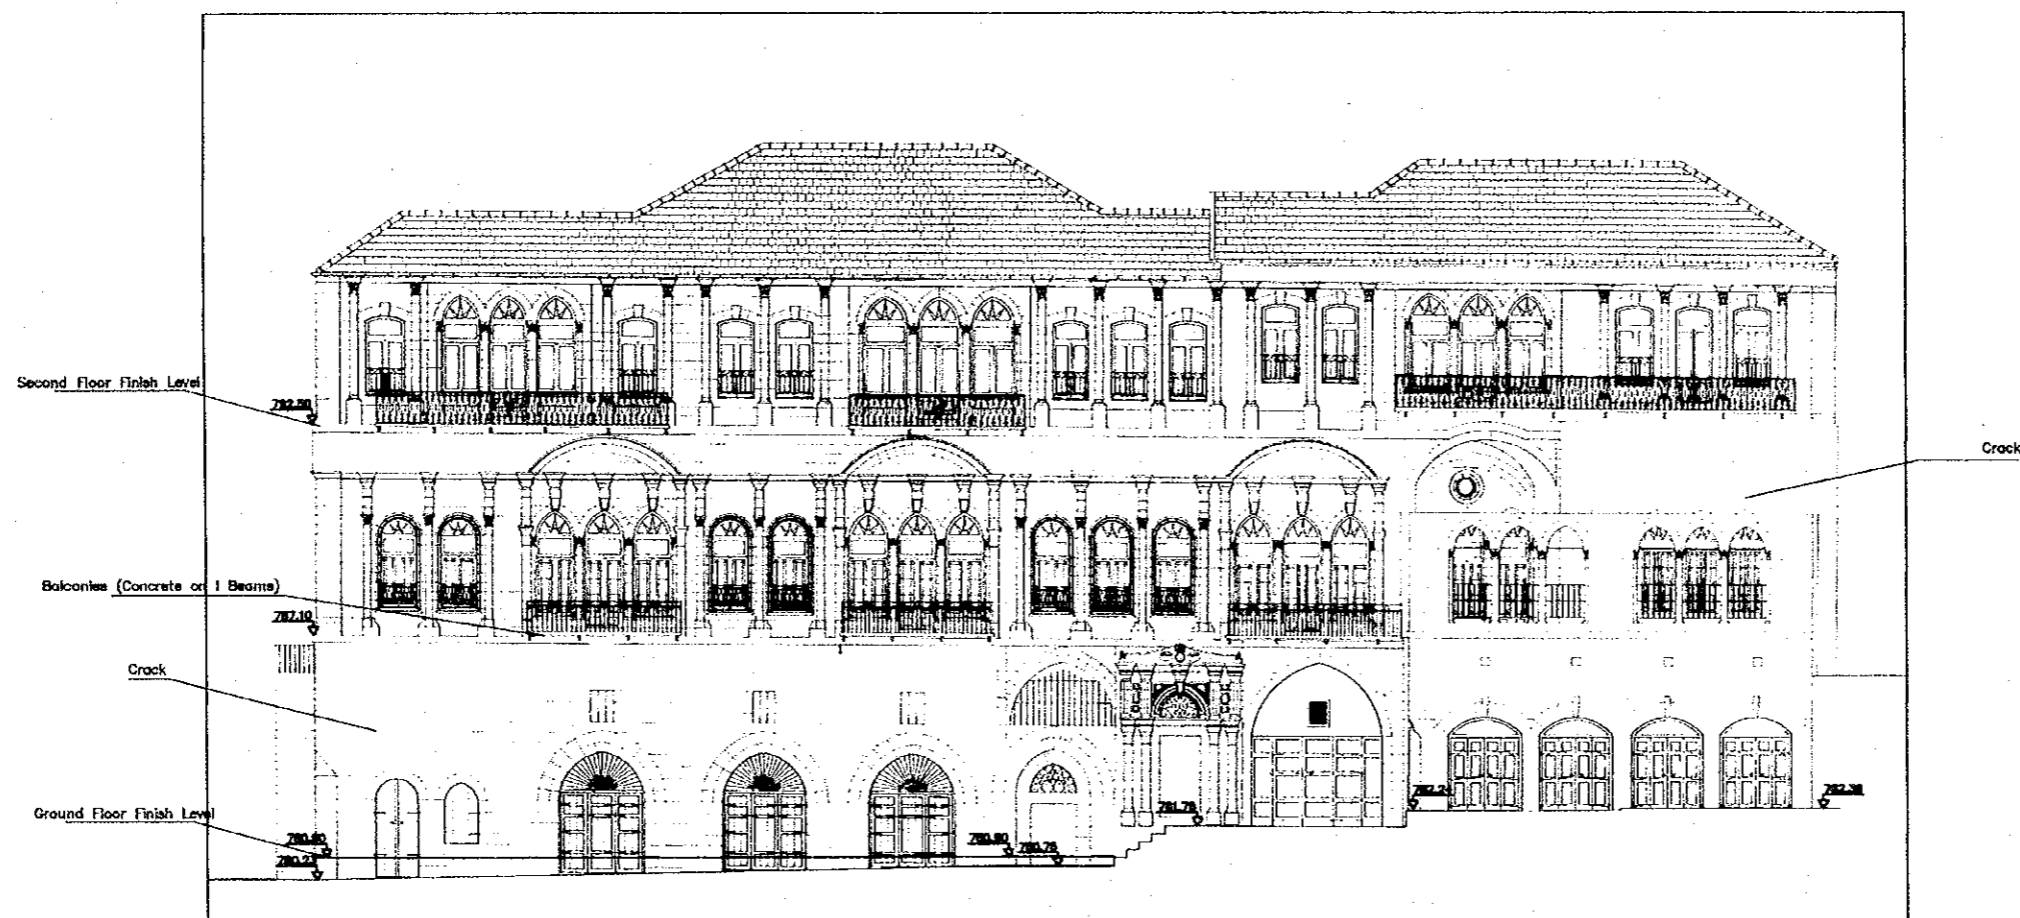
Historic House Museum Of
Abu Jaber
Drawing Title:
Existing Condition
North Elevation

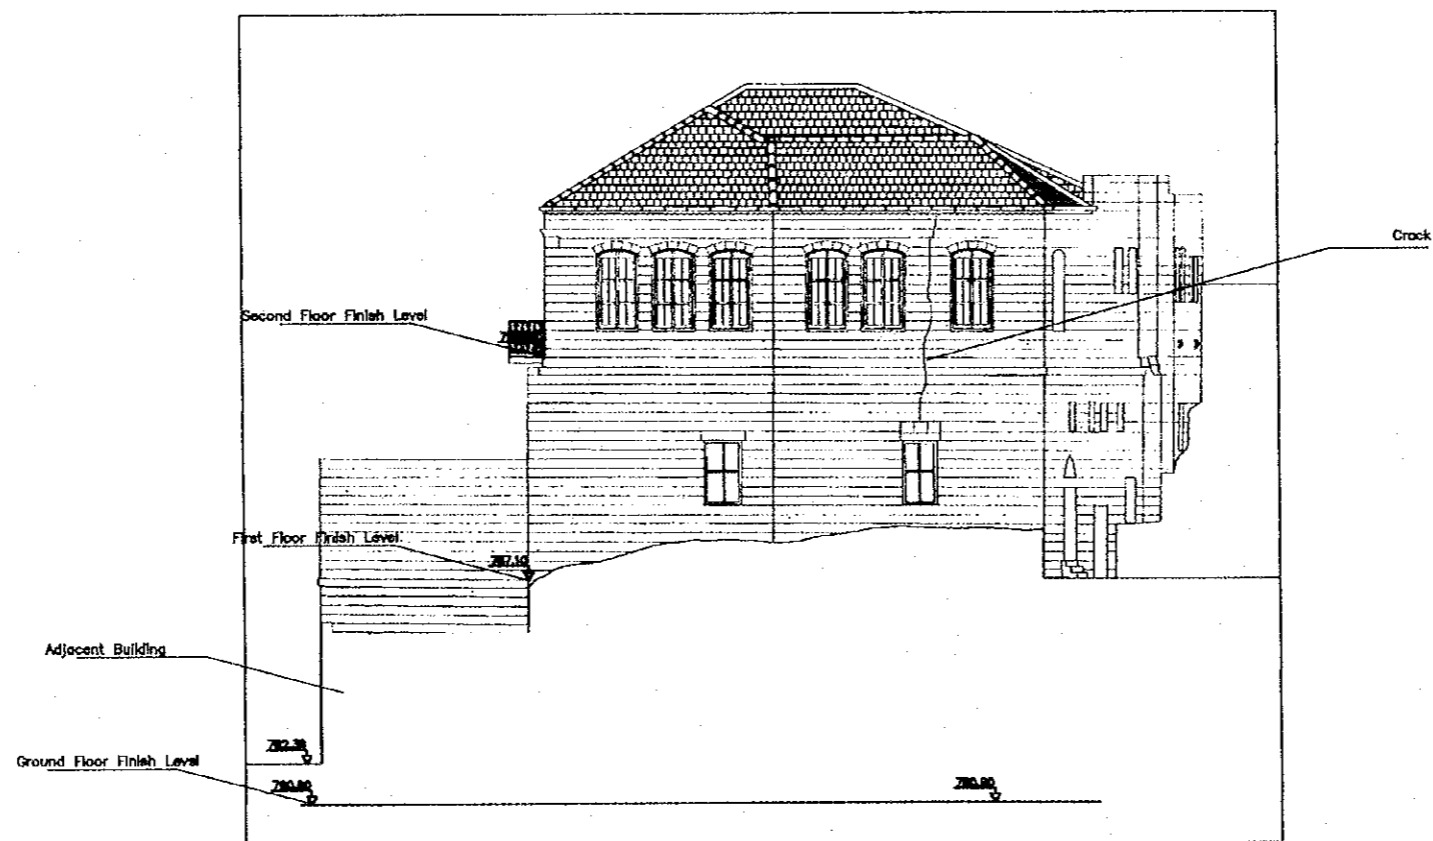
Drawing Title:
Existing Condition
West Elevation

- Windows in the Side Elevation (West Elevation)
 - The wooden shutters in the windows in the West Elevation need to be repaired when needed.
- Windows in South Elevation:

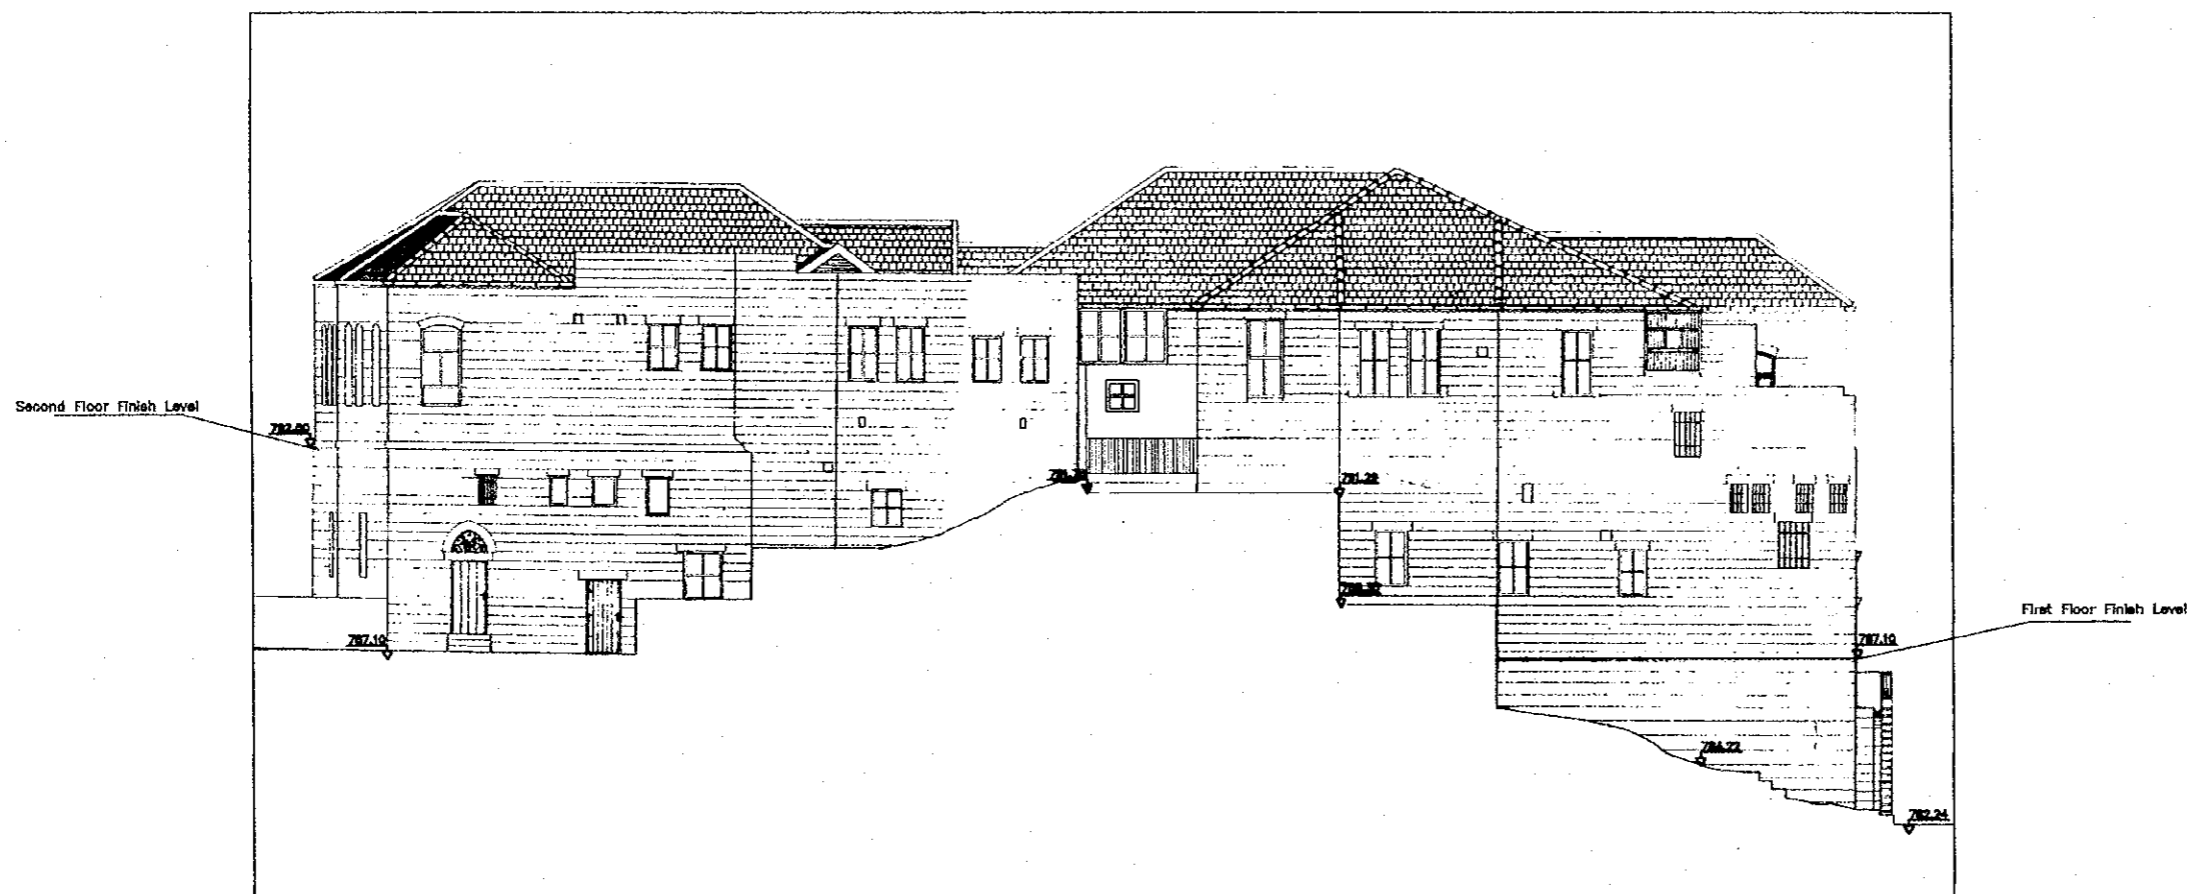
Drawing title:
Existing Condition
South Elevation

- Wooden frames need to be added to windows in the South Elevation sustaining and repairing existing simple ironwork.
- Small Square Windows Above main Shop Doors (Front Elevation) or in South Elevation:

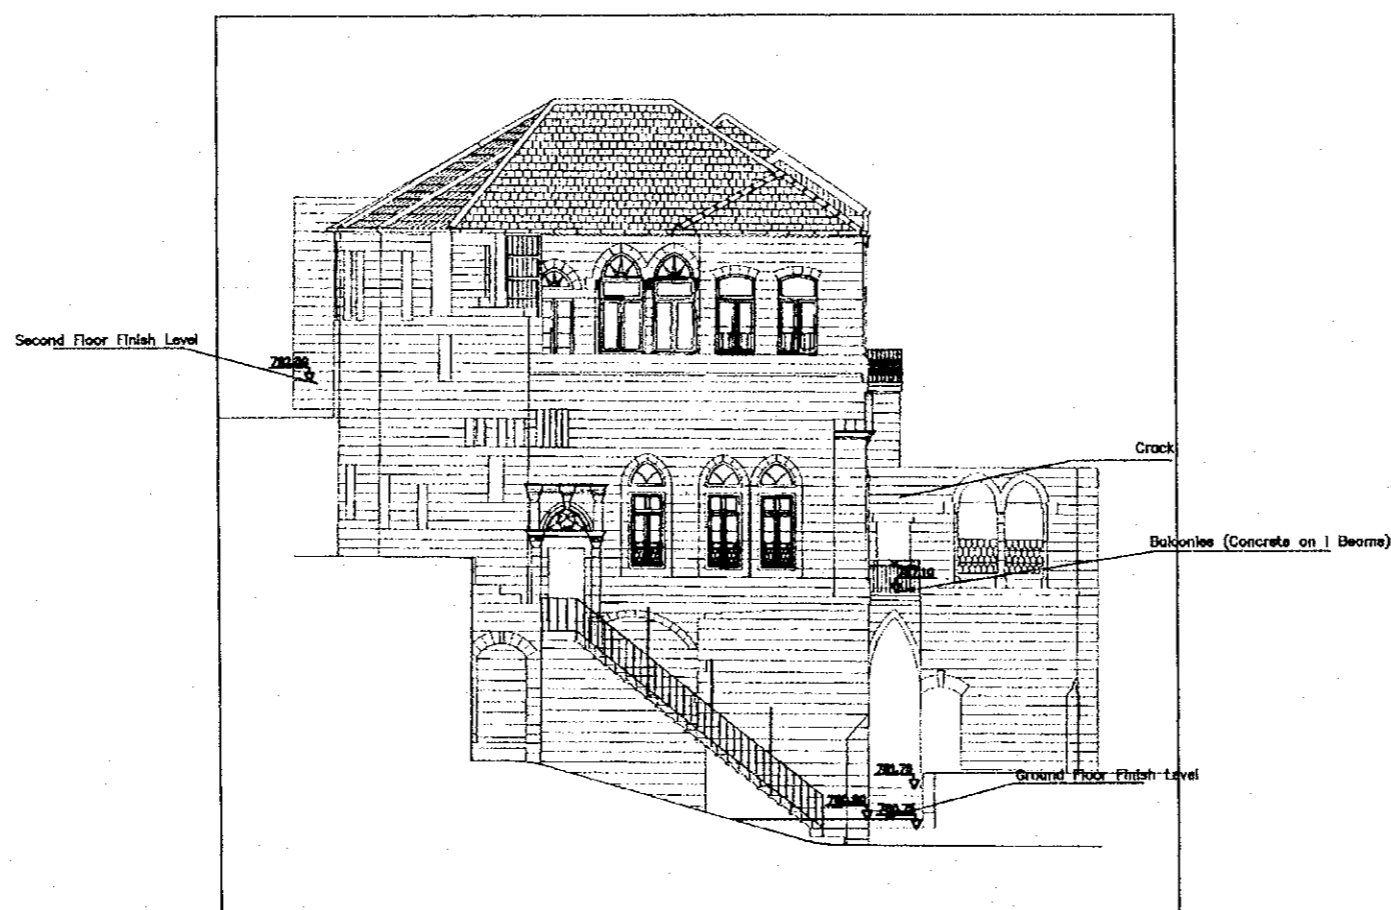
Historic House Museum Of
Abu Jaber
Drawing Title:
Existing Condition
East Elevation

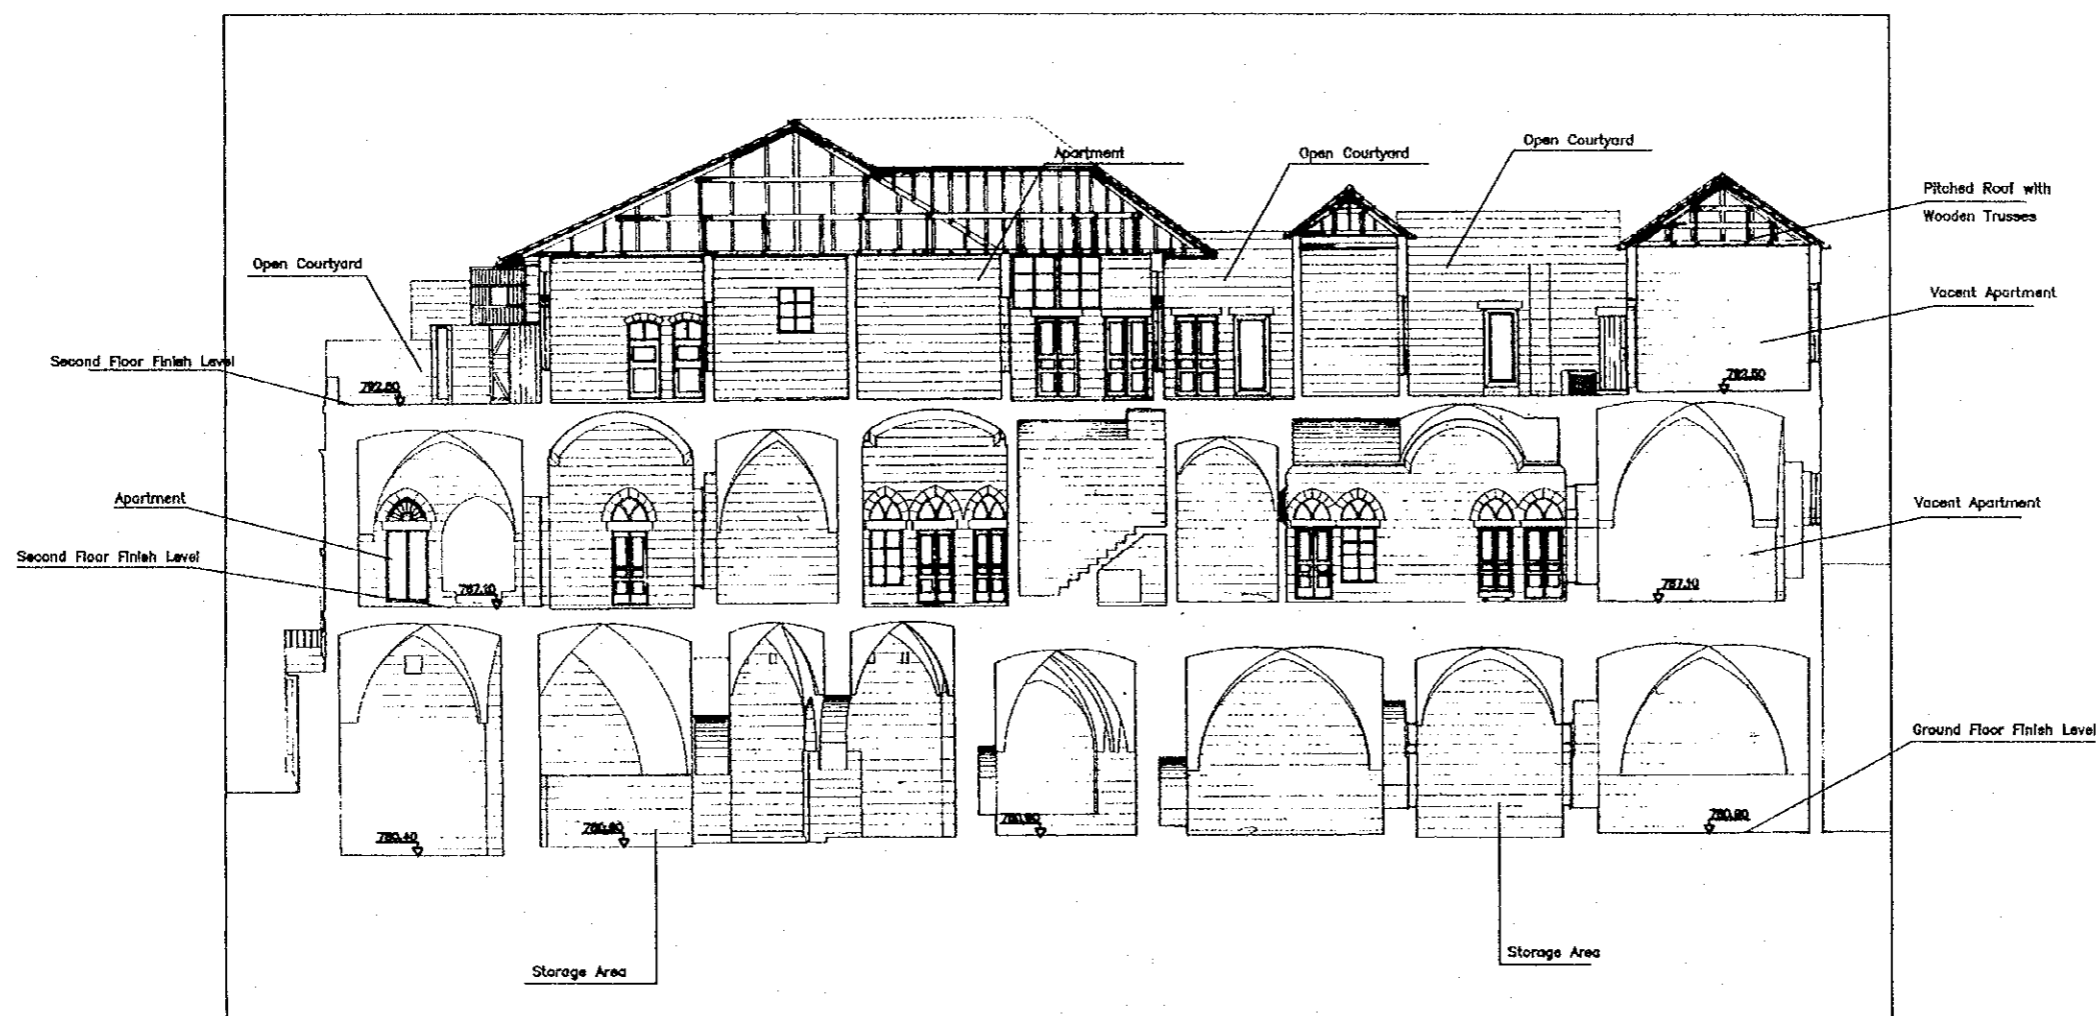
Historic House Museum Of
Abu Jaber
Drawing Title:
Existing Condition
Section 1

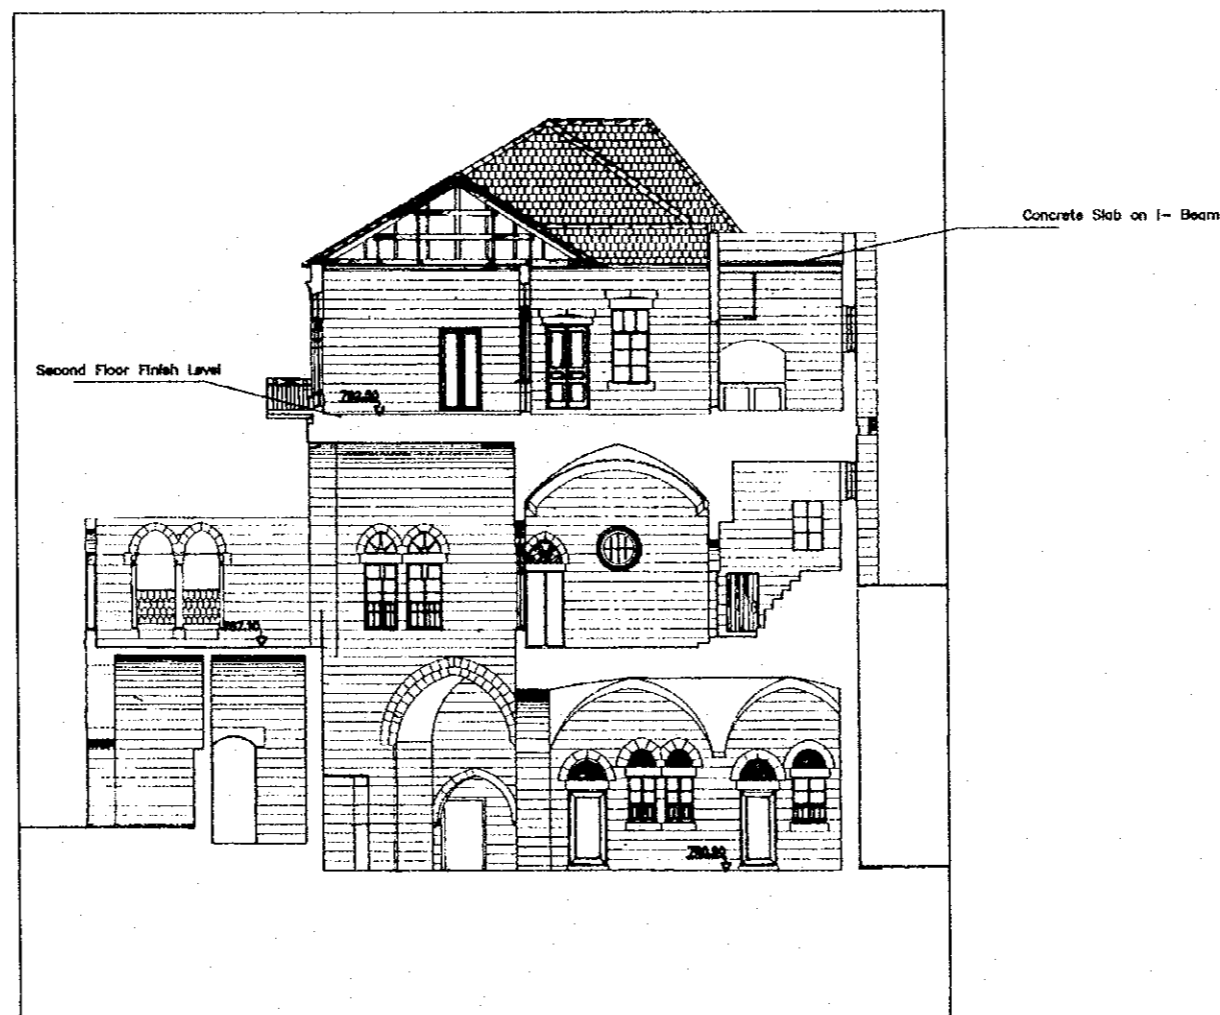
Historic House Museum Of
Abu Jaber
Drawing Title:
Existing Condition
Section 2
