DRAFT
TENDER DOCUMENTS FOR CONSTRUCTION
OF
HISTORIC OLD SALT DEVELOPMENT SUB-PROJECT
THE TOURISM SECTOR DEVELOPMENT PROJECT

VOLUME IV
DRAWINGS

(2) NEW HISTORIC OLD SALT MUSEUM

Historic House Museum Of
Abu Jaber
Drawing Title:
Existing Condition
Site Plan

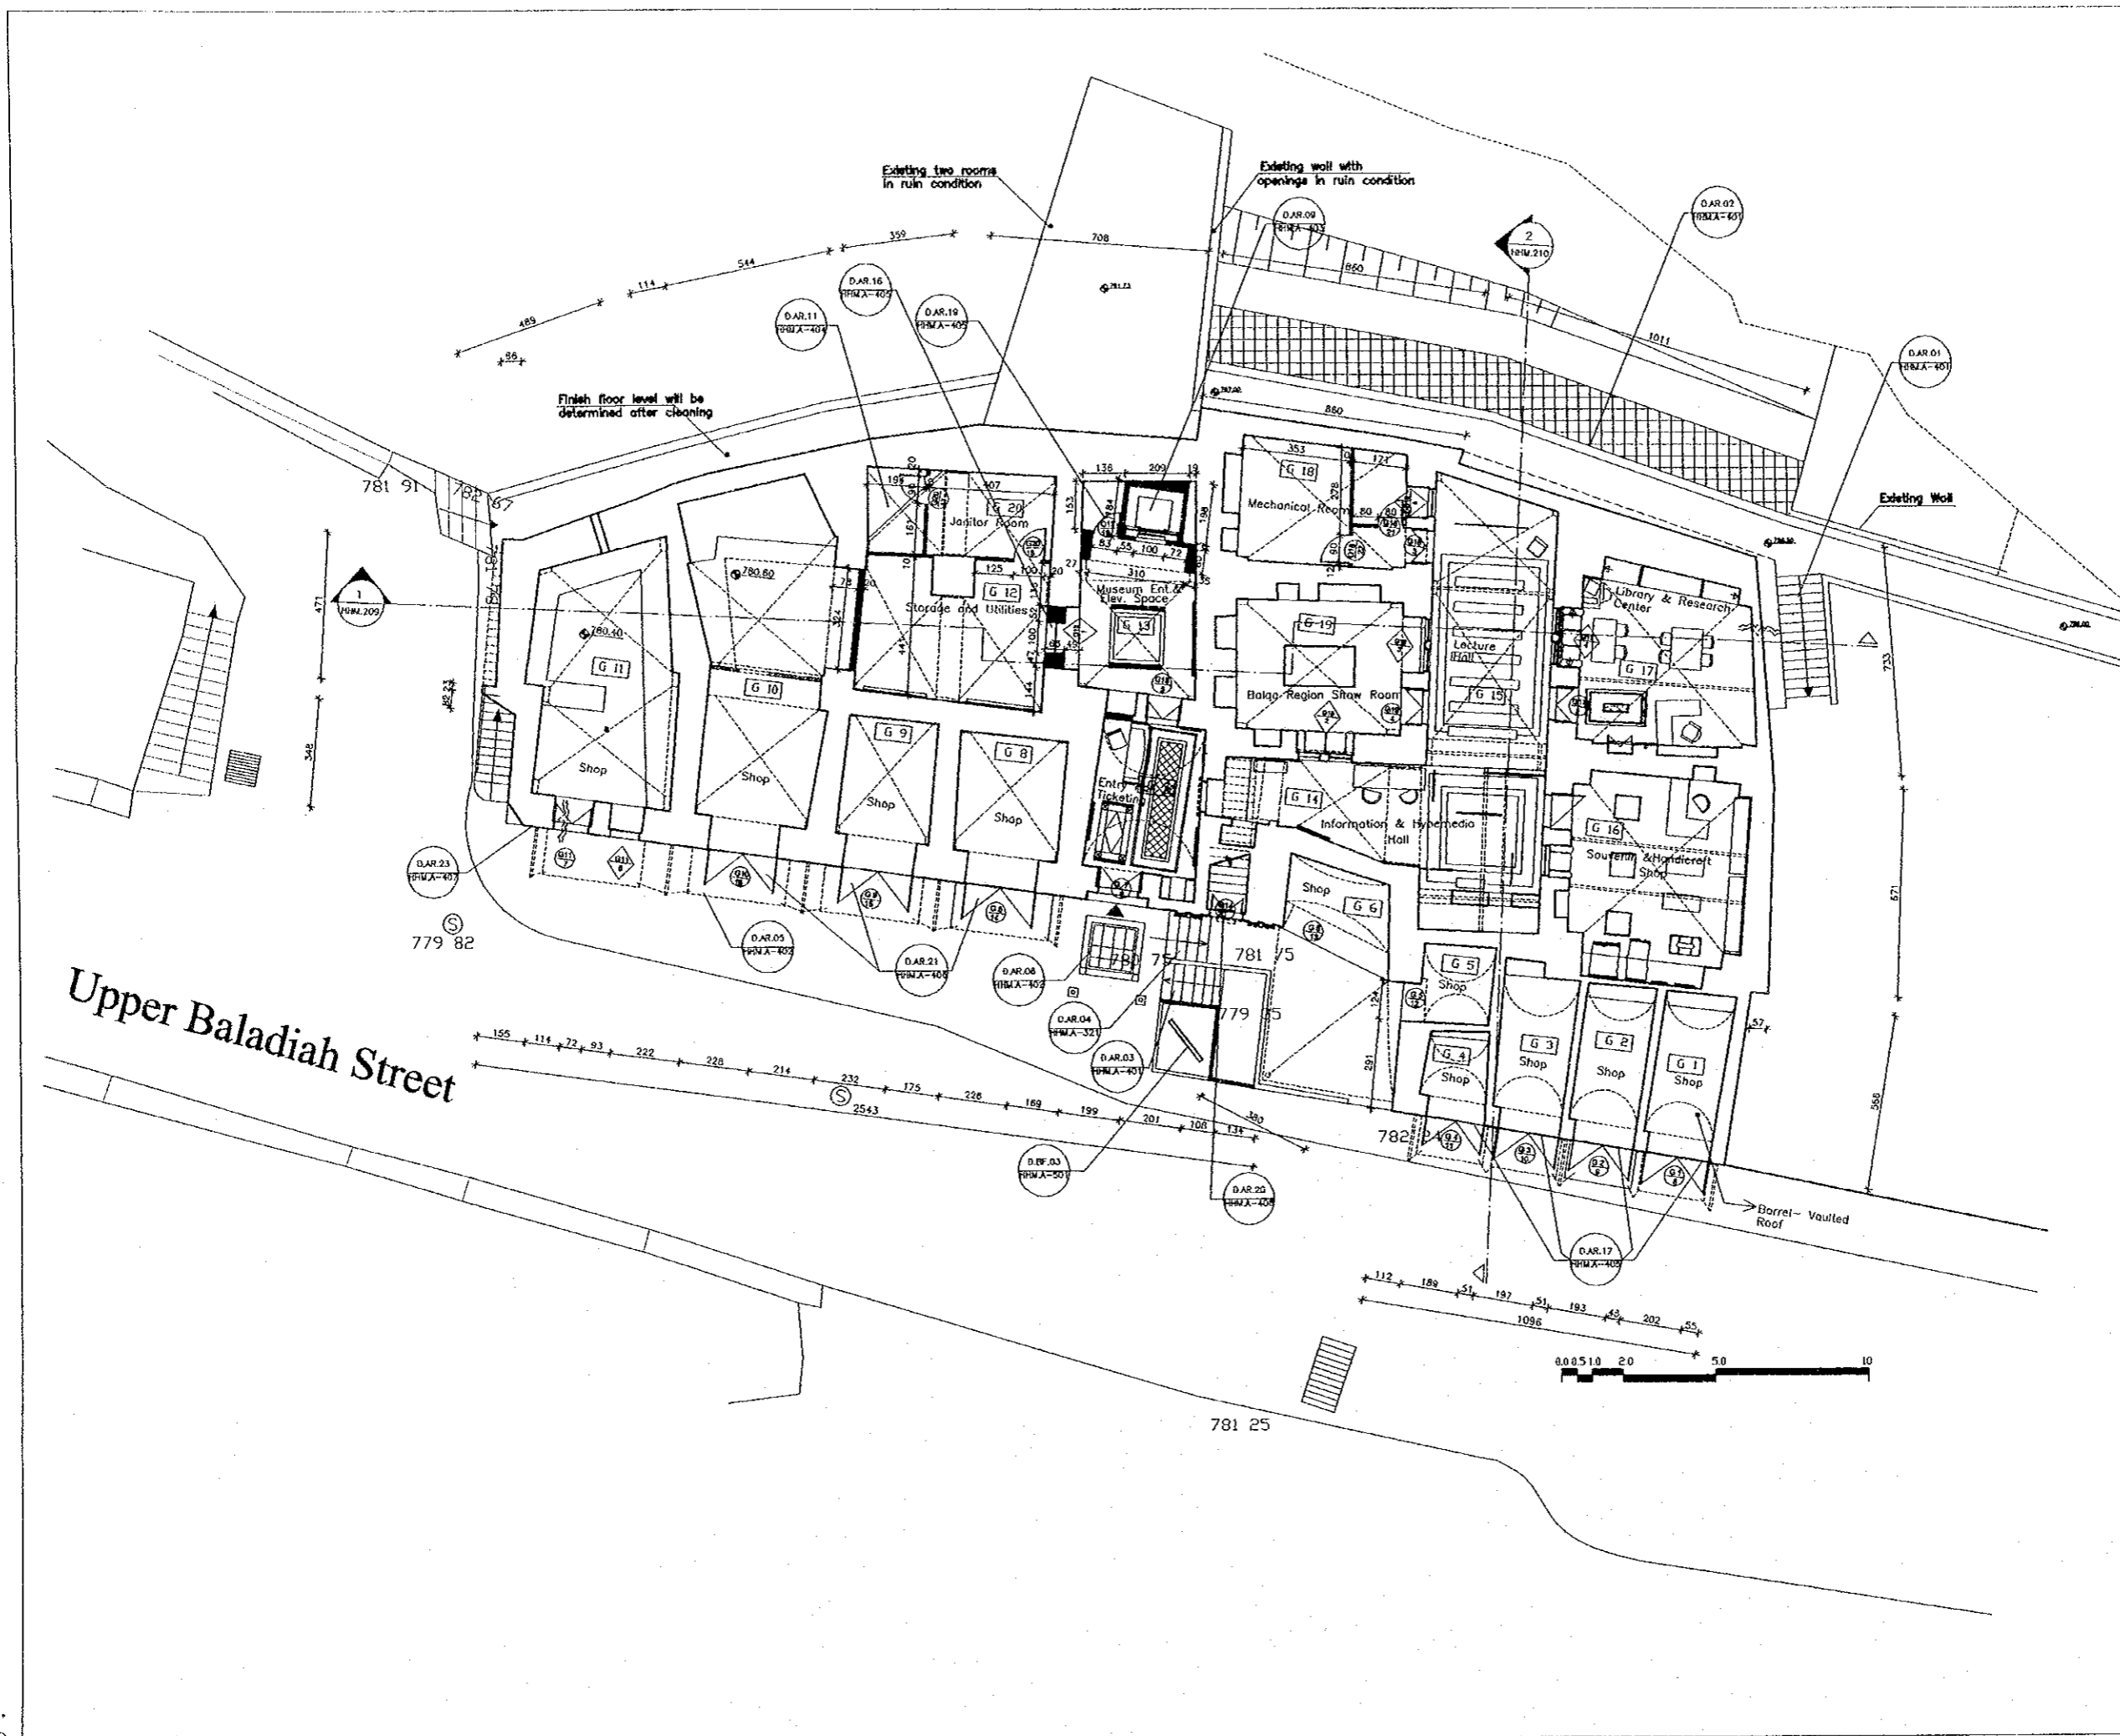
Scale: 1:100
Drawing No: HHM.A-202

Drawing Title:
Proposed Condition
Ground Floor Plan

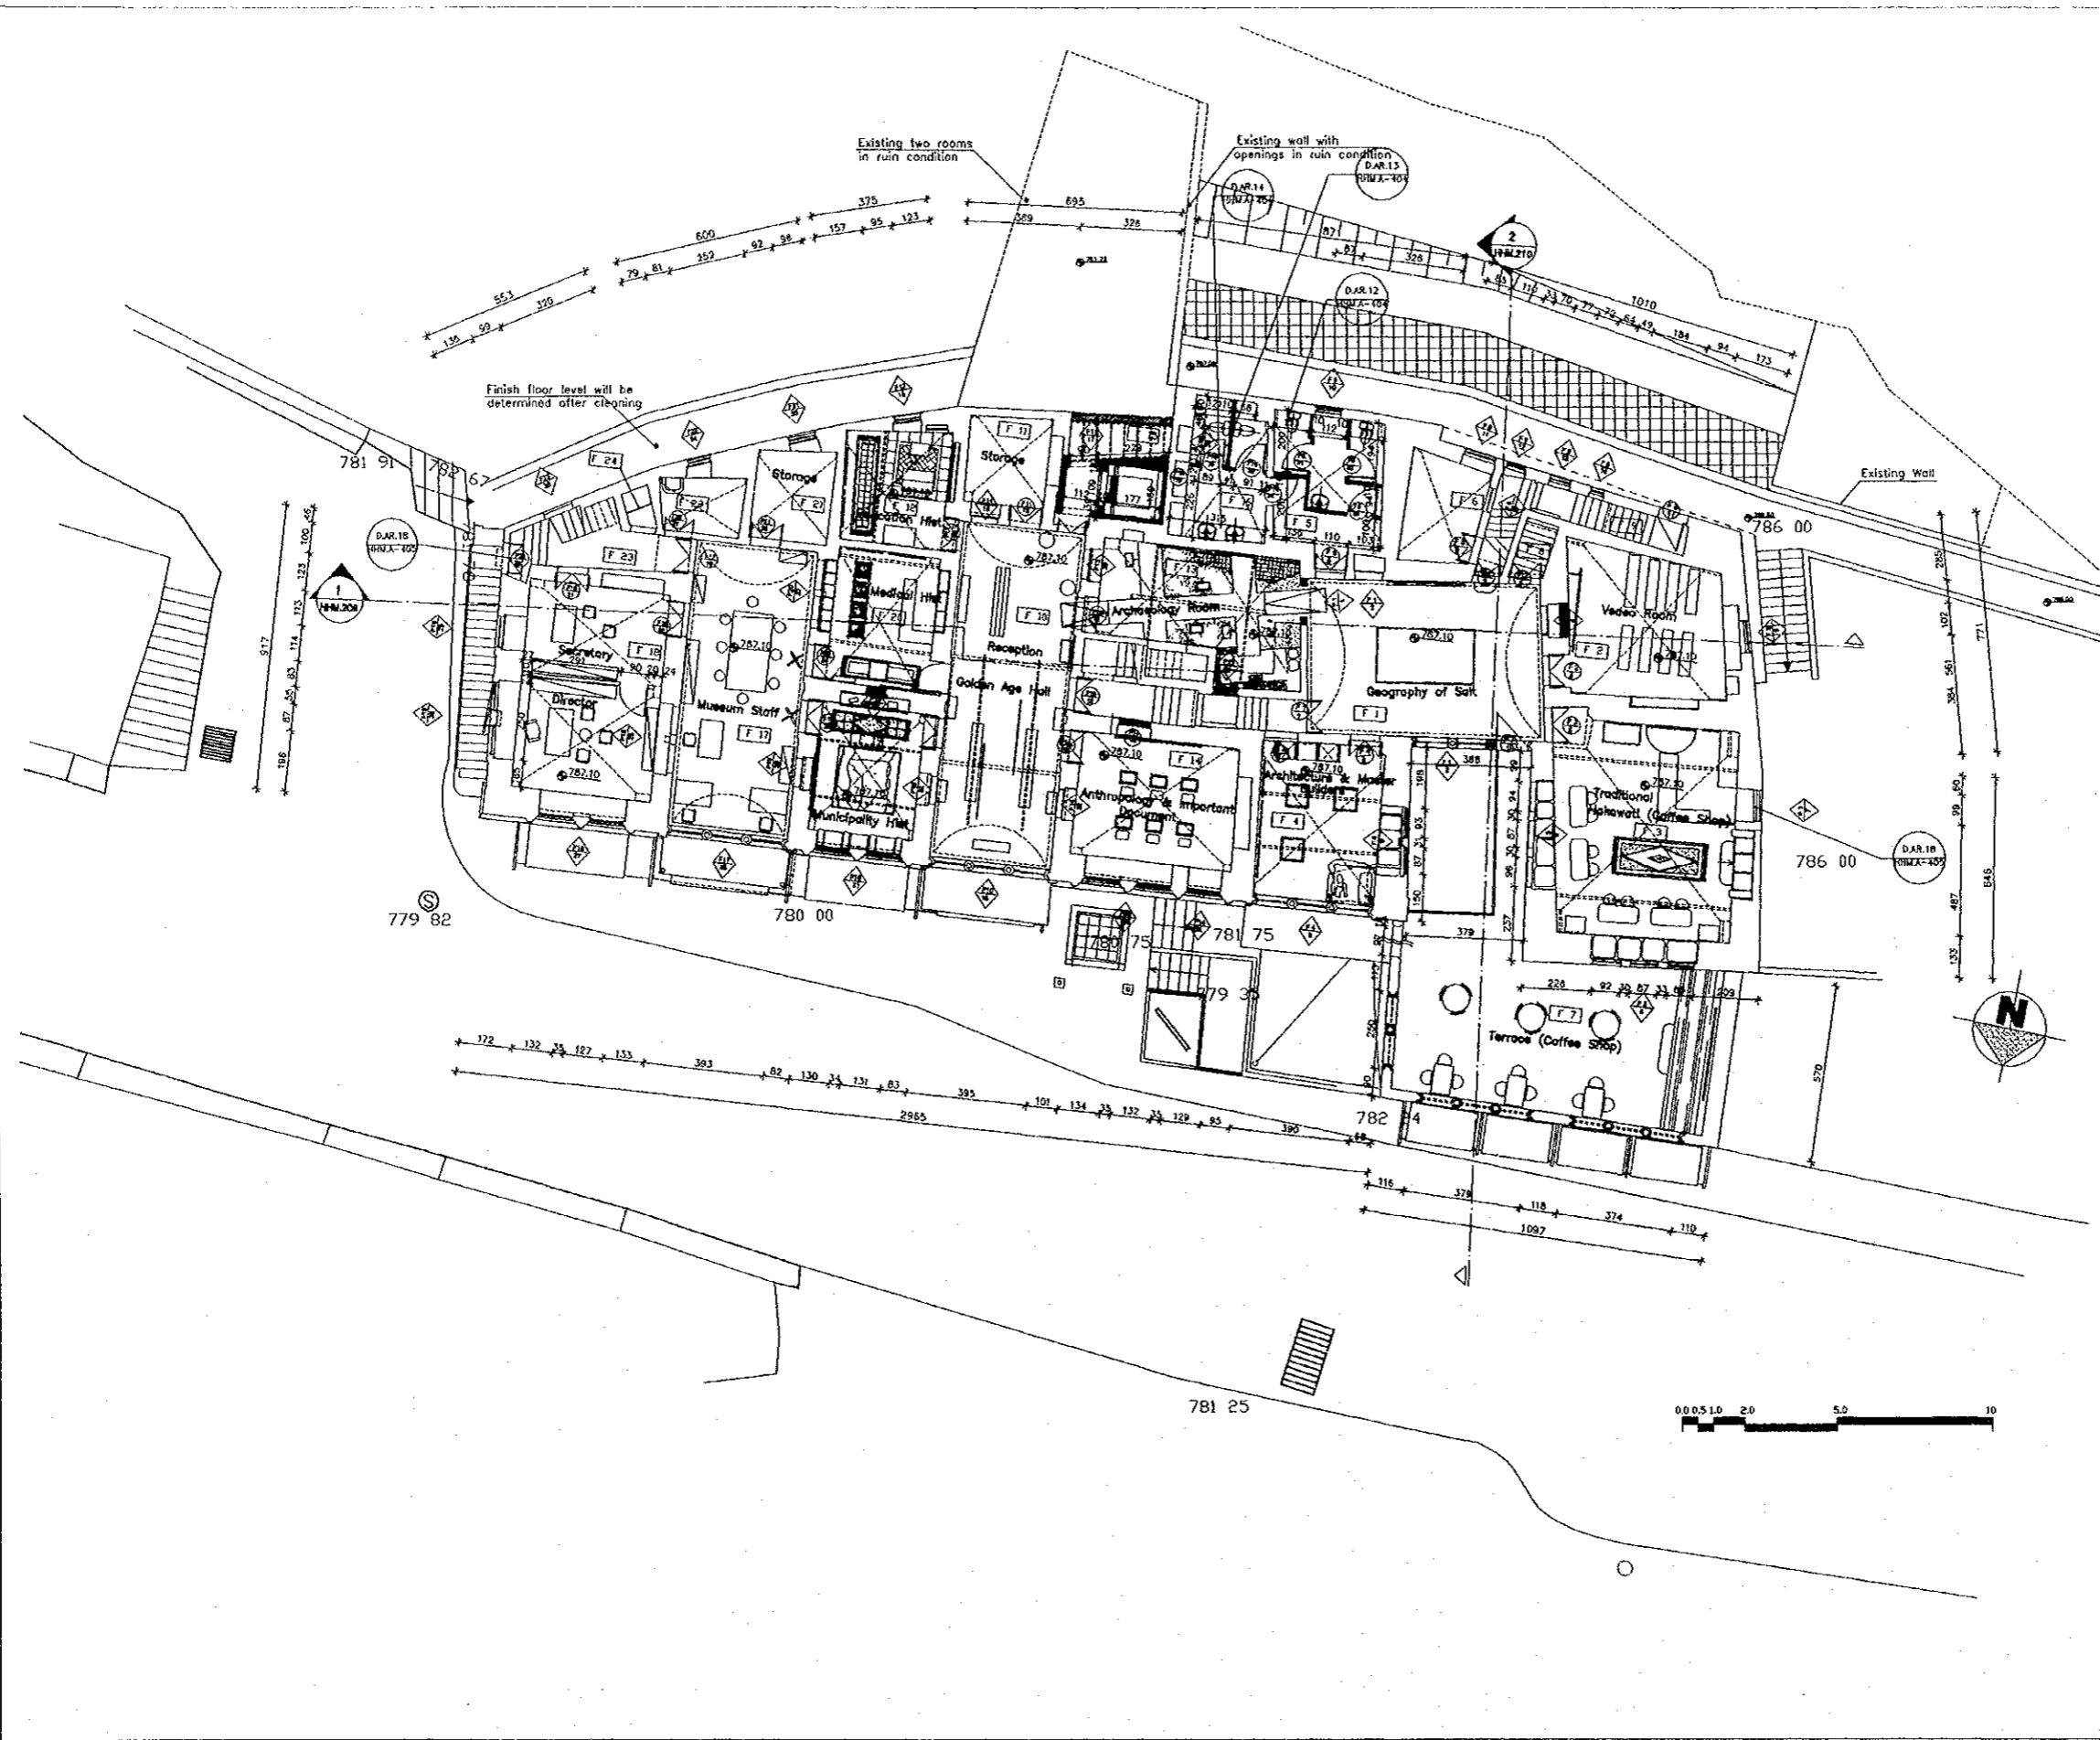
Scale: 1:100
Drawing No.: HHM.A-203

- Existing (Authentic)
 - Existing (Later Addition)
 - New Intervention
 - Floor
 - Doors
 - Windows
 - Roofing System
 - Cracks
 - F1 Geography of Salt.
 - F2 Video Room.
 - F3 Traditional (Hakawati) Coffee Shop.
 - F4 Architecture & Master Builders .
 - F5 W.C.
 - F6 Storage.
 - F7 Terrace (Coffee Shop).
 - F8 Storage.
 - F9 Emergency Exit.
 - F10 Reception / Golden Age Hall.
 - F11 Storage.
 - F12 Education Hist.
 - F13 Archaeology Room.
 - F14 Anthropology & Important Document
 - F15 Elevator Space.
 - F16 W.C.
 - F17 Museum Staff.
 - F18 Administration /Director & Sec.
 - F19 Municipality Hist.
 - F20 Medical Hist.
 - F21 Storage.
 - F22 W.C.
 - F23 Entrance & Service Area.
- * For Dimensions of Interior rooms
And More Interior Details
Please Refer to 1/50 Enlargements
For Each Space (Sheets A-301 A-324)

Historic House Museum Of
Abu Jaber
Drawing Title:
Proposed Condition
First Floor Plan

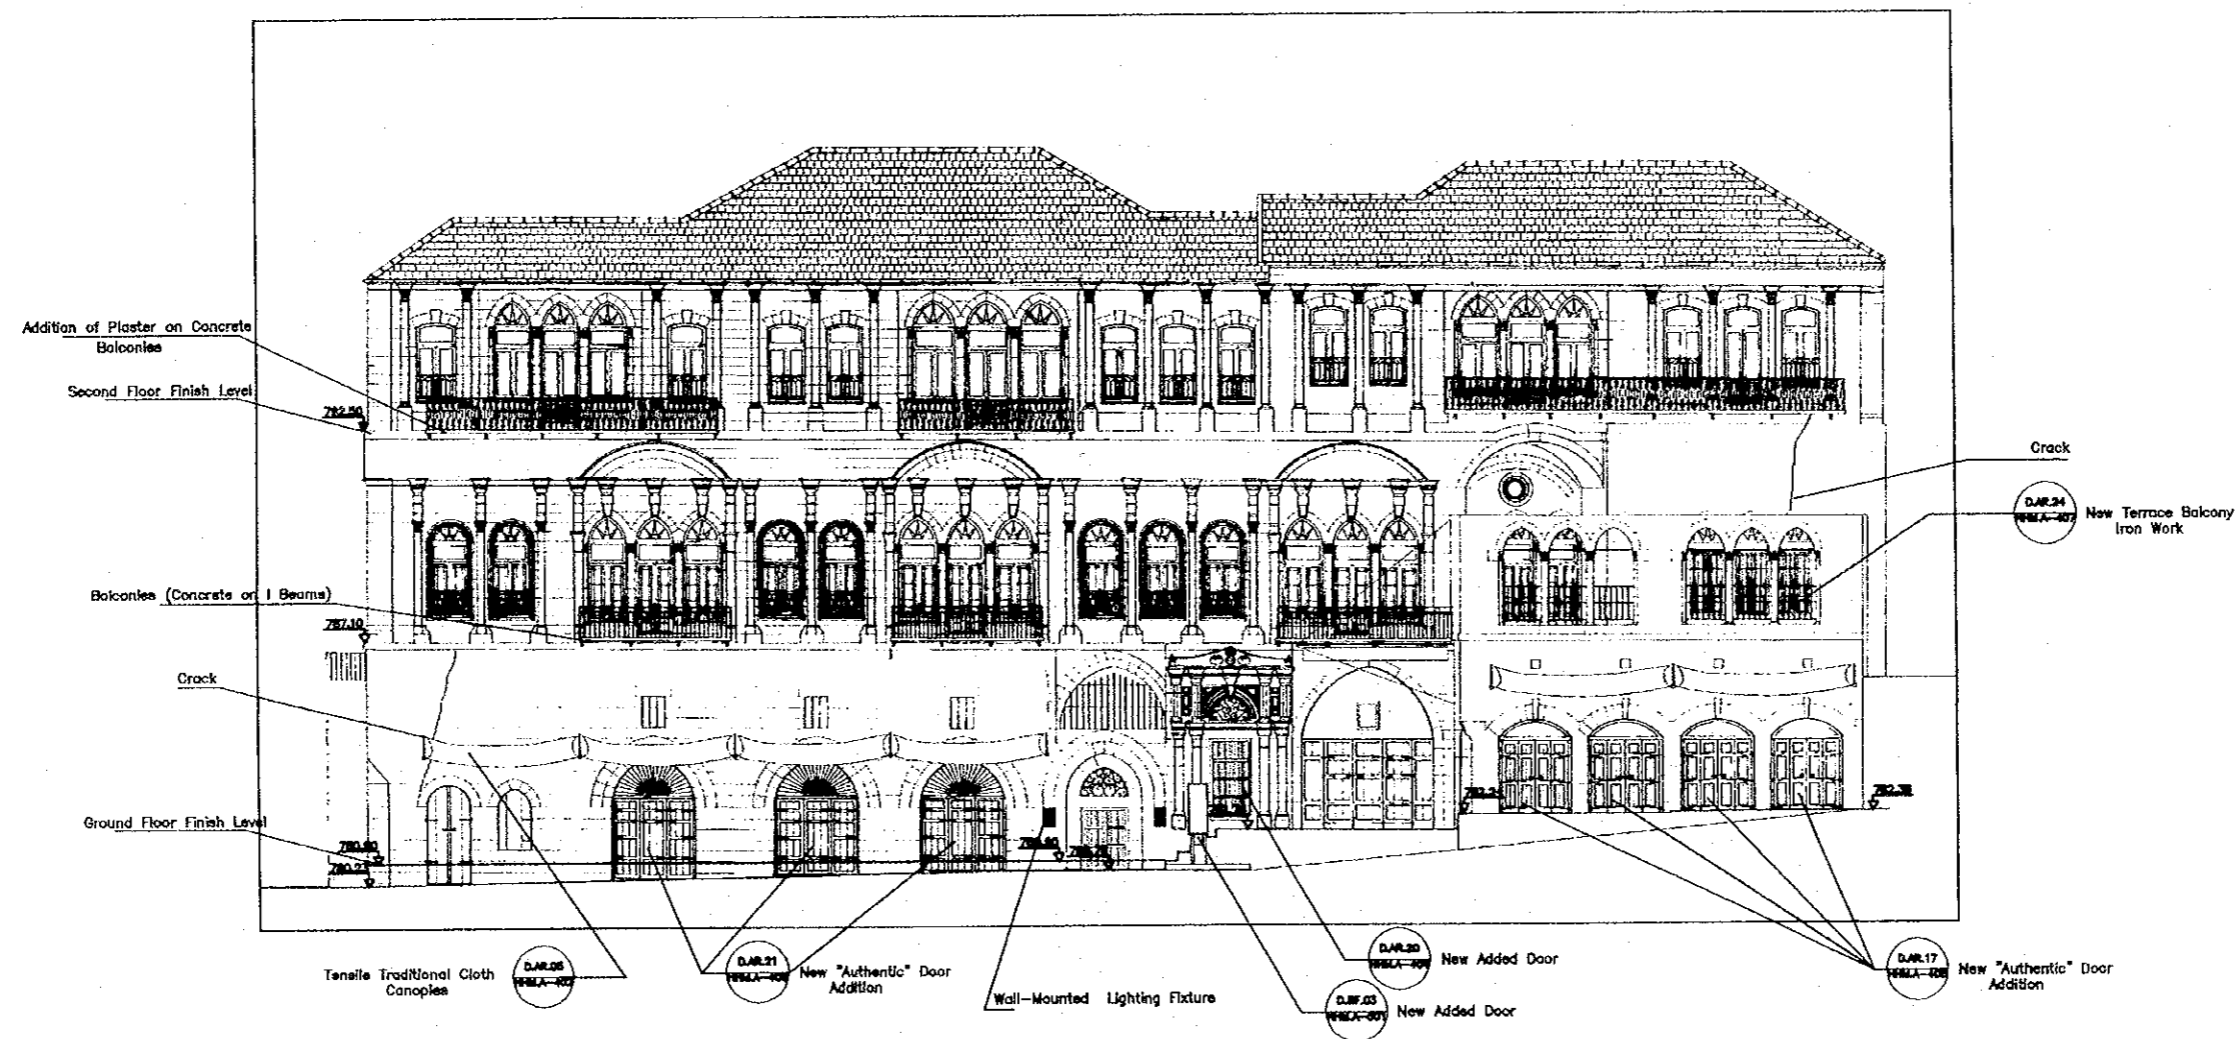
Historic House Musuem Of
Abu Jaber
Drawing Title:
Proposed Condition
North Elevation

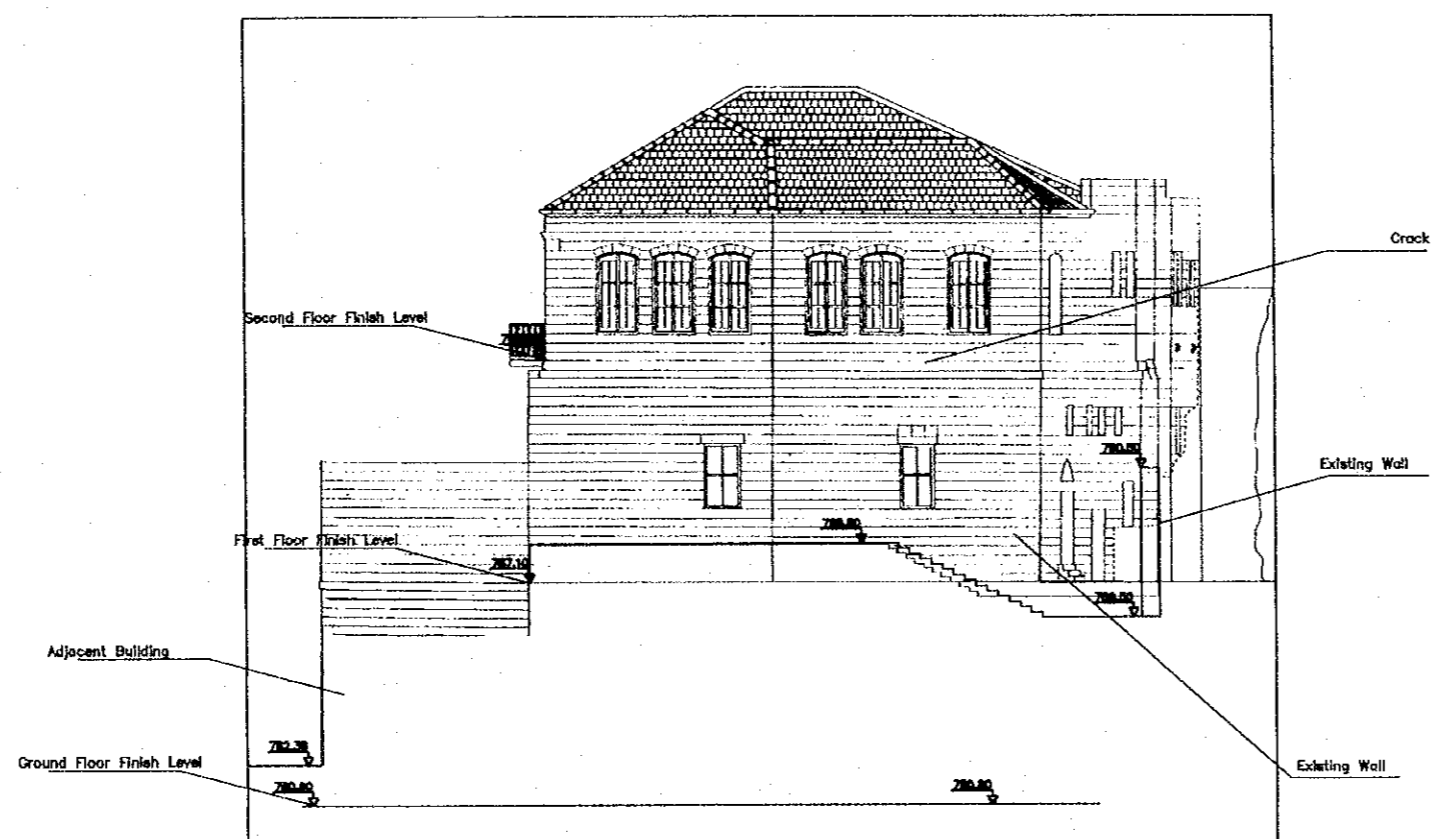
Historic House Museum Of
Abu Jaber
Drawing Title:
Proposed Condition
West Elevation

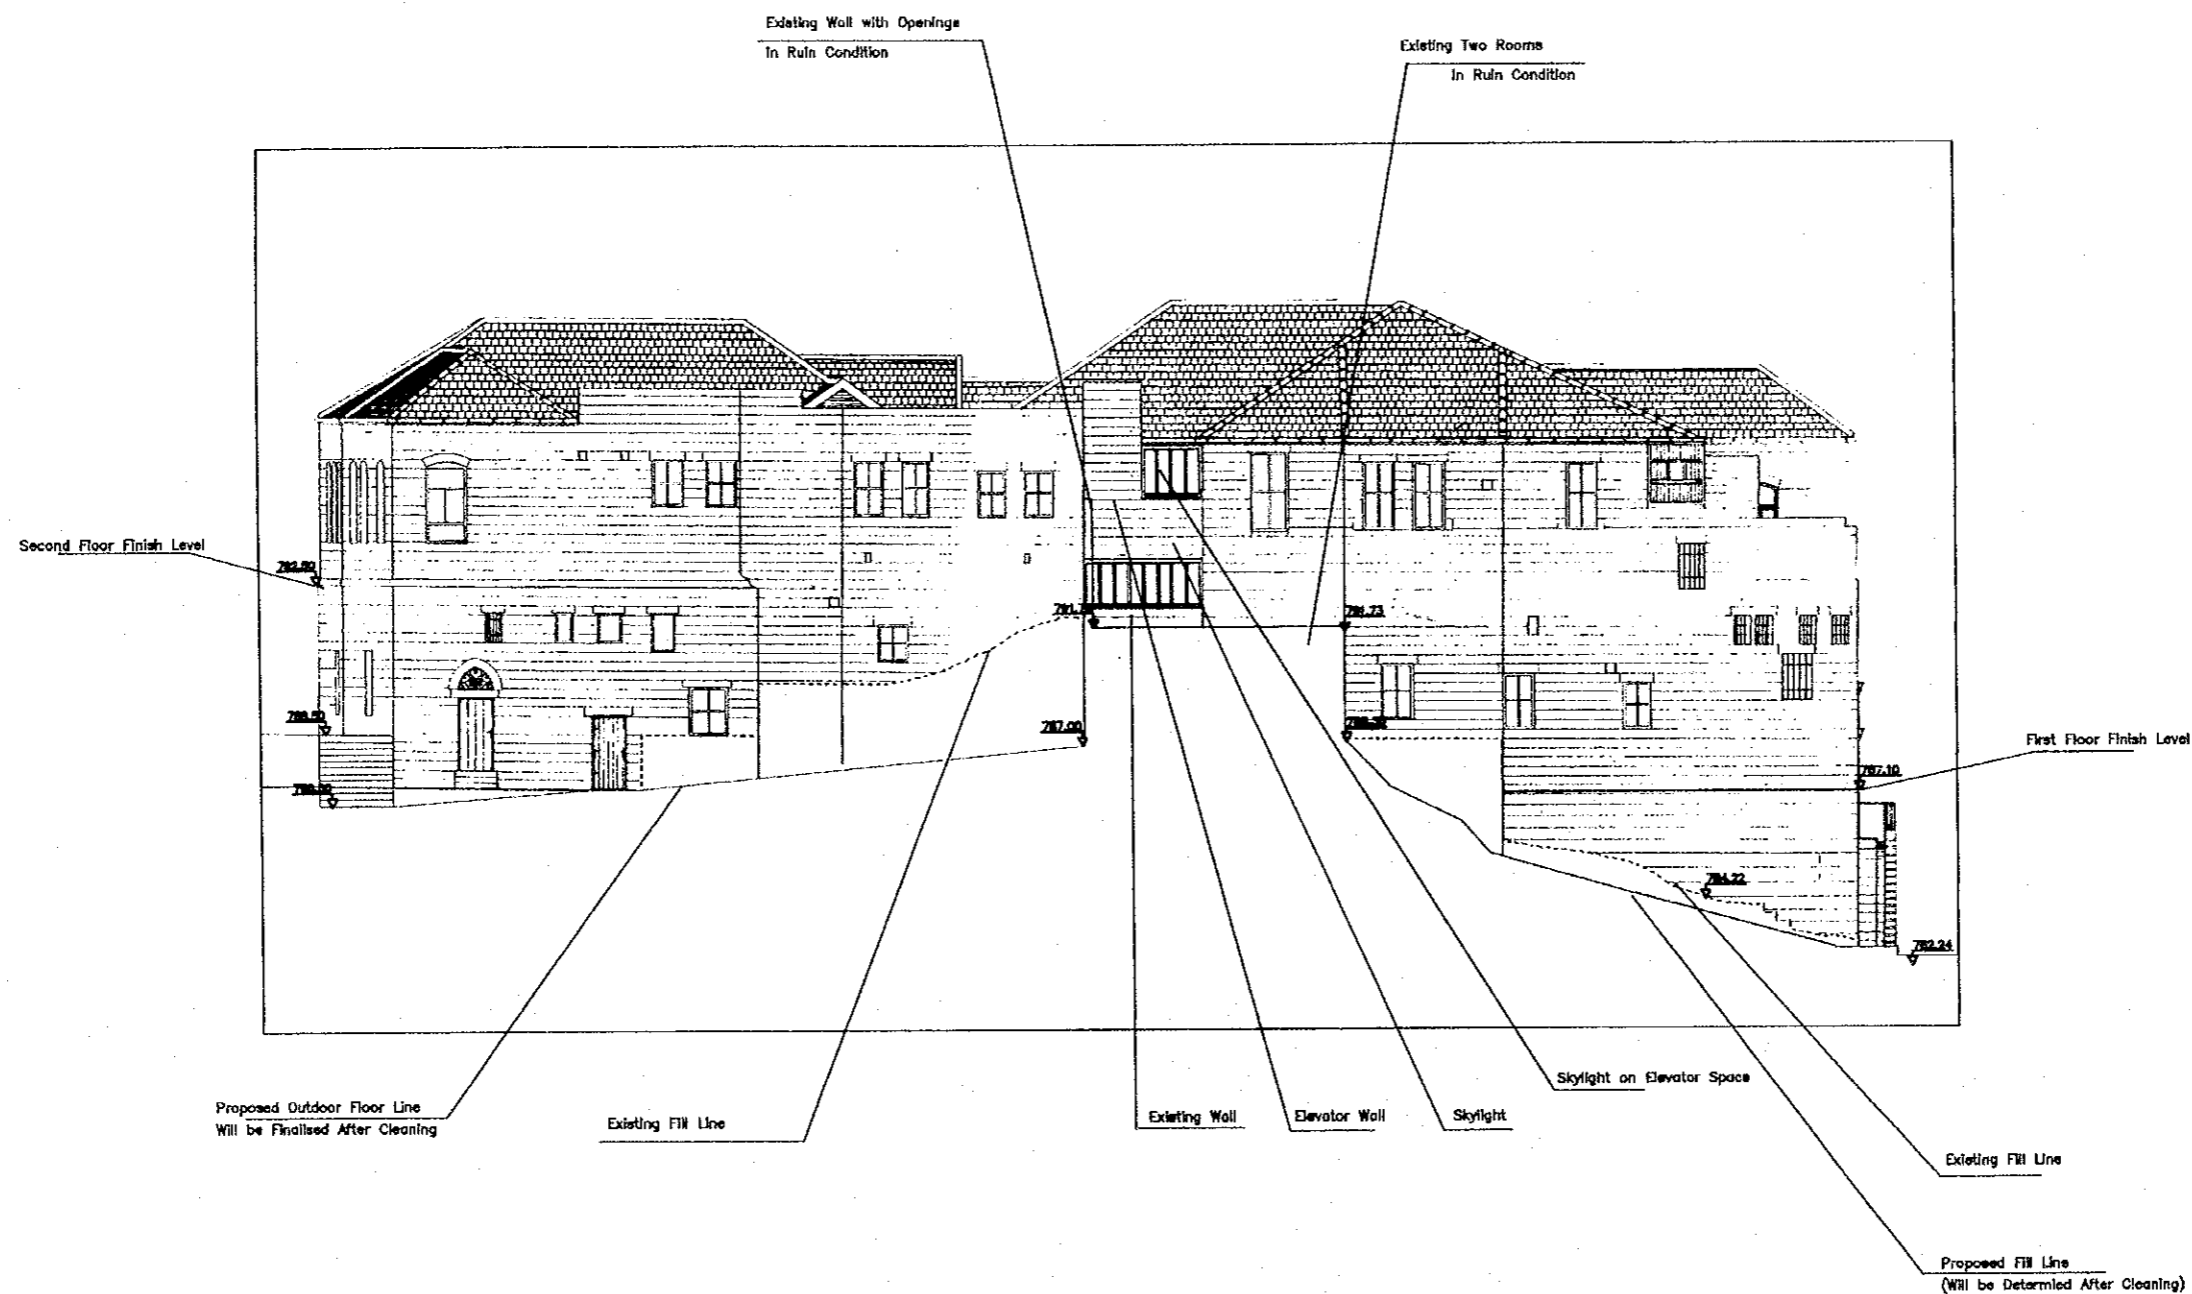
Drawing Title:
Proposed Condition
South Elevation

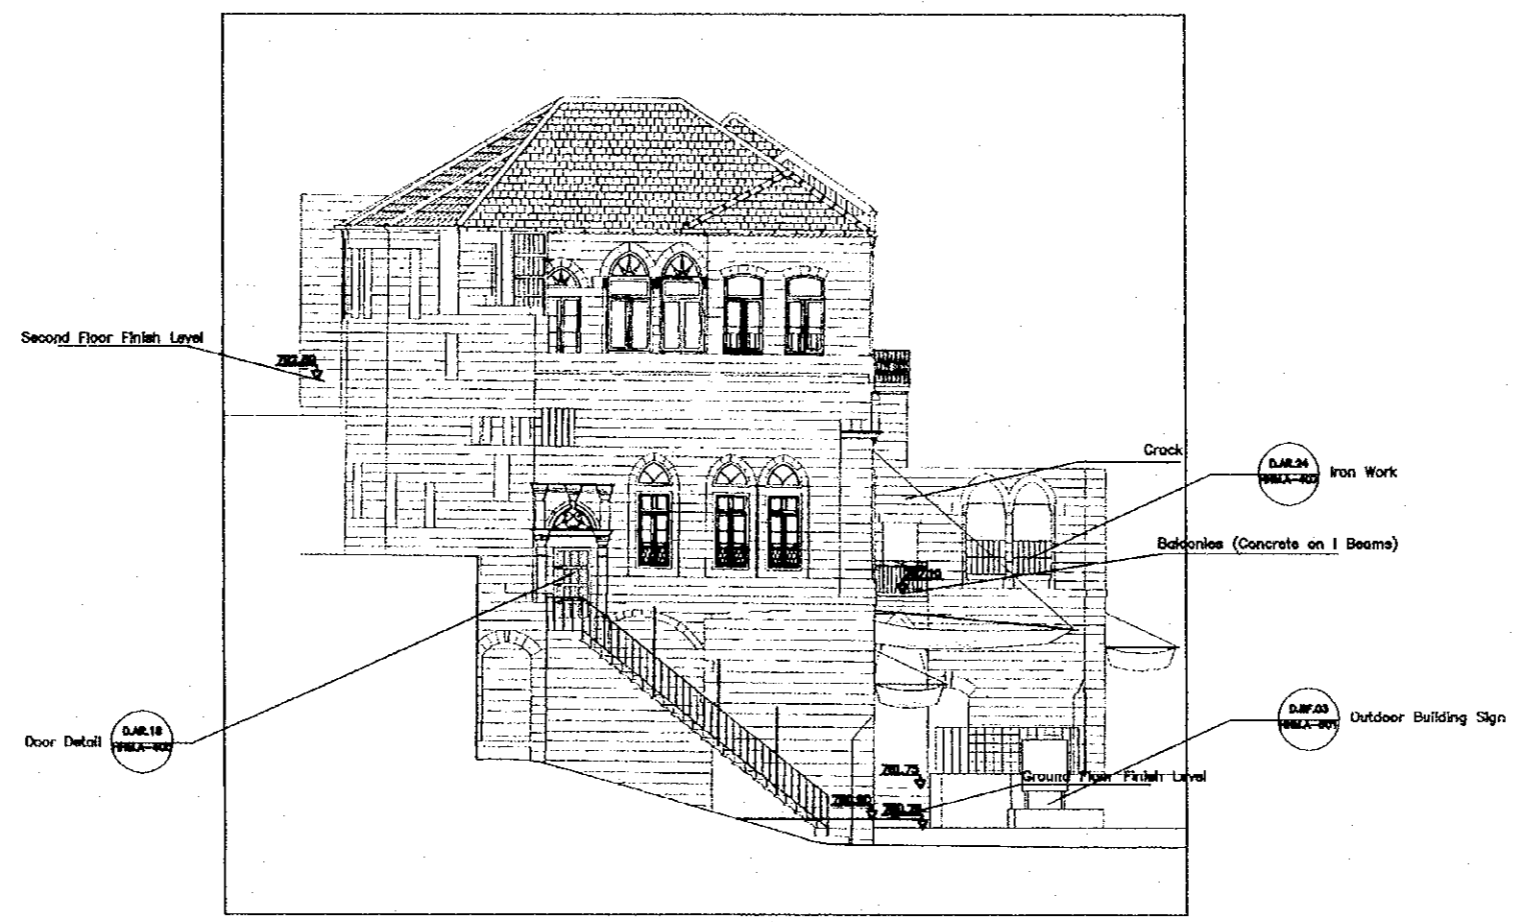
Historic House Musuem Of
Abu Jaber
Drawing Title:
Proposed Condition
East Elevation

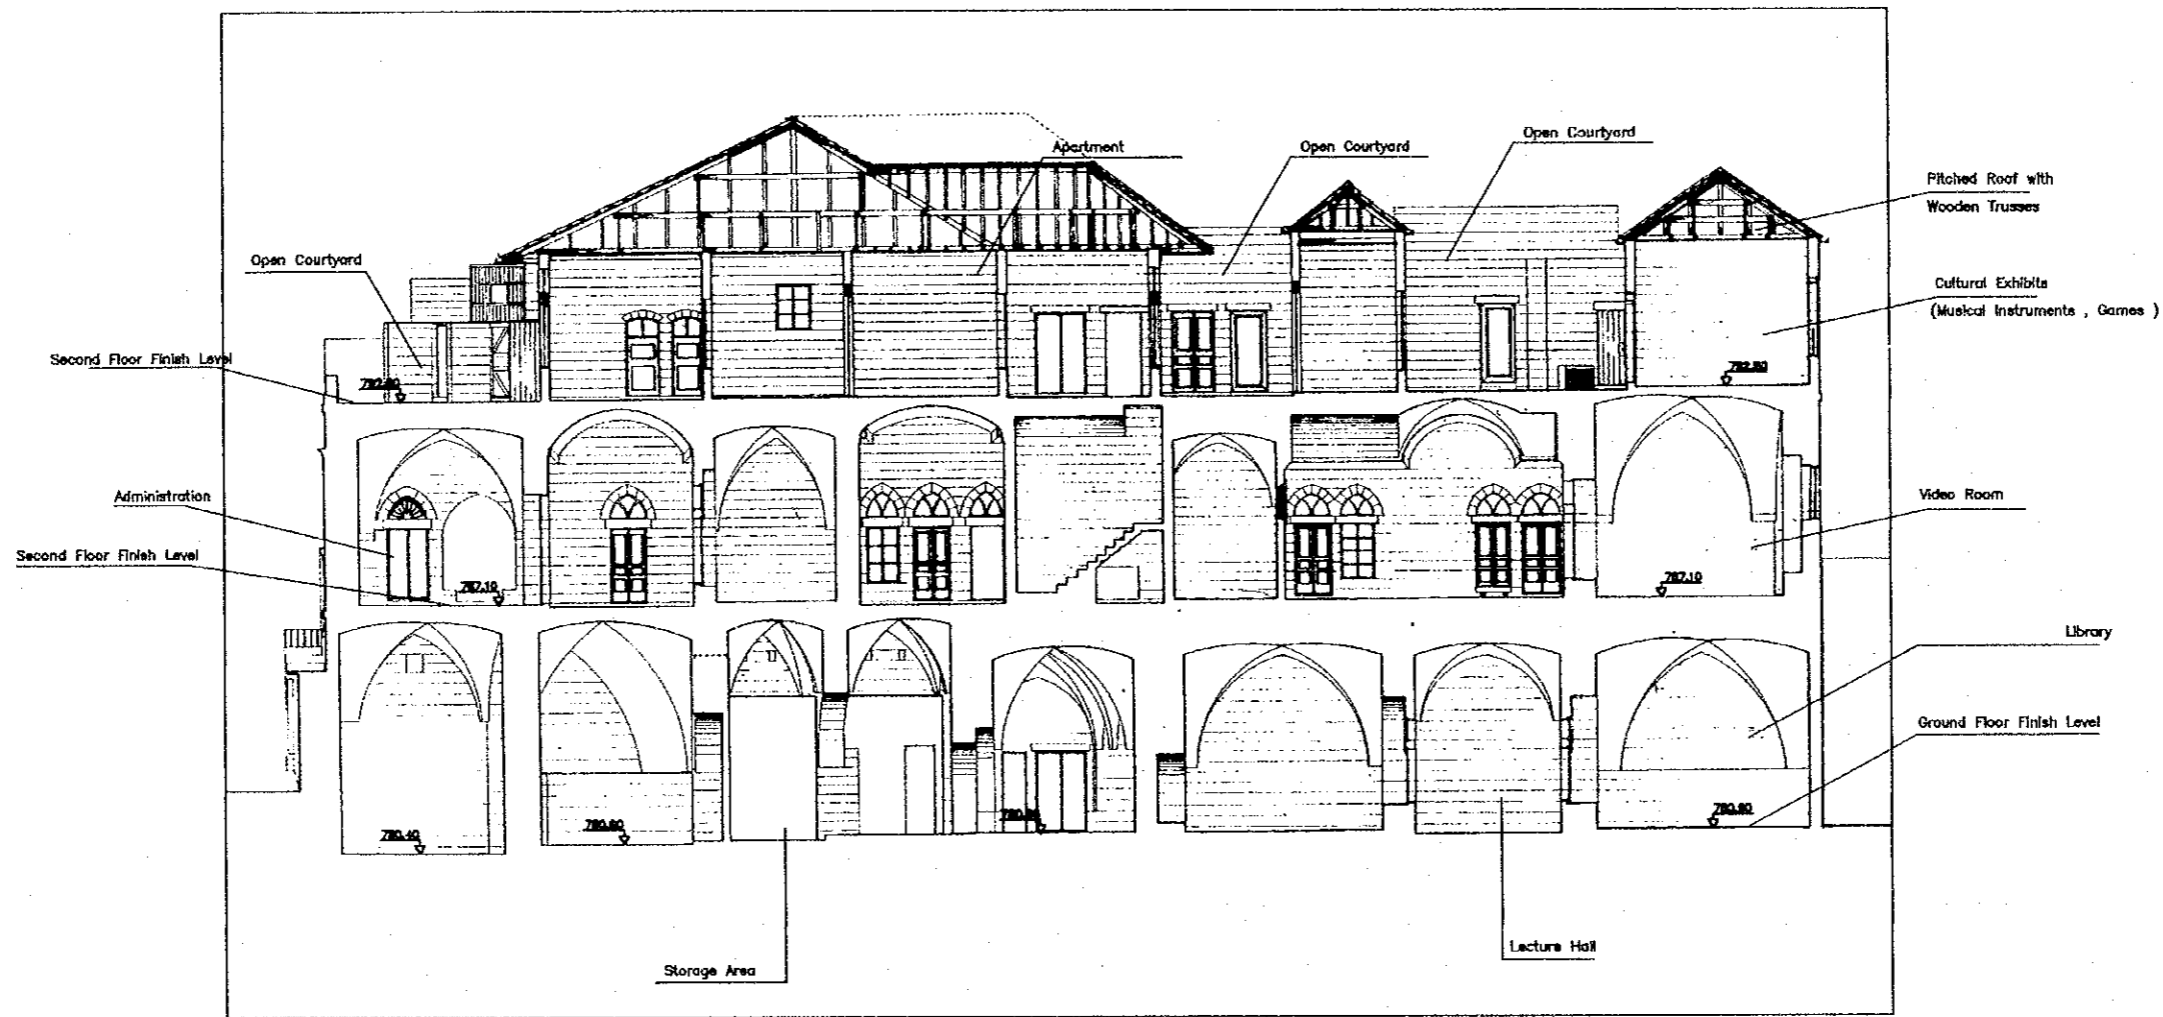
Historic House Museum Of
Abu Jaber
Drawing Title:
Proposed Condition
Section 1

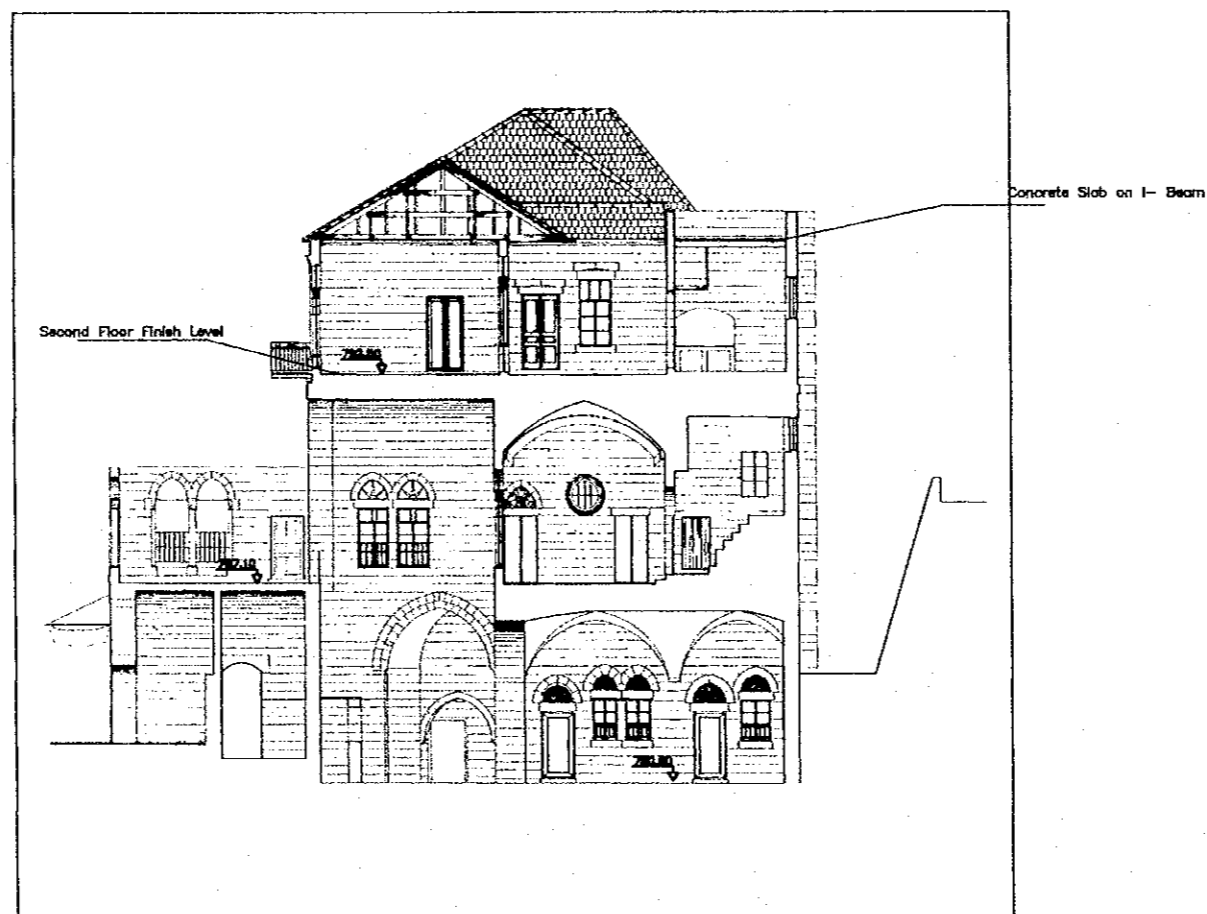
Historic House Museum Of
Abu Jaber
Drawing Title:
Proposed Condition
Section 2

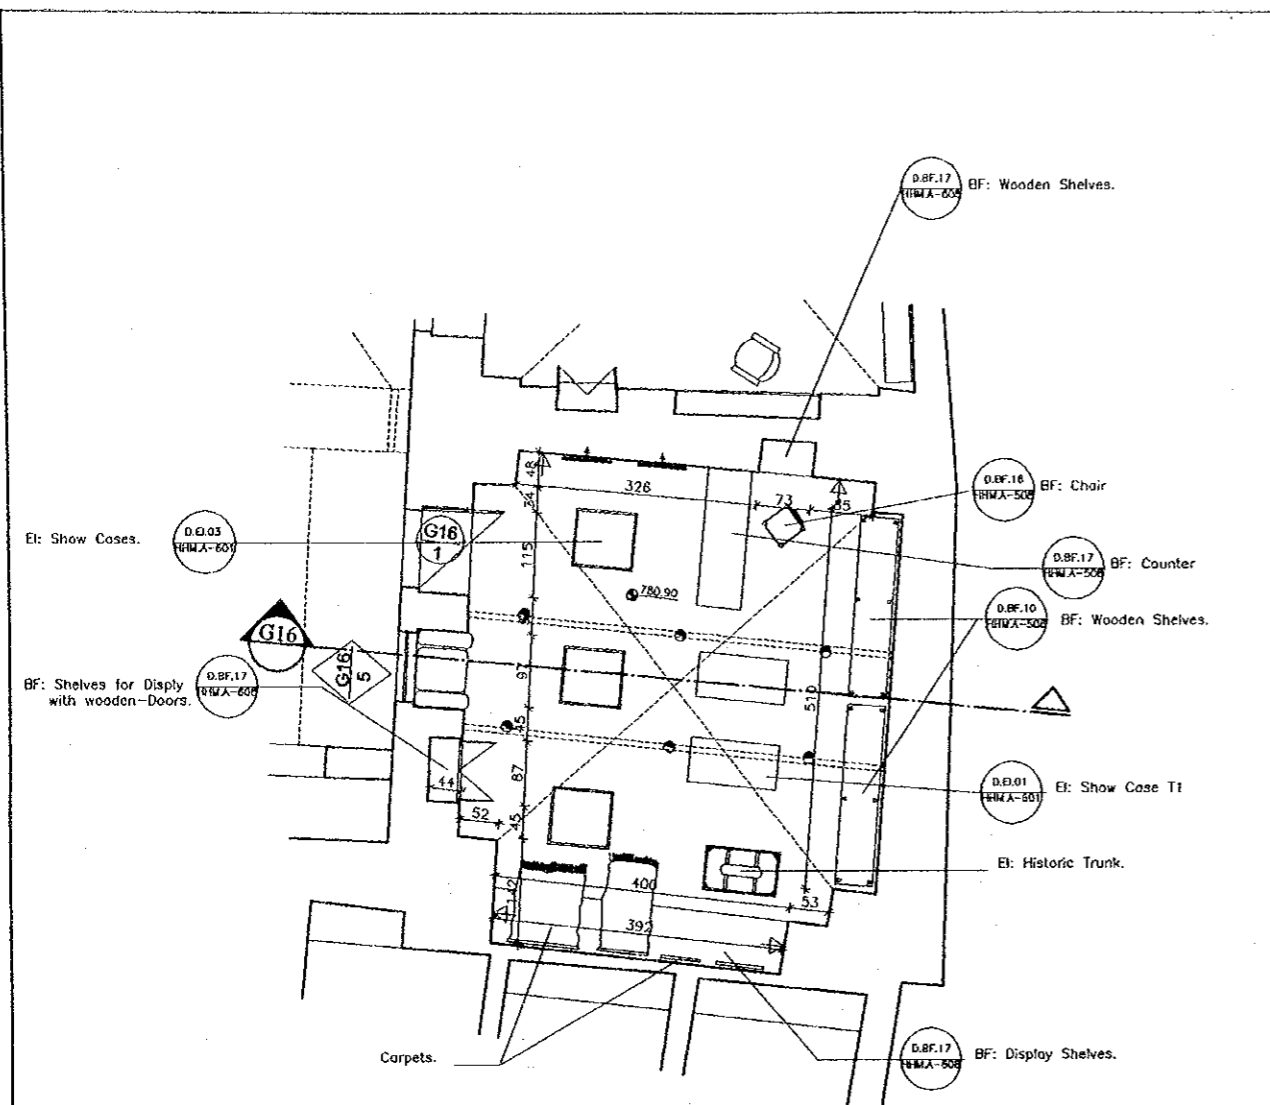
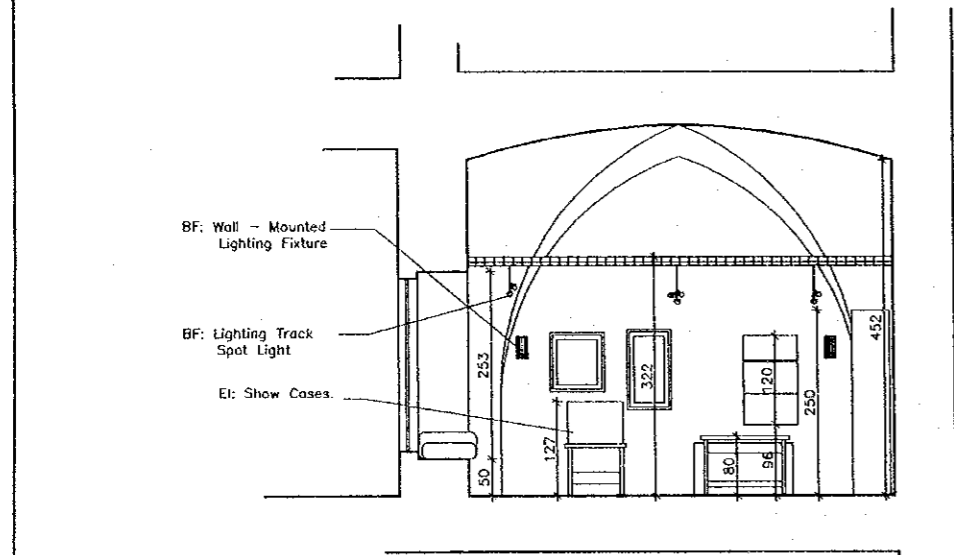
Section G16
Scale 1/50

G16 Souvenir & Handicraft Shop

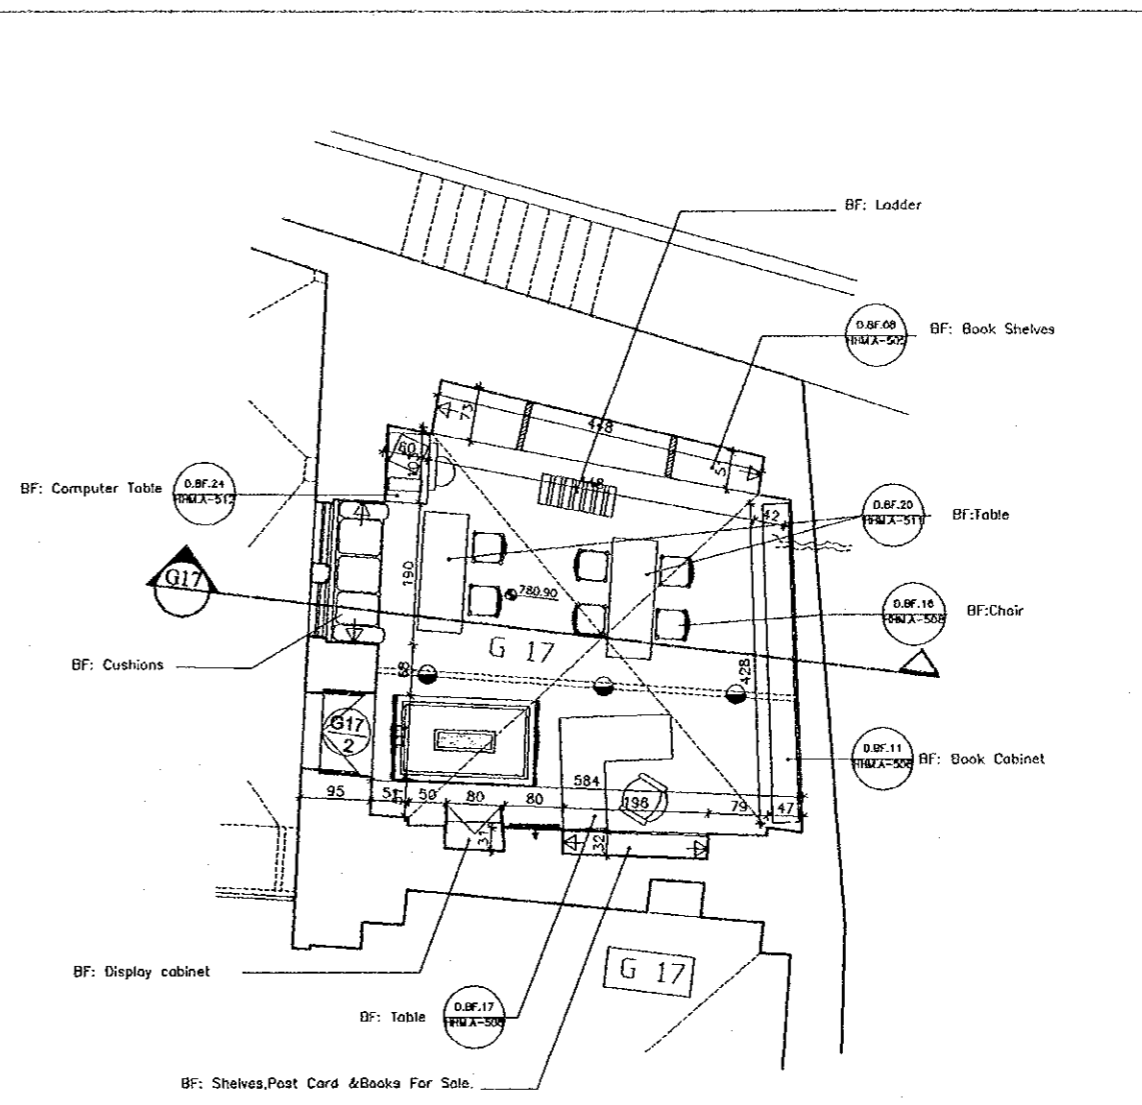
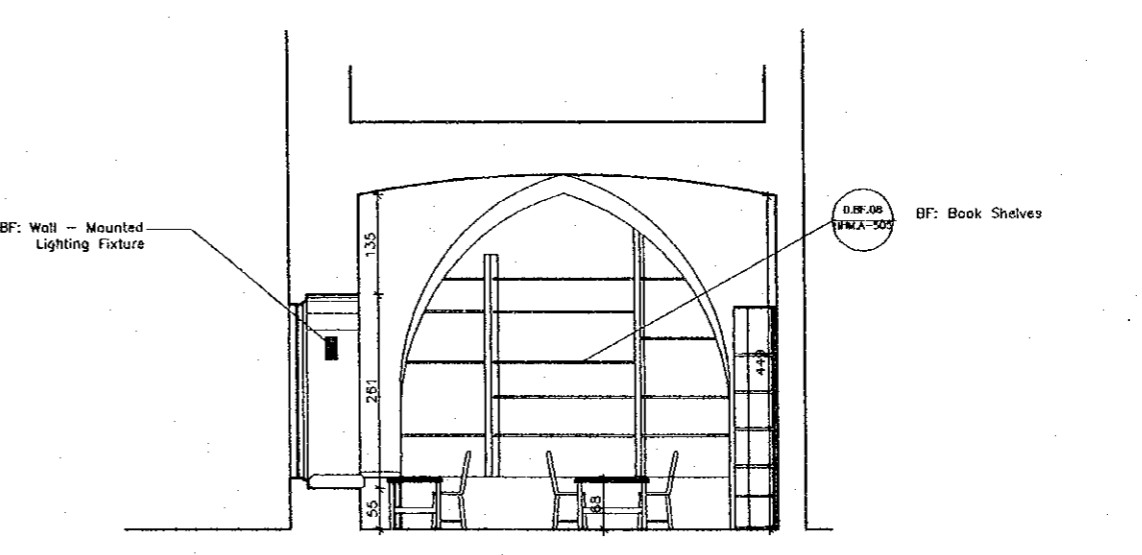
Section G17
Scale 1/50

G17 Library
