DRAFT
TENDER DOCUMENTS FOR CONSTRUCTION
OF
HISTORIC OLD SALT DEVELOPMENT SUB-PROJECT
THE TOURISM SECTOR DEVELOPMENT PROJECT

VOLUME IV
DRAWINGS

(2) NEW HISTORIC OLD SALT MUSEUM

Historic House Museum Of
Abu Jaber
Drawing Title:
Existing Condition
Site Plan

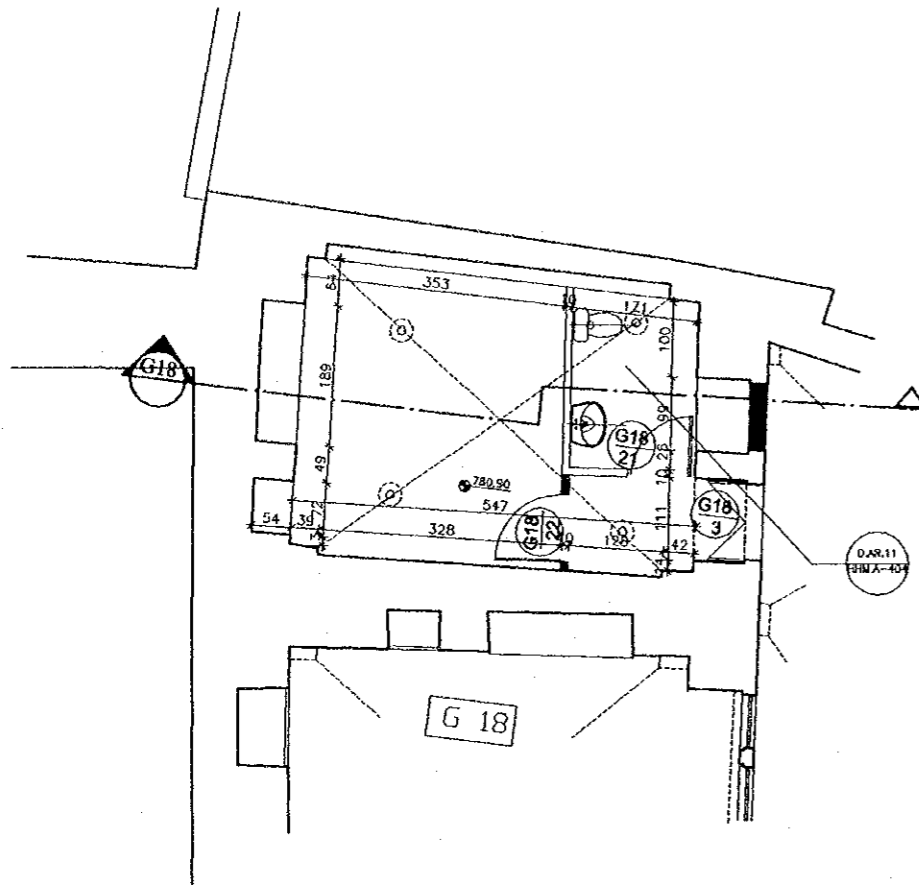
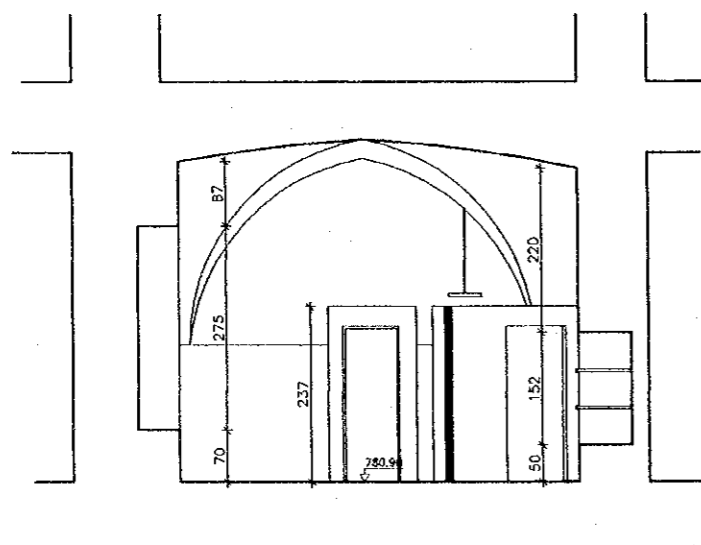
Section G18
Scale 1/50

G18 Mechanical Room

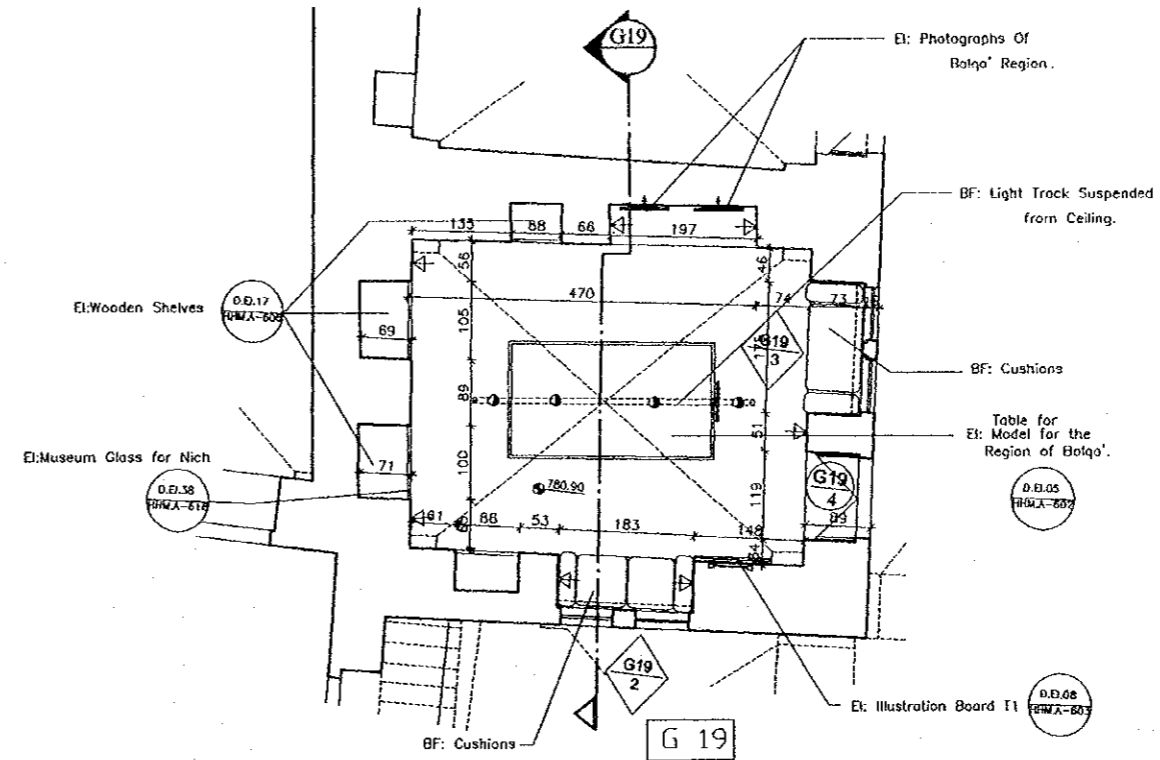
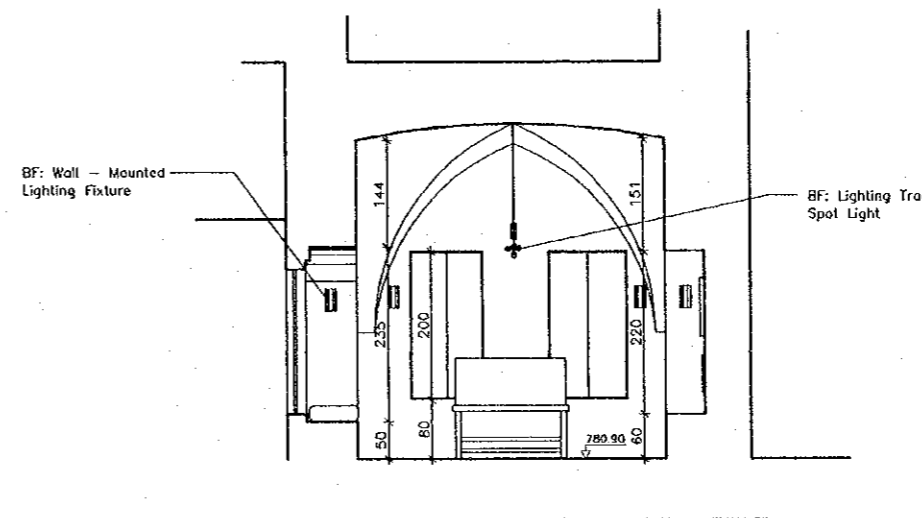
Section G19
Scale 1/50

G19 Balqa' Region Show Room

- Wooden Frames and Glass need to be added to small square windows described above.
- Mashrabiiah Repair in the Ground Floor:
 - Mashrabiiahs in Window G19/2 need repair. Similar Mashrabiiahs in the Ground Floor need repair.

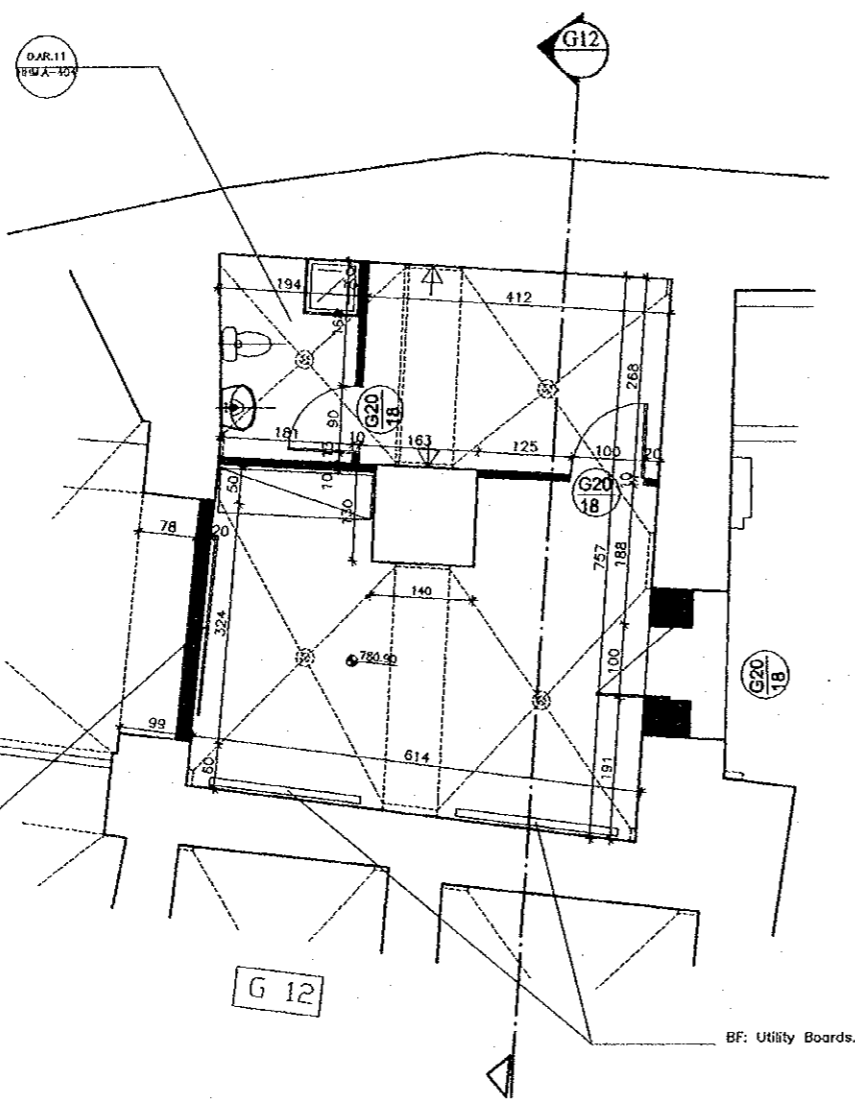
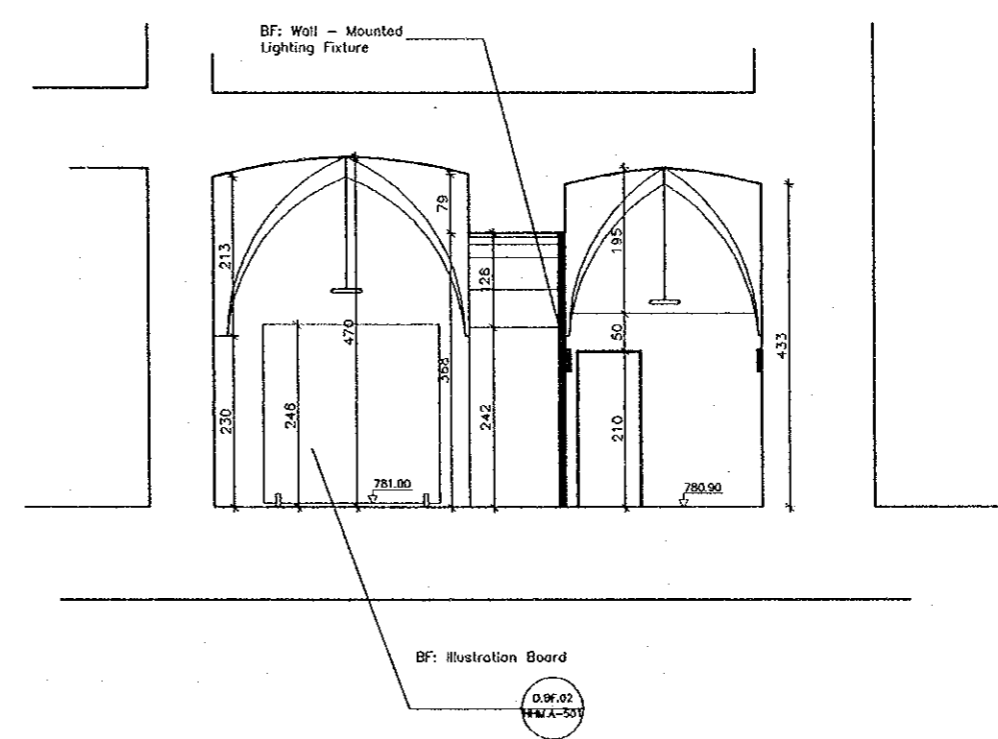
Section G12
Scale 1/50

G12 Storage & Janitor Room

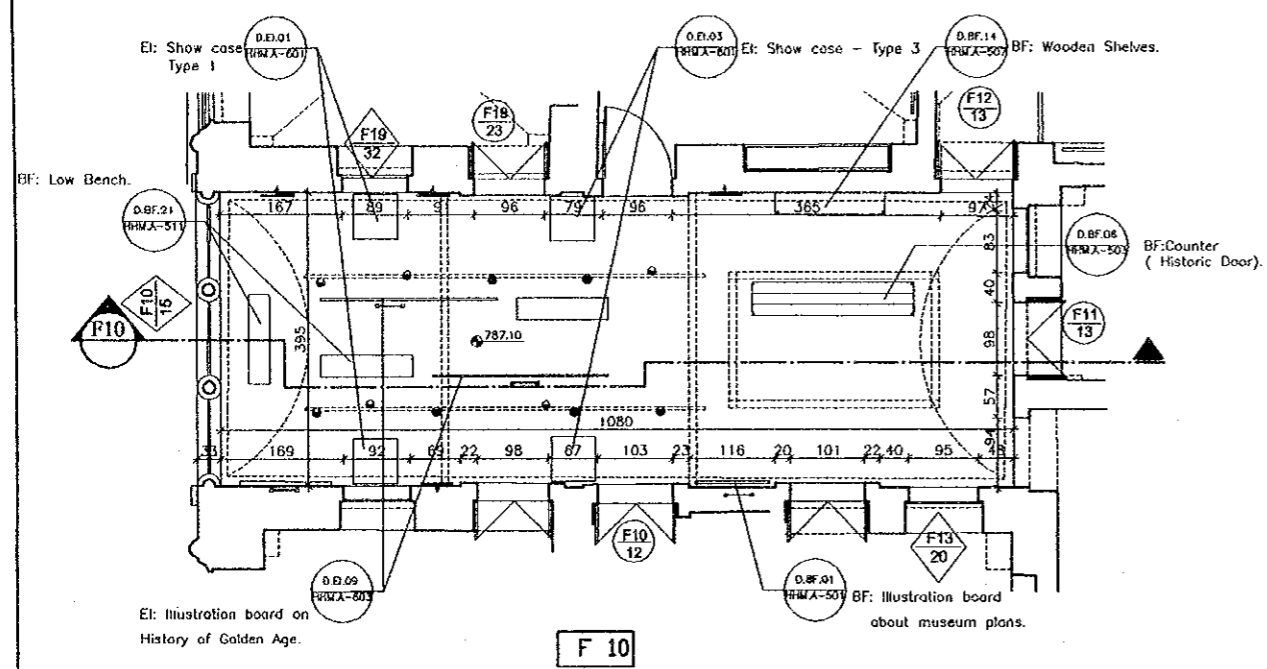
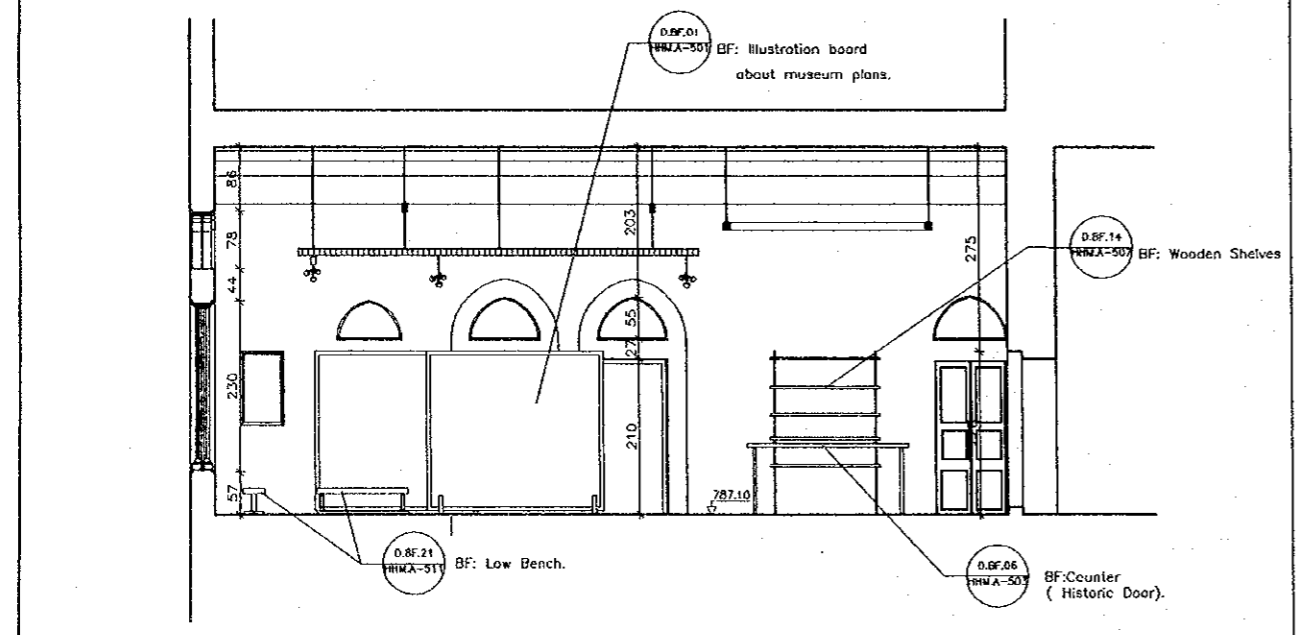
Section F10
Scale 1/50

F10 Reception / Golden Age Hall

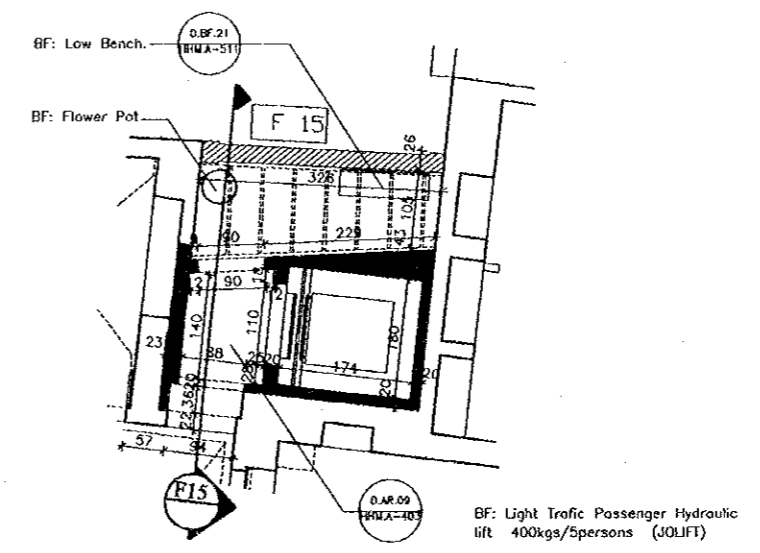
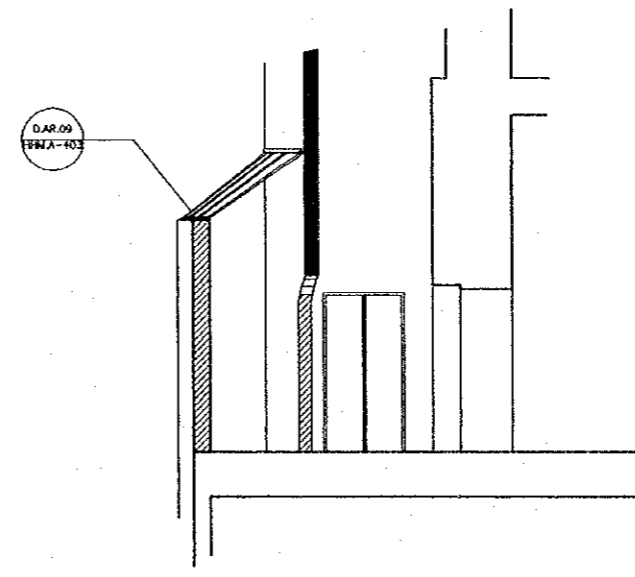
Section F15
Scale 1/50

F15 Elevator Space

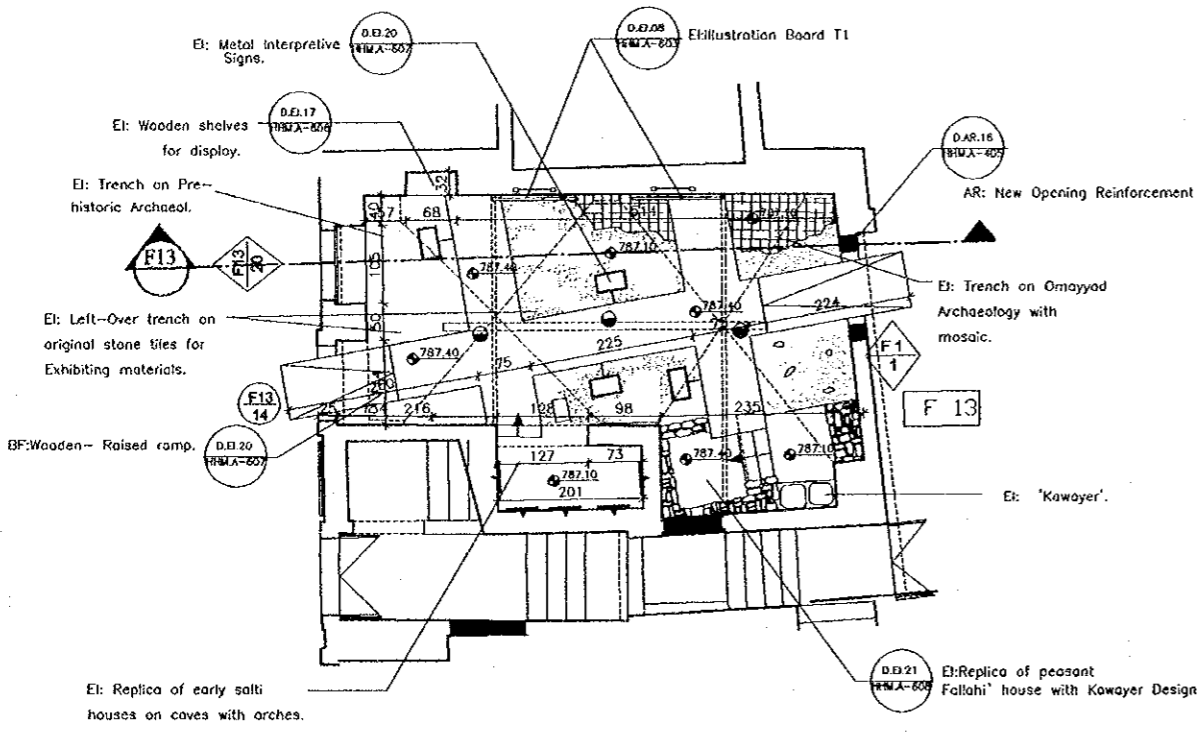
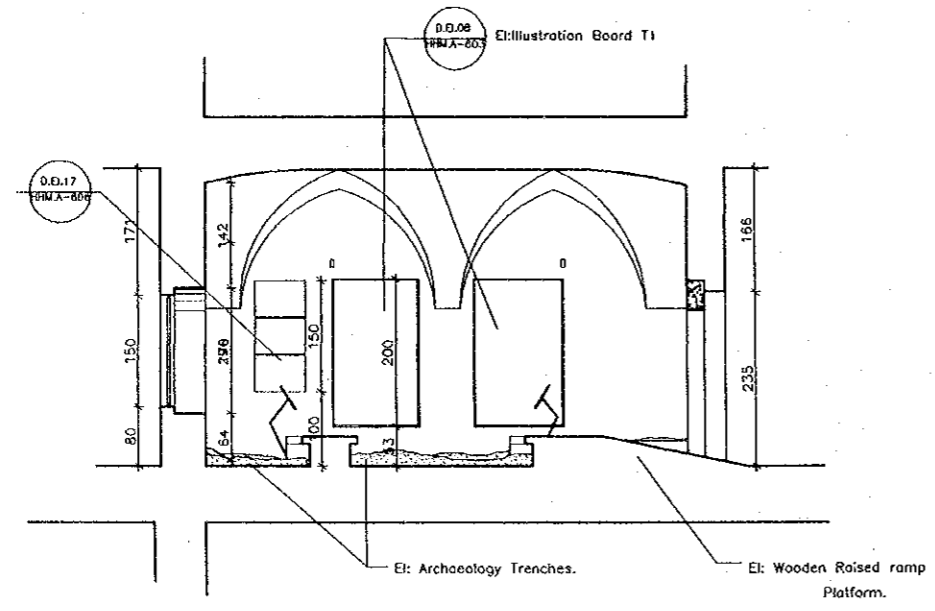
Section F13
Scale 1/50

F13 Archaeology Room

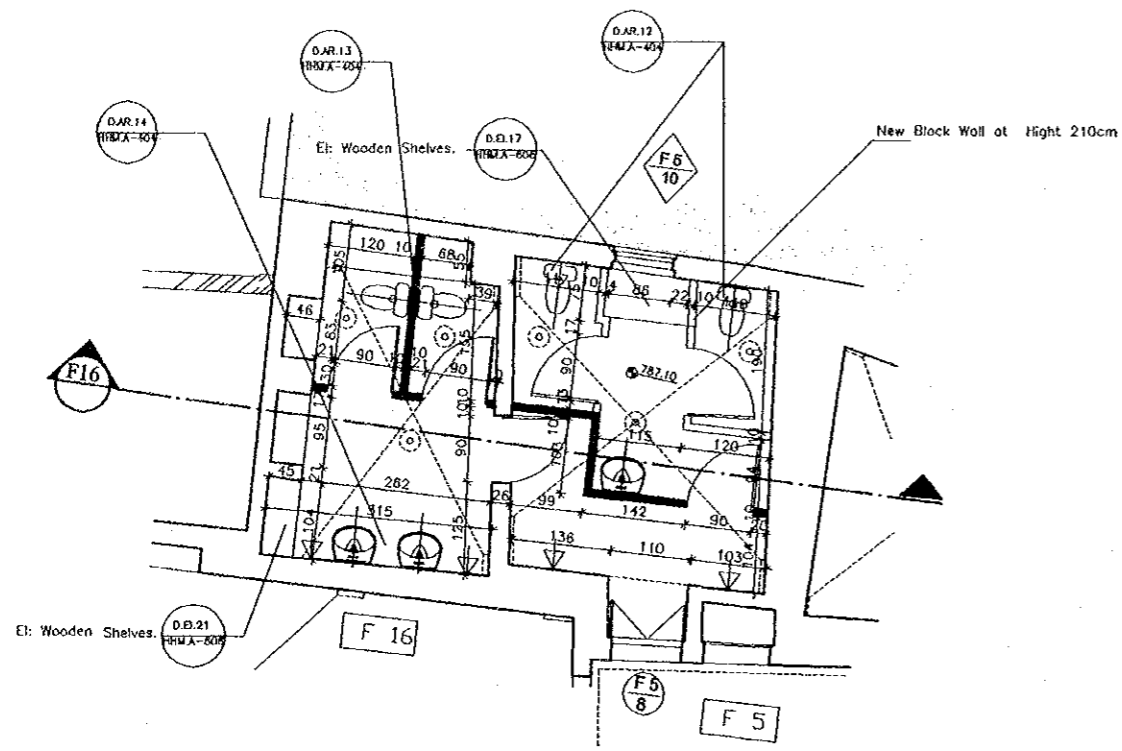
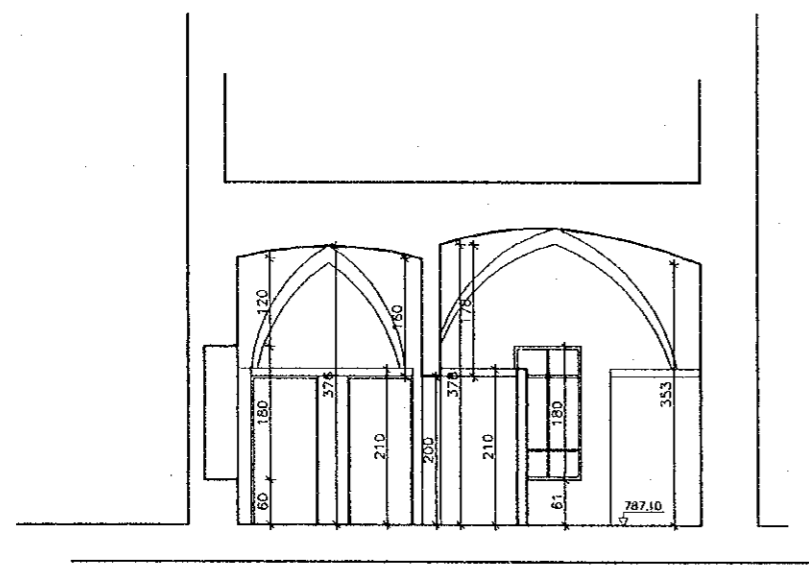
Section F16
Scale 1/50

F16 Bathrooms (Females)
F05 Bathrooms (Males)

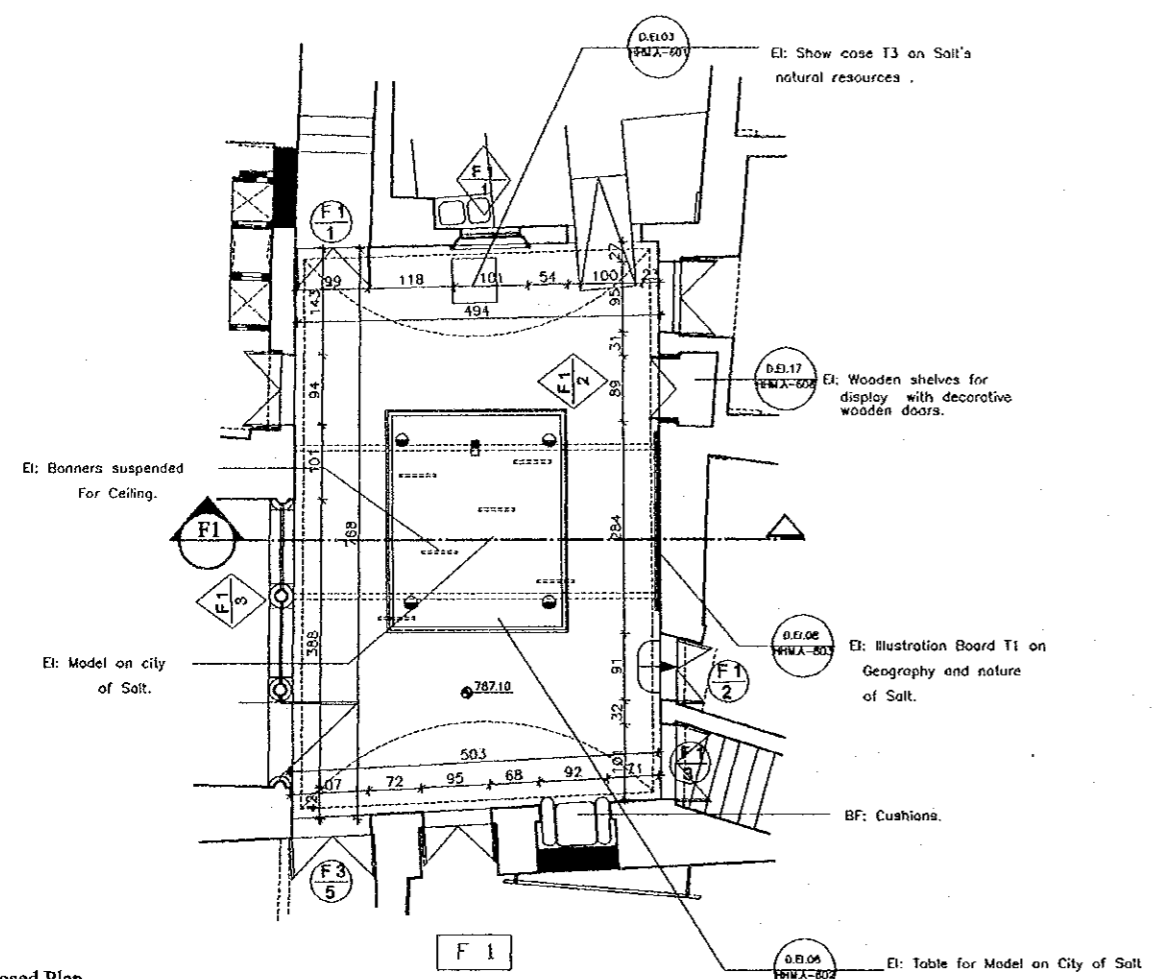
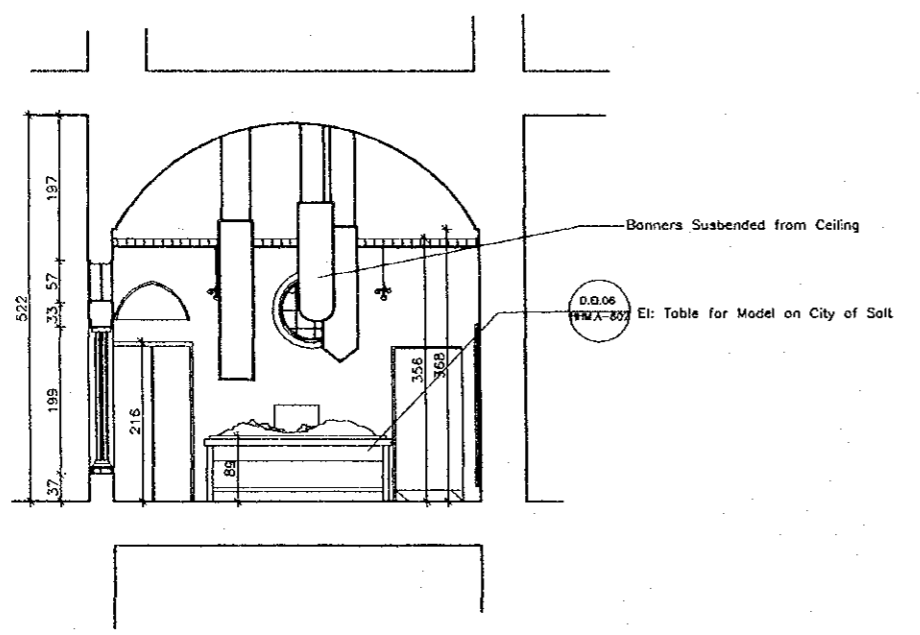
Section F1
Scale 1/50

F1 Geography of Salt
