APPENDIX I

Field Survey

I.4 PICTORIAL ACCOUNT OF DANIDA ENGINEERING ACTIVITIES

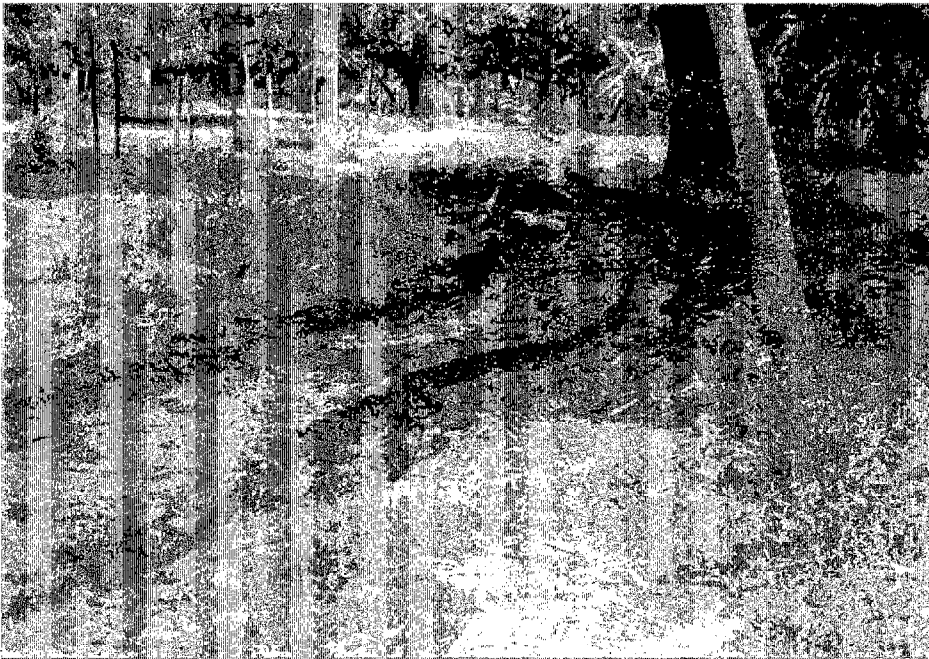
Consider a damaged part of Road type E shown in figure 1 below. The spot improvement here required raising the ground using importing suitable material brought from selected quarry within the proximity. To improve the drainage situation at the same spot will require the use of culvert.

Figure I-1. Damaged part of class D road requiring spot improvement.

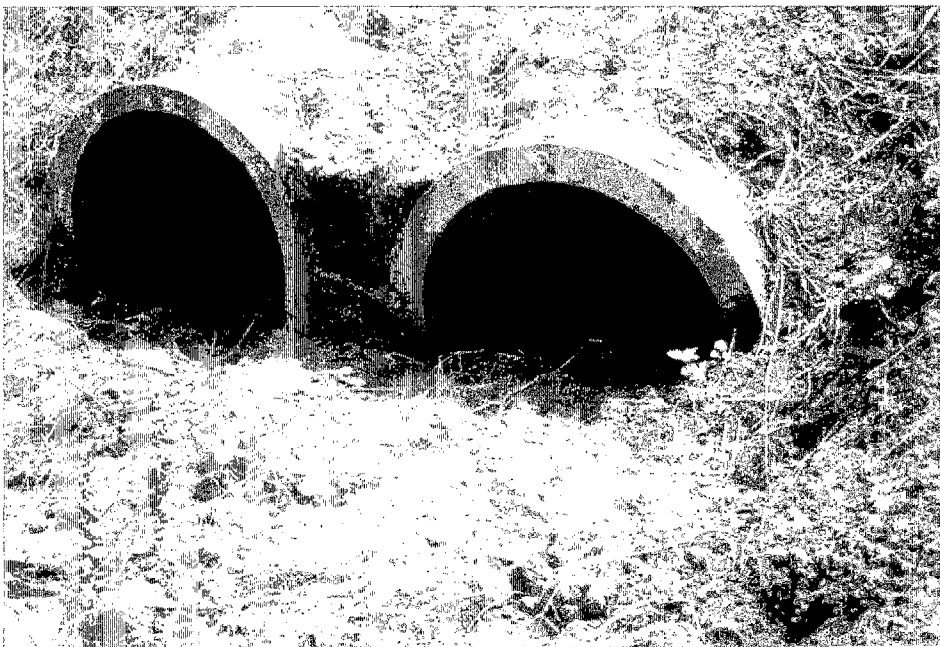
A typical solution of such a defect is shown here in figure I-2. Note that the culverts are locally made at the District Resident Engineer's yard as exemplified in figures I-3 and I-4 overleaf.

Figure I-2. Typical solution to the defect (in Figure I-1).

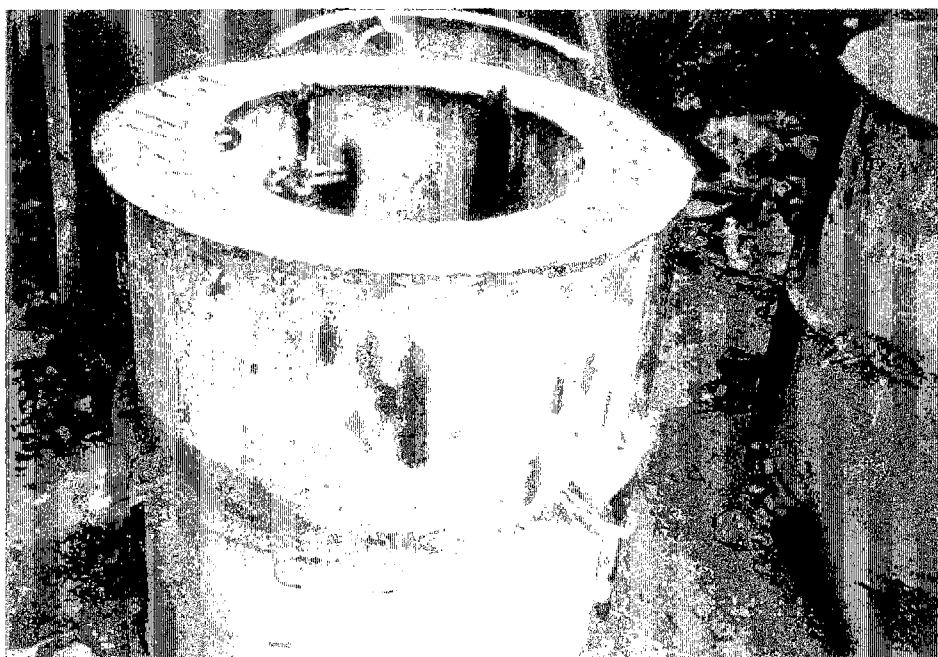
Figure I-3. Making of Culverts at the District Roads Engineer's yard.

The making of culverts requires very simple molds and aggregates and cement. This methodology (which is both appropriate and cost effective) of making culverts in the Danish project is shown in figure I-3 above. Each culvert made is calibrated with the date of manufacture for purposes of curing.

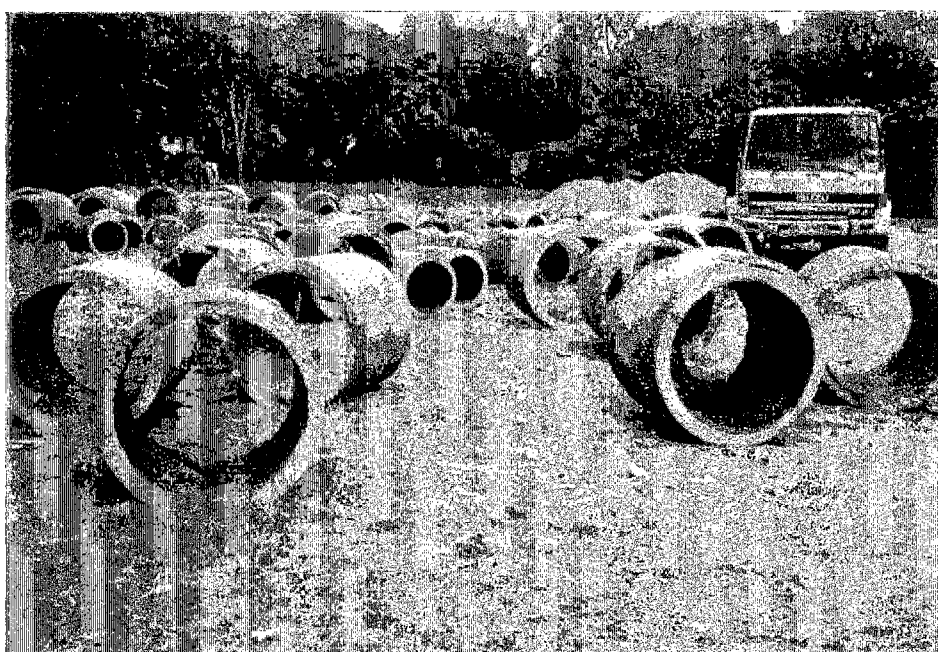
Figure I-4. Fully cured Culverts read for use at the District Roads Engineer's yard.

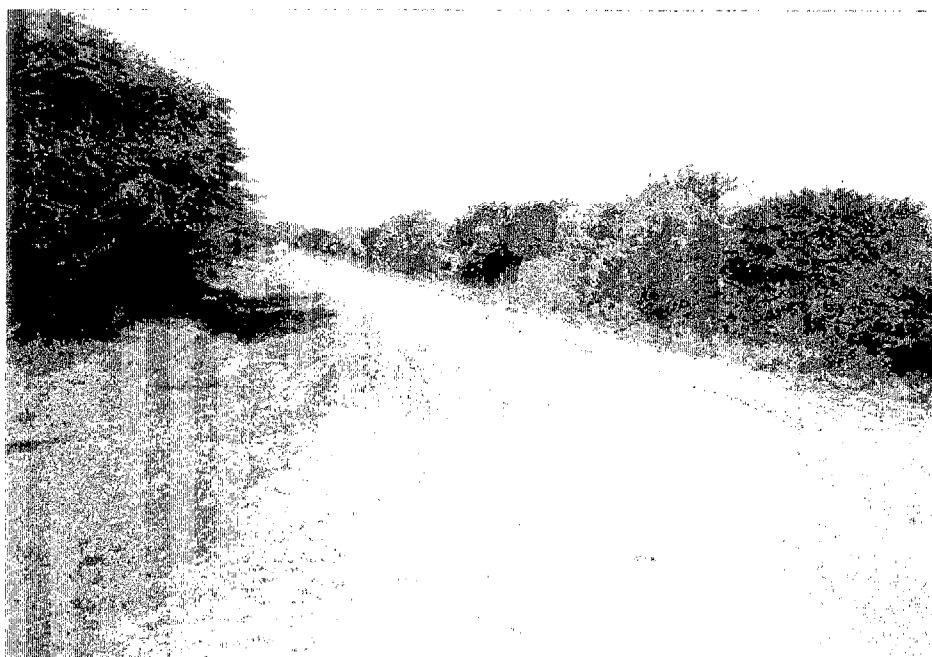
Figure I-5: Properly Maintained class D road in Malindi District.

Routinely maintained earth road is possible. For instance, if the drainage system and potholes are addressed, we obtain very pleasant trafficable roads as shown in figure I-5 (above) and figure I-6 (below) respectively.

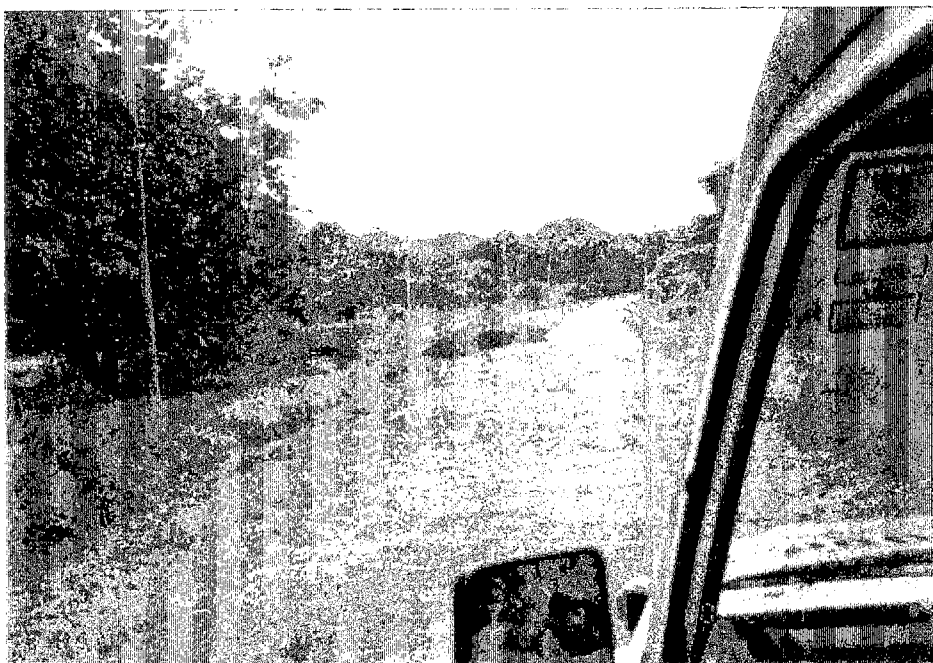
Figure I-7. Routine Maintenance of a classified road using lengthman.

Routine maintenance requires use of very simple tools such as slasher and jembe for cleaning weed (see figure I-7 above). The DRE has a four-wheel drive Japanese car for routine inspection of maintenance works (see figure I-8 below).

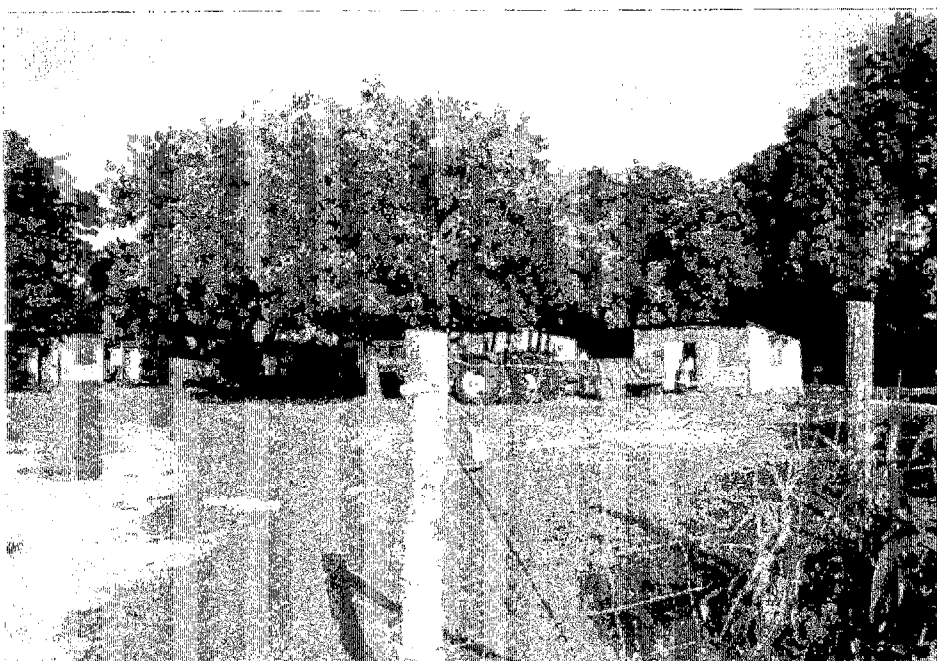
Figure I-9: Light Machinery for Transportation needs at Fundisa.

Off site quarry material transportation done by trailer-tractors centrally located in a maintenance camp established by MORPW (see figure I-9 above). Equipment maintenance is done at the camps. The trailers are simplistic as depicted in figure I-10 and spare parts are available locally at reasonable prices.

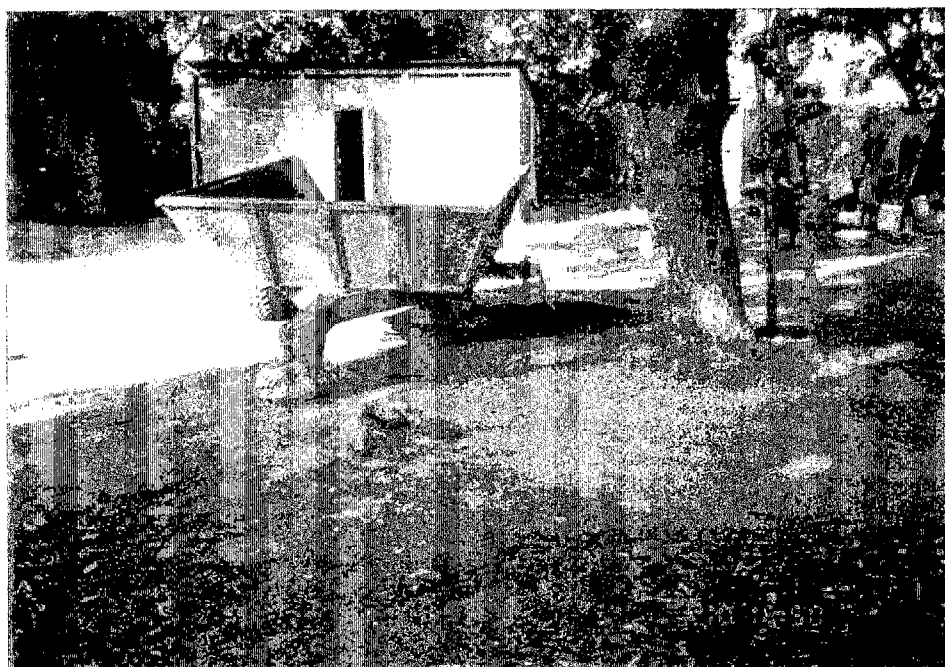
Figure I-10: Simple Trailer (locally assembled).

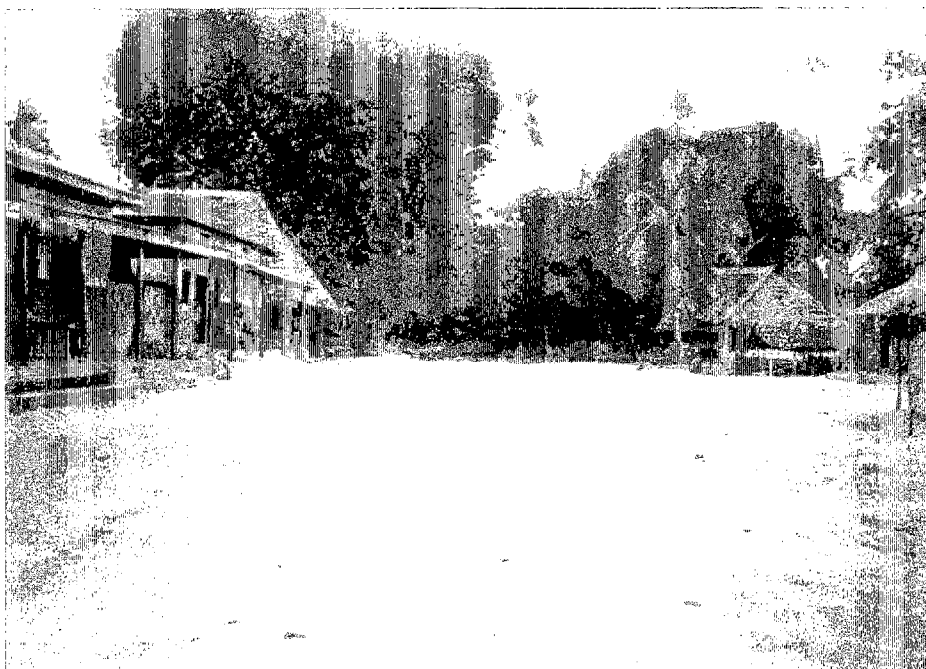
Figure I-11: Properly Maintained class C road serving a rural-urban center in the Province.

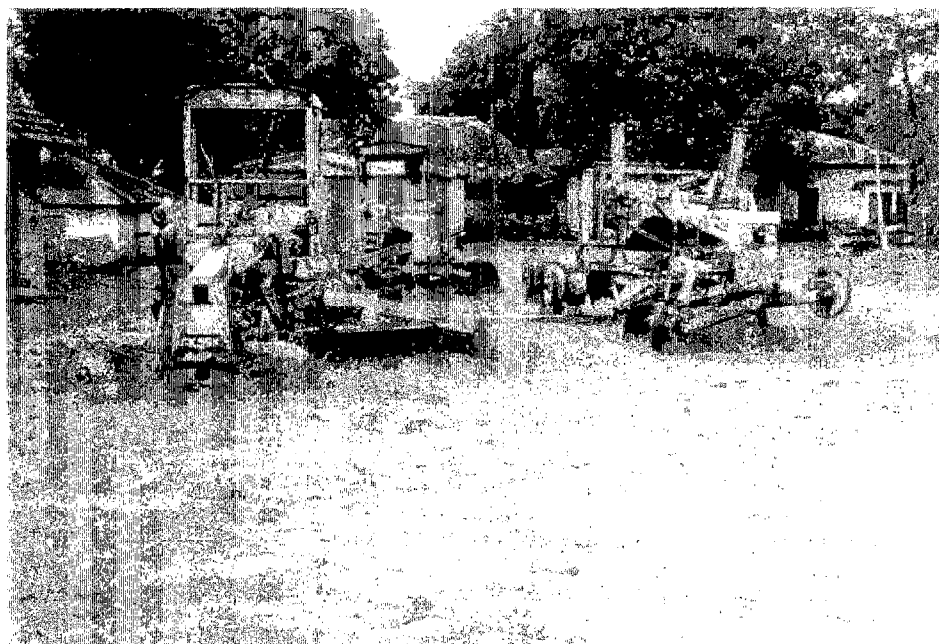
Finally, lack of vision and inappropriate road maintenance practices led to failure of RARP and MRP programs as illustrated in figure I-12 below. Similar scenario can be seen all over the Republic of Kenya, heralding the fact that equipment based methods are none sustainable in Kenya.

Figure I-12: Fruits of Unsustainable Maintenance Programs.

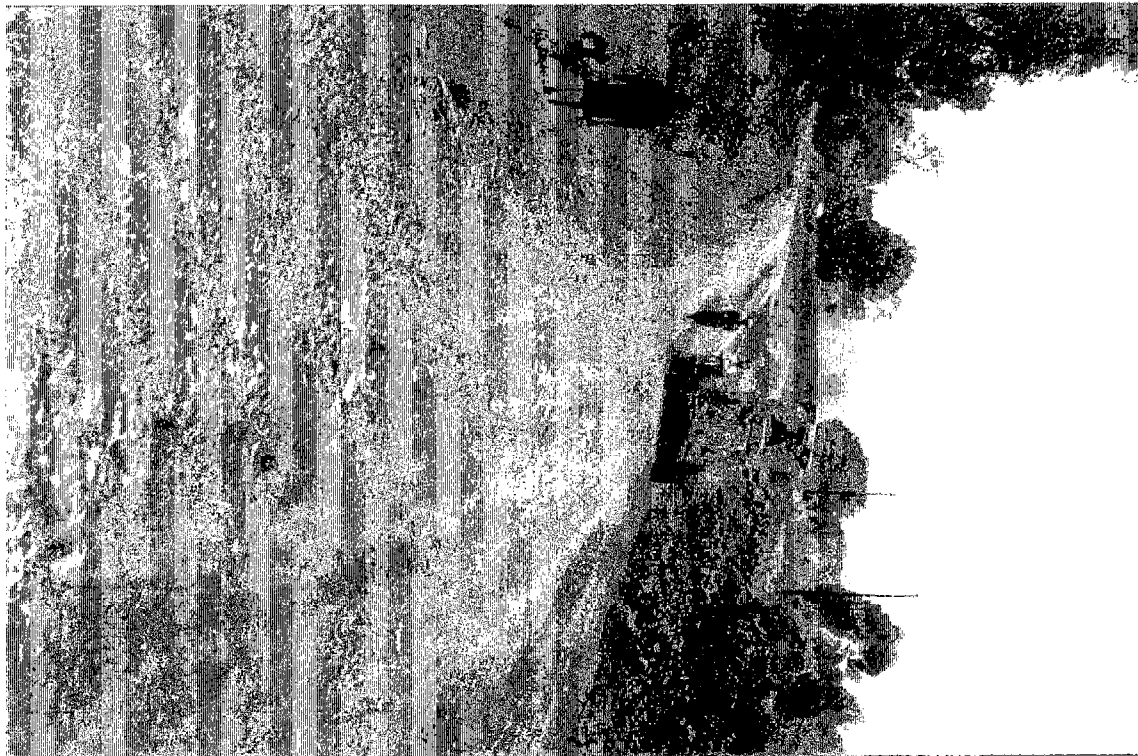
The first step in the maintenance procedure is grading of the roads, mostly with the use of GoK Grader machines to achieve the required road longitudinal and lateral profiles. The road profiles are made such that they follow the natural terrain as nearly as possible (see figure II-1). In a few instances labor-based methods are substitute by Grader equipment.

Figure II-1. MORPW Grader spreading quarry waste.

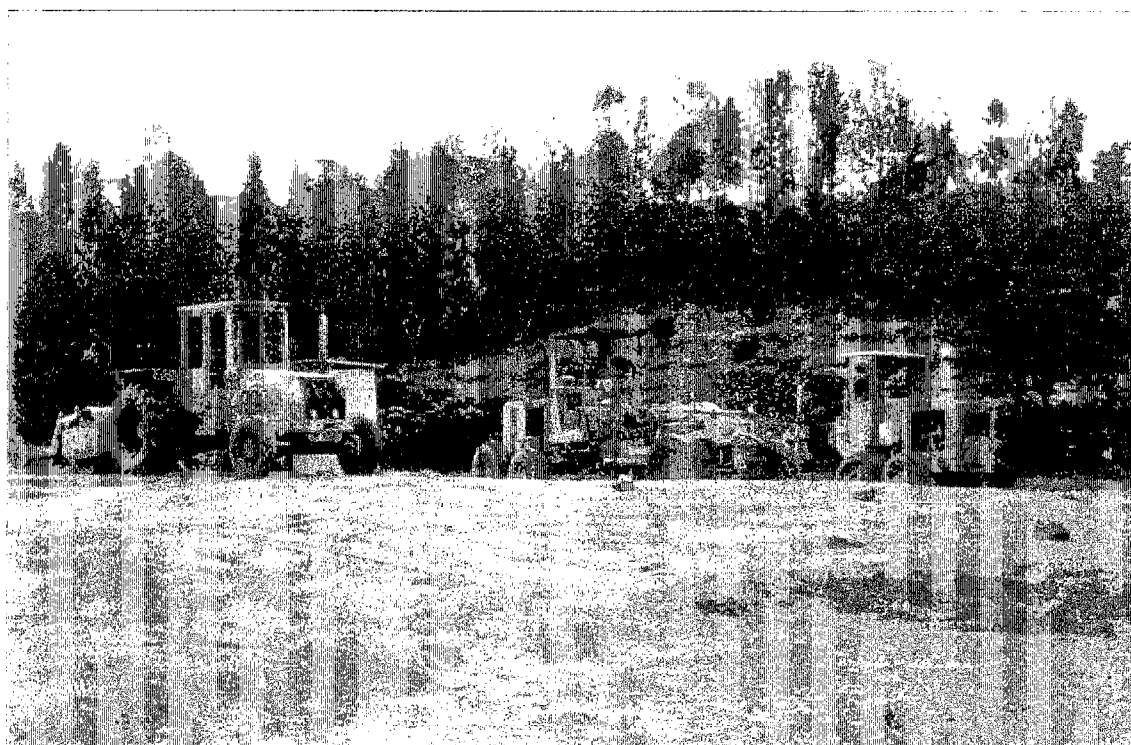
Due to lack of adequate machinery, the MORPW is compelled to hire plants from the private sector to expedite the construction activities. At the moment the government has only four graders and several rollers in good working condition. This machinery at the MORPW District camp yard is shown in figure II-2.

Figure II-2. MORPW Machinery on Roads 2000 Programme.

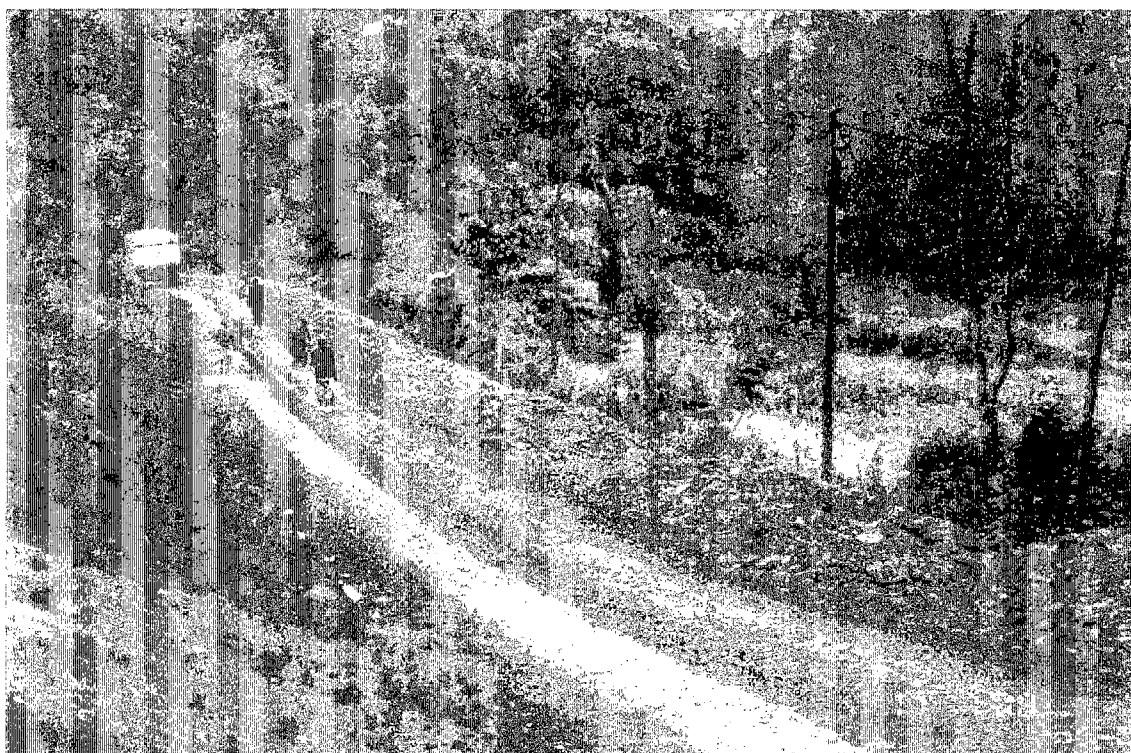
The local contractors supply the gravel and tip it at intervals adequate to form a 150 mm thick wearing course under the supervision of the District Roads Engineer's (DRE's). This is shown in figure II-3. The amount of gravel per unit length of the road under maintenance depends on a number of variables including the carriageway width. The source of gravel is from selected quarries which are readily available and in cross proximity to the works.

Figure II-3. Heaping of murrum/quarry waste prior to spreading

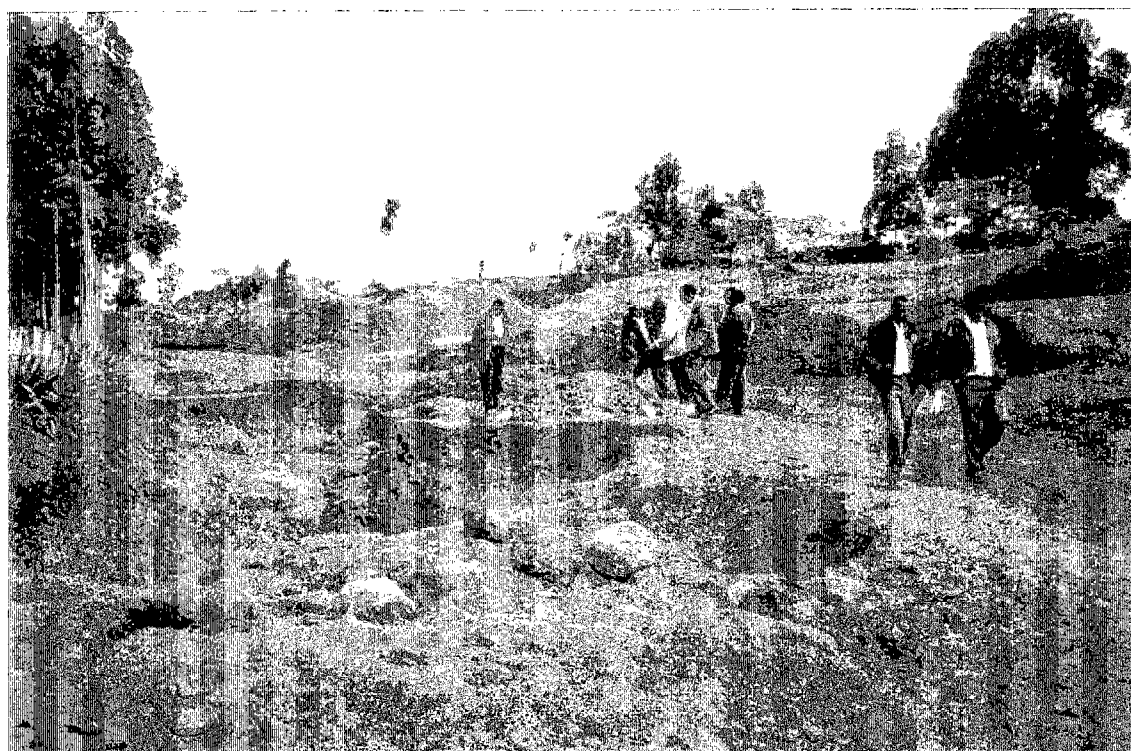
The MORPW Materials Department technical personnel identifies the quarries with good and adequate supply through field and laboratory tests and they continuously monitor the quarried material to note any changes in quality (refer to figure II-4).

Figure II-4. Identification and inspection of quarry/murrum source.

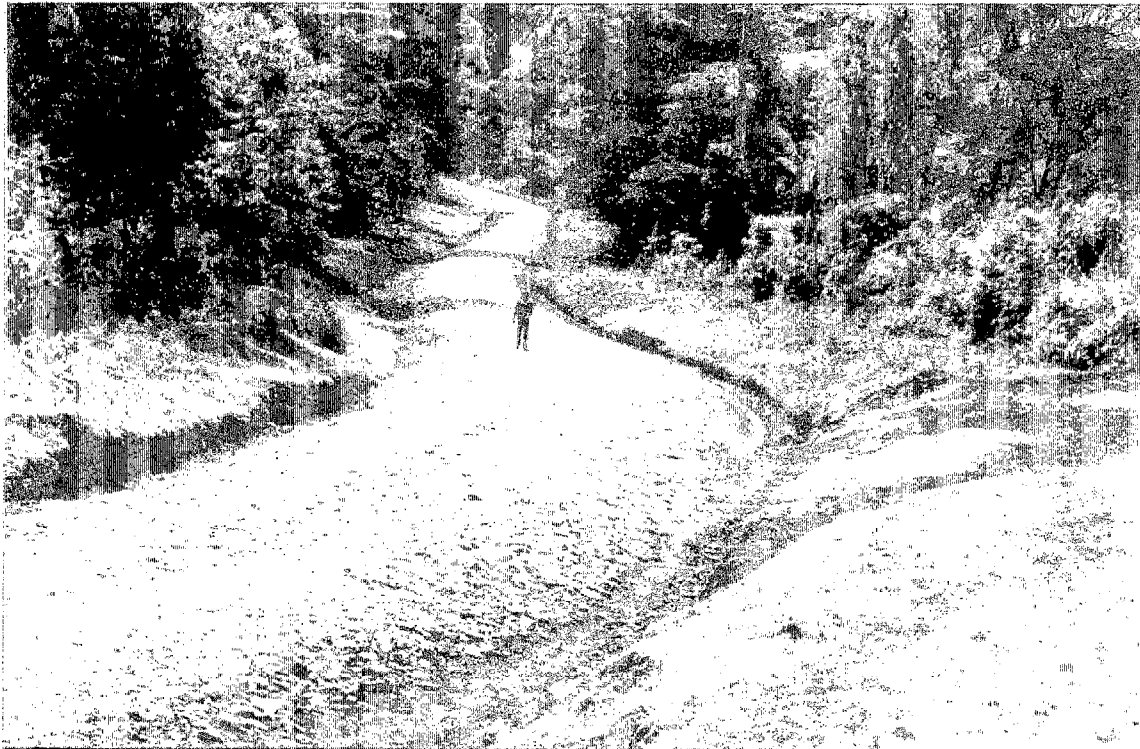
Either labor-based methods or machinery is employed to spread and level the gravel (or quarry waste) to the required grade and falls. These methods are well illustrated in figure II-5 and figure II-6. Reference can also be made to figure II-1 above.

Figure II-5. Spreading murram/quarry waste using labor based methods.

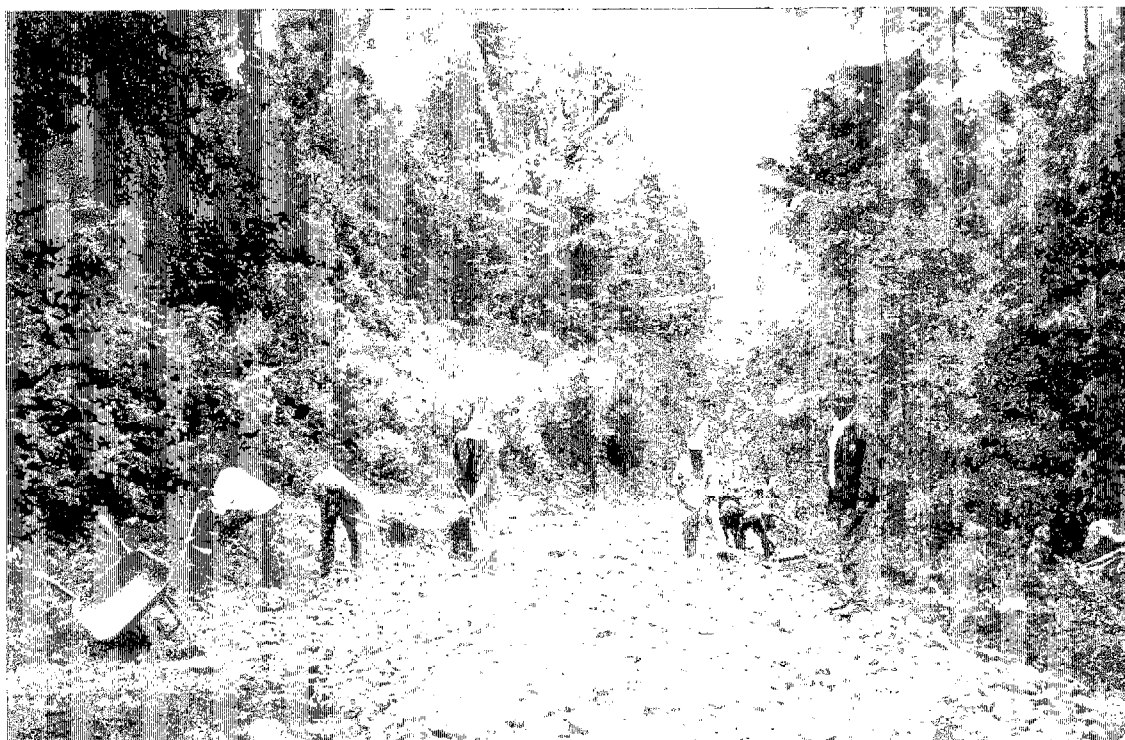
Figure II-6. Labor methods on Roads 2000 showing simple equipment.

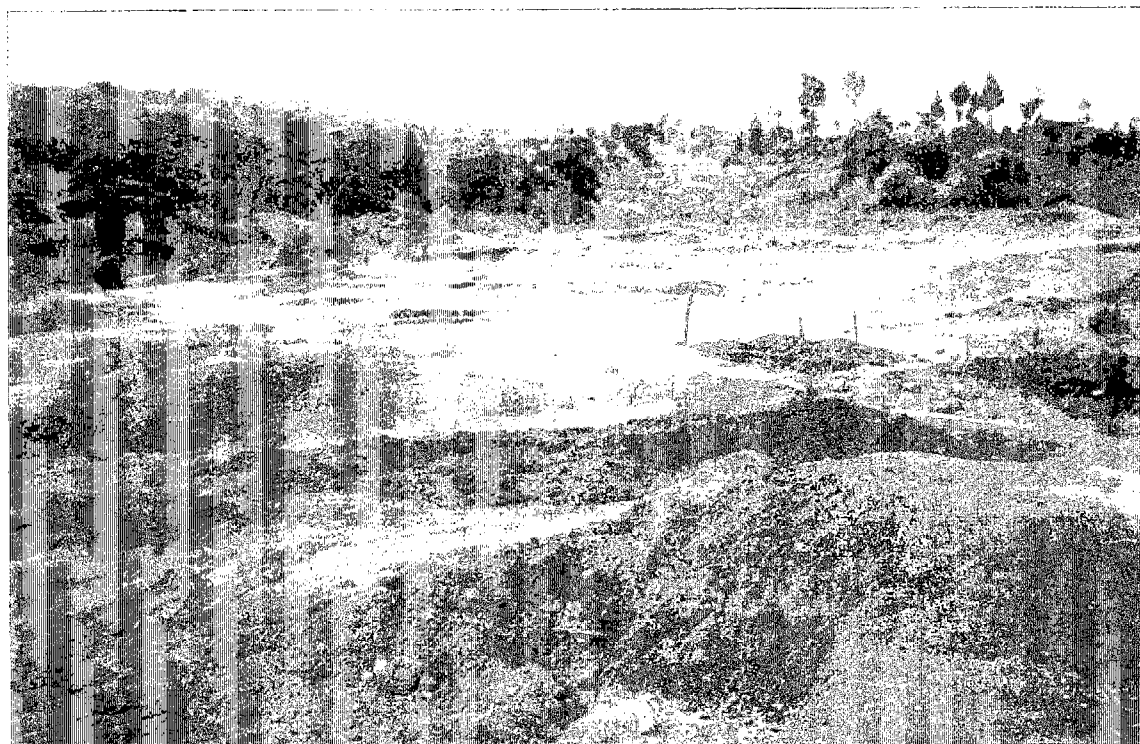
Figure II-7. Damage to the environment as a result of quarry mining.

Local contractors have the necessary equipment for mining the gravel and adequate labor force for excavating murram. Unfortunately the open mine methods of extraction have adverse effect on the environment since the depressions and pits created are not backfilled. This leads to soil erosion, degradation of natural vegetation, stagnation of rainwater leading to proliferation of water-borne diseases. A typical quarry left behind after material excavation is shown in figure II-7. From this picture it can be appreciated that the status of this zone is in great contrast with the other greener areas in the neighborhood. So far the GoK-Sida counterpart efforts have not properly addressed the aftermath of exploiting the environment.

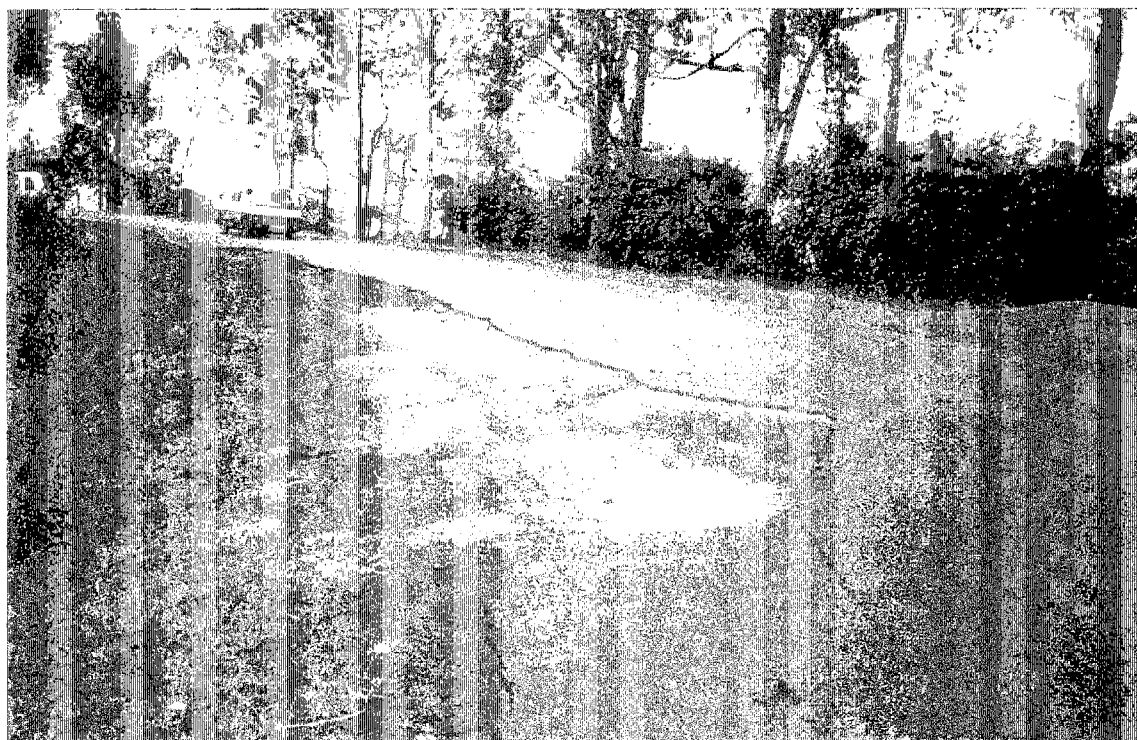
The major trunk and classified roads (class A, B, and C) in the district are not covered by this Programme. These are funded from different kitty. Some of these roads are heavily in need of rebuilding as they serve a lot of traffic and are fed by the roads covered by the Programme (see figure II-11). In one instance, a firm contracted by the government to rehabilitate a class "B" road abandoned works after stripping the pavement and getting paid full contract amounts for works not carried out.

Figure II-11. Damage part of class B road requiring spot improvement.

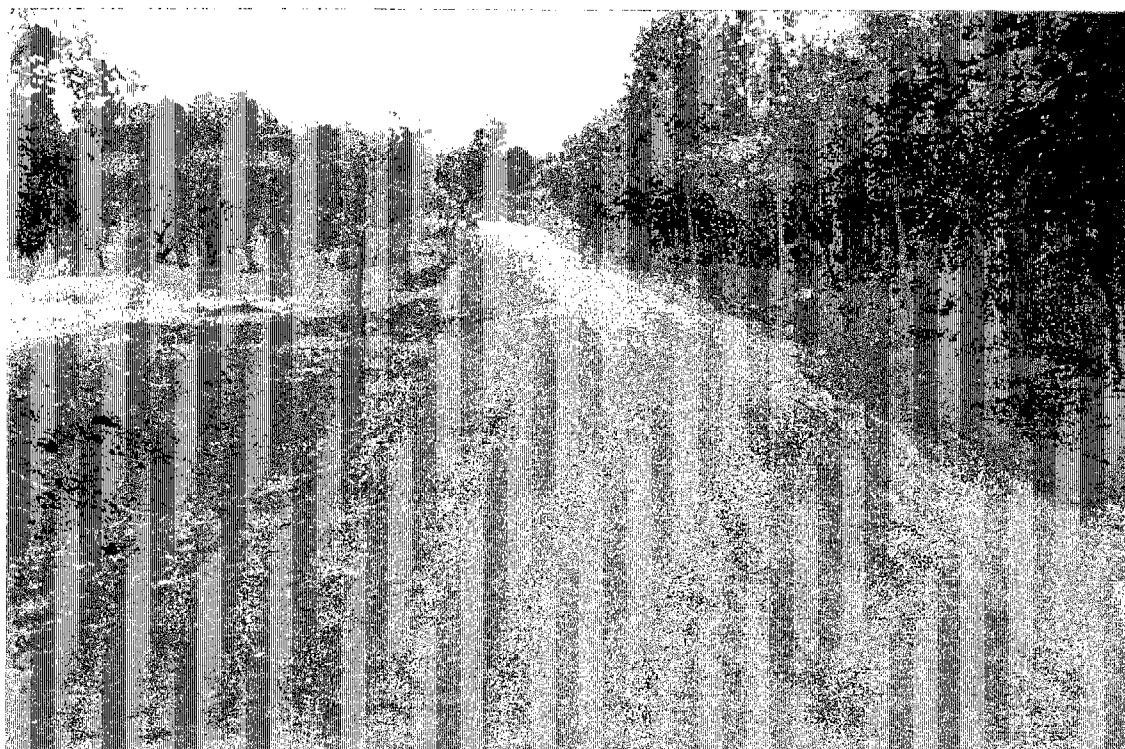
The reason behind this project stalling is a dispute on the contractor certificate of payment which had been prepared with a lot of flaws. He was asking money for works either not done or down below the expected standards. The Donor's appointed consultant refused to approve this claim. Therefore, the contractor abandoned the site claiming that the consultant had no mandate to object to a certificate prepared by a compromised resident engineer. Initial Survey Works on the project are available but the consequent measurements to determine the amount of works already done by the contractor were not available. This is due to the laxity on the part of the resident engineer to take measurements. The resident engineer has signed the payment certificate for payment albeit having no build up computations (back up) to authenticate the certificate. While the contractor insists

that he had completed the works and was due for payments, figure III-2 conveys a different message.

Figure III-2. Bush clearing and drainage structures incomplete in a class D road.

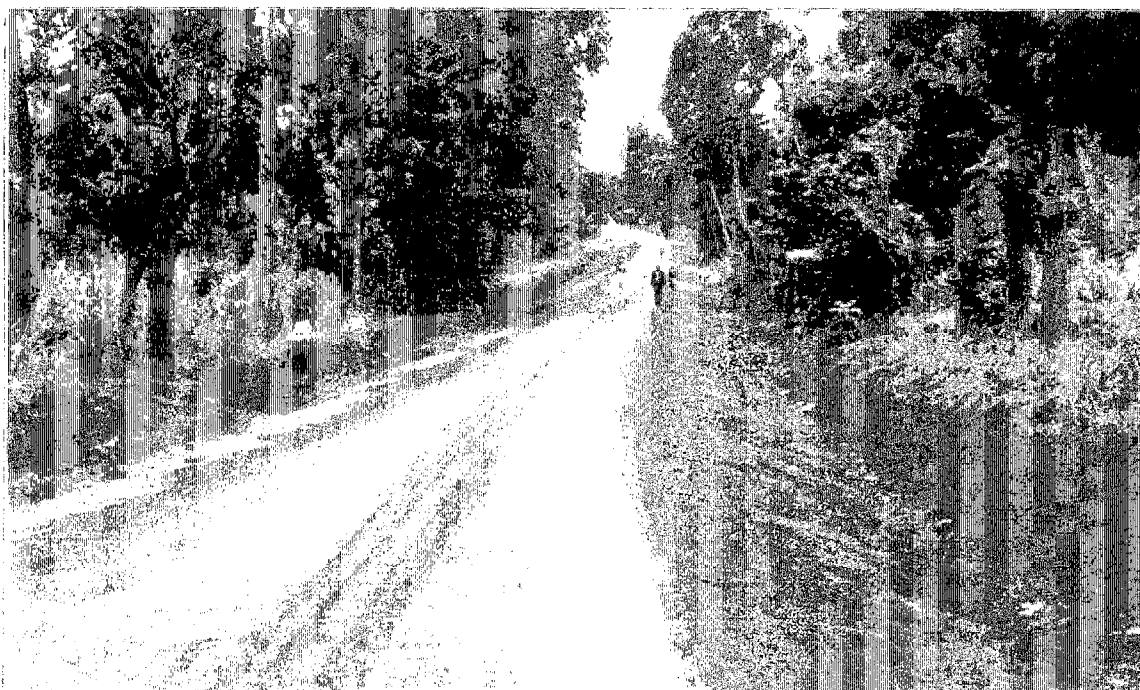
This class D road is located in the same neighbourhood as the privately contracted road. This is a direct labor project and the supervising authority is public works through the DRE. The reshaping of the longitudinal and cross files to formation level is all done by human labor as illustrated in figure III-3.

Figure III-3. A class D road at formation level using labor intensive methods.
