Town Maliana	No. & Facility: 12-Lesubotang Reservoir	Year of Construction	Financed by:
Existing Condition: <i>Facility:</i> Service Reservoir <i>Structure:</i> reinforced concrete <i>Shape:</i> rectangular <i>Dimension:</i> 5.5m x 6.3m x 2.1m height <i>Storage Capacity:</i> 50m ³ <i>Function:</i> Supplies the Santa Cruz Reservoir from Dabuci springs. <i>Source of Water:</i> Beapelu/Dabuci/Beamos spring <i>Elevation (amsl):</i> <i>Accessories:</i>		Photograph:

Table 5.15 REHABILITATION PLAN FOR MALIANA

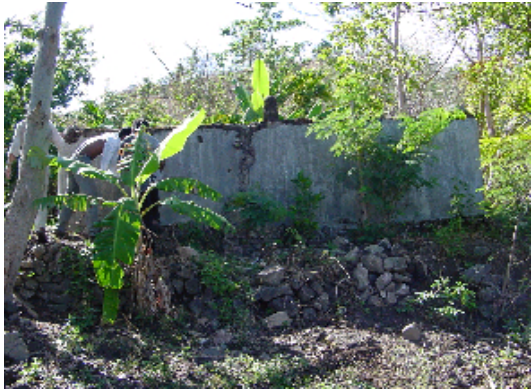
(Date:)	
Evaluation: a) In operation b) Tank is not covered with floating foreign matters. c) Lacks routine maintenance.			
Rehabilitation Plan: 1) <i>Basic Consideration</i> 2) <i>Civil Work:</i> Installation of appropriate cover/roof and construction of security fence. Installation of water level gauge. Mortar lining on the concrete walls 3) <i>Piping work:</i> Installation of 75mm flow meter and controller. 4) <i>Mechanical work:</i> none 5) <i>Electrical work:</i> none 6) <i>Miscellaneous:</i> Installation of chlorine dosing devices.

Estimated cost: US\$10,040		Construction schedule:	Priority: B-2

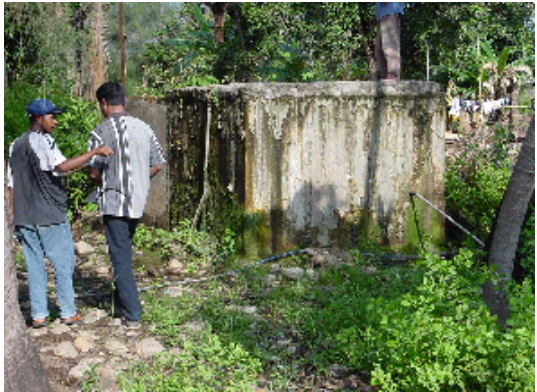
Town Maliana	No. & Facility: 13-Ritabou Reservoir	Year of Construction	Financed by:
Existing Condition: <i>Facility:</i> Service Reservoir <i>Structure:</i> Reinforced concrete <i>Shape:</i> Rectangular <i>Dimension:</i> 3.8m x 2.3m x 1.8m separated two rooms <i>Storage capacity:</i> 3m ³ <i>Function:</i> storage <i>Source of Water:</i> Colegio spring <i>Elevation (amsl):</i> <i>Accessories:</i>		Photograph:

(Date:)	
Evaluation: a) In operation b) Lacks routine maintenance			
Rehabilitation Plan: 1) <i>Basic Consideration</i> This community based system will be connected to the town's water supply. 2) <i>Civil Work:</i> Construction of security fence 3) <i>Piping work:</i> Installation of distribution main 50mm x1km to connected with the town's water supply. 4) <i>Mechanical work:</i> none 5) <i>Electrical work:</i> none 6) <i>Miscellaneous:</i> none			
Estimated cost: US\$12,200		Construction schedule:	Priority: B-2
