3) Soil Investigation

(3) No.9 Taskourt

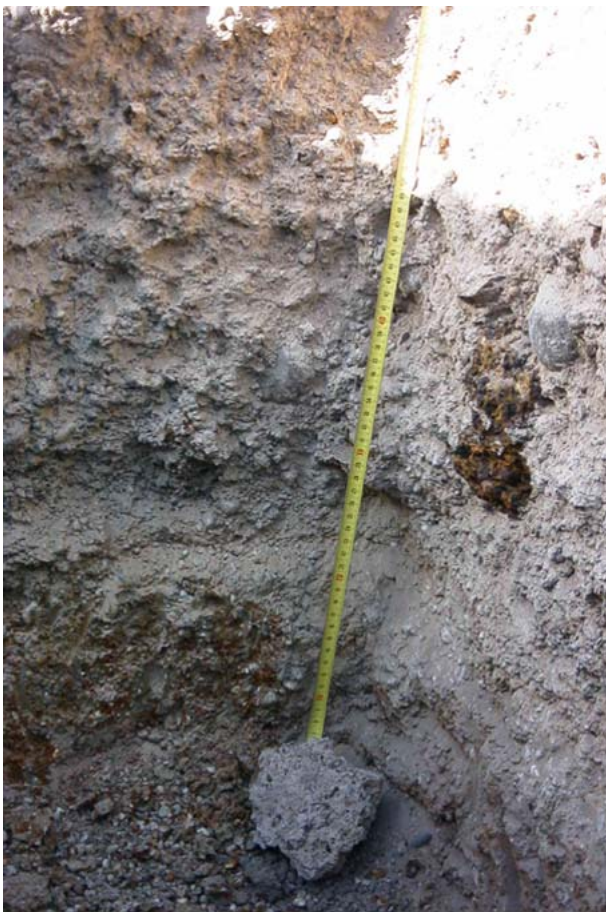
Photo No.16
Point ① Class IV

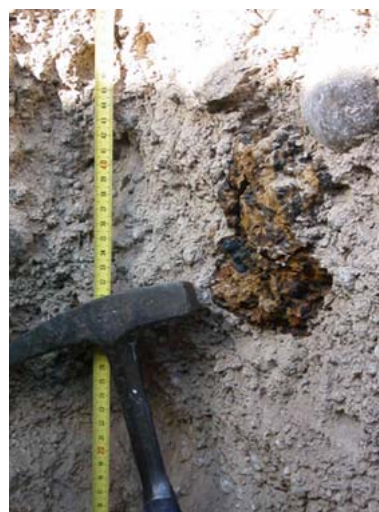
Photo No.17
Concretion in impermeable layer

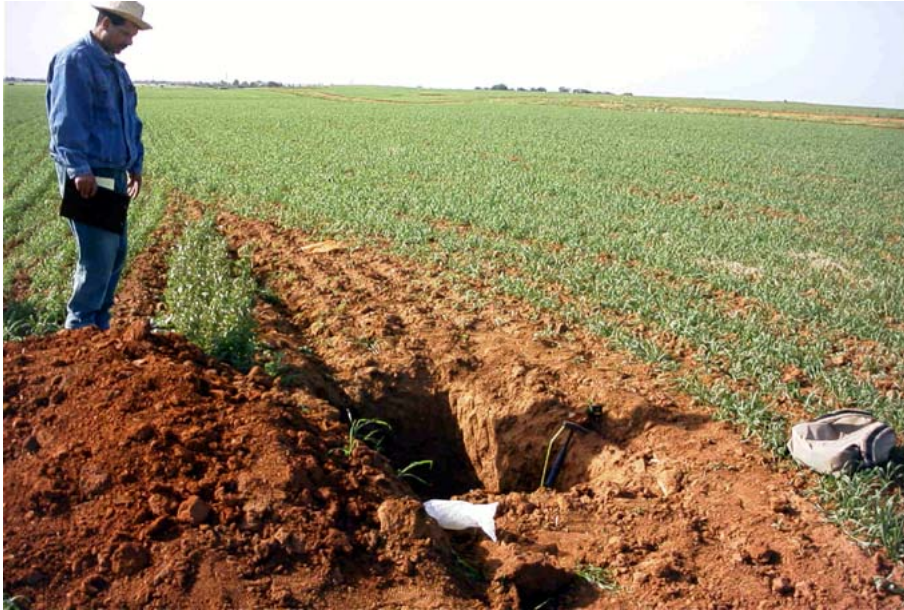
Photo No.18
Point ② Soil Profile
and View
(Northeast of Potential
Area)

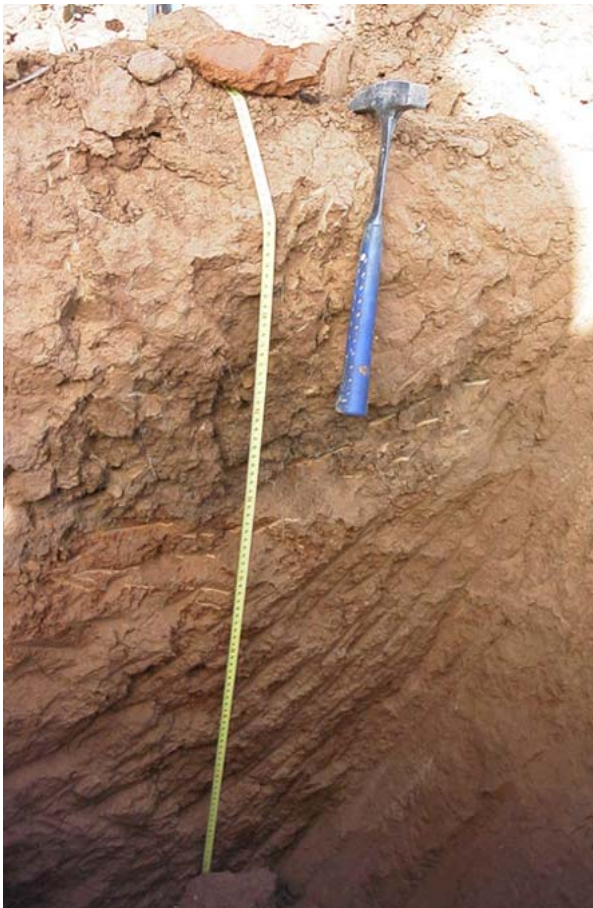
Photo No.19
Point② Soil Profile
Land Suitability: Class II

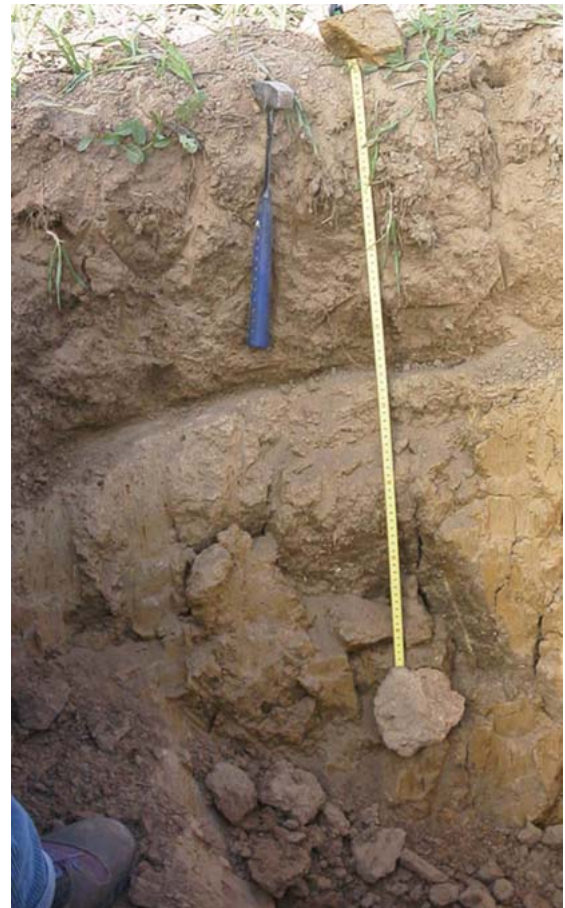
Photo No.20
Point③ Soil Profile
Land Suitability: Class III

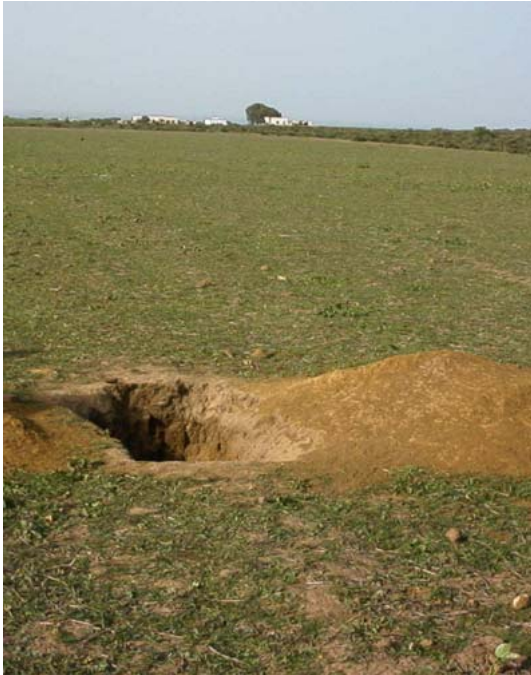
Photo No.21
Point⑤ Soil Profile
Land Suitability: Class III

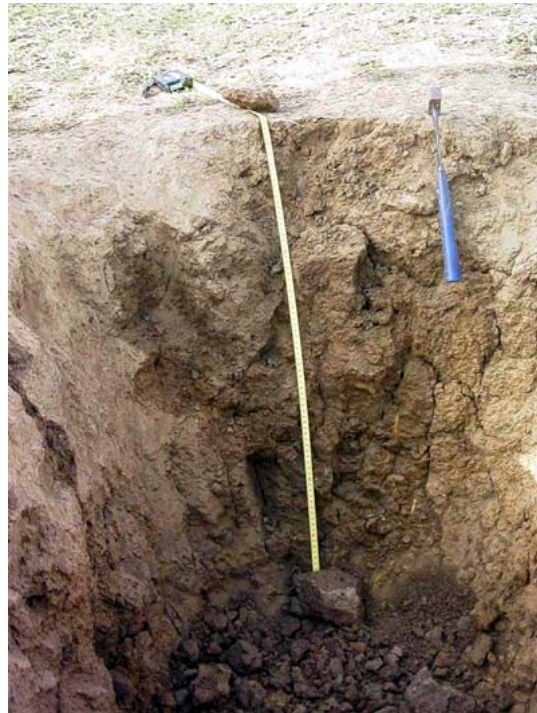
Photo No.22
Point⑤ Soil Profile
Land Suitability: Class III

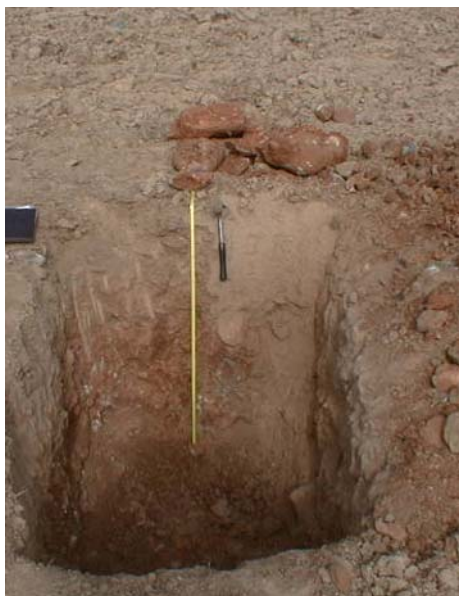
Photo No.26
Point①, Class III
Sol a Sequioxydes de Fer

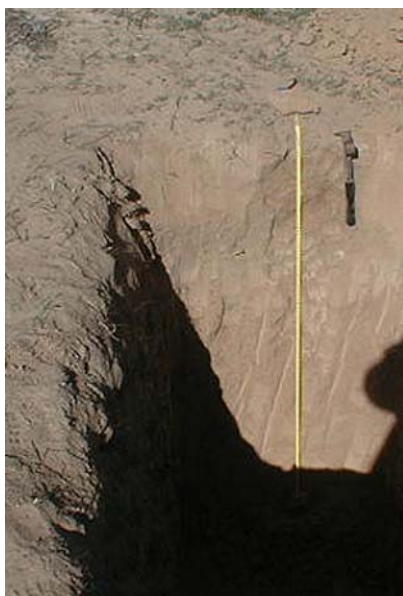
Photo No.27
Point②, Class II
Sols Peu Evolues

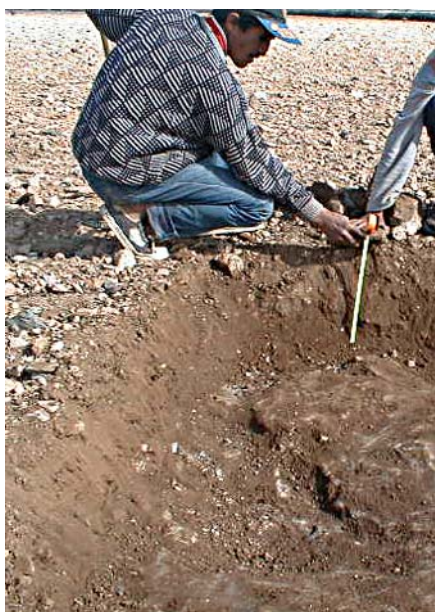
Photo No.28
Point③, Class IV
Calcimagnesiques
Shallow Soil Depth
