No. 41 Hun Nam

No.44 Song Thuan

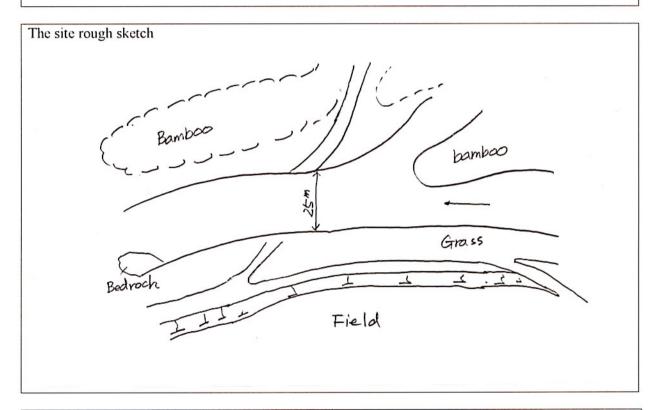
Photo 2: Proposed Location

- 1) There has been no bridge there. People in the vicinity communes cross the river in dry season.
- 2) There is little traffic on the access road to this crossing point due to the narrow earth road. People in the vicinity communes cross the river to access to NR1.
- 3) Whereas the water level in dry season is 0.5m in depth, it reaches to 5.5m in rainy season. In rainy season, as the flow become fast, some people have been drown when crossing the river.

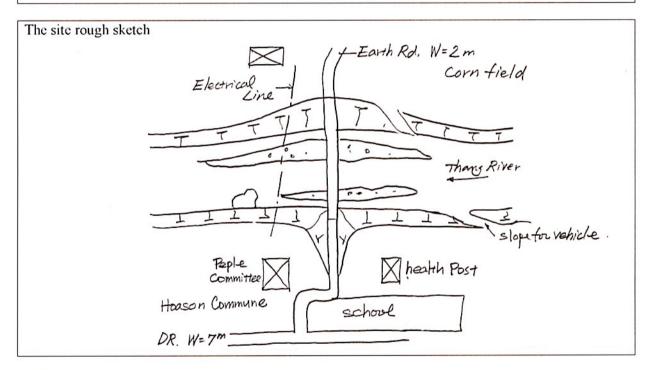
Photo 2: Existing Bridge

- 1) This bridge connects 4 communes on the right bank with school, health post and people committee and district center of Ninh Son on the left bank. It was constructed to ensure the safety crossing. Vehicles can cross the river in the dry season. Since the access road bound for opposite direction on the right bank has bad condition in rainy season, it is difficult for vehicles to pass on.

- 2) The bridge is a suspension bridge type for pedestrian and bikes constructed in 1999. All components of the bridge still looks stable. Although A2 abutment has seriously damaged by flooding in 2000, it was repaired by gabion mattresses.

- 3) HWL is assumed to be 0.3m below the bridge surface according to interview result.
- 4) An access road on the left bank has already upgraded by WB fund. Provincial government is looking for fund for upgrading the road on the right bank.

- 5) Proposed bridge location should be shifted away from school and health post on the left bank. The riverbed is covered by boulders and bedrocks and expanded foundation will be applicable.
