Village Name : *Mtinko*

Village Name : *Malamba*

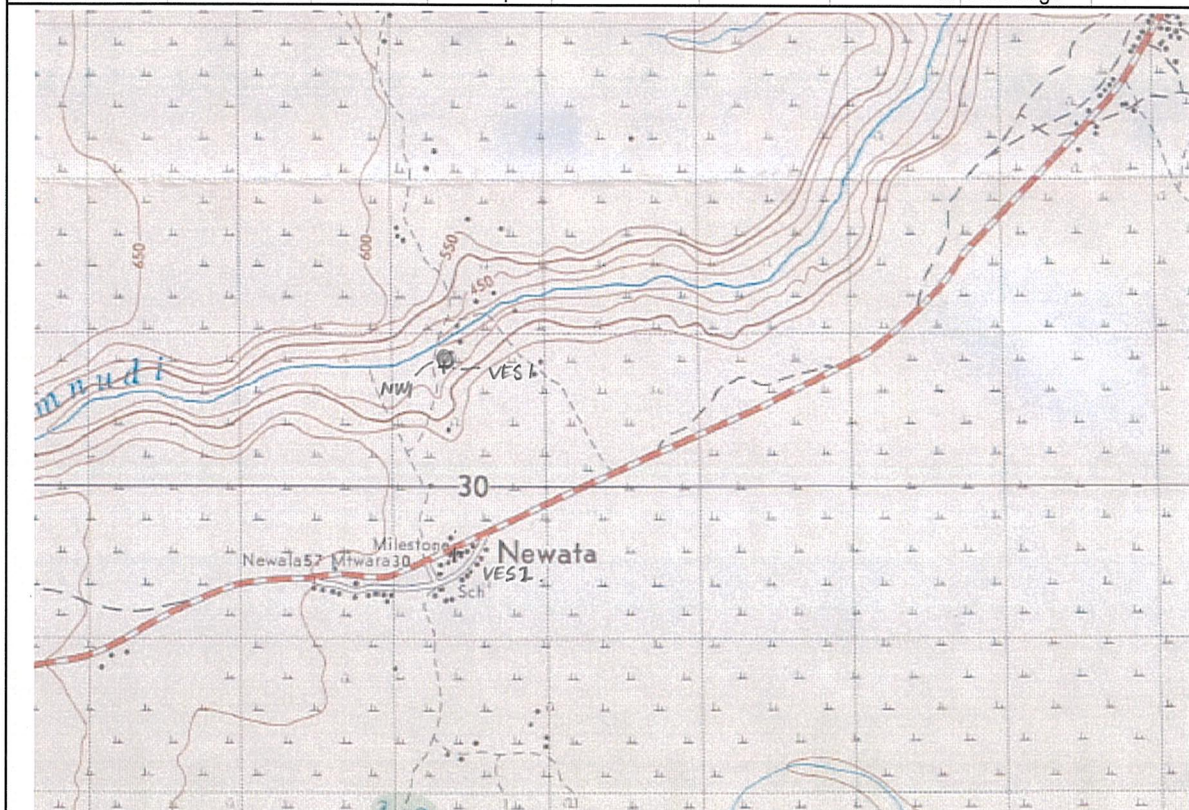
| Geology | Surface : <i>sand</i> | | Underground : <i>fine sandstone</i> | | |
| Geological Structure | Lineaments : | | Direction : <i>N90E</i> | Strike/Dip | / of |

| Vertical Electric Survey Result | Value range | <i>40 - 70</i> | Sequence | <i>60 -</i> |
| Comments | <i>Insufficient data to analyse deep profile</i> | | | |

| Groundwater Development Plan | | | Type | | | |
|---|---|---|---|---|---|---|
| NW1 | N: 88 30 750 | E: 604 350 | ± 140 | 60-120 m | 150 m | E (37021 m³/h) |

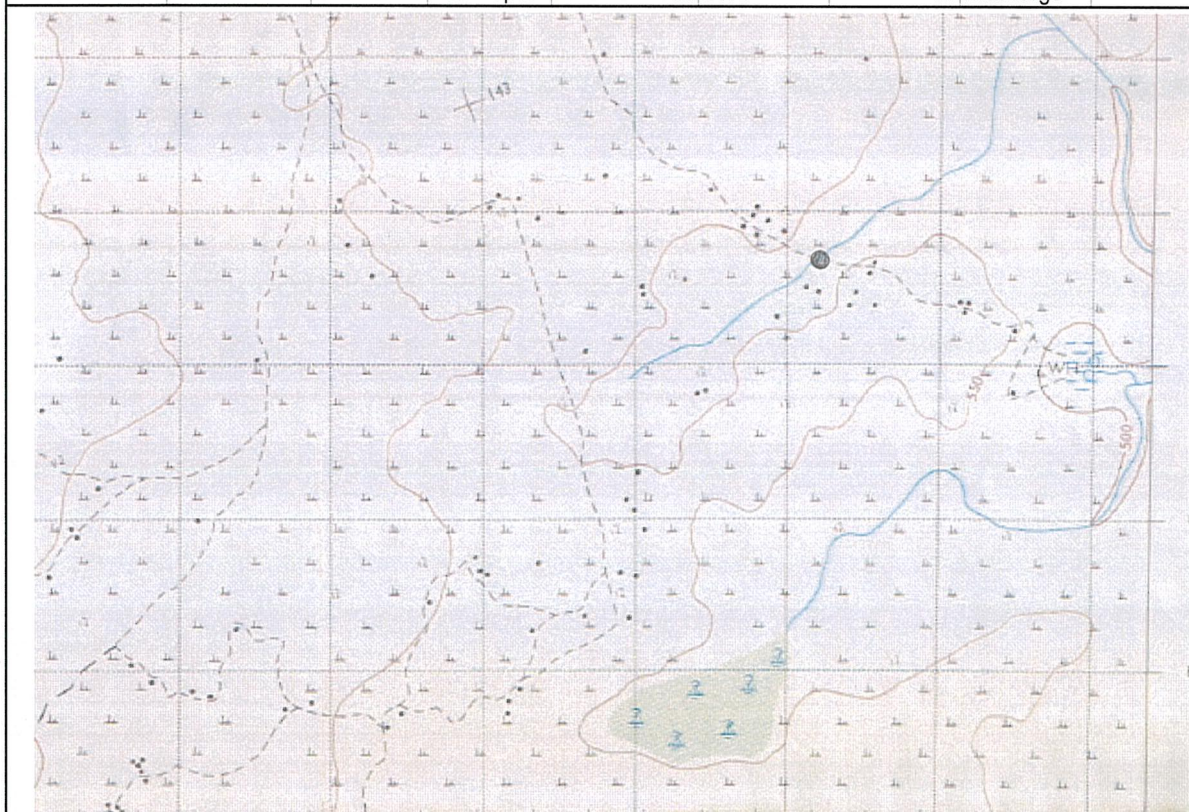
| Geology | Surface : <i>sand</i> | | Underground : <i>sandstone</i> | | |

| Comments | <i>VES1 90m ~, 12Ωm VES2 29m ~, 12m</i> | | | |

| Groundwater Development Plan | | Type | | | | |
|---|---|---|---|---|---|--|
| | N: E: | 170 | 60 m | 120 m | <i>D (3~5 m³/h)</i> | |
