Village Name : Mahurunga

Village Name : *Dihimba*

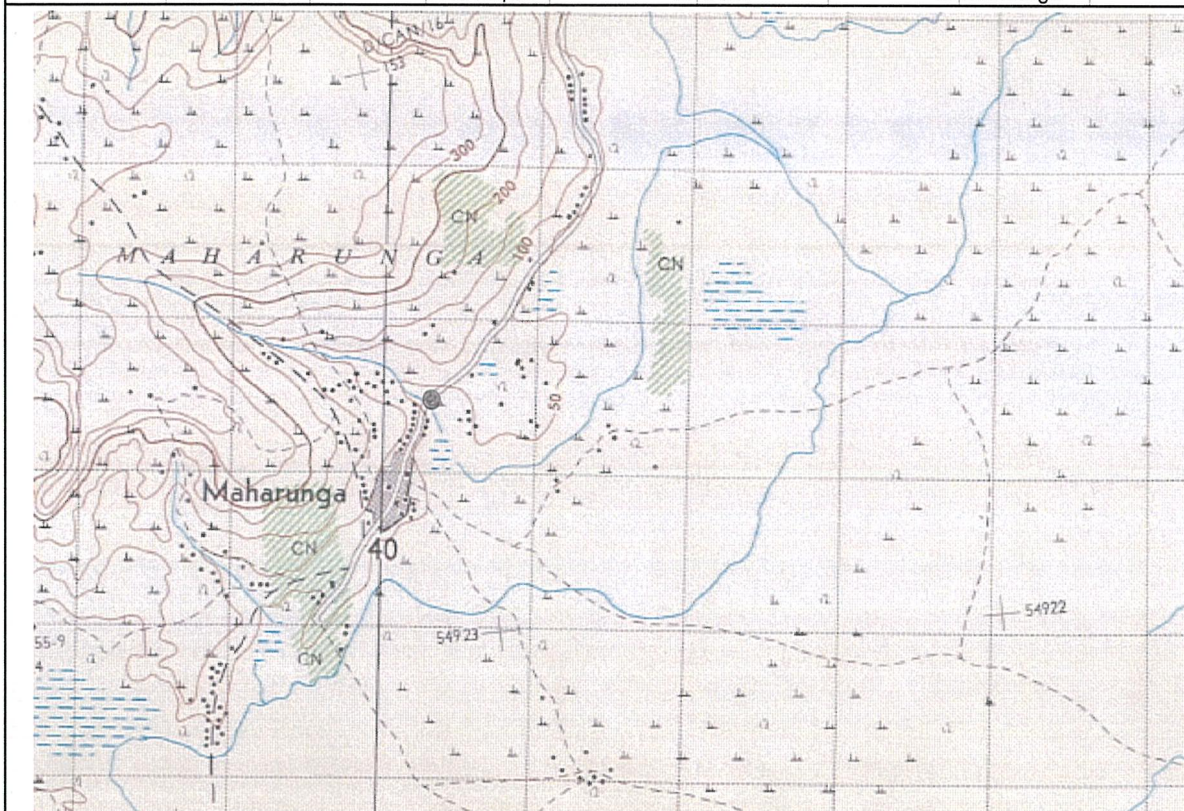
| Topographical feature | Flood plain | | | | |
| Geology | Surface : sand ~ gravel | | Underground : lime stone ~ sandstone | | |

| Vertical Electric Survey Result | Value range | 20 - 30 | Sequence | 60 - |

| Groundwater Development Plan | | Type | | | | |
|---|---|---|---|---|---|--|
| | N: 8834 500 E: 640 300 | 15 | 20 m | 100 m | B (10 ~ 30 m <sup>3</sup> /h) | |

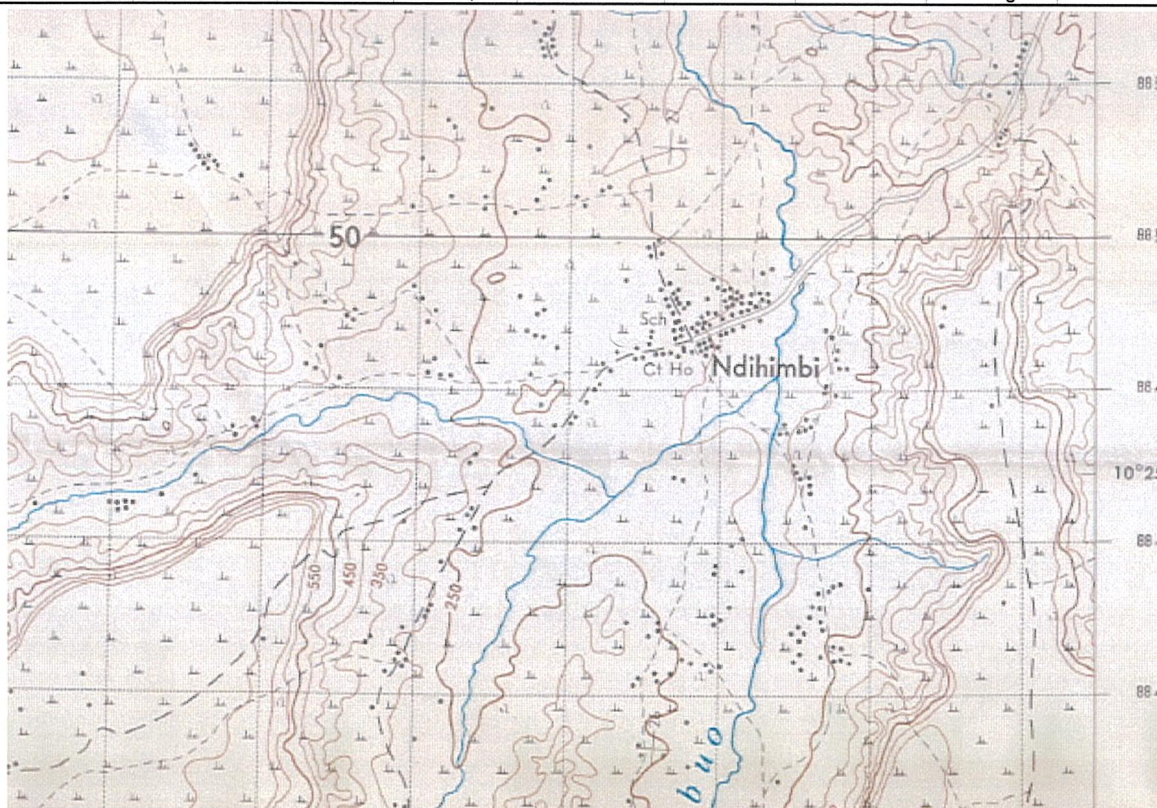
| Geology | Surface <input type="checkbox"/> <i>sand</i> | <input type="checkbox"/> Underground : | | <input type="checkbox"/> <i>sandstone</i> | |
| Geological Structure | Lineaments : <i>clear</i> | Direction : <i>E-W, N-S</i> | Strike/Dip | / of | |

| Groundwater Development Plan | | Type | | | | |
|---|---|---|---|---|---|--|
| | N: 8849250 E: 606600 | 90 | 40 | m 150 | C (10 > Q > 5 m <sup>3</sup> /h) | |
