Figure 5.6.1 Overview of New Settlement Areas in the Kathmandu Valley

Figure 5.10.1 Existing Road Network

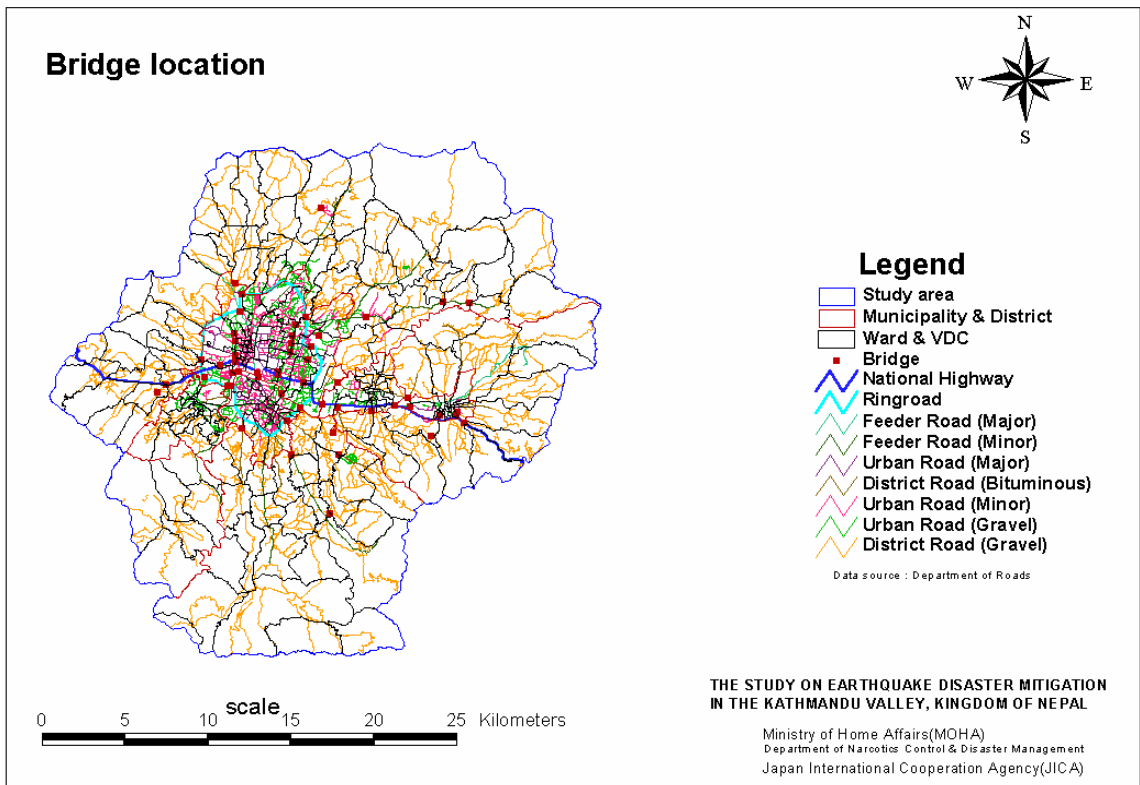
Figure 5.10.2 Existing Bridges

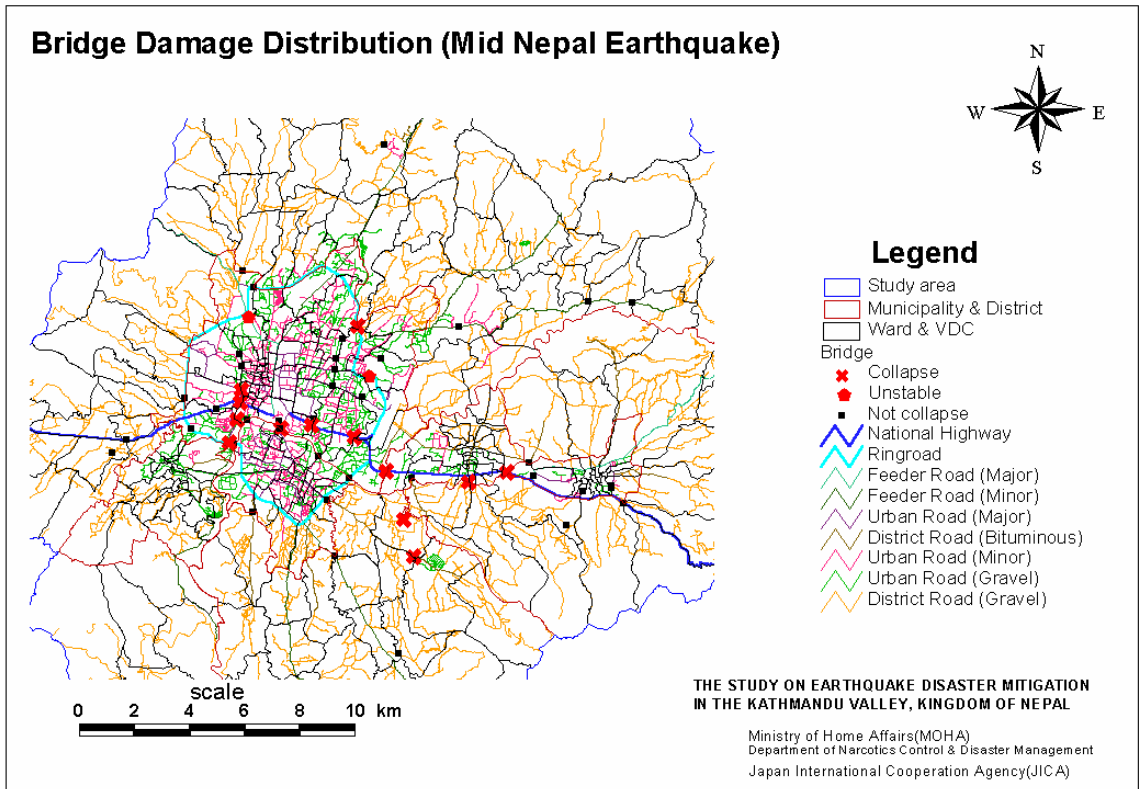
Figure 5.10.3 Damage to Bridge

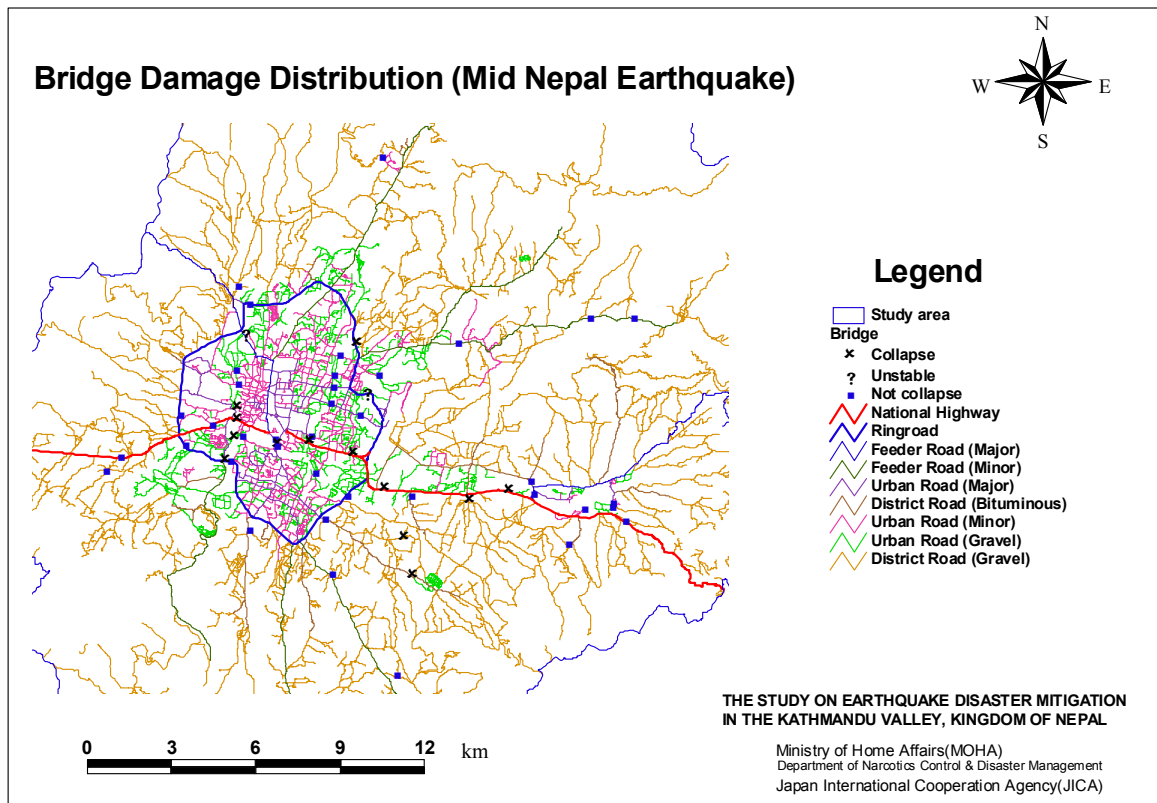
Figure 5.10.4 The Strategic Road Network for Earthquake Disaster Mitigat

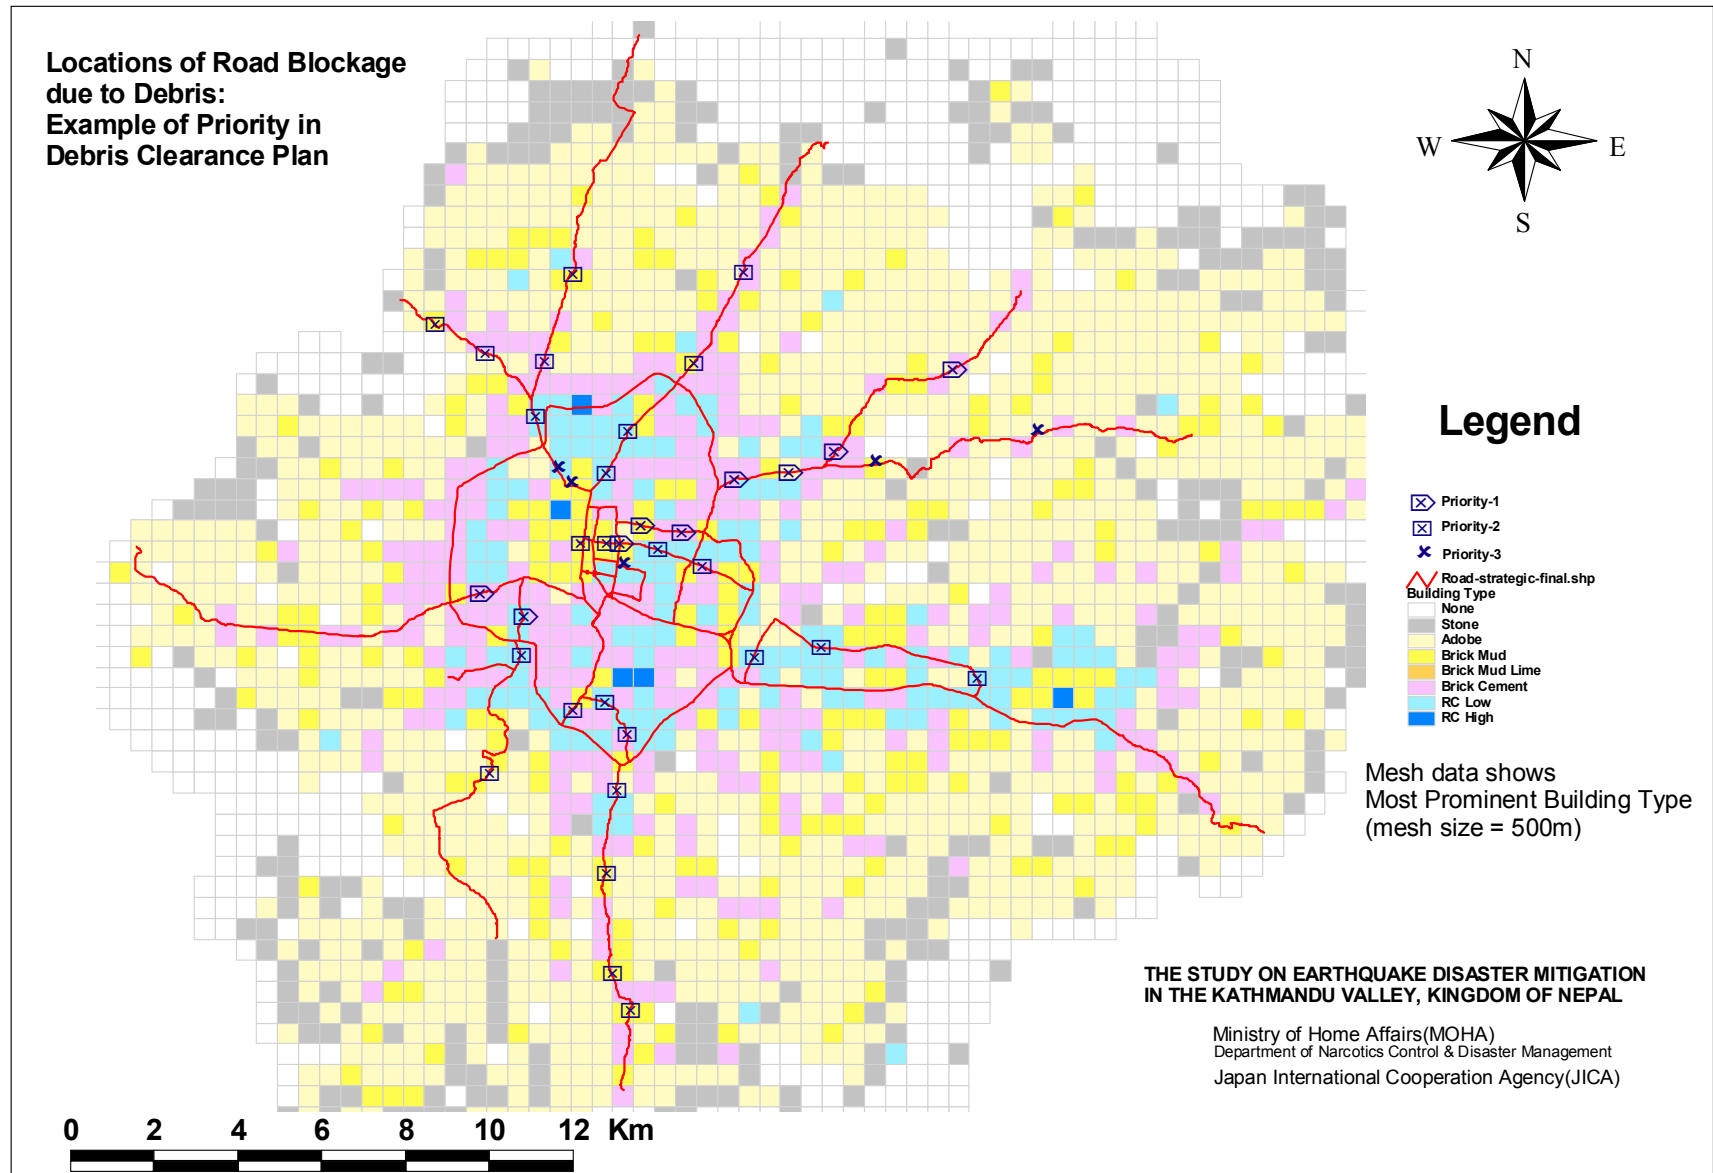
Figure 5.10.5 Example of Priority in Debris Clearance Plan

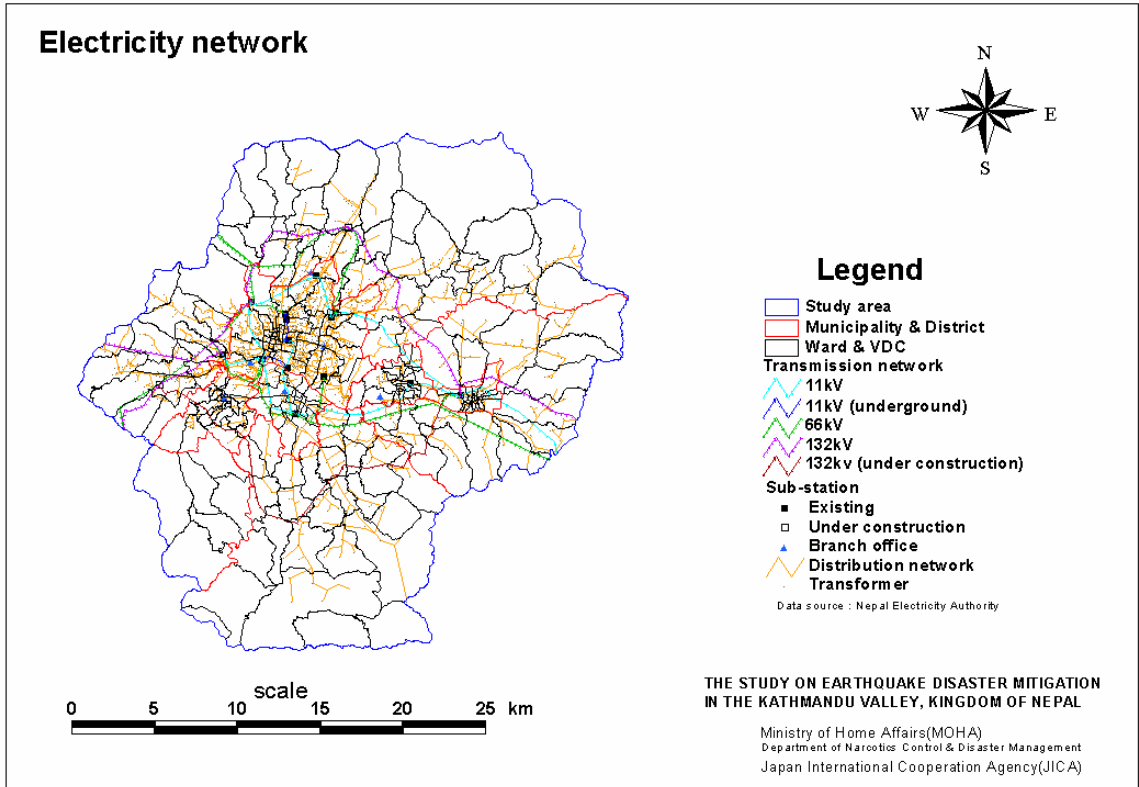
Figure 5.11.1 Existing Electricity Network

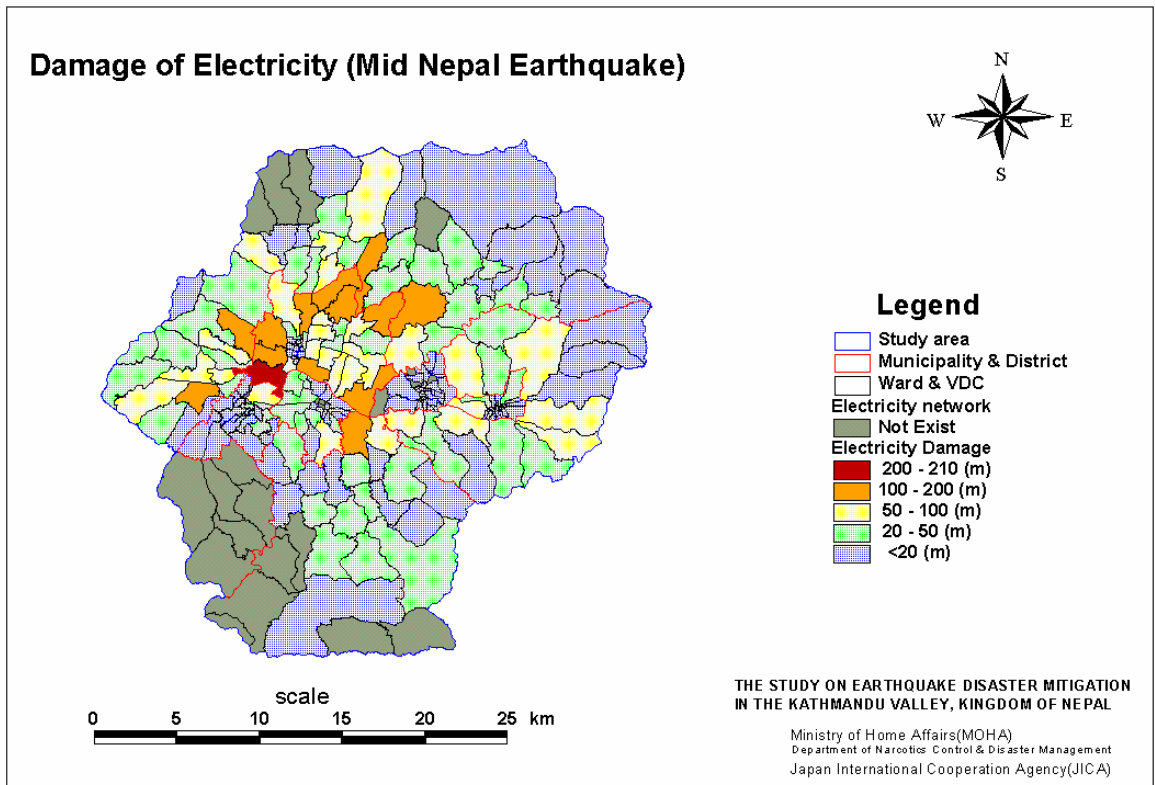
Figure 5.11.2 Damage to Electricity Supply Lines

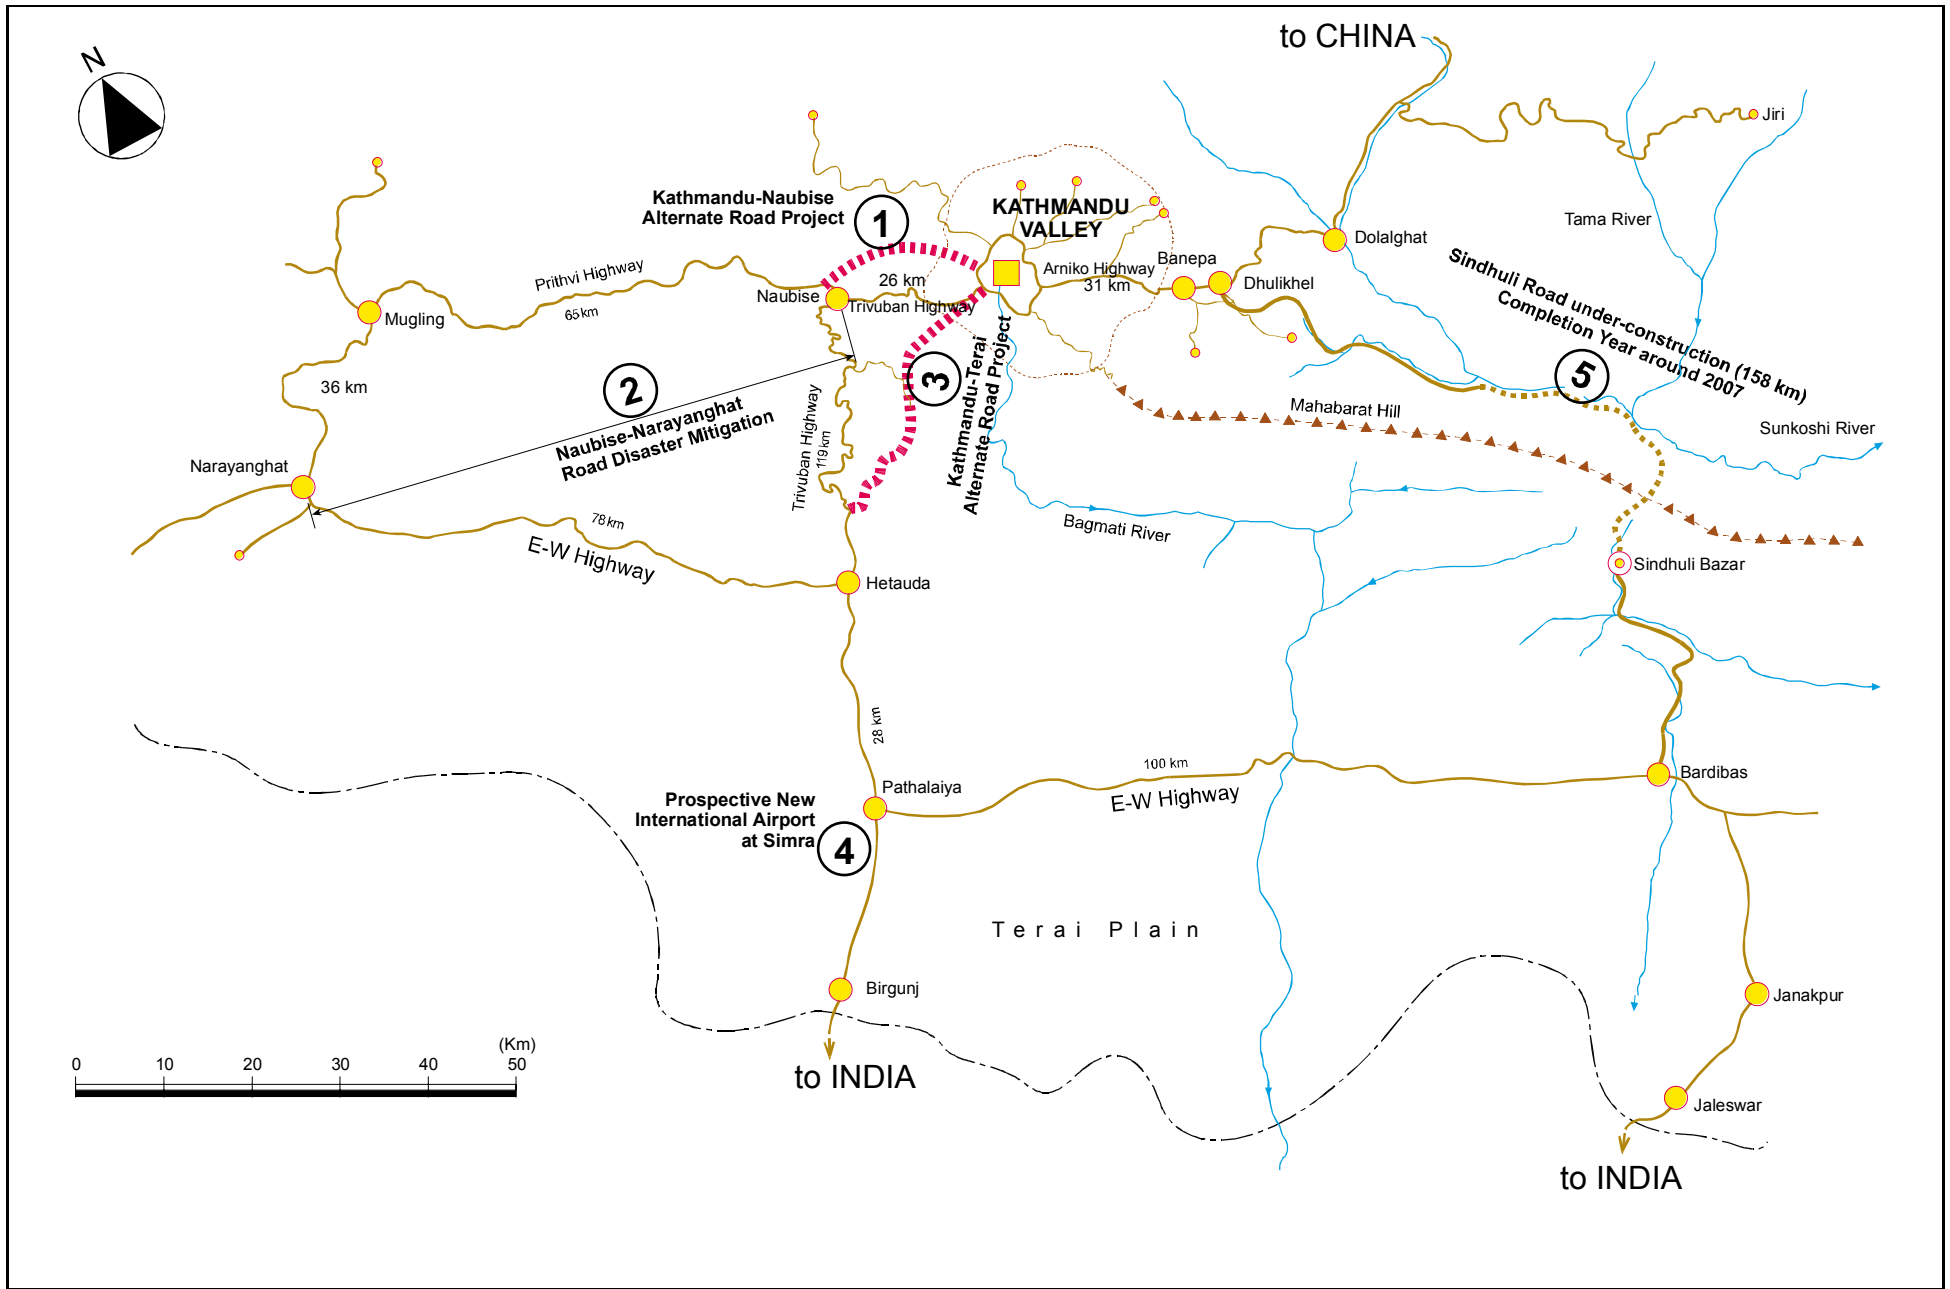
Figure 6.2.1 Development Plans to Improve Access to the Valley

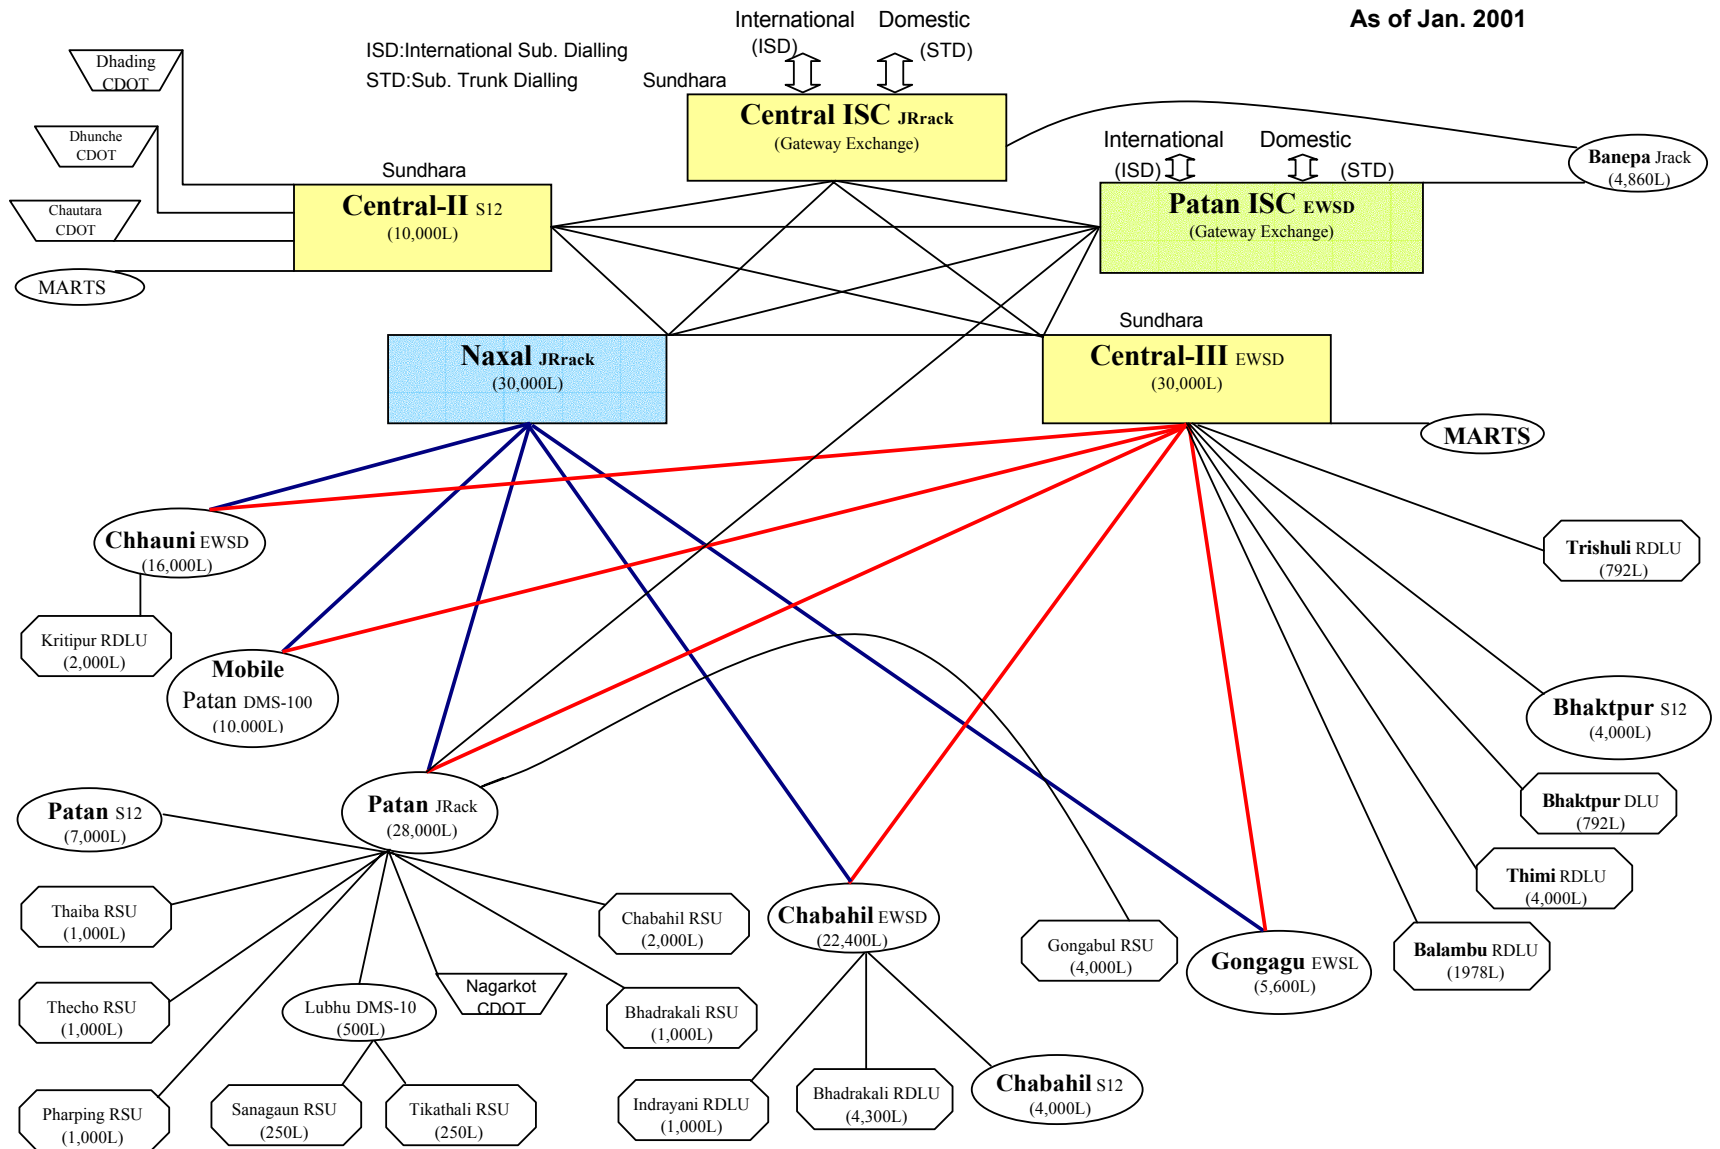
Figure 6.5.1 Trunk Network in Bagmati Zone

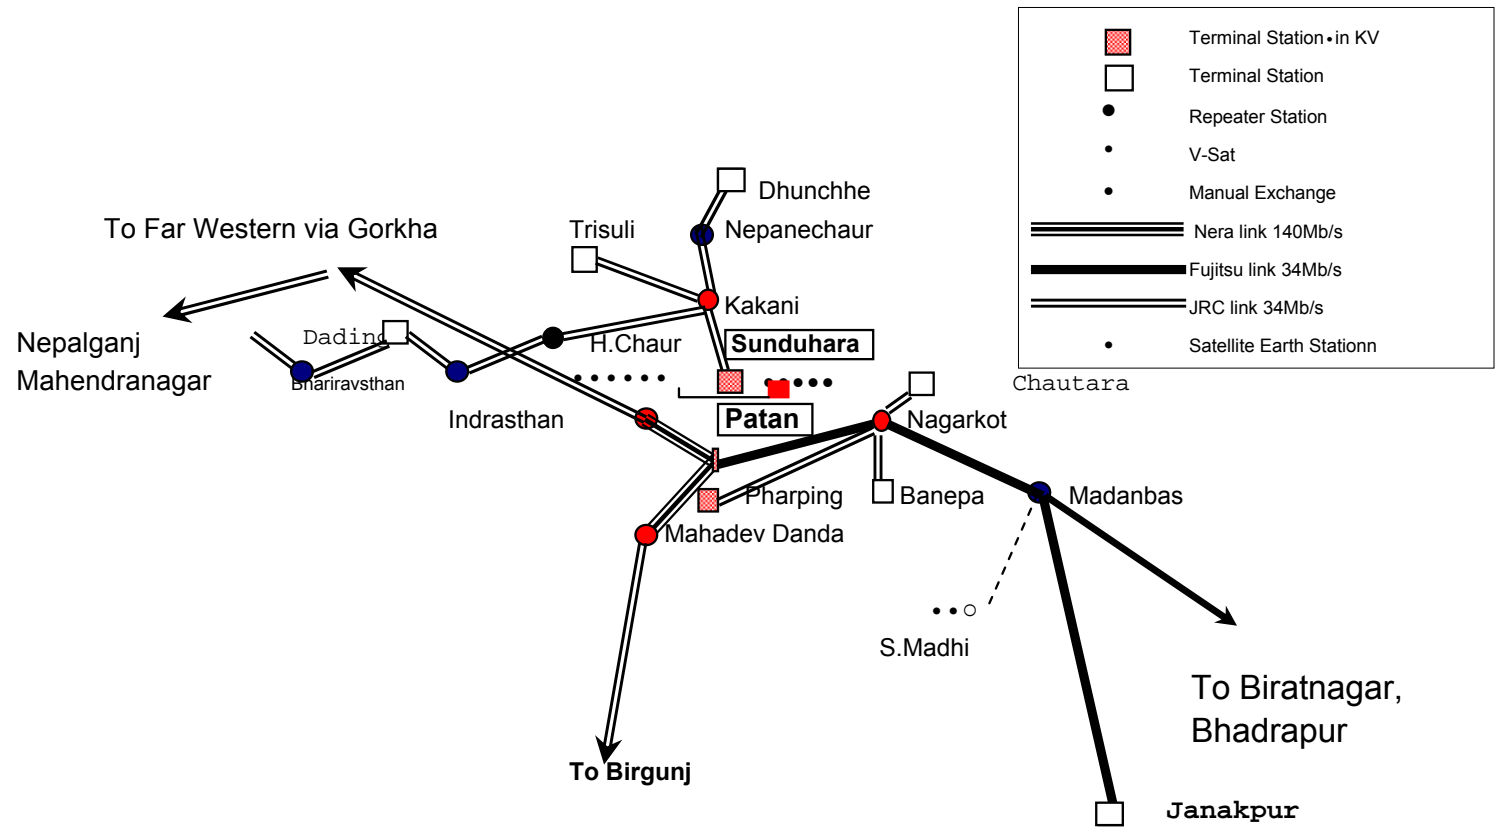
Figure 6.5.2 Long Distance Radio Transmission Network around the Kathmandu Valley

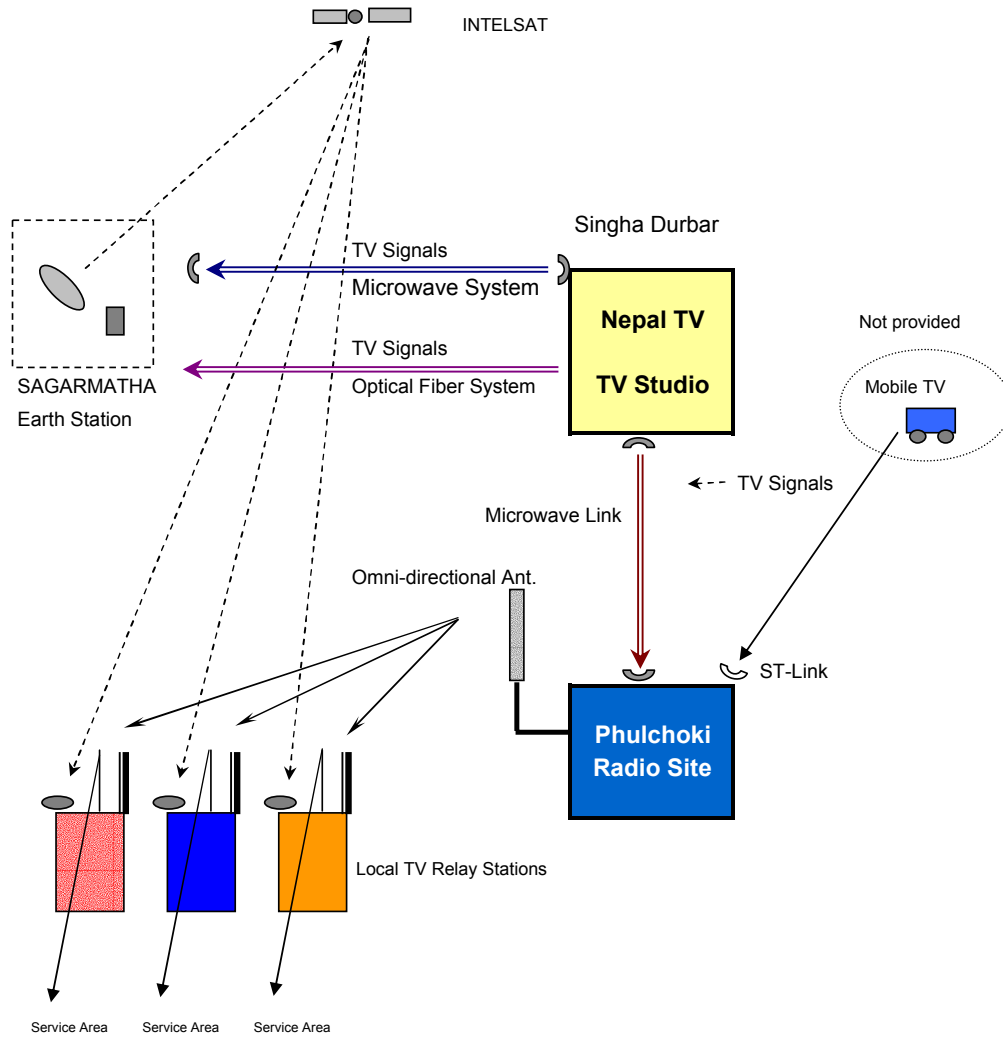
Figure 6.5.3 TV Signal Transmission Network
(Nepal National Television)
