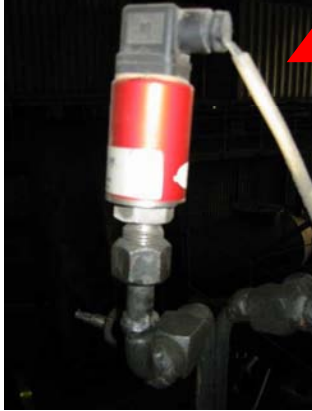
The pressure transmitter for turbine bearing

- (1) Turbine equipment is divided roughly into basic equipment (main turbine) and auxiliary equipment (condenser, HP/LP feed water heater, steam ejector).
- (2) The sensor signal level of the surrounding basic equipment is updated to 4-20mA. The parameters are sent to the computer and supervision was made possible by CRT in CCR. (Metal, bearings, etc.)
- (3) The turbine metal temperature signals are converted into the 4-20mA signal at the local area beside the turbine and converted at the relay room for computer supervision.

In connection with rehabilitation for the turbine control system, all of the signal levels of important sensors will be updated to 4-20mA, and the range possible for the operation and supervision from CCR is to be expanded. In parallel, the reliability of the whole turbine control system is to be raised.

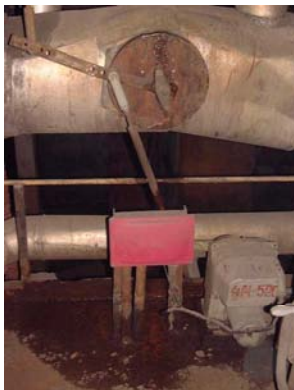
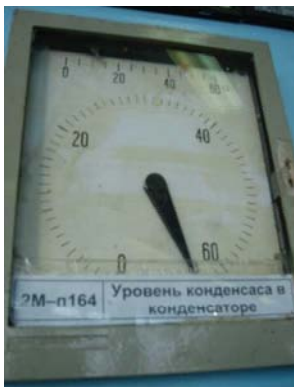
Fig.5.1-16

- (1) The condenser hotwell level control valve is manually set to full open, and condenser hotwell level control is performed with the local bypass valve.
- (2) There is a difference in condenser hotwell level reading value between CCR and local.
- (3) Condenser hotwell level is supervised with the temperature of condenser hotwell and the local water level gauge.

- (1) The condenser level control valve shall be replaced and condenser level control will be of automatic control.
- (2) In connection with rehabilitation for the turbine control system, the condenser hotwell level indicator, operation devices and condenser hotwell level control valve position indicator etc., in CCR, are to be replaced with new ones.

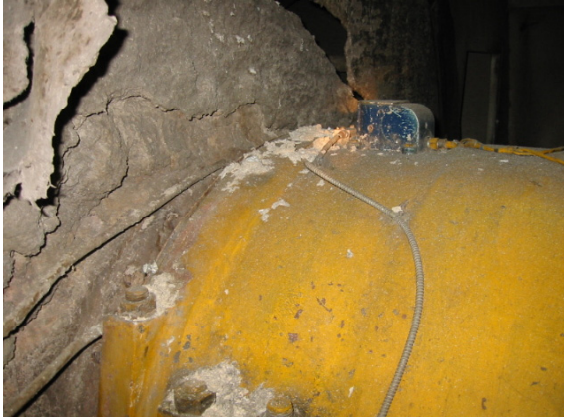
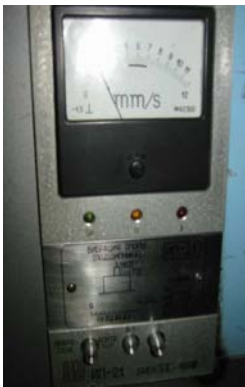
Fig.5.1-17

Since the turbine vibration sensor is unreliable, it is now test-running by a Russian vibration sensor installed in the bearing cover.

Since the turbine and generator bearing vibration supervisory instruments are very important to the security of the equipment, they are to be replaced at the same time as turbine overhaul.

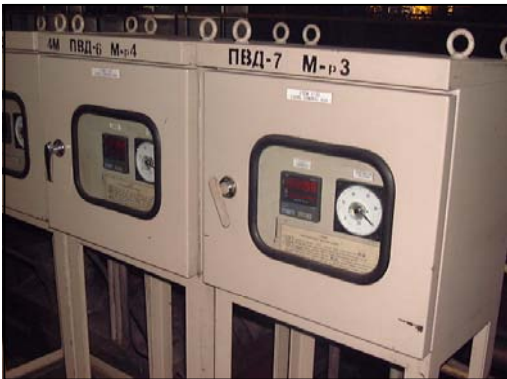
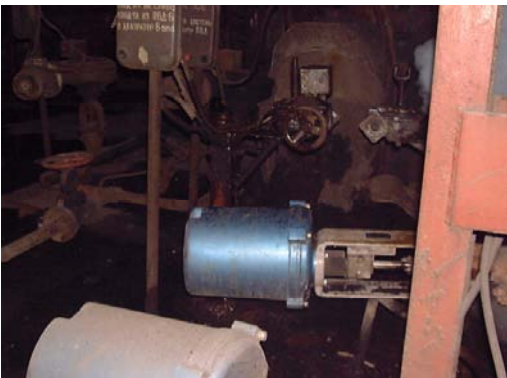
Fig.5.1-18

- (1) The left photograph shows HP feed water level controllers and control valves which were replaced by Japanese grant aid.
- (2) LP feed water heater level controllers have much failure, and the local level gauges have also much failure.

In parallel with the rehabilitation for LP feed water heater, the same level controller and same control valve as HP feed water heater will be replaced, and the supervision of feed water heater level and control valve position will be enabled in CCR.

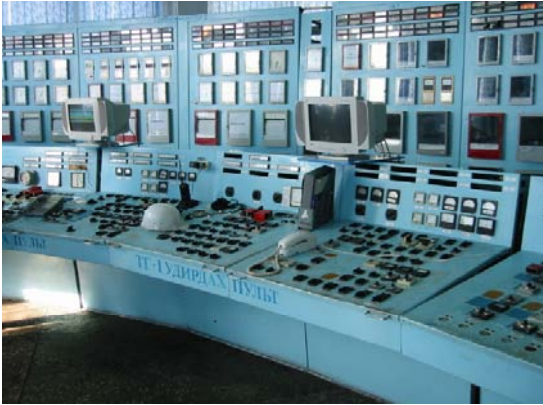
- (1) The major parameters of basic equipment are sent to the turbine computer, and supervision is possible with CRT which was installed additionally in CCR.
- (2) Hard-wired relay circuits for alarms and interlocks are being updated in the relay logic functions (controller) of the computer.
- (3) Electric motor valves and control valves associated with turbine equipment have many failed parts, and its maintenance and rehabilitation is not sufficient.
- (4) The turbine portion has a low automation level and damage by misoperation of operators has occurred.
- (5) As a whole, although the turbine supervisory instruments have been considerably updated by the power station, there are still many broken or unusable devices such as control switches, position indicators, and recorders.

Corresponding to progress of turbine rehabilitation to be executed by the power station, turbine control and instrumentation is to be rehabilitated.
