The Study on Flood Control and Water Management in Limboto-Bolango-Bone Basin in the Republic of Indonesia
Japan International Cooperation Agency

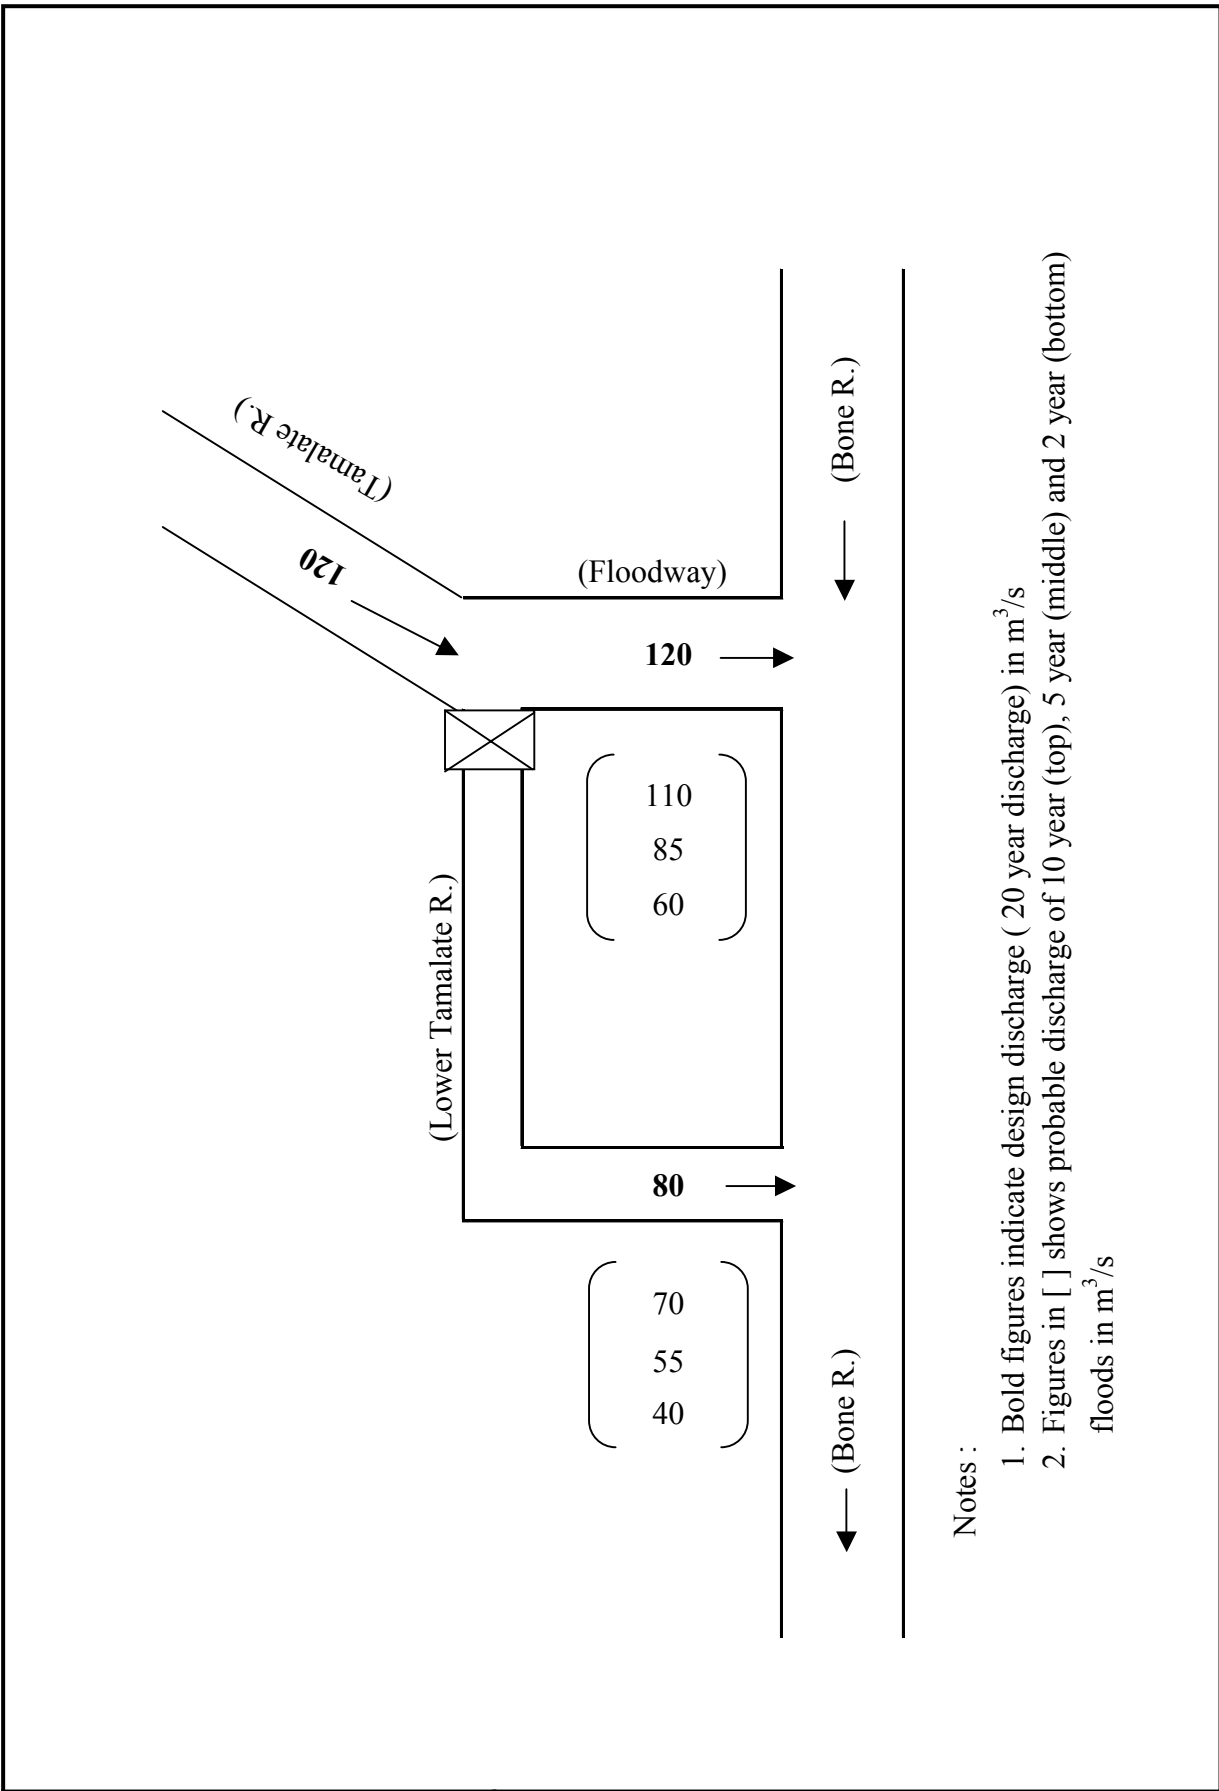
- Notes :
1. Bold figures indicate design discharge (20 year discharge) in m³/s
 2. Figures in [] shows probable discharge of 10 year (top), 5 year (middle) and 2 year (bottom) floods in m³/s
