*The Study on Storm Water Drainage Plan
for the Colombo Metropolitan Region
in the Democratic Socialist Republic of Sri Lanka*

JAPAN INTERNATIONAL COOPERATION AGENCY

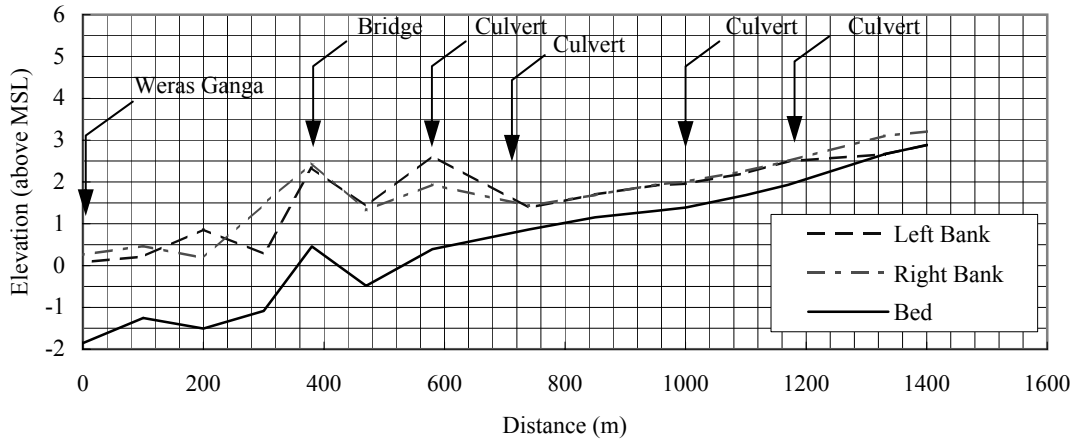
Figure 2.2.13
Present Condition of Drainage Channels
in Ratmalana-Moratuwa Sub-basin

Weras Ganga Tributary - Kandawala

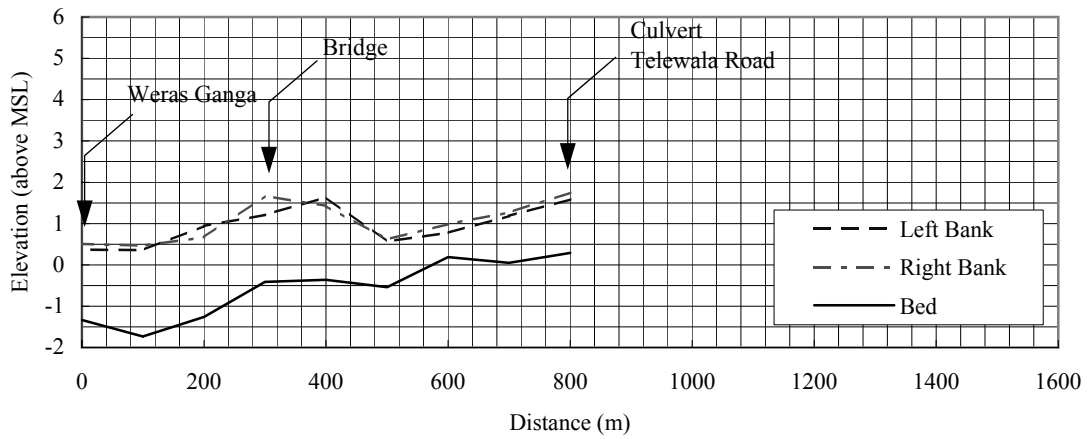
Weras Ganga Tributary - Telawala

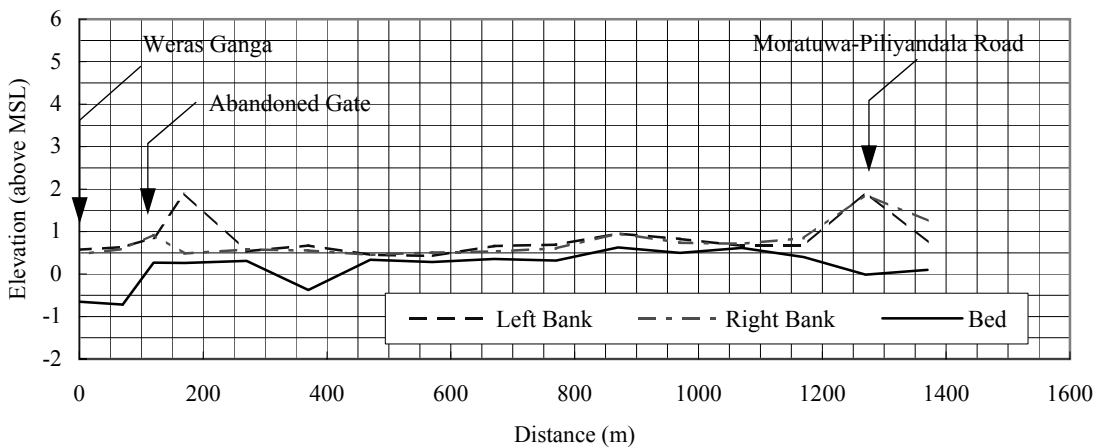
Weras Ganga Tributary - Katubedda

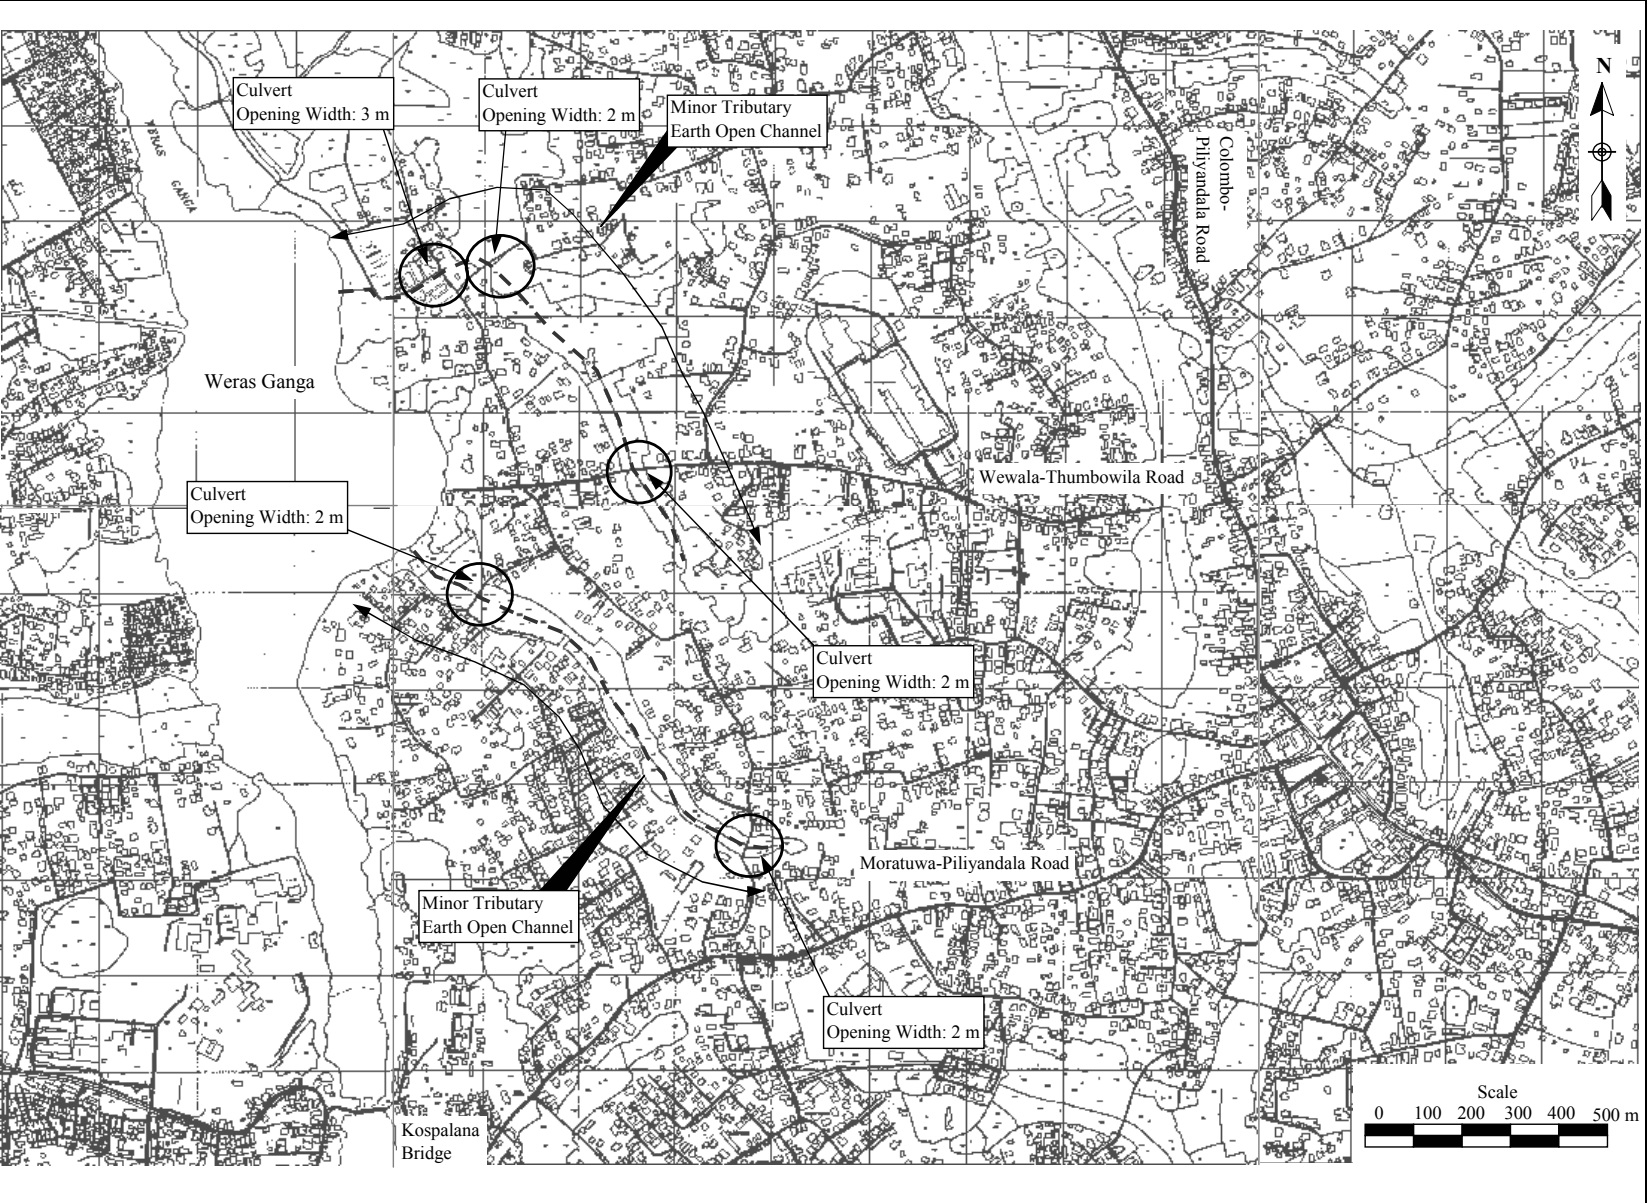
Figure 2.2.14
Longitudinal Profiles of Drainage Channel
in Ratmalana-Moratuwa Sub-basin

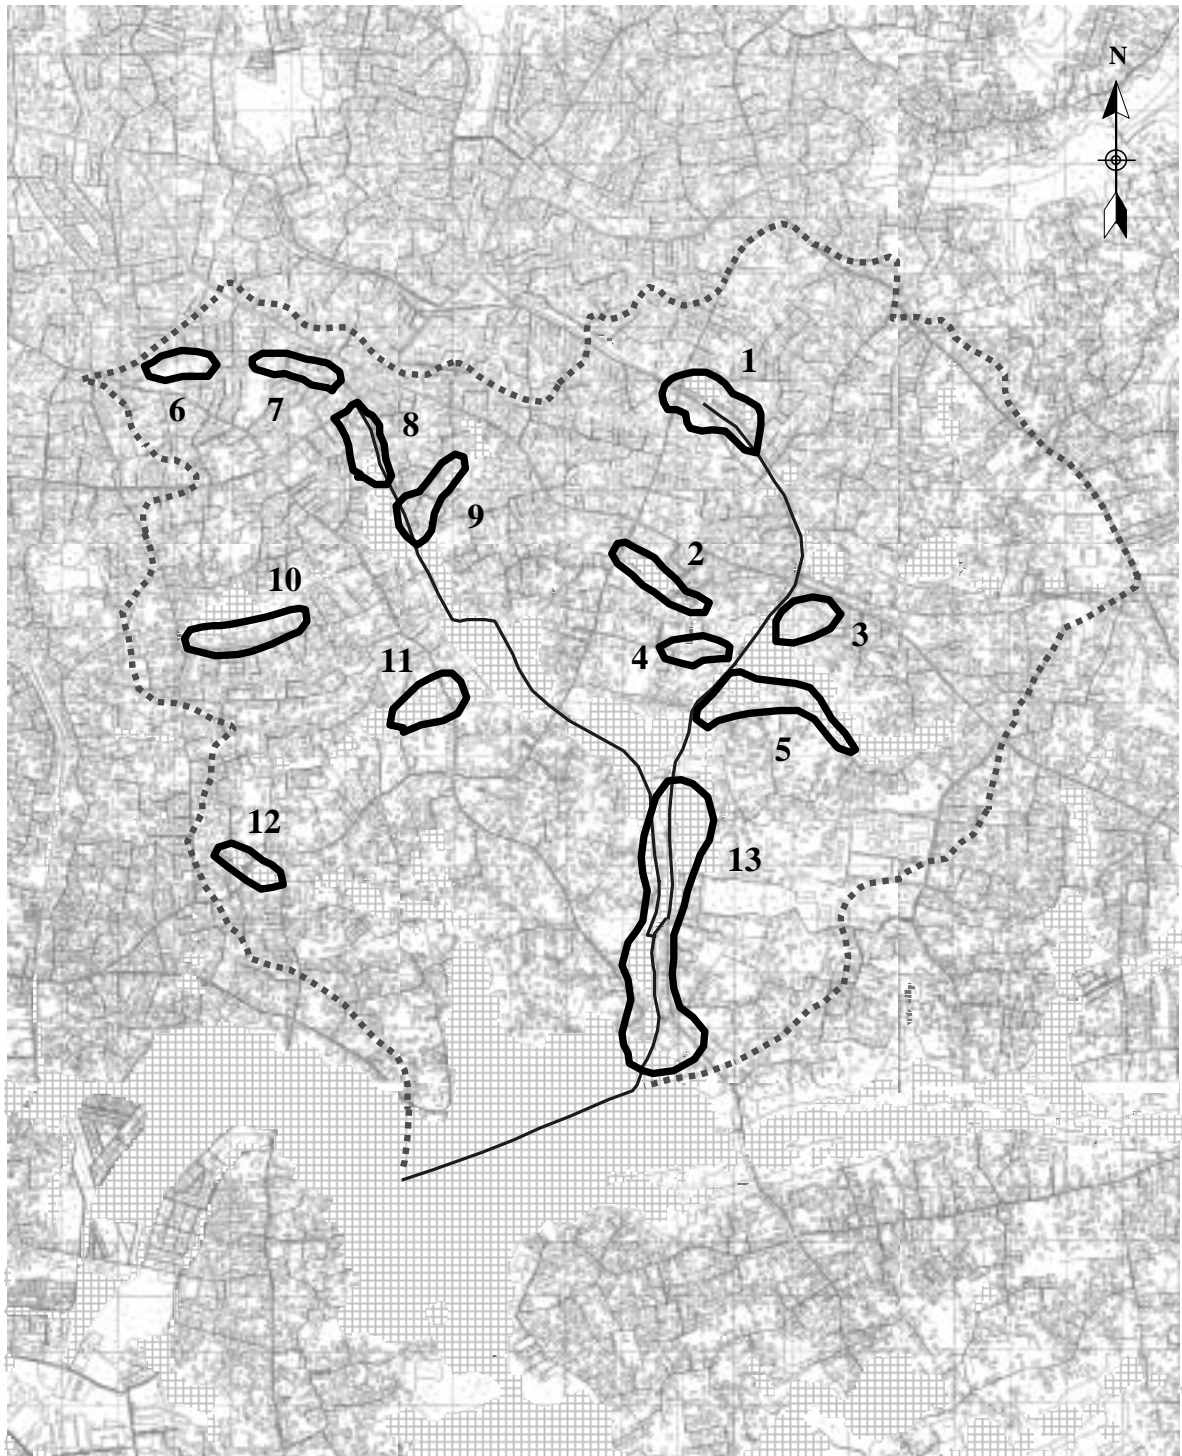
Figure 3.1.1
Flood Prone Areas in Werasingha
Basin
