THE STUDY ON COMPREHENSIVE FLOOD MITIGATION  
AND ENVIRONMENTAL IMPROVEMENT PLAN  
OF LAI NULLAH BASIN  
IN THE ISLAMIC REPUBLIC OF PAKISTAN

JAPAN INTERNATIONAL COOPERATION AGENCY

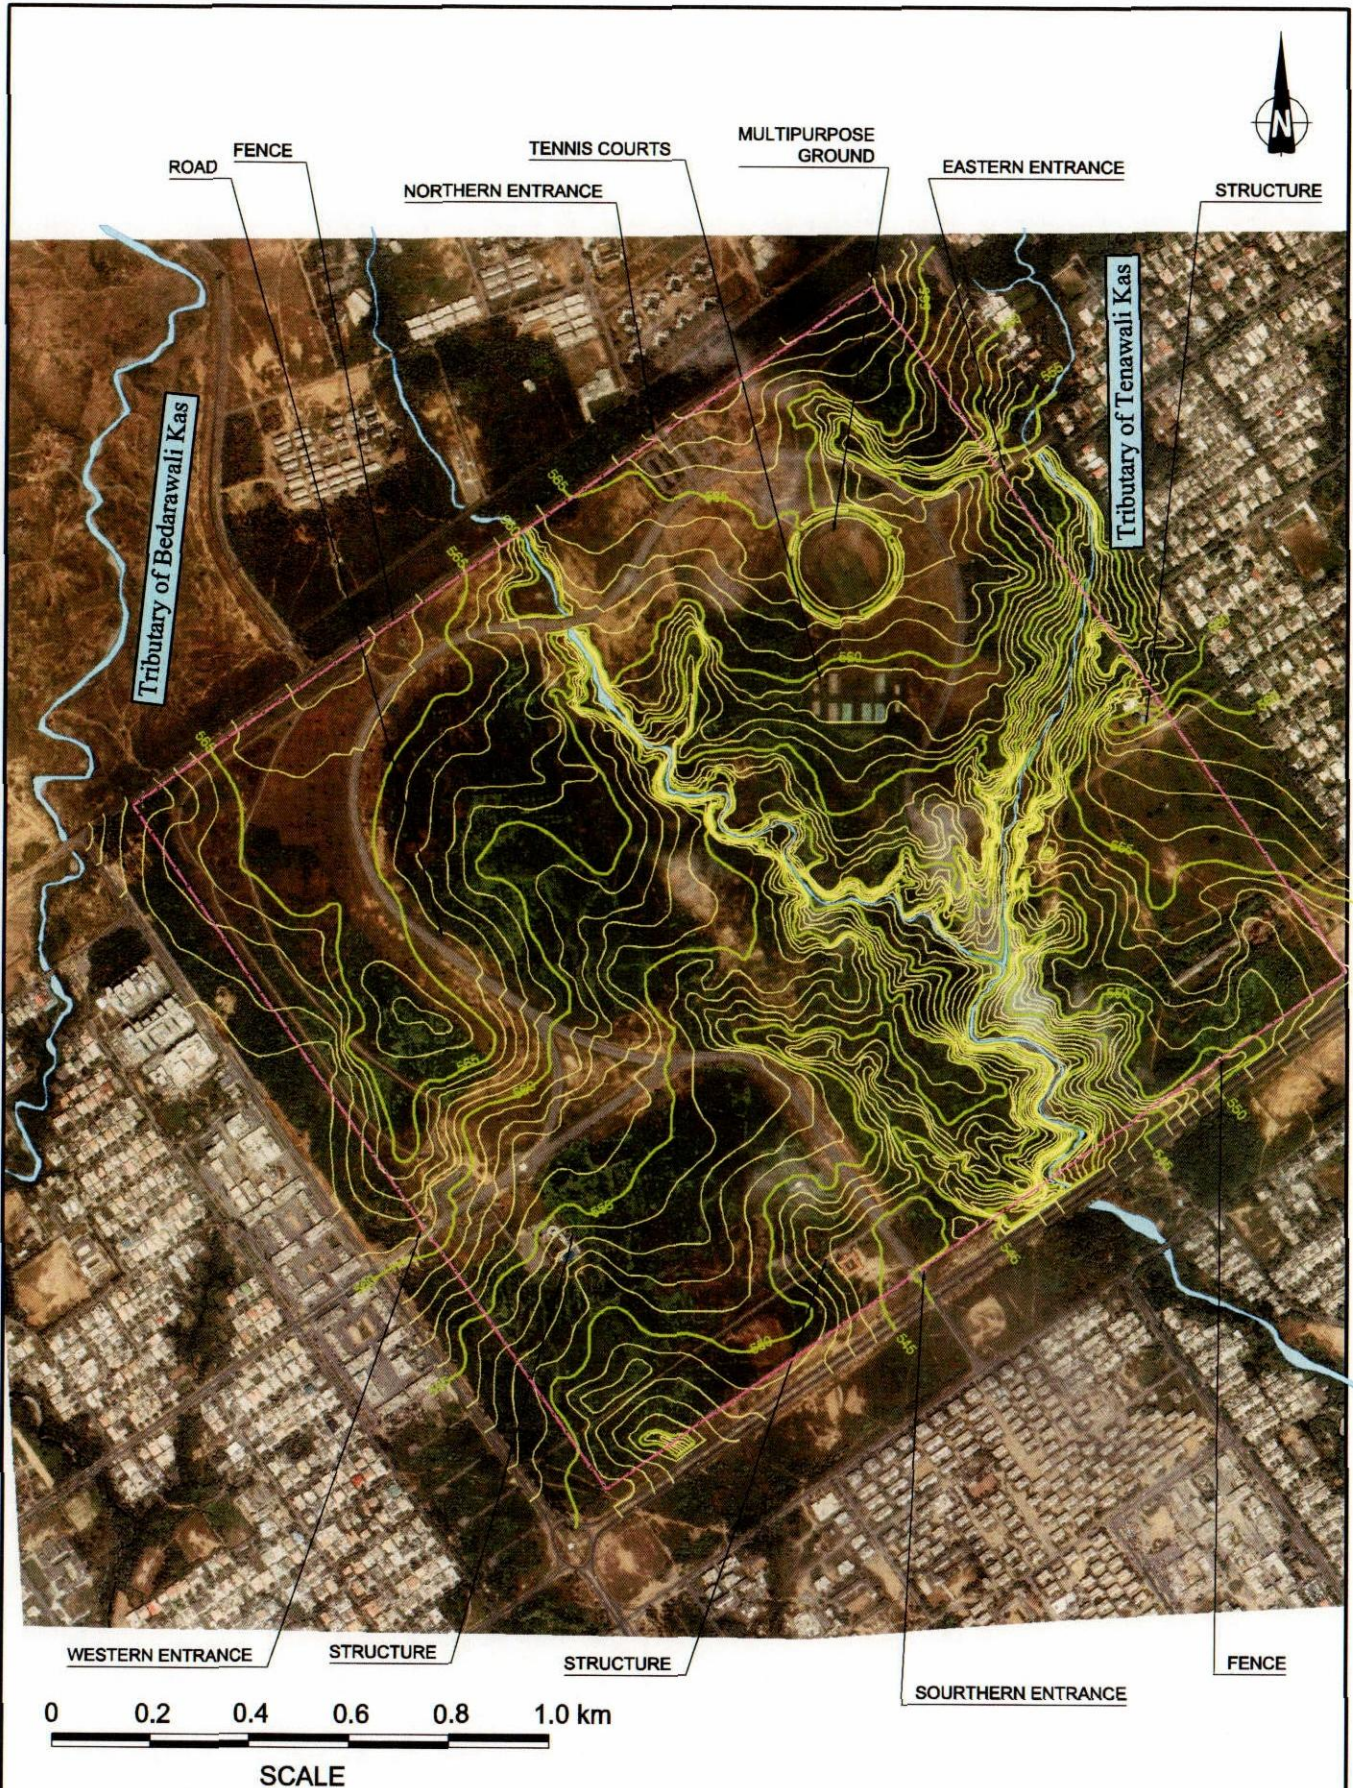
図 14

ファティマジンナー公園の現況

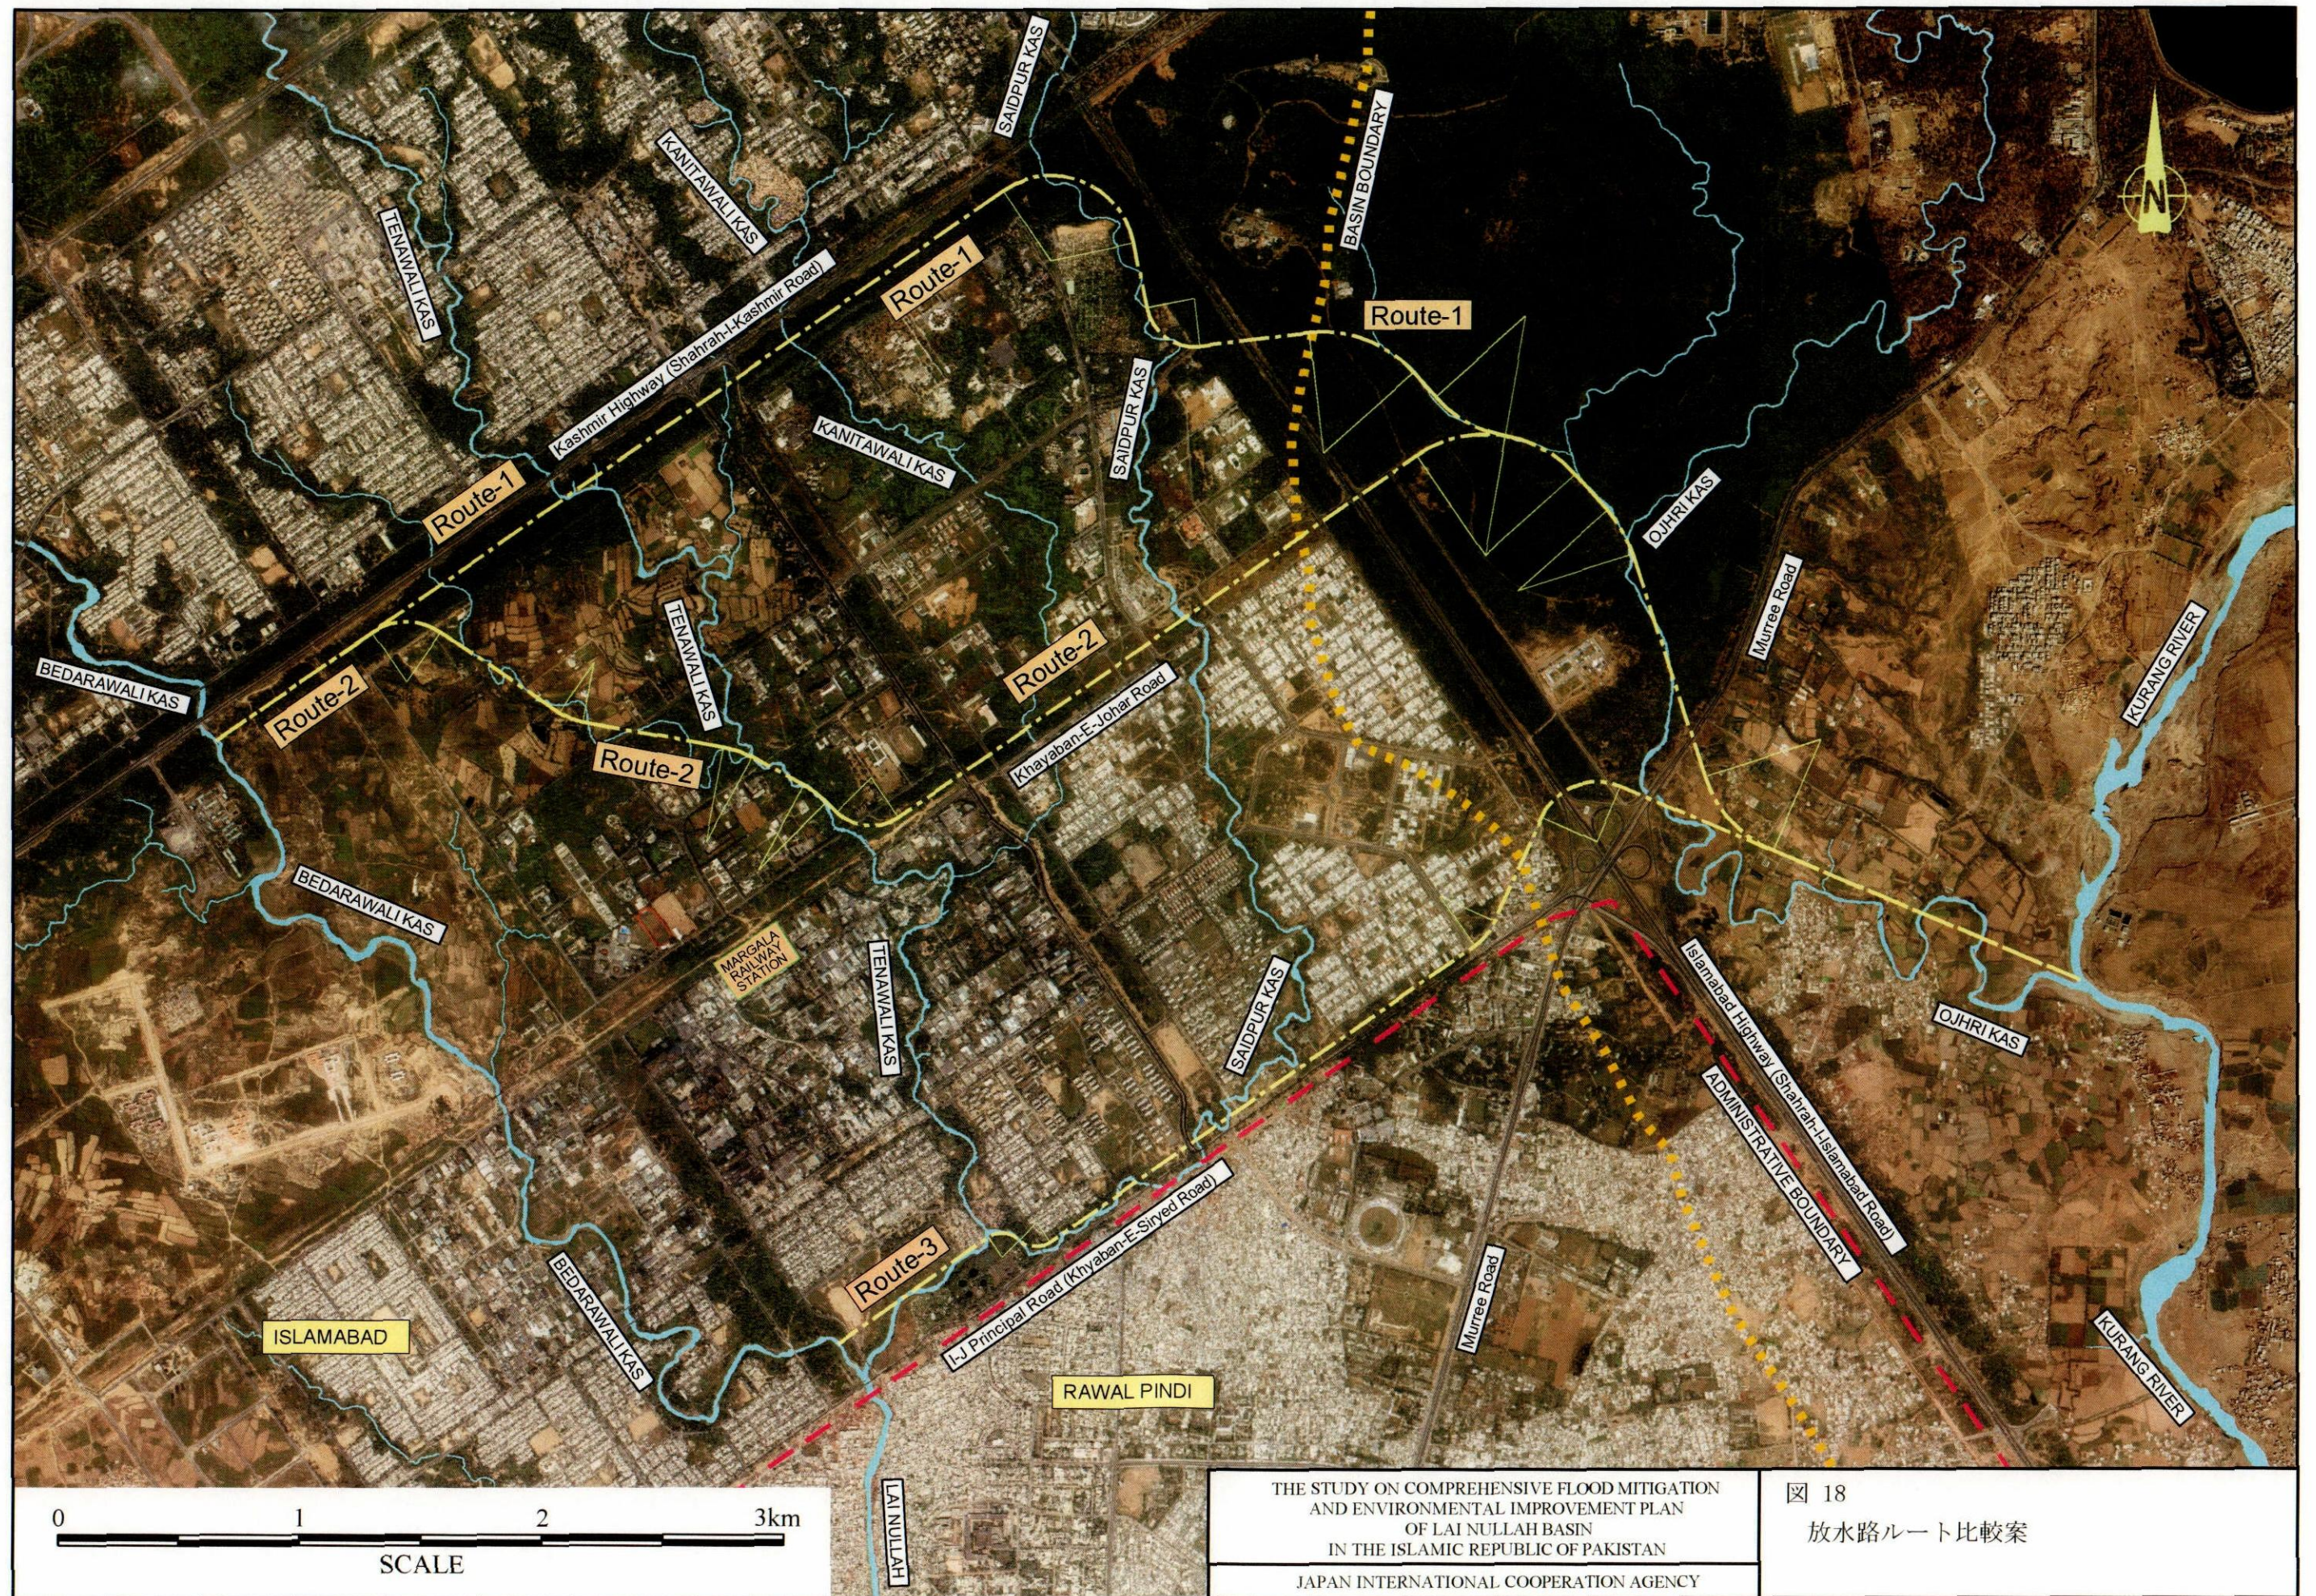
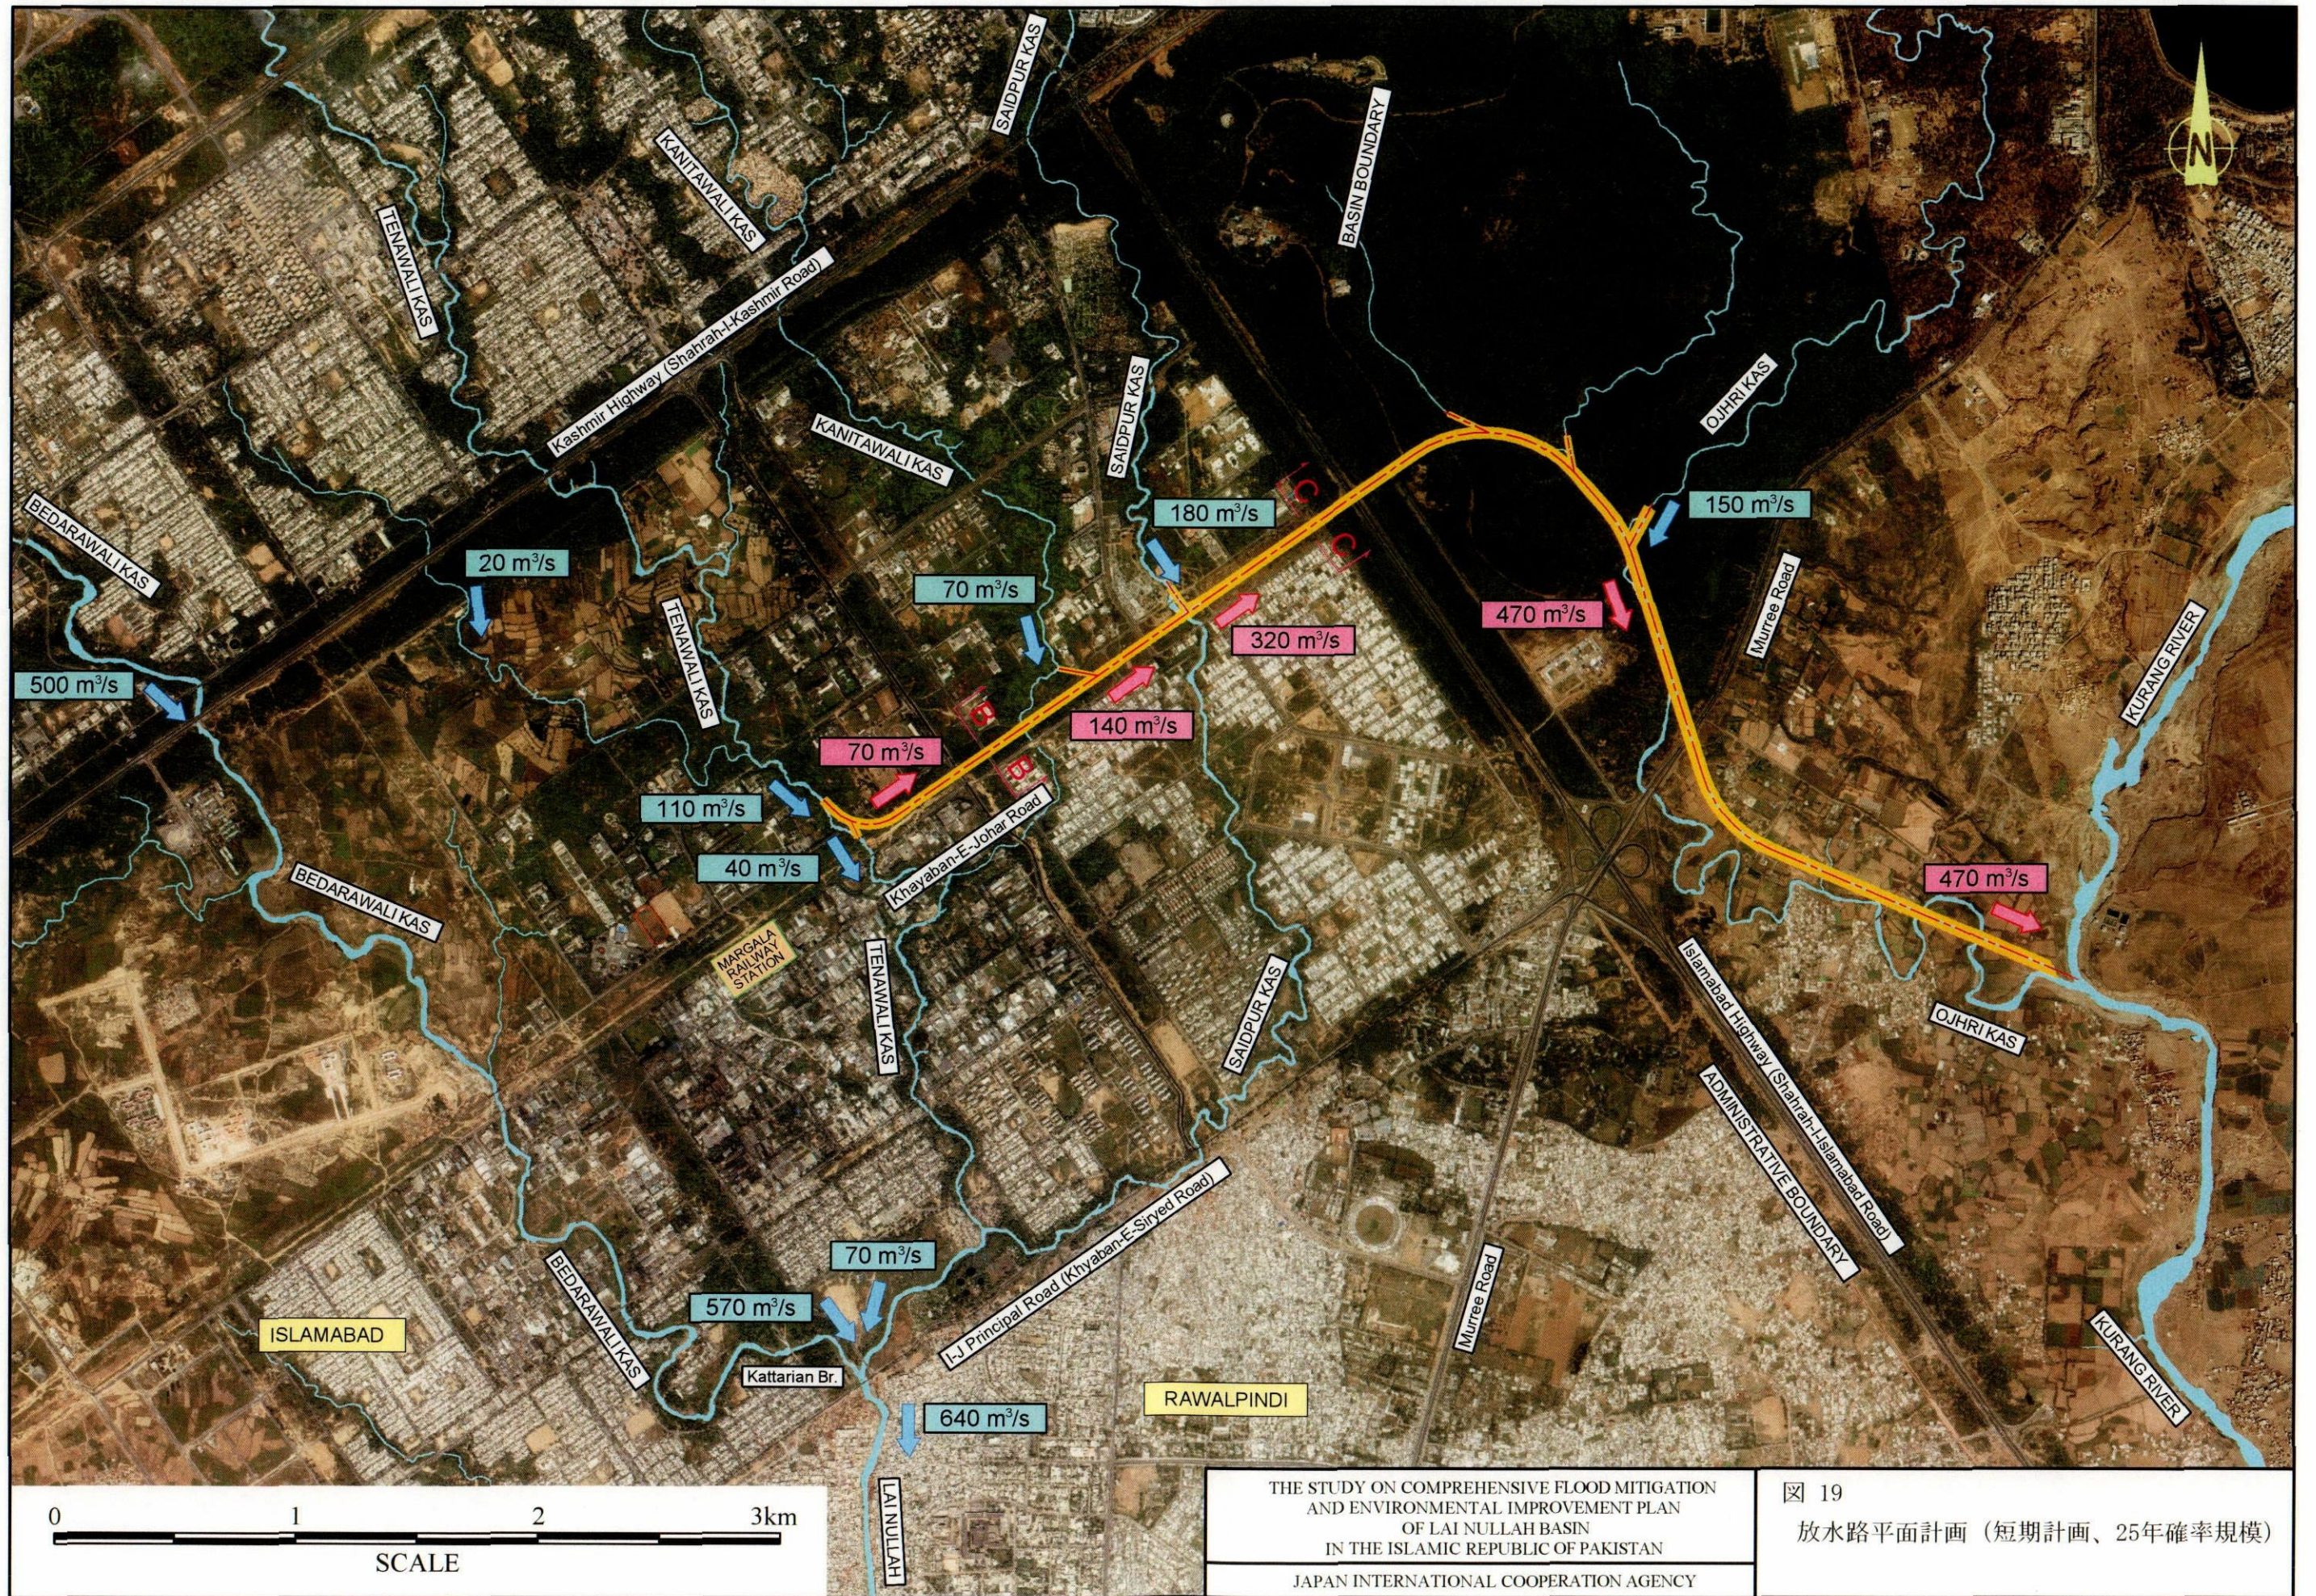
図 17  
洪水軽減ダム平面計画

Flood Mitigation Dam at Block E-11  
Dam Height H=20m,  
Effective Storage Volume V=2,640,000m<sup>3</sup>

Surcharge Water Level  
EL.571.6m
