THE STUDY ON COMPREHENSIVE FLOOD MITIGATION
AND ENVIRONMENTAL IMPROVEMENT PLAN
OF LAI NULLAH BASIN
IN THE ISLAMIC REPUBLIC OF PAKISTAN

Japan International Cooperation Agency

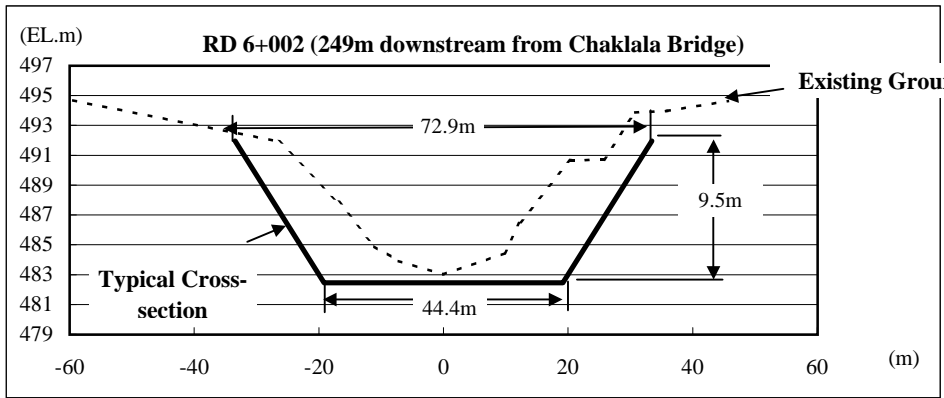
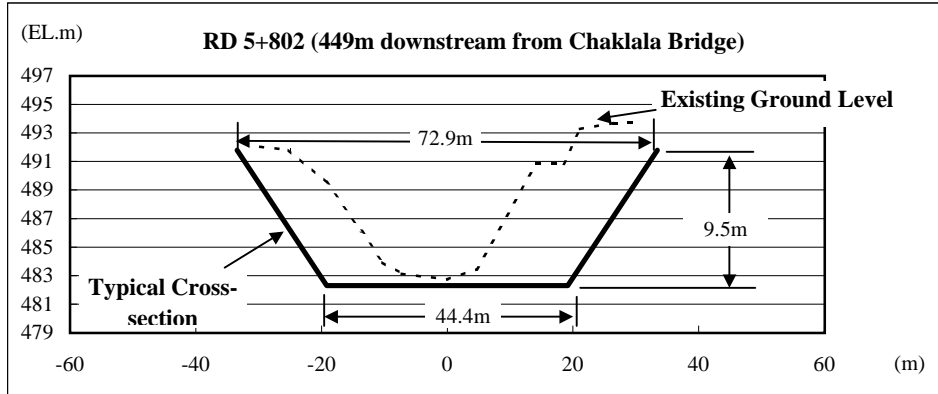
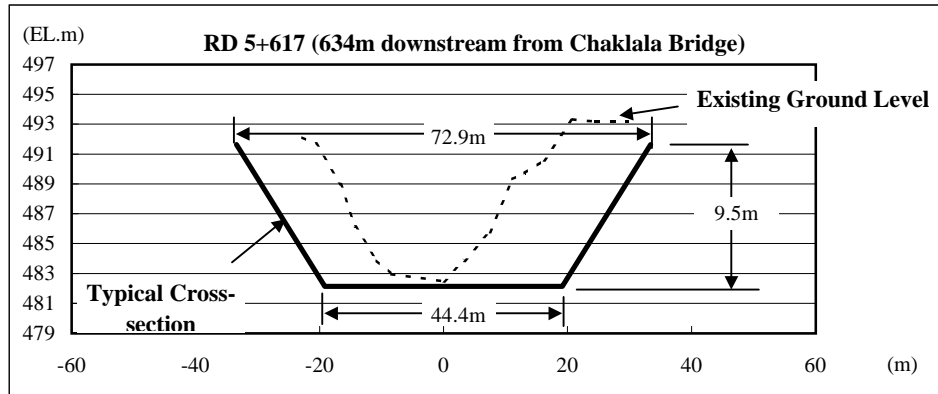
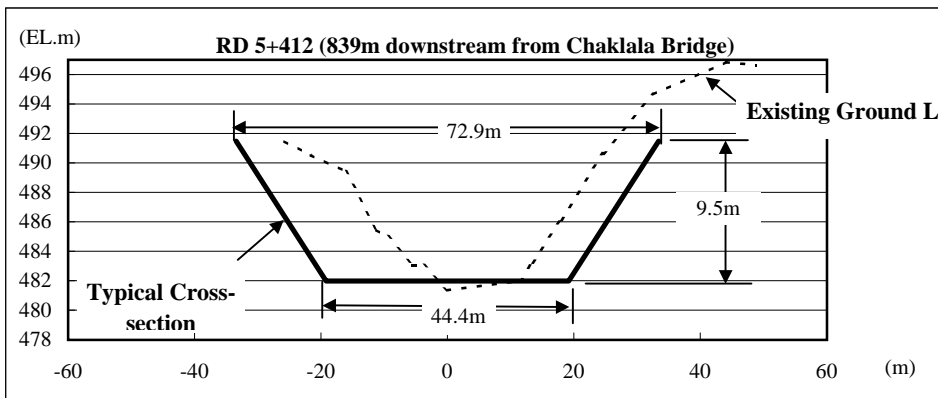
Note: Proposed section is subject to channel deepening for the on-going improvement section above Chaklala Bridge

Fig. 11
Proposed Typical Cross-section below Chaklala
Bridge (In Case of Channel Deepening above
Chaklala Bridge)

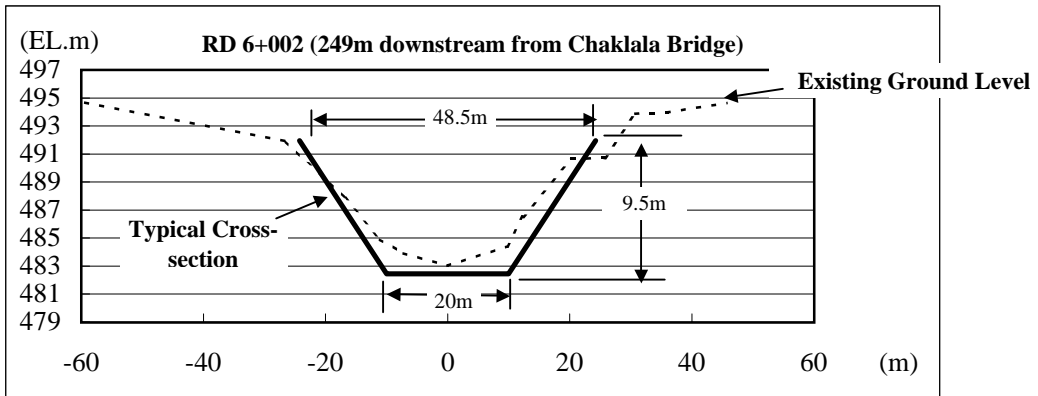
Fig. 12

Note: Proposed section is subject to no channel deepening for the on-going improvement section above Chaklala Bridge

Proposed Typical Cross-section below Chaklala
Bridge (In Case of Non-Channel Deepening above
Chaklala Bridge)
