THE STUDY ON COMPREHENSIVE FLOOD MITIGATION
AND ENVIRONMENTAL IMPROVEMENT PLAN
OF LAI NULLAH BASIN
IN THE ISLAMIC REPUBLIC OF PAKISTAN
JAPAN INTERNATIONAL COOPERATION AGENCY

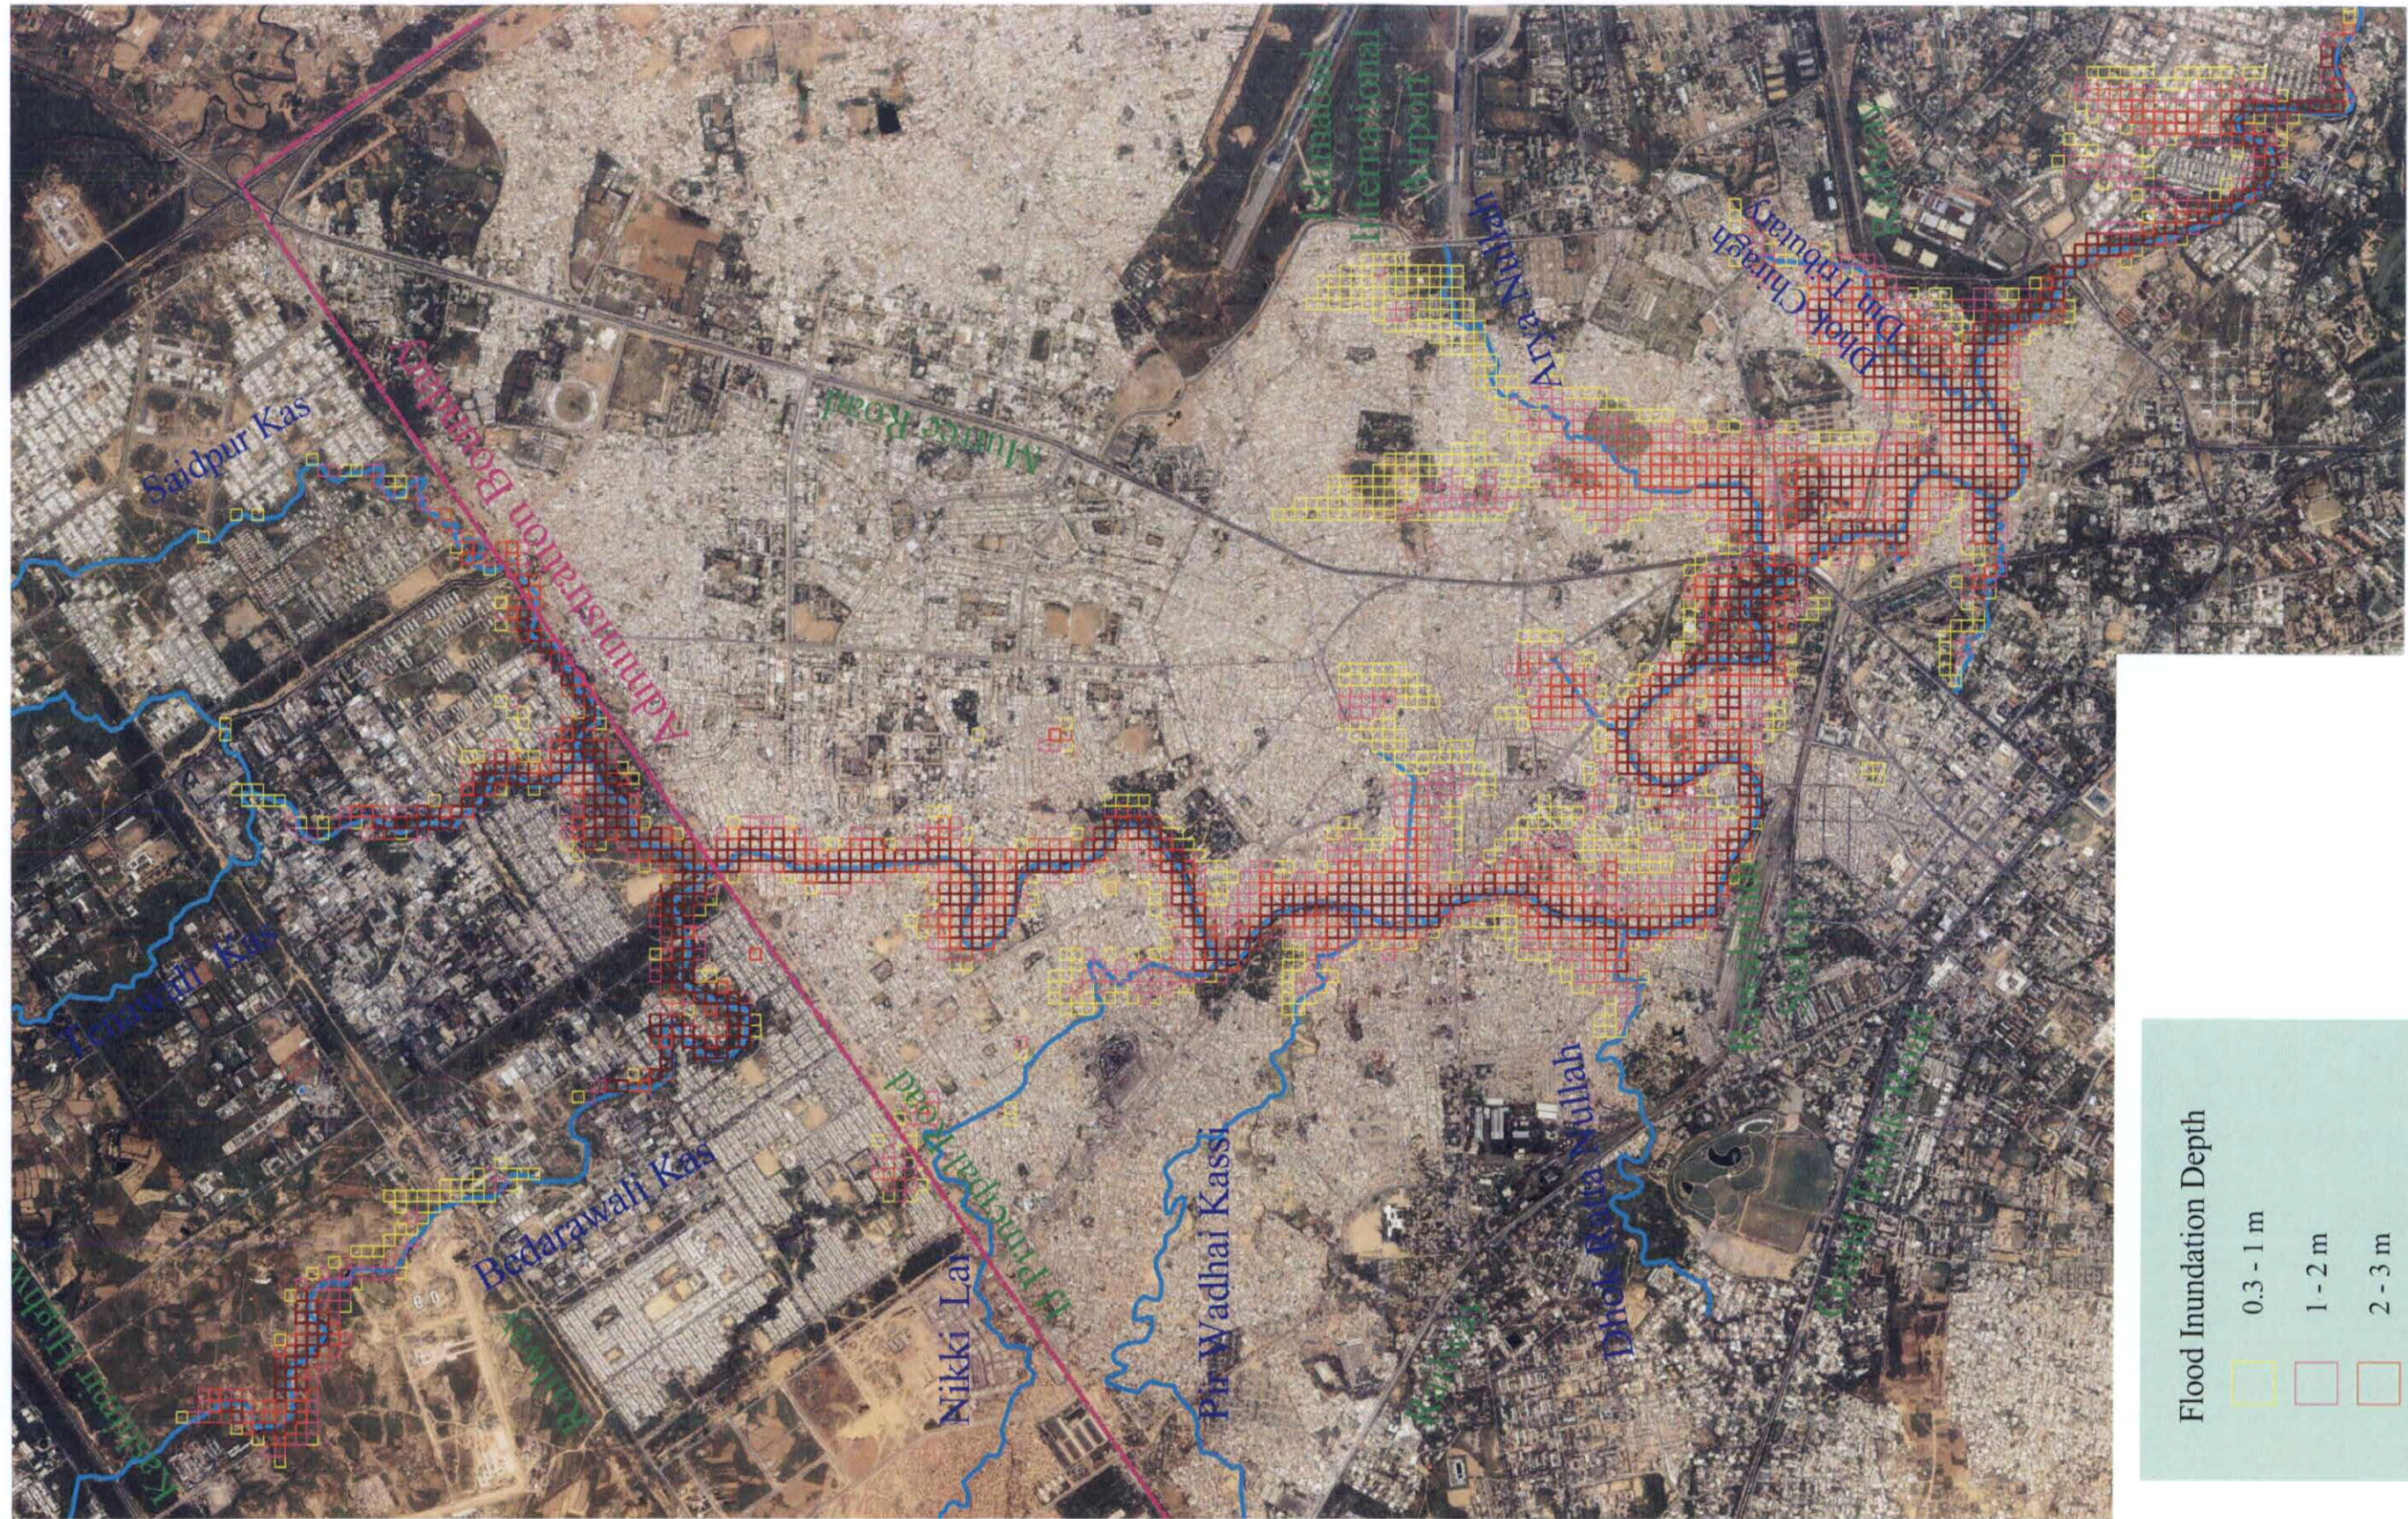
Fig. 6.4.4

Flood Risk Map
(Flood Inundation Area by
23 July 2001 Flood after ADB
Lai Nullah Improvement Project)

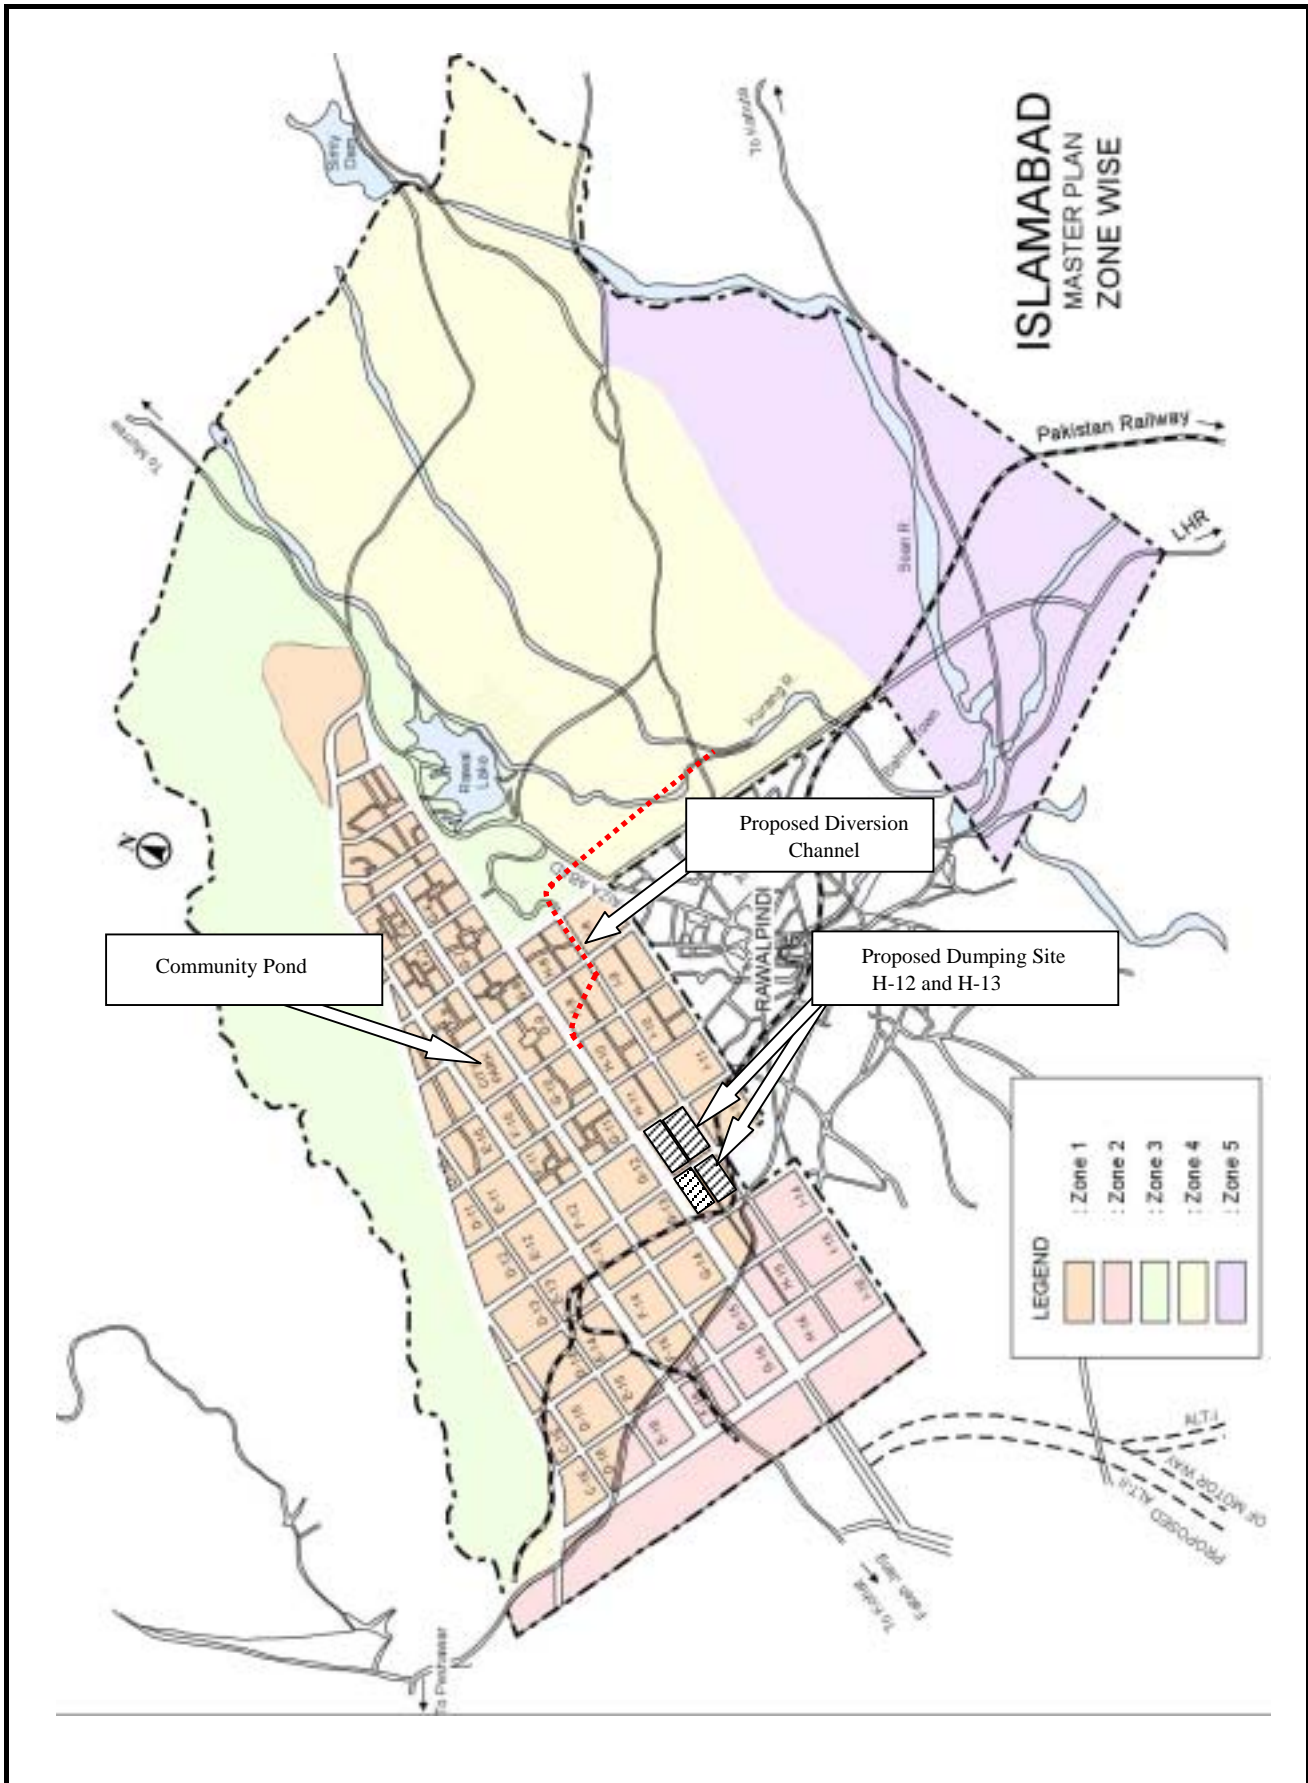
Fig. 7.2.1

Proposed Dumping Area for Excavated Soil from Community
Pond and Diversion Channel
