SECTOR A

FIGURES

THE STUDY ON COMPREHENSIVE FLOOD MITIGATION
AND ENVIRONMENTAL IMPROVEMENT PLAN
OF LAI NULLAH BASIN
IN THE ISLAMIC REPUBLIC OF PAKISTAN

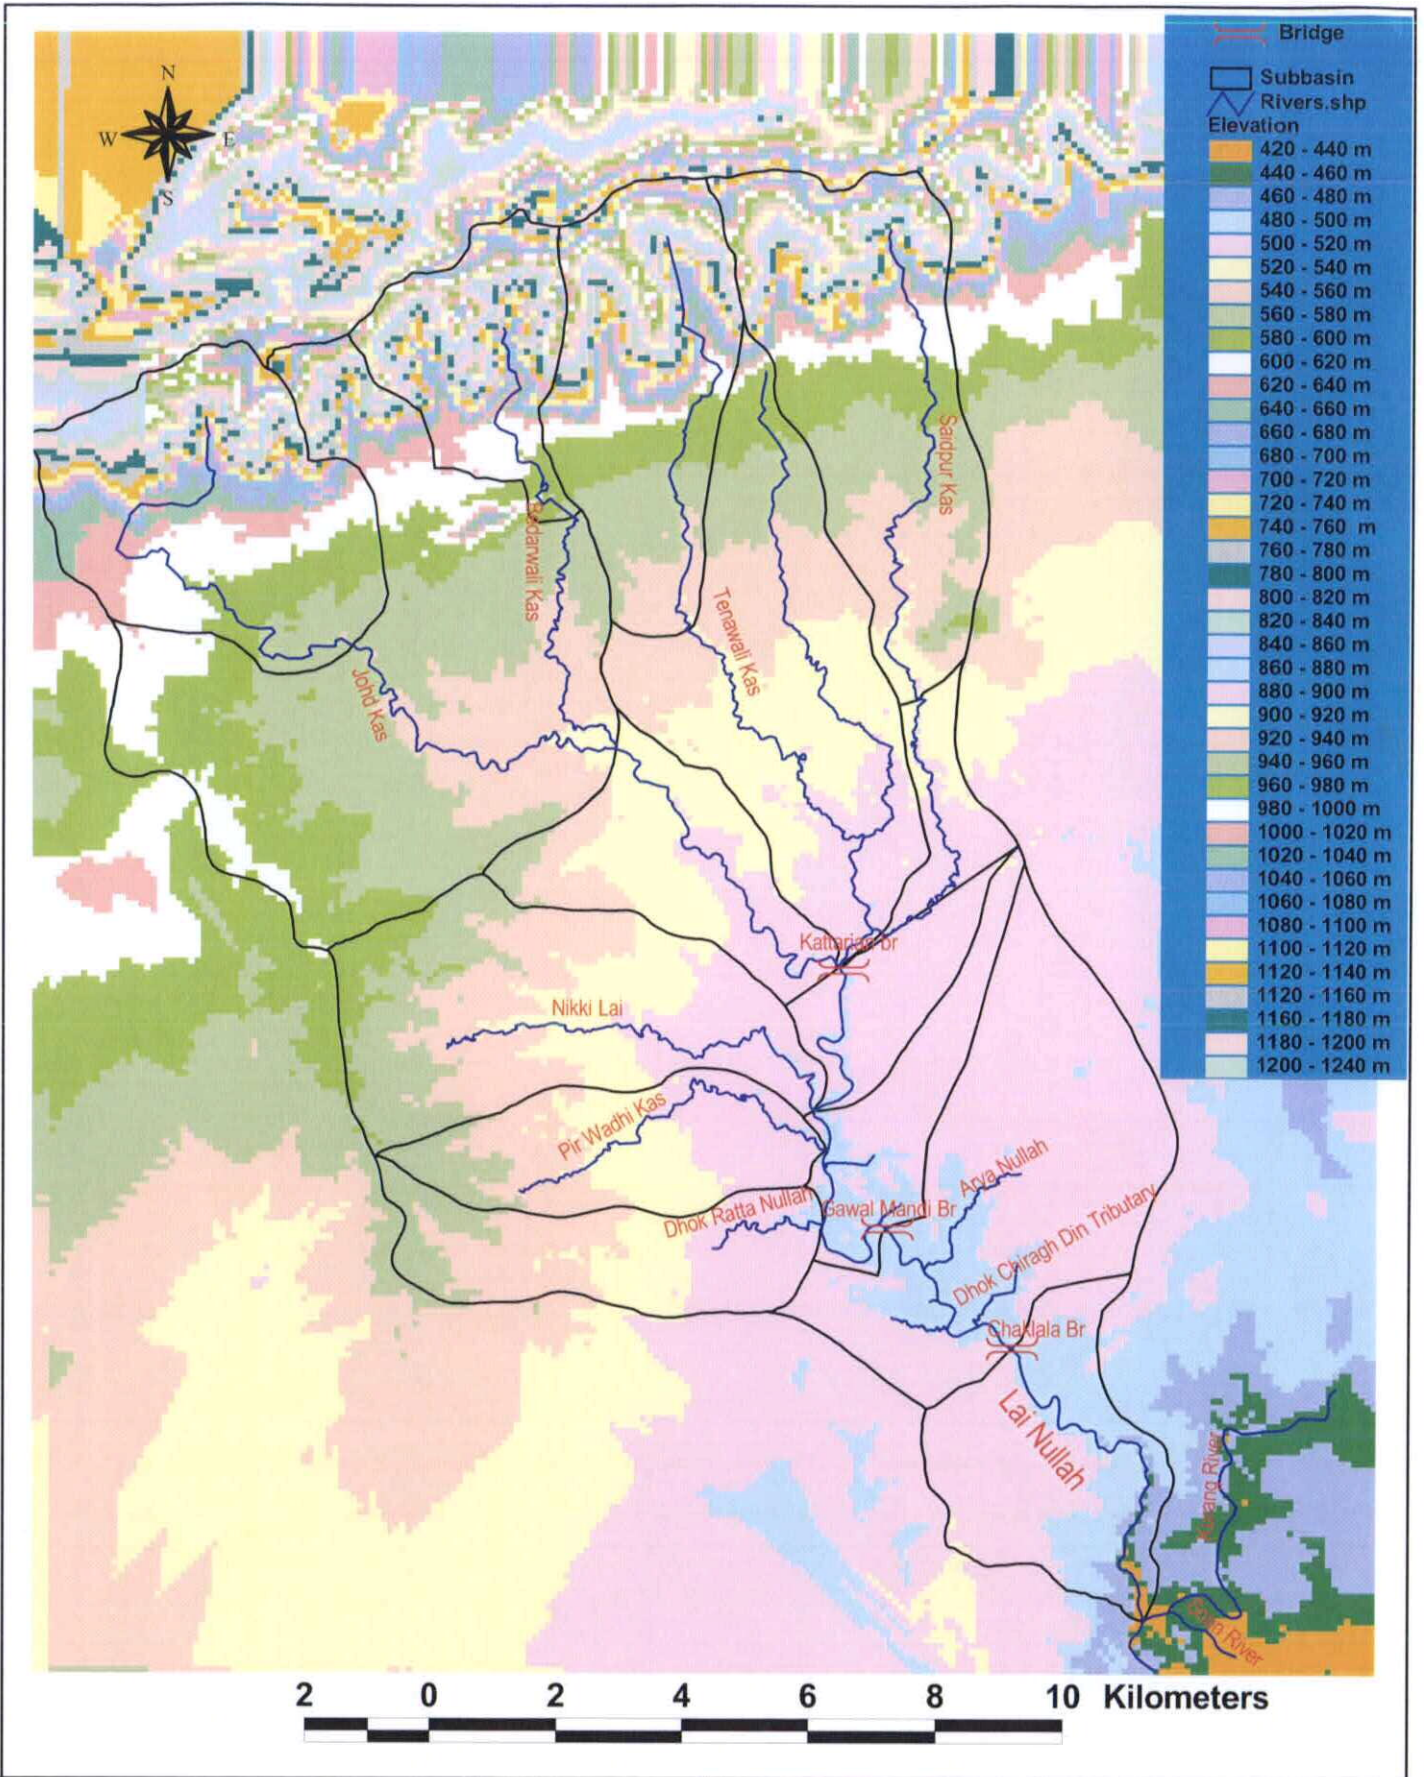
Fig. A.1
Elevation Map of Lai Nullah Basin

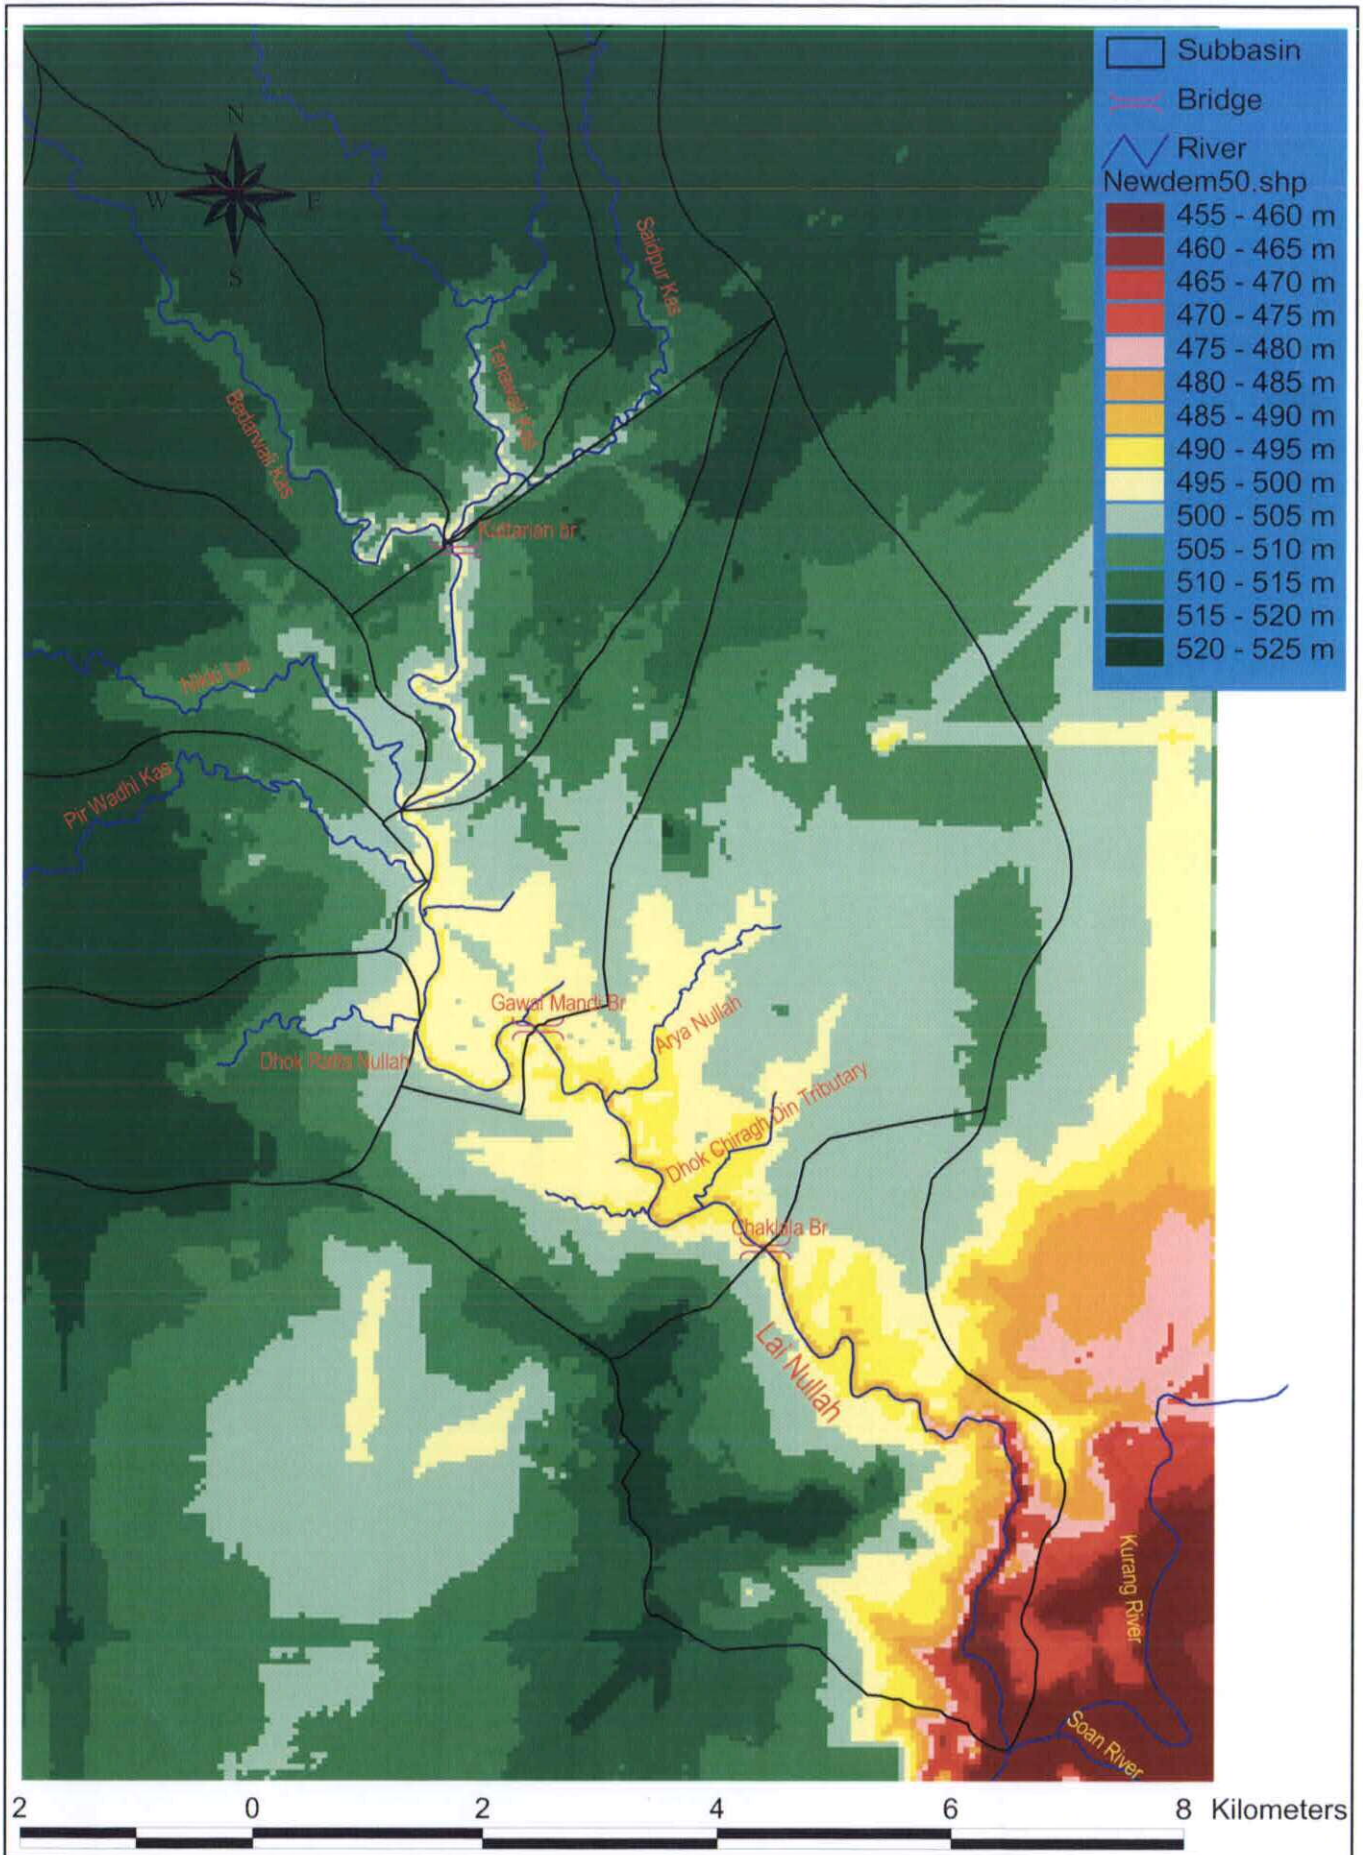
Fig. A.2
Ground Elevation along Lai Nullah

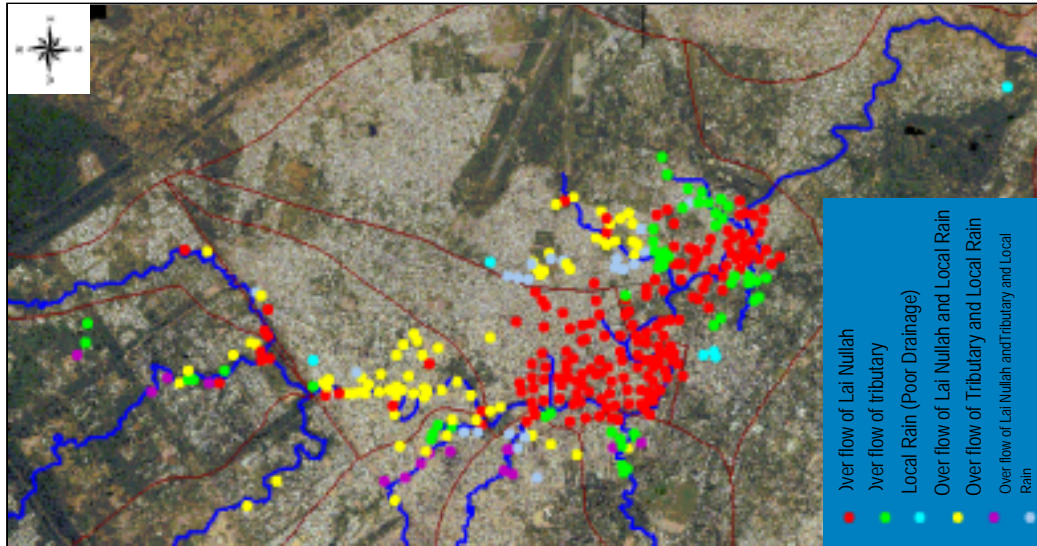
**Causes Of Flood Inundation
During 2001 Flood**

Fig. A.3
Results of Flood Inundation Interview
Survey

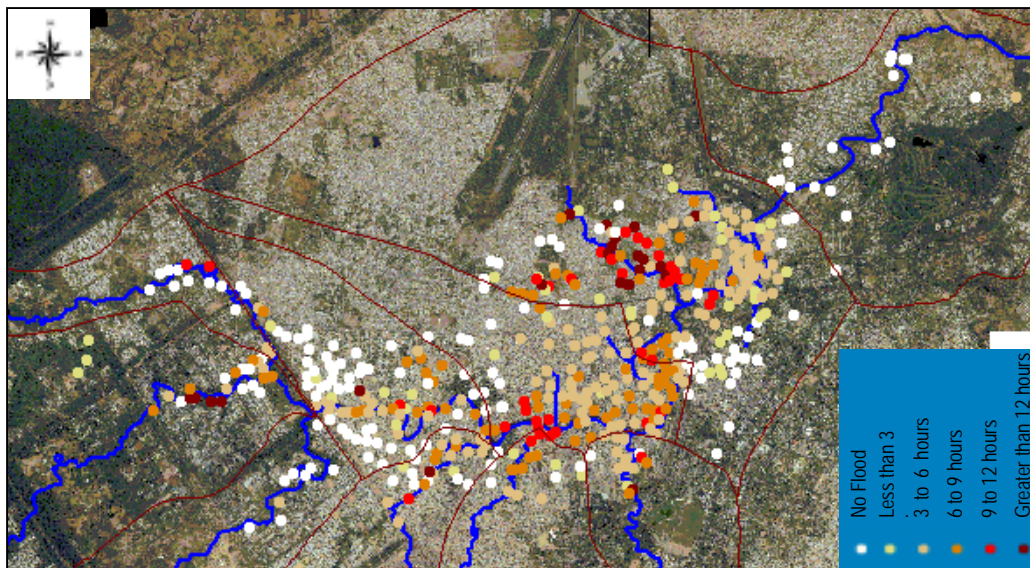
**Duration Of Flood Inundation
During 2001 Flood**

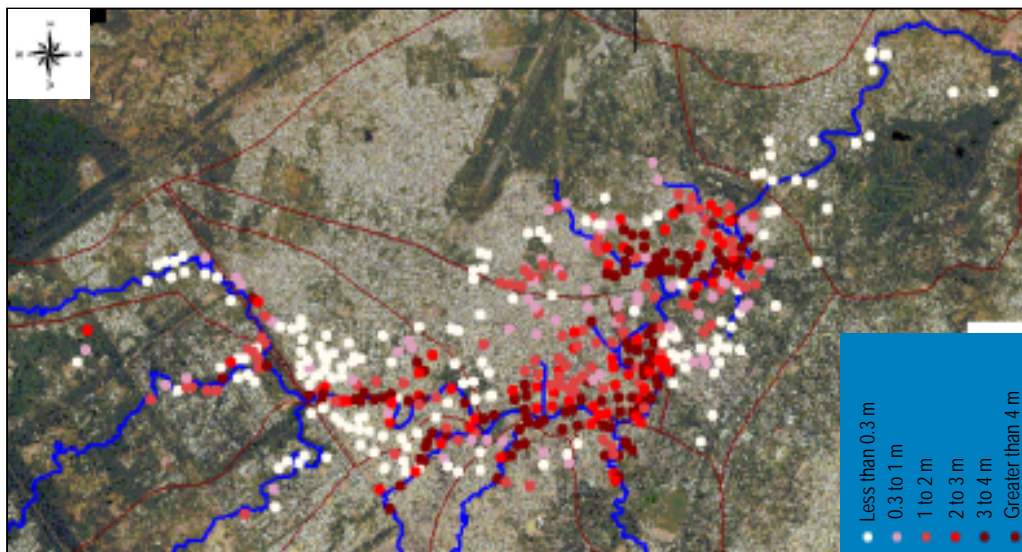
**Maximum Flood Inundation Depths
During 2001 Flood**
