THE GOVERNMENT OF THE PHILIPPINES  
THE DEPARTMENT OF PUBLIC WORKS AND HIGHWAYS

**The Study on Sabo and Flood Control for  
Western River Basins of Mount Pinatubo in  
the Republic of the Philippines**

JAPAN INTERNATIONAL COOPERATION AGENCY

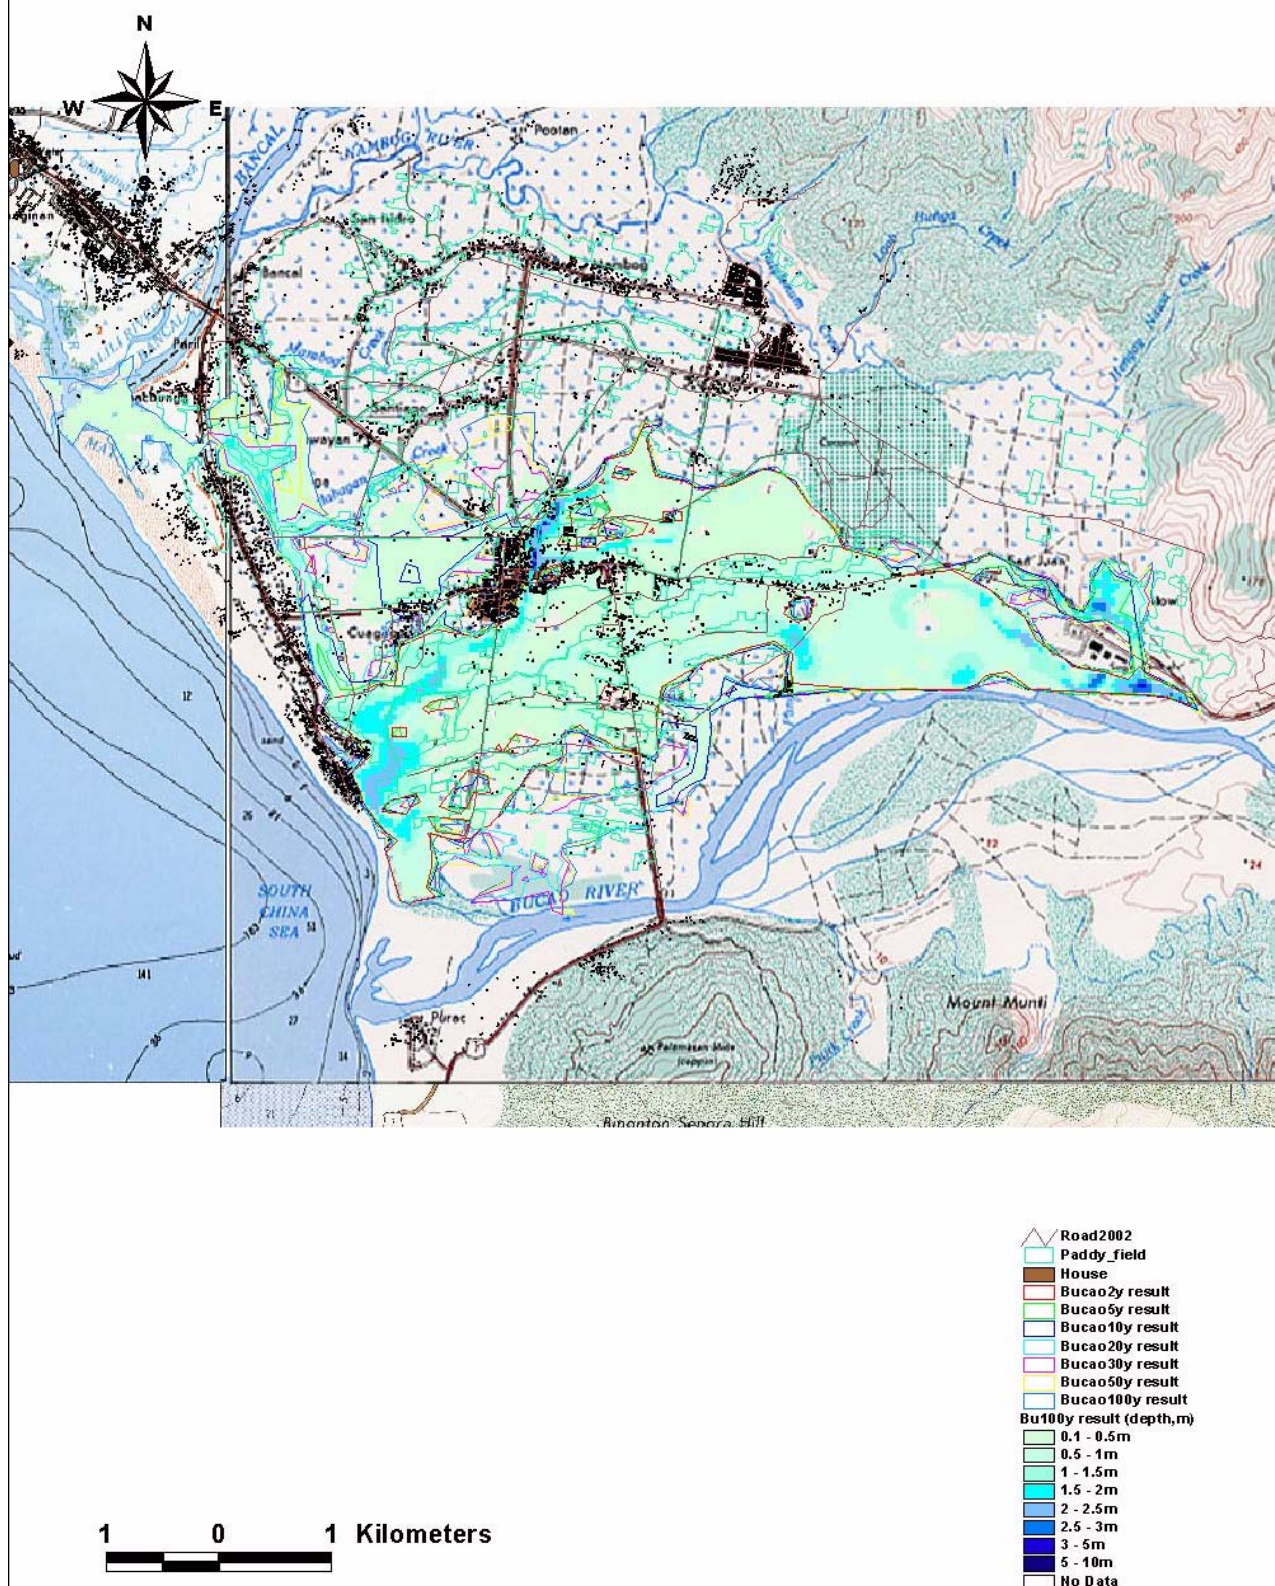
**Figure 7.2.1**

**Mudflow Hazard Area in the Bucao River  
Basin under 100-year Probable Flood**
