THE GOVERNMENT OF THE PHILIPPINES
THE DEPARTMENT OF PUBLIC WORKS AND HIGHWAYS

**The Study on Sabo and Flood Control for
Western River Basins of Mount Pinatubo
in the Republic of the Philippines**

JAPAN INTERNATIONAL COOPERATION AGENCY

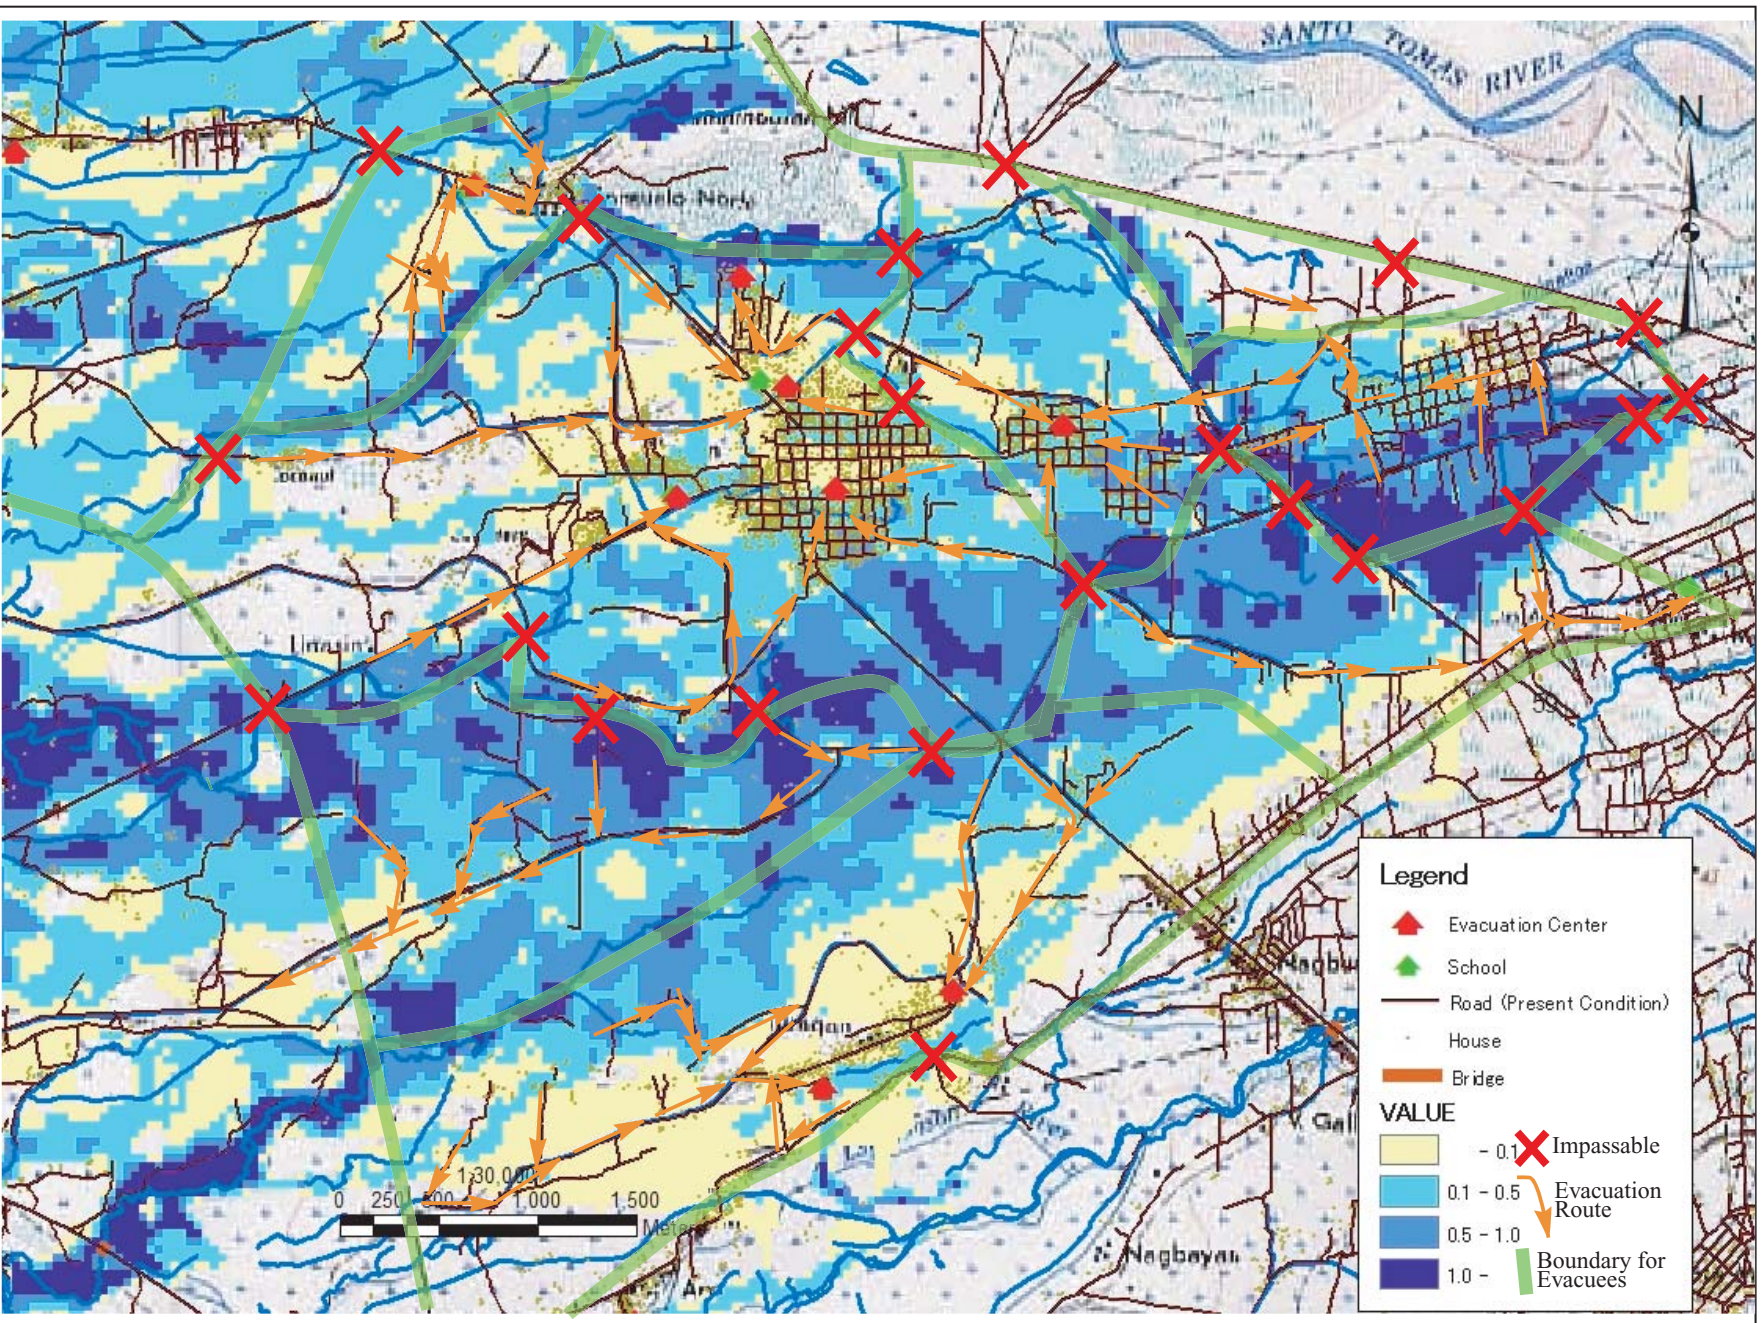
Figure 9.3.9

**Hazard Map
(Sto. Tomas River Basin : Left Side III)**
