THE GOVERNMENT OF THE PHILIPPINES
THE DEPARTMENT OF PUBLIC WORKS AND HIGHWAYS

**The Study on Sabo and Flood Control for
Western River Basins of Mount Pinatubo
in the Republic of the Philippines**

JAPAN INTERNATIONAL COOPERATION AGENCY

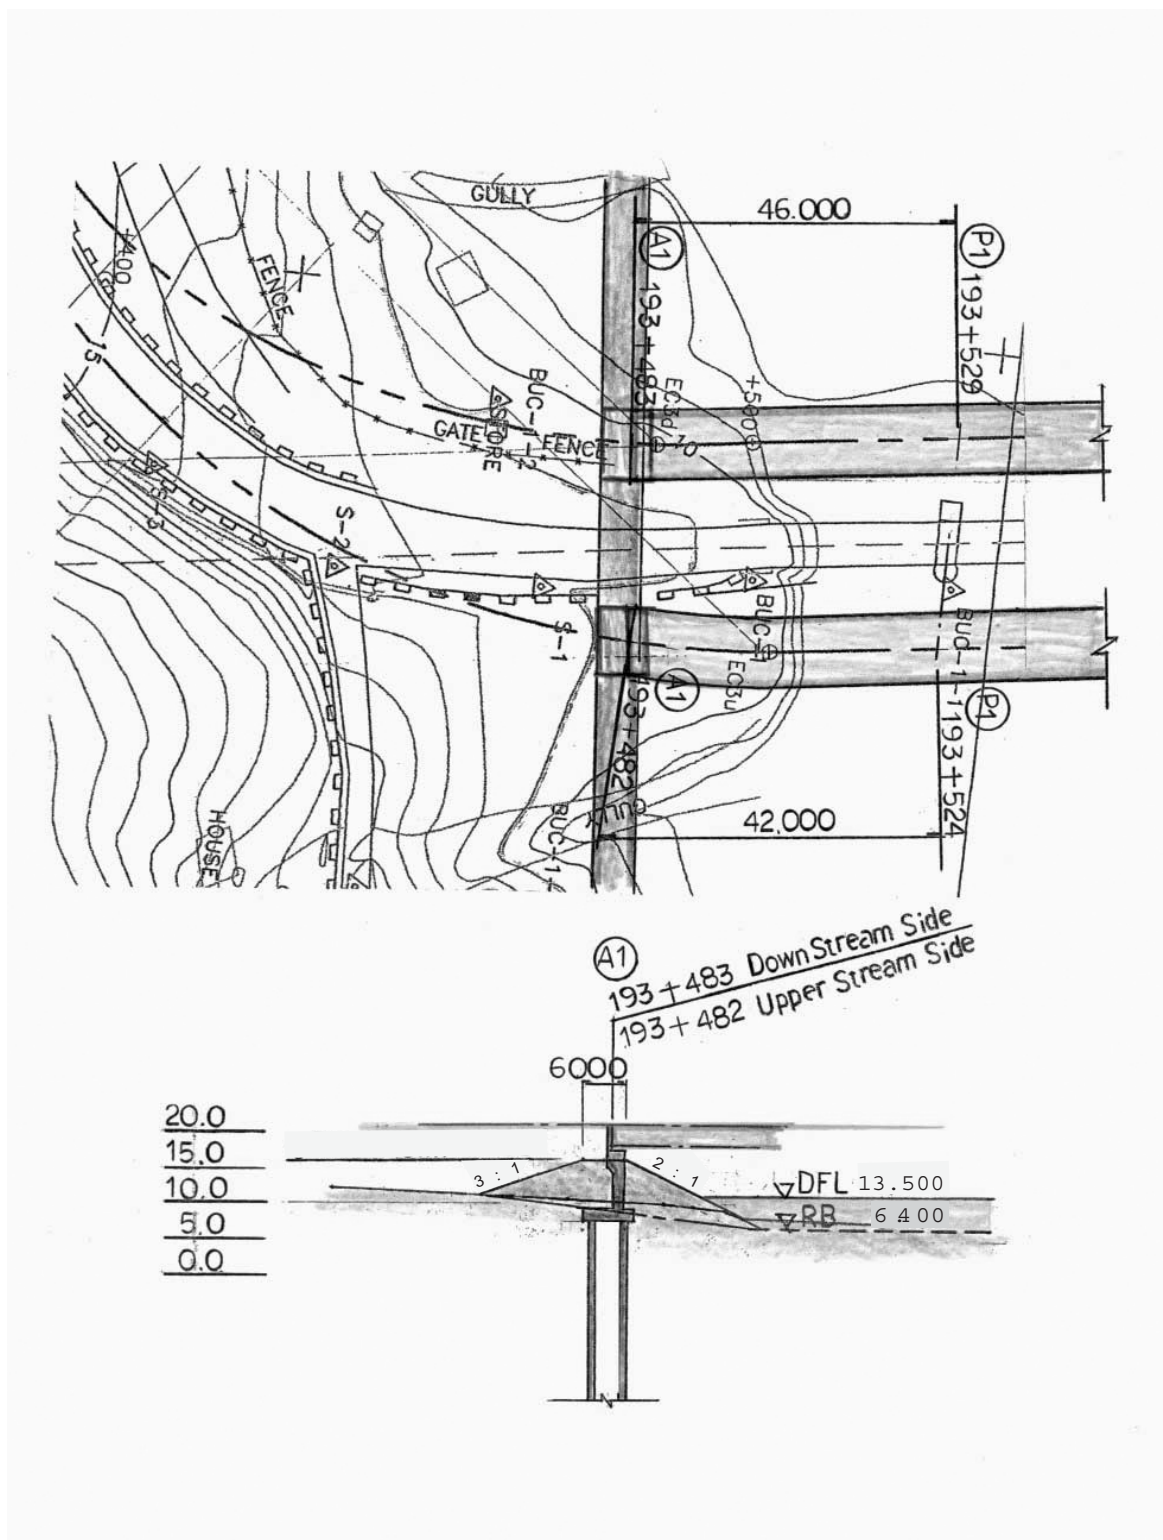
Figure 15.2.1

**Abutment Location of Manila Side of the
Budao Bridge for Reconstruction**

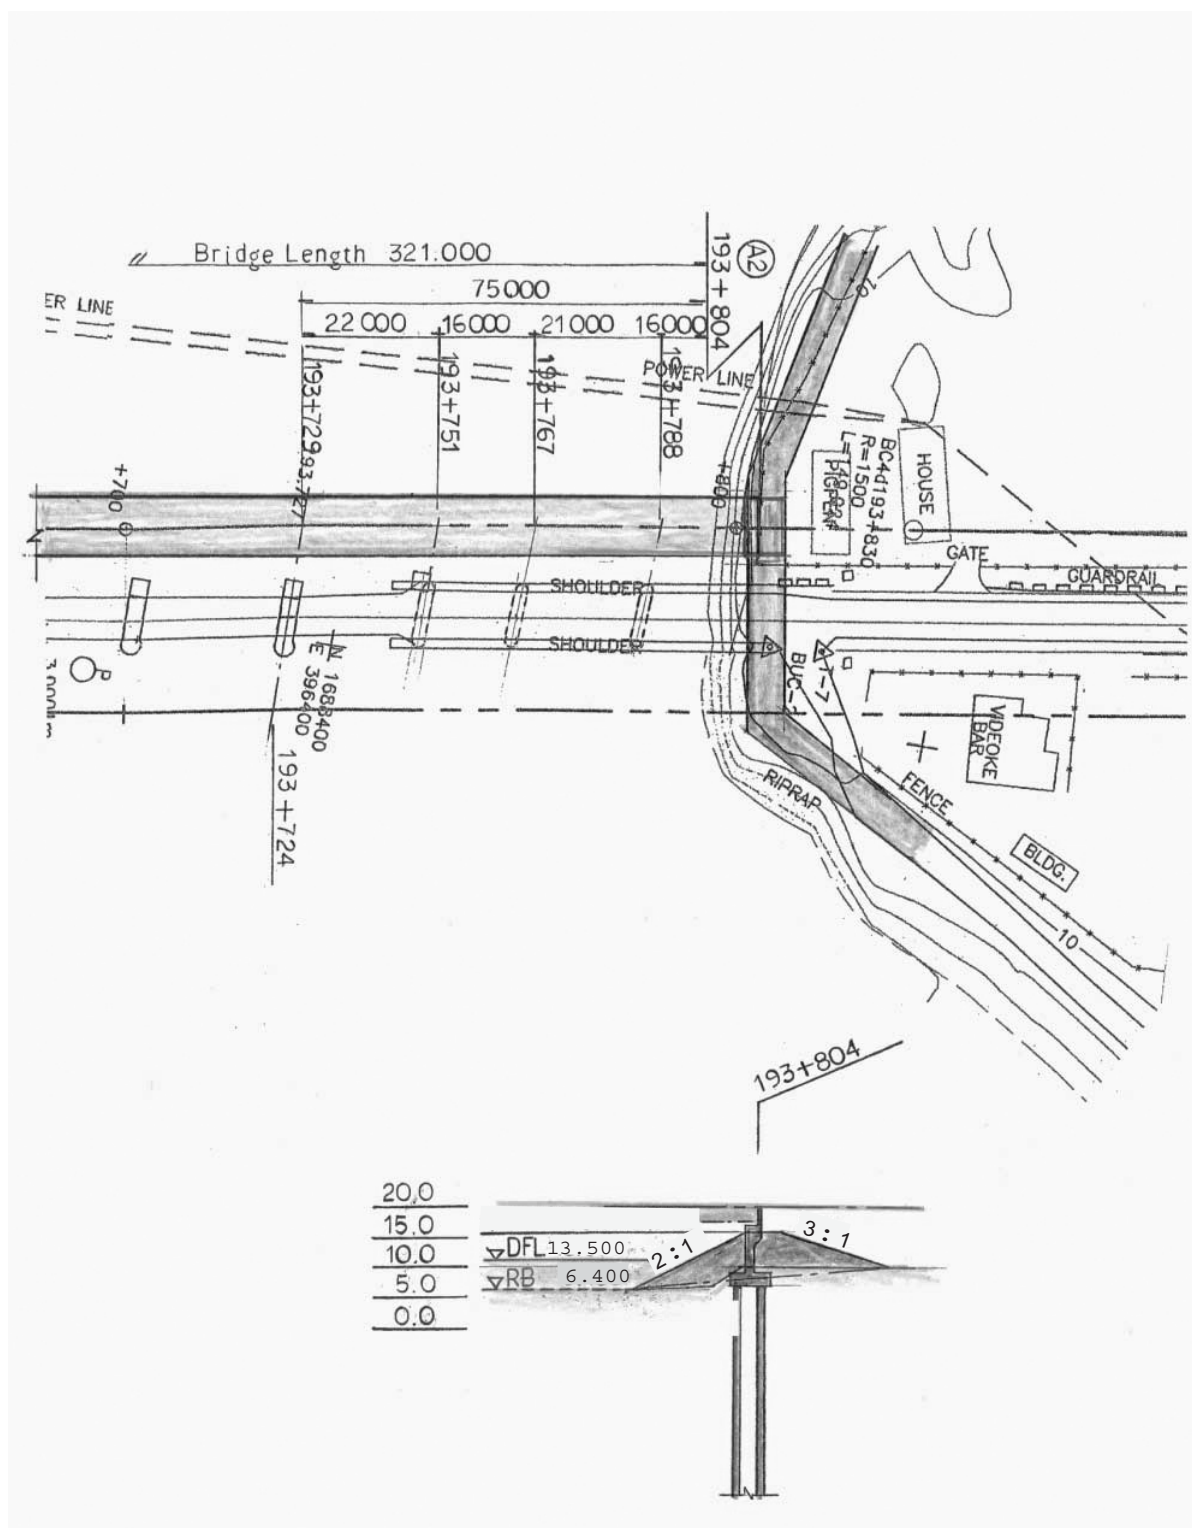
Figure 15.2.2

**Abutment Location of Iba Side at
Downstream for Reconstruction**

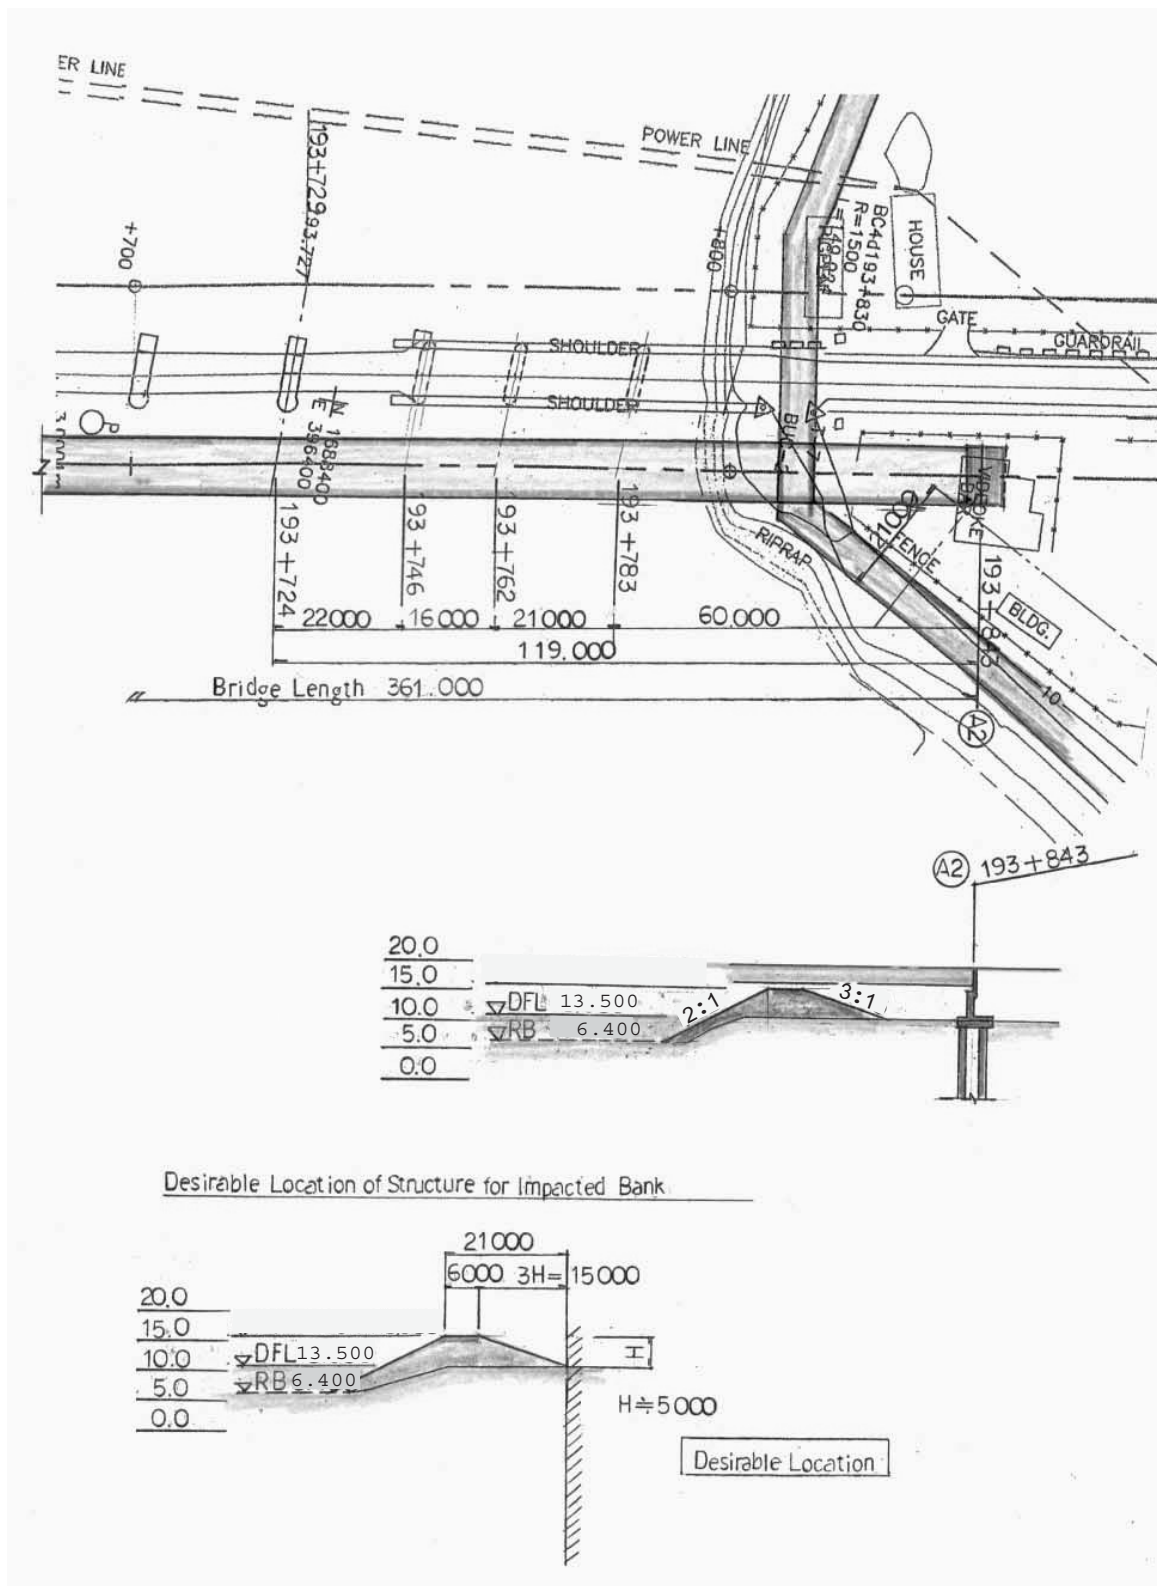
Figure 15.2.3

**Abutment Location of Iba Side at the Upper
Stream Side for Reconstruction**

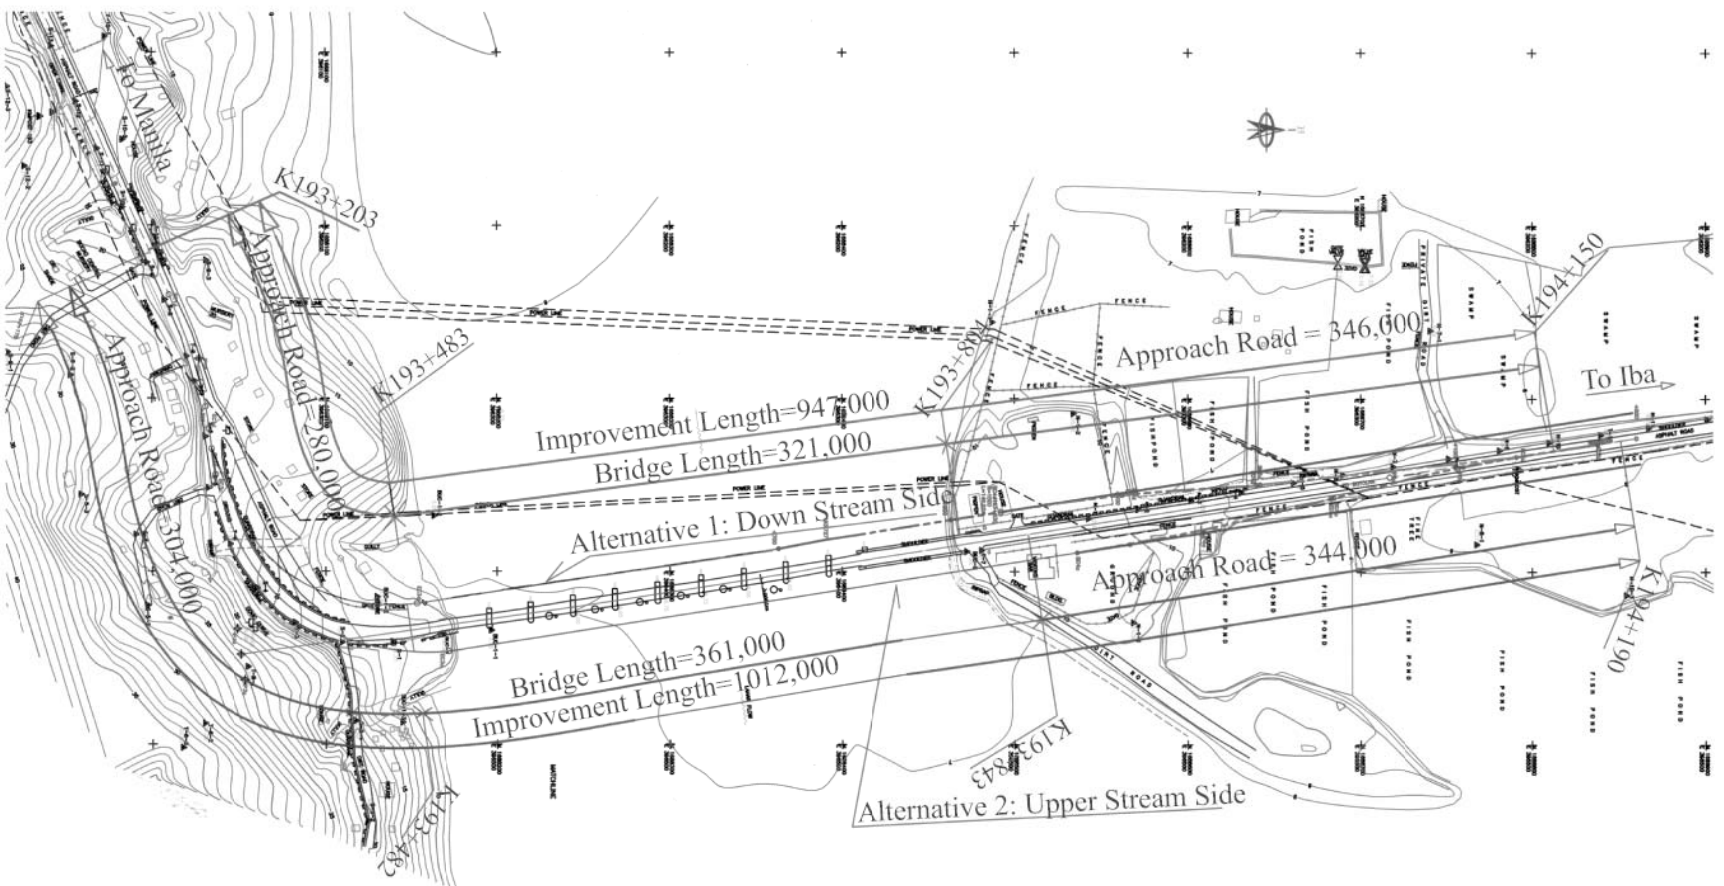
Figure 15.2.5

Plan of the Bucao Bridge for Reconstruction

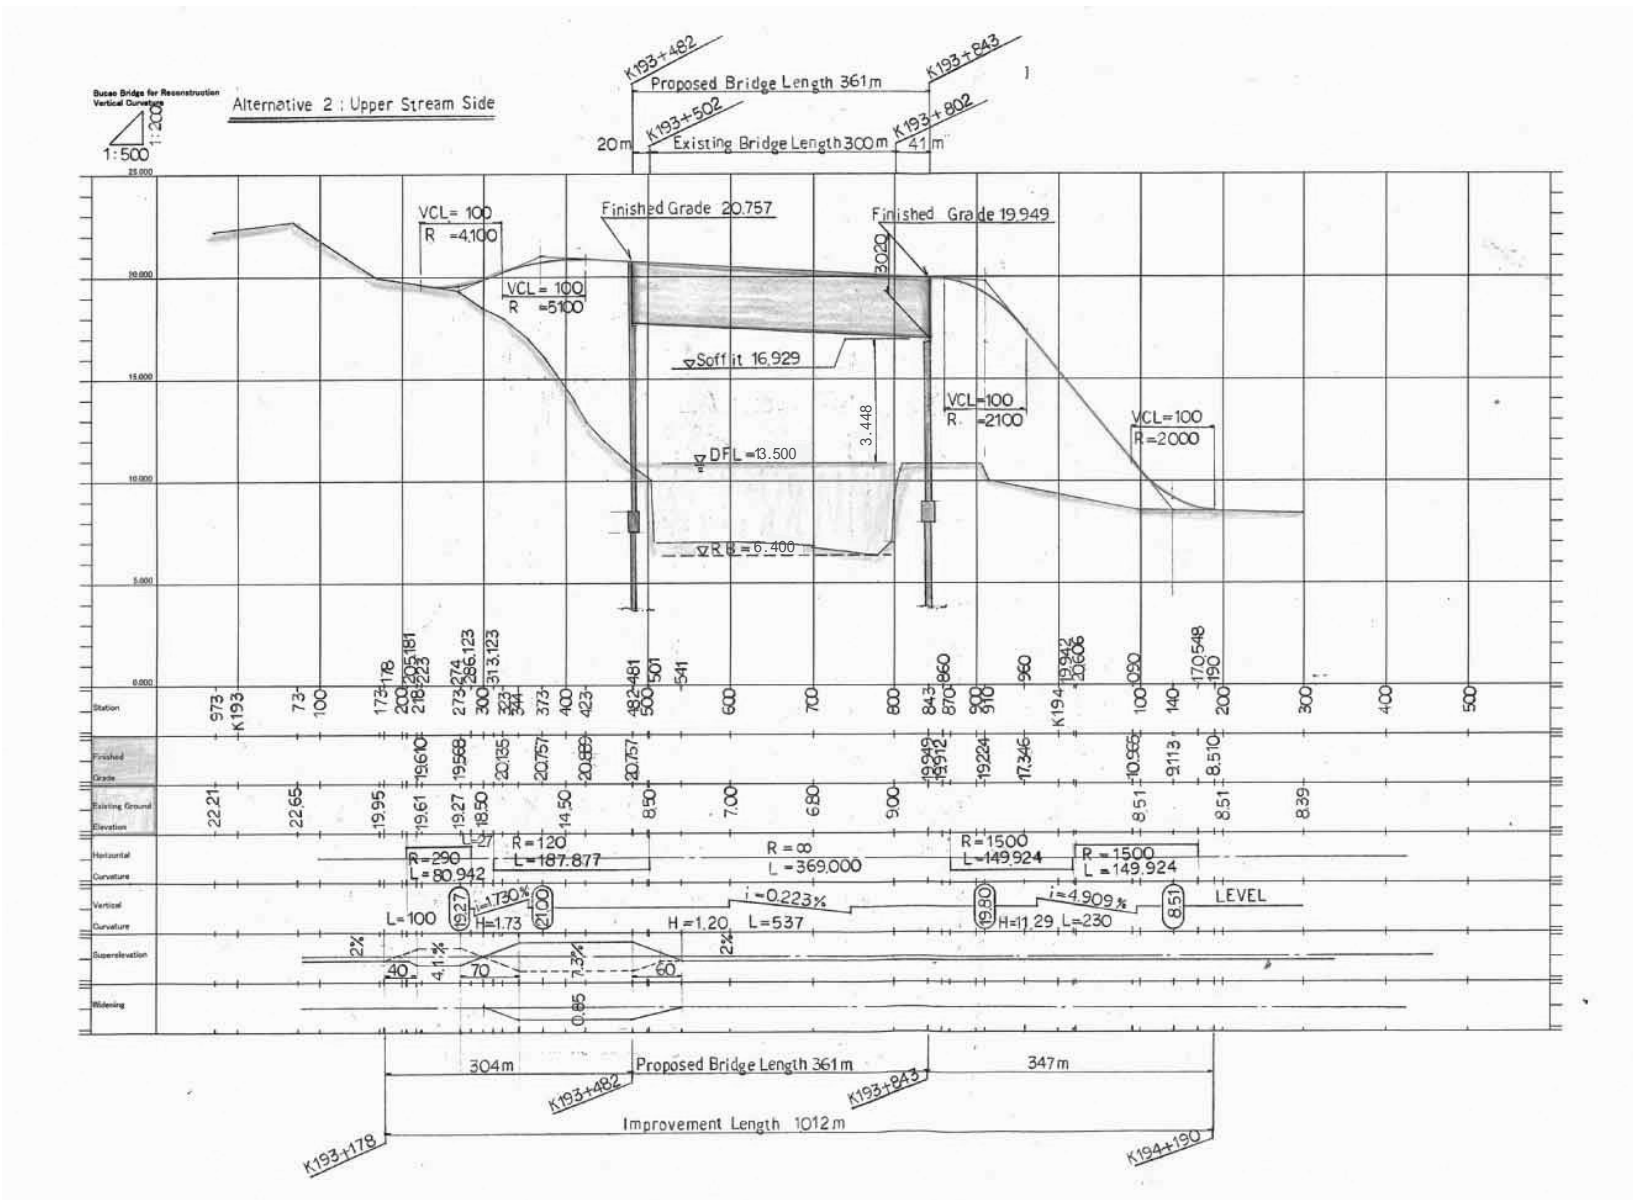
Figure 15.2.7
Vertical Curvature, Alternative 2, Upper
Stream Side for Reconstruction
