**The Study on Sabo and Flood Control for
Western River Basins of Mount Pinatubo in
the Republic of the Philippines**

**Proposed Structural Measures in Recovery
Action Plan (1994) for the Sto. Tomas River**

**Schematic Layout of Alternative Structural
Measures for the Marounot Notch**

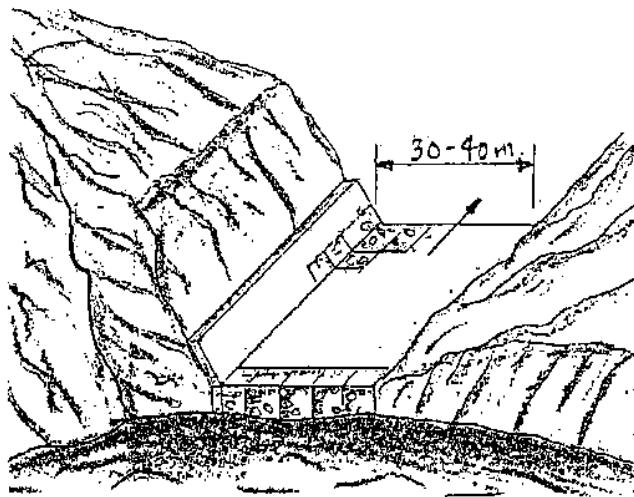
Figure 1.3.3

Training Channel with Gabion Structure Type

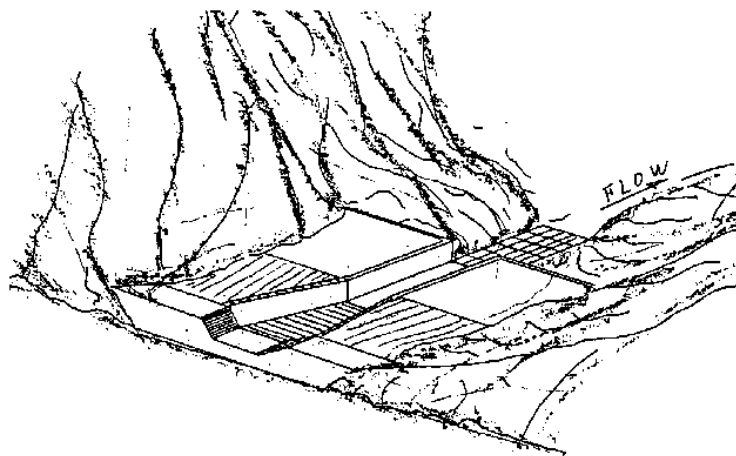
Overflow Weir and Training Channel Type

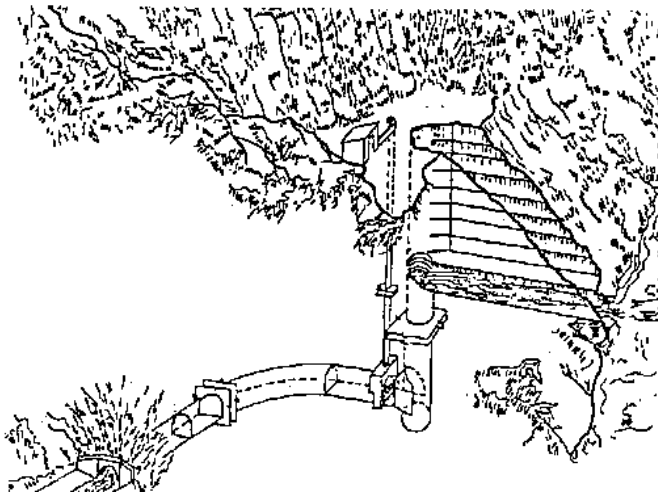
Tunnel Outlet Type

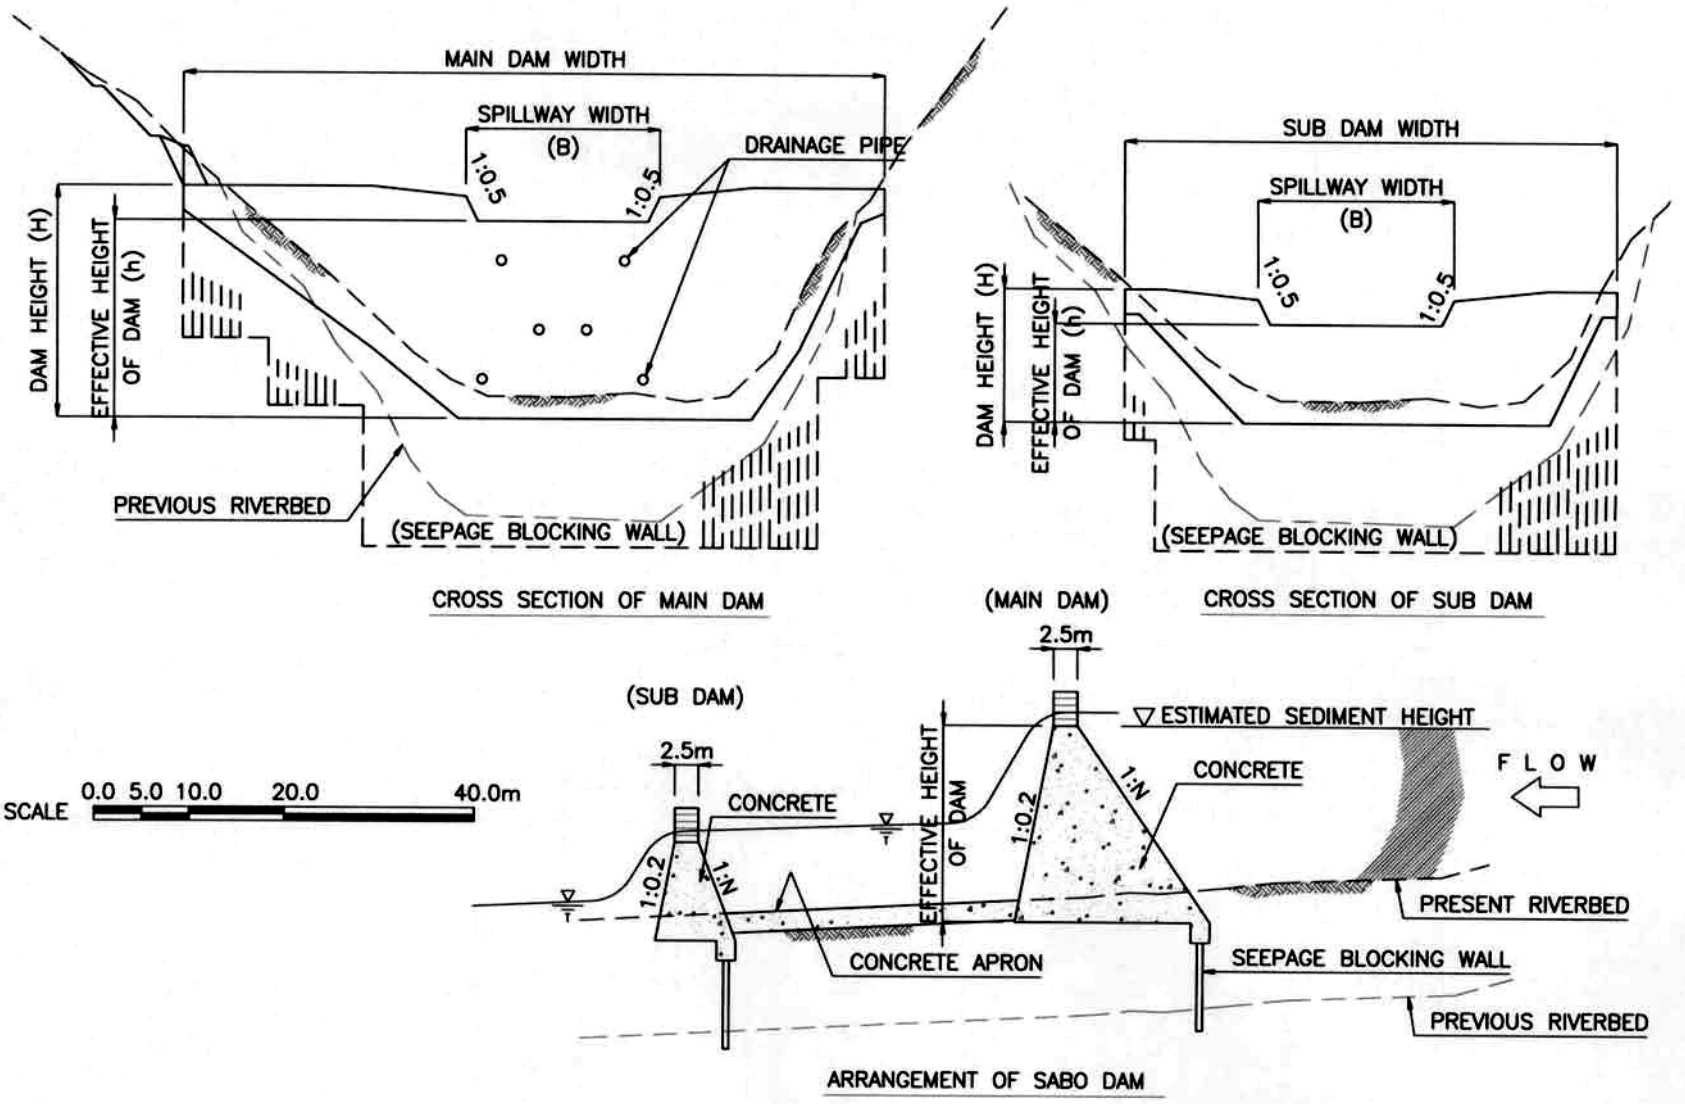
Figure 1.5.2

Proposed Sabo Dam Sites in the Three River Basins
