THE GOVERNMENT OF THE PHILIPPINES  
THE DEPARTMENT OF PUBLIC WORKS AND HIGHWAYS

**The Study on Sabo and Flood Control for  
Western River Basins of Mount Pinatubo in the  
Republic of the Philippines**

JAPAN INTERNATIONAL COOPERATION AGENCY

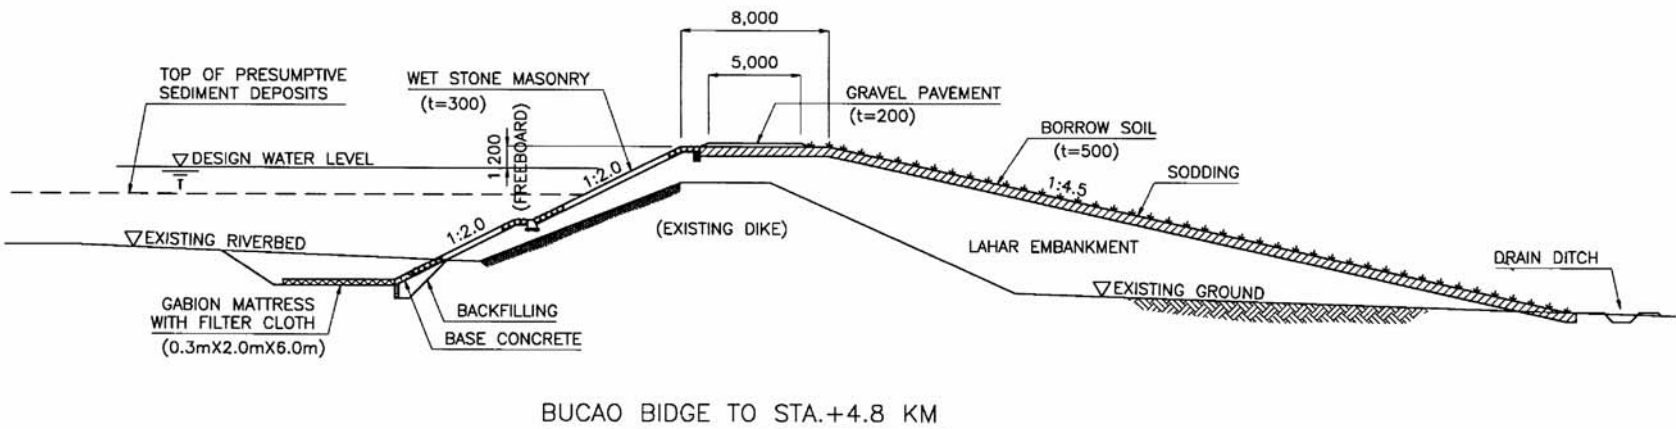
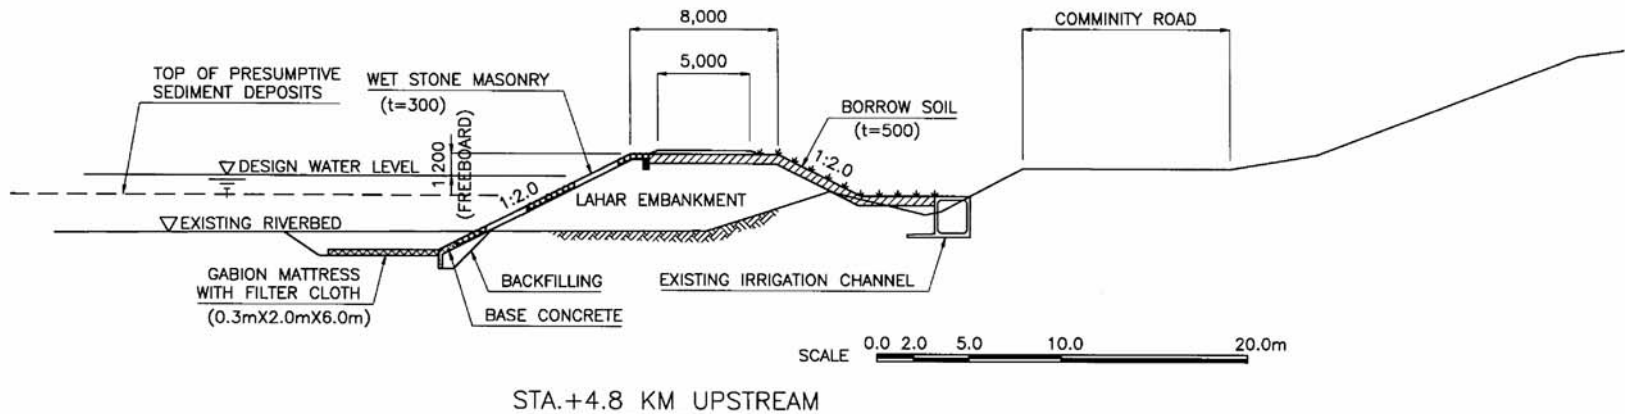
**Figure 2.3.4**

**Typical Cross Sections of Proposed Dike  
Heightening in the Bucao River**

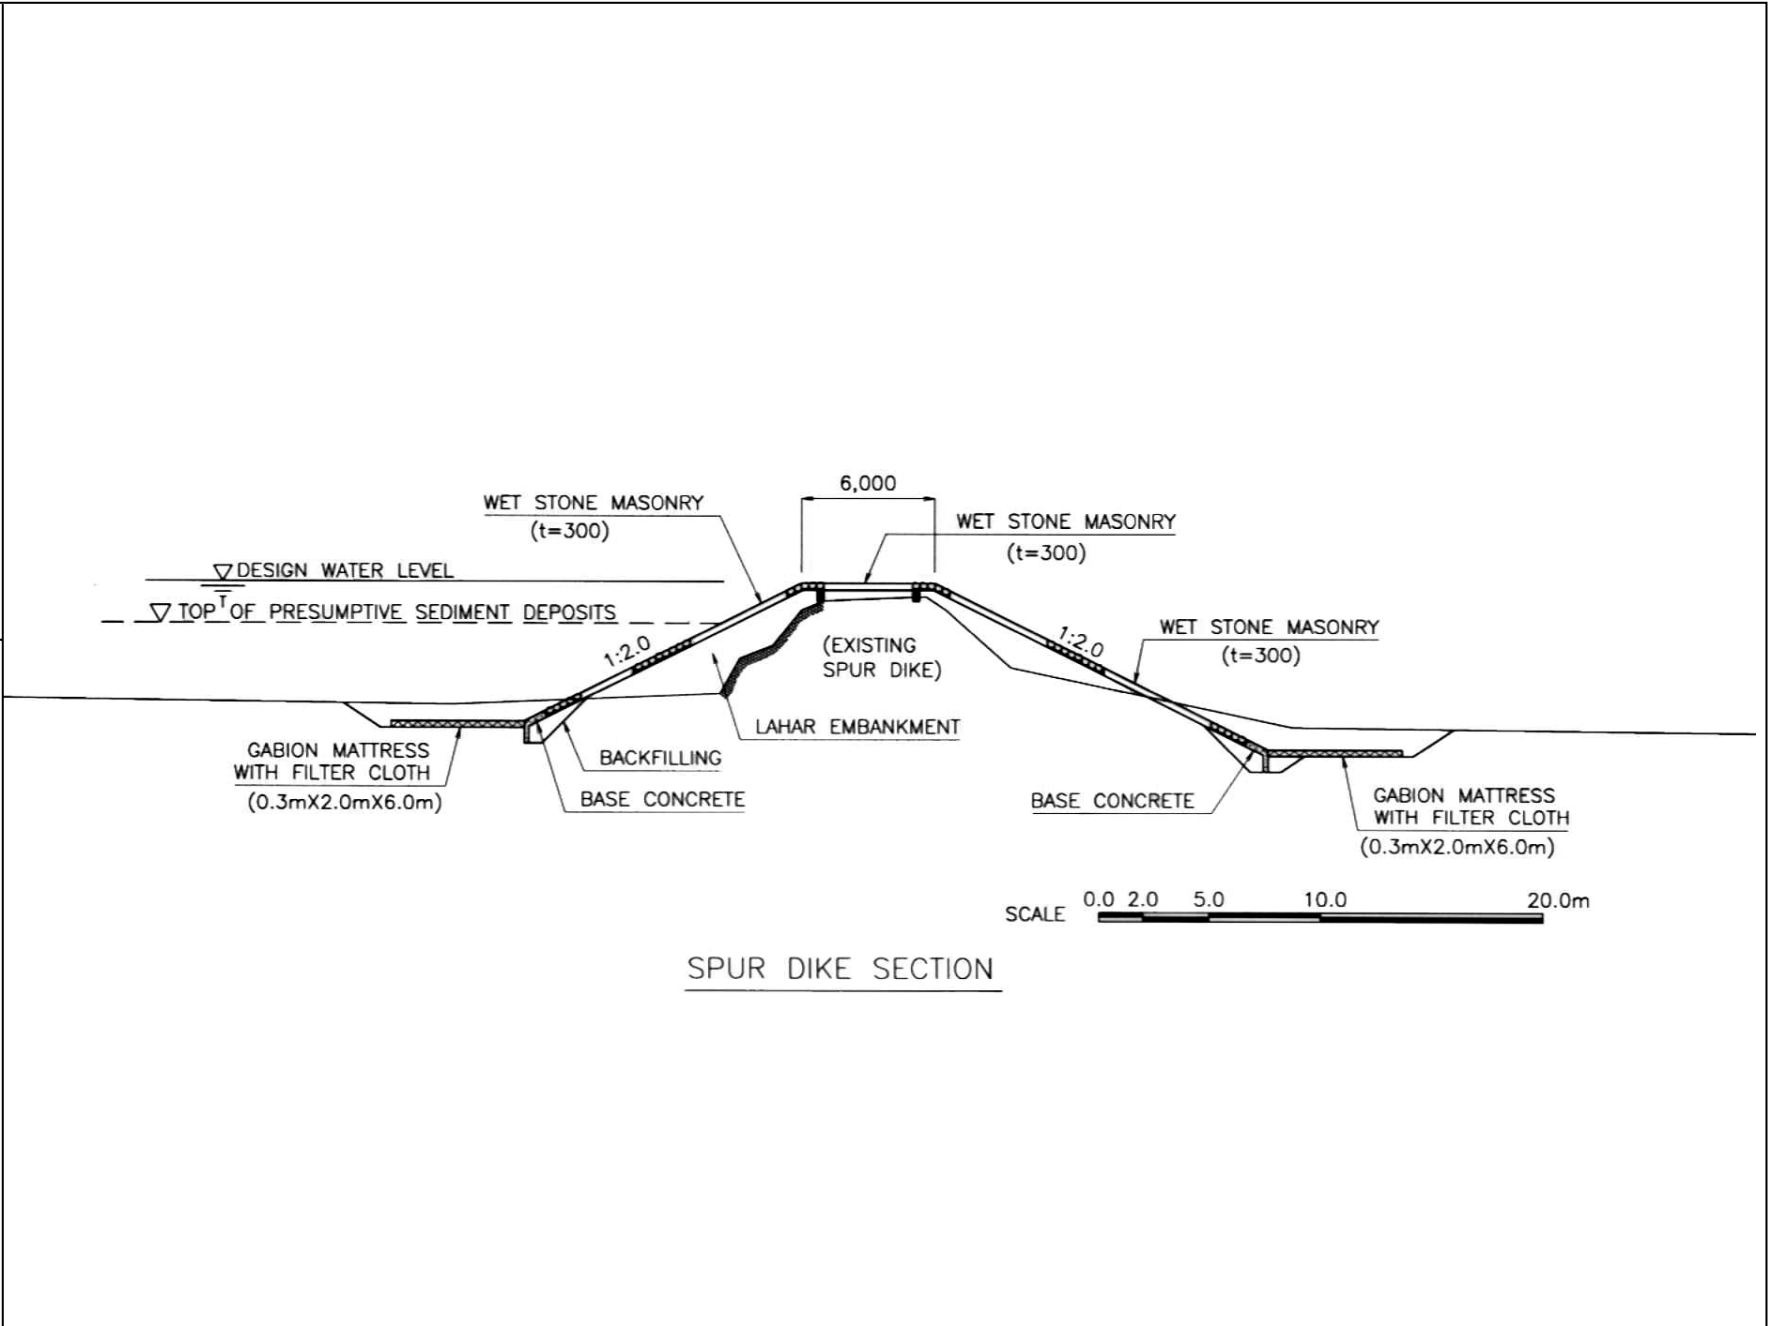
**Figure 2.3.5**  
**Typical Cross Section of Proposed Spur Diike**  
**Strengthening in the Bucao River**

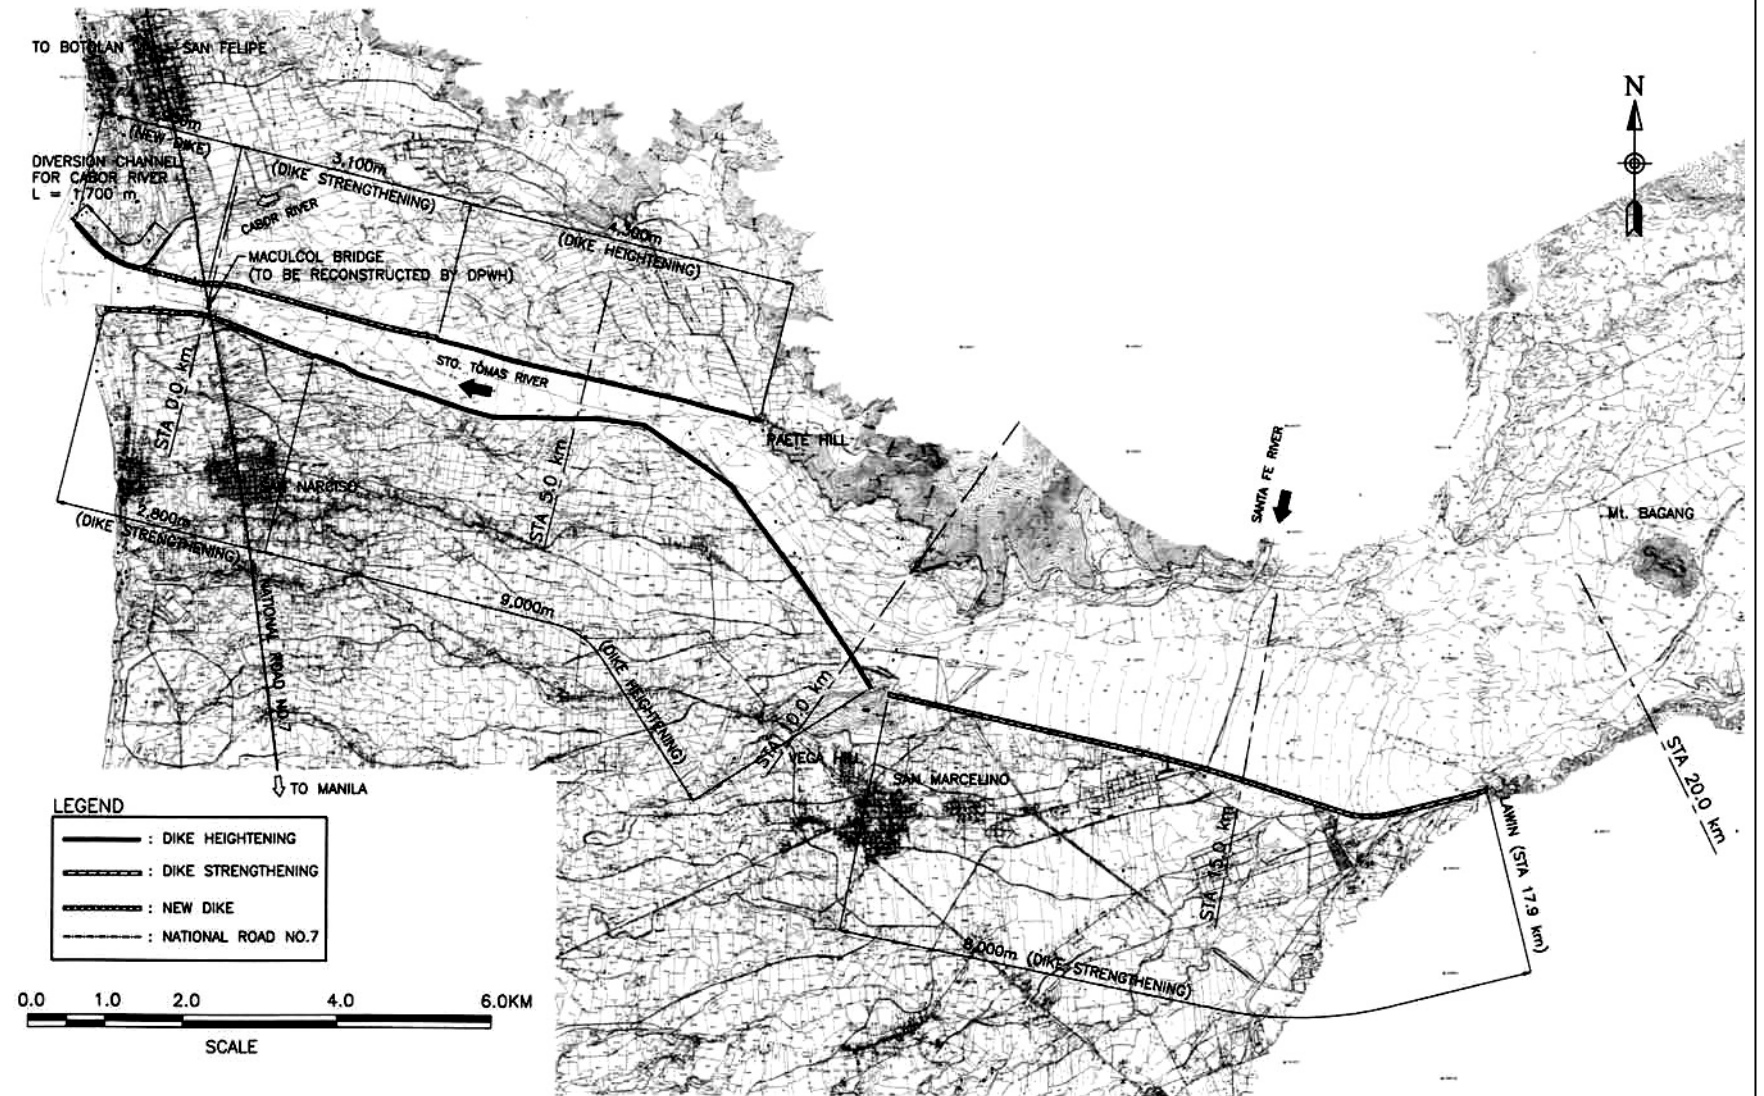
**Figure 3.2.1**

**General Plan of Proposed River Improvement  
 in the Sto. Tomas River**

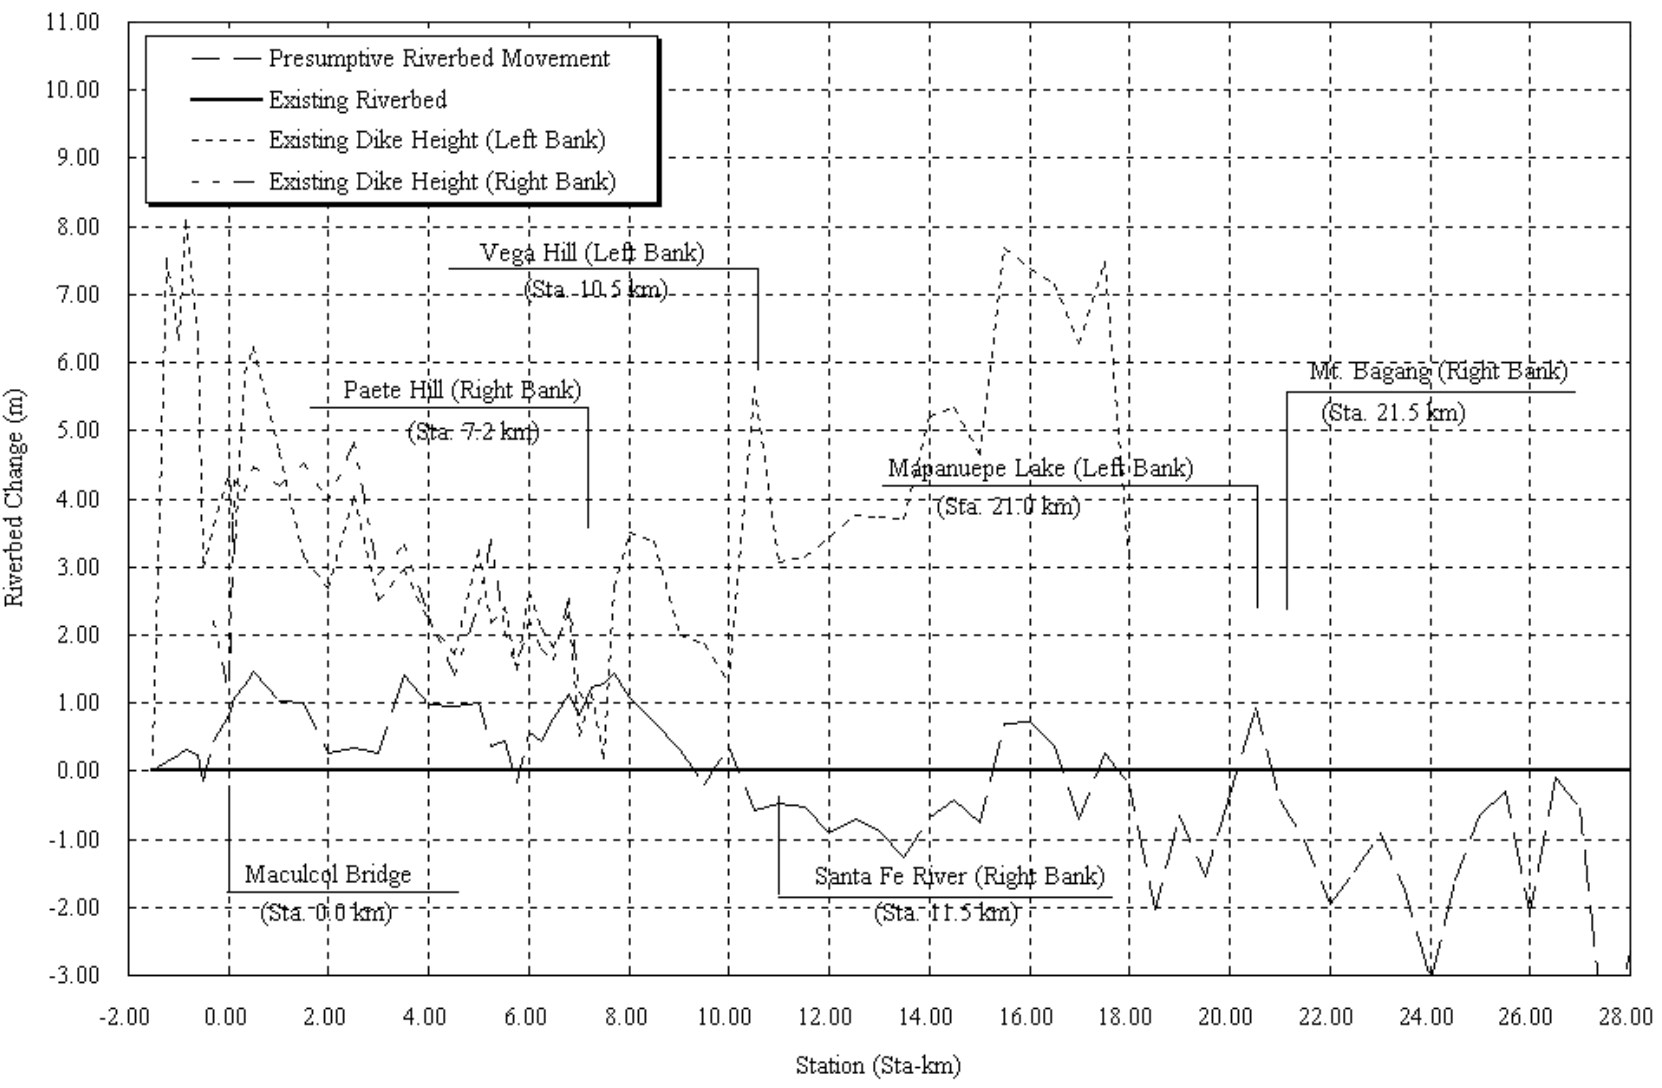
Figure 3.2.2

Presumptive Riverbed Change after 20 Years  
in the Sto. Tomas River

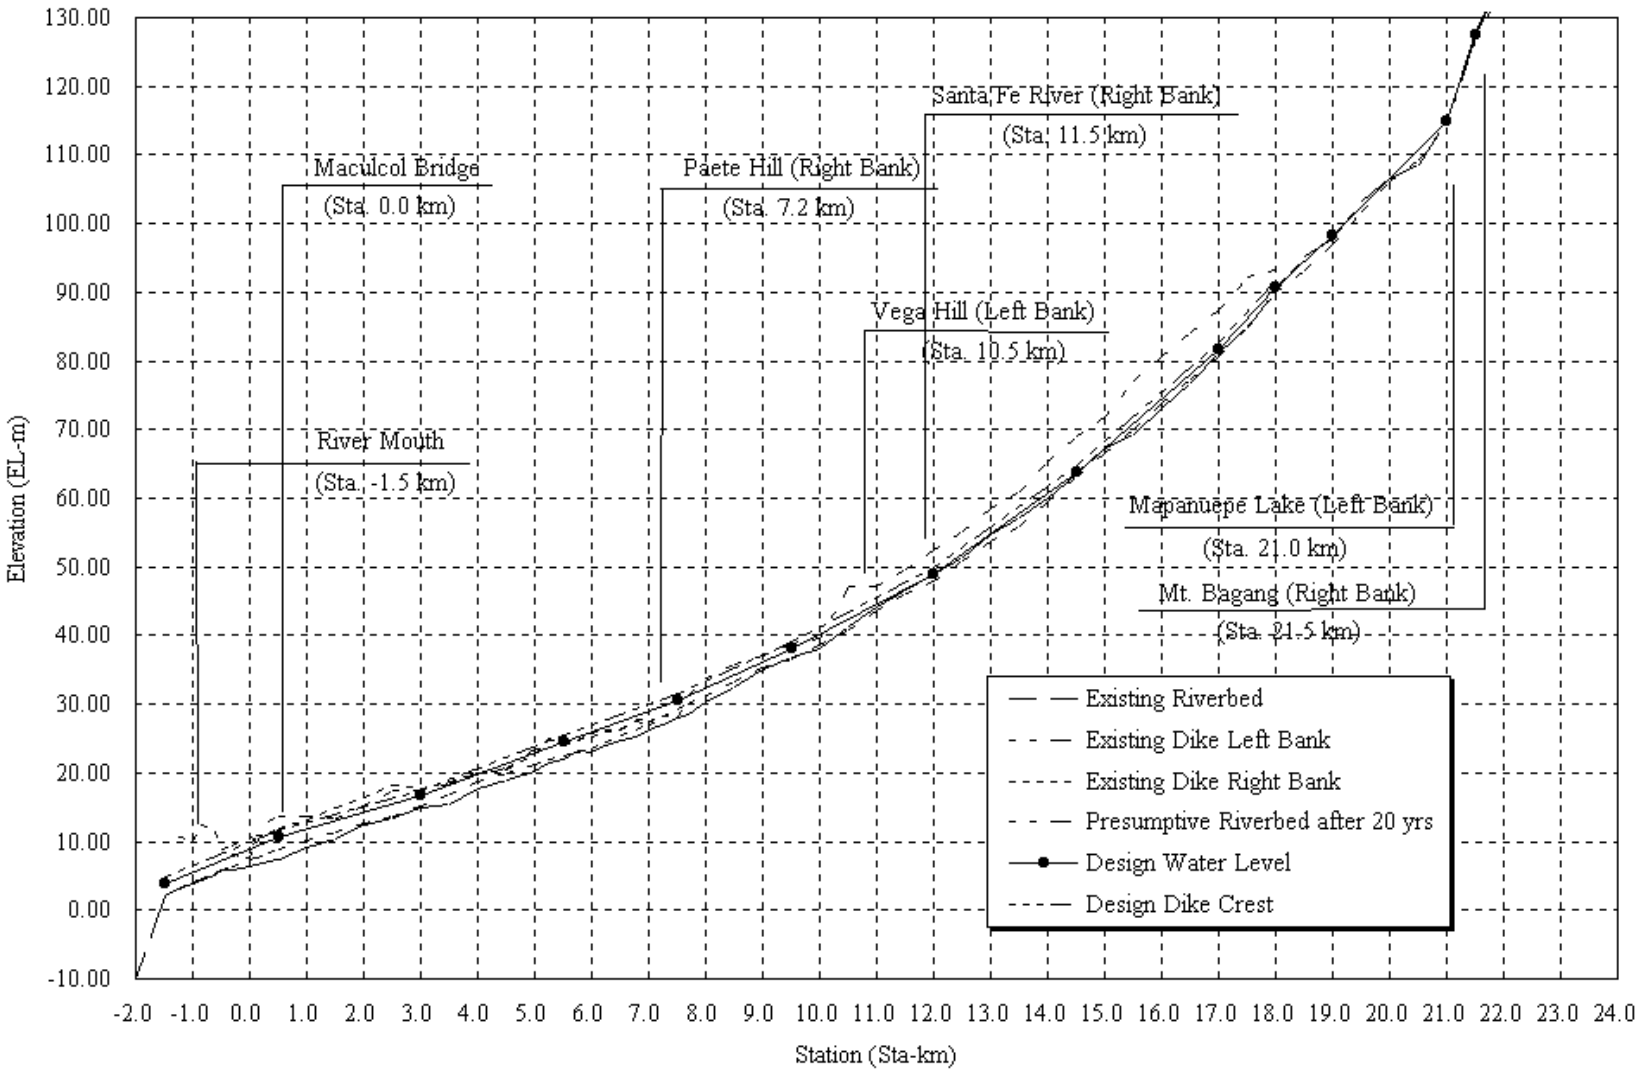
Figure 3.2.3 (1/4)

Longitudinal Profile of River Improvement  
in the Sto. Tomas River

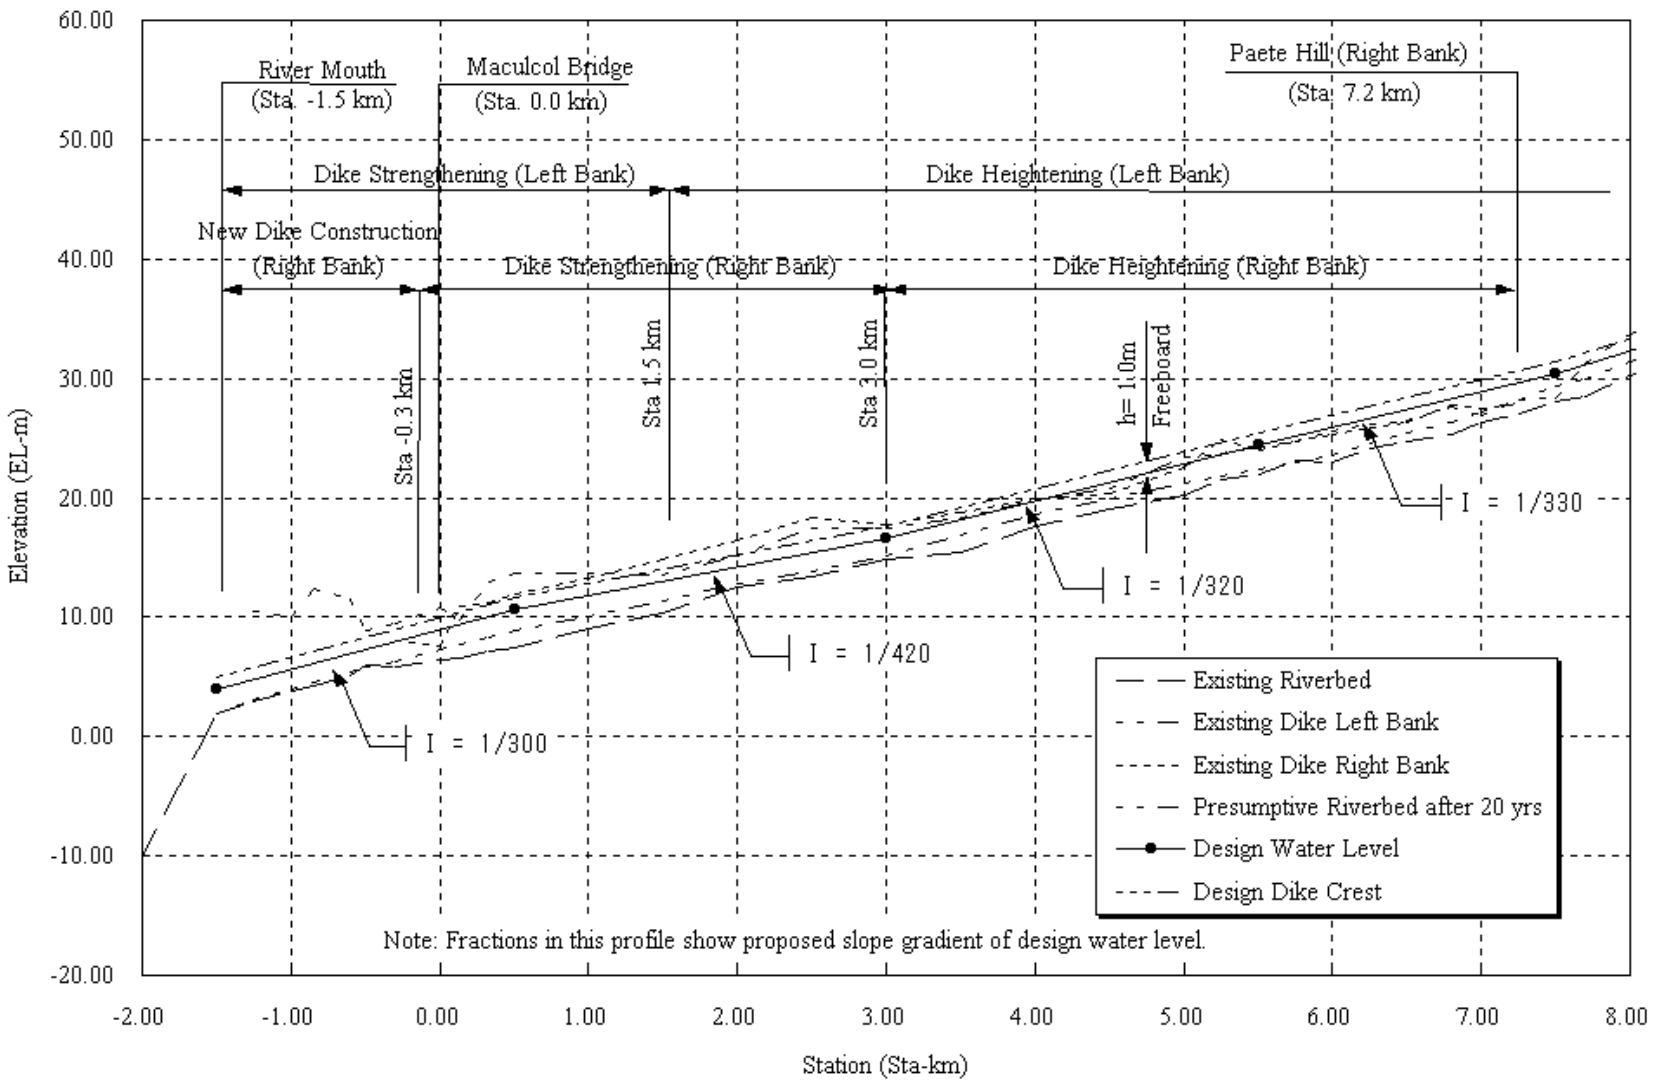
Figure 3.2.3 (2/4)

Longitudinal Profile of River Improvement  
in the Sto. Tomas River

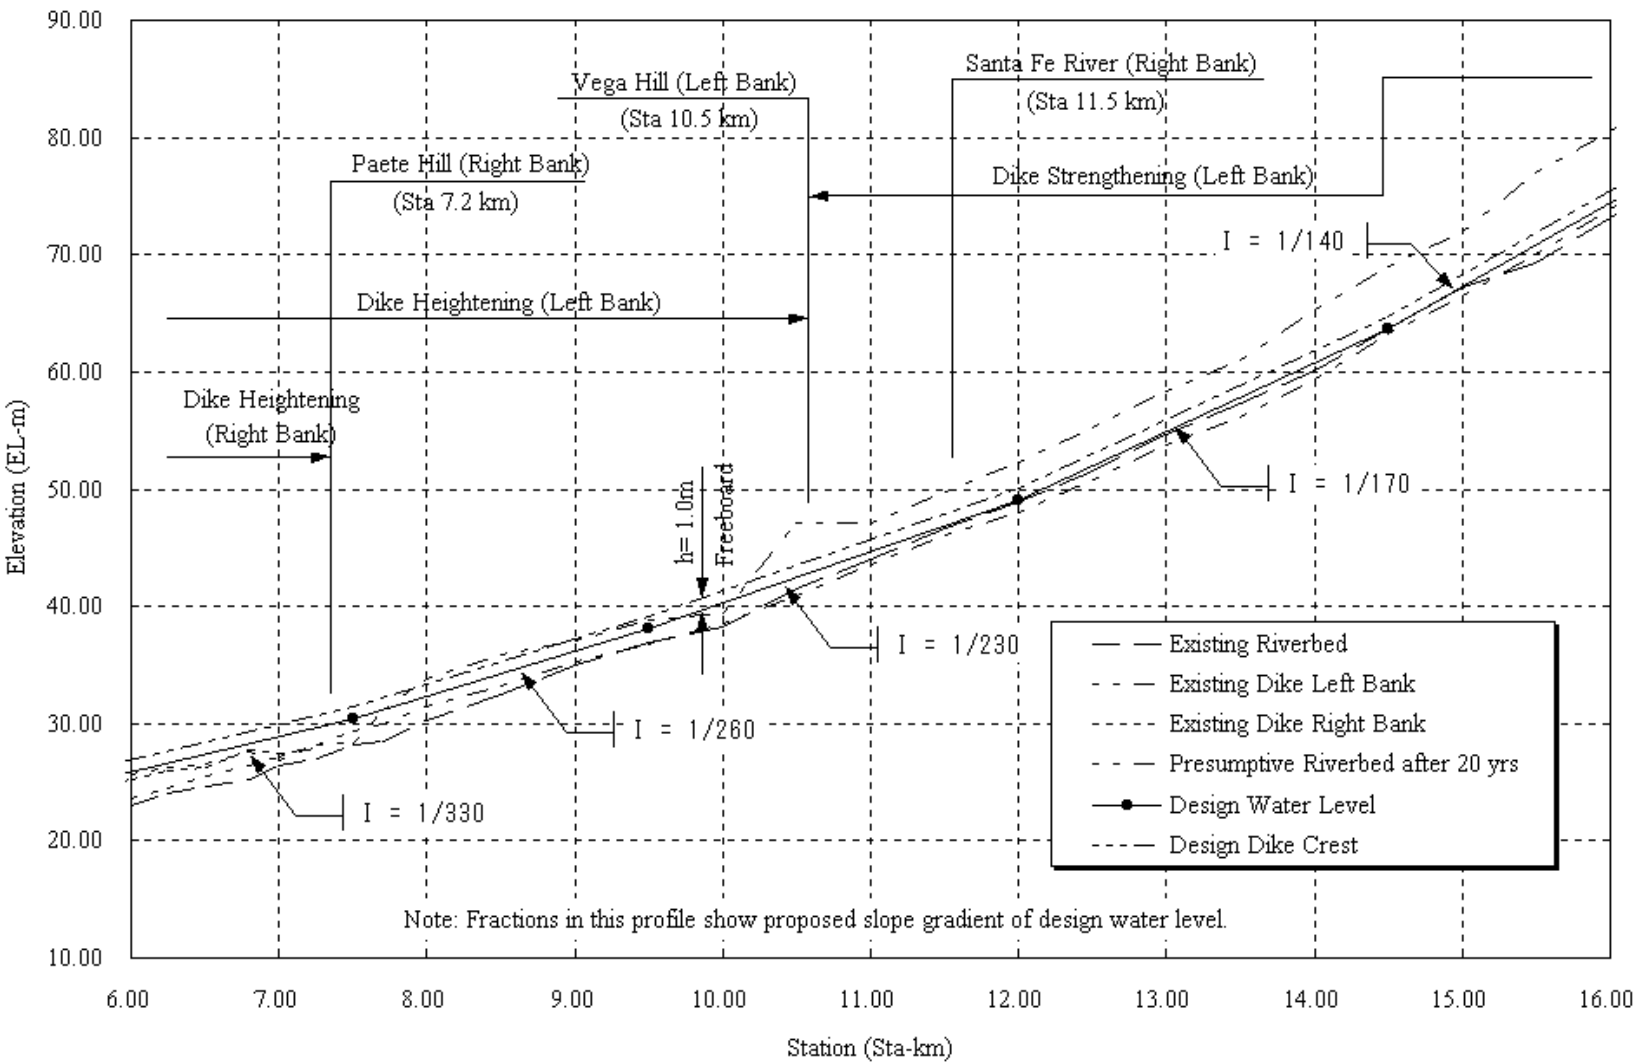
Figure 3.2.3 (3/4)

Longitudinal Profile of River Improvement  
in the Sto. Tomas River

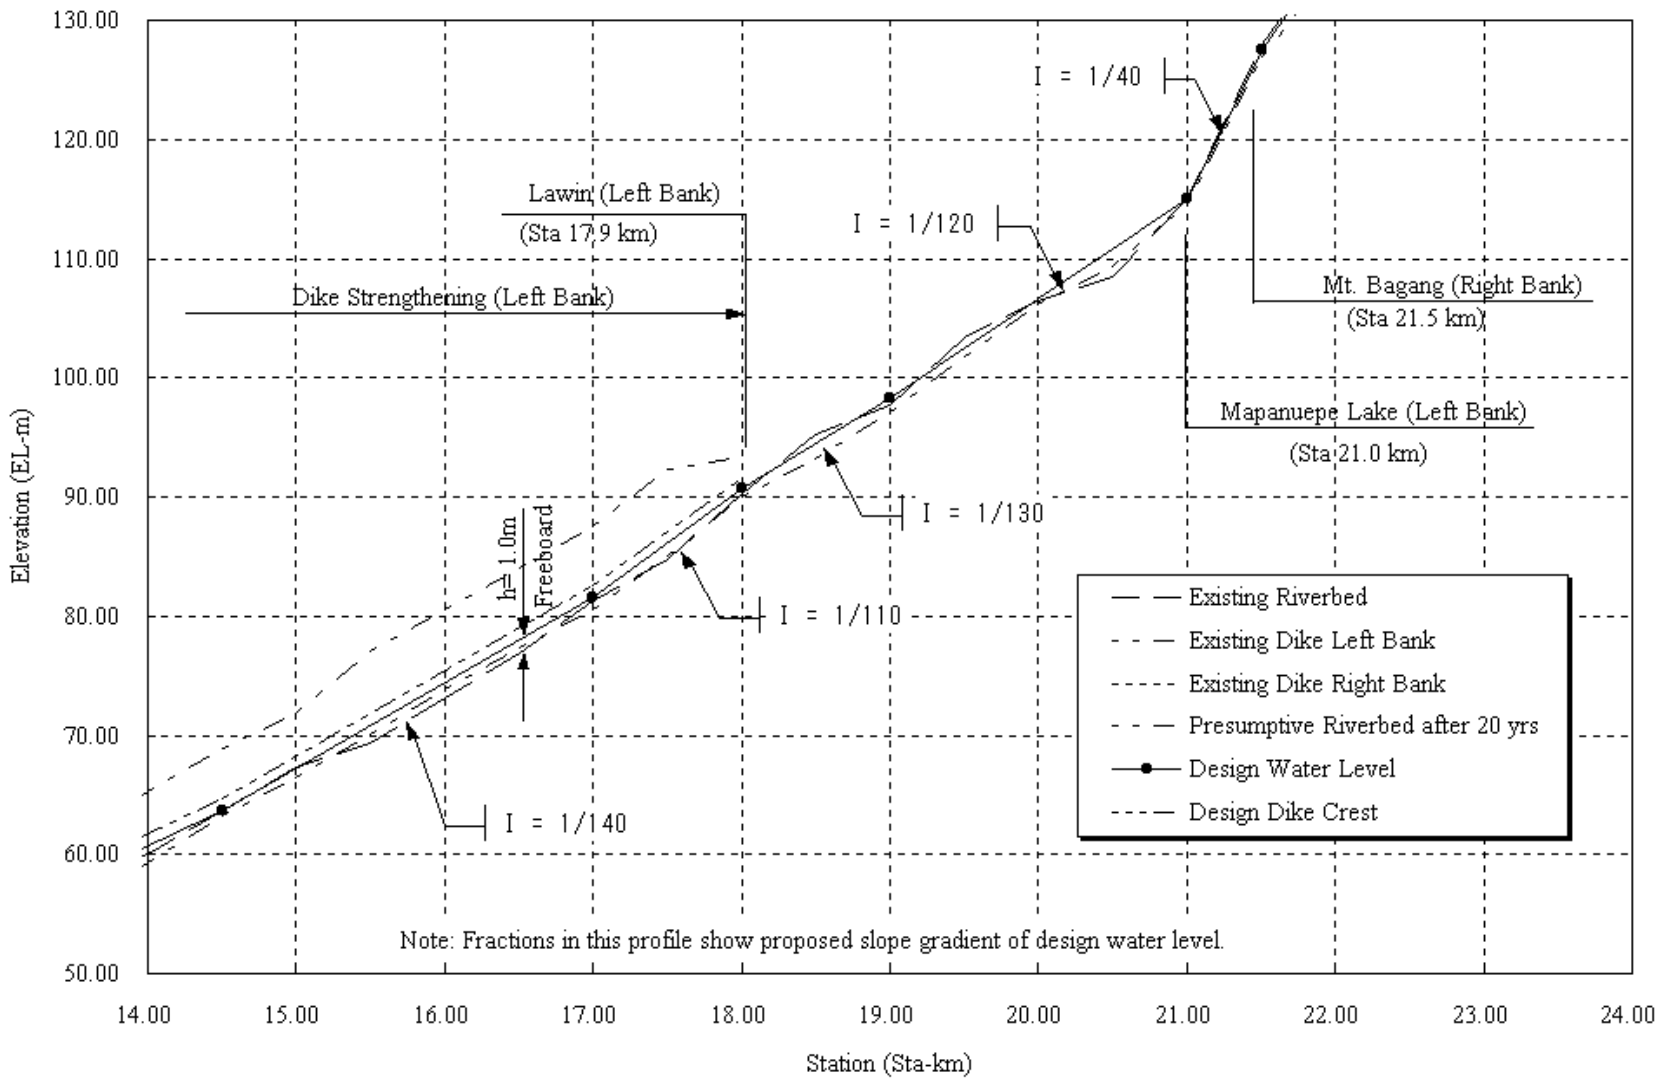
Figure 3.2.3 (4/4)

Longitudinal Profile of River Improvement  
in the Sto. Tomas River
