Figure 1.3.8
**General View of the Bucaco Bridge for
Reconstruction**

**The Study on Sabo and Flood Control for
Western River Basins of Mount Pinatubo in the
Republic of the Philippines**

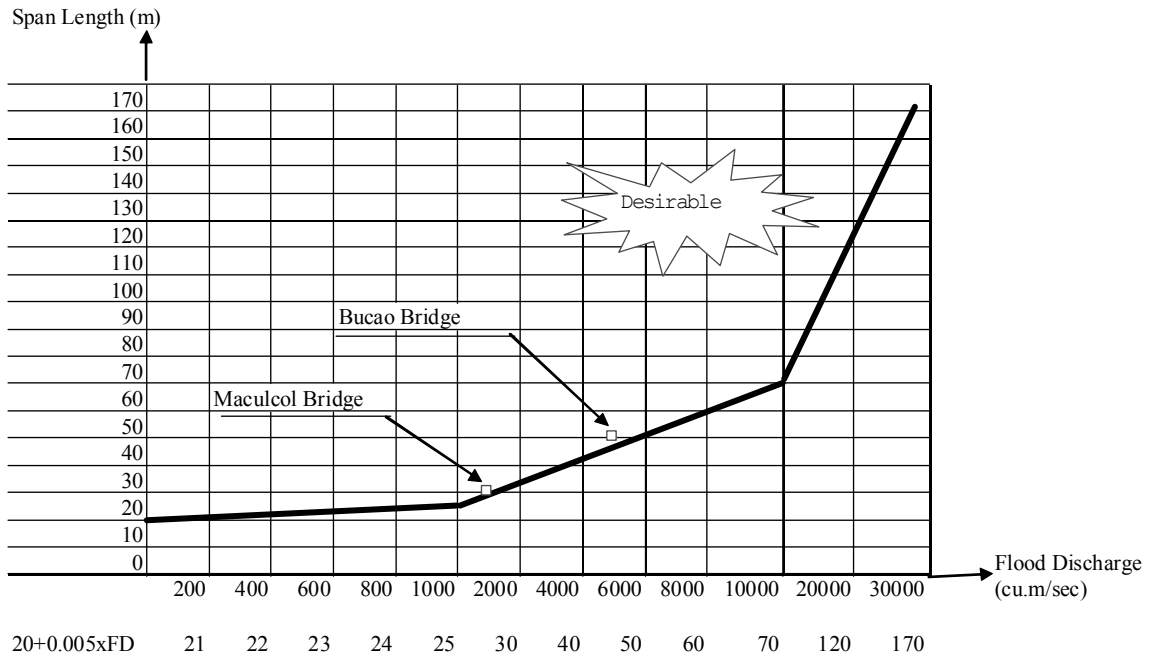
Desirable Span Length & Bridge Length by Flood Discharge

Figure 1 Span Length

Desirable Span for Flood Discharge

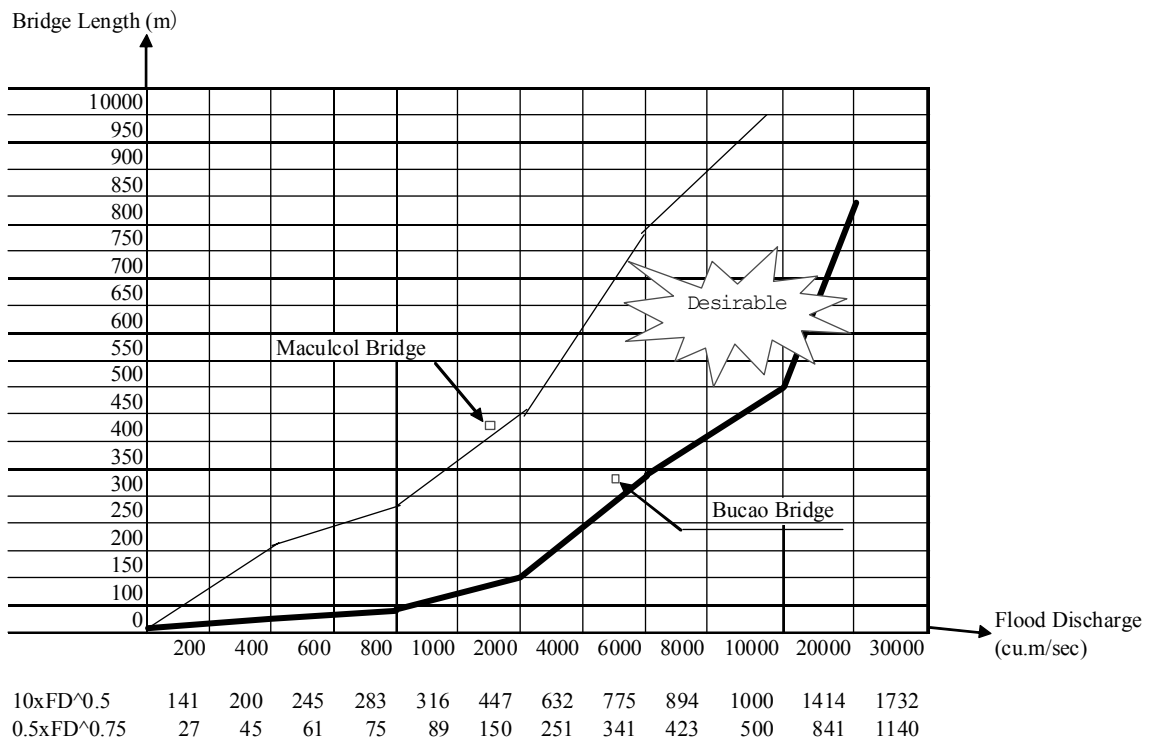
Figure 2 Bridge Length
