THE GOVERNMENT OF THE PHILIPPINES
THE DEPARTMENT OF PUBLIC WORKS AND HIGHWAYS

**The Study on Sabo and Flood Control for
Western River Basins of Mount Pinatubo in
the Republic of the Philippines**

JAPAN INTERNATIONAL COOPERATION AGENCY

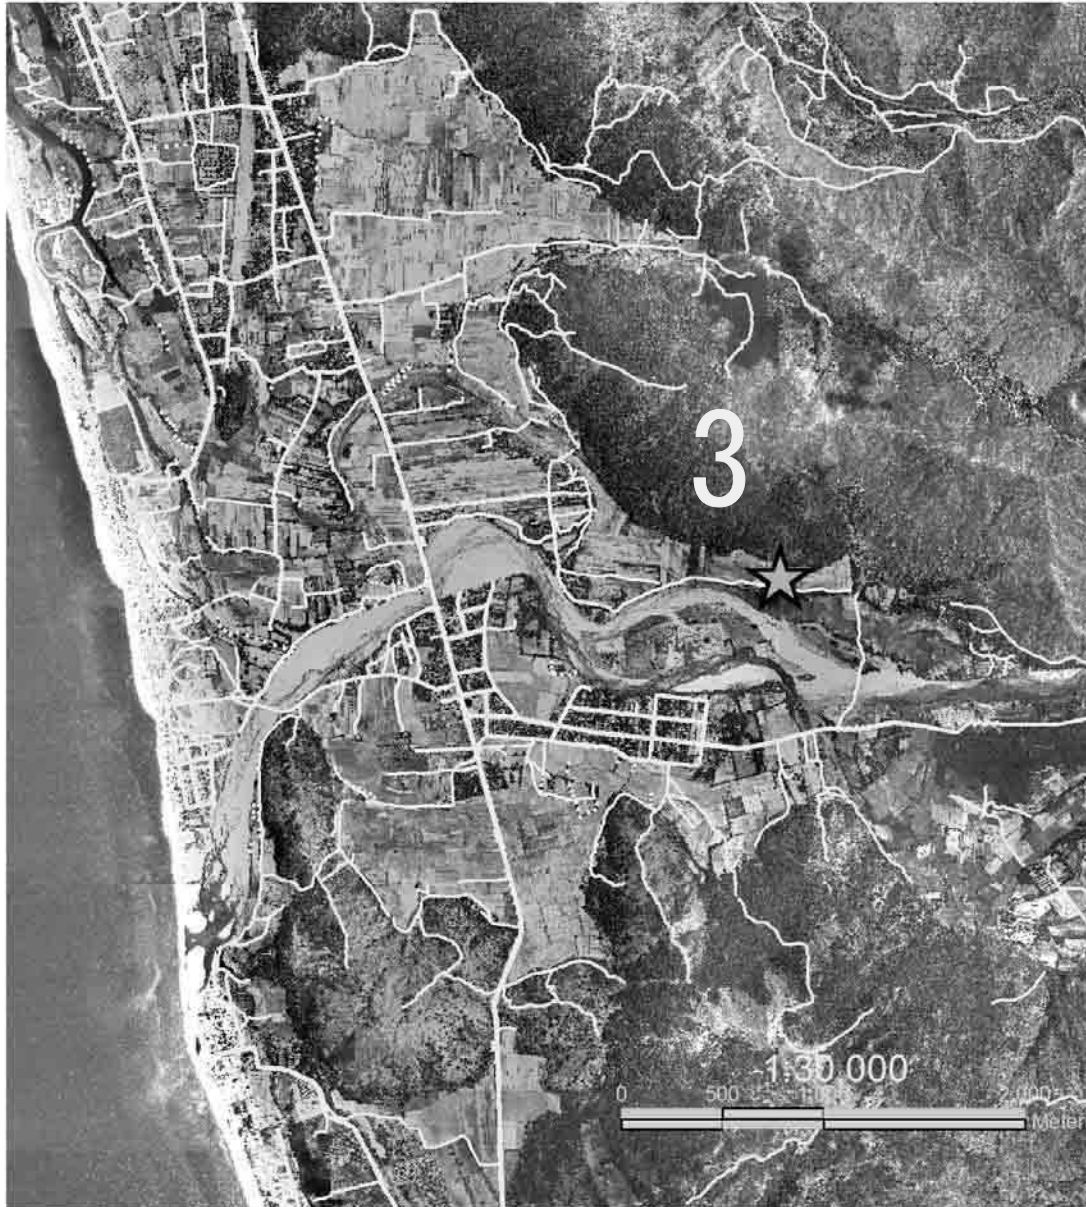
Figure 3.5.2 (2/5)

**Area for Nomination of Evacuation Center
(Maloma River Basin)**

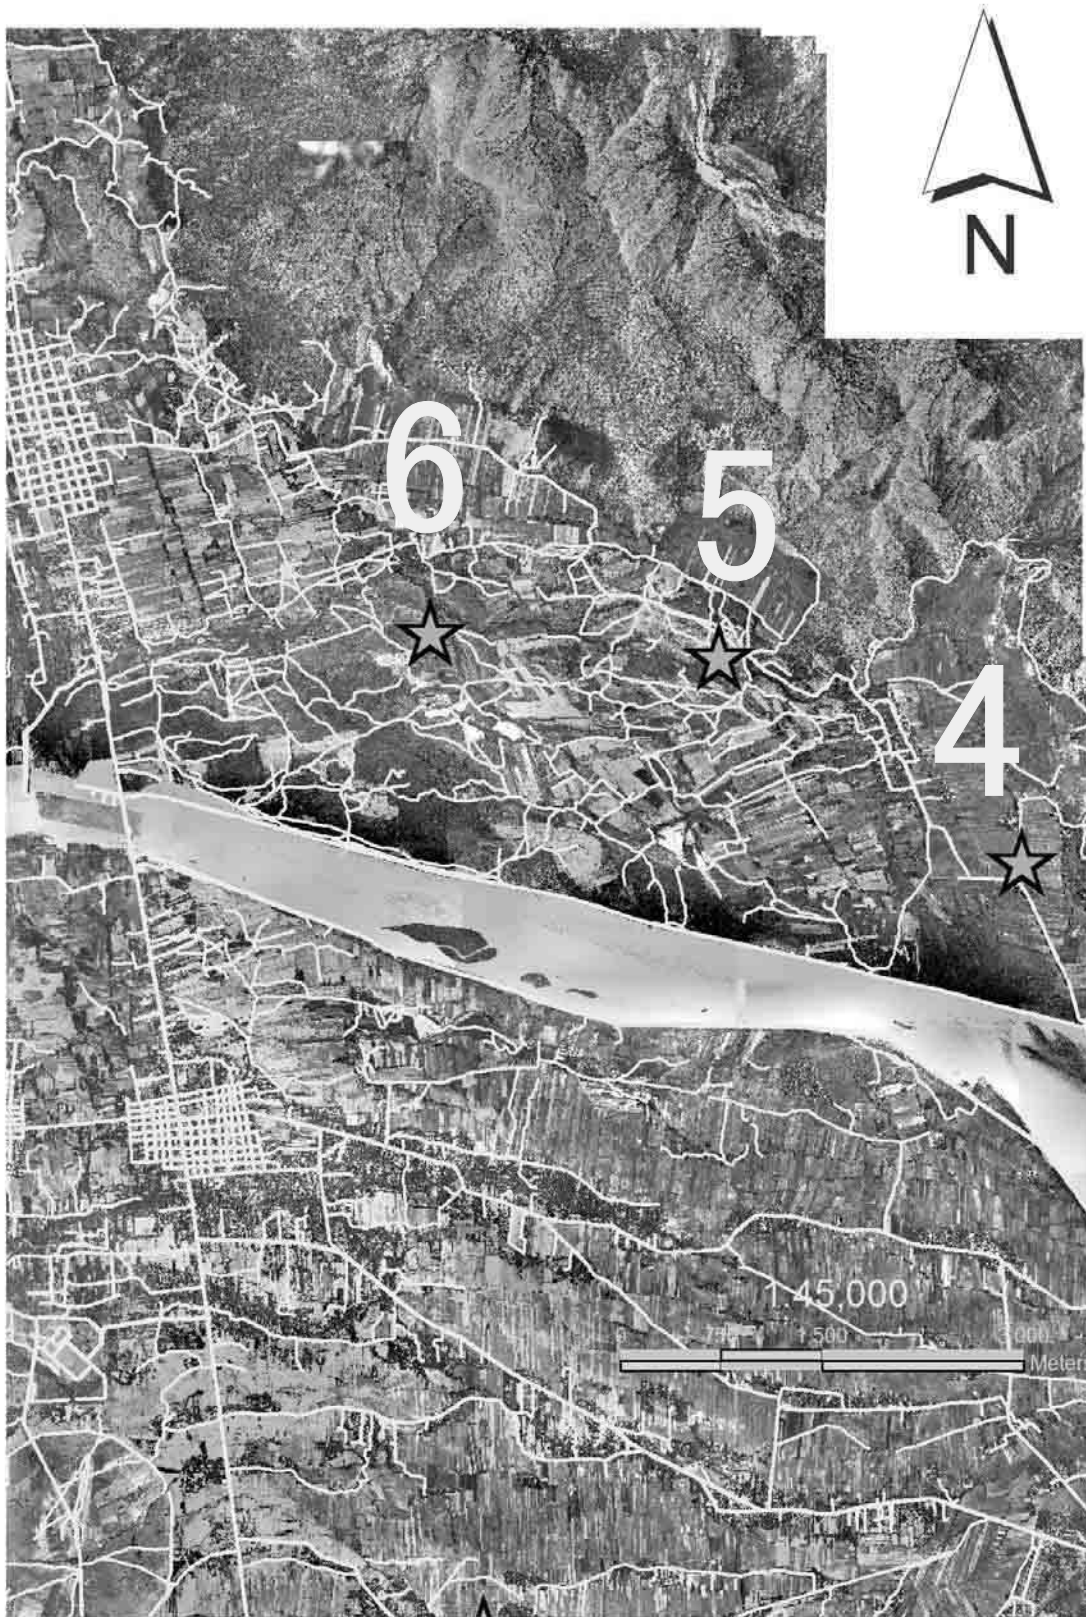
Figure 3.5.2 (3/5)

**Area for Nomination of Evacuation Center
 (Right Side of Sto. Tomas River Basin)**

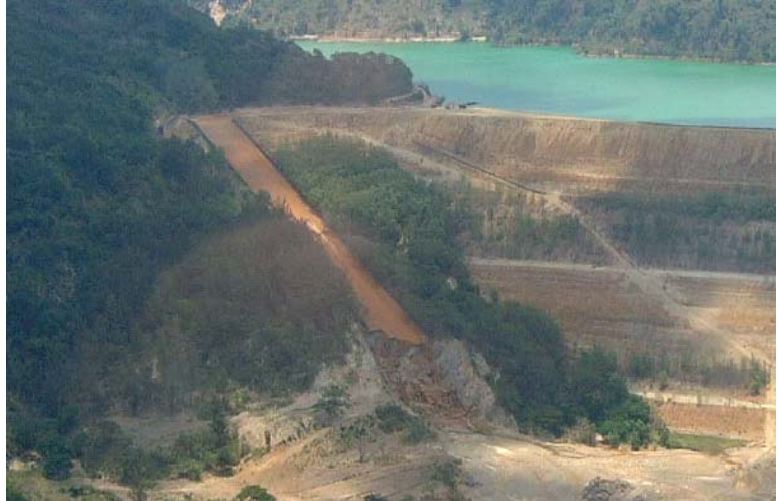
Figure 4.6.1

As of 07 May 2002

**Progress of Collapse at Spillway Portion of Dizon
Mines Tailing Dam**

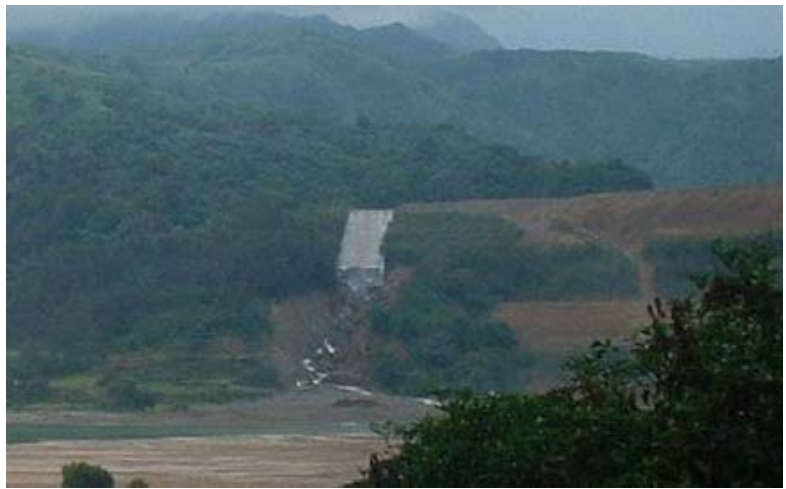
As of 29 August 2002

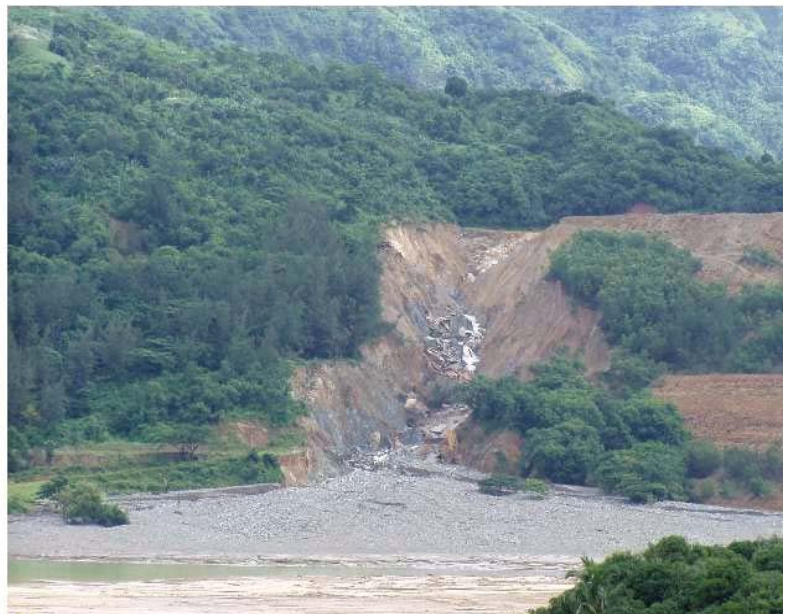
As of 17 September 2002

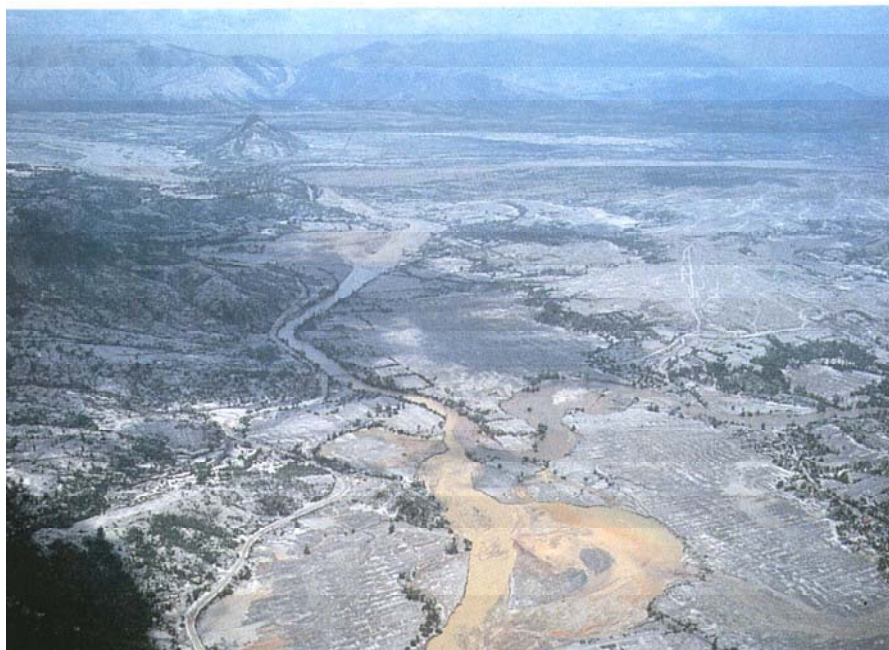
Figure 4.6.2

Before Lake Formation
July 1991

Before and After Formation of Mapanuepe Lake

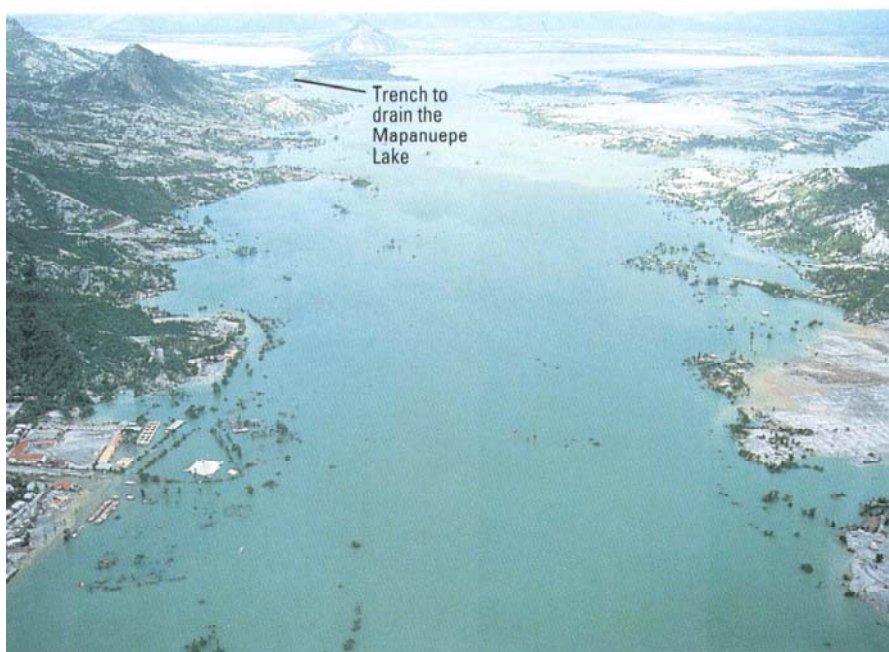
After Lake Formation
Nov 1991
