THE GOVERNMENT OF THE PHILIPPINES
 THE DEPARTMENT OF PUBLIC WORKS AND HIGHWAYS

**The Study on Sabo and Flood Control for
 Western River Basins of Mount Pinatubo in the
 Republic of the Philippines**

JAPAN INTERNATIONAL COOPERATION AGENCY

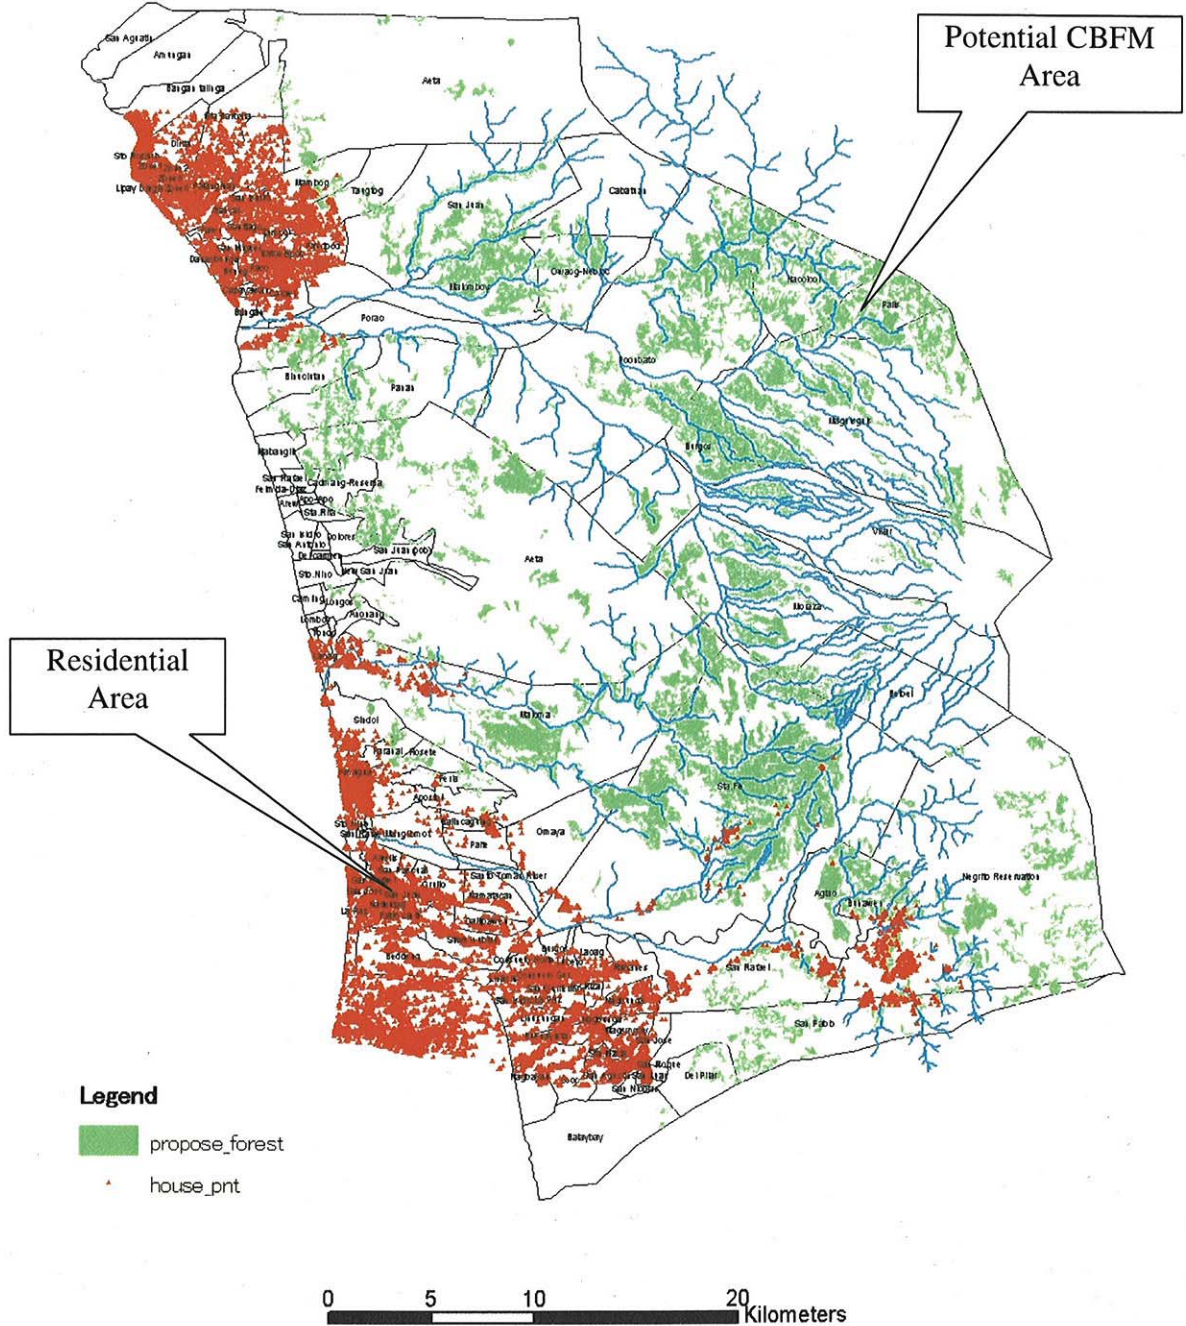
Figure 3.2.2
Potential CBFM Area

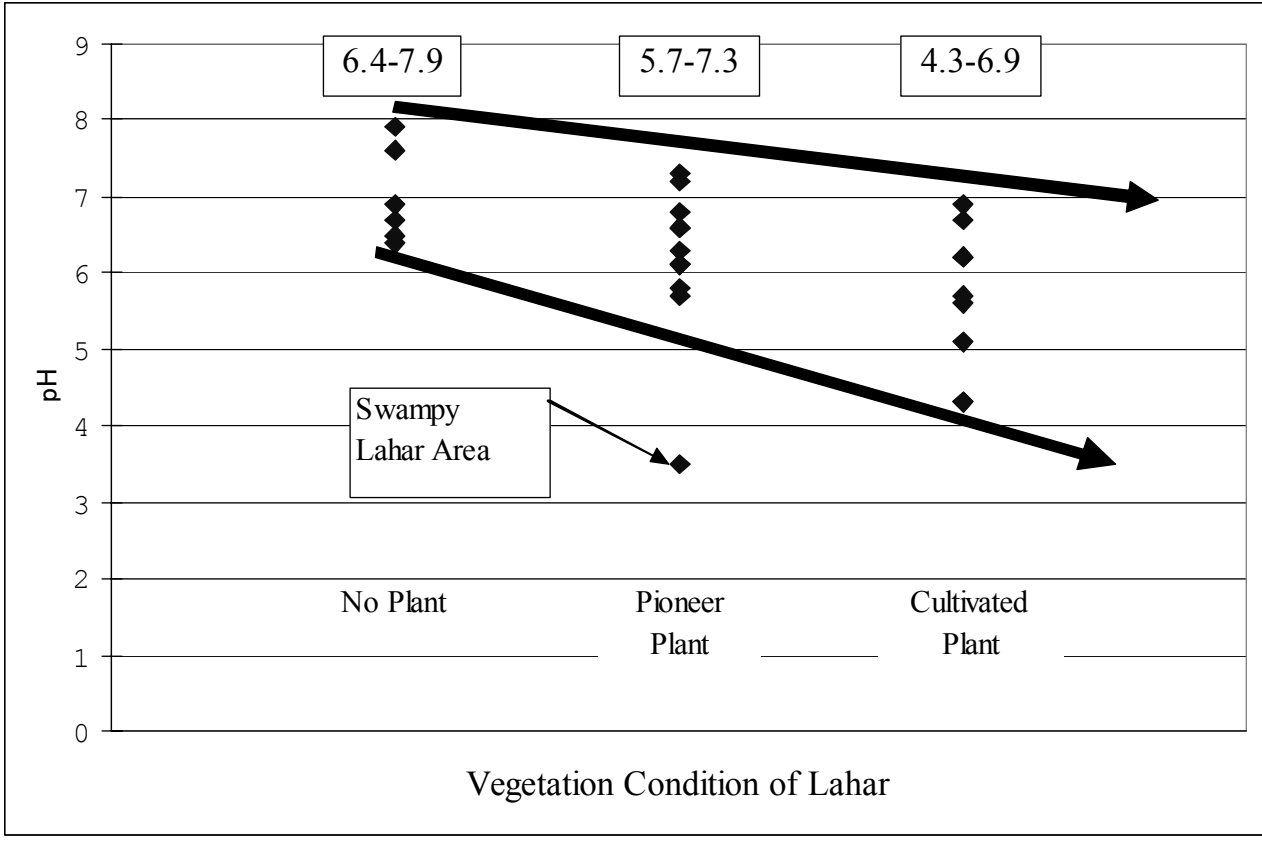
Figure 3.3.2
**Co-relation between Vegetation Condition
 of Lahar and pH**

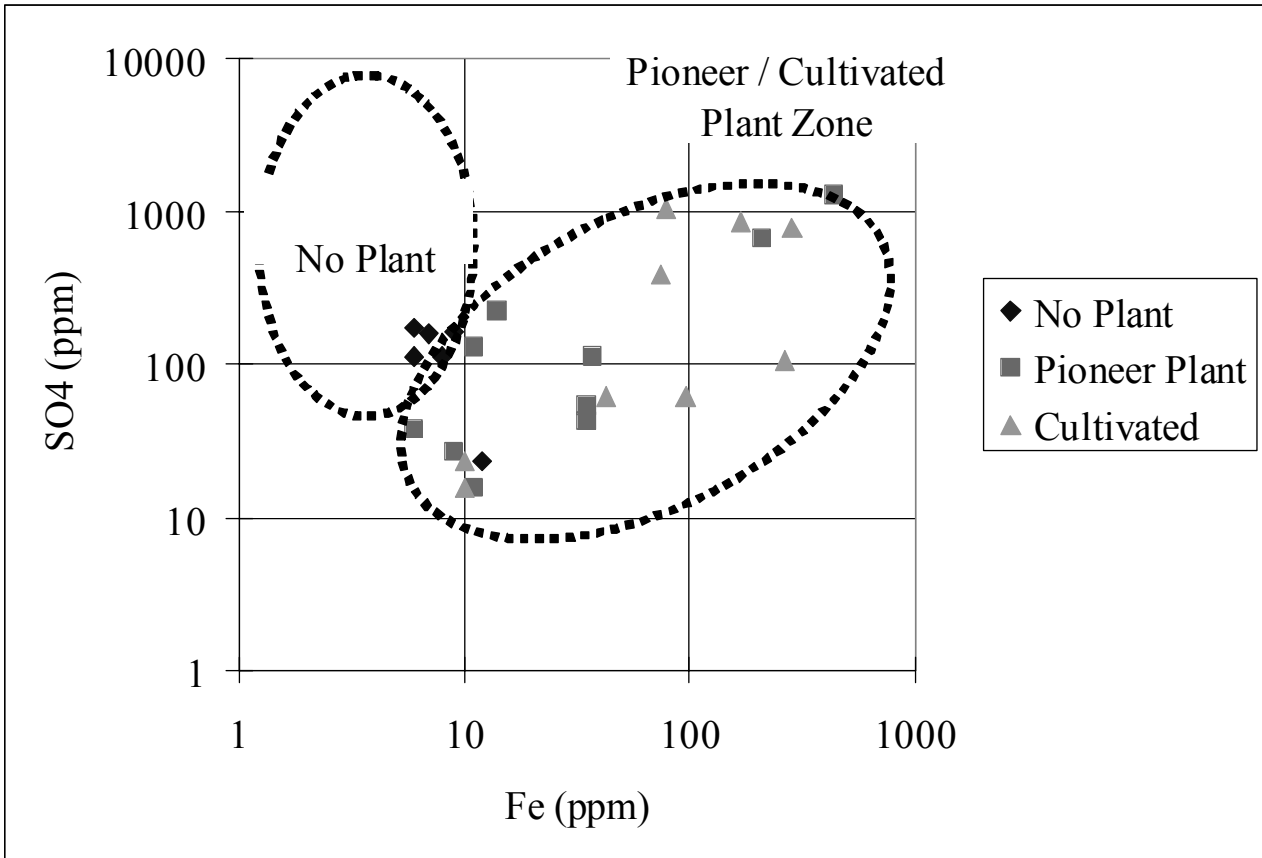
Figure 3.3.4

Co-relation between Iron (Fe) and Sulfate (SO4) Concentration
