3. 新設プラント設備輸送ルート 調査報告書

Route Survey

**Over-dimensional Project cargo
transportation.**

**Turkmenbashi Port, Turkmenistan -
Tashkent Power station, Uzbekistan
2,420 kilometers**

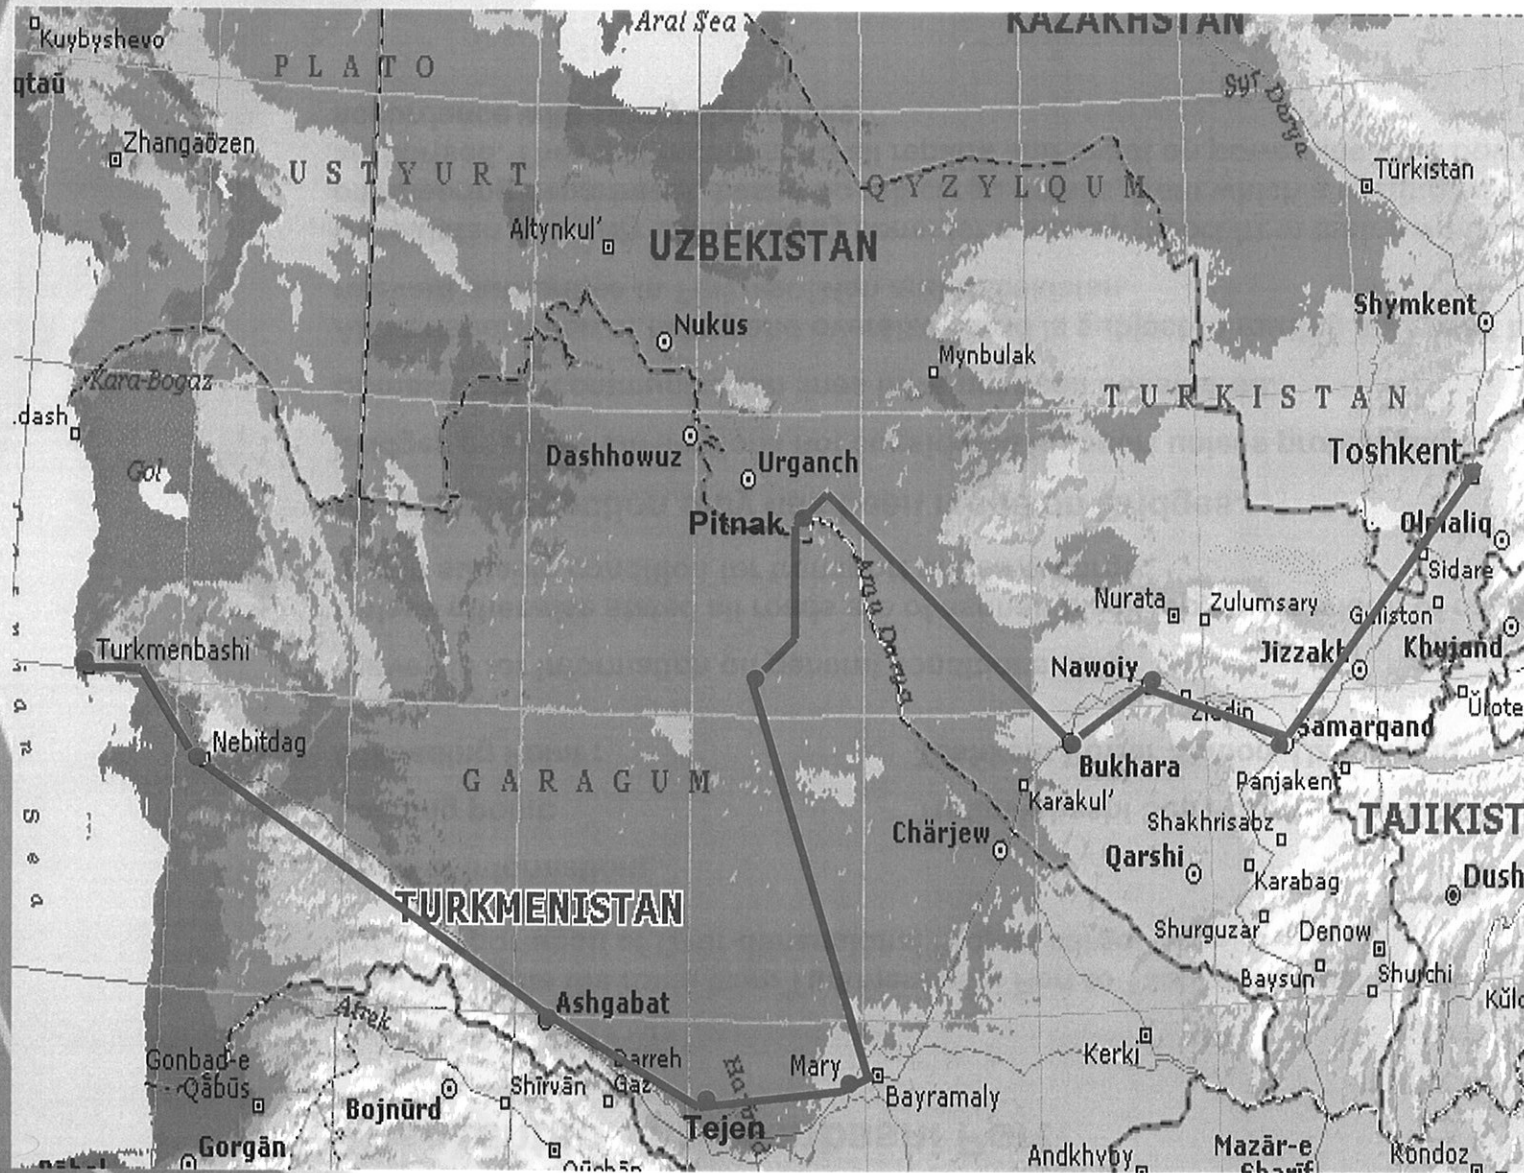
Route

- Tashkent
- Samarkand
- Navoiy
- Bukhara
- Pitnak
- Bayramaly
- Mary
- Tejen
- Ashgabat
- Nebitdag
- Turmenbashi

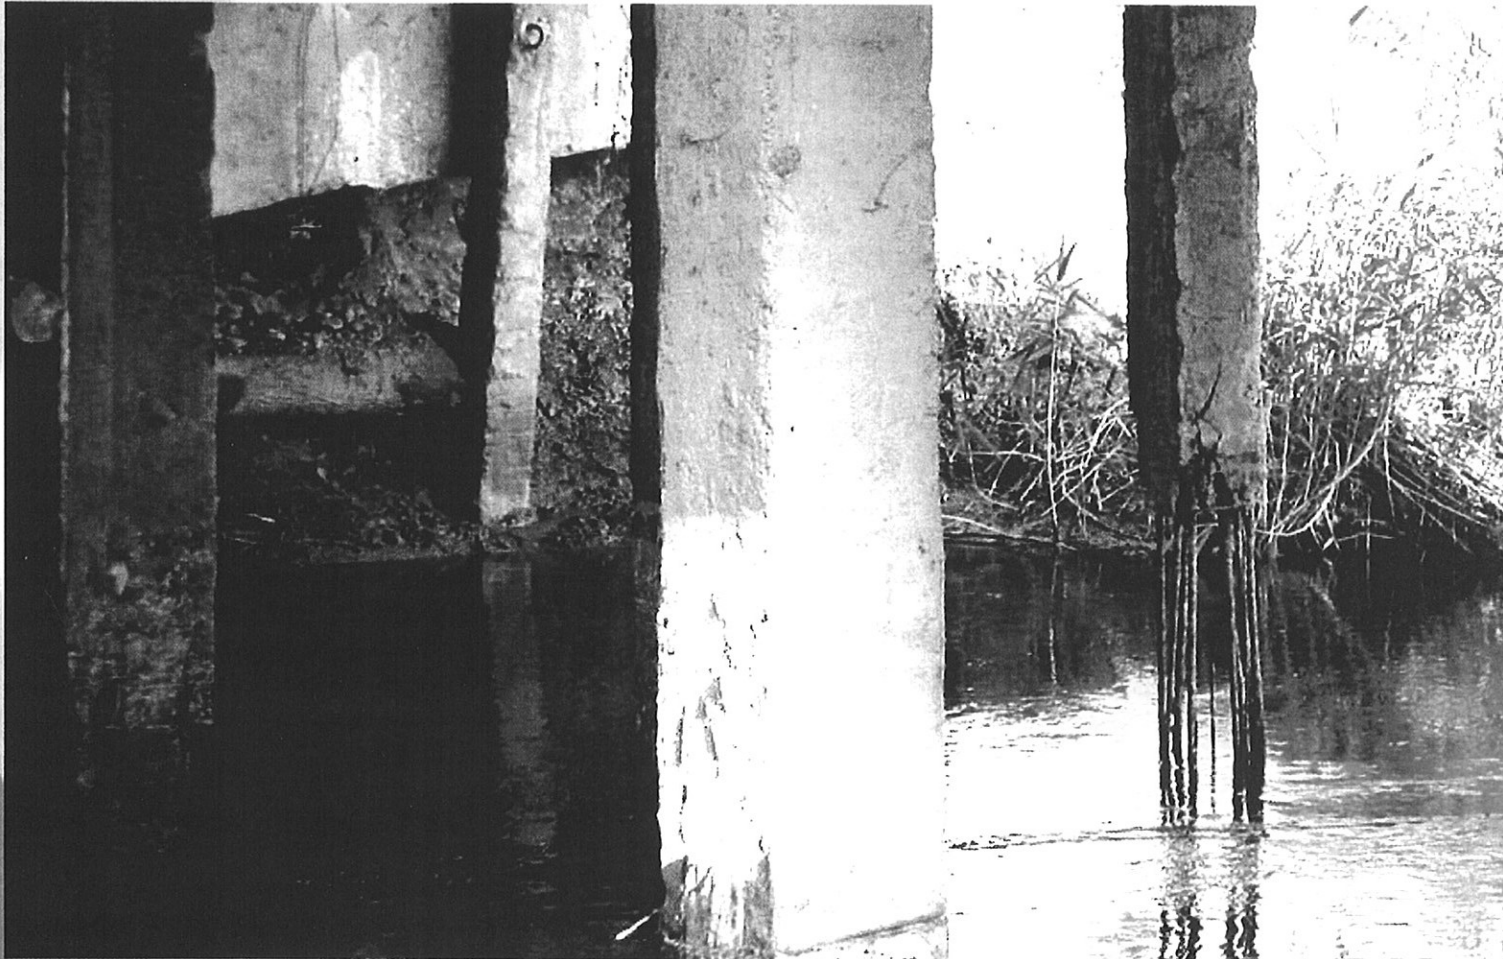
It should always be noted that there are several hundred bridges on this route and many Of the bridge pier support columns are poorly constructed and of unknown quality. Visual inspection above ground/water only has been made and this report cannot rule out situations as shown below where no inspection can take place.
