THE BASIC DESIGN STUDY ON CONSTRUCTION OF EASTERN ARTERIAL ROAD IN MONGOLIA

JAPAN INTERNATIONAL COOPERATION AGENCY (JICA)
MINISTRY OF INFRASTRUCTURE,
THE GOVERNMENT OF MONGOLIA

PACIFIC CONSULTANTS INTERNATIONAL
JAPAN OVERSEAS CONSULTANTS

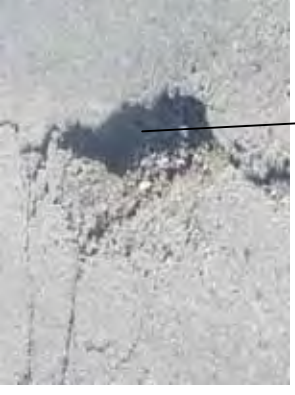
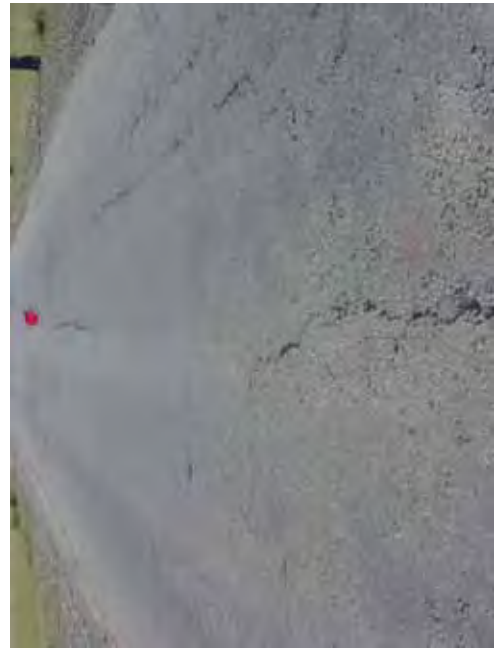
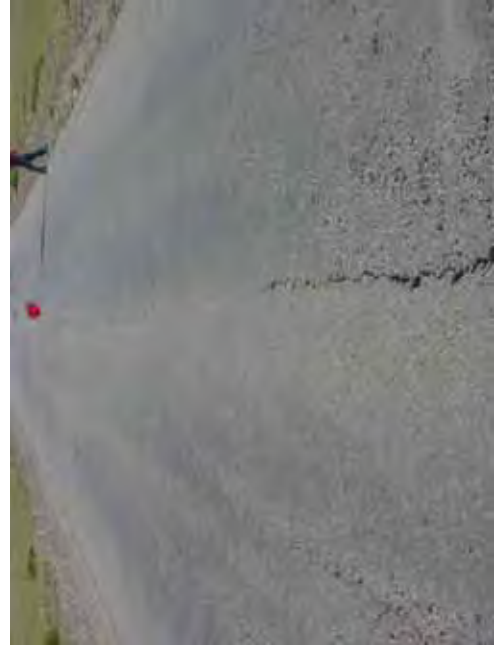
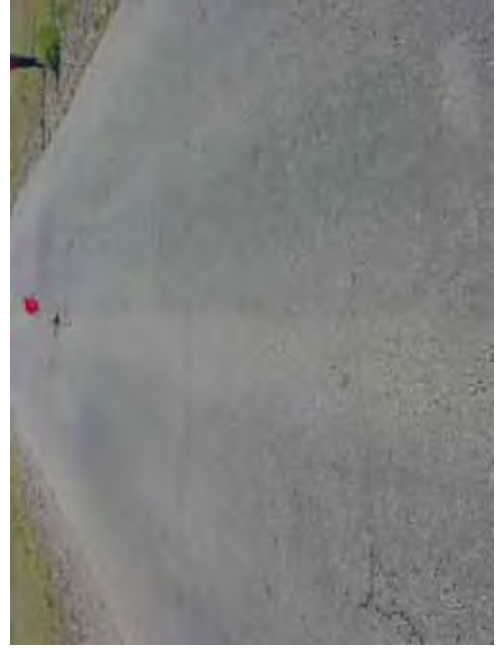
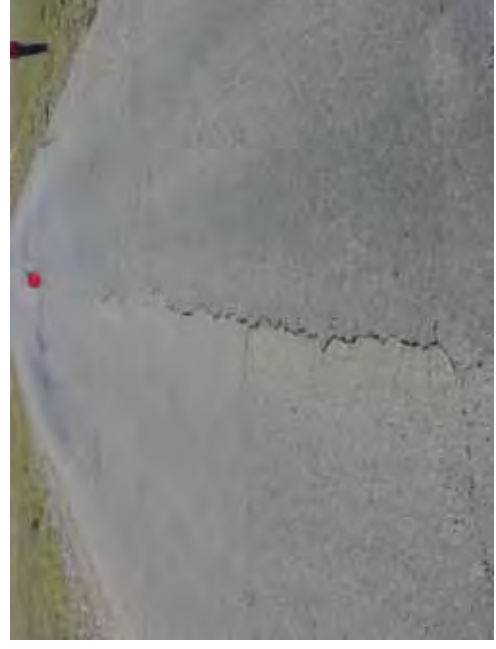
No.
D-63

COMMENT	Volume of crackle: less Width of crackle: 05-10mm 246 / 2800 * 100 = 8.79%	Volume of crackle: less Width of crackle: 05-10mm There is a pothole in + 6571 metre. (800*300*70mm) 172 / 2800 * 100 = 61.4%	Volume of crackle: less Width of crackle: 05-15mm 139 / 2800 * 100 = 4.96%
SUBJECTIVE EVALUATION	4	3	3
OBJECTIVE EVALUATION	b, d	b, c	b
TYPE OF PAVEMENT REHABILITATION	B	B	B

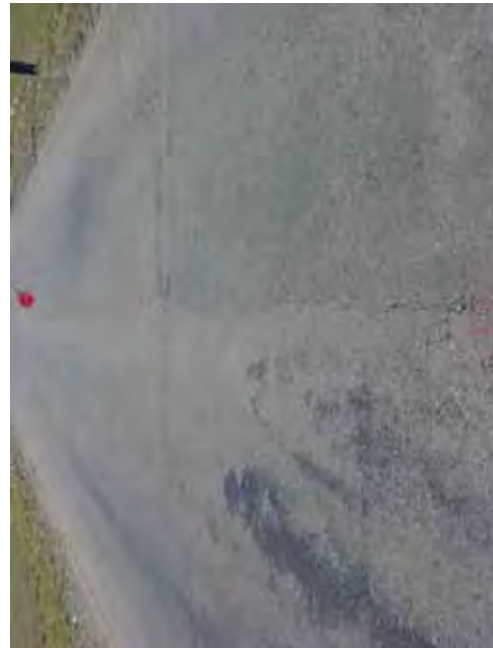
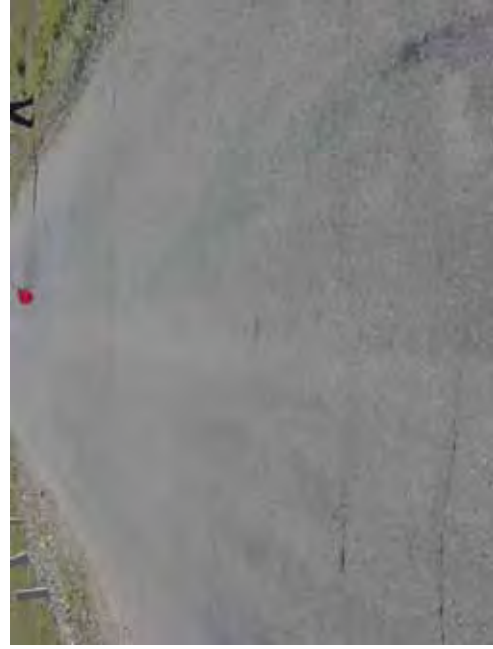
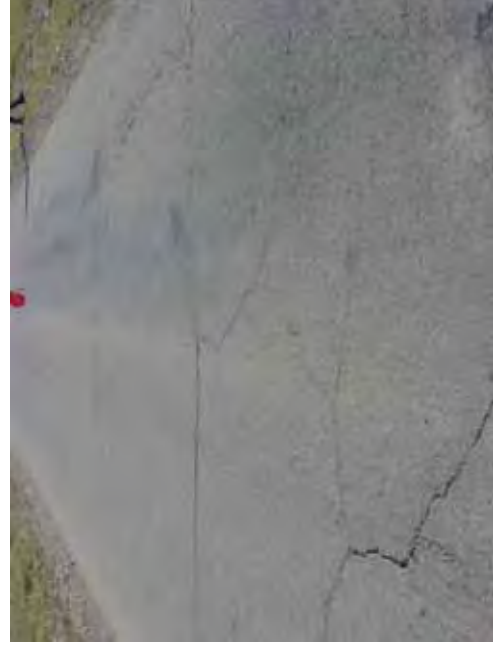
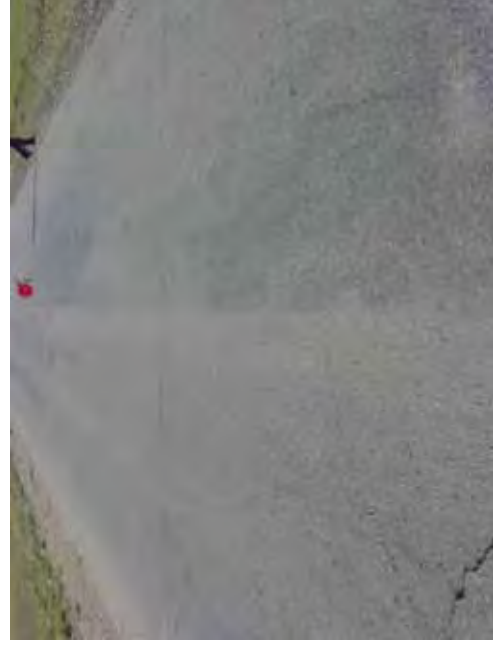
D-64

COMMENT	Volume of crackle: less Width of crackle: 05-10mm $193 / 2800 * 100 = 6.89\%$	Volume of crackle: less Width of crackle: 05-15mm $127 / 2800 * 100 = 4.54\%$	Volume of crackle: less Width of crackle: 05-20mm $217 / 2800 * 100 = 7.75\%$	Volume of crackle: less Width of crackle: 05-15mm $190 / 2800 * 100 = 6.79\%$
SUBJECTIVE EVALUATION	3	3	3	3
OBJECTIVE EVALUATION	b	b	b, d	b
TYPE OF PAVEMENT REHABILITATION	B	B	B	B

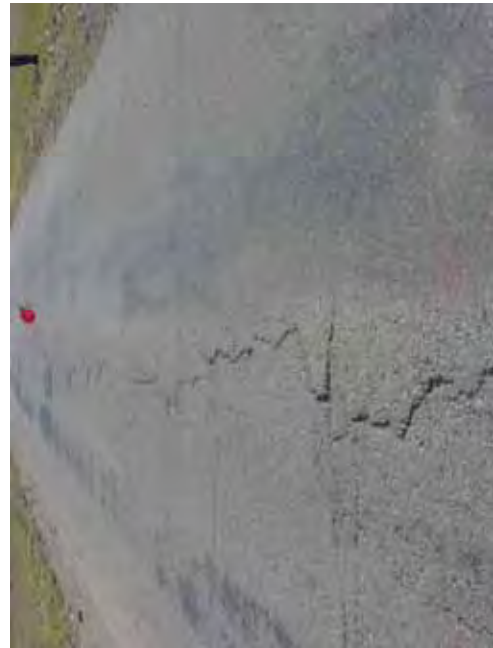
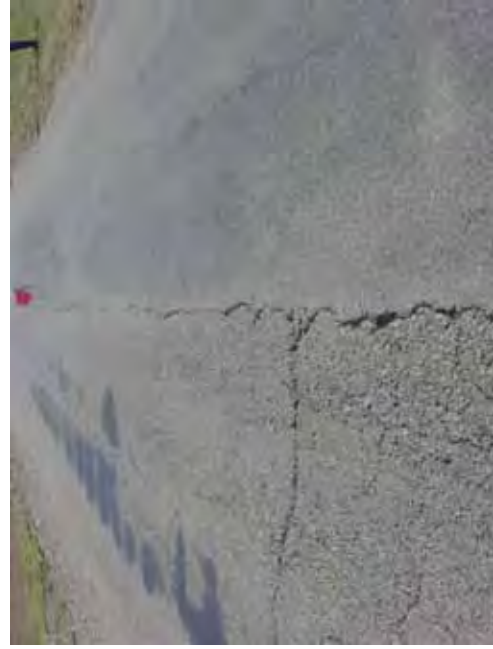
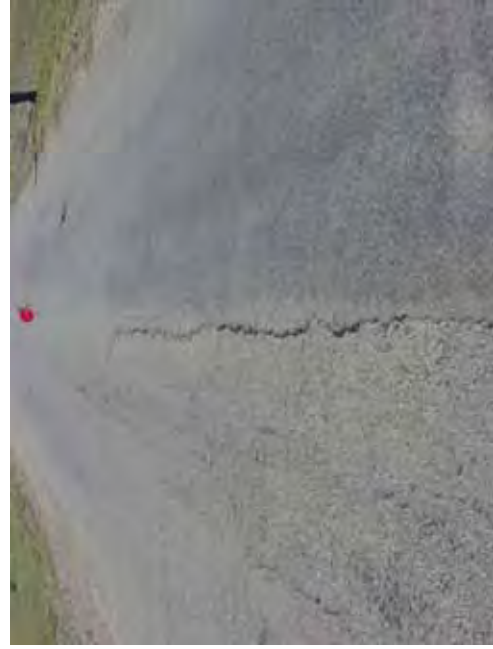
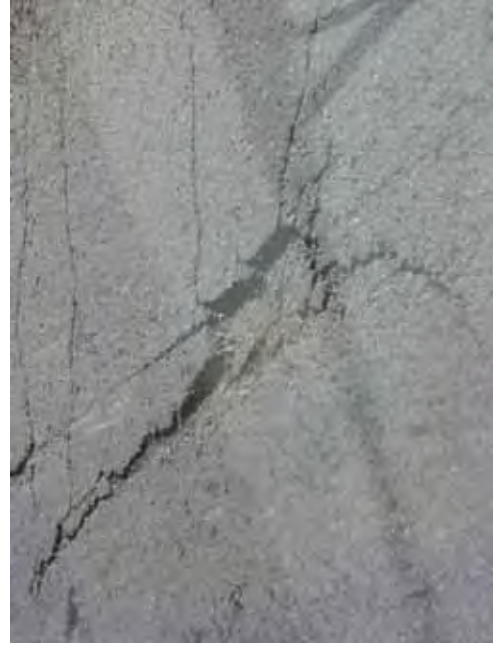
No.
D-65

COMMENT	Volume of crackle: medium Width of crackle: 05-25mm 280 / 2800 * 100 = 10.00%	Volume of crackle: medium Width of crackle: 05-80mm 264 / 2800 * 100 = 9.43%	Volume of crackle: less Width of crackle: 05-40mm There is a pothole in + 6768 metre. (200*250*40mm) 264 / 2800 * 100 = 9.43%	Volume of crackle: less Width of crackle: 05-10mm 209 / 2800 * 100 = 7.49%
SUBJECTIVE EVALUATION	3	4	4	4
OBJECTIVE EVALUATION	b	b	b, c	b
TYPE OF PAVEMENT REHABILITATION	B	B	B	B

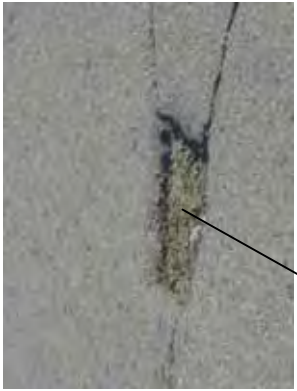
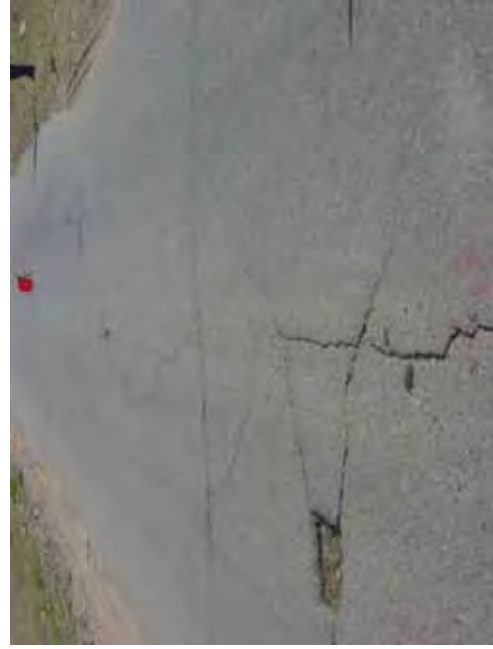
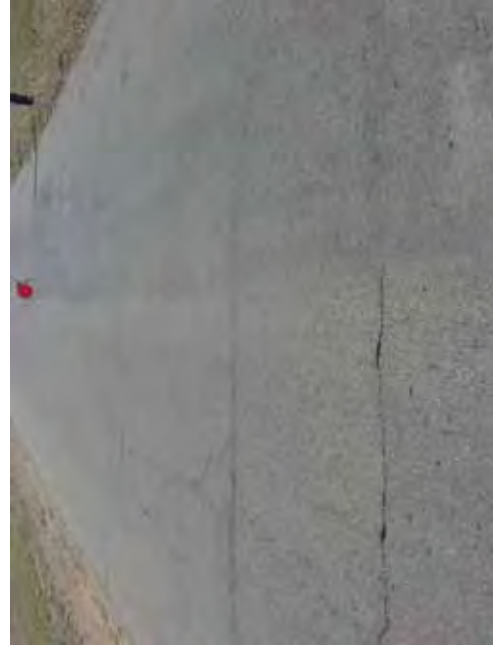
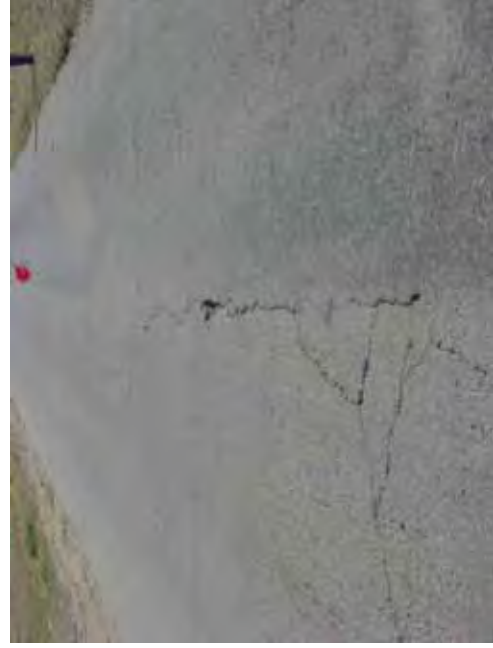
D-66

COMMENT	Volume of crackle: less Width of crackle: 05-15mm There is a pothole in + 6801 metre. (200*350*30mm) 239 / 2800 * 100 = 8.54%	Volume of crackle: less Width of crackle: 05-20mm 154 / 2800 * 100 = 5.50%	Volume of crackle: less Width of crackle: 05-25mm 204 / 2800 * 100 = 7.29%	Volume of crackle: medium Width of crackle: 05-30mm There are the most crackle in central axis of the road. 198 / 2800 * 100 = 7.07%
SUBJECTIVE EVALUATION	3	3	3	3
OBJECTIVE EVALUATION	b	b, c	b	b
TYPE OF PAVEMENT REHABILITATION	B	B	B	B

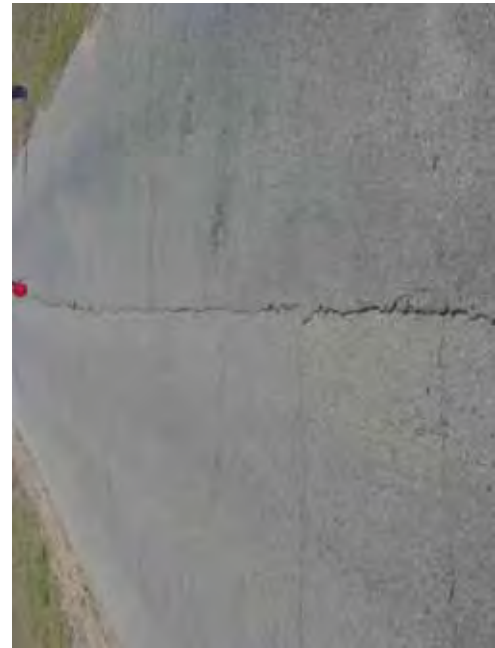
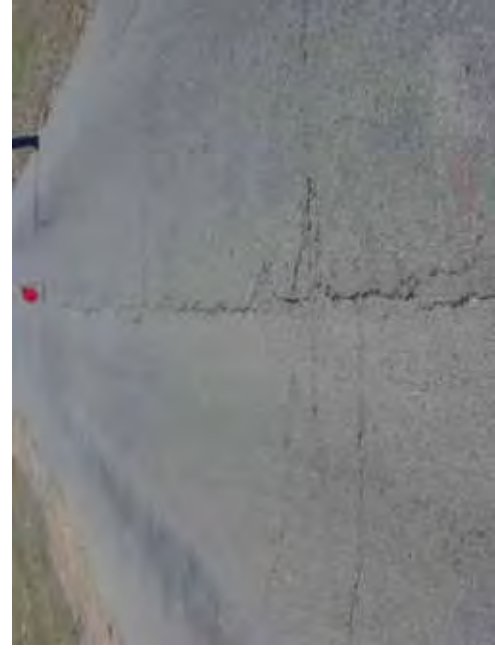
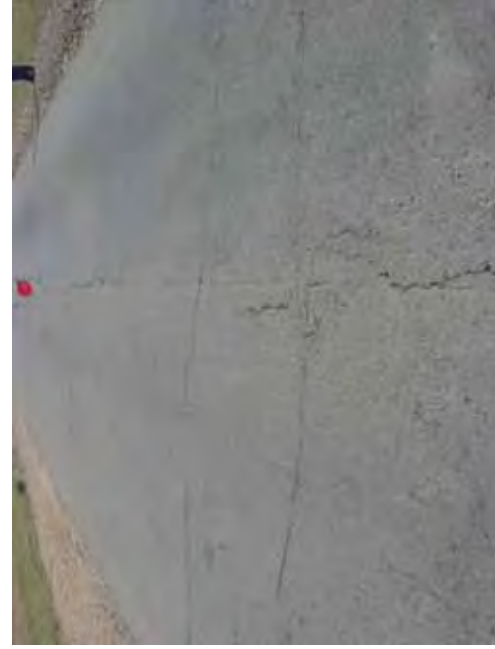
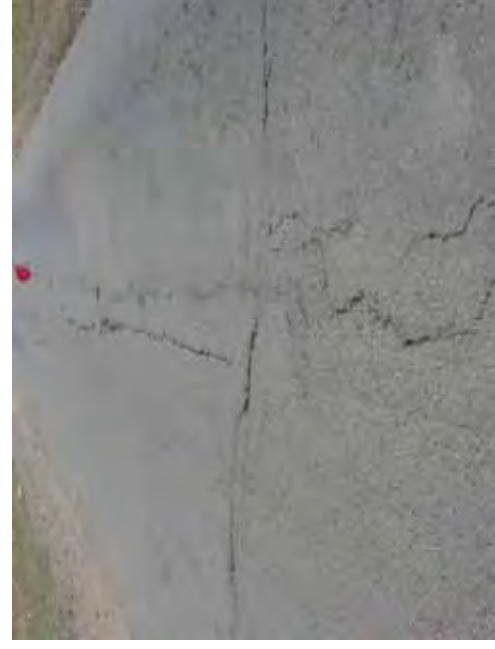
No.
D-67

COMMENT	Volume of crackle: less Width of crackle: 05-20mm There are the most crackle in central axis of the road. 243 / 2800 * 100 = 8.68%	Volume of crackle: medium Width of crackle: 05-30mm 274 / 2800 * 100 = 9.79%	Volume of crackle: medium Width of crackle: 05-60mm 293 / 2800 * 100 = 10.46%	Volume of crackle: medium Width of crackle: 05-30mm 221 / 2800 * 100 = 7.89%
SUBJECTIVE EVALUATION	3	3	3	3
OBJECTIVE EVALUATION	b	b	b	b
TYPE OF PAVEMENT REHABILITATION	B	B	B	B
