The Study on
The Urgent Rehabilitation and Reconstruction Support Program
for
Aceh Province and Affected Areas in North Sumatra
(Urgent Rehabilitation and Reconstruction Plan for Banda Aceh City)
in
The Republic of Indonesia

**Tsunami Damage Assessment Map
(Roads and Bridges)**

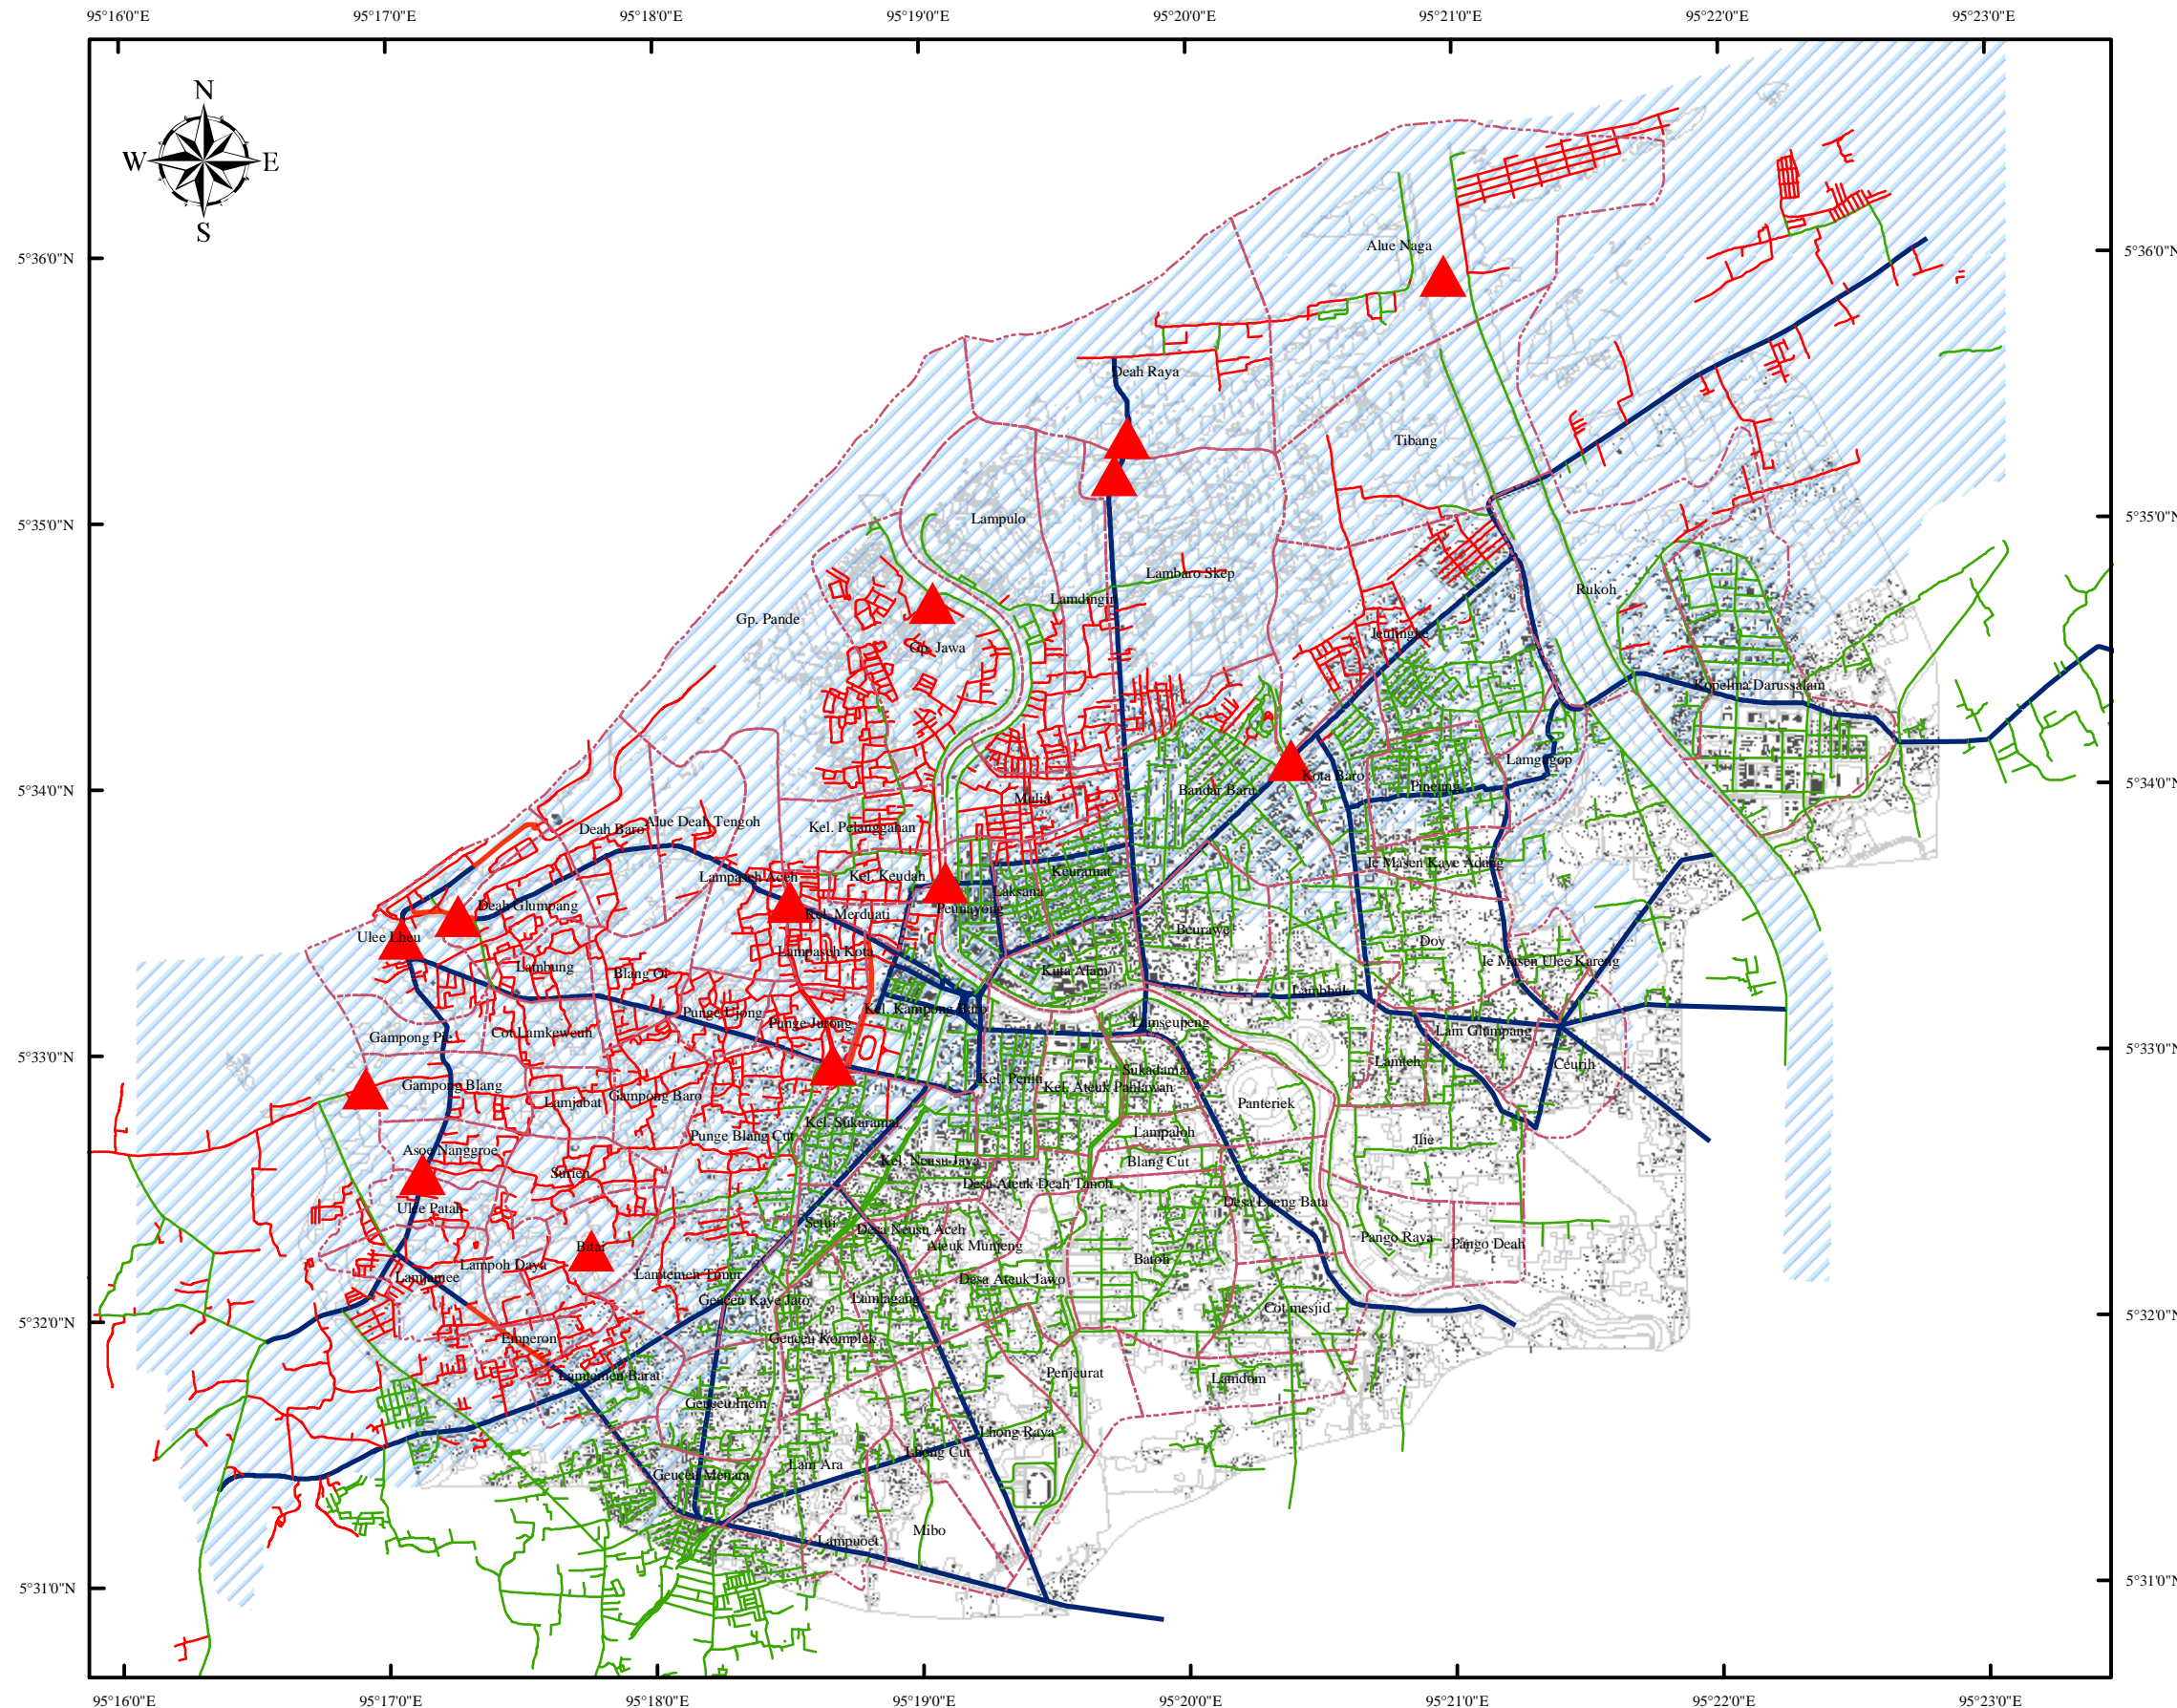
Map Reference ID: DA-0007

The data shown on this map are based on a series of quick damage assessments conducted by JICA at the middle of March, 2005.

Tsunami-inundated areas were interpreted by Syiah Kuala University.

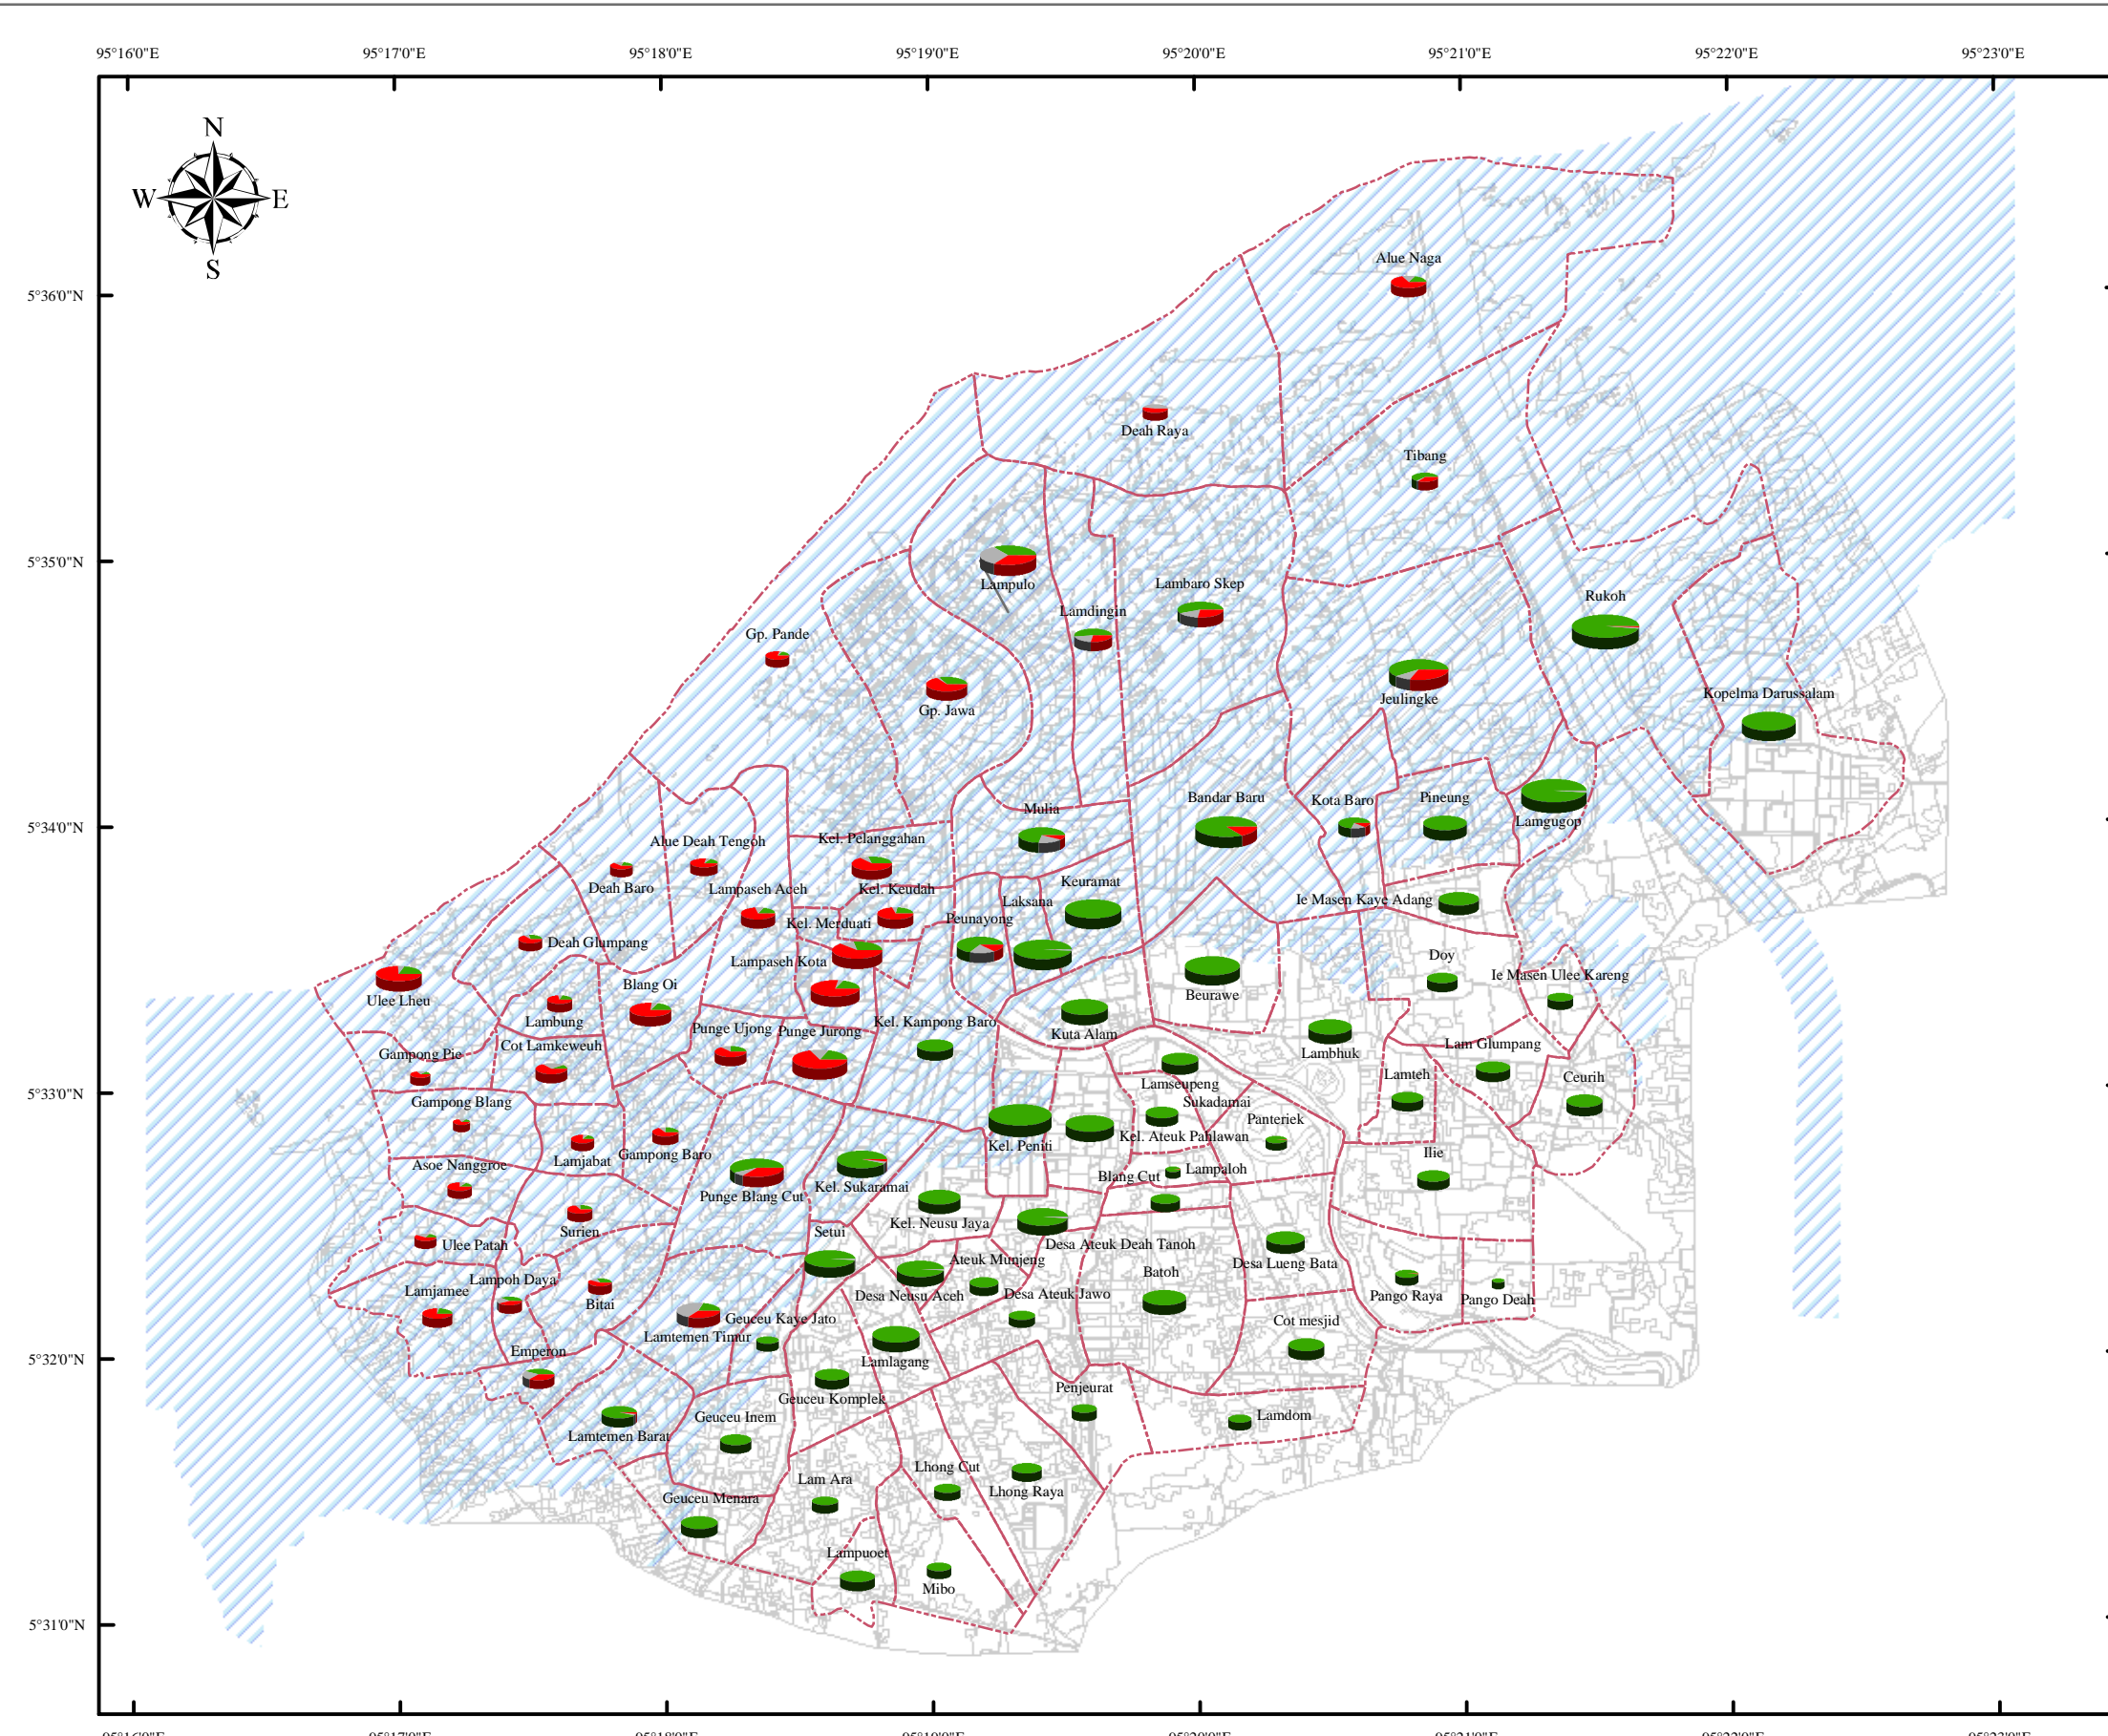
Map Reference ID: DA-0008

The data shown on this map are based on a series of quick damage assessments conducted by JICA at the middle of March, 2005.

**Tsunami Damage Assessment Map
(Demography as of April 12, 2005)**

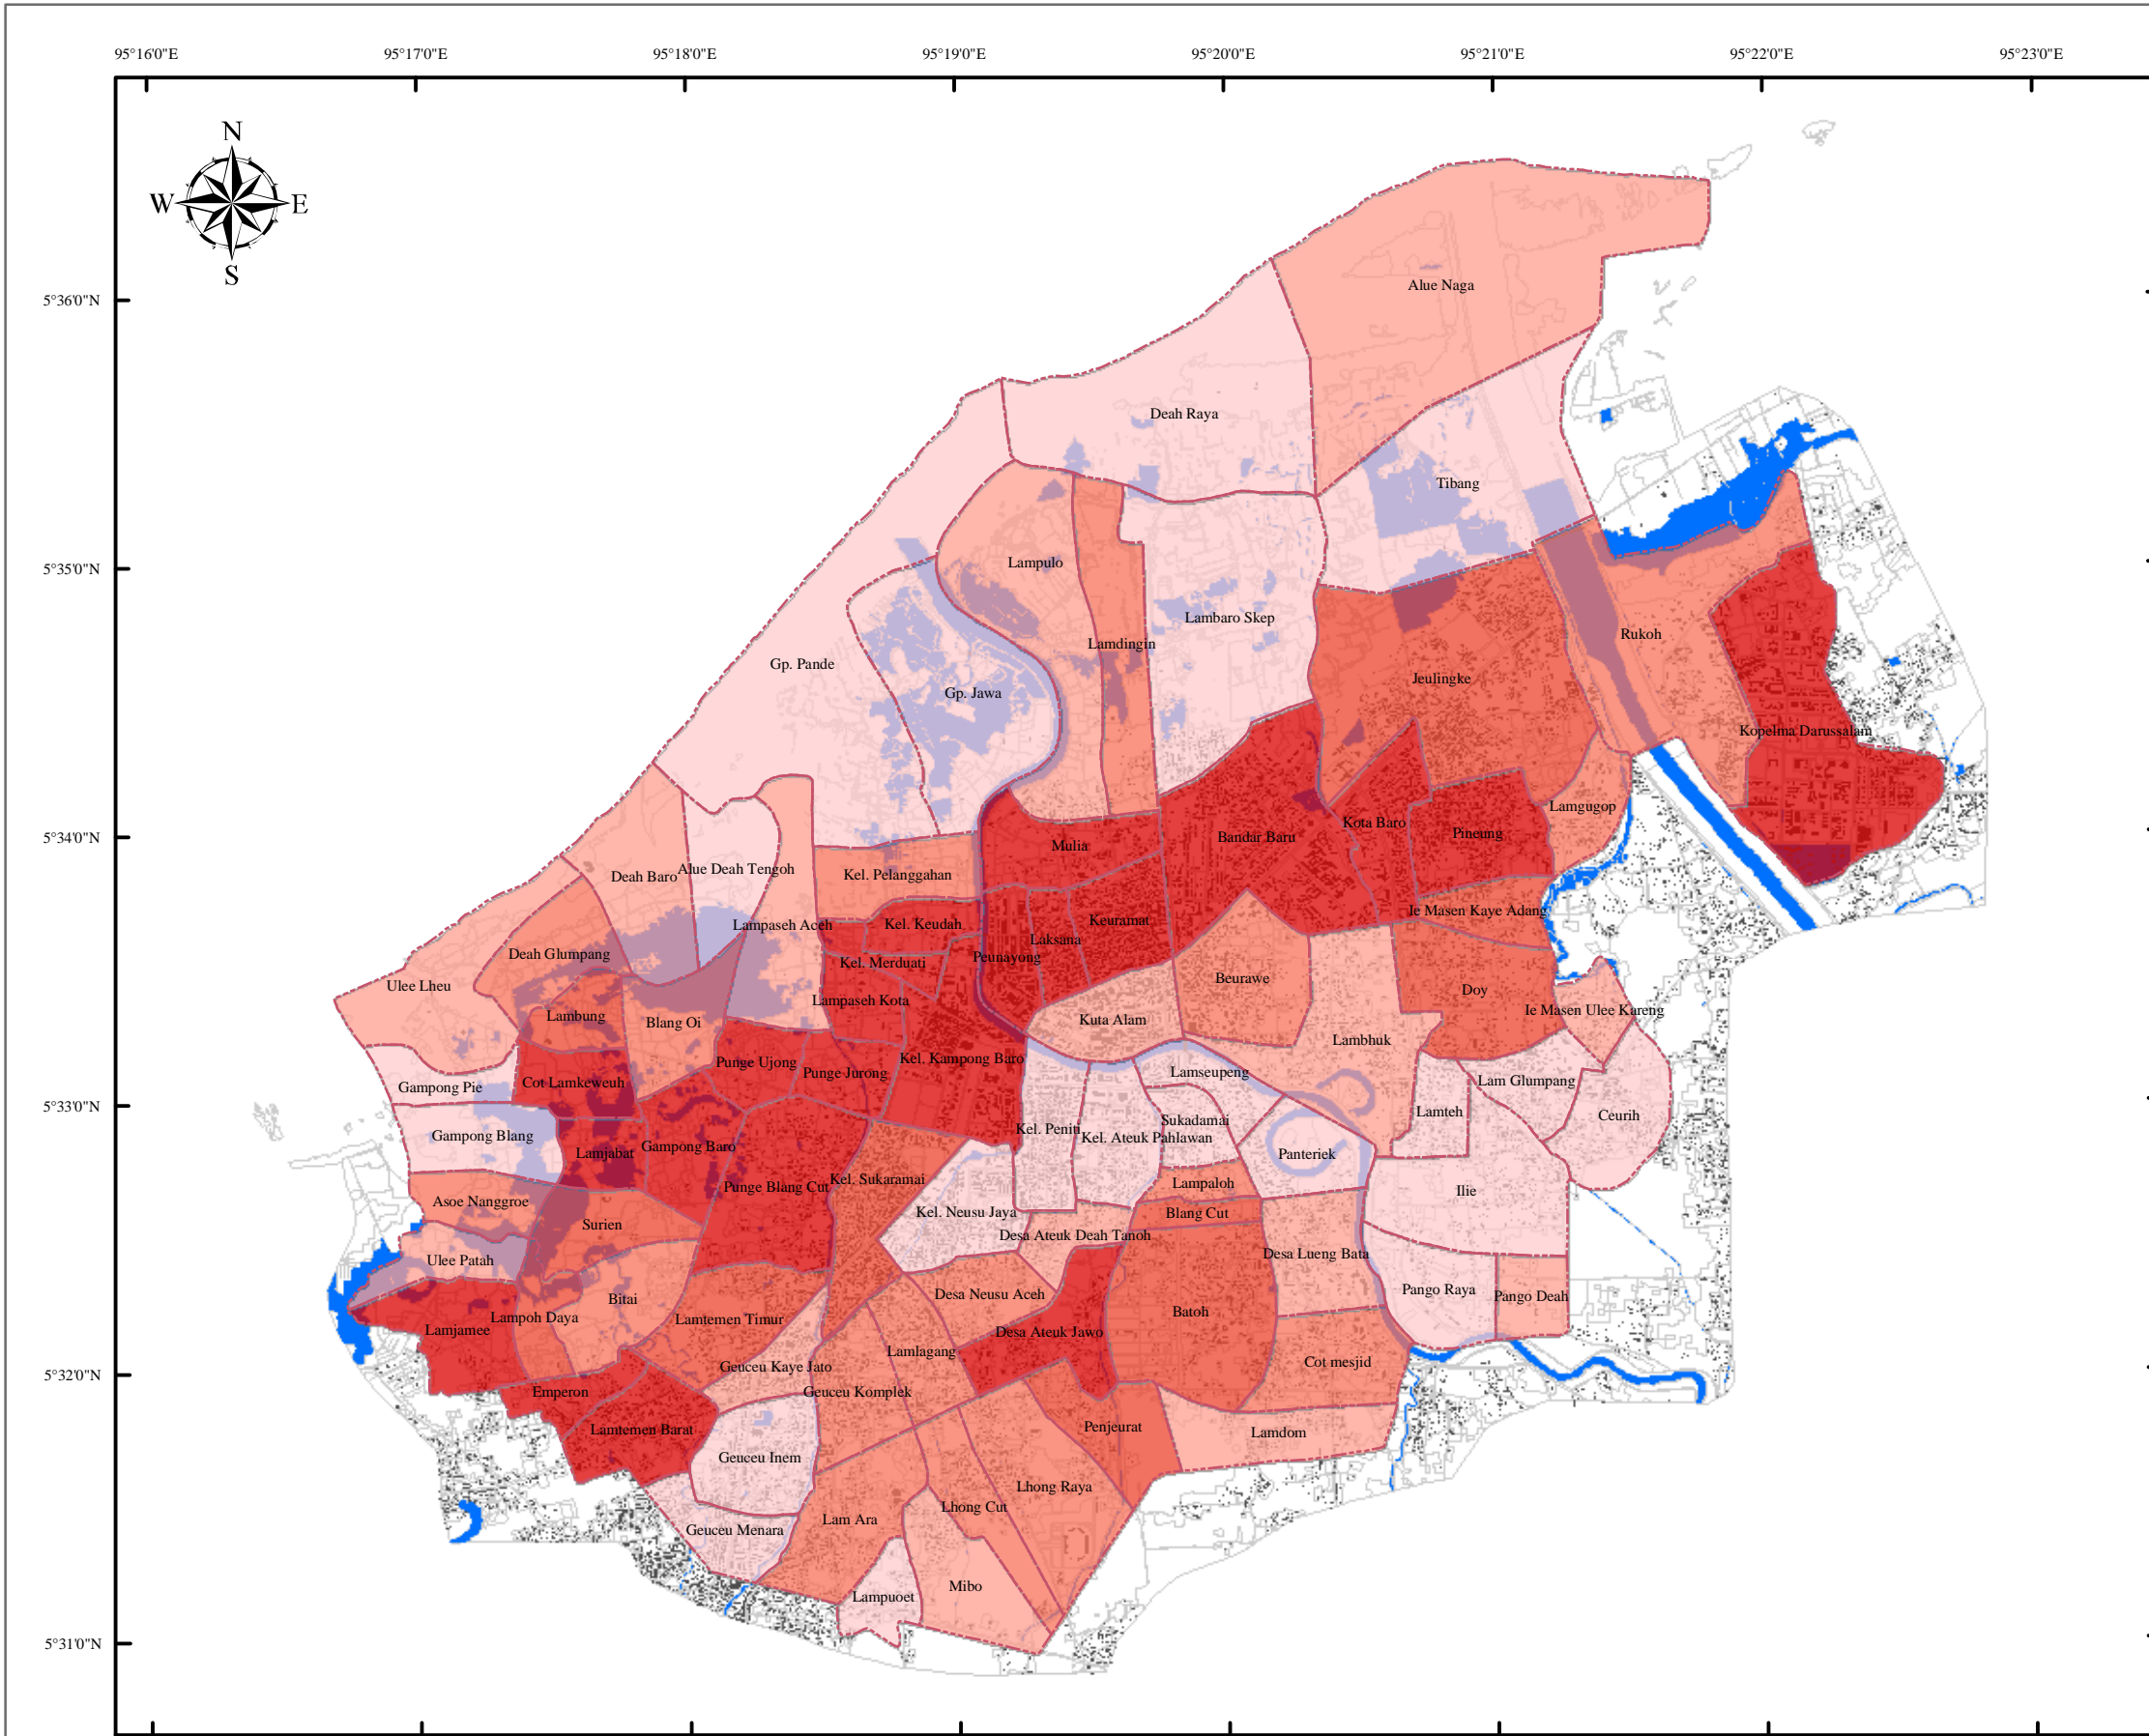
Map Reference ID: HP-0001

**Hazard Potential Map
(Earthquake; Liquefaction)**

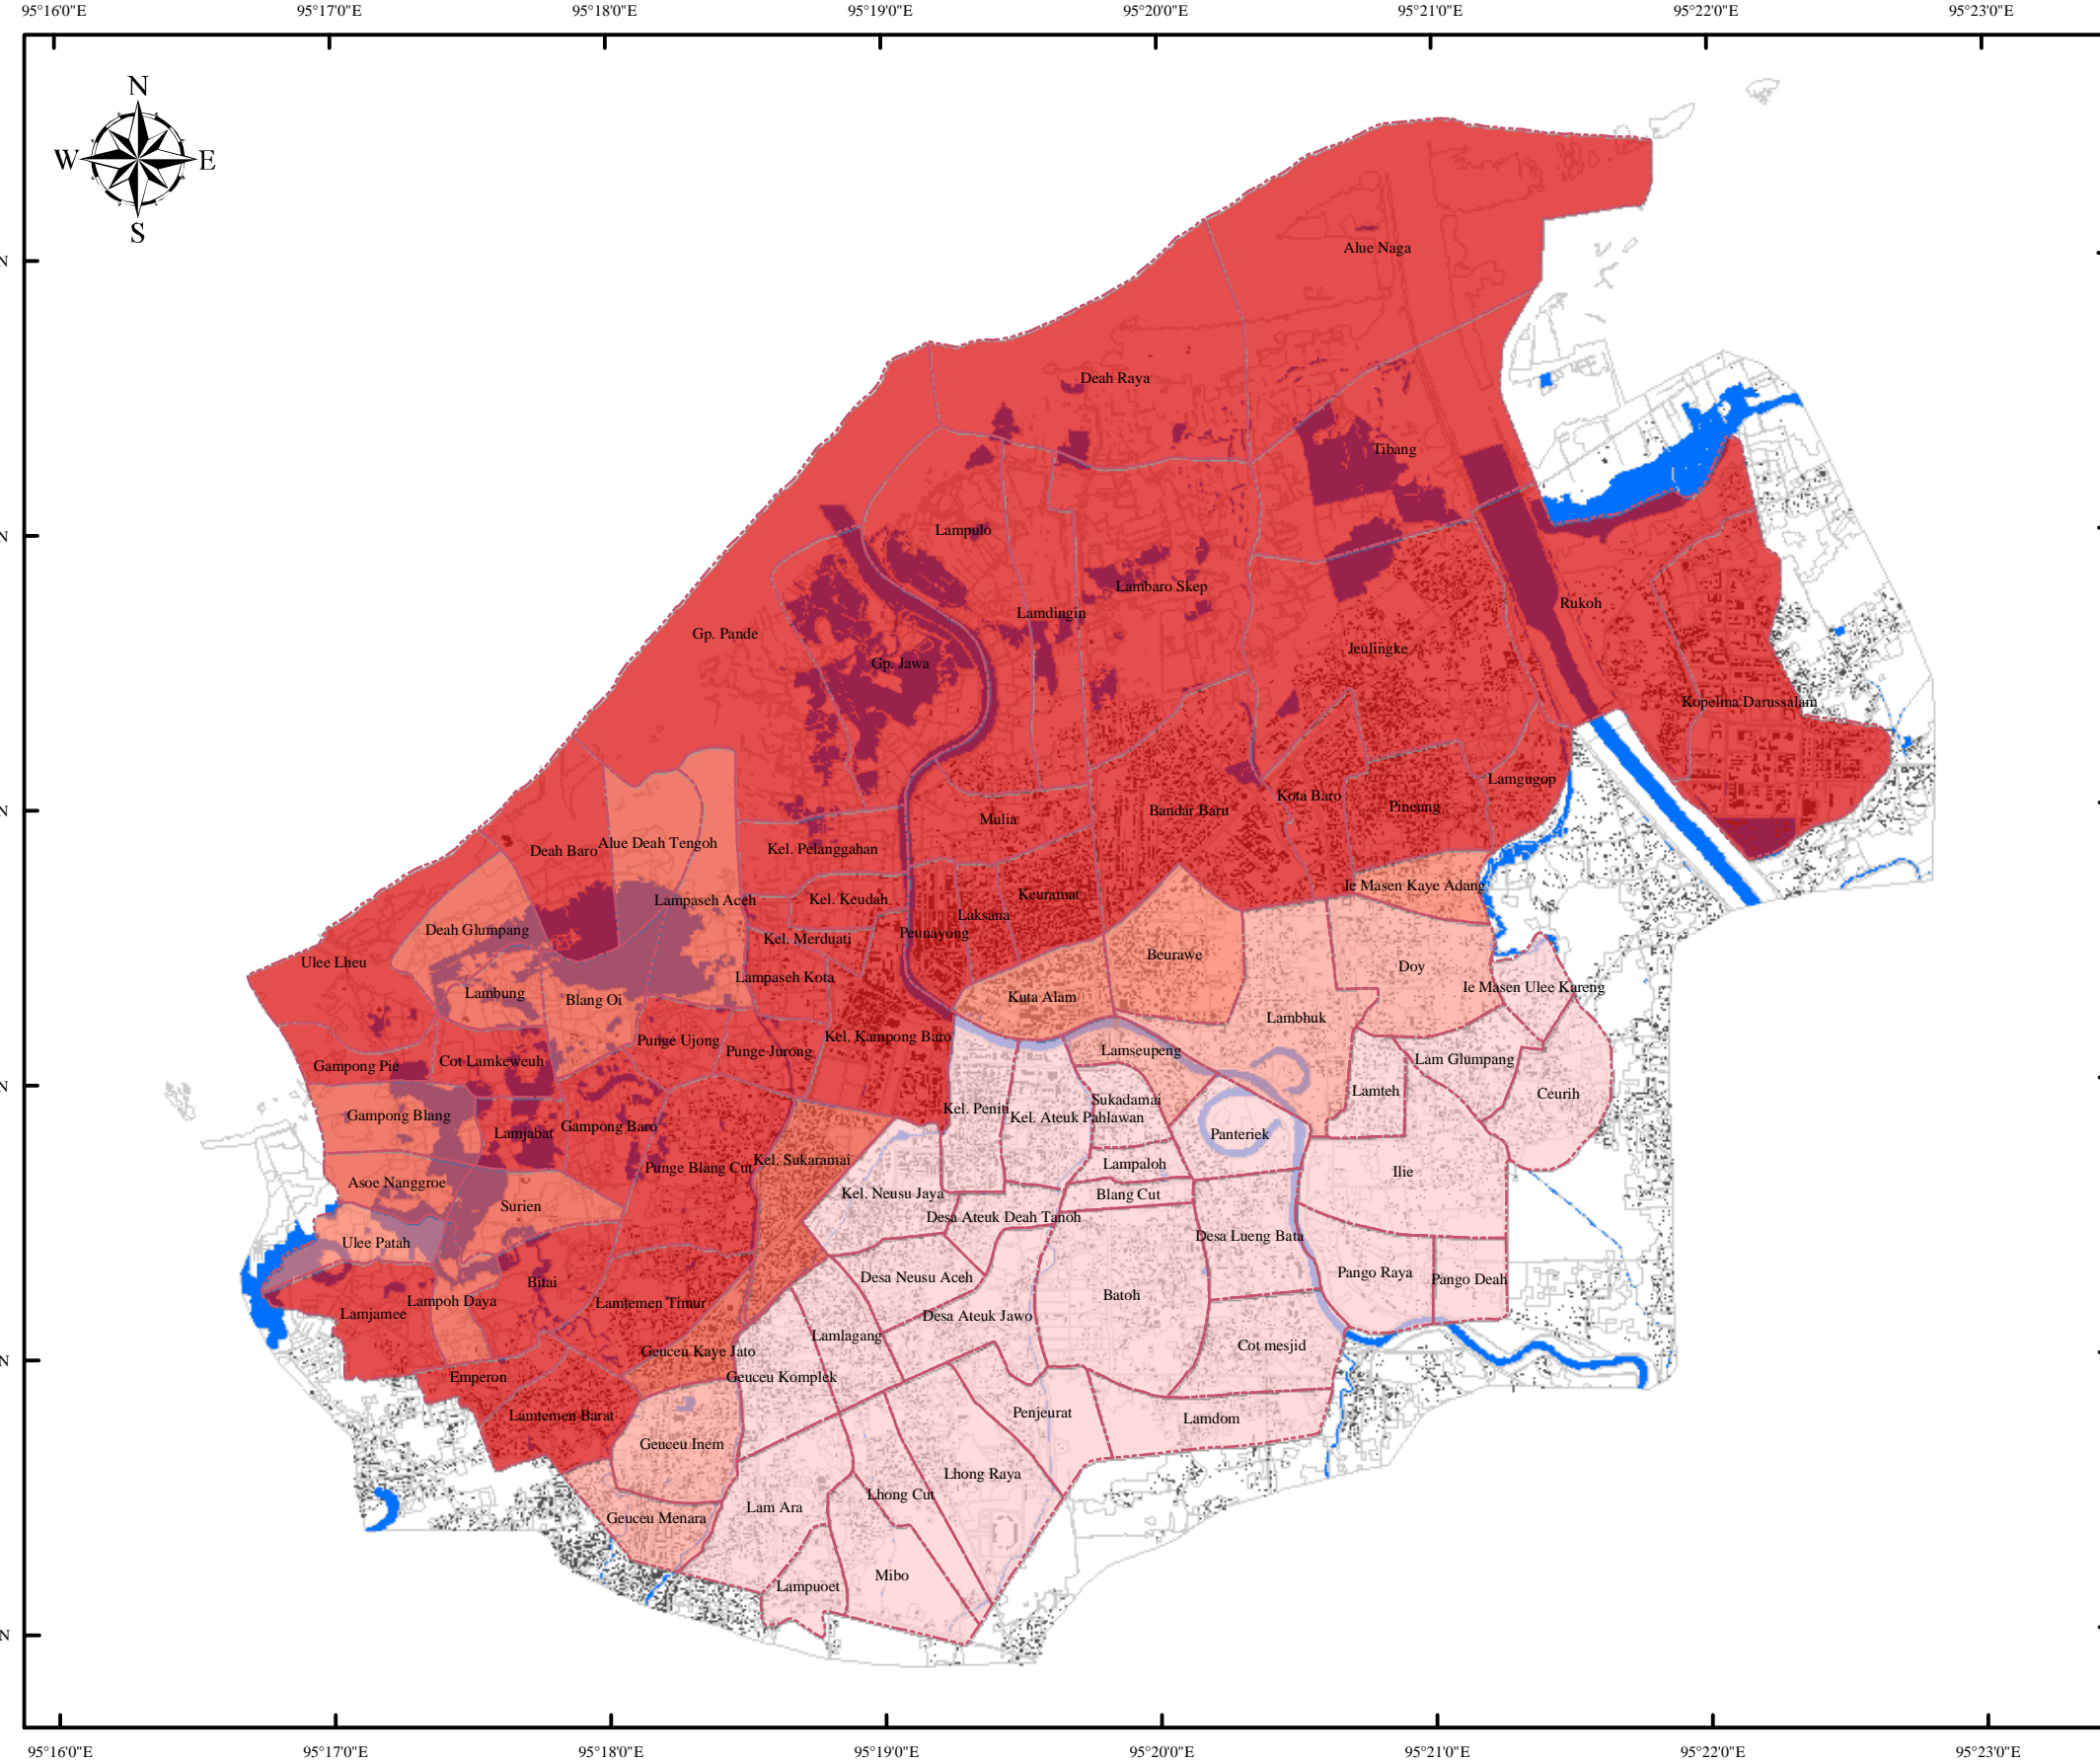
Map Reference ID: HP-0002

Hazard Potential Map (Tsunami; Inundation)

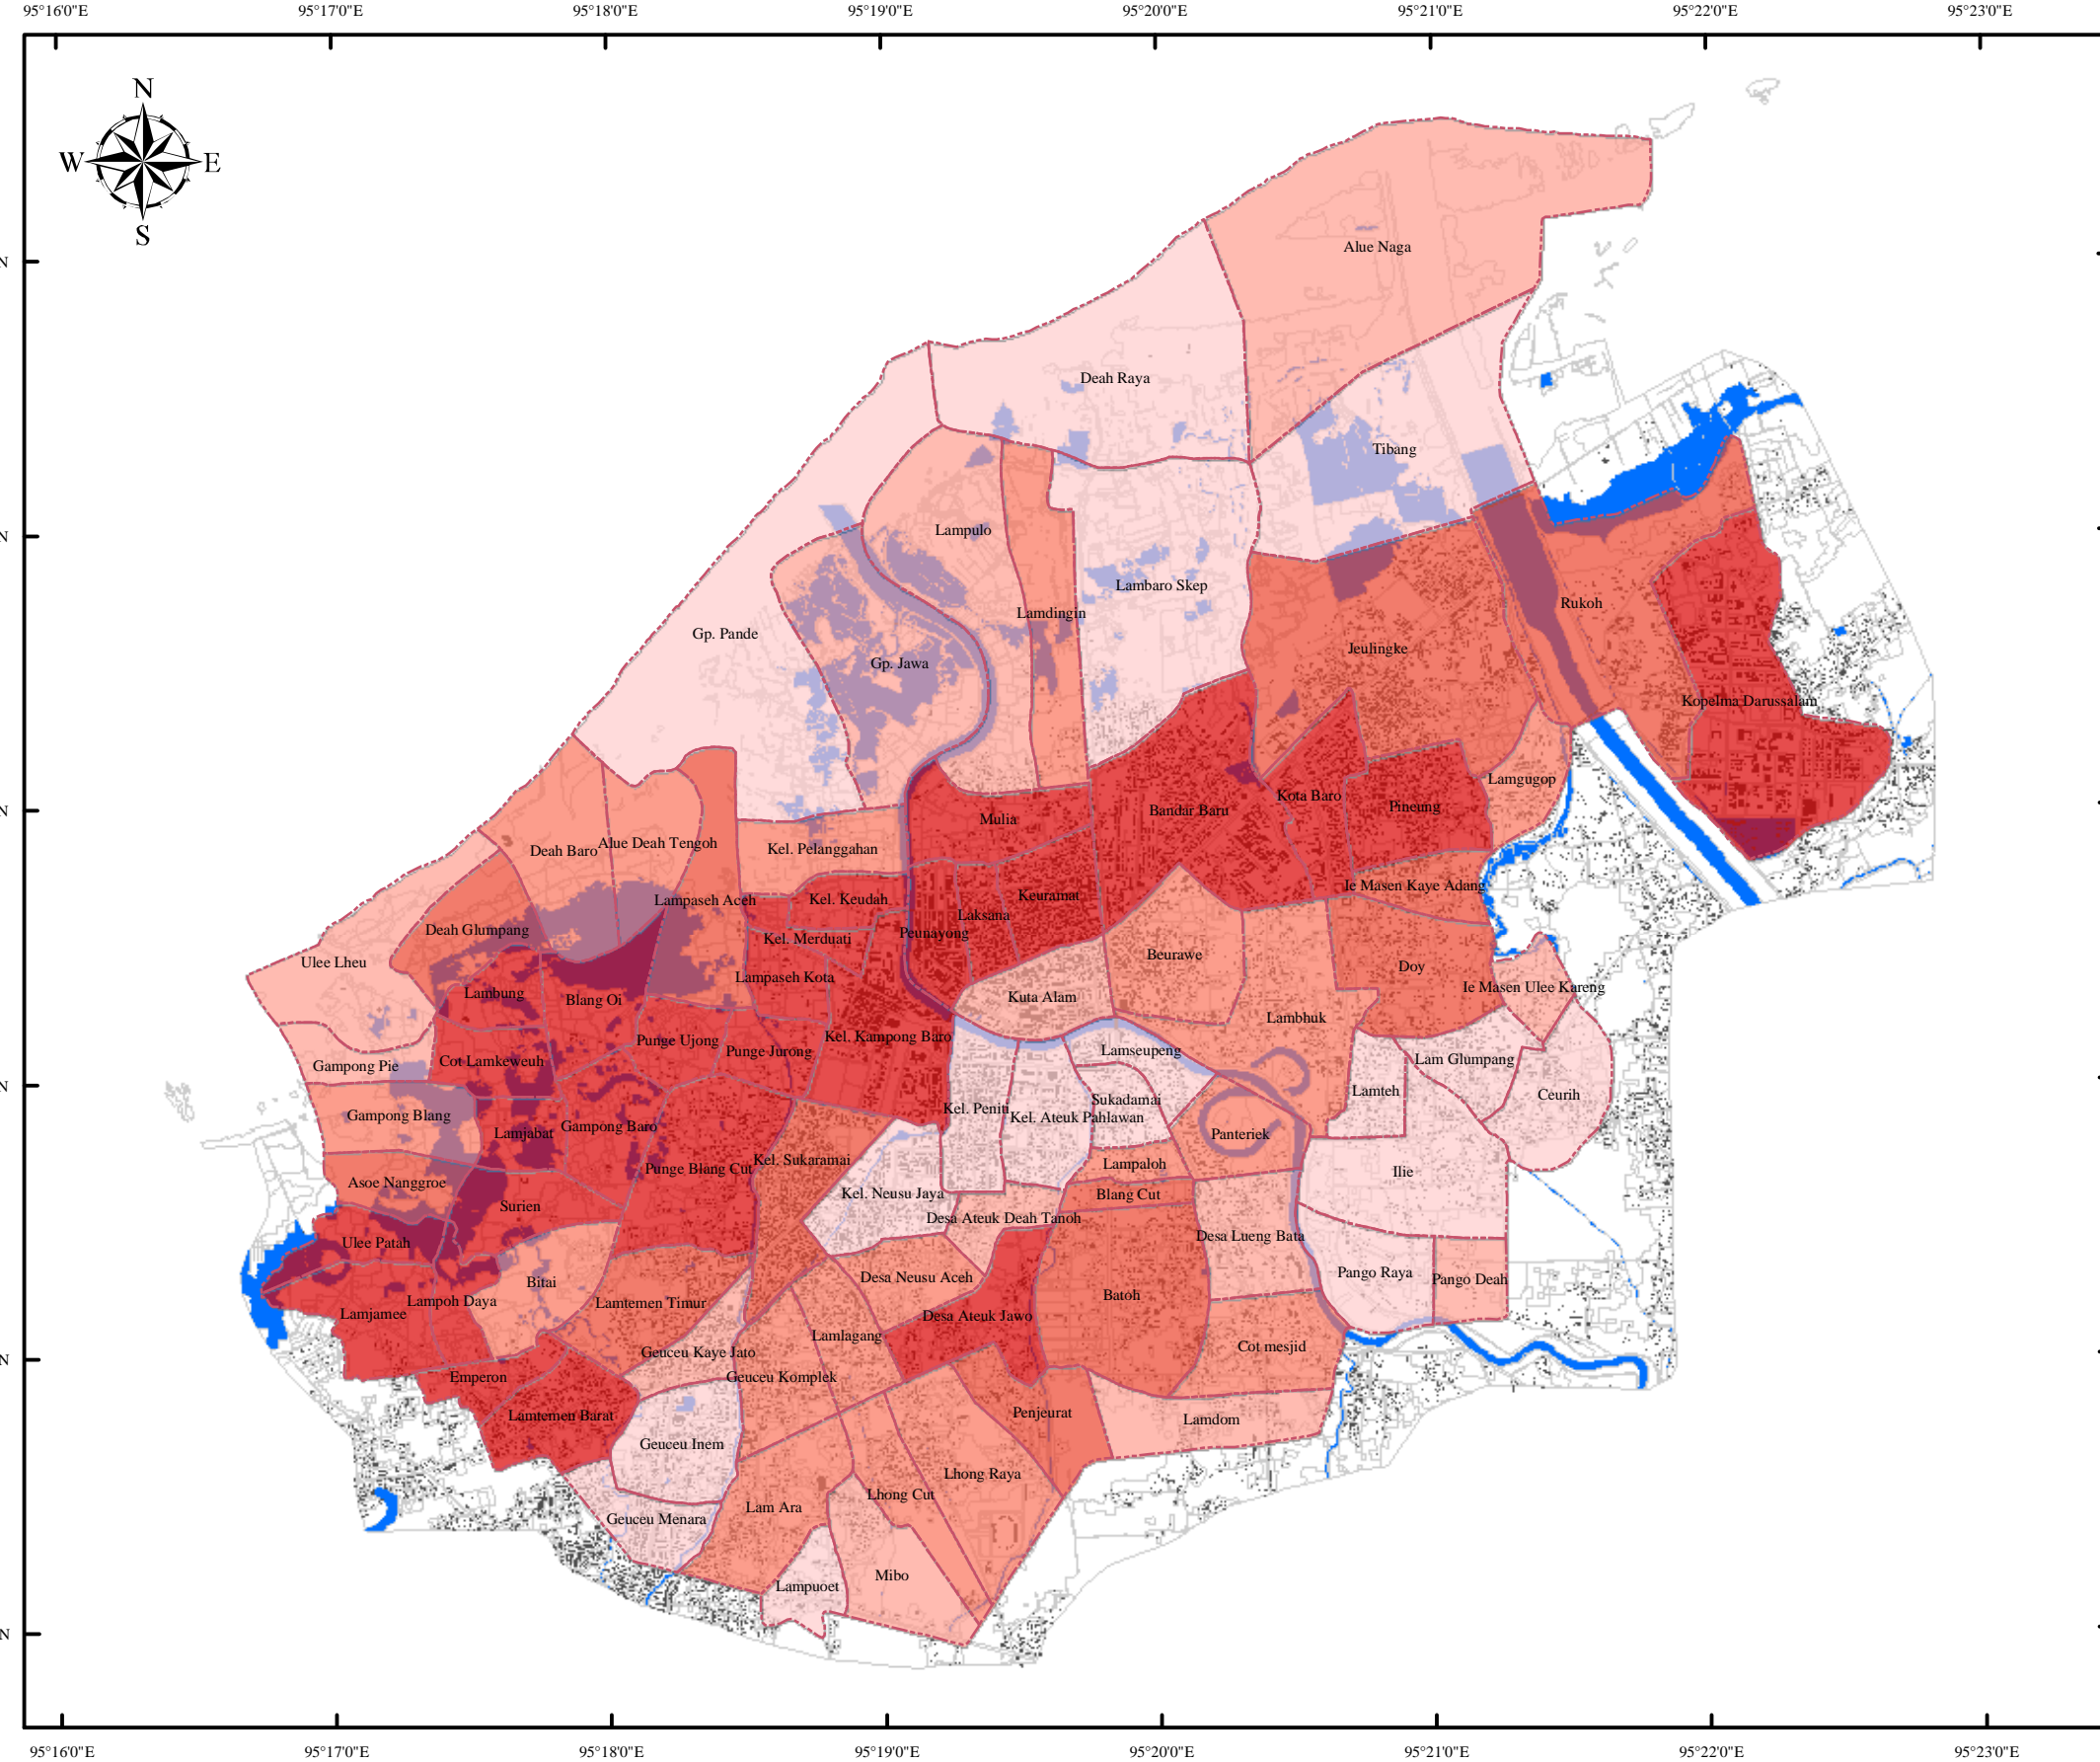
Map Reference ID: HP-0003

**Hazard Potential Map
(Flood; Drainage)**

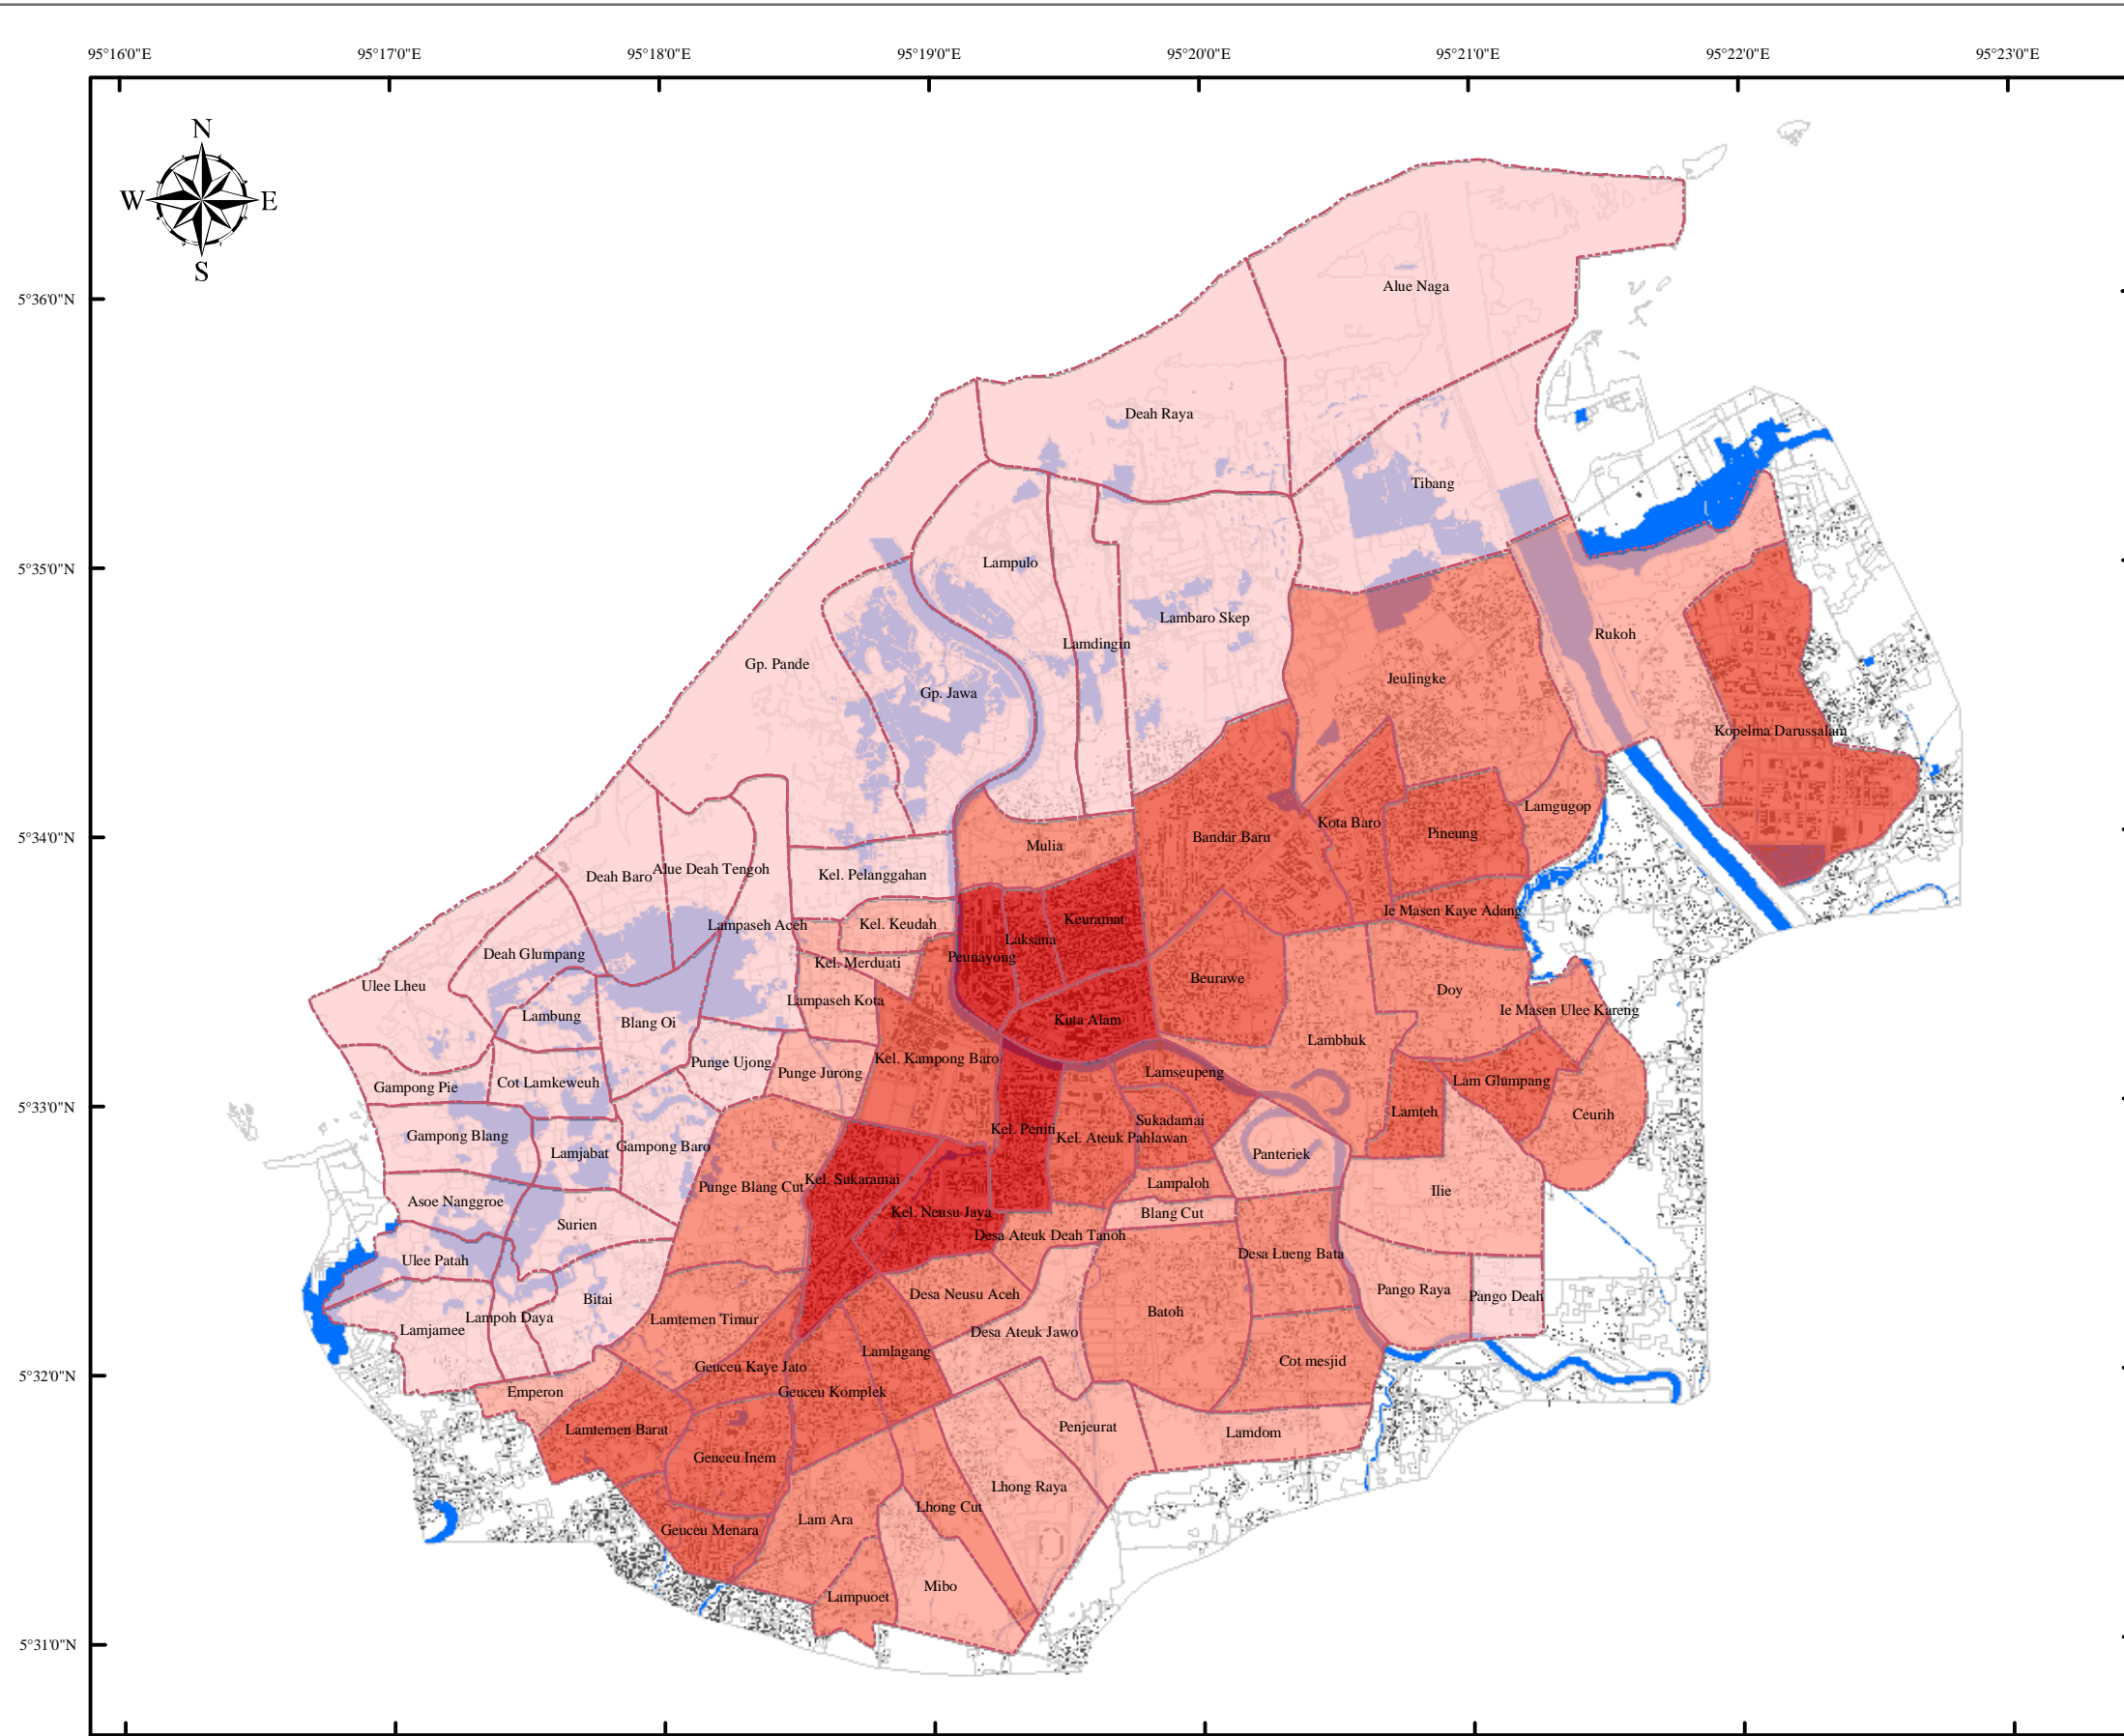
Map Reference ID: HP-0004

**Hazard Potential Map
(Fire Spreading)**
