The Study on
The Urgent Rehabilitation and Reconstruction Support Program
for
Aceh Province and Affected Areas in North Sumatra
(Urgent Rehabilitation and Reconstruction Plan for Banda Aceh City)
in
The Republic of Indonesia

**Tsunami Damage Assessment Map
(Roads and Bridges)**

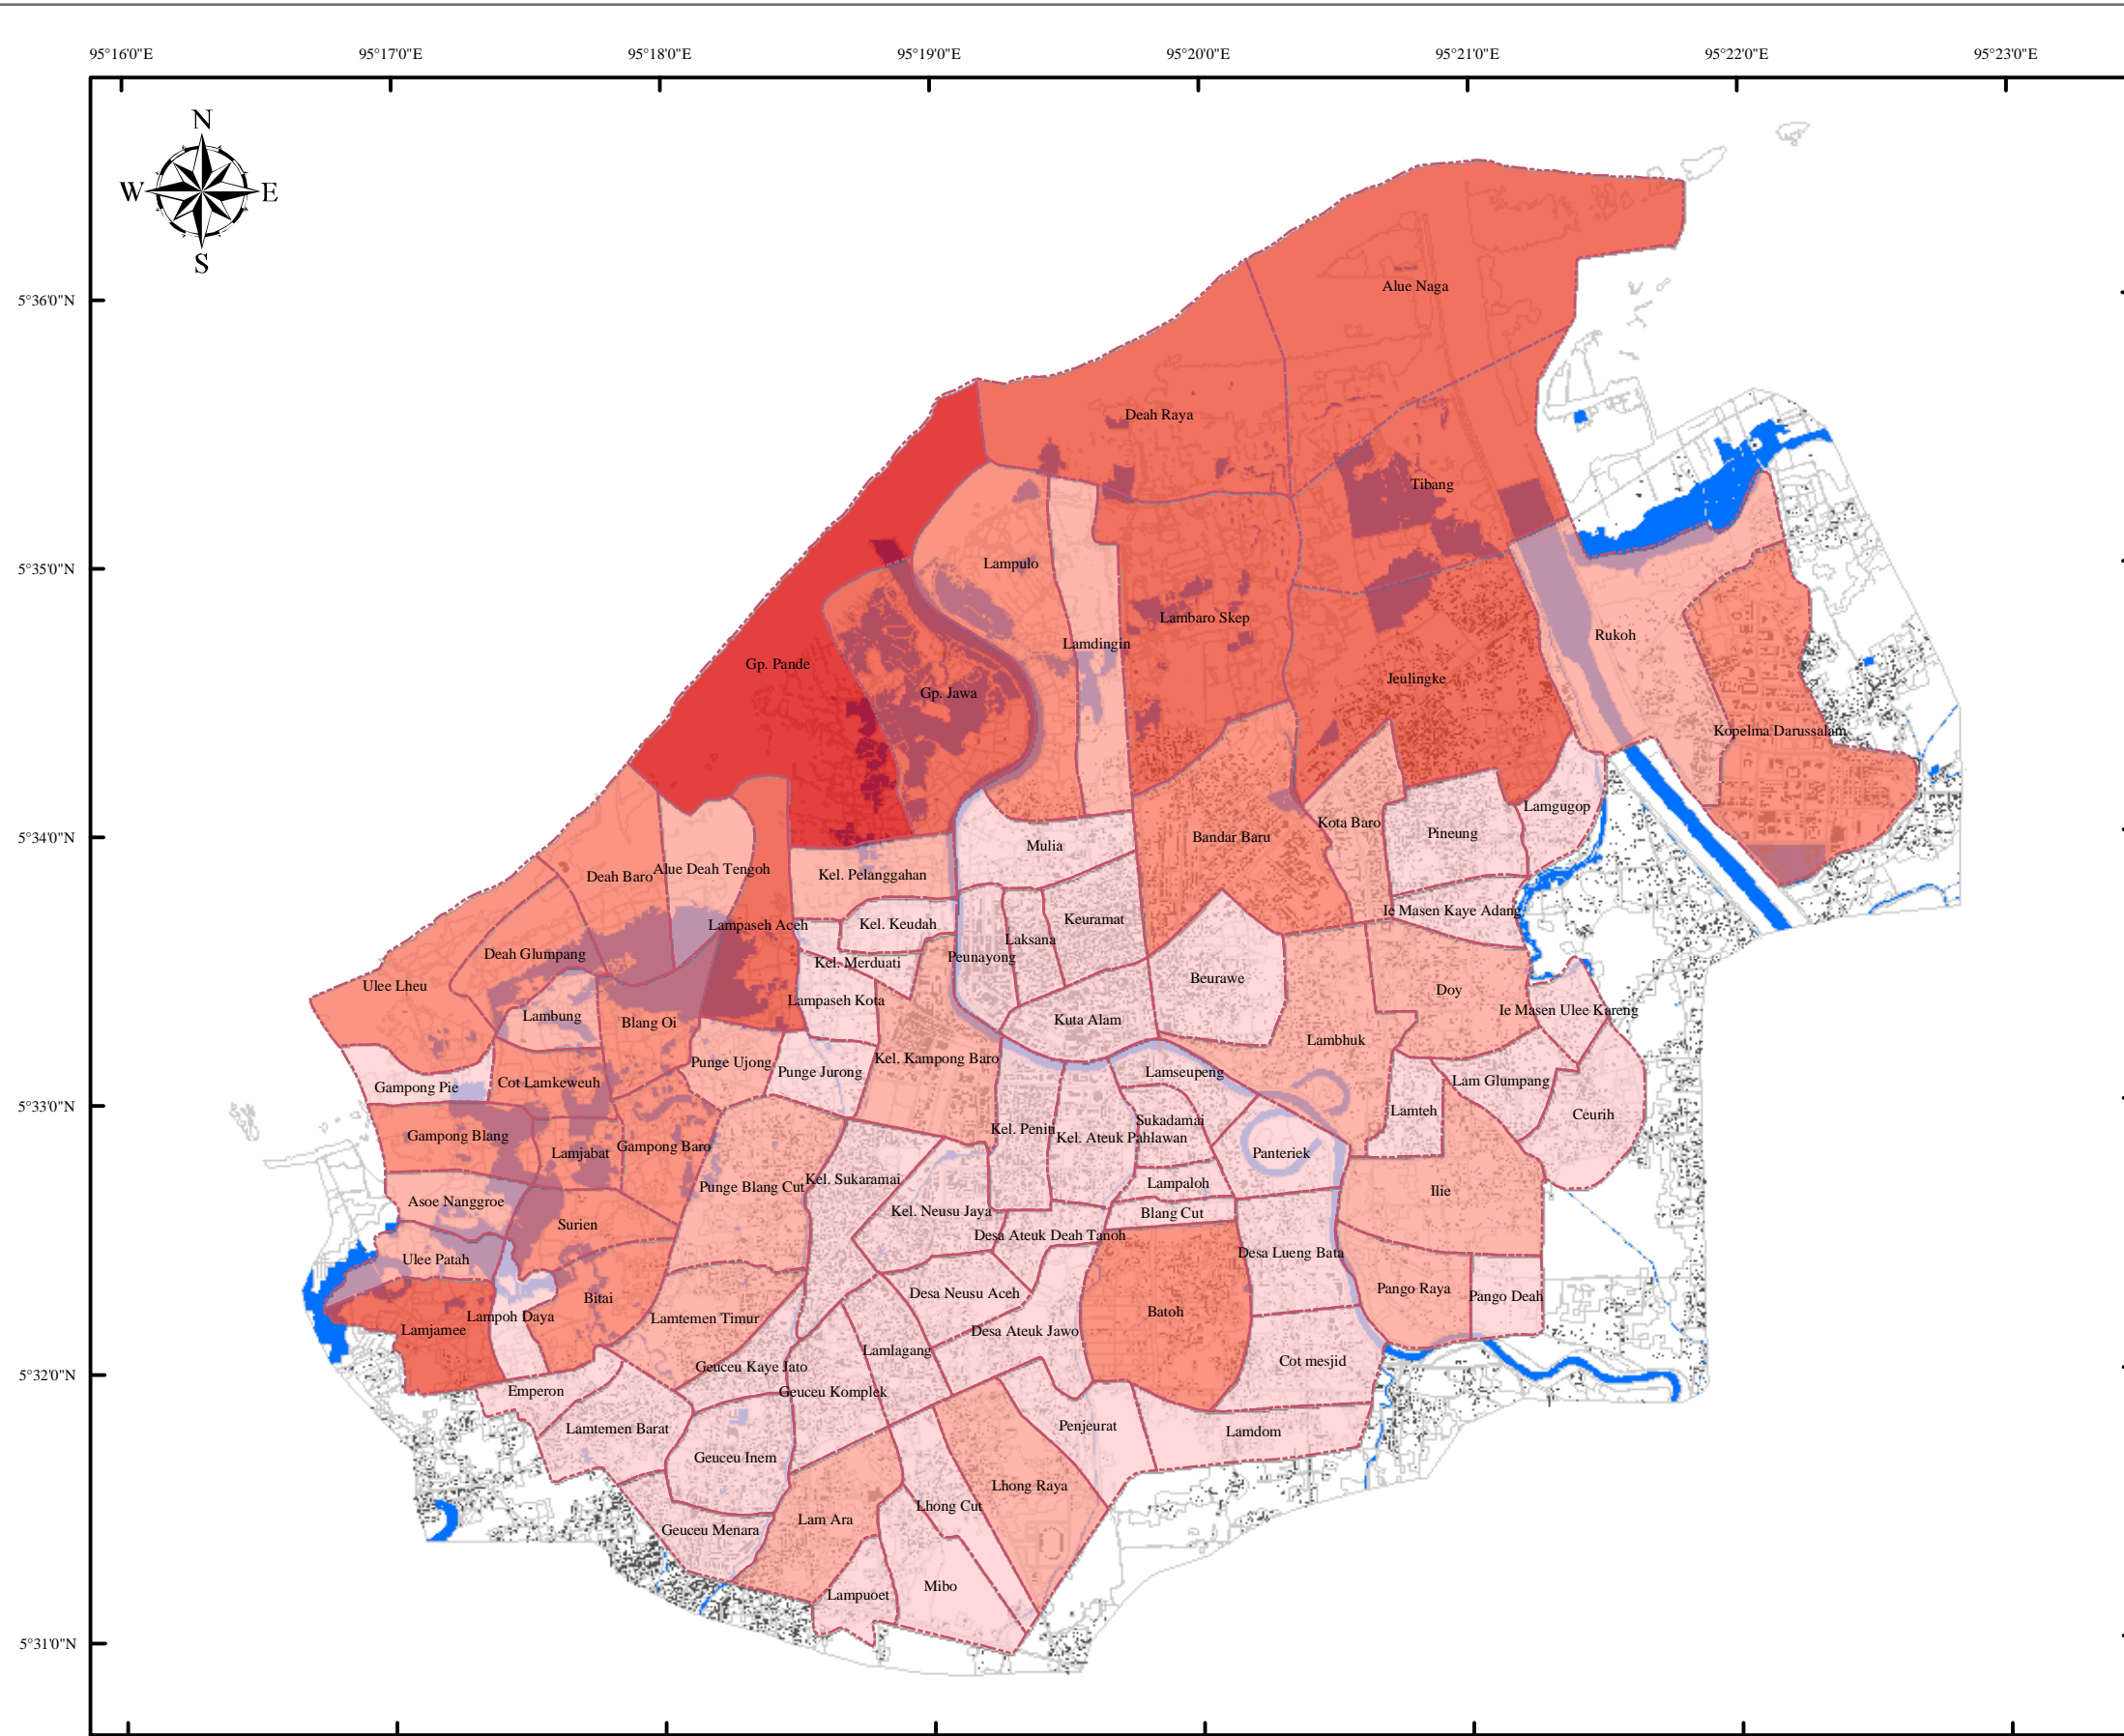
Map Reference ID: HP-0005

**Hazard Potential Map
(Escaping Activity)**

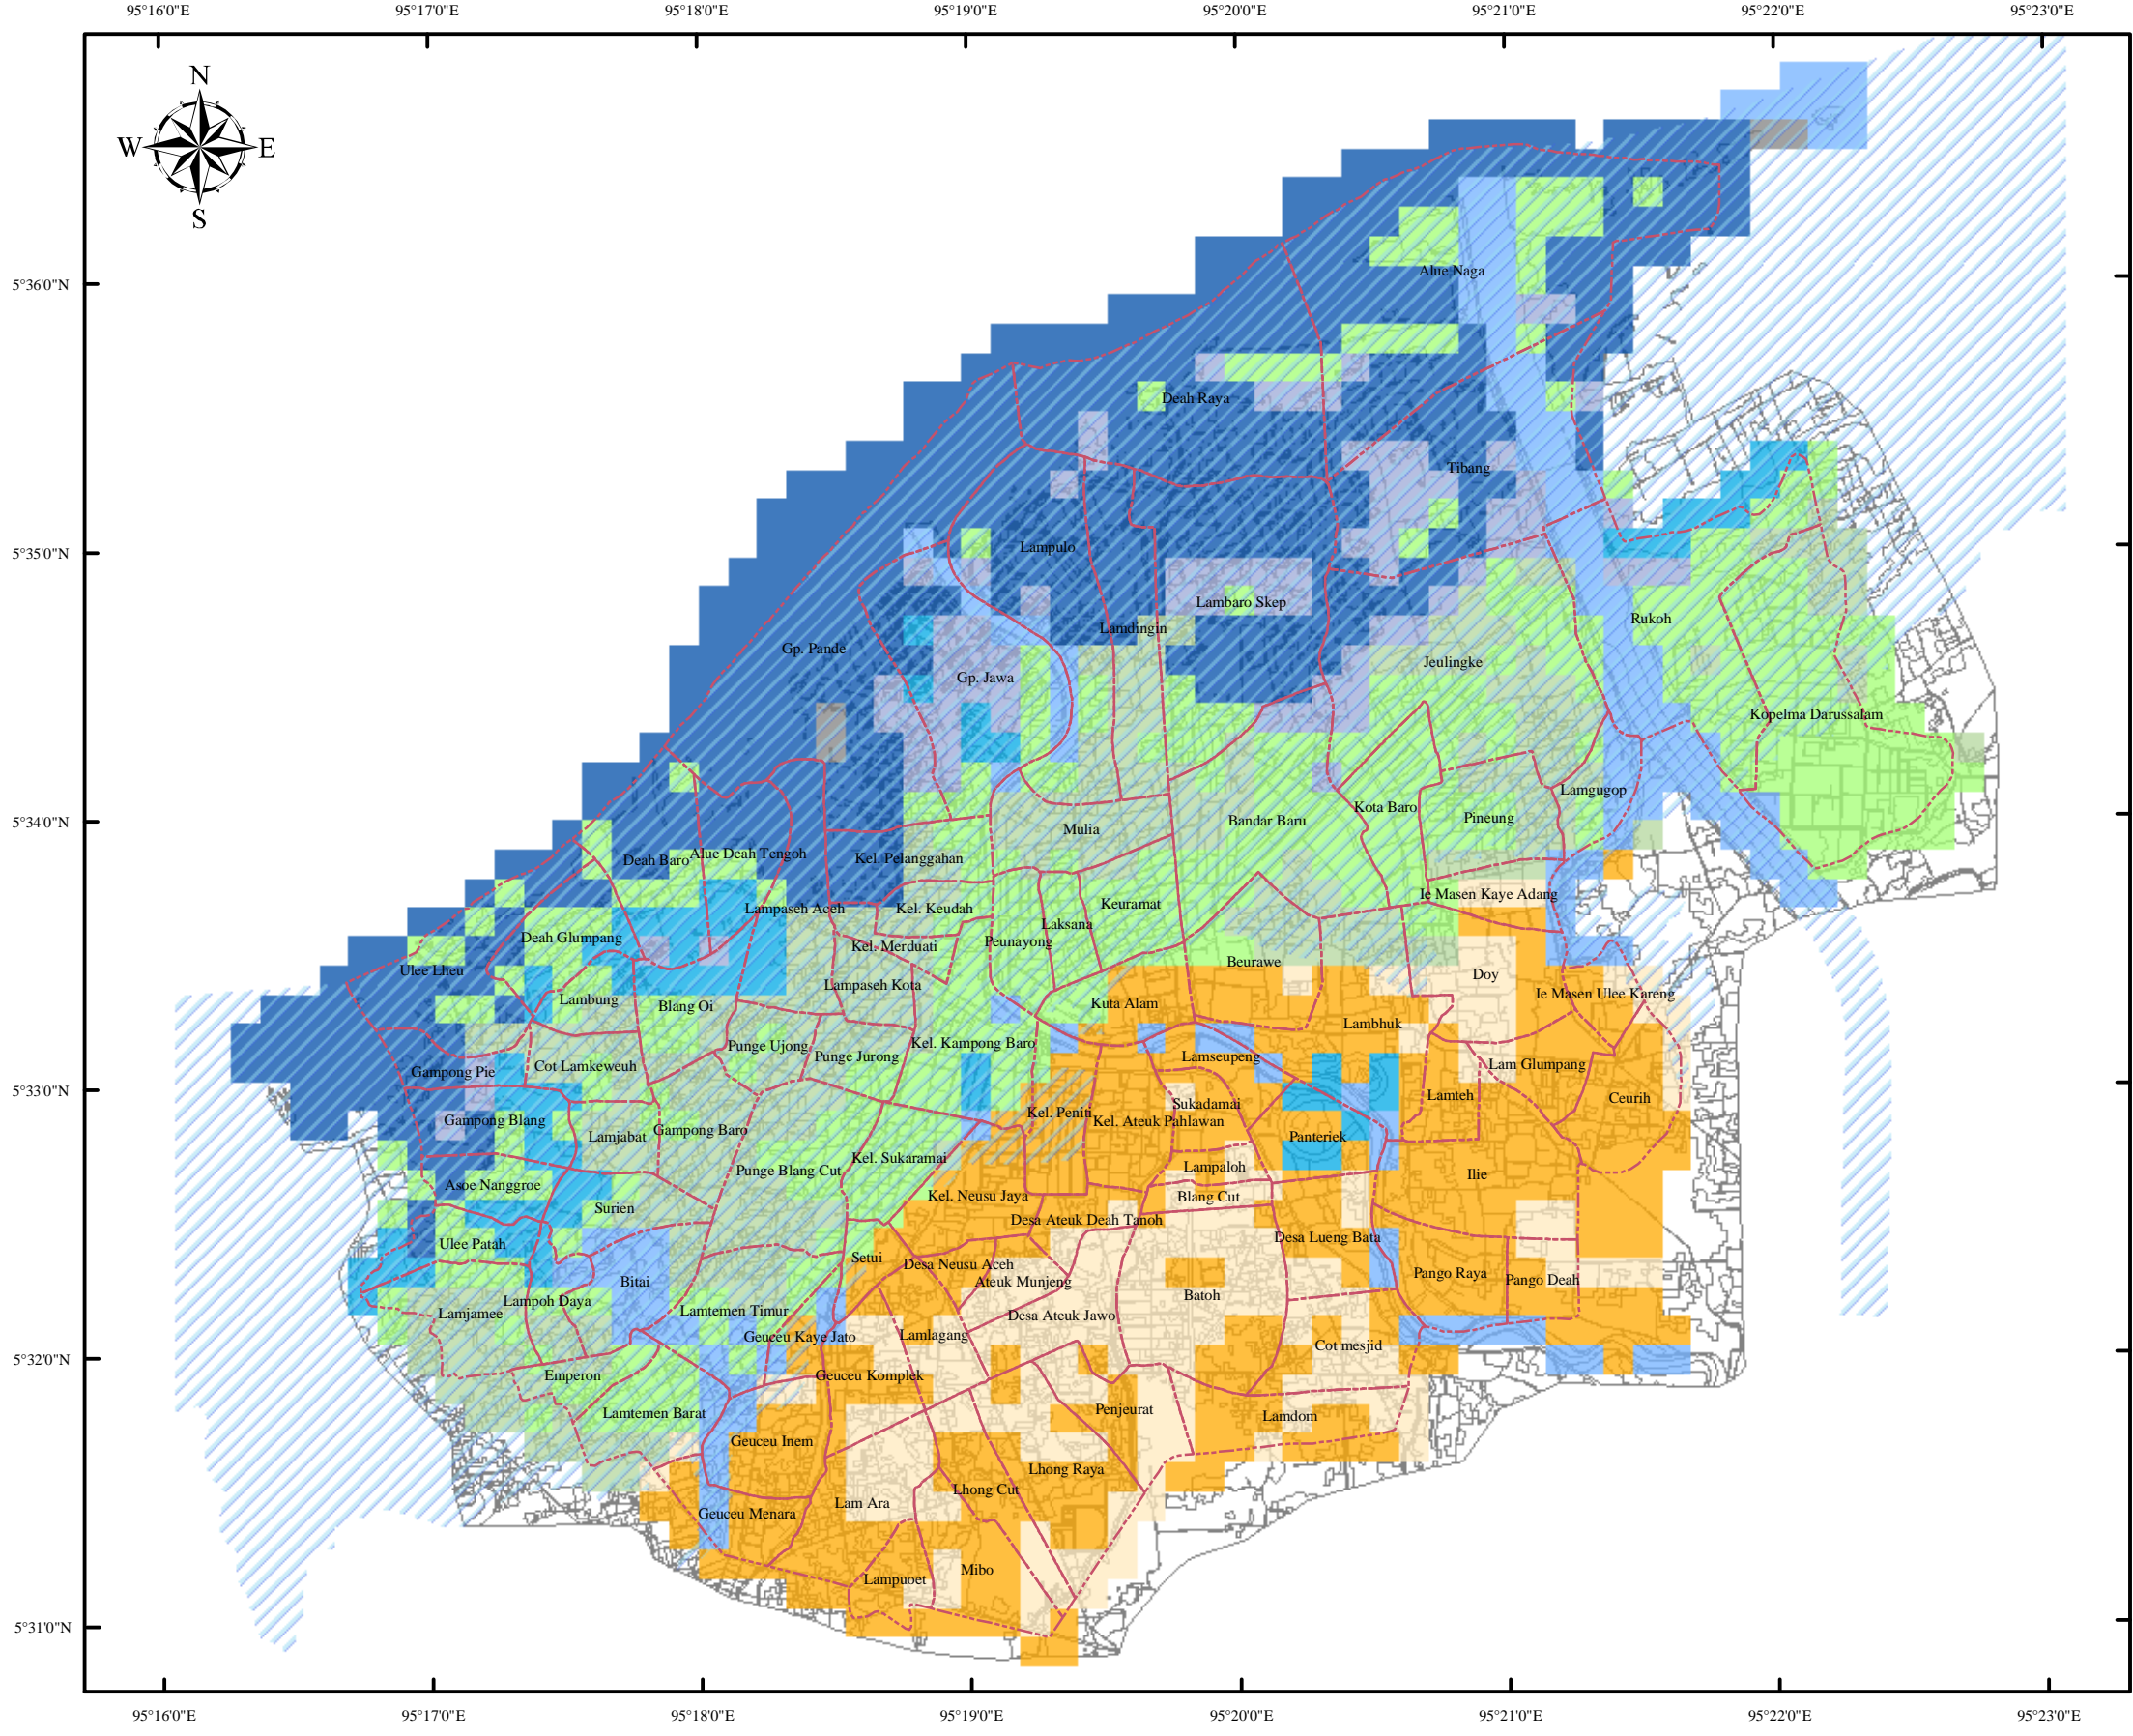
Map Reference Map: HP-0006

Topographic Zoning Map

Topographic zoning was made by interpreting post-tsunami IKONOS Satellite images.

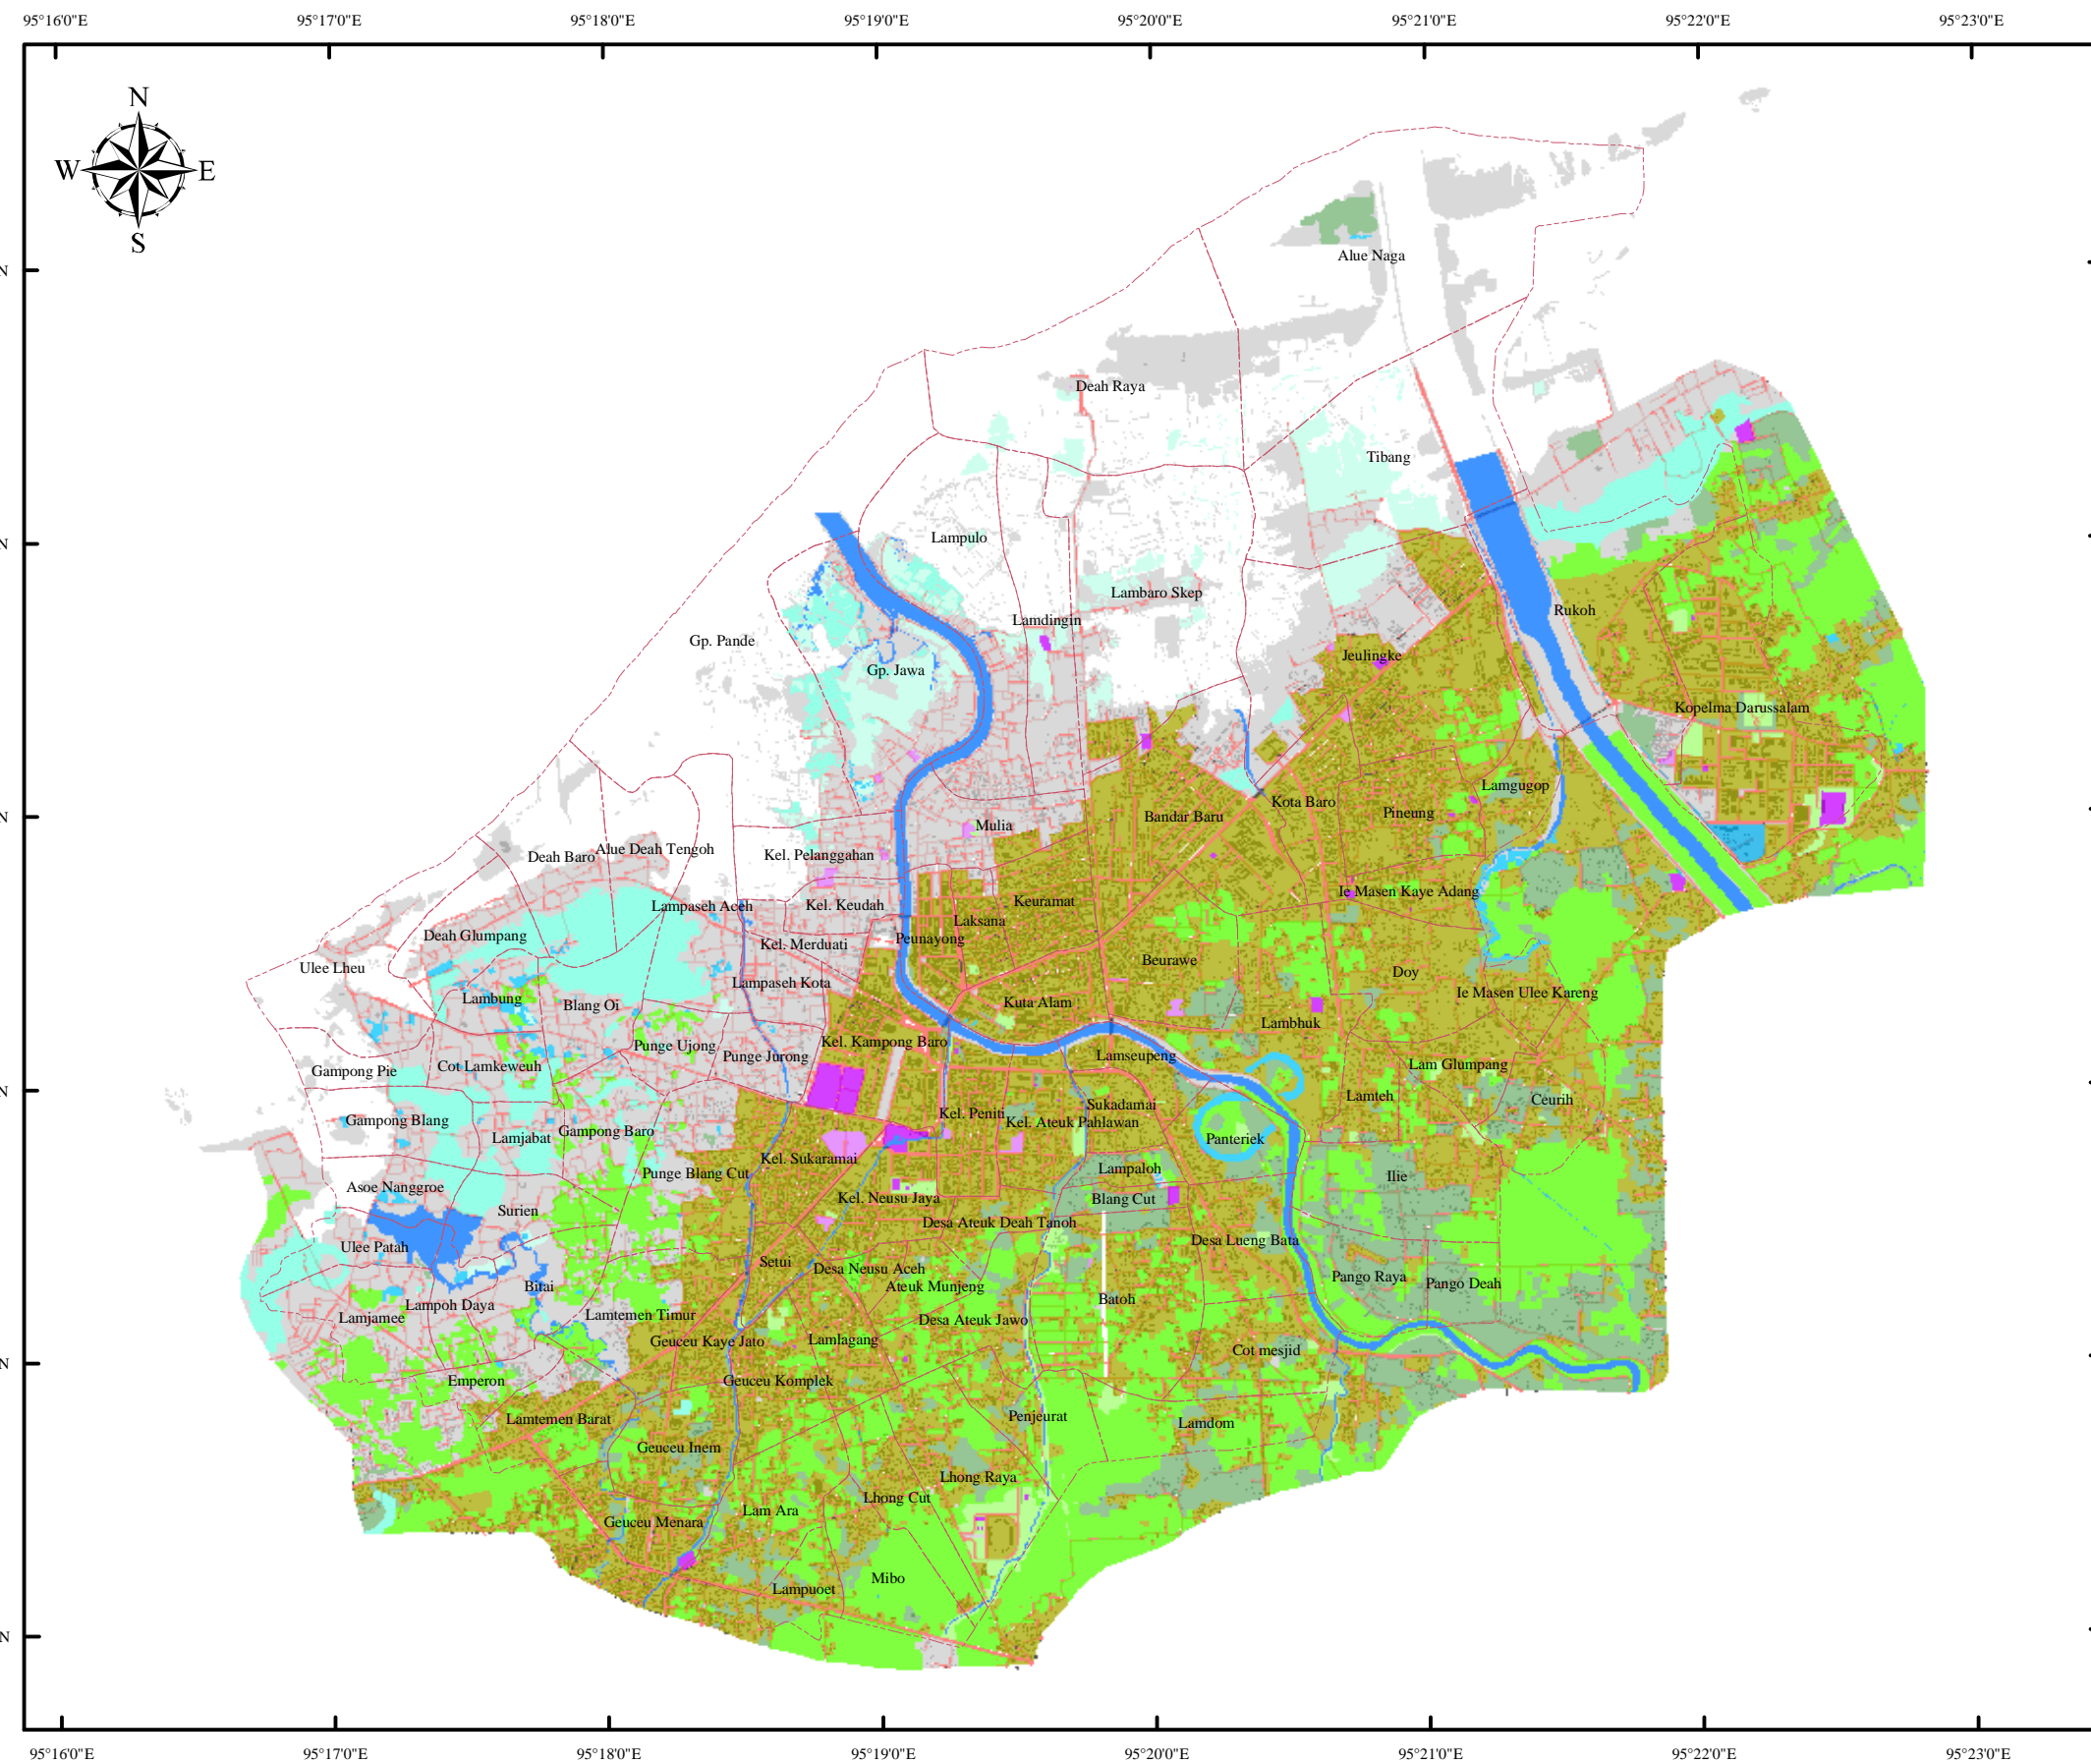
Map Reference ID: CP-0001

**Post-Tsunami Landuse Map
(Actual Condition)**

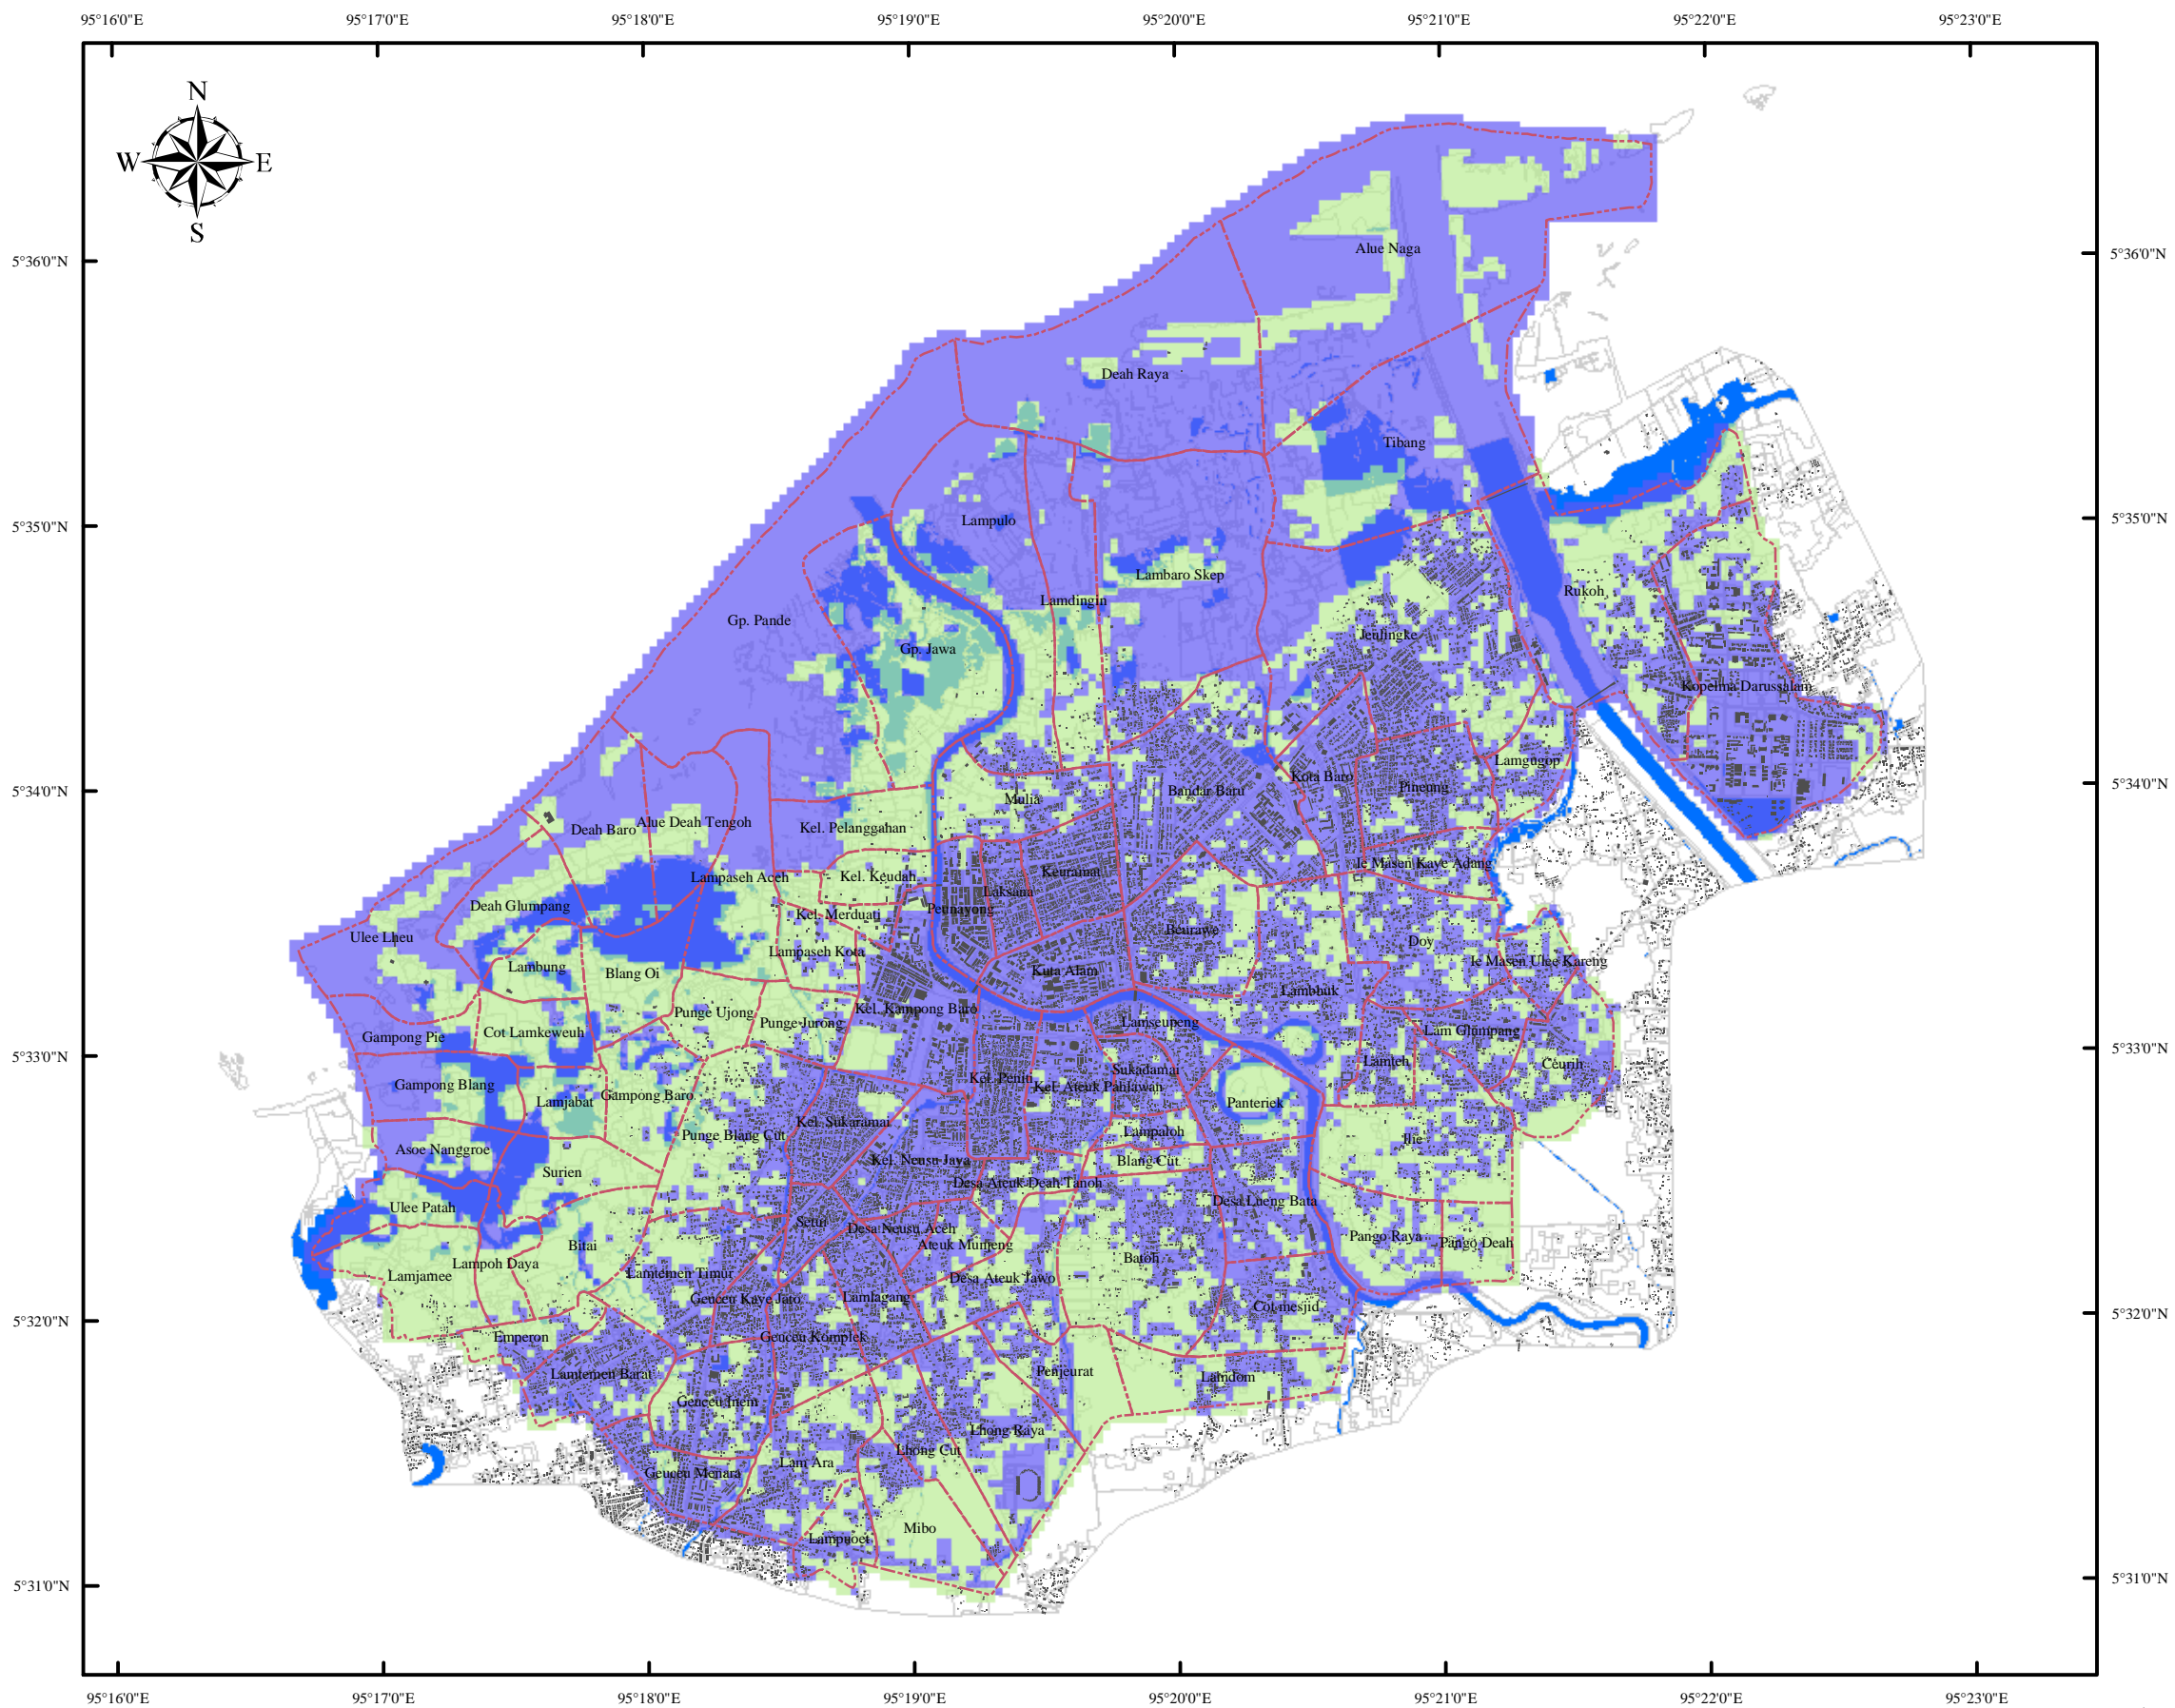
Map Reference ID: CP-0002

Post-Tsunami Vacancies in Banda Aceh

Map Information:
 Projection: UTM Zone 46N (WGS 1984)
 The vacancies shown on this map was made by interpreting IKONOS satellite imagery acquired after December 26, 2004.
