B. Inspection Sheet

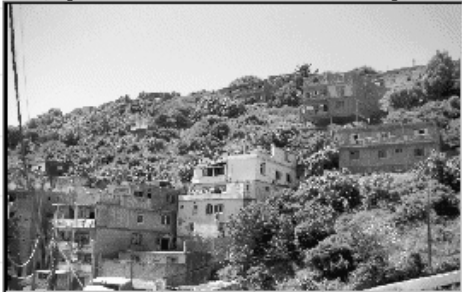
Photographie du Site

Localisation du site			
No.	2	Xcoordinates	500585
Location Name	S2	Y coordinates	4073870
Commune Name	RAIS HAMIDOU	Longitude	
Checking date	2006/06/05	Latitude

>X	A	Slope evaluation with seismic intensity
IX-X	A	
VIII-IX	A	
VII-VIII	B	
VI-VII	C

Slope conditions		
Slope Height	50m <=H	10
Slope angle	45 <= a < 60	4
Overhang	No	0
Evaluation4	ure rich/Highly weathe	6
Evaluation5	more than 0.5m	3
Evaluation6	No Water seepage/Dry	0
Evaluation7	None	0
Evaluation8	23

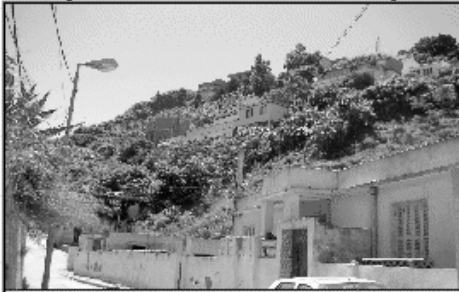
Photographie du Site

Localisation du site			
No.	4	Xcoordinates	500720
Location Name	S4	Y coordinates	4073960
Commune Name	RAIS HAMIDOU	Longitude	
Checking date	2006/06/05	Latitude

>X	A	Slope evaluation with seismic intensity
IX-X	A	
VIII-IX	A	
VII-VIII	B	
VI-VII	C

Slope conditions		
Slope Height	30m <= H < 50 m	8
Slope angle	45 <= a < 60	4
Overhang	Yes	4
Evaluation4	ure rich/Highly weathe	6
Evaluation5	more than 0.5m	3
Evaluation6	No Water seepage/Dry	0
Evaluation7	None	0
Evaluation8	25

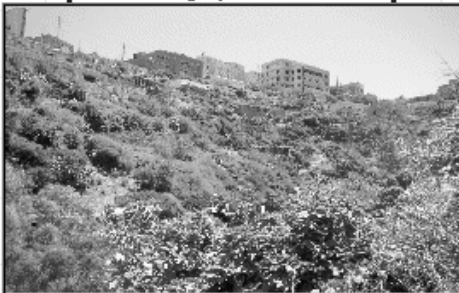
Photographie du Site

Localisation du site			
No.	5	Xcoordinates	500790
Location Name	S5	Y coordinates	4073910
Commune Name	RAIS HAMIDOU	Longitude	
Checking date	2006/06/05	Latitude

>X	A	Slope evaluation with seismic intensity
IX-X	A	
VIII-IX	B	
VII-VIII	C	
VI-VII	C

Slope conditions		
Slope Height	30m <= H < 50 m	8
Slope angle	45 <= a < 60	4
Overhang	No	0
Evaluation4	ure rich/Highly weathe	6
Evaluation5	more than 0.5m	3
Evaluation6	No Water seepage/Dry	0
Evaluation7	None	0
Evaluation8	21

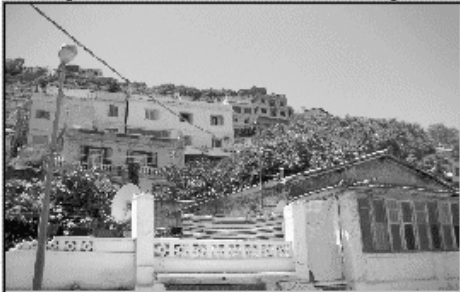
Photographie du Site

Localisation du site			
No.	6	Xcoordinates	501330
Location Name	S6	Y coordinates	4074045
Commune Name	RAIS HAMIDOU	Longitude	
Checking date	2006/06/05	Latitude

>X	A	Slope evaluation with seismic intensity
IX-X	A	
VIII-IX	A	
VII-VIII	B	
VI-VII	C

Slope conditions		
Slope Height	50m <=H	10
Slope angle	45 <= a < 60	4
Overhang	No	0
Evaluation4	ure rich/Highly weathe	6
Evaluation5	more than 0.5m	3
Evaluation6	No Water seepage/Dry	0
Evaluation7	None	0
Evaluation8		23

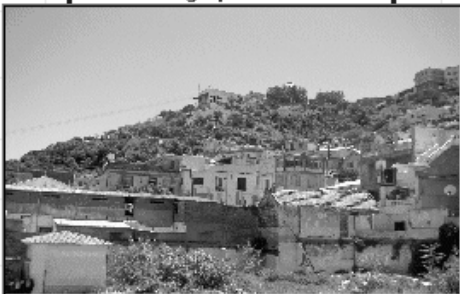
Photographie du Site

Localisation du site			
No.	7	Xcoordinates	503840
Location Name	S7	Y coordinates	4072660
Commune Name	HINE IBNOU ZIRI	Longitude	
Checking date	2006/06/05	Latitude

>X	A	Slope evaluation with seismic intensity
IX-X	A	
VIII-IX	A	
VII-VIII	B	
VI-VII	C

Slope conditions		
Slope Height	50m <=H	10
Slope angle	60 <= a	7
Overhang	No	0
Evaluation4	ure rich/Highly weathe	6
Evaluation5	more than 0.5m	3
Evaluation6	No Water seepage/Dry	0
Evaluation7	None	0
Evaluation8		26

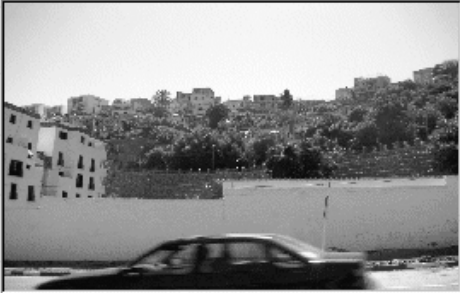
Photographie du Site

Localisation du site			
No.	8	Xcoordinates	503805
Location Name	S8	Y coordinates	4070390
Commune Name	OUED KORICHE	Longitude	
Checking date	2006/06/06	Latitude

>X	A	Slope evaluation with seismic intensity
IX-X	A	
VIII-IX	B	
VII-VIII	C	
VI-VII	C

Slope conditions		
Slope Height	50m <= H	10
Slope angle	a < 45	1
Overhang	No	0
Evaluation4	ure rich/Highly weathe	6
Evaluation5	more than 0.5m	3
Evaluation6	No Water seepage/Dry	0
Evaluation7	None	0
Evaluation8	20

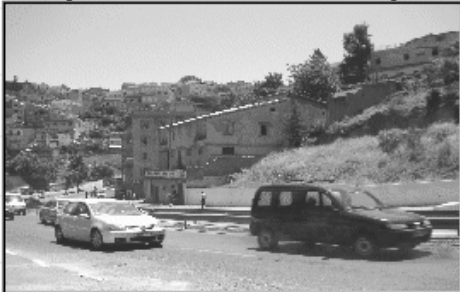
Photographie du Site

Localisation du site			
No.	10	Xcoordinates	502938
Location Name	S10	Y coordinates	4069285
Commune Name	EL BIAR	Longitude	
Checking date	2006/06/06	Latitude

>X	A	Slope evaluation with seismic intensity
IX-X	A	
VIII-IX	B	
VII-VIII	C	
VI-VII	C

Slope conditions		
Slope Height	10m <= H < 30 m	7
Slope angle	a < 45	1
Overhang	No	0
Evaluation4	ure rich/Highly weathe	6
Evaluation5	more than 0.5m	3
Evaluation6	No Water seepage/Dry	0
Evaluation7	None	0
Evaluation8		17

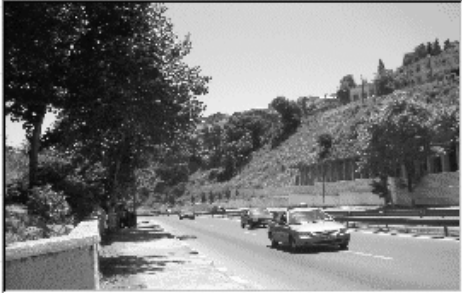
Photographie du Site

Localisation du site			
No.	12	Xcoordinates	502660
Location Name	S12	Y coordinates	4069220
Commune Name	EL BIAR	Longitude	
Checking date	2006/06/06	Latitude

>X	A	Slope evaluation with seismic intensity
IX-X	A	
VIII-IX	B	
VII-VIII	C	
VI-VII	C

Slope conditions		
Slope Height	30m <= H < 50 m	8
Slope angle	45 <= a < 60	4
Overhang	No	0
Evaluation4	ure rich/Highly weathe	6
Evaluation5	more than 0.5m	3
Evaluation6	No Water seepage/Dry	0
Evaluation7	None	0
Evaluation8	21

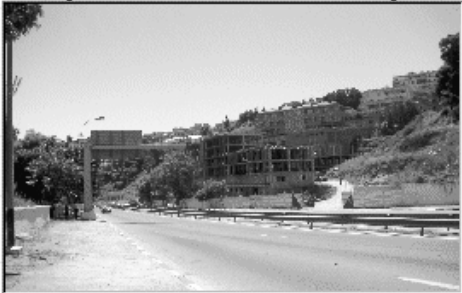
Photographie du Site

Localisation du site			
No.	13	Xcoordinates	502560
Location Name	S13	Y coordinates	4069215
Commune Name	EL BIAR	Longitude	
Checking date	2006/06/06	Latitude

>X	A	Slope evaluation with seismic intensity
IX-X	A	
VIII-IX	B	
VII-VIII	C	
VI-VII	C

Slope conditions		
Slope Height	10m <= H < 30 m	7
Slope angle	a < 45	1
Overhang	No	0
Evaluation4	ure rich/Highly weathe	6
Evaluation5	more than 0.5m	3
Evaluation6	No Water seepage/Dry	0
Evaluation7	None	0
Evaluation8	17

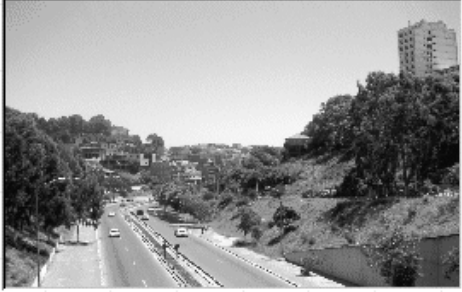
Photographie du Site

Localisation du site			
No.	14	Xcoordinates	502495
Location Name	S14	Y coordinates	4069315
Commune Name	EL BIAR	Longitude	
Checking date	2006/06/06	Latitude

>X	A	Slope evaluation with seismic intensity
IX-X	A	
VIII-IX	B	
VII-VIII	C	
VI-VII	C

Slope conditions			
Slope Height	30m <= H < 50 m		8
Slope angle	45 <= a < 60		4
Overhang	No		0
Evaluation4	ure rich/Highly weathe		6
Evaluation5	more than 0.5m		3
Evaluation6	No Water seepage/Dry		0
Evaluation7	None		0
Evaluation8			21

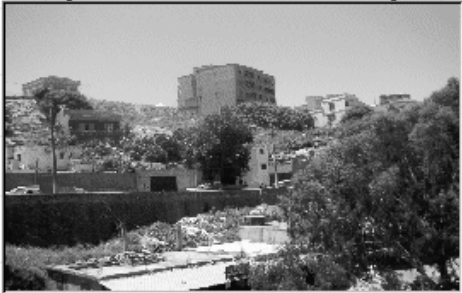
Photographie du Site

Localisation du site			
No.	15	Xcoordinates	502285
Location Name	S15	Y coordinates	4069270
Commune Name	EL BIAR	Longitude	
Checking date	2006/06/06	Latitude

>X	A	Slope evaluation with seismic intensity
IX-X	A	
VIII-IX	A	
VII-VIII	B	
VI-VII	C

Slope conditions			
Slope Height	10m <= H < 30 m		7
Slope angle	60 <= a		7
Overhang	Yes		4
Evaluation4	ure rich/Highly weathe		6
Evaluation5	more than 0.5m		3
Evaluation6	No Water seepage/Dry		0
Evaluation7	None		0
Evaluation8			27

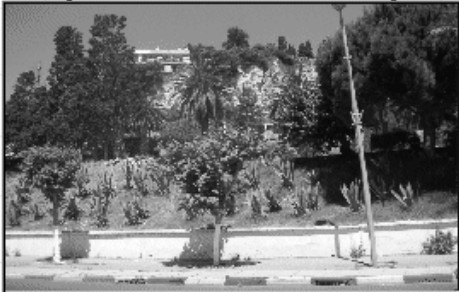
Photographie du Site

Localisation du site			
No.	16	Xcoordinates	503575
Location Name	S16	Y coordinates	4068420
Commune Name	EL BIAR-ALGER	Longitude	
Checking date	2006/06/07	Latitude

>X	A	Slope evaluation with seismic intensity
IX-X	A	
VIII-IX	A	
VII-VIII	B	
VI-VII	C

Slope conditions		
Slope Height	10m <= H < 30 m	7
Slope angle	60 <= a	7
Overhang	Yes	4
Evaluation4	ure rich/Highly weathe	6
Evaluation5	less than 0.5m	0
Evaluation6	No Water seepage/Dry	0
Evaluation7	None	0
Evaluation8	24

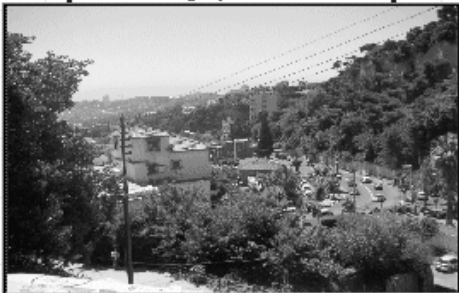
Photographie du Site

Localisation du site			
No.	17	Xcoordinates	503735
Location Name	S17	Y coordinates	4068210
Commune Name	ALGER CENTER	Longitude	
Checking date	2006/07/07	Latitude

>X	A	Slope evaluation with seismic intensity
IX-X	A	
VIII-IX	A	
VII-VIII	B	
VI-VII	C

Slope conditions		
Slope Height	10m <= H < 30 m	7
Slope angle	60 <= a	7
Overhang	Yes	4
Evaluation4	ure rich/Highly weathe	6
Evaluation5	less than 0.5m	0
Evaluation6	No Water seepage/Dry	0
Evaluation7	None	0
Evaluation8	24

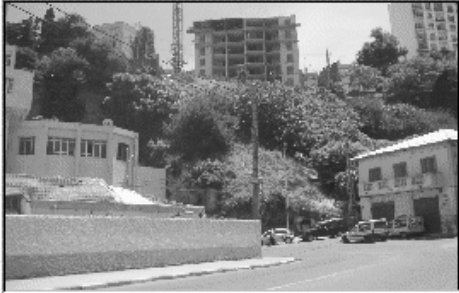
Photographie du Site

Localisation du site			
No.	18	Xcoordinates	504950
Location Name	S18	Y coordinates	4066705
Commune Name	A-EL MOURADIA	Longitude	
Checking date	2006/06/07	Latitude

>X	A	Slope evaluation with seismic intensity
IX-X	A	
VIII-IX	A	
VII-VIII	B	
VI-VII	C

Slope conditions		
Slope Height	10m <= H < 30 m	7
Slope angle	60 <= a	7
Overhang	Yes	4
Evaluation4	soil rich/Highly weathe	6
Evaluation5	less than 0.5m	0
Evaluation6	No Water seepage/Dry	0
Evaluation7	None	0
Evaluation8	24

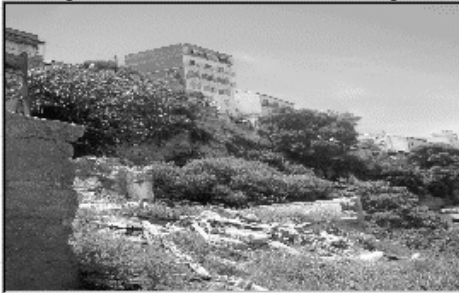
Photographie du Site

Localisation du site			
No.	19	Xcoordinates	505655
Location Name	S19	Y coordinates	4066775
Commune Name	EL ANNASSERS	Longitude	
Checking date	2006/06/07	Latitude

>X	A	Slope evaluation with seismic intensity
IX-X	A	
VIII-IX	A	
VII-VIII	B	
VI-VII	C

Slope conditions		
Slope Height	50m <=H	10
Slope angle	45 <= a < 60	4
Overhang	No	0
Evaluation4	open crack/Boulder in slo	10
Evaluation5	more than 0.5m	3
Evaluation6	Water seepage	2
Evaluation7	None	0
Evaluation8	29

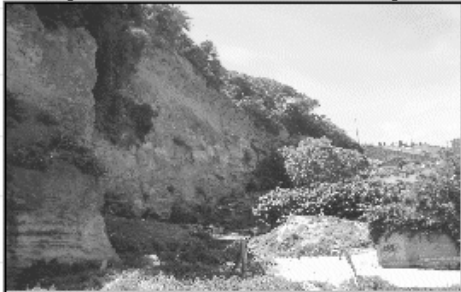
Photographie du Site

Localisation du site			
No.	20	Xcoordinates	505730
Location Name	S20	Y coordinates	4066740
Commune Name	A EL ANNASSER	Longitude	
Checking date	2006/06/07	Latitude

>X	A	Slope evaluation with seismic intensity
IX-X	A	
VIII-IX	A	
VII-VIII	B	
VI-VII	C

Slope conditions		
Slope Height	50m <= H	10
Slope angle	60 <= a	7
Overhang	No	0
Evaluation4	ure rich/Highly weathe	6
Evaluation5	more than 0.5m	3
Evaluation6	Water seepage	2
Evaluation7	None	0
Evaluation8	28

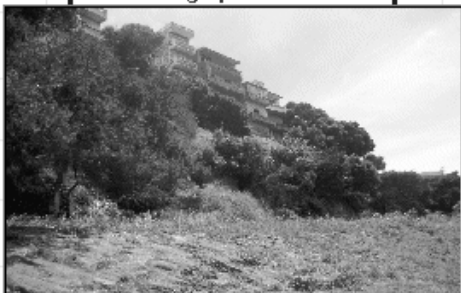
Photographie du Site

Localisation du site			
No.	21	Xcoordinates	507520
Location Name	S21	Y coordinates	4065235
Commune Name	KOUBA	Longitude	
Checking date	2006/06/07	Latitude

>X	A	Slope evaluation with seismic intensity
IX-X	A	
VIII-IX	A	
VII-VIII	B	
VI-VII	C

Slope conditions		
Slope Height	10m <= H < 30 m	7
Slope angle	60 <= a	7
Overhang	Yes	4
Evaluation4	ure rich/Highly weathe	6
Evaluation5	more than 0.5m	3
Evaluation6	No Water seepage/Dry	0
Evaluation7	None	0
Evaluation8	27

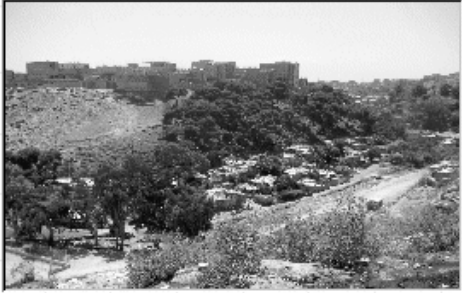
Photographie du Site

Localisation du site			
No.	22	Xcoordinates	509395
Location Name	S22	Y coordinates	4064485
Commune Name	EL MAGHARIA	Longitude	
Checking date	2006/06/11	Latitude

>X	A	Slope evaluation with seismic intensity
IX-X	A	
VIII-IX	B	
VII-VIII	C	
VI-VII	C

Slope conditions		
Slope Height	10m <= H < 30m	7
Slope angle	45 <= a < 60	4
Overhang	No	0
Evaluation4	ure rich/Highly weathe	6
Evaluation5	more than 0.5m	3
Evaluation6	No Water seepage/Dry	0
Evaluation7	None	0
Evaluation8	20

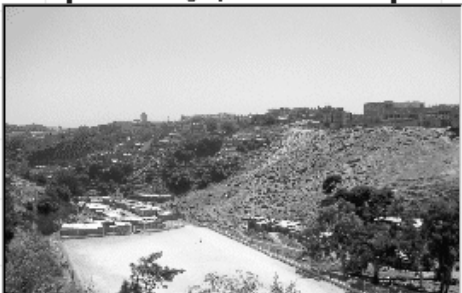
Photographie du Site

Localisation du site			
No.	23	Xcoordinates	509630
Location Name	S23	Y coordinates	4064440
Commune Name	EL MAGHARIA	Longitude	
Checking date	2006/06/11	Latitude

>X	A	Slope evaluation with seismic intensity
IX-X	A	
VIII-IX	B	
VII-VIII	C	
VI-VII	C

Slope conditions		
Slope Height	30m <= H < 50m	8
Slope angle	45 <= a < 60	4
Overhang	No	0
Evaluation4	ure rich/Highly weathe	6
Evaluation5	more than 0.5m	3
Evaluation6	No Water seepage/Dry	0
Evaluation7	None	0
Evaluation8	21

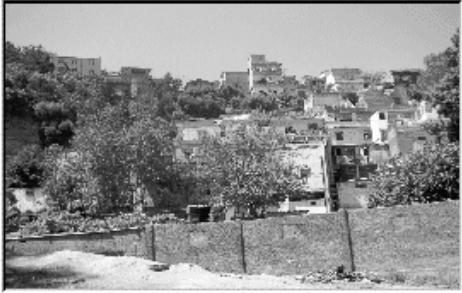
Photographie du Site

Localisation du site			
No.	24	Xcoordinates	509750
Location Name	S24	Y coordinates	4064325
Commune Name	BACHDJARAH	Longitude	
Checking date	2006/06/11	Latitude

Slope evaluation with seismic intensity	
>X	A
IX-X	A
VIII-IX	A
VII-VIII	B
VI-VII	C

Slope conditions		
Slope Height	10m <= H < 30 m	7
Slope angle	60 <= a	7
Overhang	Yes	4
Evaluation4	soil rich/Highly weathered	6
Evaluation5	more than 0.5m	3
Evaluation6	Water seepage	2
Evaluation7	None	0
Evaluation8	29

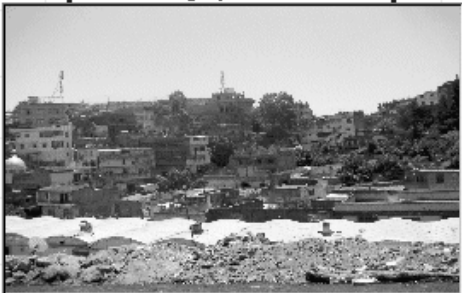
Photographie du Site

Localisation du site			
No.	25	Xcoordinates	509960
Location Name	S25	Y coordinates	4064210
Commune Name	BACHDJARAH	Longitude	
Checking date	2006/06/11	Latitude

Slope evaluation with seismic intensity	
>X	A
IX-X	B
VIII-IX	C
VII-VIII	C
VI-VII	C

Slope conditions		
Slope Height	10m <= H < 30 m	7
Slope angle	a < 45	1
Overhang	No	0
Evaluation4	weathered rock/Cohesive	0
Evaluation5	more than 0.5m	3
Evaluation6	No Water seepage/Dry	0
Evaluation7	None	0
Evaluation8	11
