## **Appendix 5. Other Relevant Data**

THE TECHNICAL NOTES ON THE BASIC DESIGN STUDY(I)  
ON THE PROJECT FOR THE IMPROVEMENT OF  
LIVINGSTONE CITY ROADS IN THE REPUBLIC OF ZAMBIA

**Technical Notes**  
**on the Basic Design Study**  
**on the Project for Improvement of Livingstone City Roads**  
**in the Republic of Zambia**

**Appendix 5-5. Technical Documentation (Results of the Study on the Drainage Structures)**

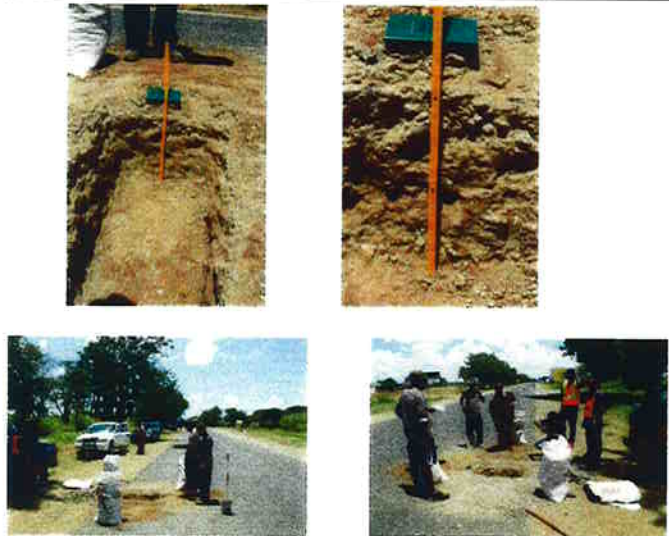
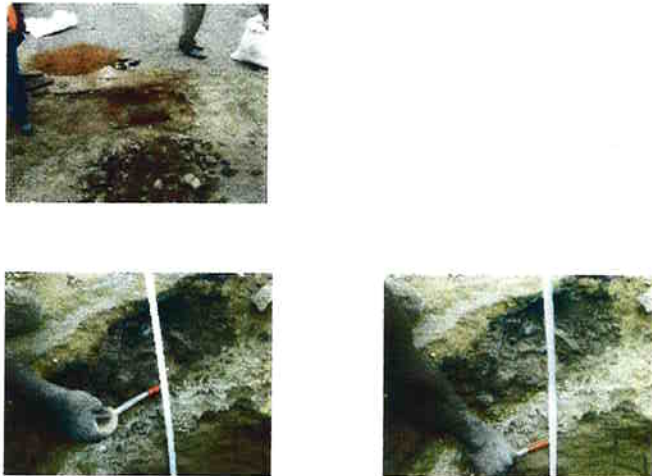
TP1 0-193 DCP1 EC Section						TP2 0+830 DCP6					
Depth (m)	Layer	Material	Thickness (m)	Converted CBR by DCP (%)	CBR (Laboratory) (%)	Depth (m)	Layer	Material	Thickness (m)	Converted CBR by DCP (%)	CBR (Laboratory) (%)
0.000						0.000					
0.020	Wearing	Bituminous Chipping	0.020			0.040	Wearing	Bituminous Chipping	0.040		
0.170	Base	Dense gravel (Stabilised)	0.150			0.140	Base	Curushed Stone	0.100		
0.295	Subbase	Dense gravel (Not Stabilised)	0.125			0.270	Subbase	Dense Gravel	0.130		
0.425	Subgrade	Sandy Clay soil	0.130			0.470	Subgrade	Sandy Soil	0.200		
1.000						1.000

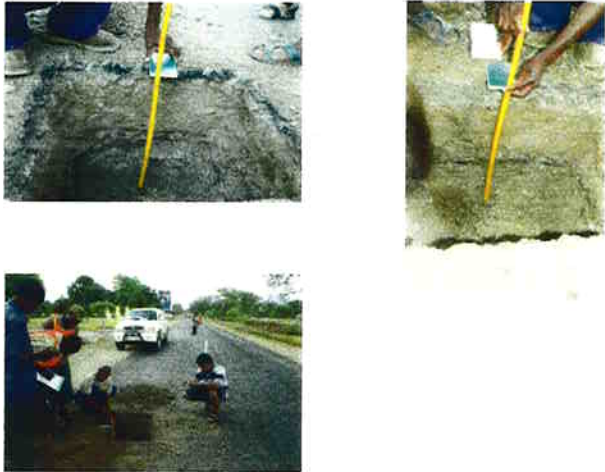
TP5 3+490 DCP19 in front of Ocean Basket						TP6 4+803 DCP26 Before SPAR					
Depth (m)	Layer	Material	Thickness (m)	Converted CBR by DCP (%)	CBR (Laboratory) (%)	Depth (m)	Layer	Material	Thickness (m)	Converted CBR by DCP (%)	CBR (Laboratory) (%)
0.000	Wearing	Bituminous Chipping	0.040			0.000	Wearing	Bituminous Chipping	0.050		
0.040	Base	Crushed Stone	0.140			0.050	Base	Crushed Stone	0.150		
0.180	Subbase	Crushed Stone (Not Stabilised)	0.155			0.200	Subbase	Crushed Stone	0.150		
0.335	Subgrade	Dense Sandy Clay Soil	0.150			0.350	Subbase	Crushed Stone	0.150		
0.650						0.375	Wearing	Bituminous Chipping	0.025		
						0.575	Subgrade	Dense Gravel	0.200		
1.000						1.000

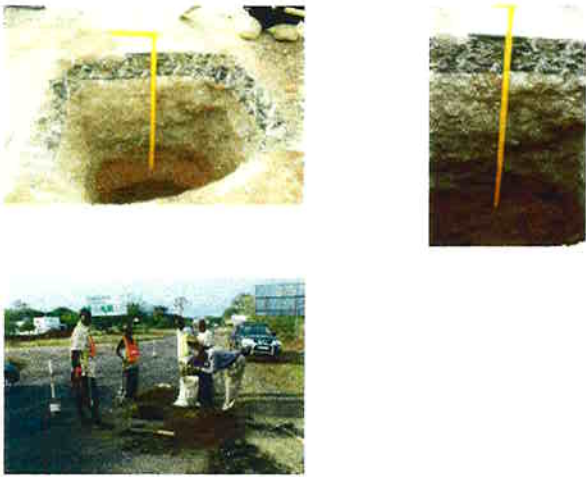
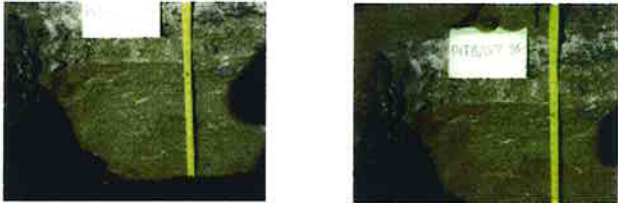
TP7 5+798 DCP31 Near Sichanga Road						TP8 6+798 DCP36					
Depth (m)	Layer	Material	Thickness (m)	Converted CBR by DCP (%)	CBR (Laboratory) (%)	Depth (m)	Layer	Material	Thickness (m)	Converted CBR by DCP (%)	CBR (Laboratory) (%)
0.000						0.000					
0.100	Wearing	Bituminous Chipping	0.100			0.400	Wearing	Bituminous Chipping	0.040		
0.200	Base	Crushed Stone (Stabilised)	0.100			0.145	Base	Crushed Stone	0.105		
0.475	Subbase	Crushed Stone (Not Stabilised)	0.275			0.422	Subbase	Crushed Stone with Sand	0.277		
0.675	Subgrade	Dense Sandy Clay Soil	0.200			0.449	Wearing	Bituminous Chipping	0.025		
						0.520	Subgrade	Dense Gravel	0.071		
1.000						1.000

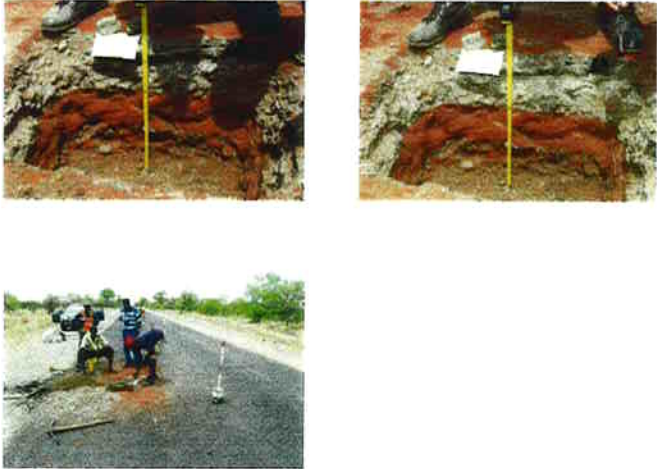
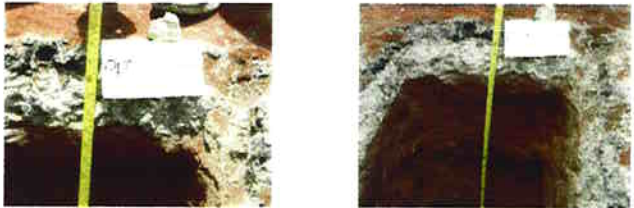
TP9 7+794 DCP41						TP10 8+798 DCP46					
Depth (m)	Layer	Material	Thickness (m)	Converted CBR by DCP (%)	CBR (Laboratory) (%)	Depth (m)	Layer	Material	Thickness (m)	Converted CBR by DCP (%)	CBR (Laboratory) (%)
0.00						0.000					
0.060	Wearing	Bituminous Chipping	0.060			0.050	Wearing	Bituminous Chipping	0.050		
0.180	Base	Crushed Stone (Stabilised)	0.120			0.130	Base	Crushed Stone (Stabilised)	0.080		
0.320	Subbase	Dense Sandy Clay Soil	0.140								
0.460	Subgrade	Crushed Stone	0.140								
						0.680					
						0.690	Wearing	Bituminous Chipping	0.010		
						0.820	Subgrade	Crushed Stone	0.130		
1.000						1.000
