THE PREPARATORY STUDY FOR
 SECTOR LOAN FOR
 DISASTER RISK MANAGEMENT

CTI Engineering International Co., Ltd.
 Nippon Koei Co., Ltd

Figure7.3
 Cagayan River Improvement Plan
 (Alternative C-3: Cut-Off Channel)

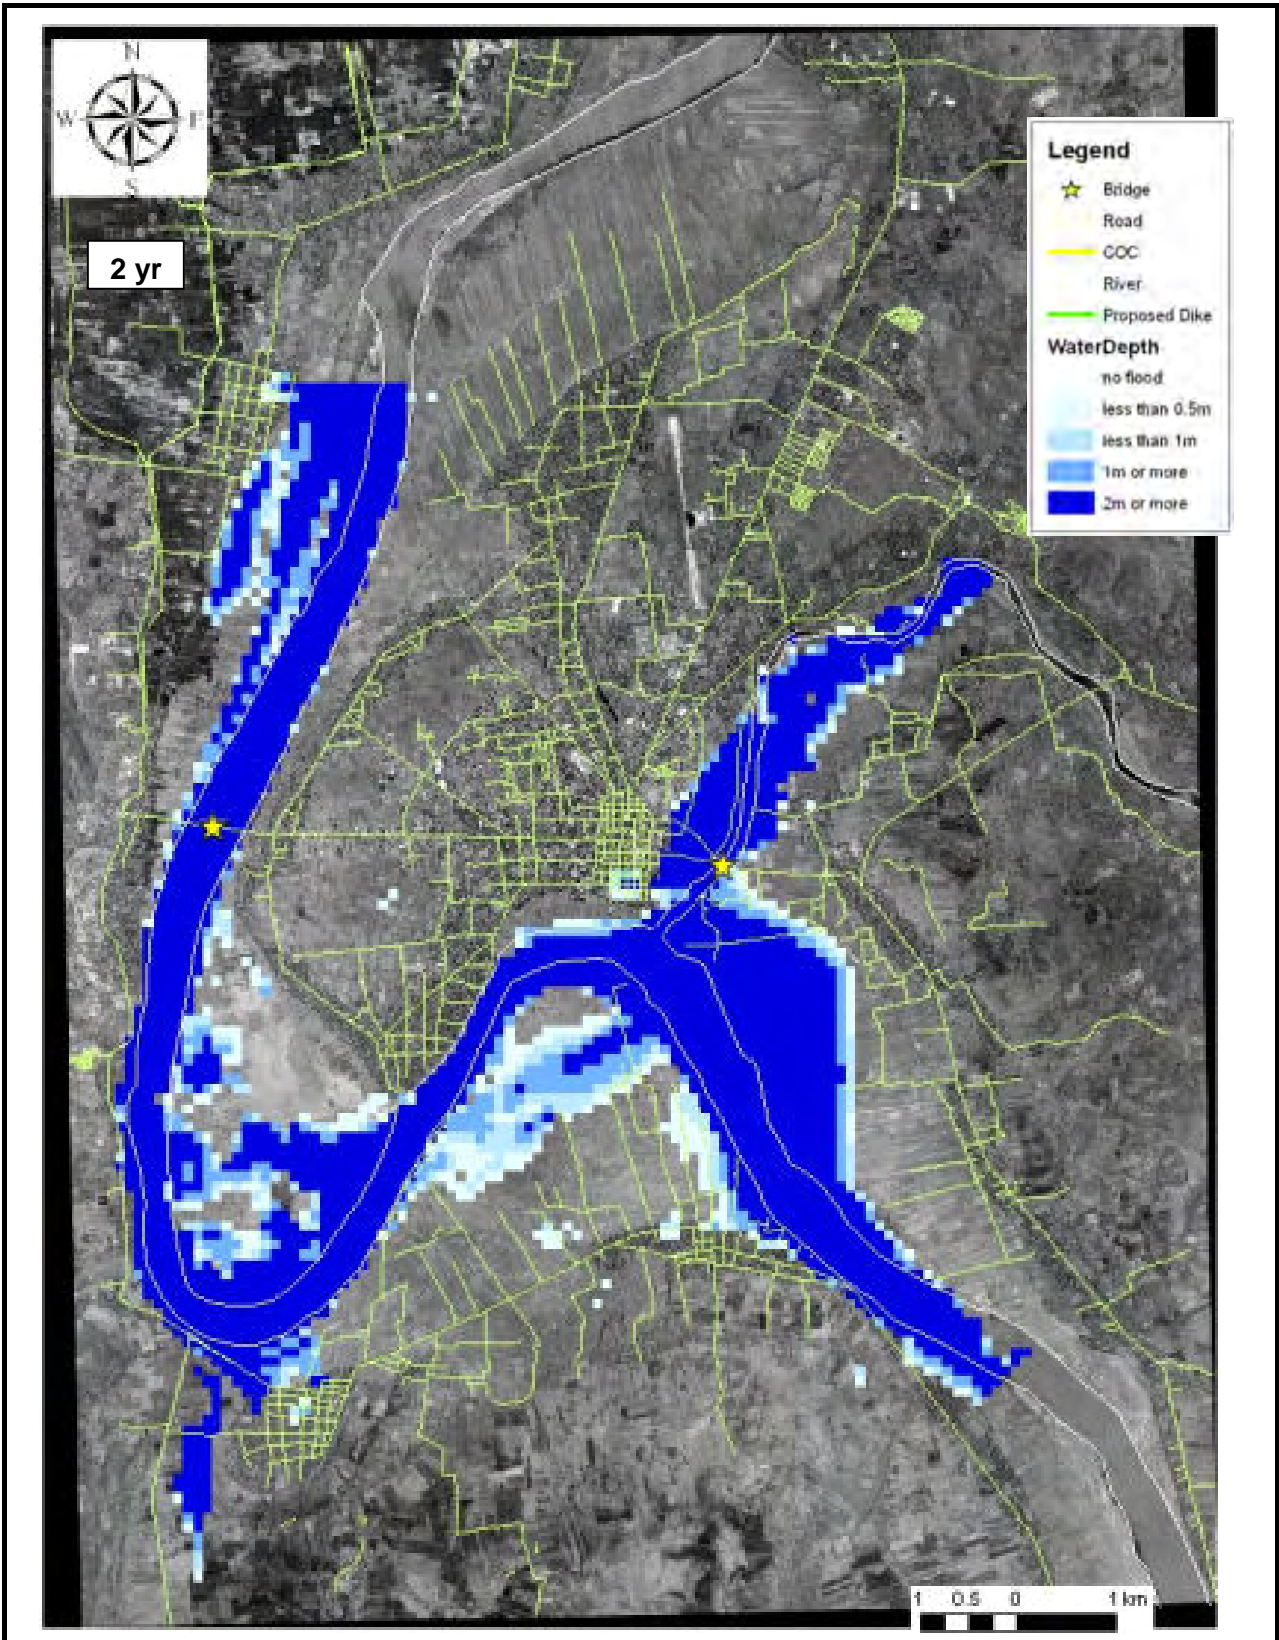
Figure 7.4 (1/6)
 Result of Flood Inundation Analysis
 (Without Project)

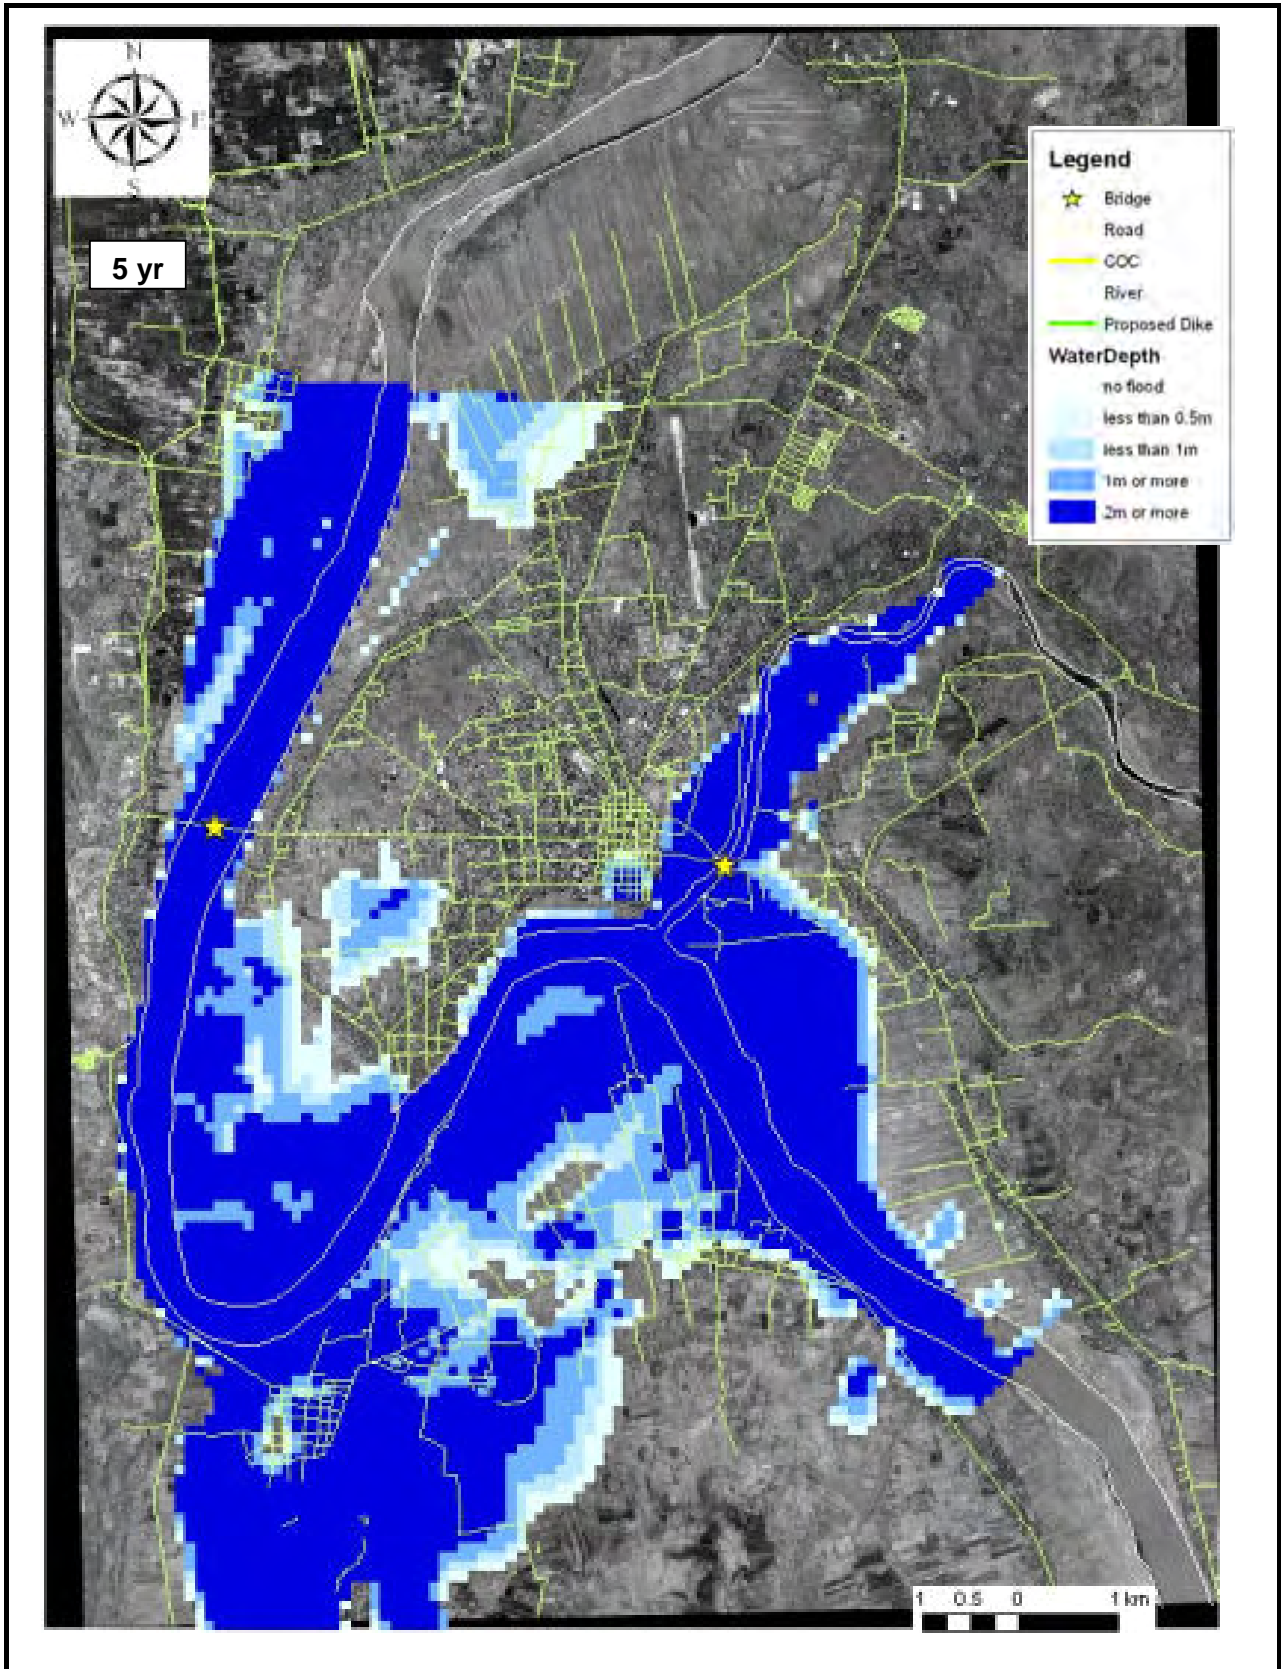
Figure 7.4 (2/6)
 Result of Flood Inundation Analysis
 (Without Project)

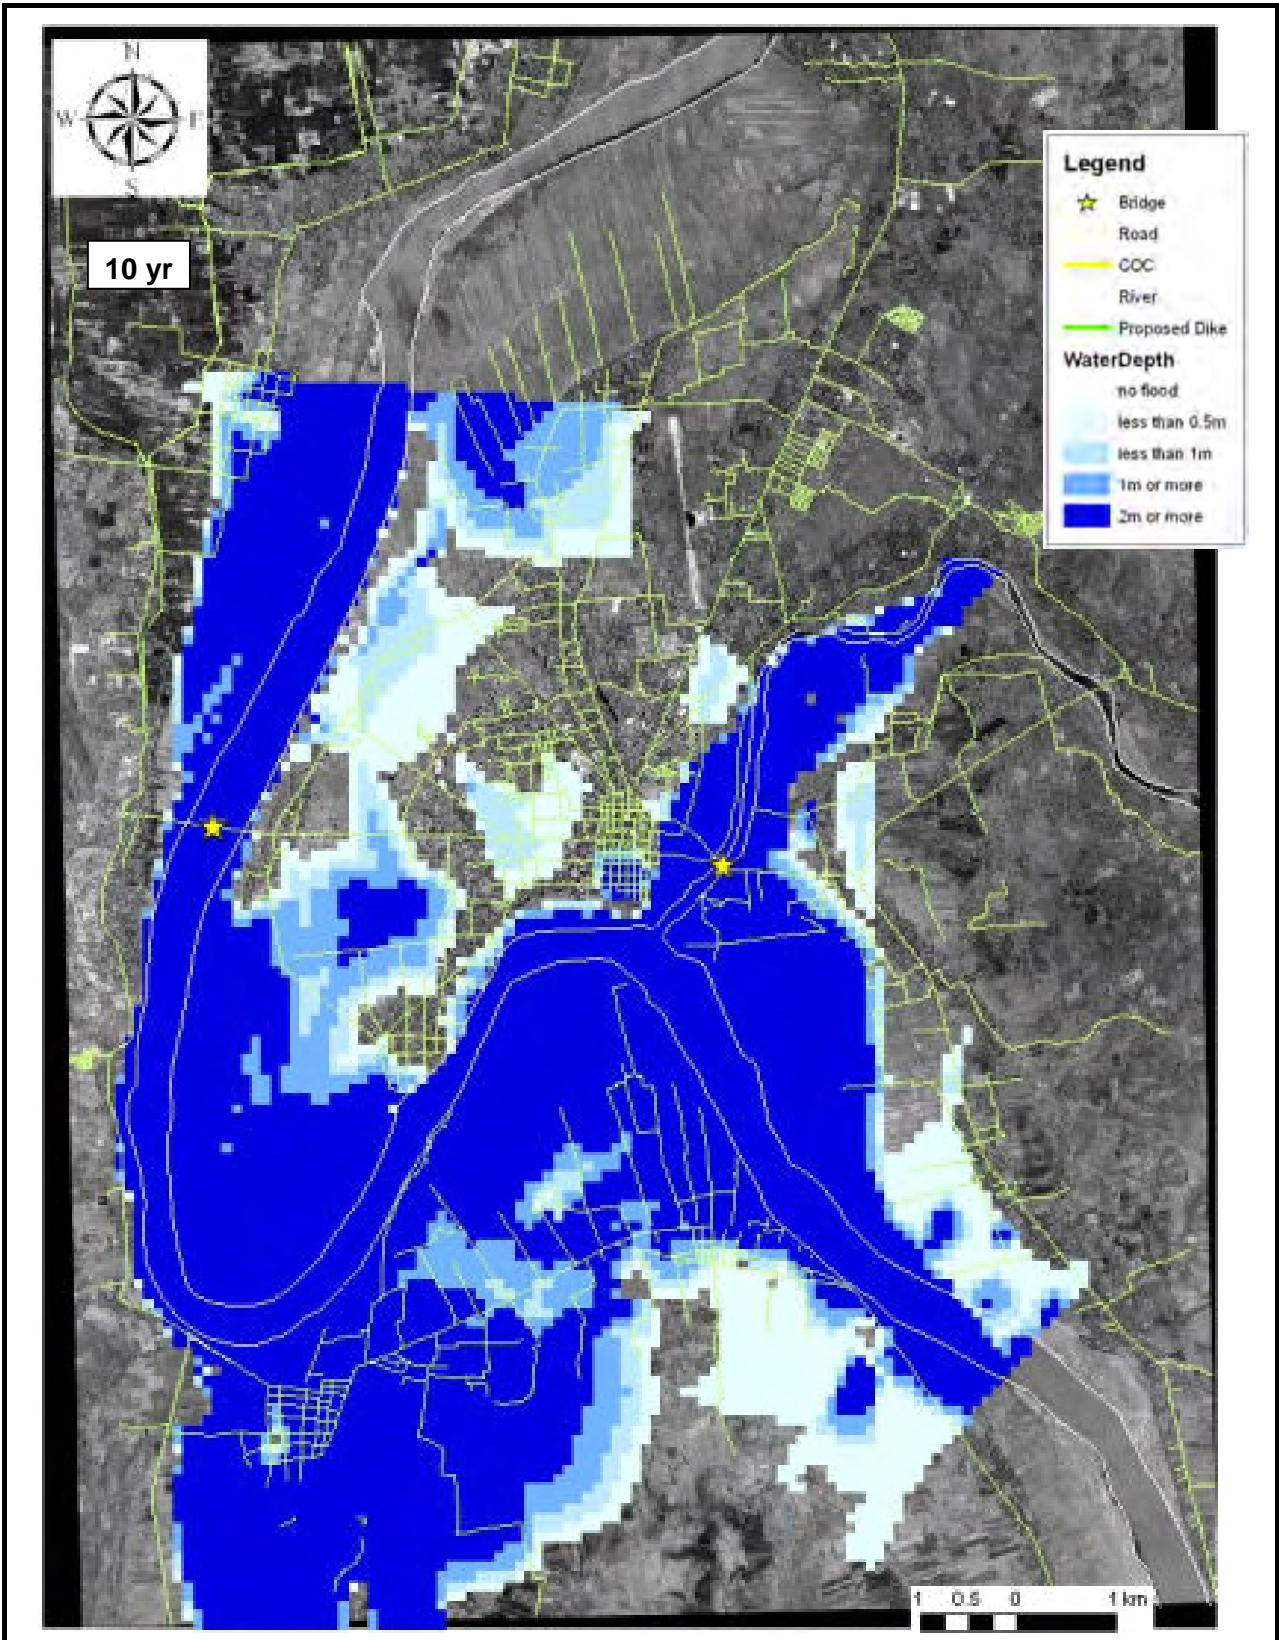
Figure 7.4 (3/6)
 Result of Flood Inundation Analysis
 (Without Project)

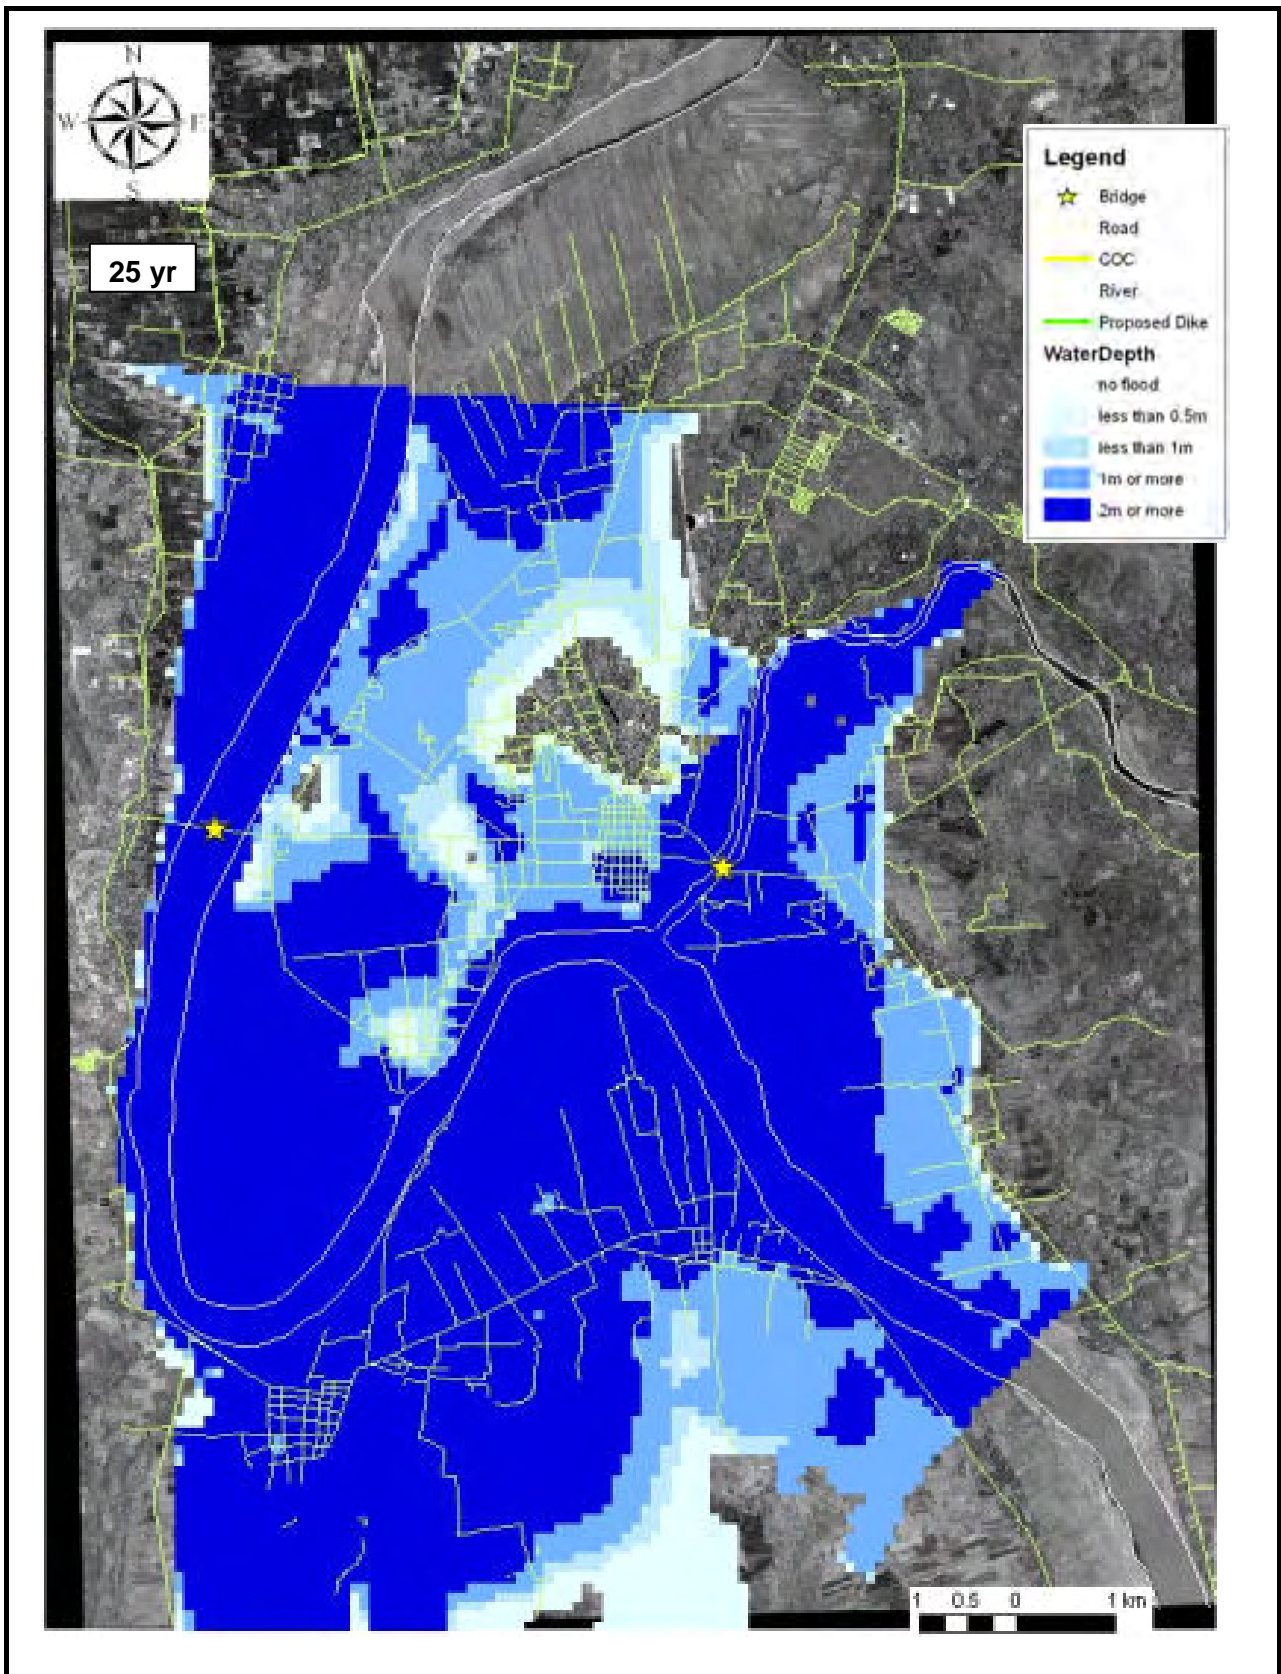
Figure 7.4 (4/6)
 Result of Flood Inundation Analysis
 (Without Project)

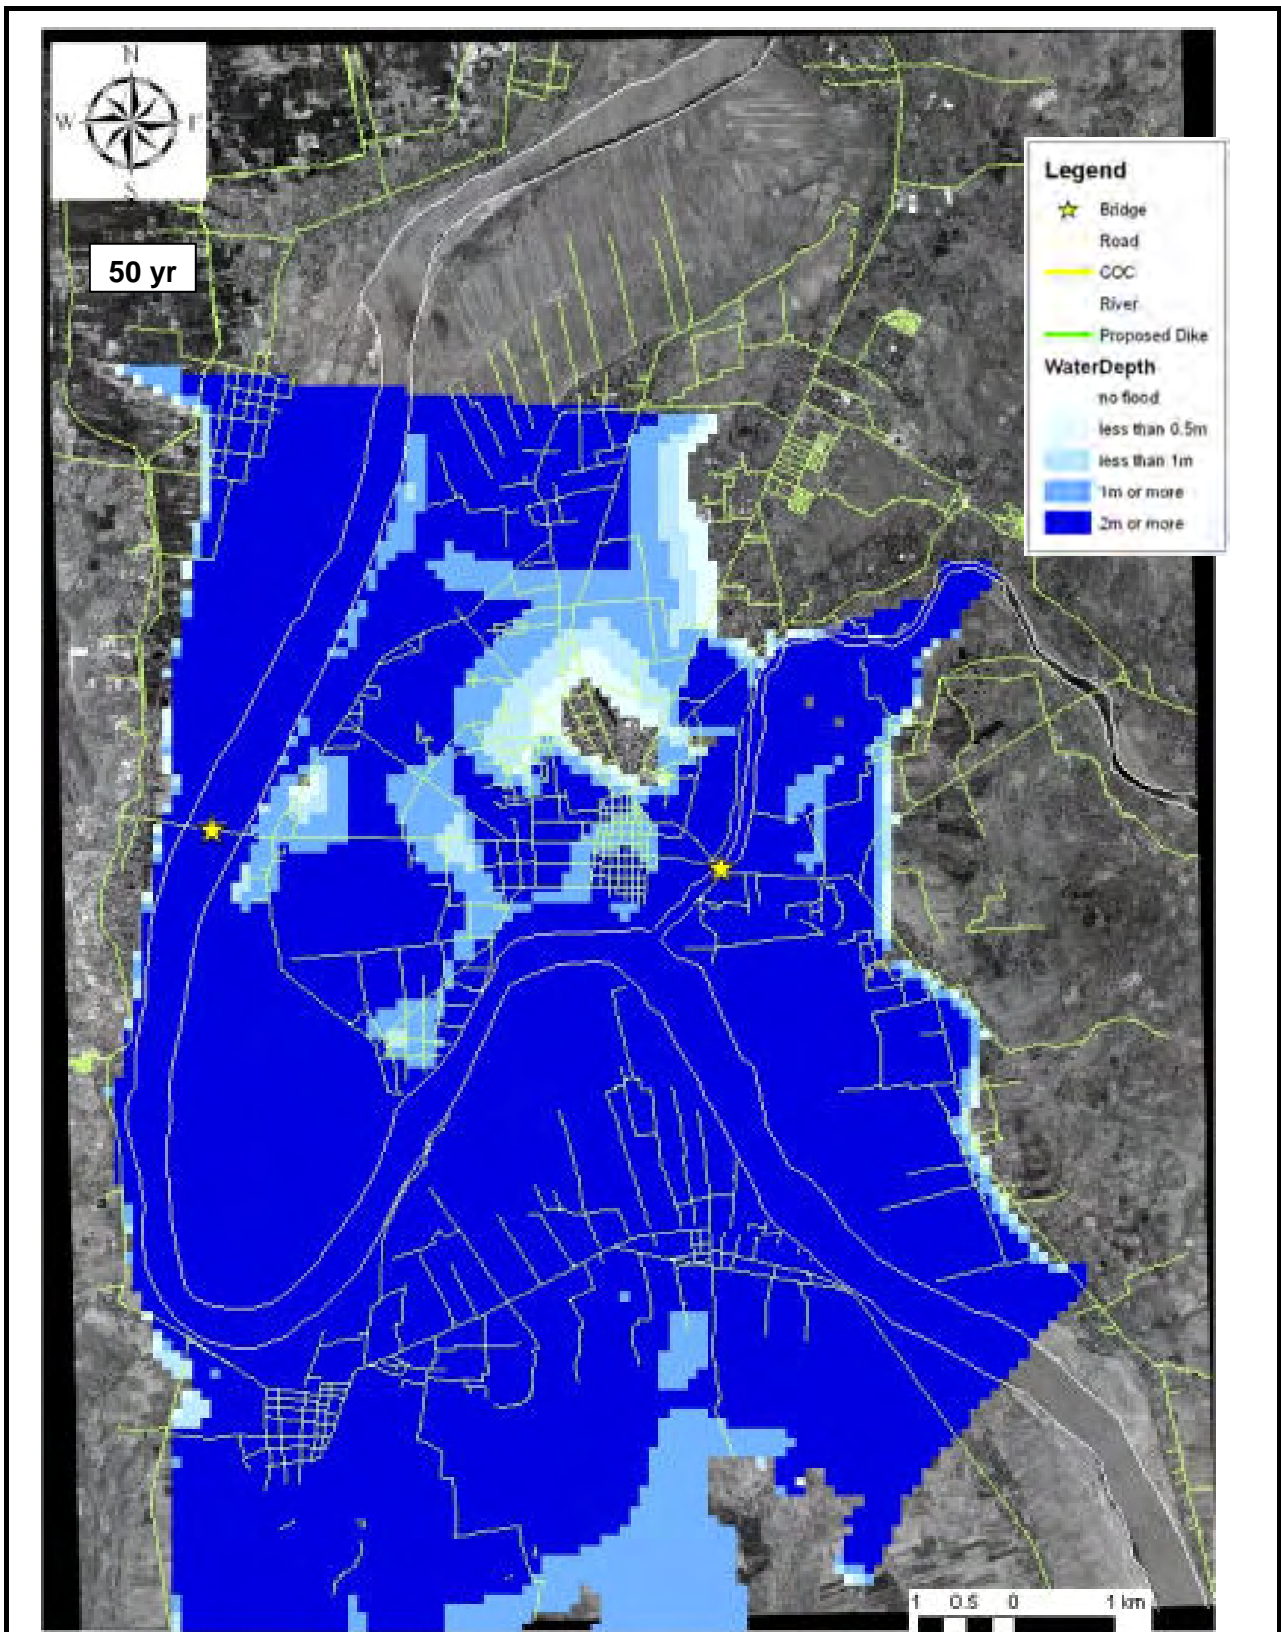
Figure 7.4 (5/6)
 Result of Flood Inundation Analysis
 (Without Project)

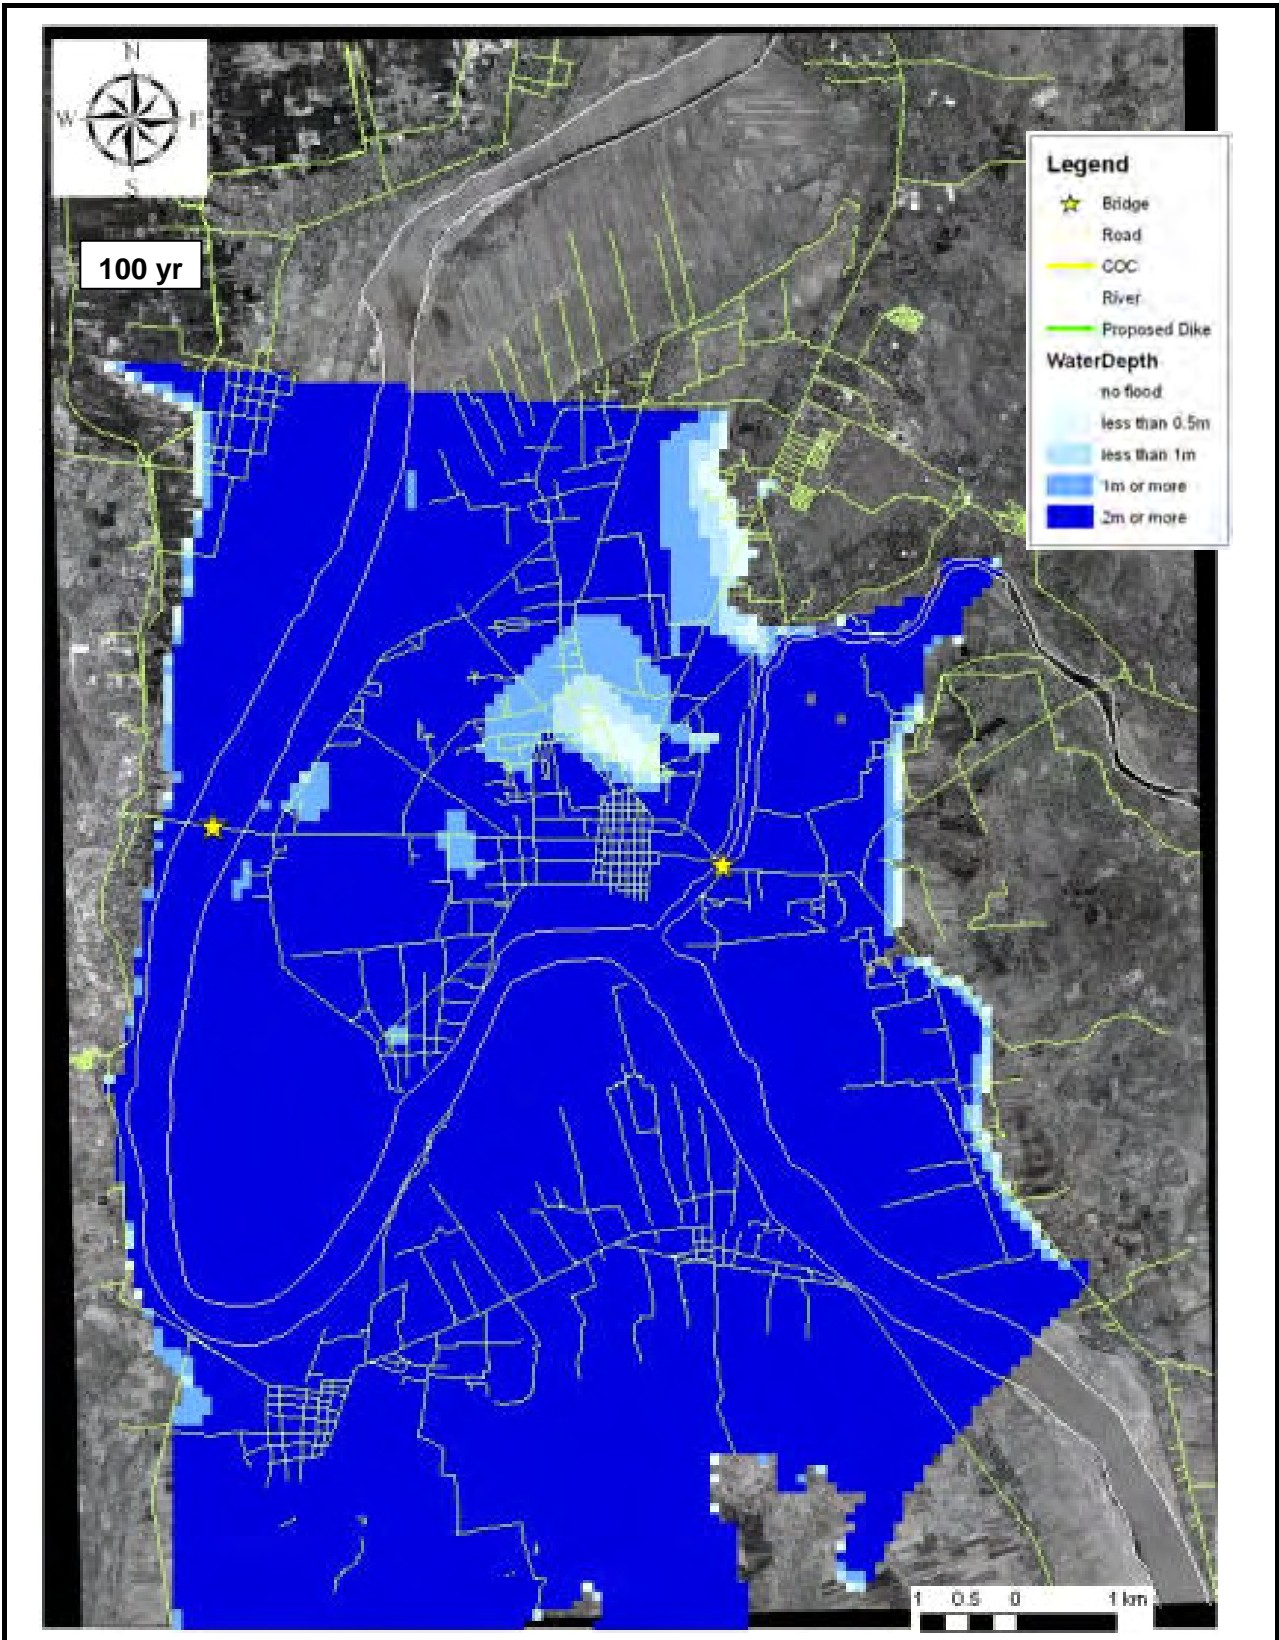
Figure 7.4 (6/6)
 Result of Flood Inundation Analysis
 (Without Project)

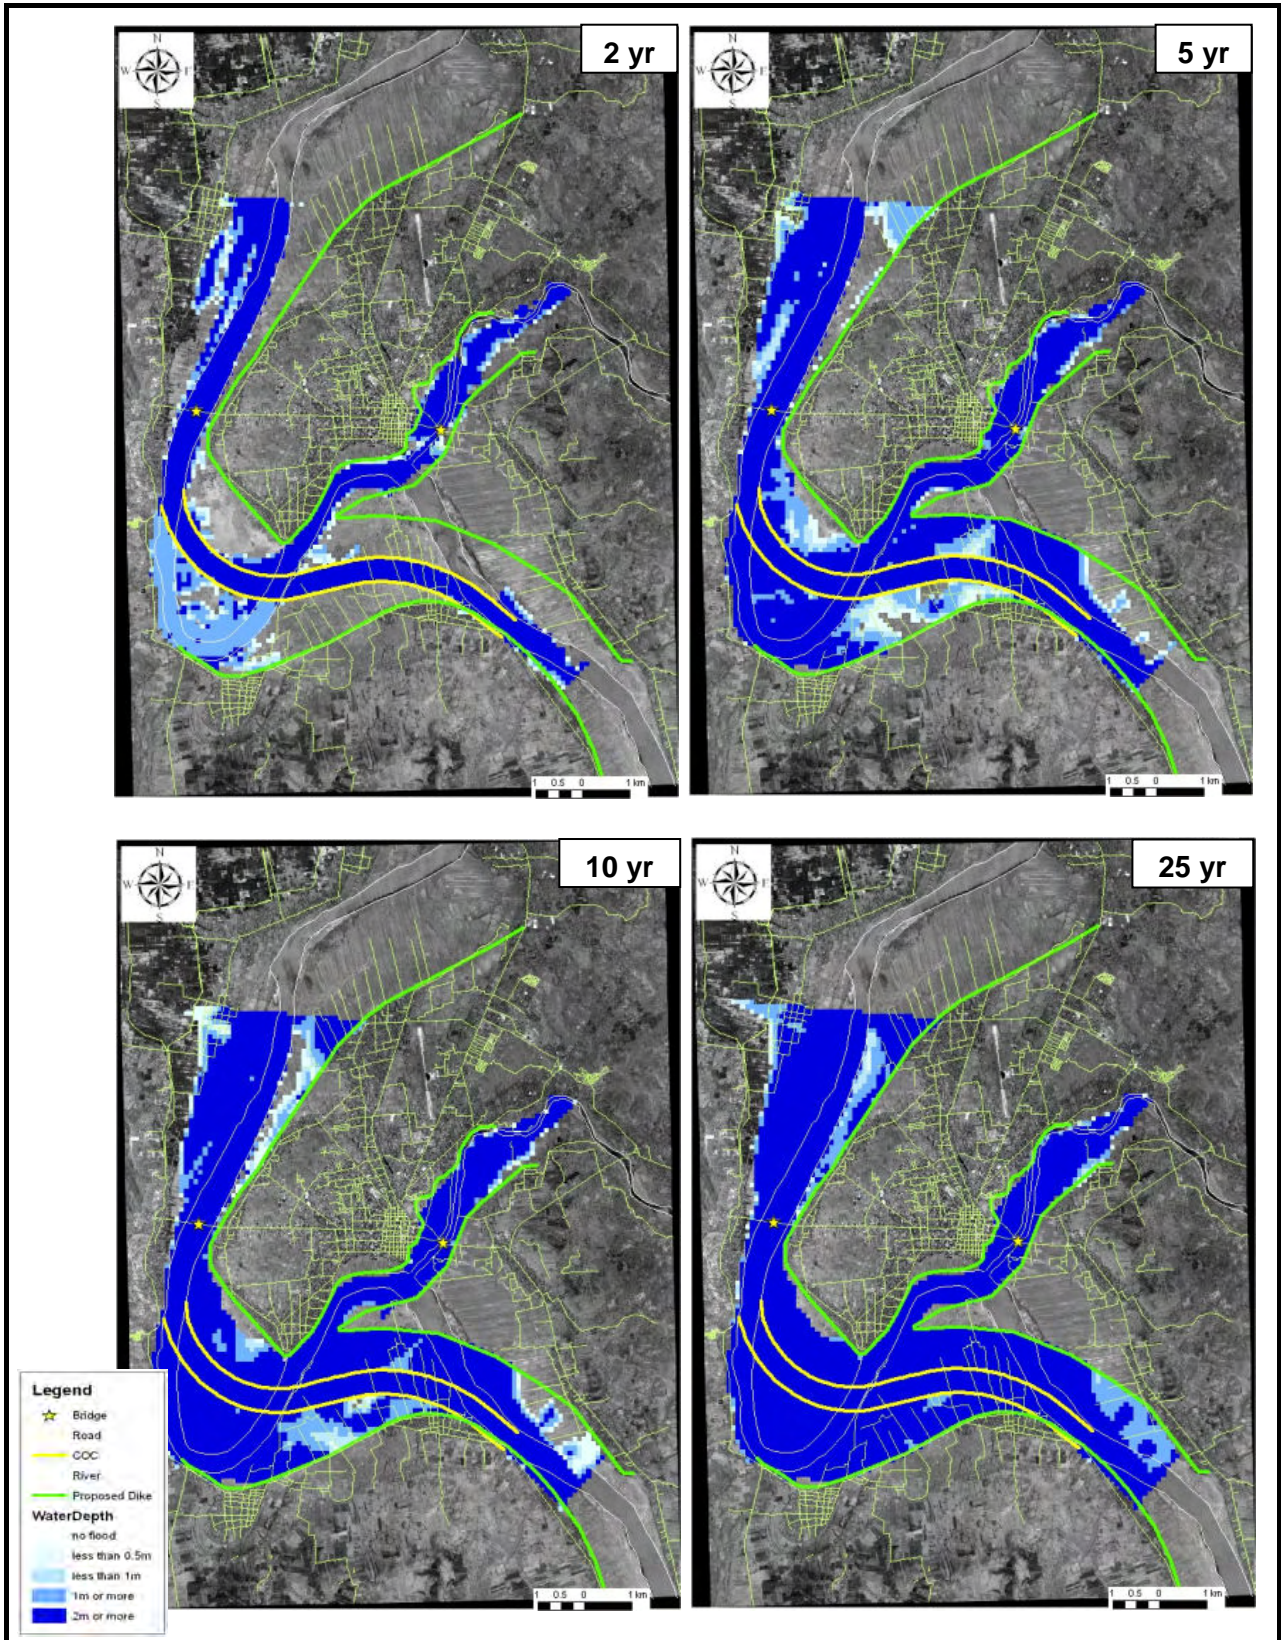
Figure 7.5
 Result of Flood Inundation Analysis
 (With Alt-C1)

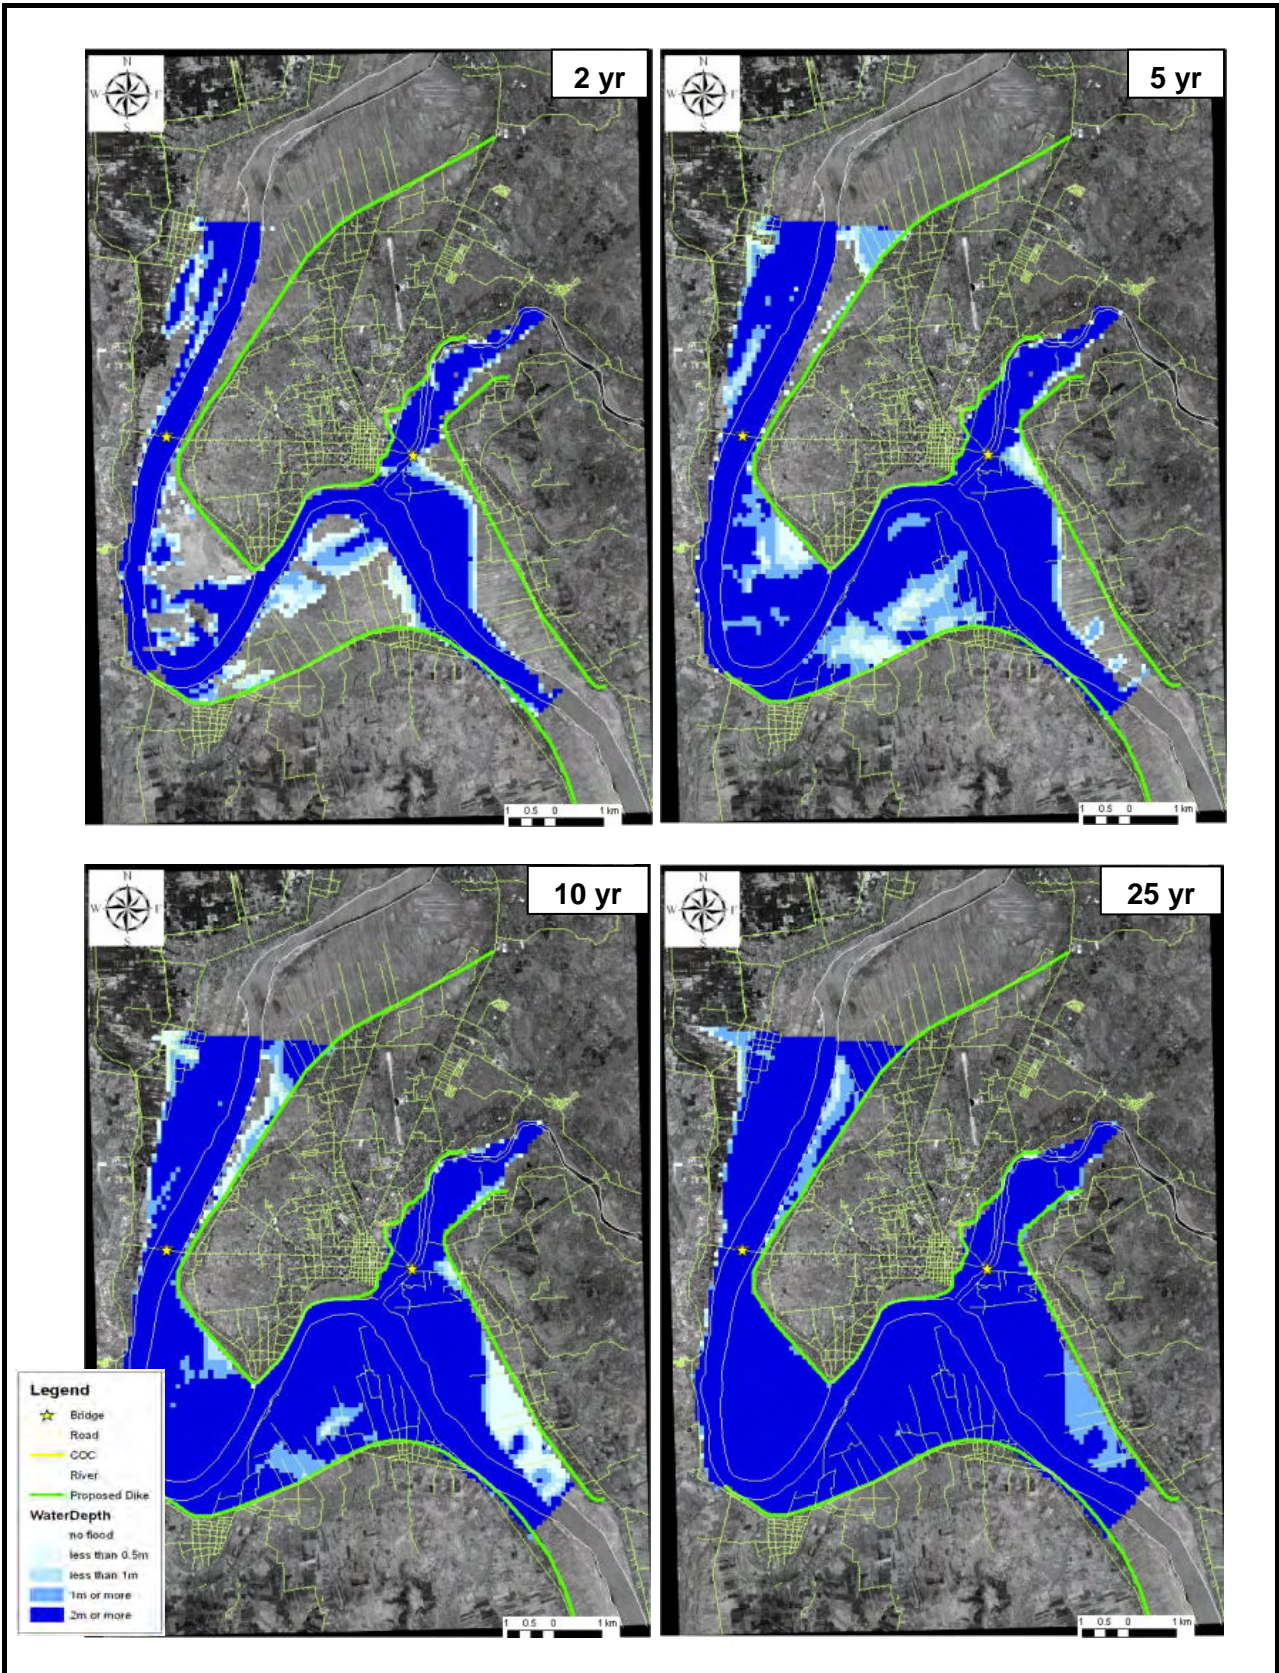
Figure 7.6
 Result of Flood Inundation Analysis
 (With Alt-C2)

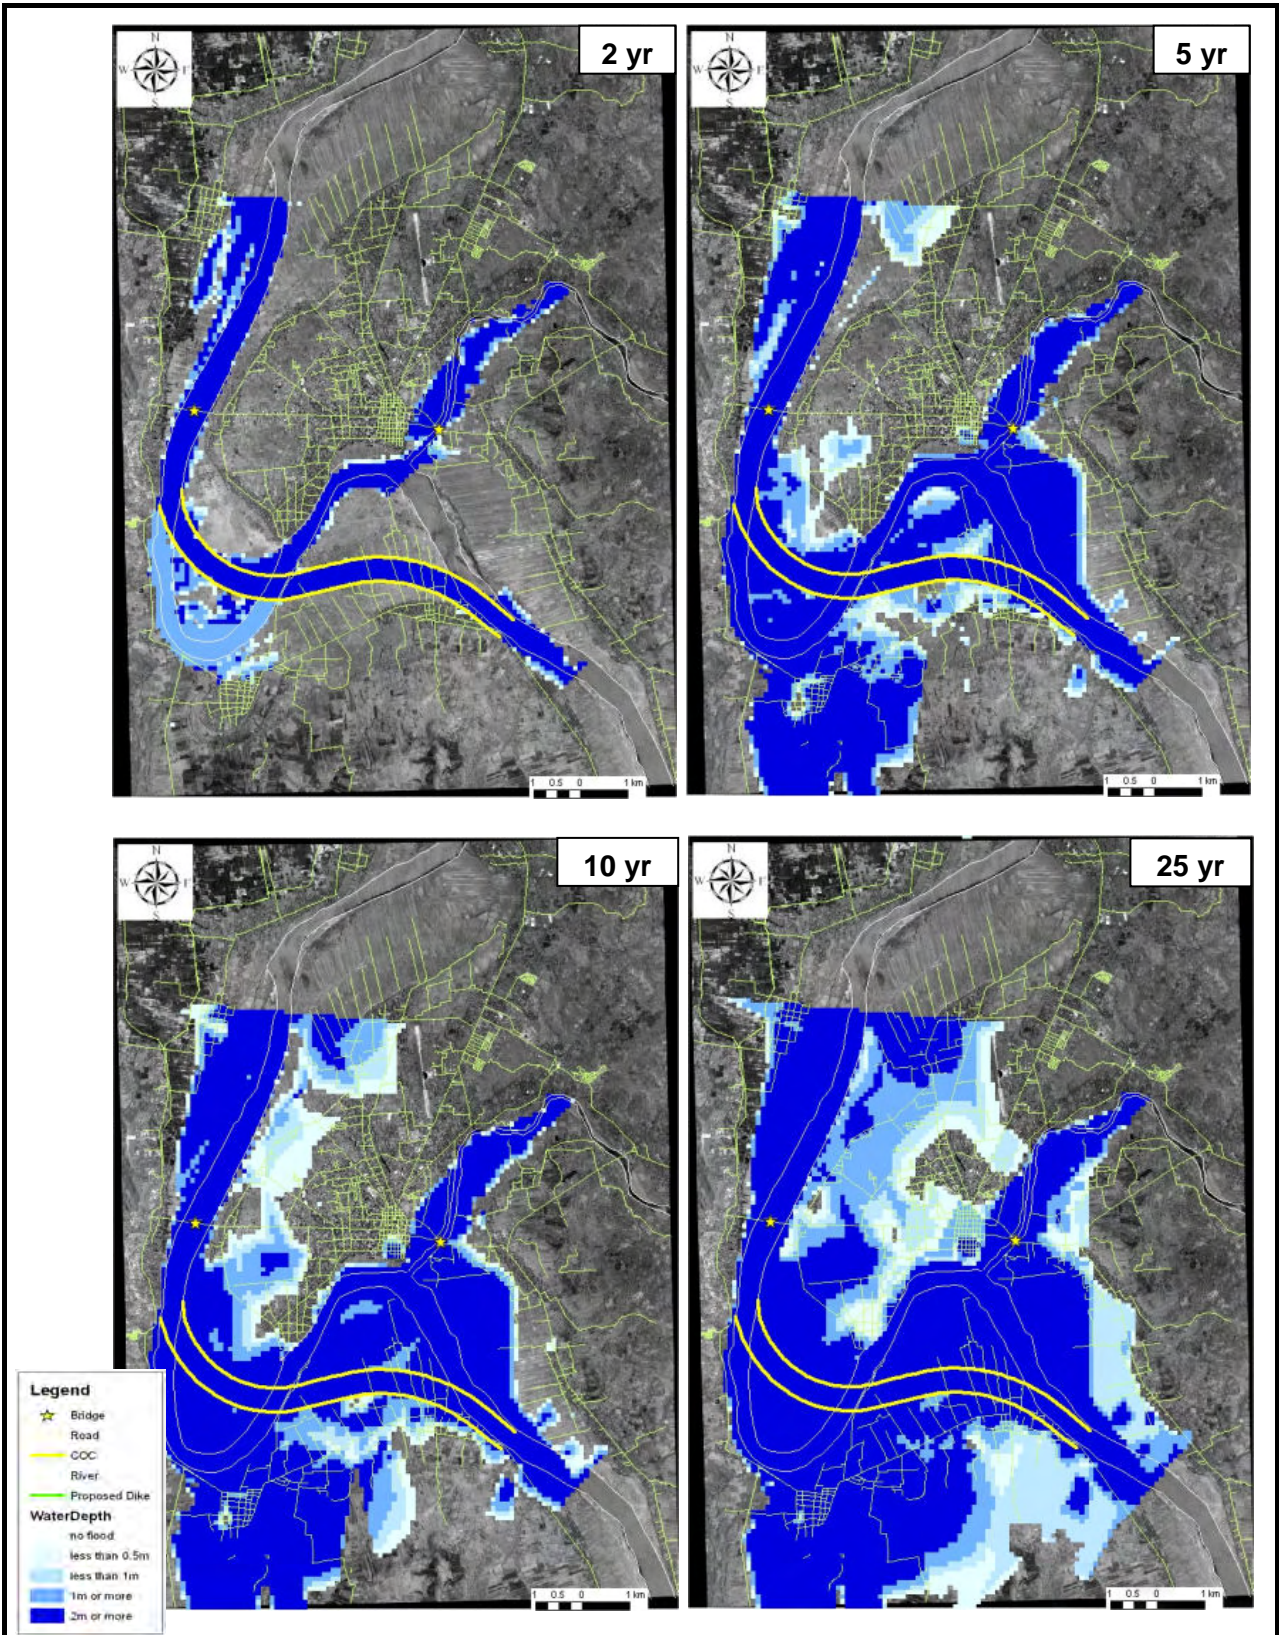
Figure 7.7
 Result of Flood Inundation Analysis
 (With Alt-C3)

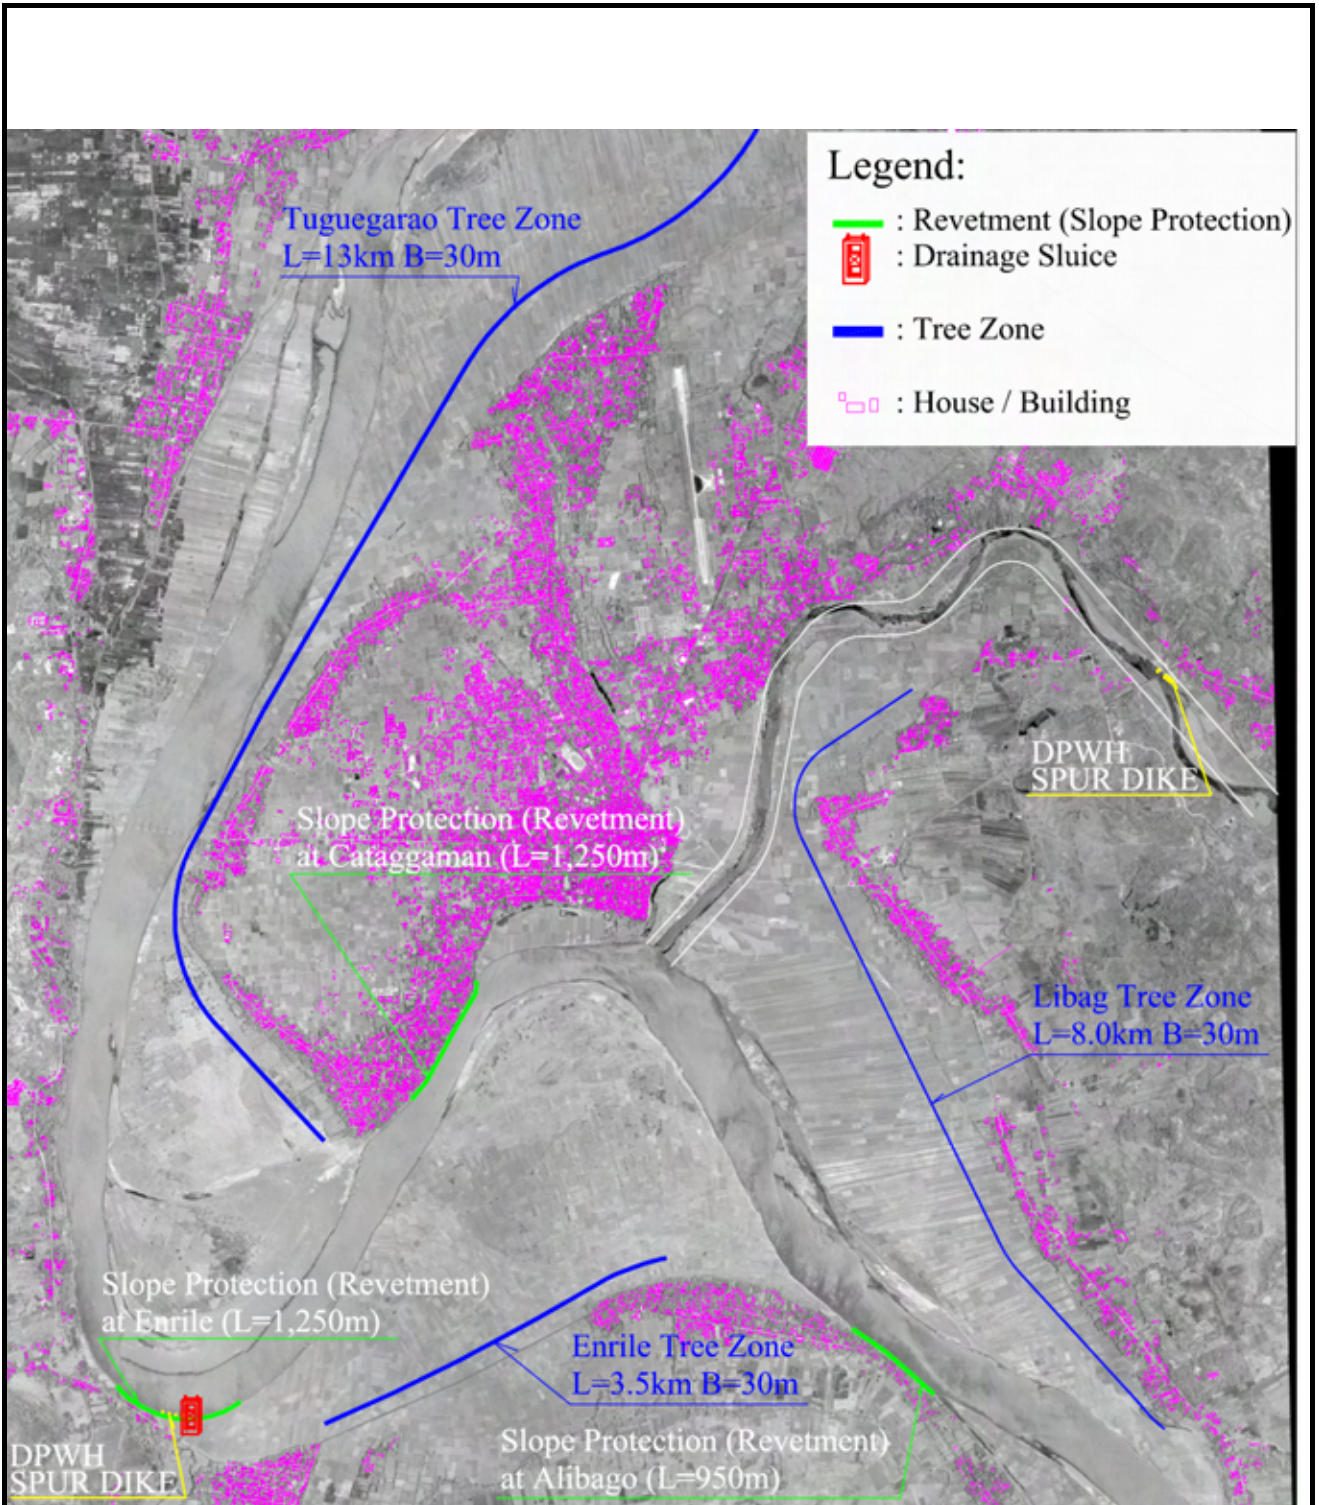
Figure 7.8
Cagayan River Improvement Plan
(Location of Three (3) Proposed Revetment
Construction Sites)
