# Ex-Post Evaluation Report of Grant Aid Projects 2009 (Mozambique)

## Ex-Post Evaluation of Japanese Grant Aid Project

“The Project for Groundwater Development for Rural Water Supply in Zambezia Province(1)(2)(3)”

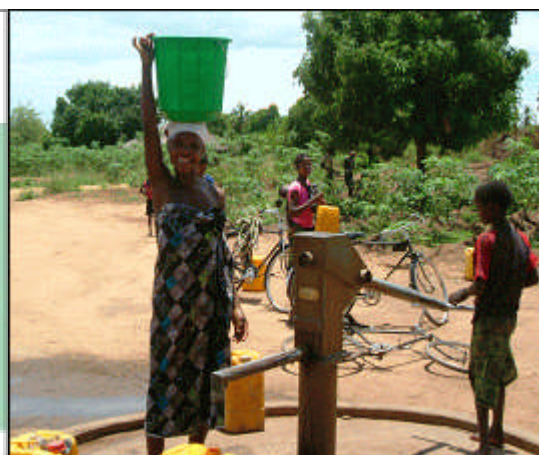
A woman using a deep well

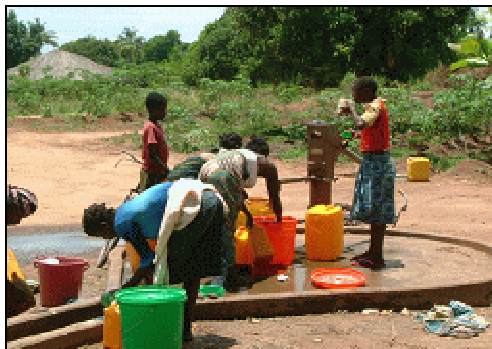
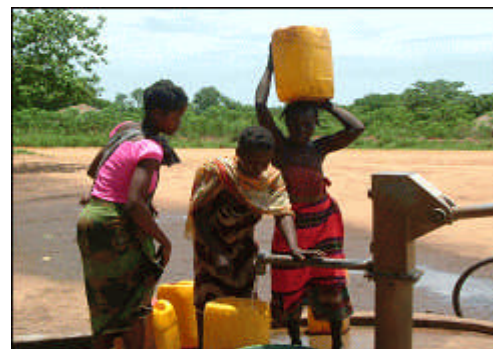
According to the beneficiary survey<sup>6</sup> that was conducted during the ex-post evaluation study, it was found that 94 households out of 100 were using deep wells constructed by the project and that six households were not using them because of the long distance from their houses to the deep wells. It was also found that of the 94 households that were using deep wells, 88 (94%) were satisfied with the water volume, in comparison to 74 satisfied households (79%) before the project. 92 households (98%) were satisfied with the water quality, in comparison to 29 households (31%) before the project. These indicate that the project has made some great contributions to the improvement of the water volume and the water quality, respectively.

Beneficiaries using deep wells constructed by the project
