Appendix-3

Reconnaissance Survey of Klongs

Appendix-5

Examination of Existing Interceptor Chamber

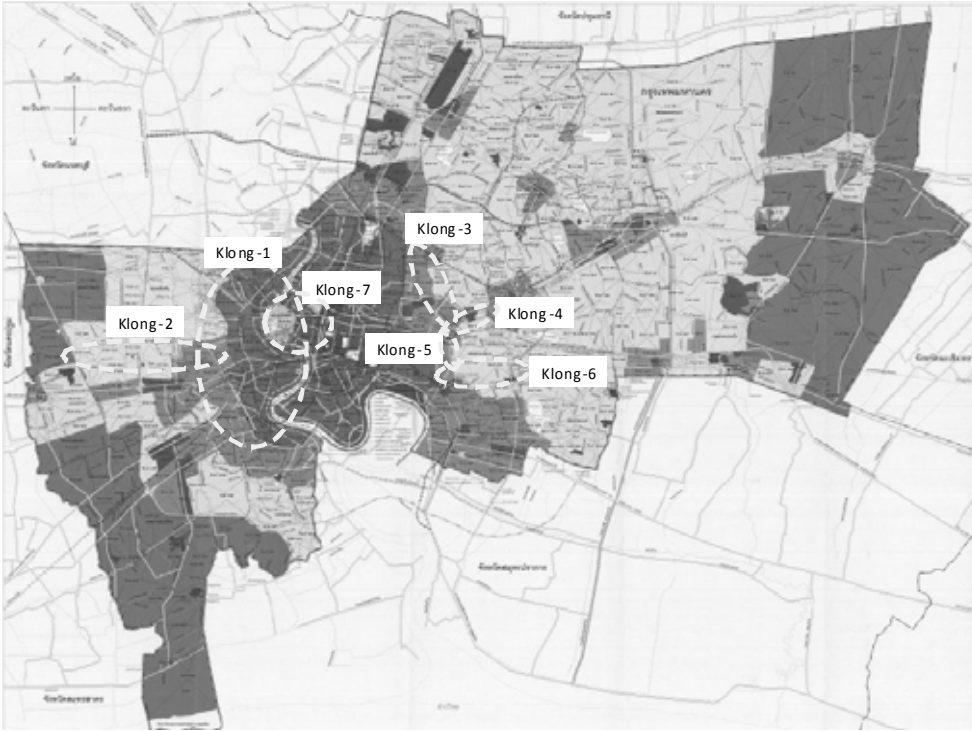
Figure A3.1 Location of Selected Klongs for the Field Survey

Reconnaissance survey of klongs in the Study Area by a small craft was carried out twice on April 12 (Thon Buri area) and on April 20, 2010 (Bangkok area). The klongs for the field survey were selected from main klongs considering land use in the klong basins. The surveyed klongs are shown in Table A3.1, and Figures A3.1 through A3.4.

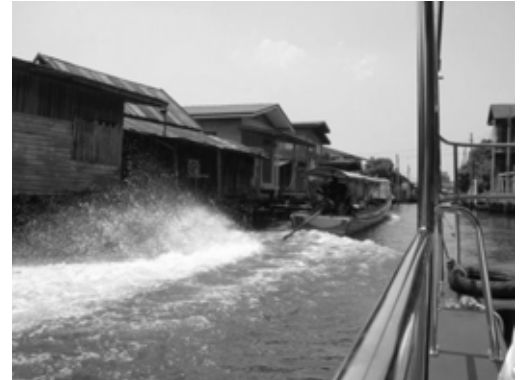
Photo A3.1 Sightseeing Boat

according to the water quality monitoring results by DDS, BOD concentrations at all the monitoring points of klongs are below 10 mg/l (as the average BOD value of 2009), and DO concentrations are also as good as 1.5 - 3.4 mg/l (as the average value of 2009). In these water bodies, many boats for the sightseeing tour around klongs are cruising (Photo A3.1). Moreover, many residences with terrace which face the klong and people enjoying cool air were able to be seen (Photo A3.2). Thus, the klong was seemed to be used as a part of life of residents and the tourist industry utilizes klongs as an important resource. There is also little quantity of the garbage (solid waste) which is floating on the surface, although the surrounding areas have been highly urbanized. The reason for this is probably because such use is performed. The field survey using a boat has also enabled us to locate the pollution sources of partially polluted water bodies easily. These are drainage pipes and small tributary klongs from which wastewater (black-gray water) is flowing. Since the water pollution situation of these klongs is alleviated by the influence of Chao Phraya River as mentioned above, sewage smell and putrid odor were not felt.

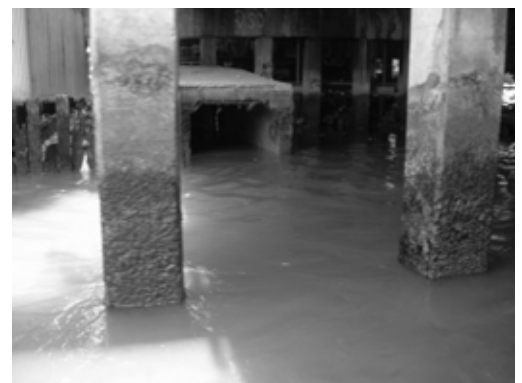
Photo A3.3 Drain Culvert

On the other hand, probably because it is influenced by the tidal effects of Chao Phraya River, the water level of klong is high, and the margin (freeboard) to the ground level is not large. As a result, the bottom of the drainage pipe was located under the water surface in many cases (Photo A3.3).

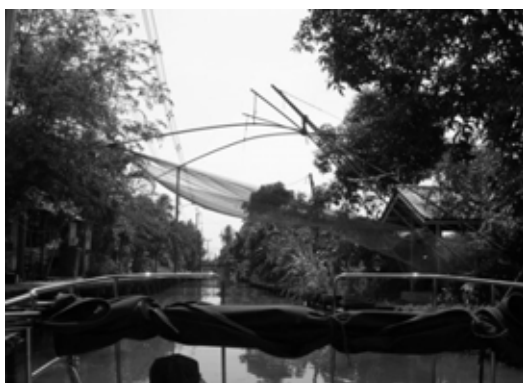
Photo A3.4 Fishing Net

There are no signs of water pollution from the result of the field survey, and the water quality situation is very good. This klong is deeply related to the life of people in neighborhood, which can be seen in various scenes, such as transportation, goods conveyance, a peddler, bathing, a children's playground, and fishery (fishing net) (Photo A3.4). Thus, it seemed that klongs linking directly to the life is maintained by people in neighborhood in good conditions, and there was almost no floating dust which was dumped. Moreover, the motion of many fishes, aquatic bird and the aquatic plant (including submerged plant) of varieties were seen, and it became clear that the biodiversity of ecosystem was also preserved soundly (Photo A.3.5).

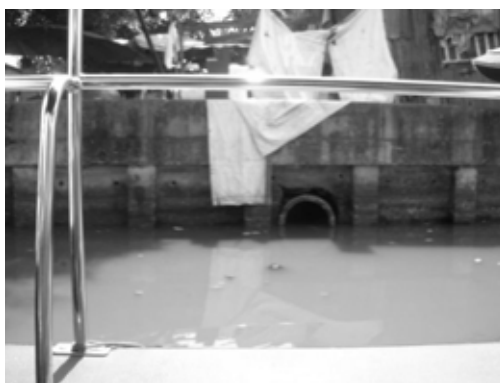
Photo A.3.6 Drainage Pipe

The water level of Klong Lard Prao at the time of the field survey was high, and flow direction could not be confirmed, and klong water seemed to be stagnated. At that time, Pra Khanong pumping station was not in operation, flap gates were pushed open by difference of water level at the pumping station, and the klong water discharged to the Chao Phraya River. As a result, bottoms of the drainage pipes were seen located under the water surface in many cases. Moreover, since the downstream part of this klong has stagnated, green algae propagate, and river water was looked green. The bad smell was felt clearly in some sections of the klong

(Photos A3.6 and A3.7).

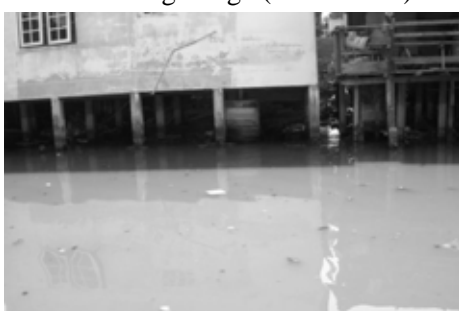
Photo A3.8 Septic Tank

In some klong reaches, the boundary of klong section is ambiguous (a part of inside of the klong is occupied by houses), and facilities like a septic tank were seen under the floor of some houses. It seems that the wastewater from a house is discharged into klong through this facility.(Photo A3.8).

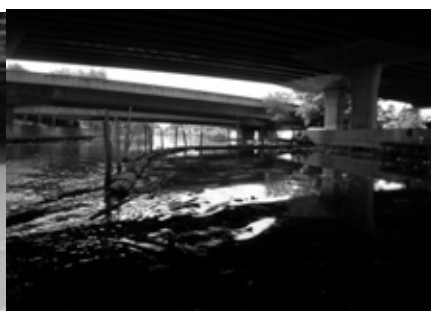
Photo A3.9 Garbage Trap

Boat navigation in Klong Lard Prao was difficult because mainly plastic garbage such as shopping bag abandoned in the klong coils around a screw and the boat stops frequently to clear the screw. This shows that not only wastewater but also solid wastes are abandoned into klongs frequently. Although traps which catch the floating garbage were seen in the klong. It is thought that many solid wastes have been deposited on the klong bottom since capture by such a trap is difficult for the sunken garbage (Photo A3.9).

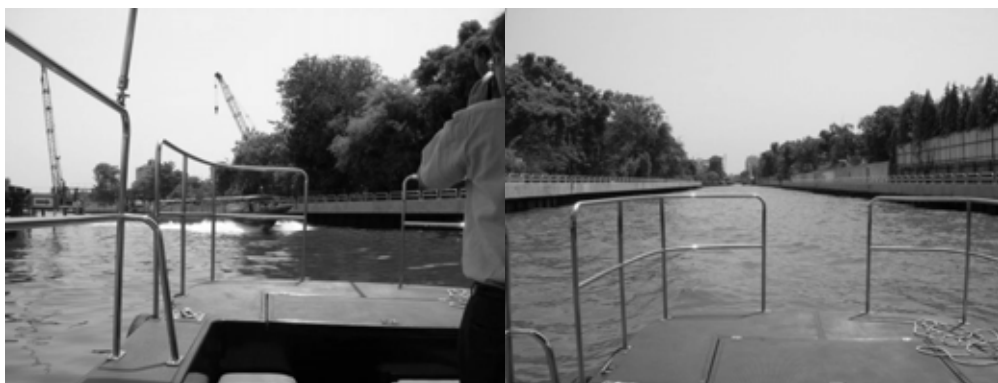
Photo A3.10 Water Bus

area and agricultural area, and water quality of the klong water is good. In the rainy season the gates of King's Dike are closed for the purpose of flood prevention, and water from the upper stream stops flowing into the klong. Water buses operate around this klong frequently as public traffic, and shore protection of the klong is being fixed. Furthermore, construction of the bicycle track and the sidewalk is progressing on both sides of banks (Photos A.3.10 and A3.11). The Klong is easily accessible to all residents and can be seen from a water bus. Positive preservation of the Klong has been advanced. All of these facts indicate that residents' concern and conscious are very high.

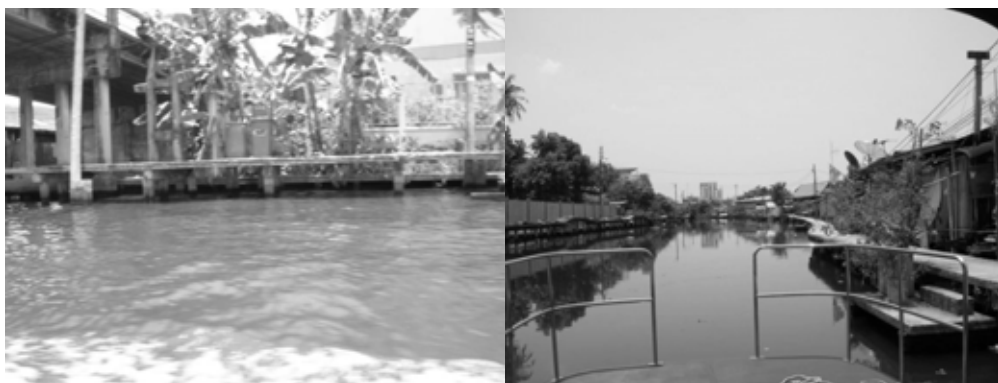
In the section where the sidewalk is built on both banks of klongs, garbage bin is put on the sidewalk. It is presumed that the ship/boat is performing garbage collection for households which do not have access by car (Photo A3.12). Moreover, although it is not so frequent as in Klong San Saep, water buses operate also in this klong.

The klong is easily accessible to all residents and can be seen from a water bus. Positive preservation of the klong has been advanced. All of these facts indicate that residents' concern and conscious are very high as in case of Klong Saen Saep (Photo A3.13)

Photo A3.12 Garbage Bin

Photo A3.13 Sidewalk

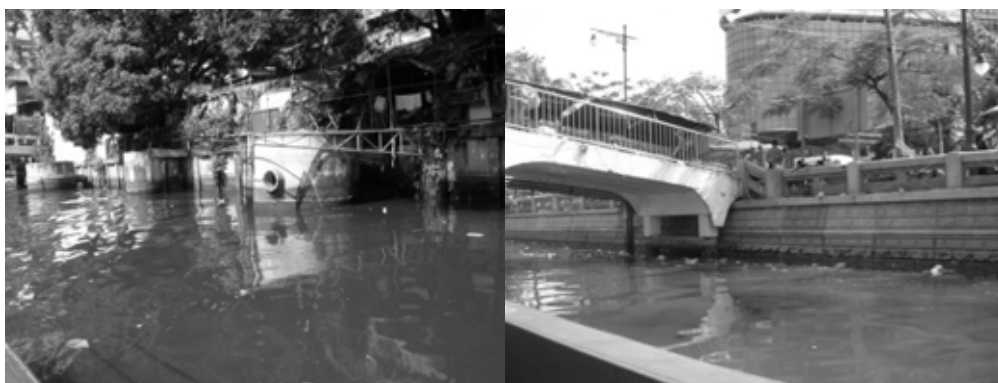
Field survey of the klong by a boat revealed that wastewater (black-gray color) is flowing into the klong at many places. From observation, it is presumed that intercepting of wastewater is not fully performed (Photo A3.14). In addition to this, many garbage (solid wastes) is seen

floating on the klong where markets are located along the klong (Photo A3.15).

Photo A3.14 Interceptor

Photo A3.15 Market

Since this klong is located in the central area of Bangkok as mentioned above, the direct relation with residents' daily life activities is weak. Prevention of wastewater intrusion is important thinking the function of this klong, since King's palace and temples are located nearby and many tourists visit the surrounding areas.
